Blade Report

I.19-06-016

Root Cause Analysis of the Uncontrolled Hydrocarbon Release from Aliso Canyon SS-25

May 16, 2019

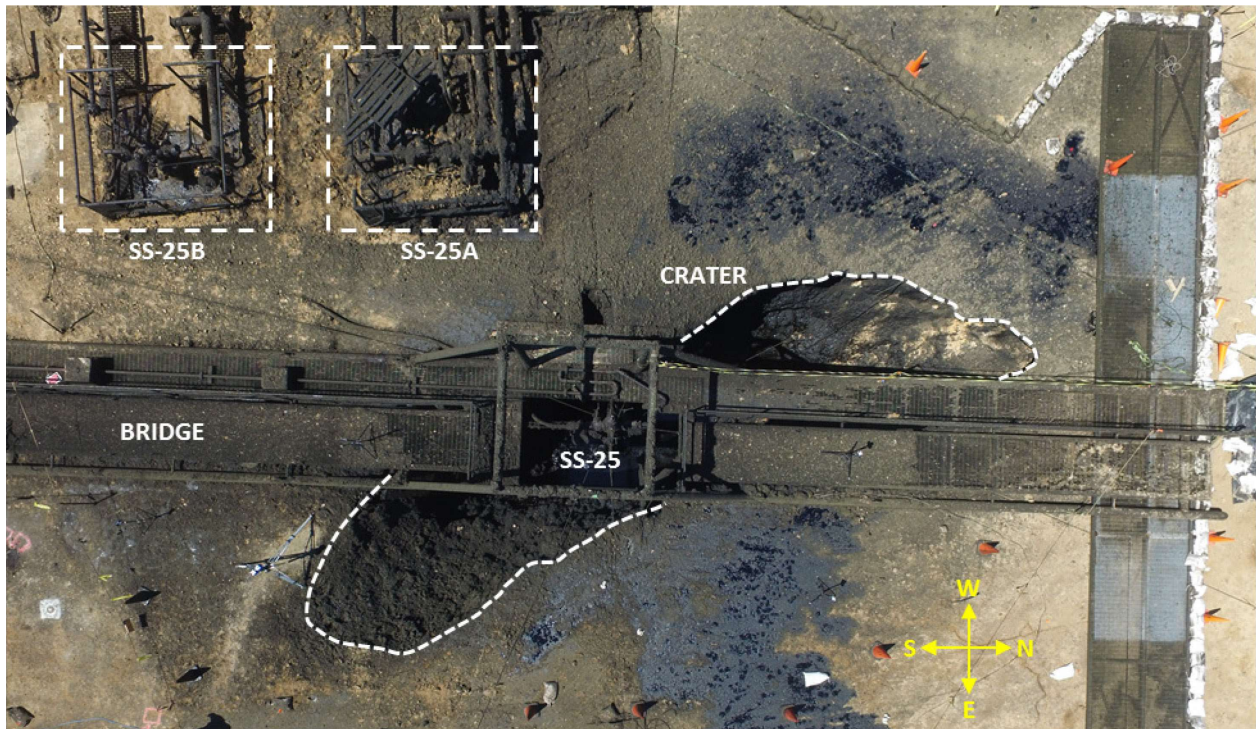
Figure 16: SS-25 Well Site Top View Aerial Photograph Post Blowout Taken on April 01, 2016

Formation of the crater occurred during various periods of the blowout. Figure 16 and Figure 17 show aerial photographs of the crater looking down and west, respectively. The images also show the SS-25A and SS-25B wellheads after removing the heat shields. The bridge and concrete beam were installed during the kill operations to provide access to the wellhead. The bridge provided a platform for personnel to connect lines and operate valves. The concrete beam was used to anchor a steel cable handrail.

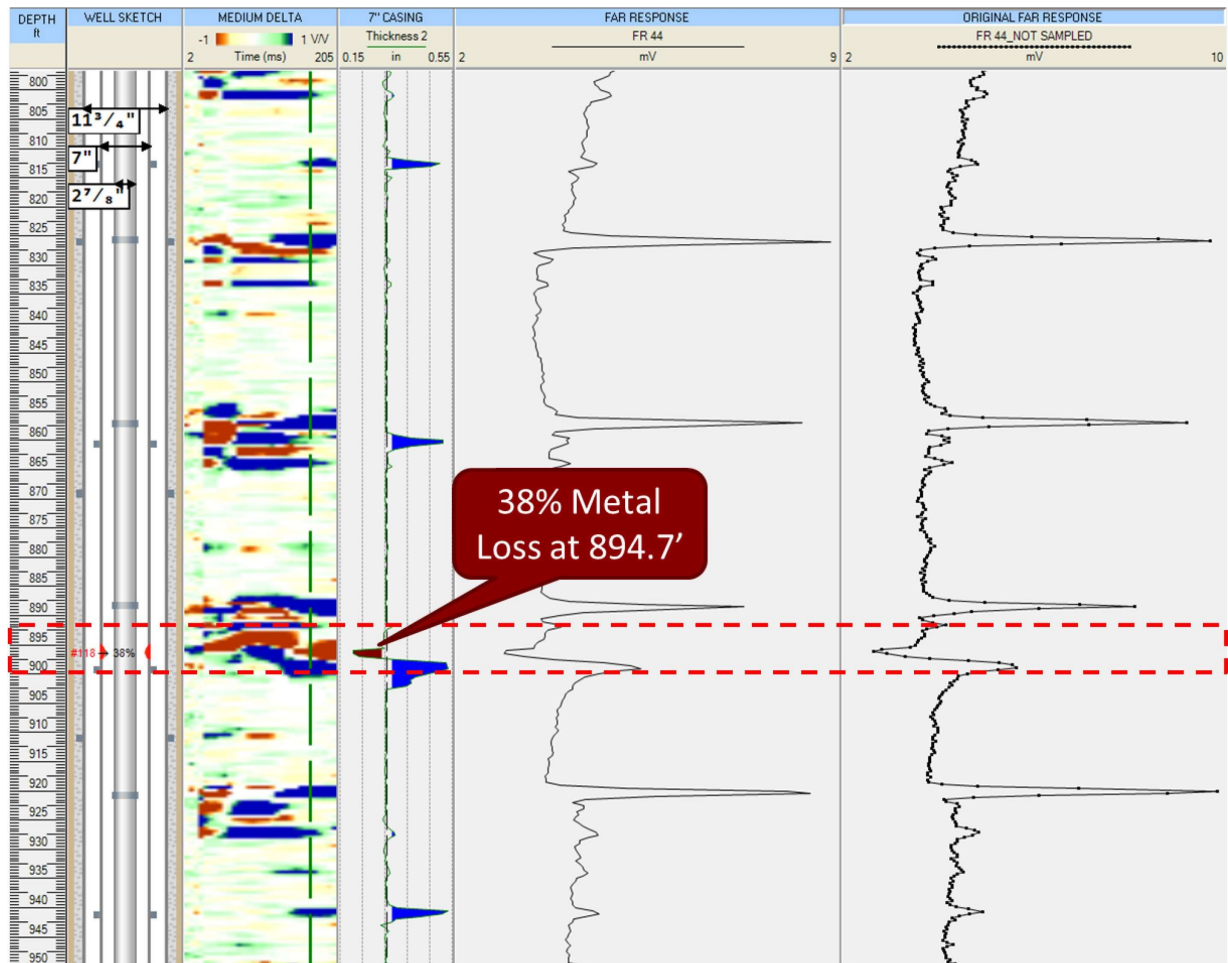
Figure 19: MID Results Showing 38% Metal Loss at Approximately 895 ft

During Phase 1, a Magnetic Imaging Defectoscope (MID) logging tool was used. This tool is designed to record the time response to electromagnetic pulses to detect metal loss or gain in up to three barriers. The MID tool was run within the 2 7/8 in. tubing (first barrier) to identify anomalies in the 7 in. casing (second barrier) and 11 3/4 in. casing (third barrier). The MID detected metal loss at several locations along the length of the 7 in. casing—the most notable one at 895ft MID log depth. Figure 19 shows the MID results at a depth of 895 ft. The well schematic in Figure 19 shows a 38% metal loss feature on the 7 in. casing, suggesting significant metal loss at that depth.

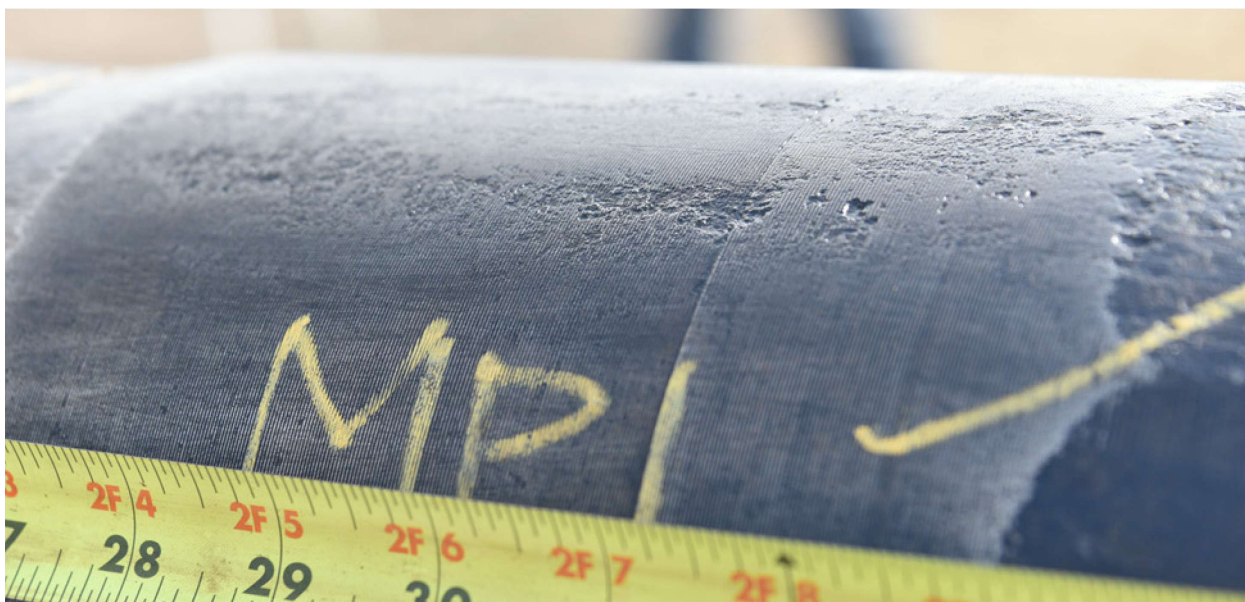
Figure 28: Shallow Metal Loss on Connection C014

Shallow metal loss was first identified on the C014 connection and was present on the remainder of the extracted casing pipe bodies and connections. Corrosion was identified on many of the connections below C014 with increasing severity. Figure 28 shows the shallow corrosion on the C014 connection. Figure 29 shows corrosion on the connections for (a) C019 and (b) C020. The corrosion is similar to C014's but more severe.

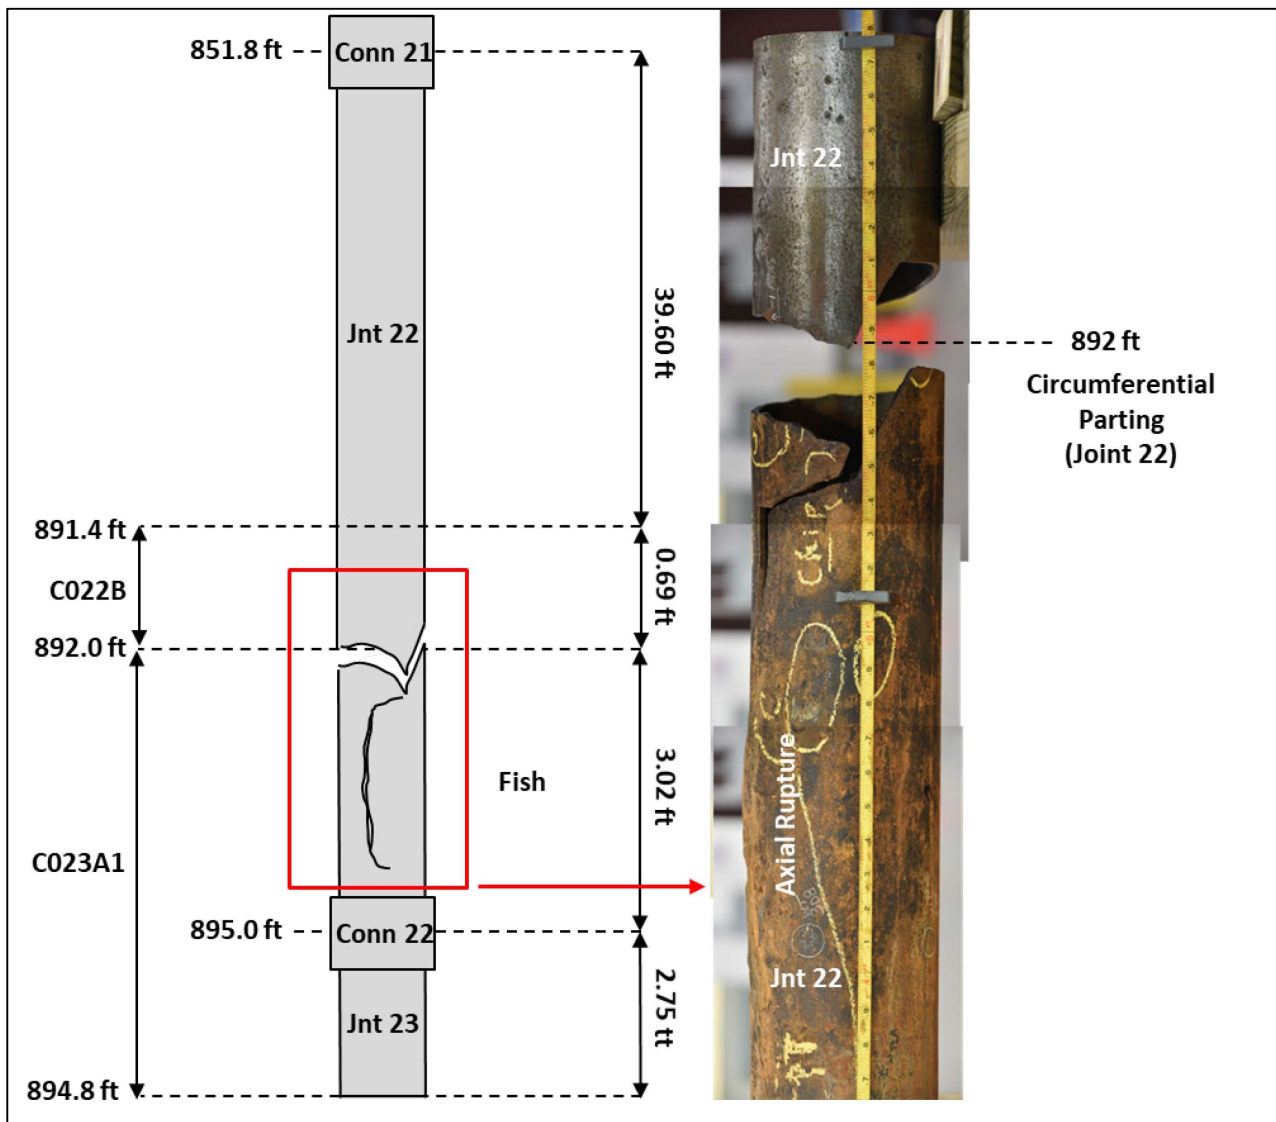
Figure 43 shows a schematic of the locations and depths for the 25 joints of 7 in. production casing extracted for the RCA. Depths are based on consolidation of data from downhole tools and physical measurements. The official depth for the circumferential parting is 892 ft, as the schematic shows. It is also apparent from Figure 43 that the 7 in. production casing was extracted from just below the shoe of the 11 3/4 in casing. Joint 24 and part of joint 25 were the last joint samples with OD corrosion as identified by the log data. Joint 22 exhibited the failure, which included the axial rupture and circumferential parting. Specimens taken from the axial rupture and circumferential parting were analyzed in detail to characterize the failure and define the failure sequence. Figure 44 shows the field photographs taken during extraction with a schematic of the axial rupture and circumferential parting. The image shows the failed casing oriented as it was in the well with the axial rupture below the circumferential parting.

Figure 44: Schematic and Photo of the Axial Rupture and Circumferential Parting (Joint 22)

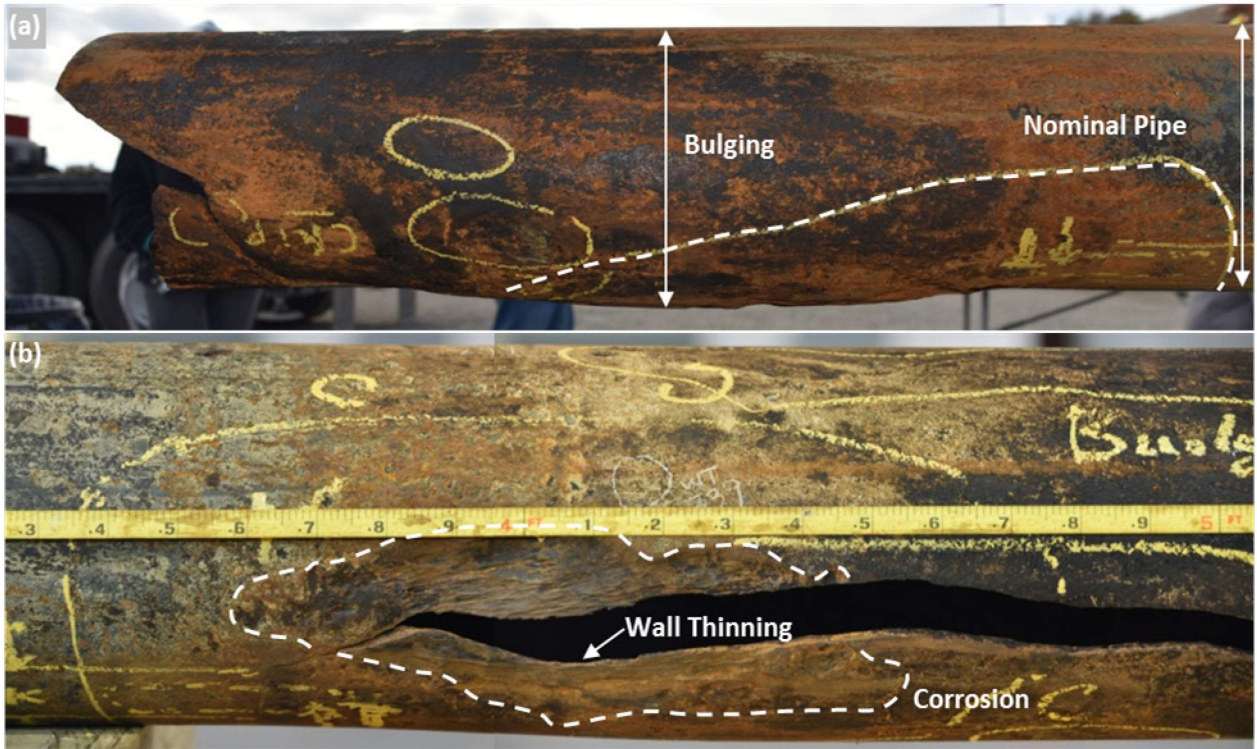
Figure 45: Images of Axial Rupture Showing (a) Bulging and (b) Corrosion Associated with the Axial Rupture

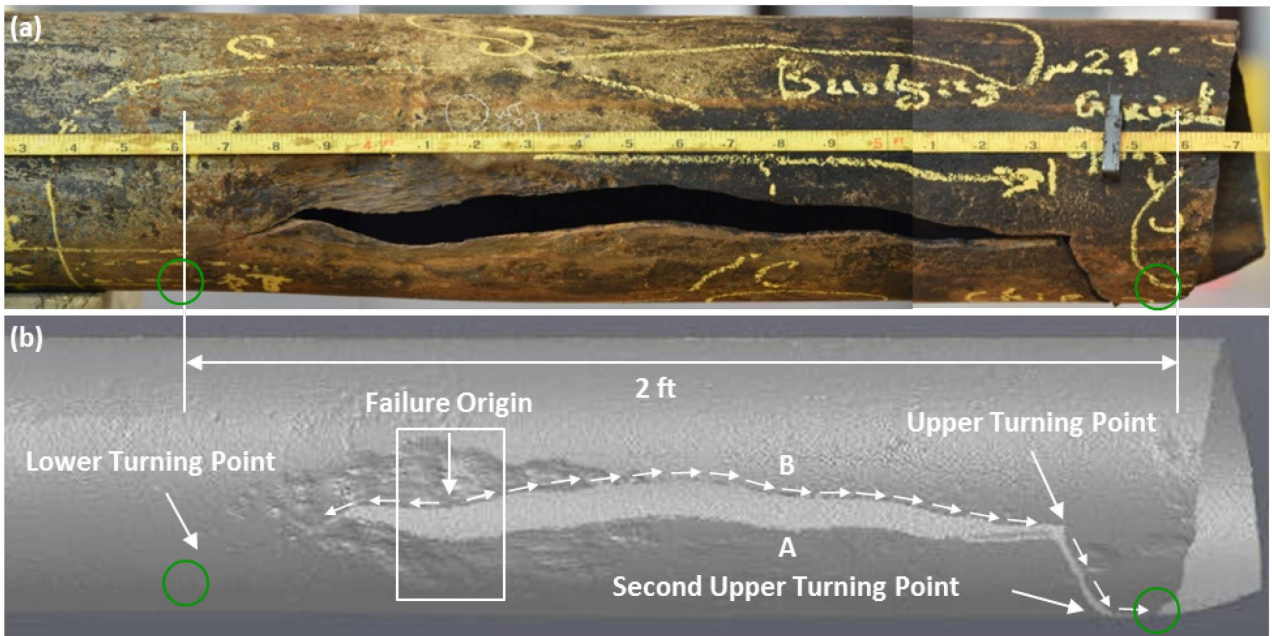
Figure 46 (a) and (b) show a close-up and laser scan image of the axial rupture. The failure origin is indicated by the white box. The direction of crack propagation is indicated on both sides of the origin by white arrows. The upper and lower crack arrest points are indicated by the green circles.

Figure 46: (a) Field Photo and (b) Laser Scan Indicating the Origin, Lower and Upper Turning Points, and Lower and Upper Arrest Points

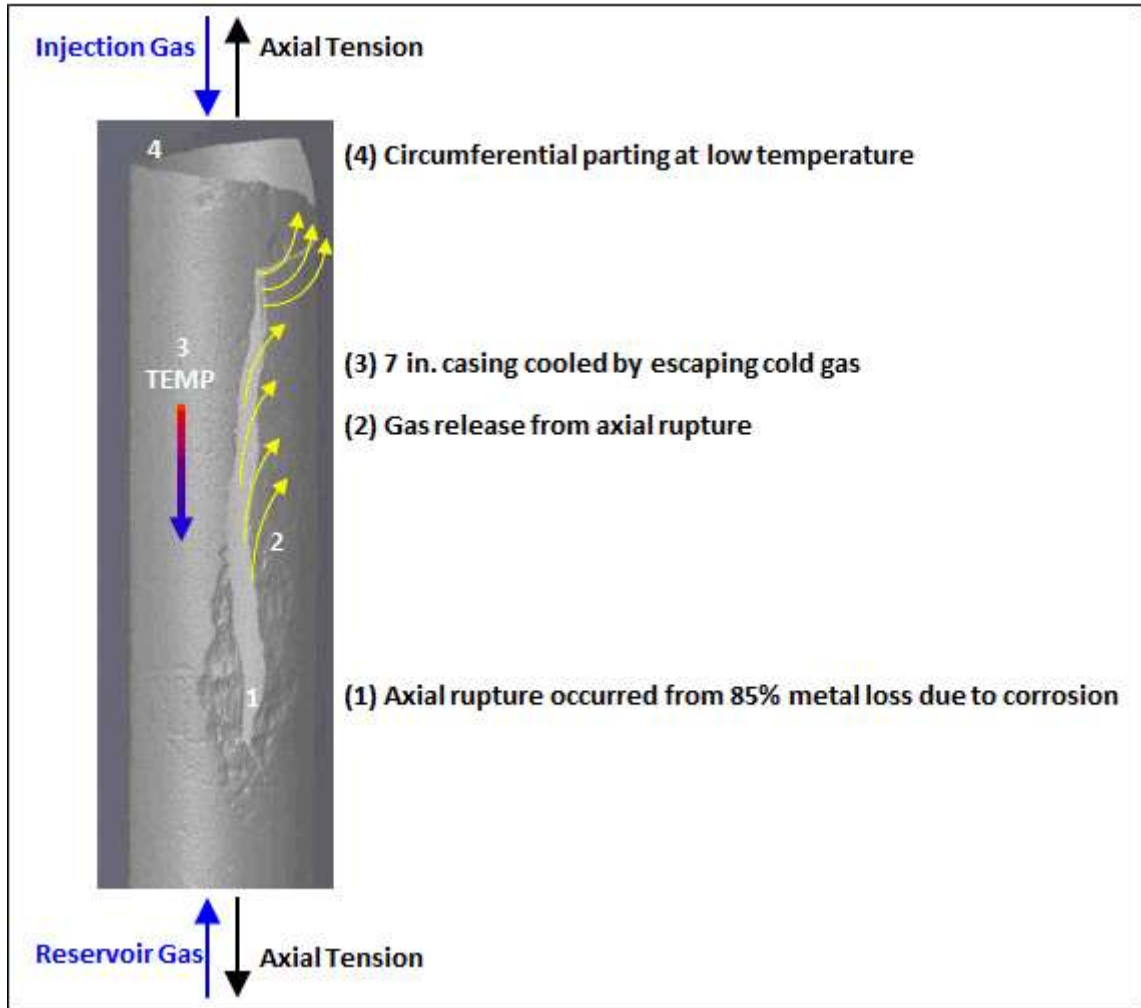
Figure 49 is a schematic based on the laser scan data of C023A1, which illustrates the failure sequence for the axial rupture and circumferential parting. The full cleavage fracture mode was examined, and a temperature for the circumferential parting was estimated to be in the range of -76°F to -38°F (-60°C to -39°C).

Figure 49: 7 in. Casing Failure Sequence Schematic

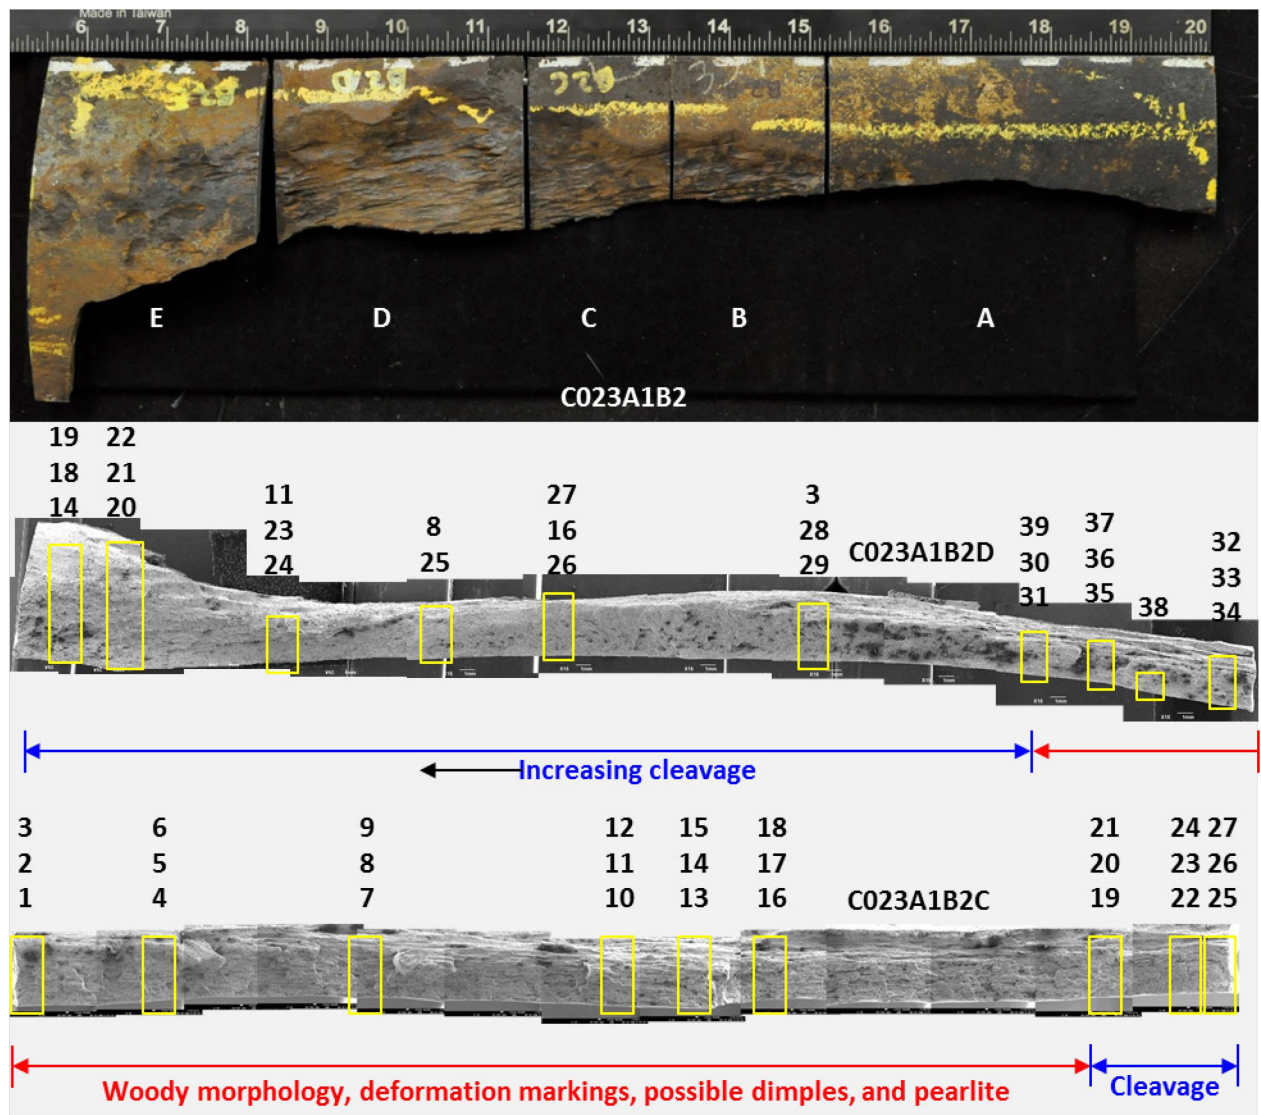
A transition from ductile to a ductile–brittle mix was observed beginning at A19 (Figure 53). The transition showed a shift from a woody-type morphology to a mix of woody-type morphology and cleavage. The amount of cleavage facets appeared to increase from location A19 to A27. The observations implied that the speed of the axial rupture was increasing through the transition zone until the crack became fully unstable. Figure 56 is a SEM image from A19 showing the ductile–brittle mixed fracture mode. The images show areas of cleavage facets and deformation markings.

Figure 53: SEM Examination of the Cleaned Fracture Surfaces of C02A1B2C and B2D

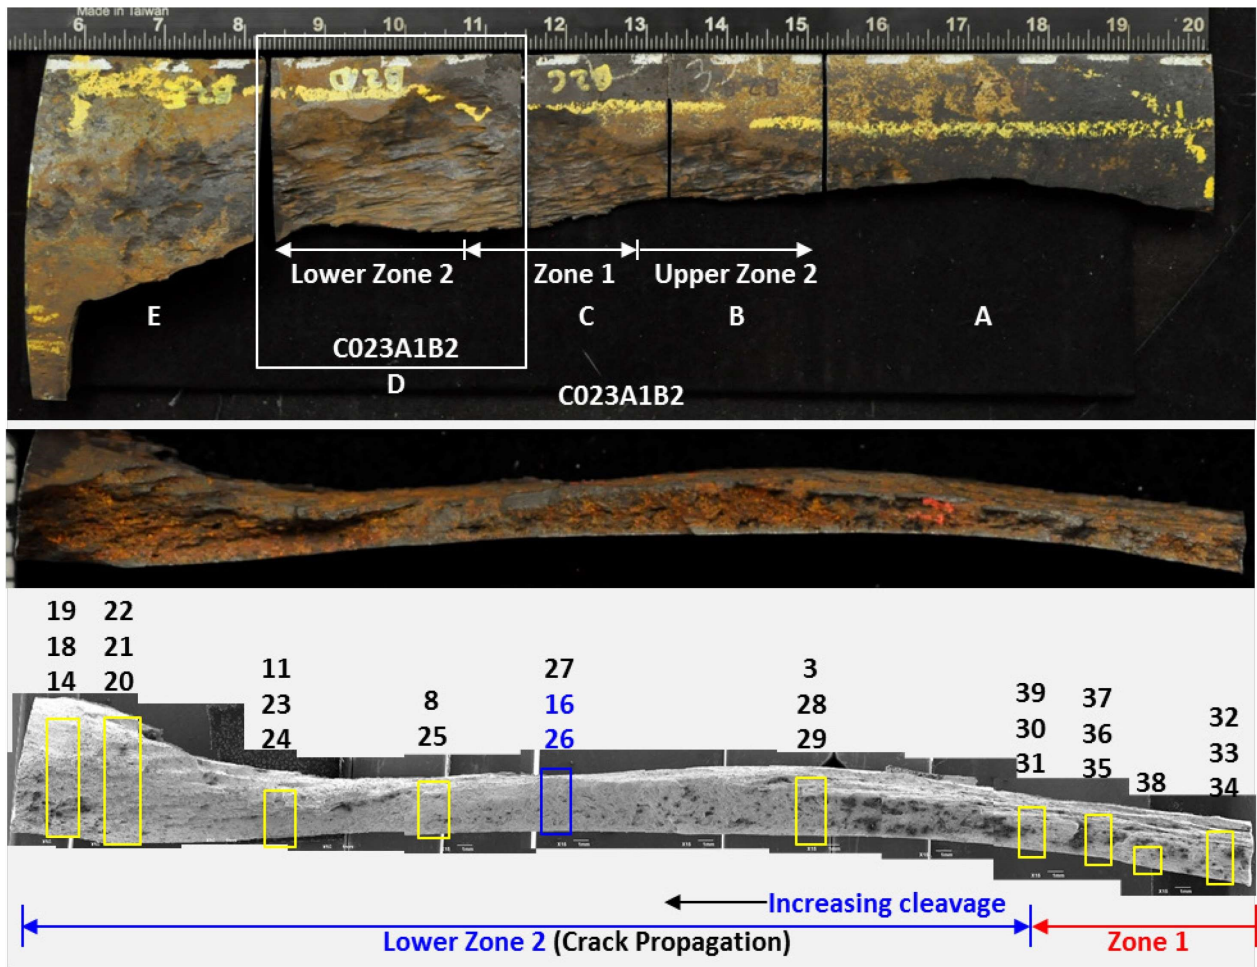
Figure 60: Images Showing Division Between Zone 1 and Lower and Upper Zone 2

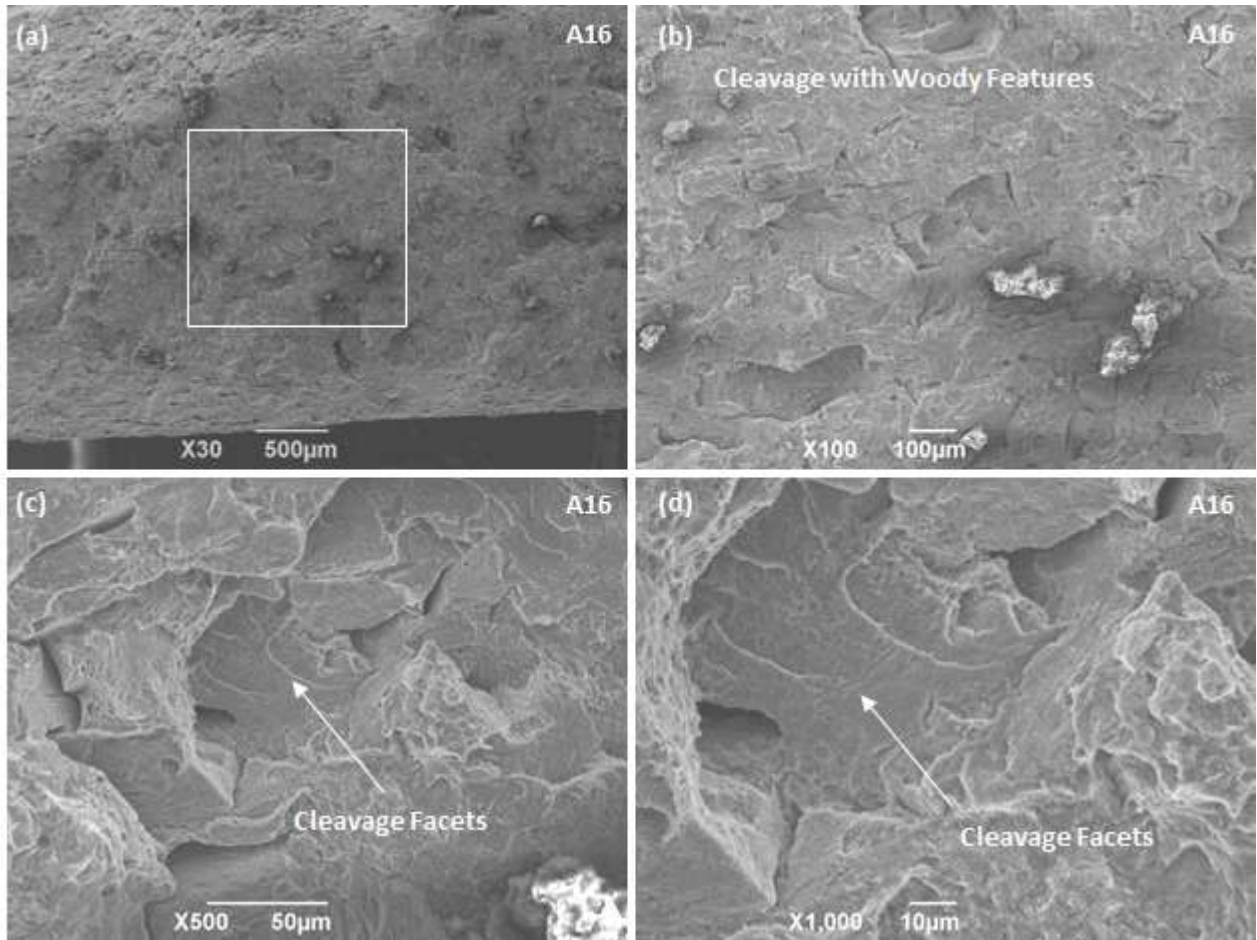
The SEM examination showed a mixed fracture mode that consisted of cleavage (brittle) and micro-void-coalescence and dimples (ductile). The amount of cleavage increased with distance from the origin, but decreased as the crack approached the lower turning point. Figure 61 shows typical SEM images taken from locations in Zone 2.

Figure 61: SEM Images from Locations A16 and A26 Showing Mixed Fracture Mode

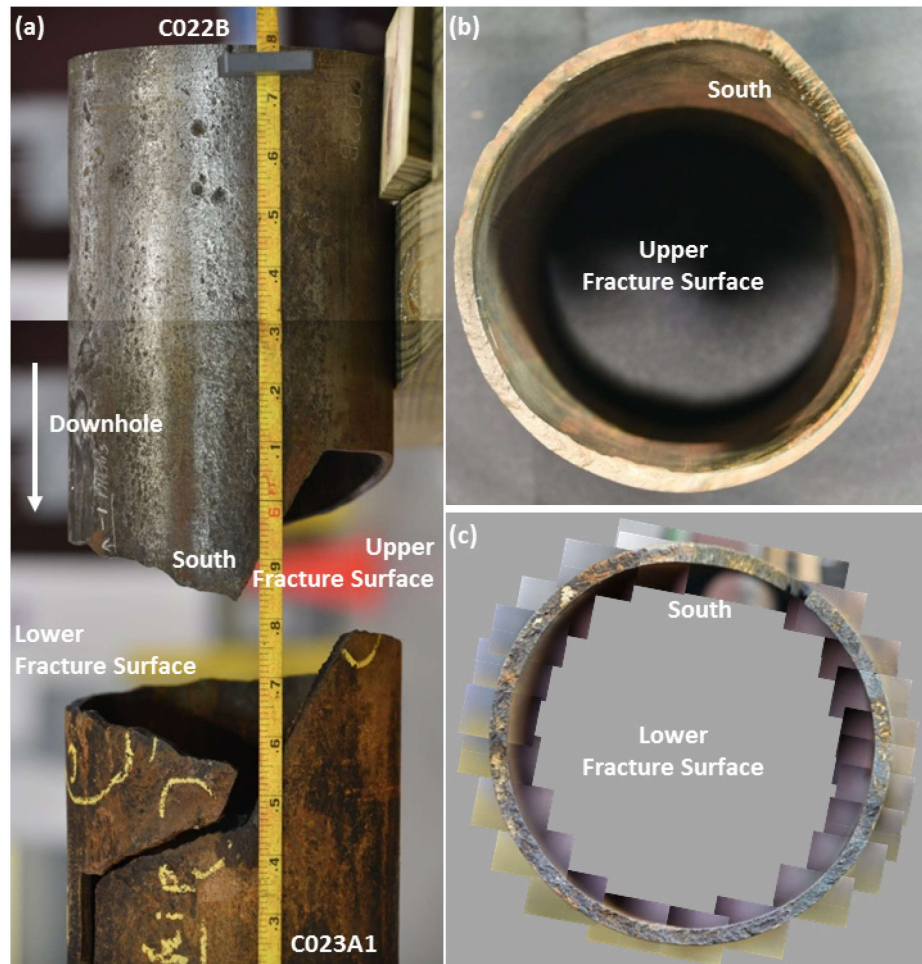
Figure 66: (a) Circumferential Parting Showing the (b) Upper and (c) Lower Fracture Surfaces

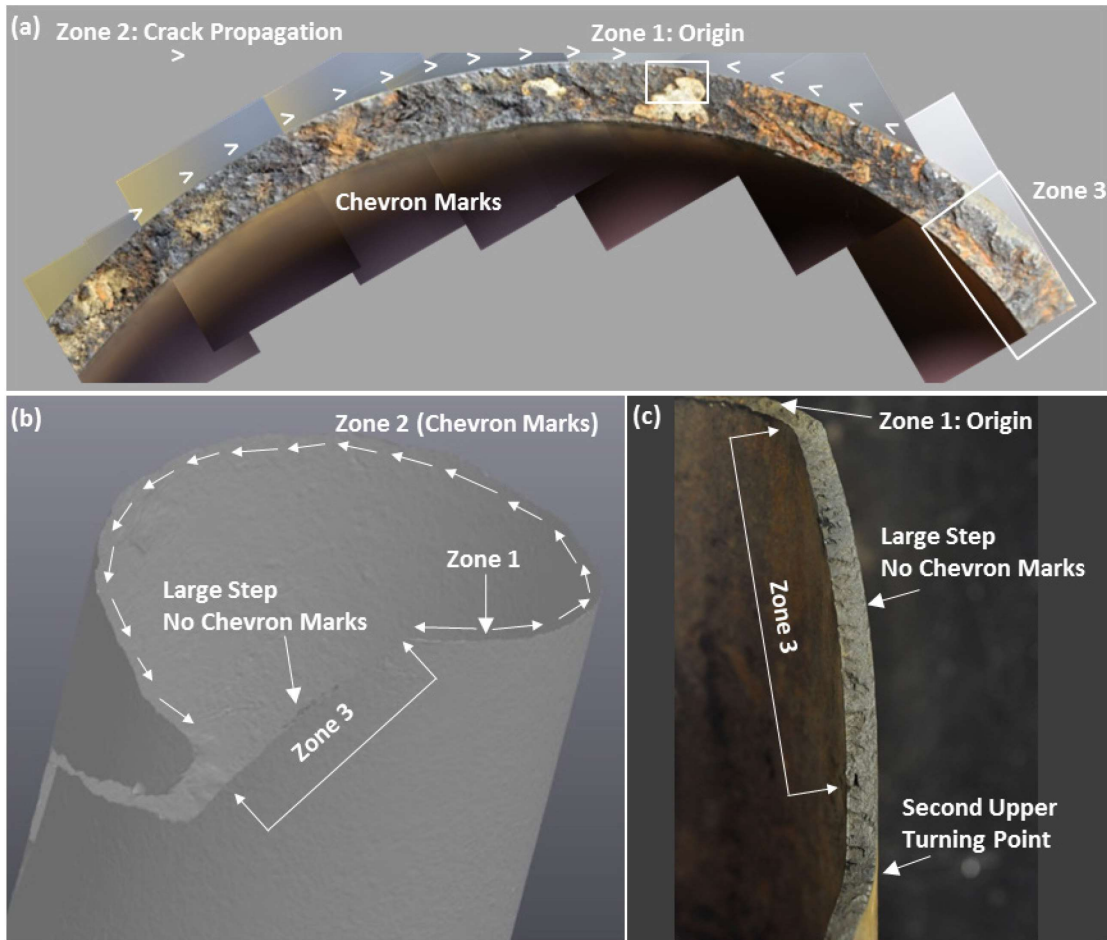
Figure 67 illustrates the three zones of the circumferential parting. Figure 67 (a) is a stereo image showing the three zones, origin, and the direction of the crack propagation. Figure 67 (b) is a 3D schematic showing the overall circumferential parting steps. Figure 67 (c) is a close-up of the Zone 3 fracture surface.

Figure 67: (a) Stereo Image (b) 3D Schematic of Zones (c) Macro Image of Three Zones

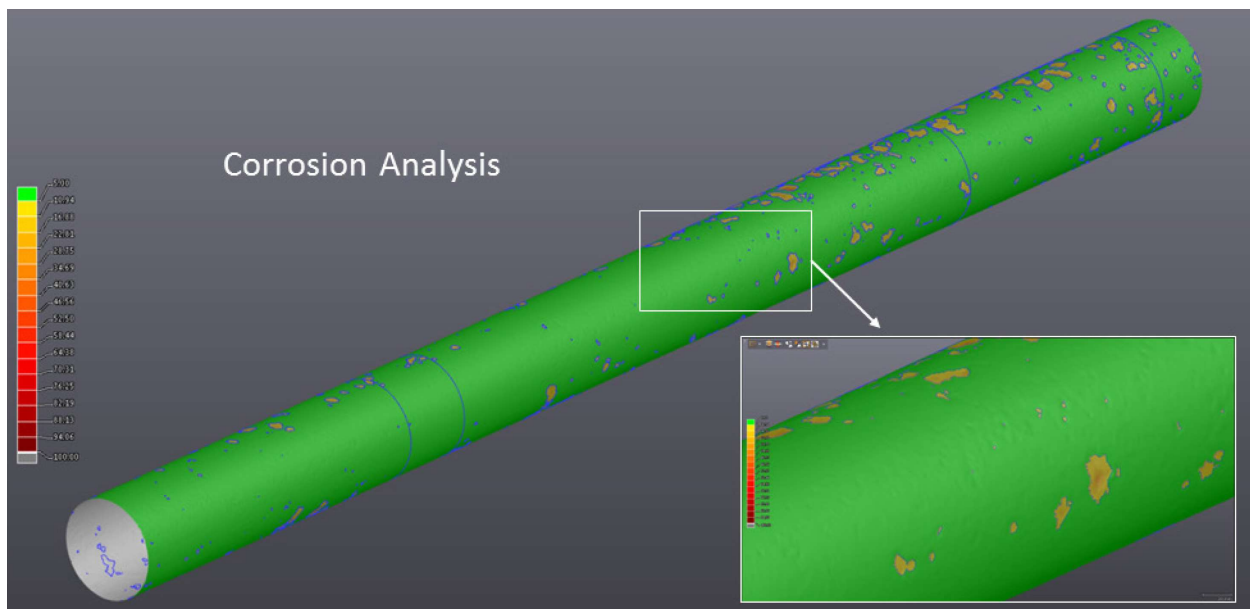
The 3D map of the corrosion on joint 18 is shown in Figure 87; all indications greater than 5% of nominal wall thickness are identified in the image. The nominal dimensions used for all the scans were 7 in. for the OD and 0.317 in. for the wall thickness.

Figure 87: 3D Color Map of Corrosion Analysis Results for C018A

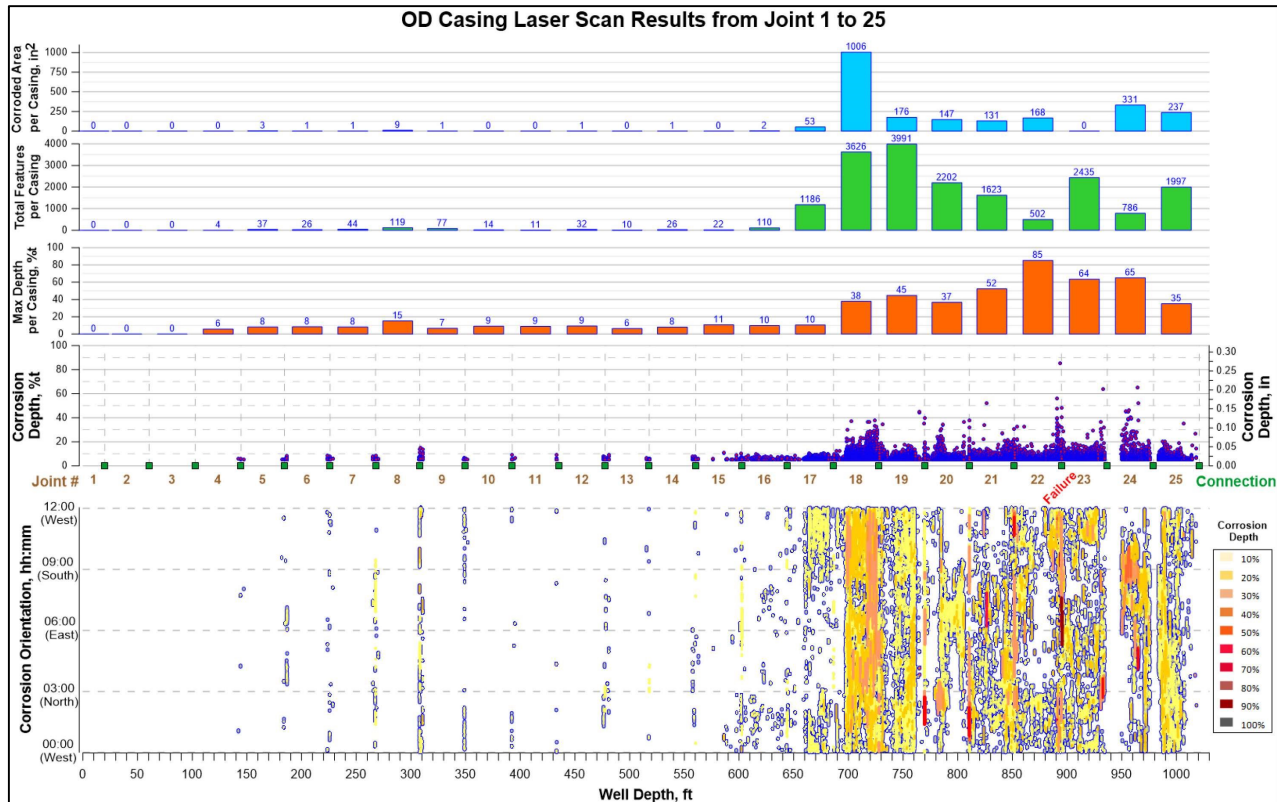
the distribution is oriented all around the circumference of the production casing. No preferential orientation was noted for the OD corrosion in the 7 in. production casing.

Figure 88: 7 in. Casing Outside Diameter Corrosion Distribution for Joints 1 through 25

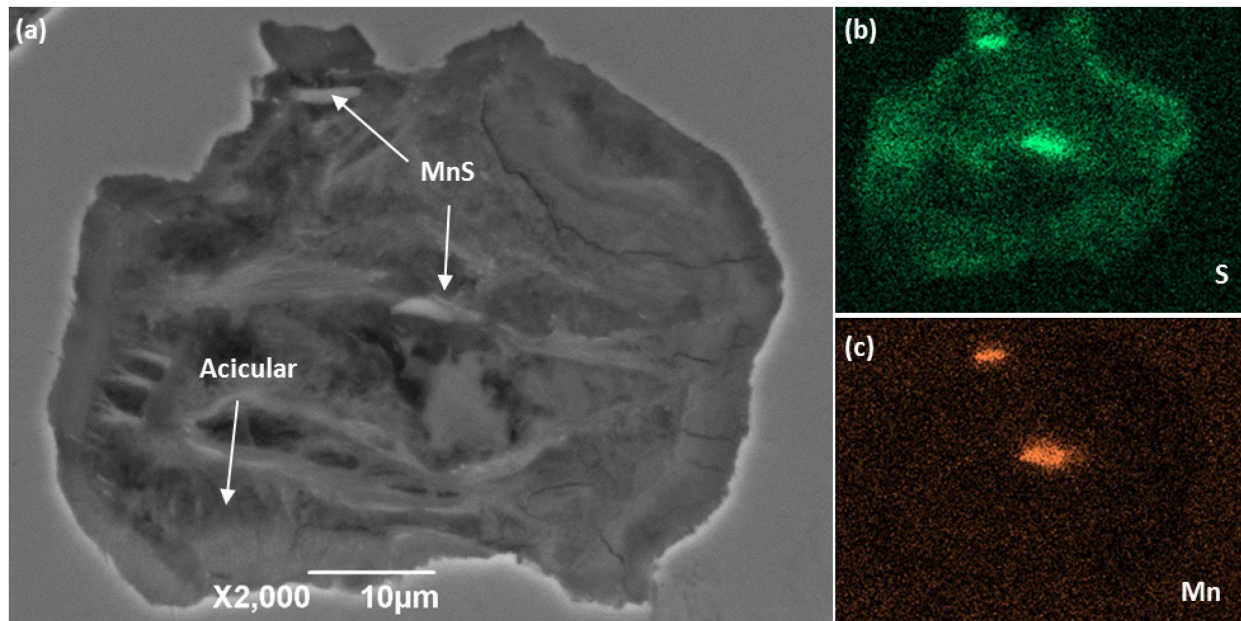
Figure 101: (a) SEM image of Tunnel with Acicular Deposit and EDS Color Maps for (b) S and (c) Mn
Corrosion Adjacent to the Circumferential Parting (C022B1)

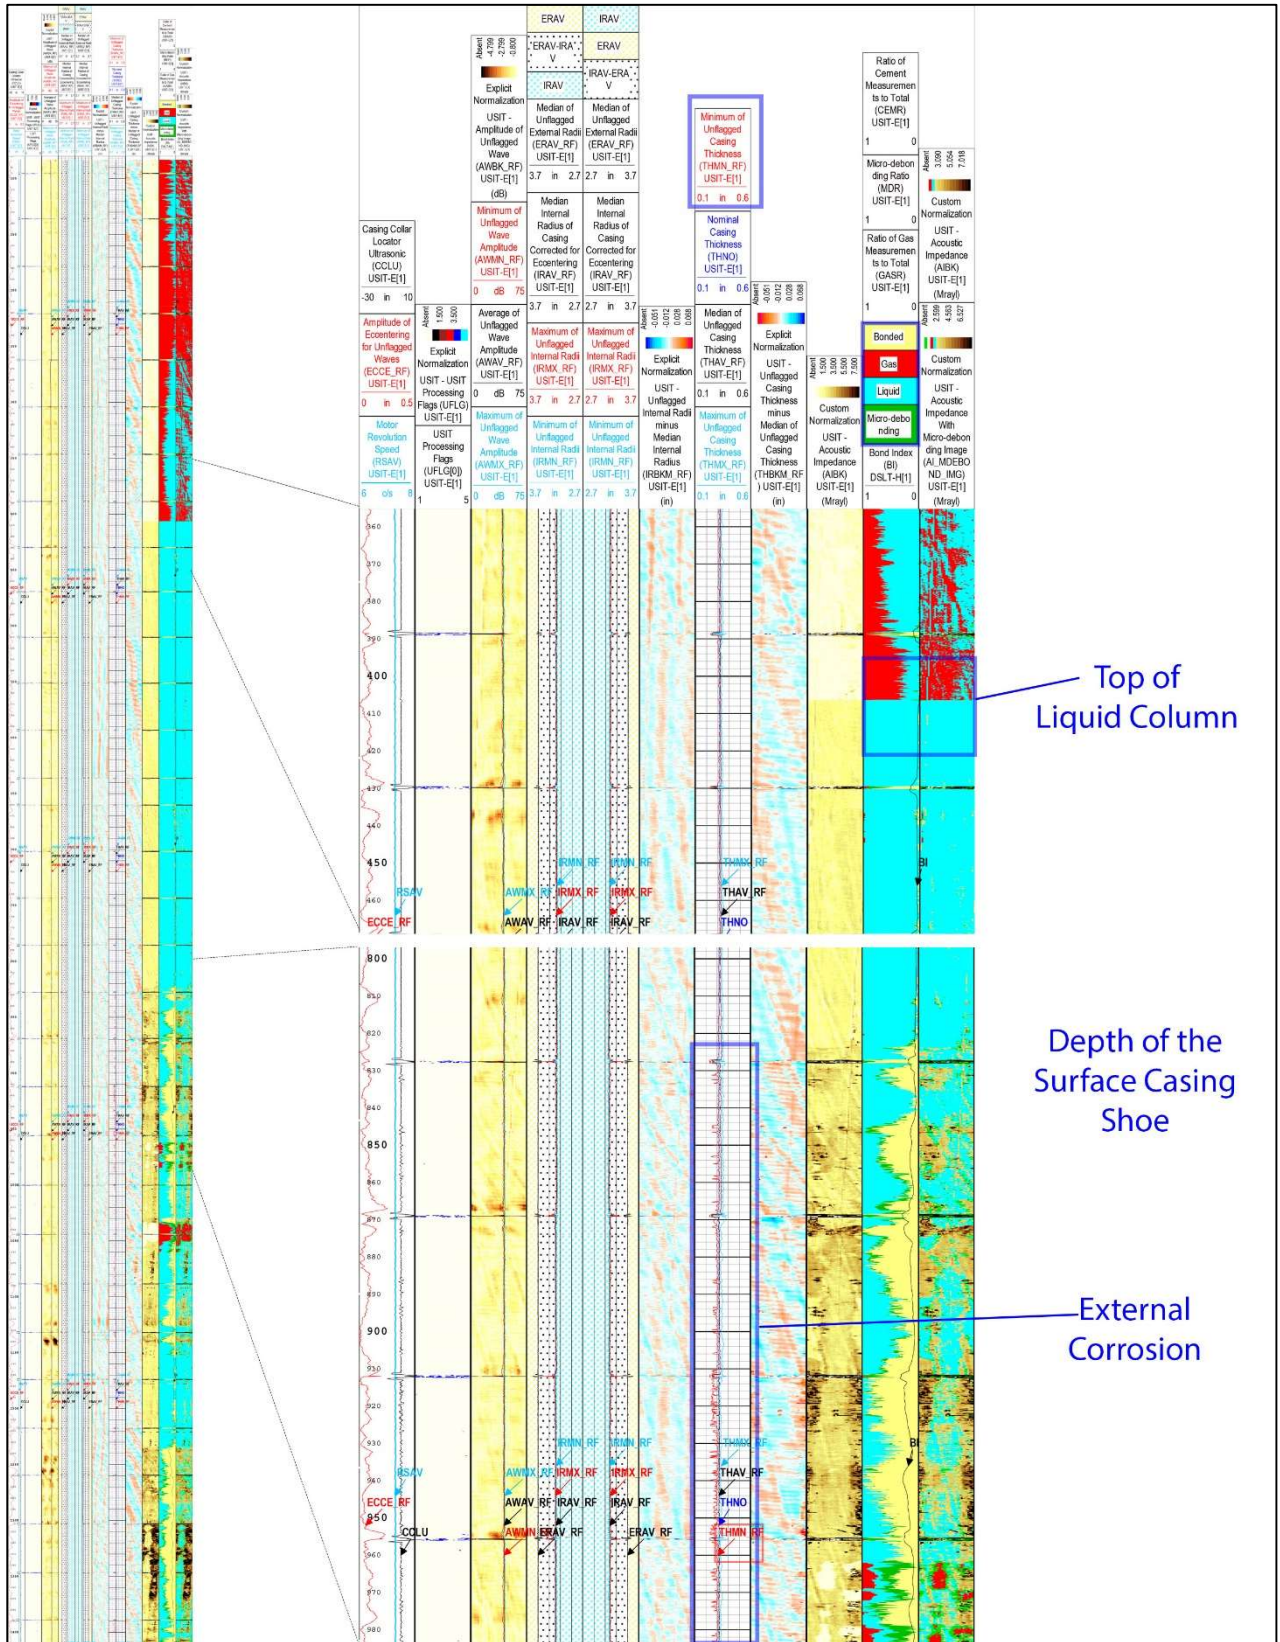
Figure 140: SF-5 Production Casing USIT Log Example of External Corrosion
