**Blade Supplemental Report (Vol. 2: SS-25 Well Failure Causes)**

# Root Cause Analysis of the Uncontrolled Hydrocarbon Release from Aliso Canyon SS-25

May 31, 2019

# SS-25 Casing Failure Analysis

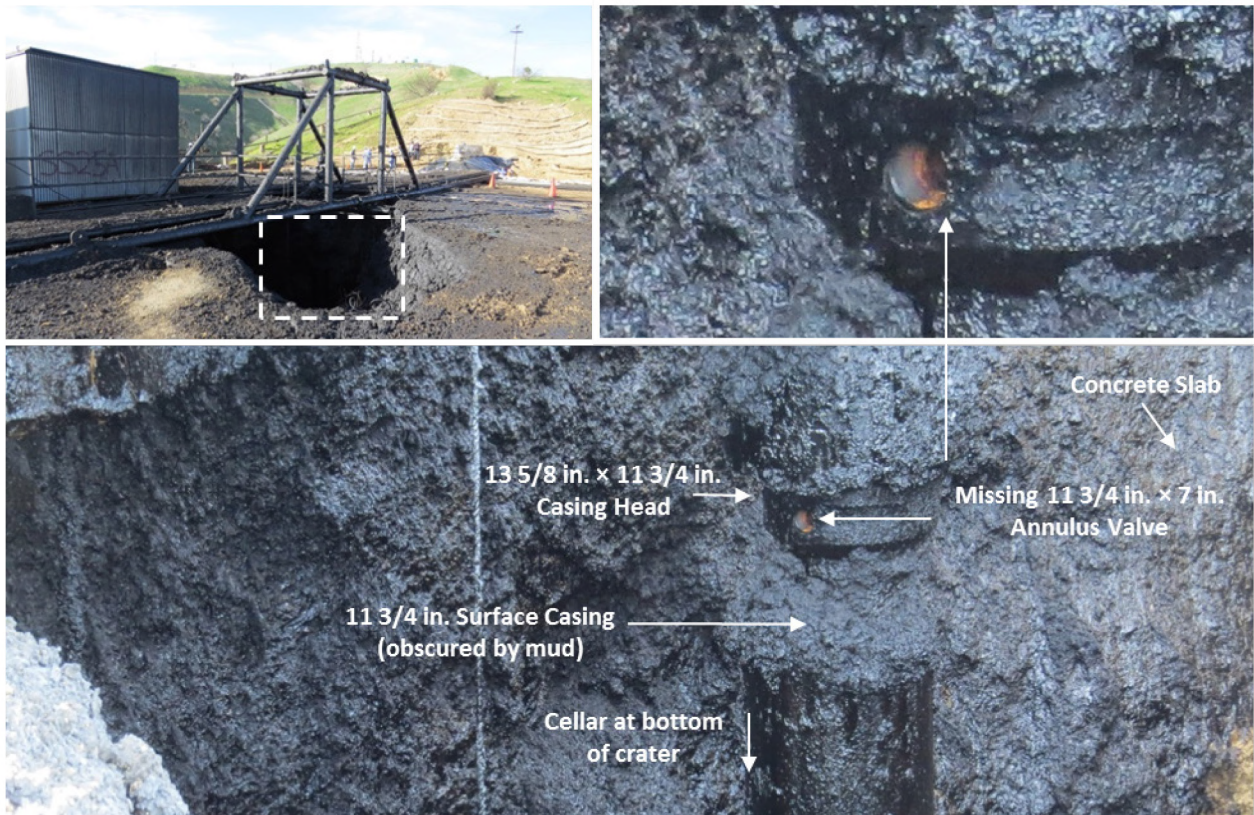
Figure 12: Missing 11 3/4 in. Casing Valve Taken on February 25, 2016

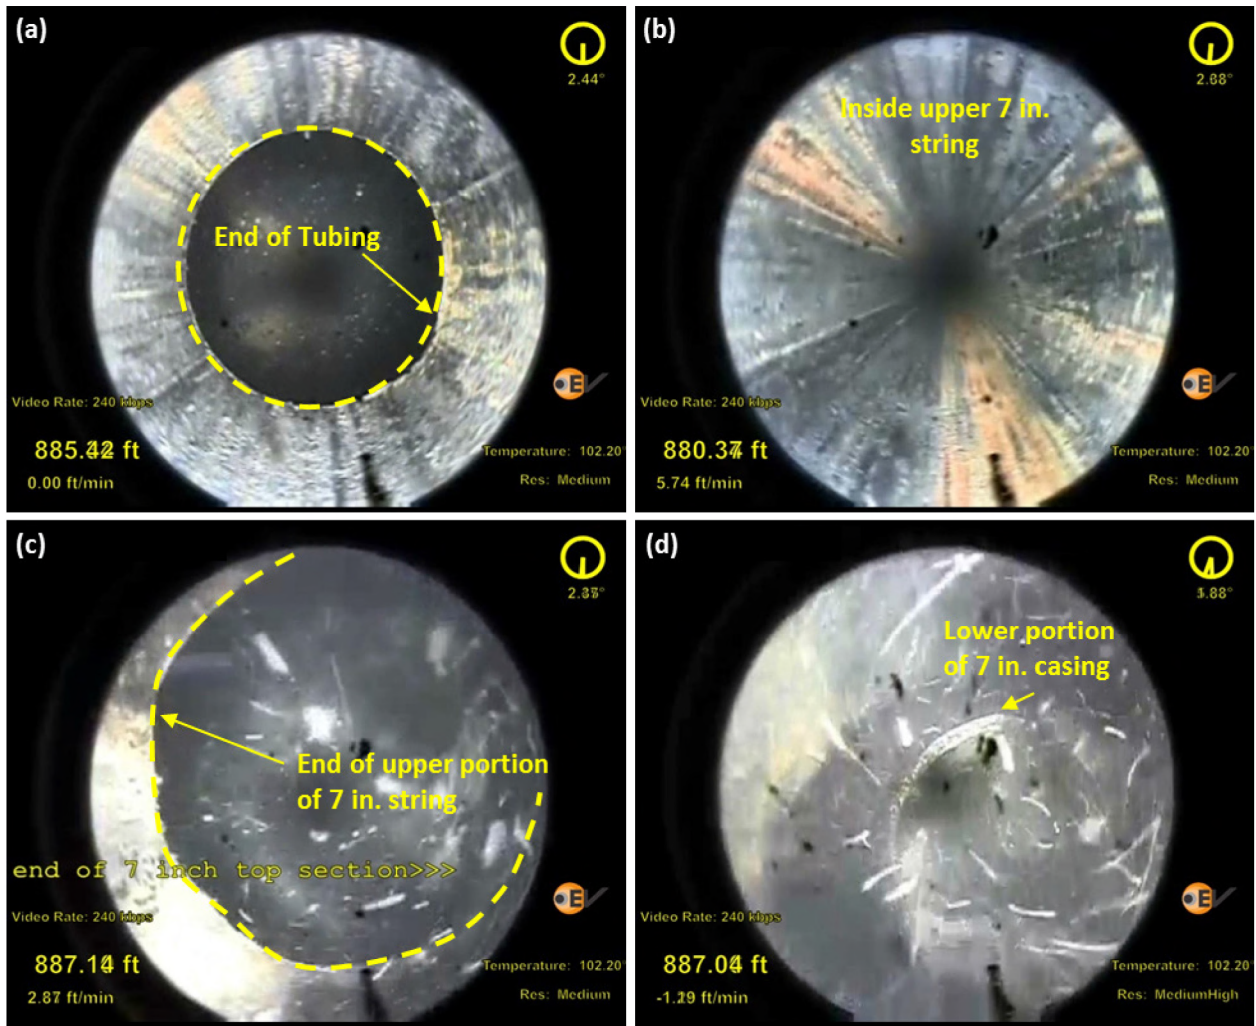
Figure 37 shows (a) the end of the tubing, which was set at approximately 885 ft; (b) the camera inside the upper 7 in. casing string after exiting the tubing; and (c) the end of the upper 7 in. casing string. This was the location of the parted 7 in. casing. The camera exited the upper string and looked down at the lower string. Figure 37 (d) shows the lower 7 in. casing string offset from the camera. The lower string was sitting at approximately 5 in. below the upper string. The camera runs confirmed that the 7 in. casing was parted and that the lower fish was offset from the upper string. Identification of the offset was significant to the fishing operations. A custom-built pawl tool was used to recover the lower fish. The pawl tool swallowed the casing, and spring-loaded pawls latched under a connection upset to pull tension while cutting. After cutting the casing, the fish was recovered in the pawl tool. A spear was not used as it could potentially contact the fracture surface several times before entering the casing.

**Figure 37: EV Lower Camera Snapshots from August 31, 2017, Showing the Parted 7 in. Casing**

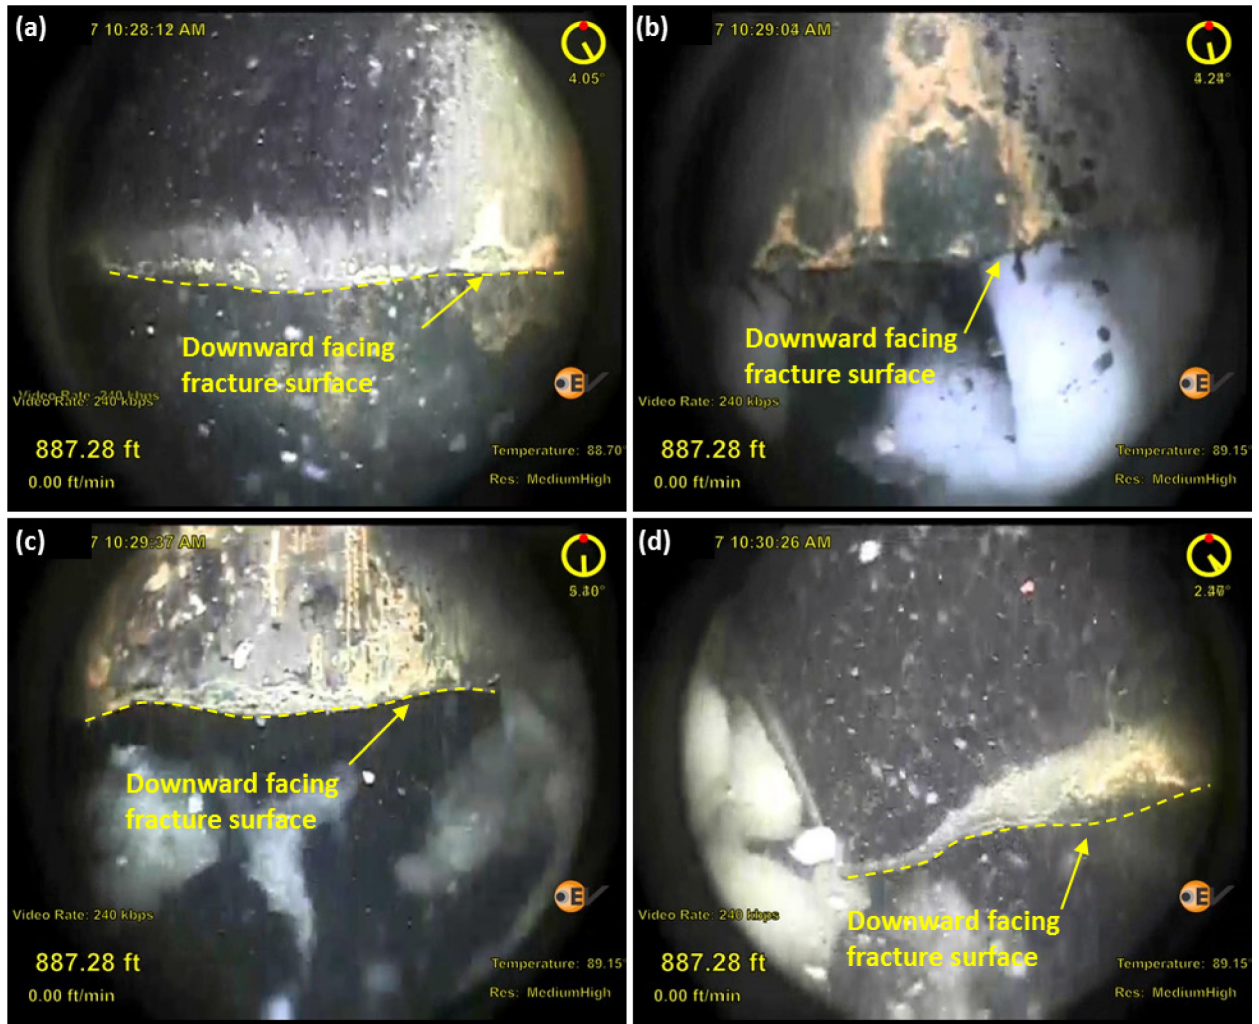
The camera was lowered so that the side camera could view the upper fracture surface. The tool was rotated 360° to provide full coverage of the fracture surface. Figure 38 shows snapshots of the upper fracture surface taken from the side camera. The surface appeared to be mostly flat, although the initial observations were limited due to the quality of the video. The camera was lowered inside the lower string so that the side camera could see the lower fracture surface. Figure 39 shows snapshots of the lower fracture surface taken from the side camera. The camera was not centered inside the lower casing due to the offset, which allowed only a small section of the surface to be in focus. Most of the fracture surface was blurred due to the proximity of the camera to the casing ID. The lower fracture surface also appeared to be flat, as expected, based on the upper fracture surface observations.

Figure 38: EV Side Camera Snapshots from August 31, 2017, Showing Upper Fracture Surface

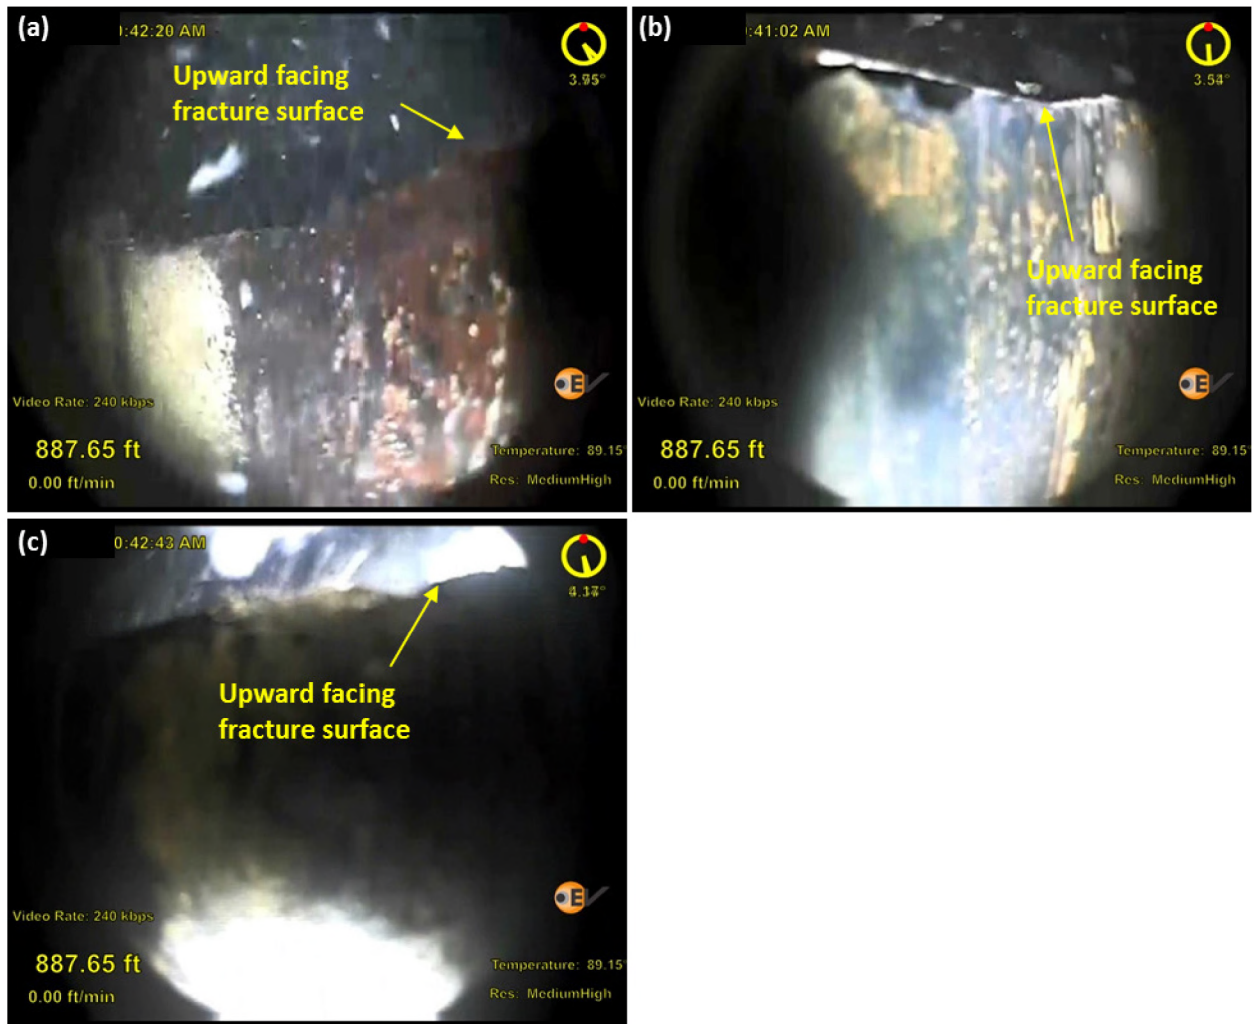
**Figure 39: EV Side Camera Snapshots from August 31, 2017, Showing Lower Fracture Surface**

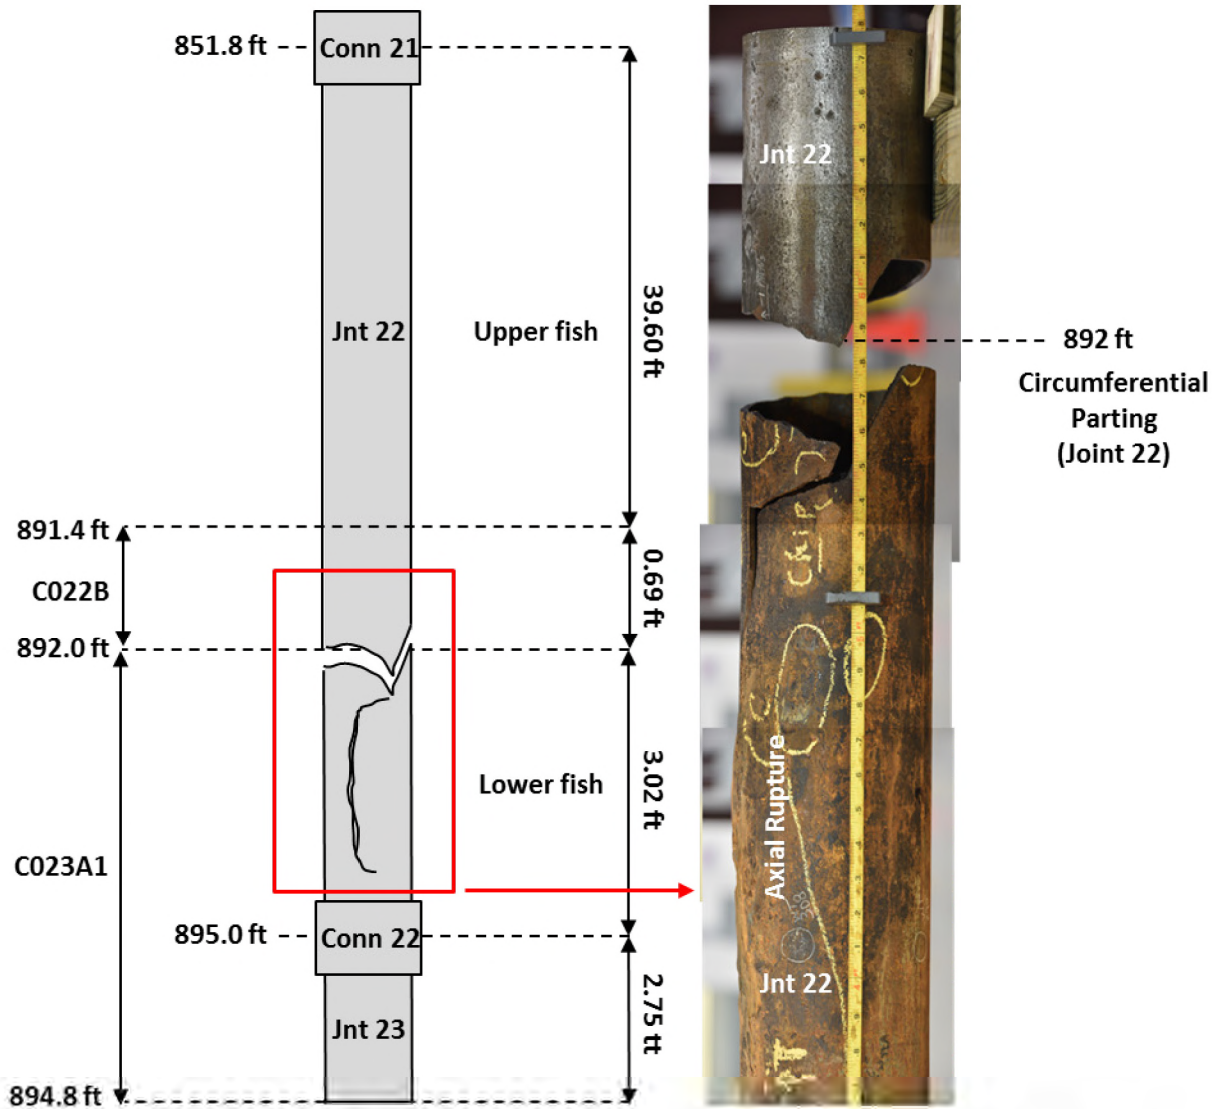
**Figure 75: Schematic and Photo of the Axial Rupture and Circumferential Parting**

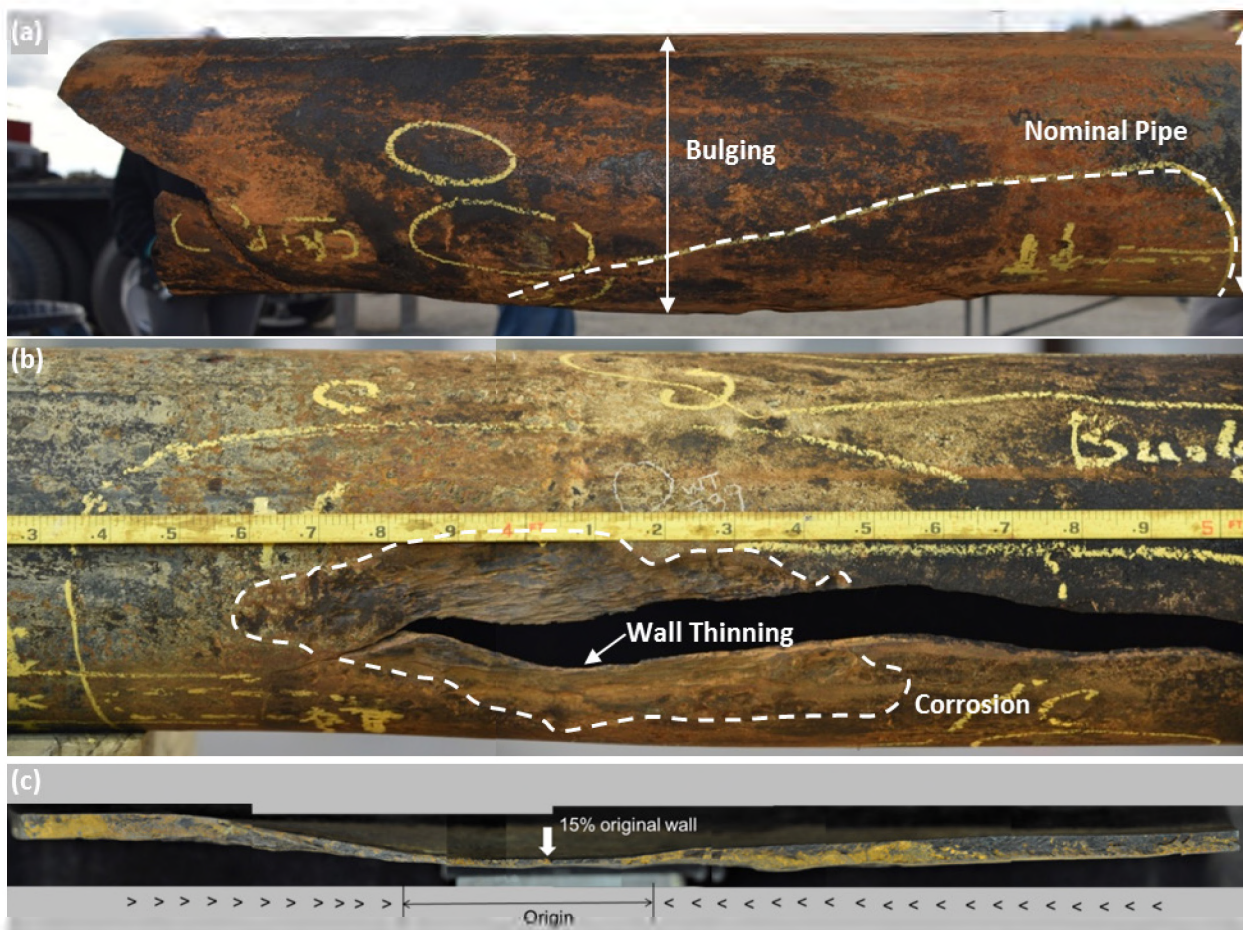
Figure 76: Images of Axial Rupture Showing (a) Bulging, (b) Corrosion, and (c) Chevron Marks

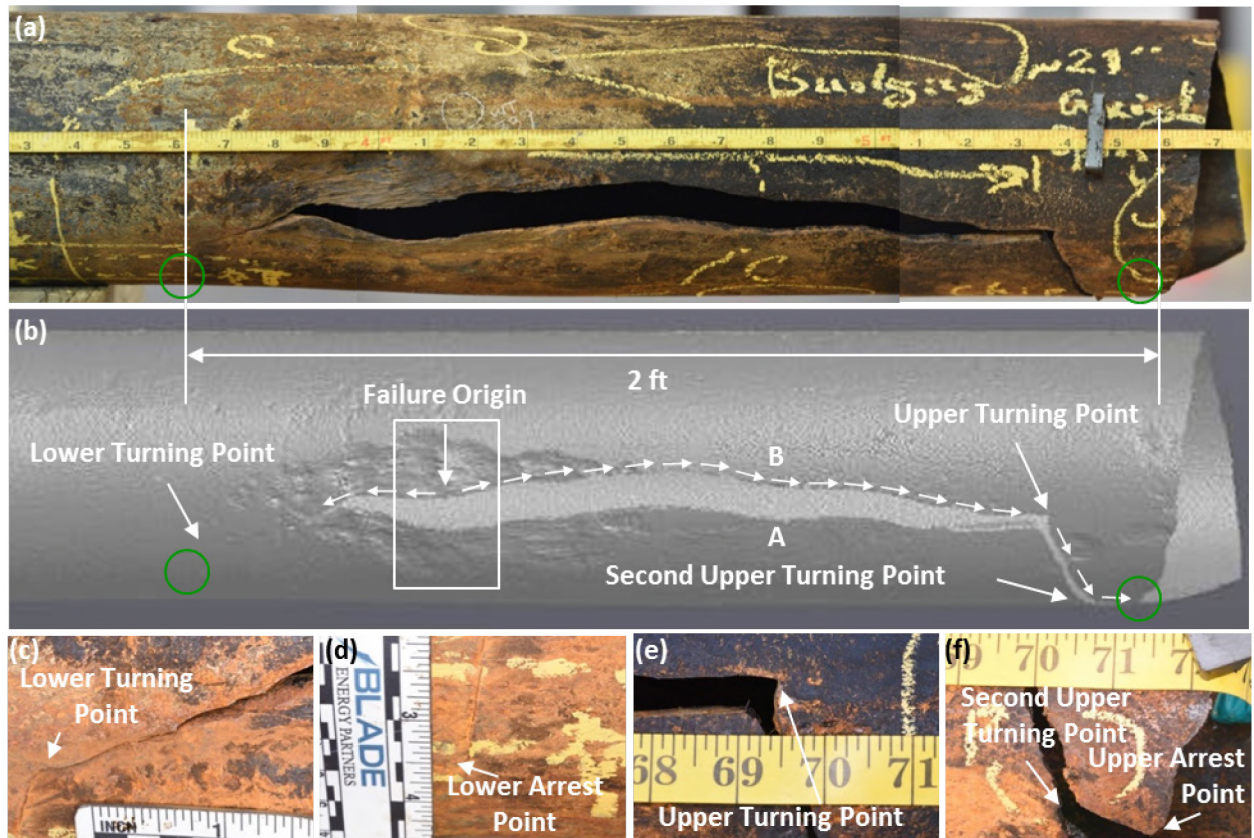
by white arrows. The upper and lower crack arrest points are indicated by the green circles. Figure 77 (c) through (f) show close-up images of the lower and upper arrest and turning points. Figure 77 (d) and (e) show the change in the direction of the crack propagation at the turning points caused by a dynamic change in the local maximum stress at the crack tip.

**Figure 77: (a) Field Photo and (b) Laser Scan Indicating the (c) Lower Turning Point and (d) Lower Arrest Point; and (e) Upper Turning Point and (f) Upper Arrest Point**

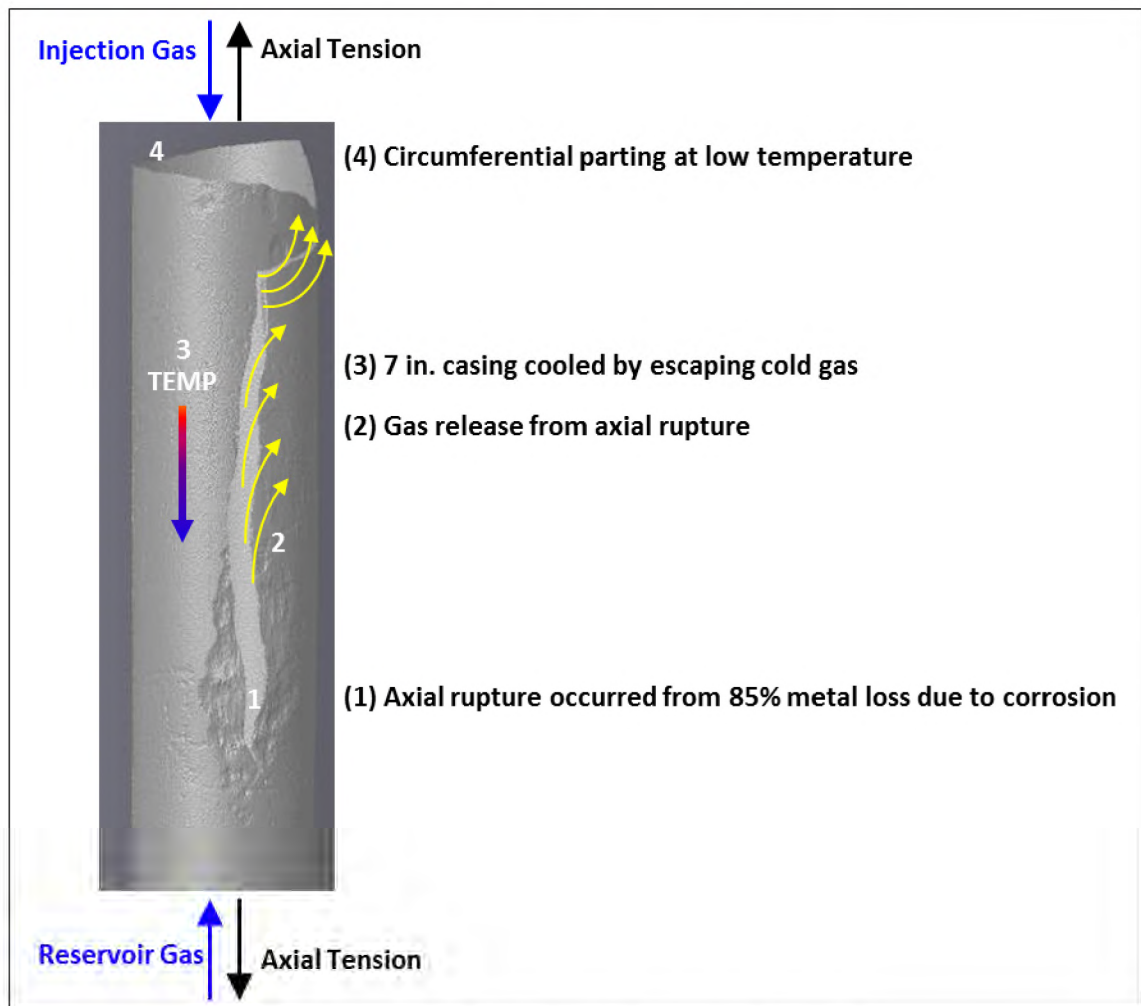
Figure 80 shows a schematic based on the laser scan data of C023A1 and illustrates the suggested failure sequence for the axial rupture and circumferential parting. The full cleavage fracture mode was examined, and the temperature for the circumferential parting was estimated to range between  $-76^{\circ}\text{F}$  ( $-60^{\circ}\text{C}$ ) and  $-38^{\circ}\text{F}$  ( $-39^{\circ}\text{C}$ ). Section 3.3.1 discusses the details of the temperature estimation.

**Figure 80: 7 in. Casing Failure Sequence Schematic**

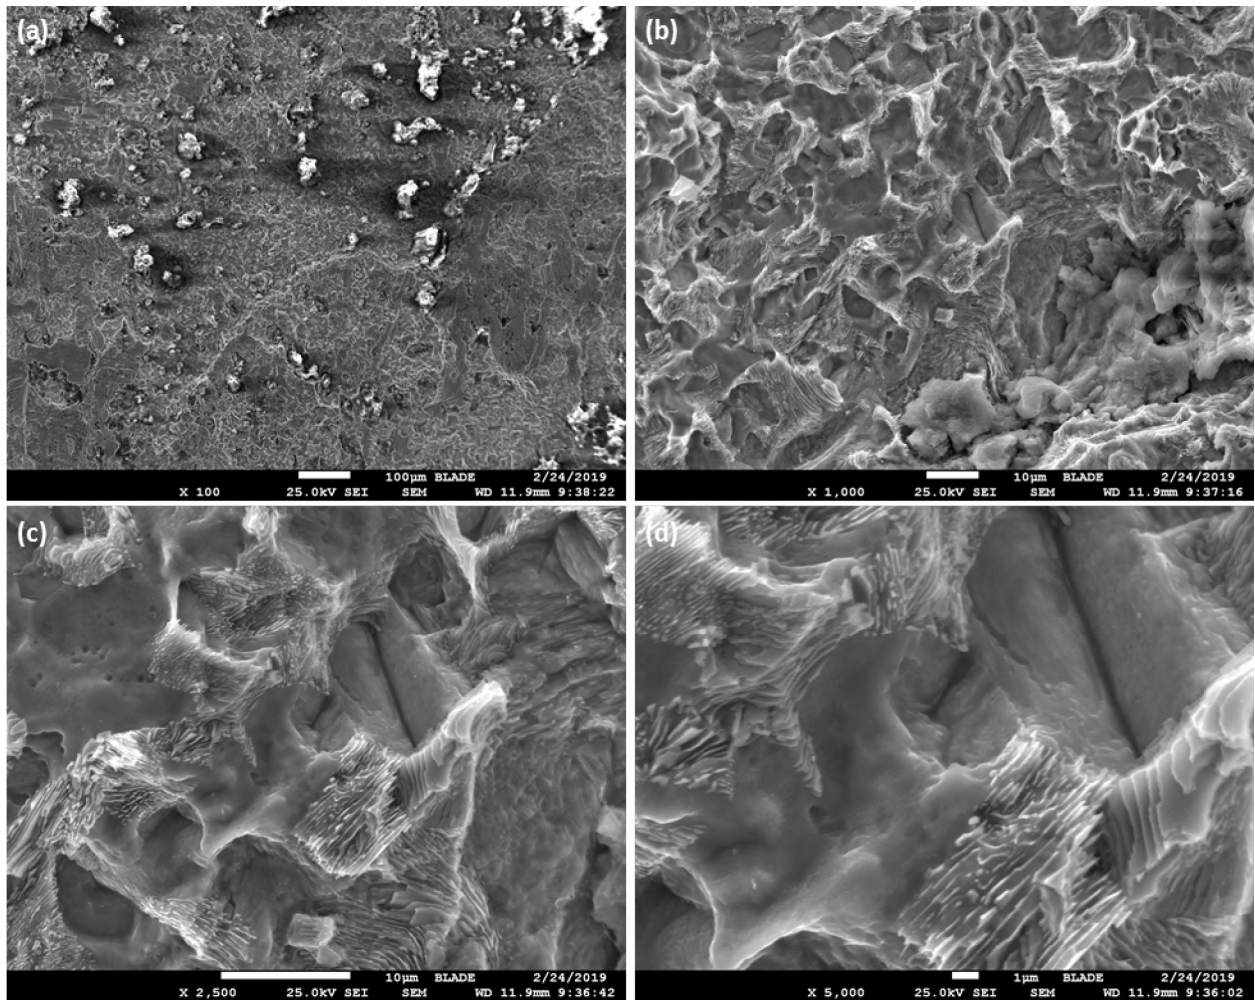
Pearlite can be revealed by corrosion alone because corrosion attacks ferrite; however, the detailed morphology in this scenario would have been different. Corrosion always attacks the ferrite in the pearlite structure and forms pits in the surrounding ferrite—Figure 97 shows an example of pearlite with corrosion pits in the surrounding ferrite. Care must therefore be taken when examining fracture surfaces so that it is distinguishable whether pearlite was revealed by ductile tearing or corrosion.

**Figure 97: Pearlite and Ferrite (Pitting) Corrosion at (a) 100 $\times$ , (b) 1,000 $\times$ , (c) 2,500 $\times$ , and (d) 5,000 $\times$**

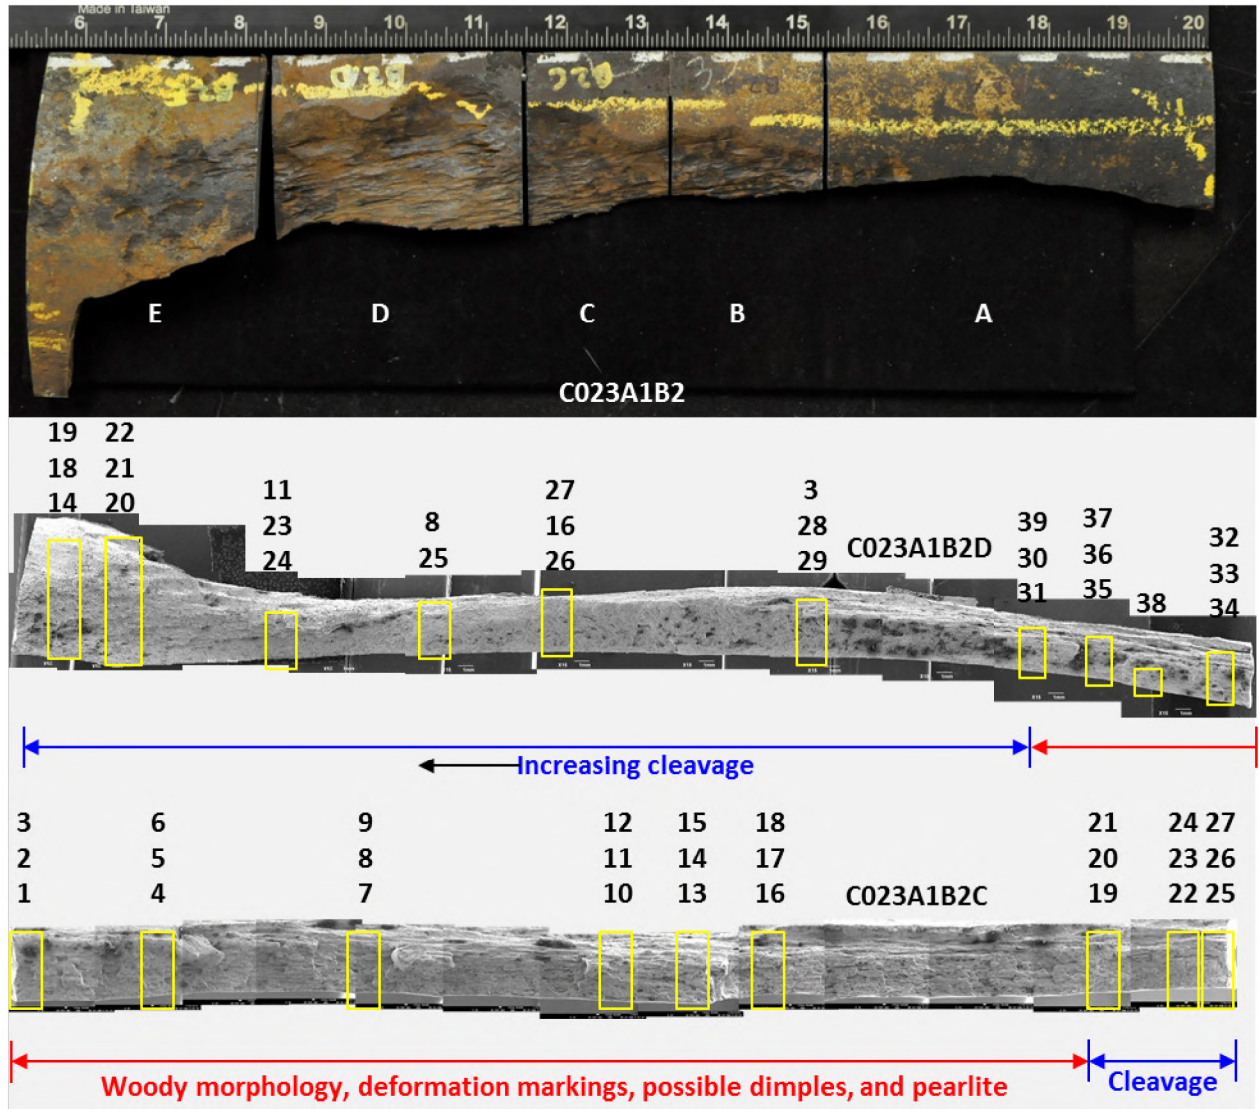
A transition from ductile to a ductile-brittle mix was observed beginning at C023A1B2C A19 (Figure 98). The transition showed a shift from woody-type morphology to a mix of woody-type morphology and cleavage. The number of cleavage facets appeared to have increased from location A19 to A27. The observations implied that the speed of the axial rupture was increasing through the transition zone until the crack became fully unstable. Figure 105 and Figure 106 show SEM images from A19 and A20 with the ductile-brittle mixed fracture mode. The images show areas of cleavage facets and deformation markings.

Figure 98: SEM Examination of Cleaned Fracture Surfaces of C023A1B2C and C023A1B2D

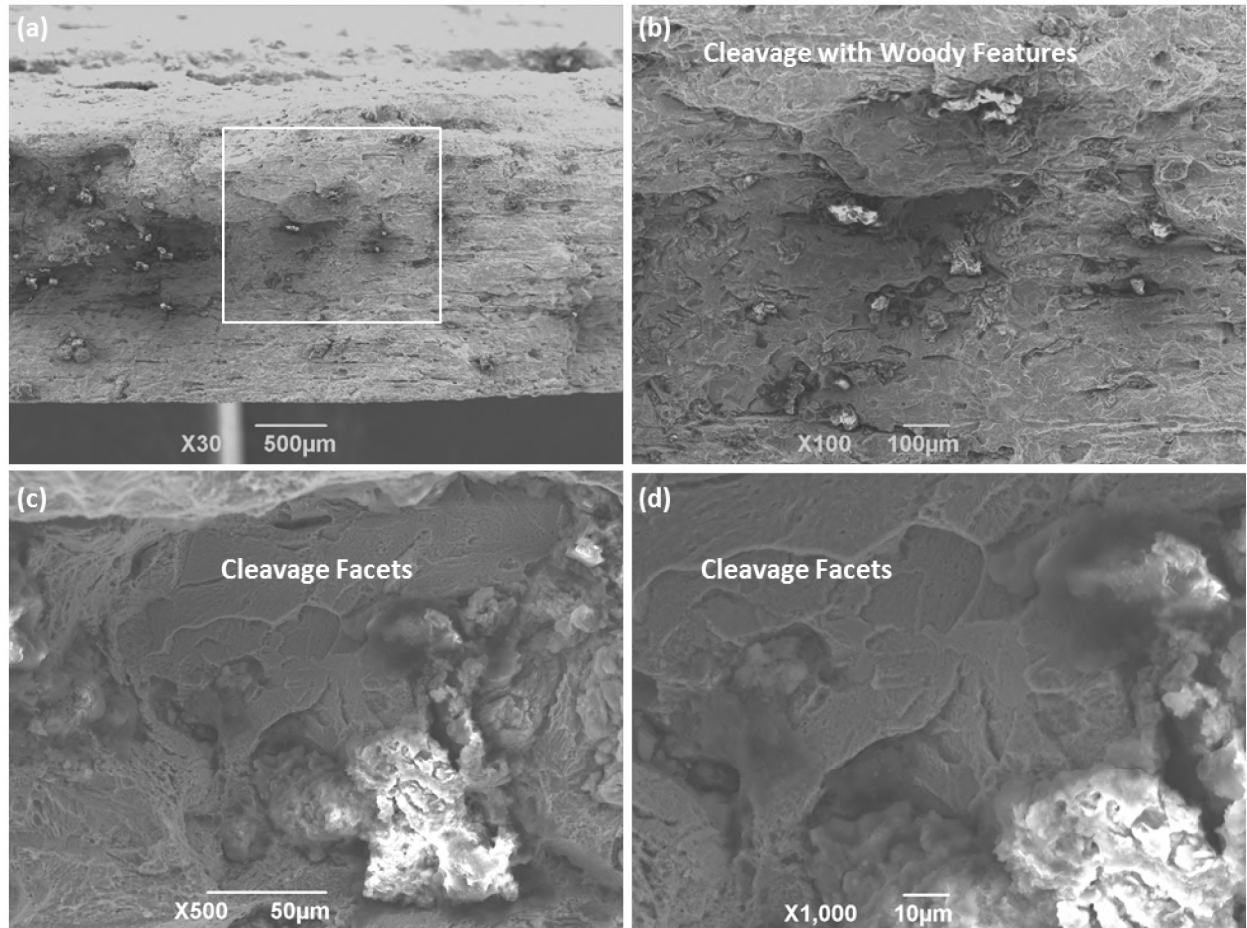
Many AOIs from specimen C023A1B2D were examined with the SEM. C023A1B2D was primarily composed of Zone 2 with a small area identified as Zone 1. Ductile features were observed in locations to the right of A30 (Figure 98). Locations to the left of A30 showed a ductile-brittle fracture mode with cleavage surrounded by deformation marks. Figure 107 shows the morphology for A30. These observations suggest that the length of the origin could be refined and measured between the transition zones identified on fracture surfaces C023A1B2C and C023A1B2D. Section 3.2.3 discusses the refining of the origin based on the observations made in this section. Figure 108 shows A37 (to the right of A30), which contained deformation marks.

Figure 107: C023A1B2D SEM Images of A30 Showing a Mixed Mode Morphology

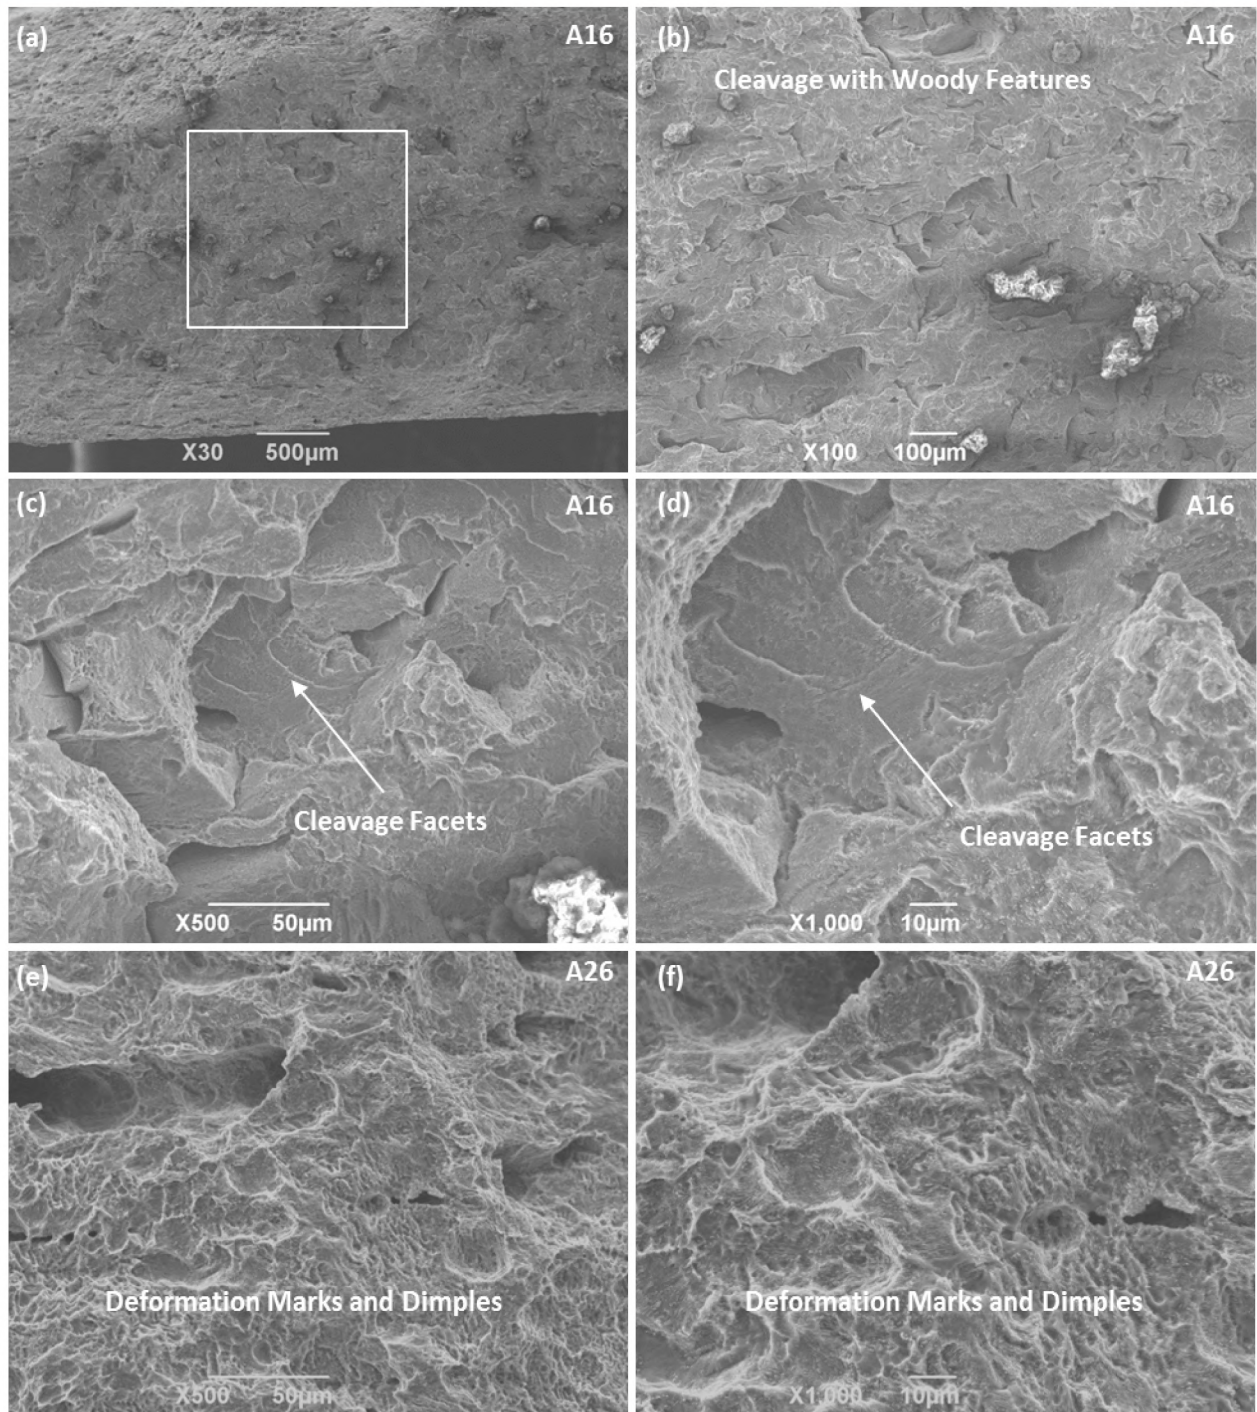
Figure 117 shows SEM images of A16 and A26, located at the MW and ID of the fracture surface, respectively. These areas were located below A28 and A29, which were farther from the origin towards the lower turning point. Figure 117 (a) and (b) show SEM images of A16 at 30 $\times$  and 100 $\times$ . The 100 $\times$  image shows cleavage mixed with woody features, which are consistent with observations for A28 and A30. Figure 117 (c) and (d) show SEM images of cleavage facets taken at 500 $\times$  and 1,000 $\times$ . Figure 117 (e) and (f) show SEM images of deformation marks and dimples at A26 near the ID taken at 500 $\times$  and 1,000 $\times$ . Observations for all the selected areas were consistent.

**Figure 117: SEM Images from Locations A16 and A26 Showing Mixed Fracture Mode**

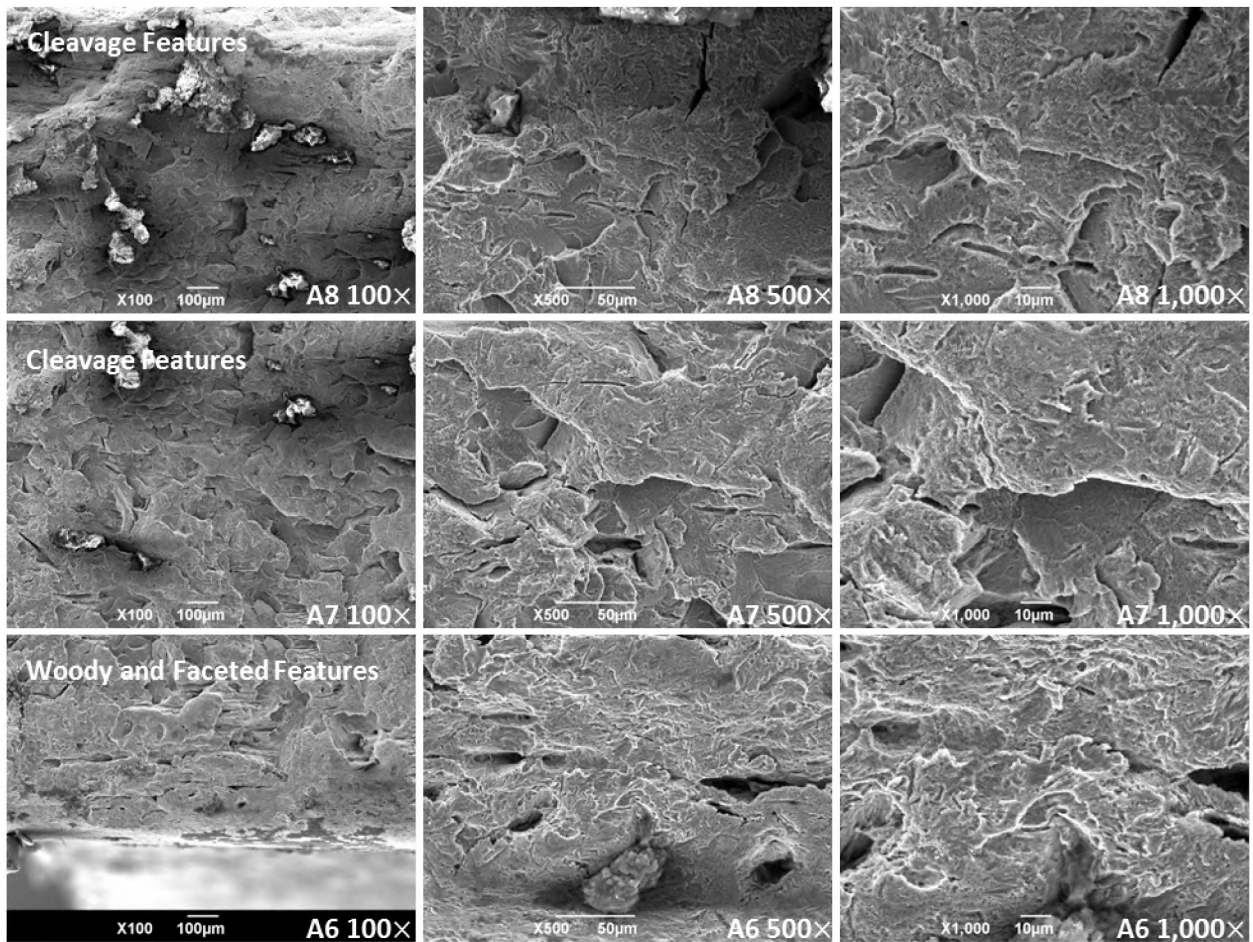
Figure 119 shows SEM images of the cleaned fracture surfaces for A6, A7, and A8. These areas were located directly above Zone 1 (origin). A6 was located at the ID and was characterized by woody and faceted features. Instead of typical cleavage, faceted features were observed in some areas; this could be because the original cleavage structure had been corroded away. A7 and A8 were at the MW and OD of the fracture surface, respectively. Both areas were characterized by cleavage features.

**Figure 119: SEM Images for Areas A6, A7, and A8 Taken at 100×, 500×, and 1,000×**

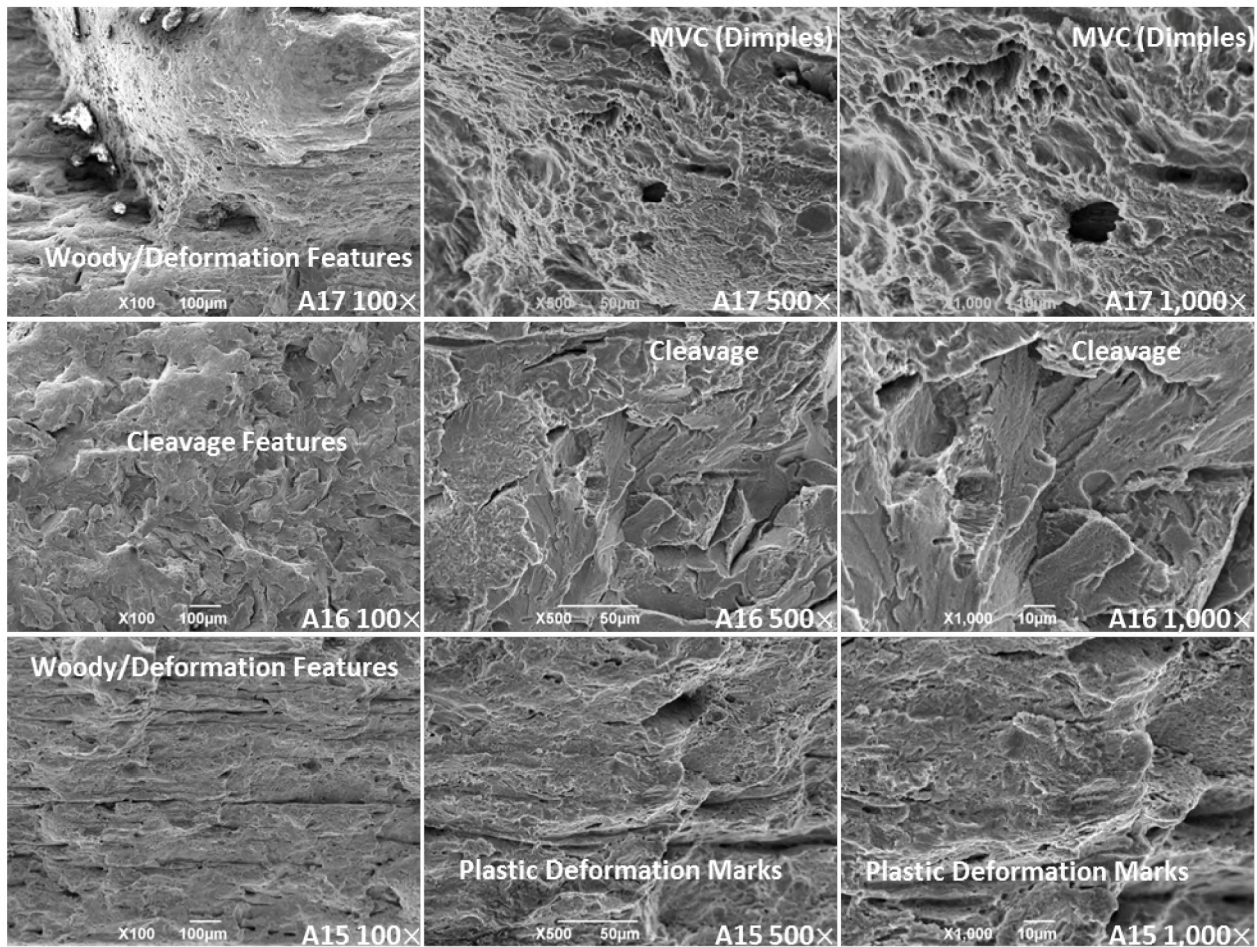
Figure 120 shows SEM images of the cleaned fracture surface for A15, A16, and A17. These areas were located above A6, A7, and A8, closer to the full wall thickness and visible chevron marks. A15 was at the ID of the fracture surface and was characterized by woody deformation features and plastic deformation marks. A16 was located at the MW of the fracture surface and was characterized by cleavage. A17 was located at the OD of the fracture surface and was characterized by both cleavage and woody deformation features. The high magnification images of A17 show MVC (dimples).

**Figure 120: SEM Images for Areas A15, A16, and A17 Taken at 100×, 500×, and 1,000×**

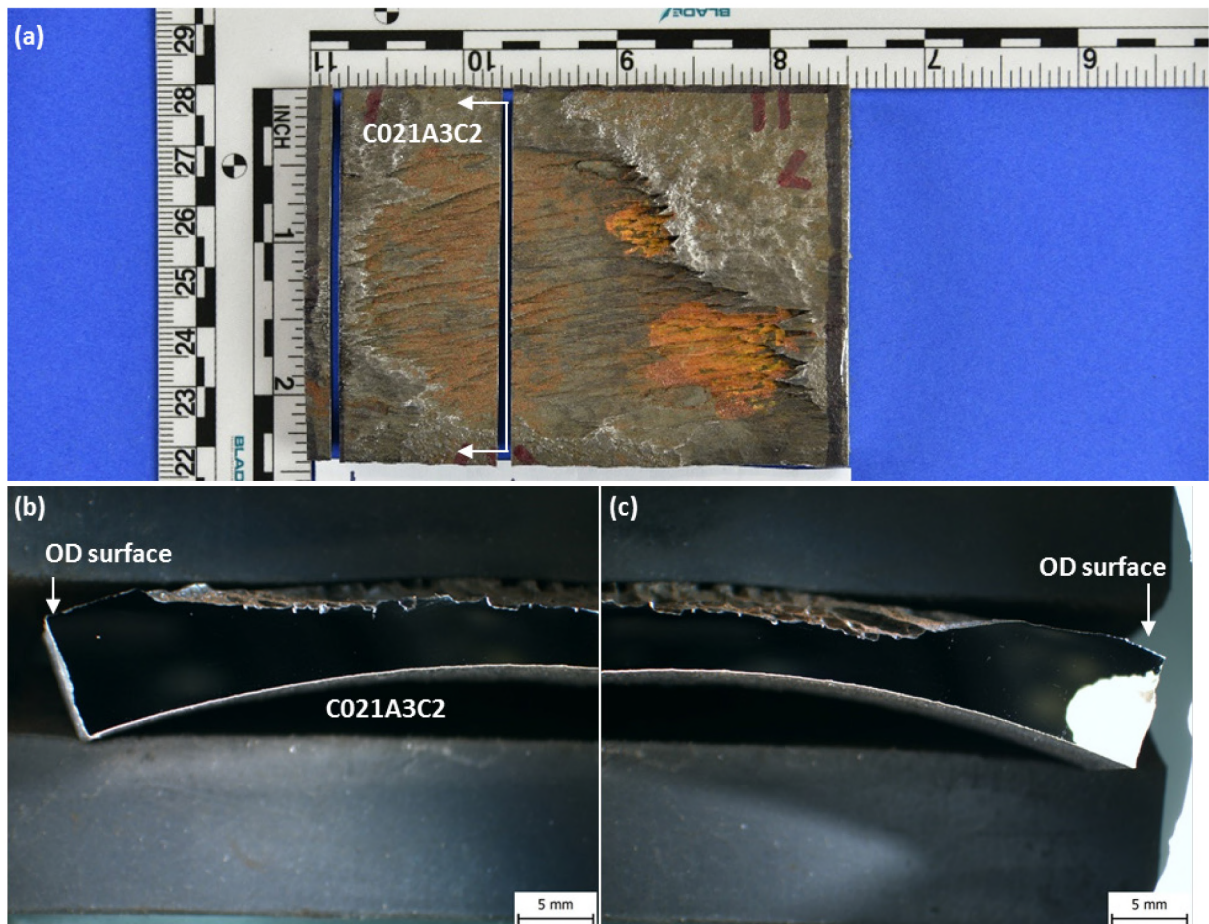
Specimen C021A3C was sectioned in order to investigate the groove profile and V-shaped groove tips (Figure 209 [a]). Figure 209 (b) and (c) show the groove profile within the corrosion patch with respect to the unaffected OD surface of the 7 in. casing. A notch-like profile was observed at each individual groove. The general contour of the corrosion appeared to be semi-elliptical with notches along the bottom of the profile. The general contour of the corrosion patch and notch-like features were incorporated into the FEA for failure pressure prediction. Section 4.1 describes the FEA modeling details.

Figure 209: (a) Specimen C021A3C Cross Section and (b) (c) Striated Groove Profile

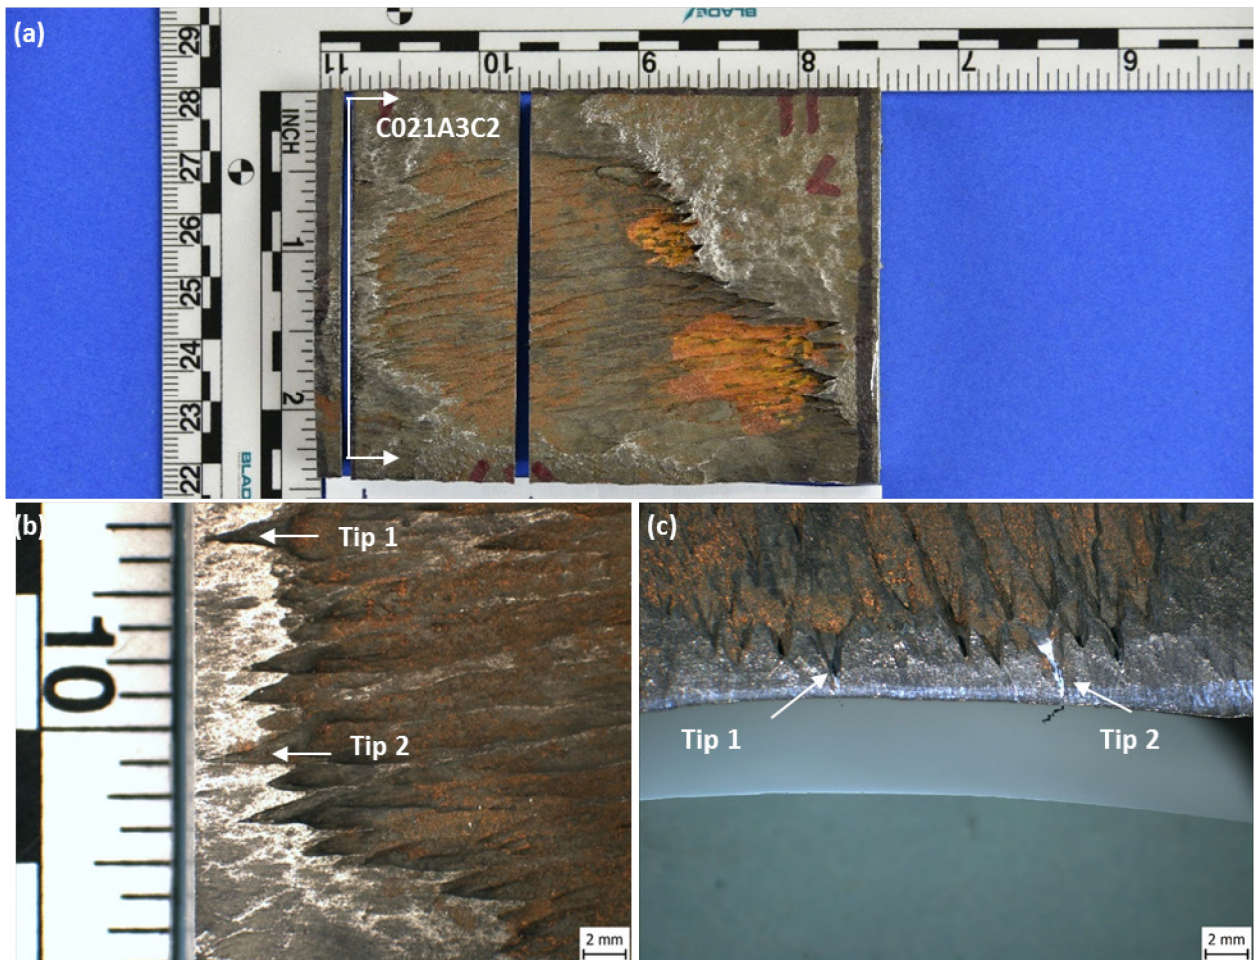
Figure 210 (a) shows the location of a transverse cross section for C021A3C that was made approximately 1 mm ahead of the V-shaped groove tips. Figure 210 (b) identifies two large groove tips designated as tips 1 and 2. Tunnels were observed beneath both groove tips (Figure 210 [c]). Figure 211 (a) and (b) are micrographs of groove tips 1 and 2 after etching with 2% nital. The micrographs clearly show tunnels as black regions ahead of the groove tips. Figure 212 (a) and (b) are metallographs of groove tips 1 and 2 taken at 50 $\times$ . The metallographs show multiple tunnels occurring as deep as 1,300  $\mu\text{m}$  below the OD surface. The inner structure of the tunnels could not be examined due to the limitations of the metallographic microscope. A detailed examination of the tunnels was conducted with the SEM.

Figure 210: (a) Top and (b) Tilted View of C021A3C2 and (c) Cross Section Showing Tips 1 and 2
