**Blade Supplemental Report (Vol. 2: SS-25 Well Failure Causes)**

# Root Cause Analysis of the Uncontrolled Hydrocarbon Release from Aliso Canyon SS-25

May 31, 2019

# SS-25 Casing Failure Analysis

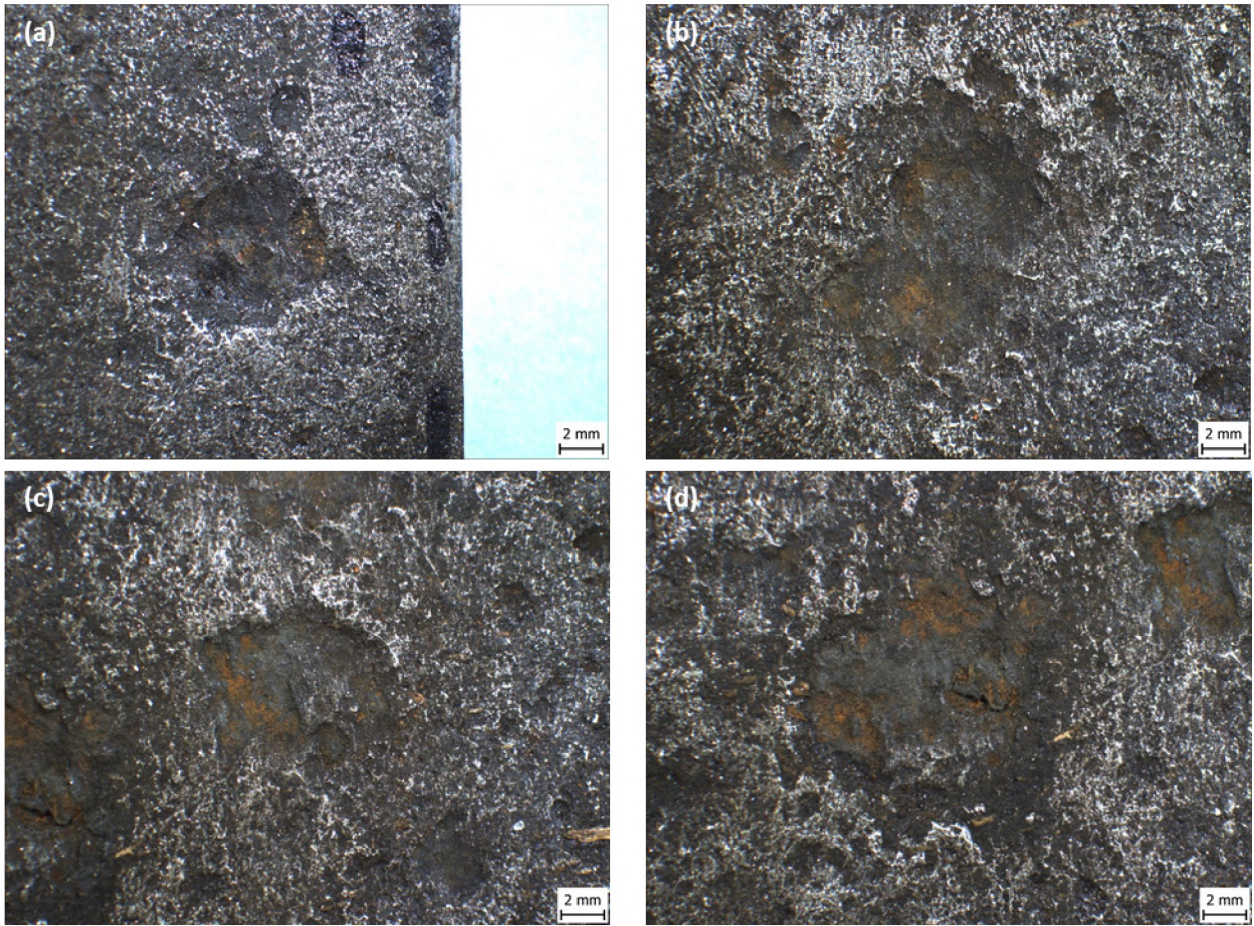
Figure 244 shows low magnification (5×) stereoscopic images of Type II corrosion features in C022A5B5 specimens. The Type II features contained smaller pits within larger pits. These were shallow metal-loss pits as compared to the Type I corrosion features. Dark orange, brown, and black deposits were present in the pits. Globules were observed in local pits on specimen C022A5B5. Figure 245 shows small acicular features within a globule. These acicular feature formations are commonly found in atmospheric corrosion of carbon steels and were generally described as flower petals in the literature [39] [40] [41] [77]. Extra-cellular material was not observed on the OD surface of the specimen.

Figure 244: Stereoscopic Image of Specimen C022B2A5B5 Type II Corrosion Feature

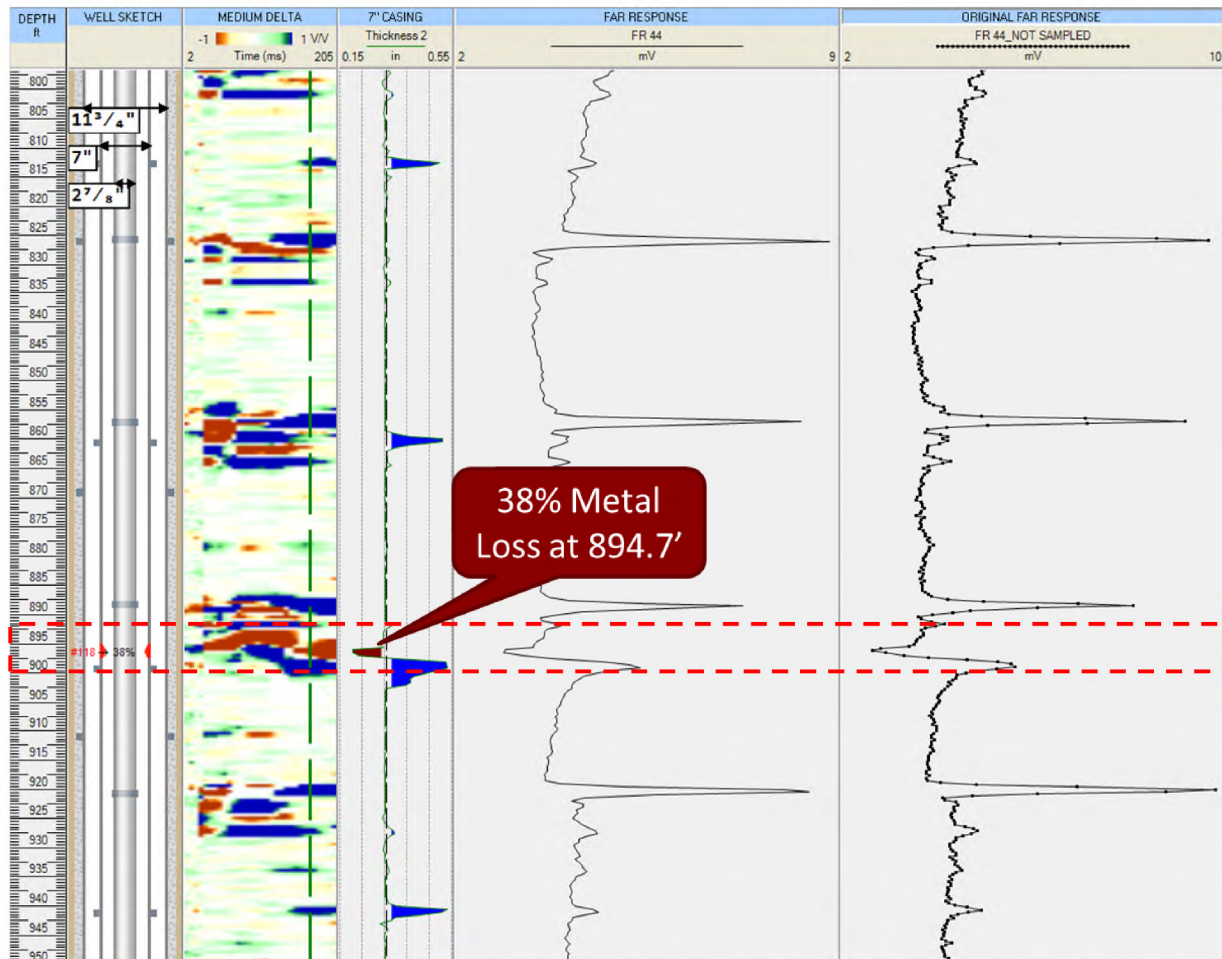
Figure 4: 7 in. Casing Defect Observed by the April 18, 2016, MID Logs at 894.7 ft (Later Revised to 892 ft)

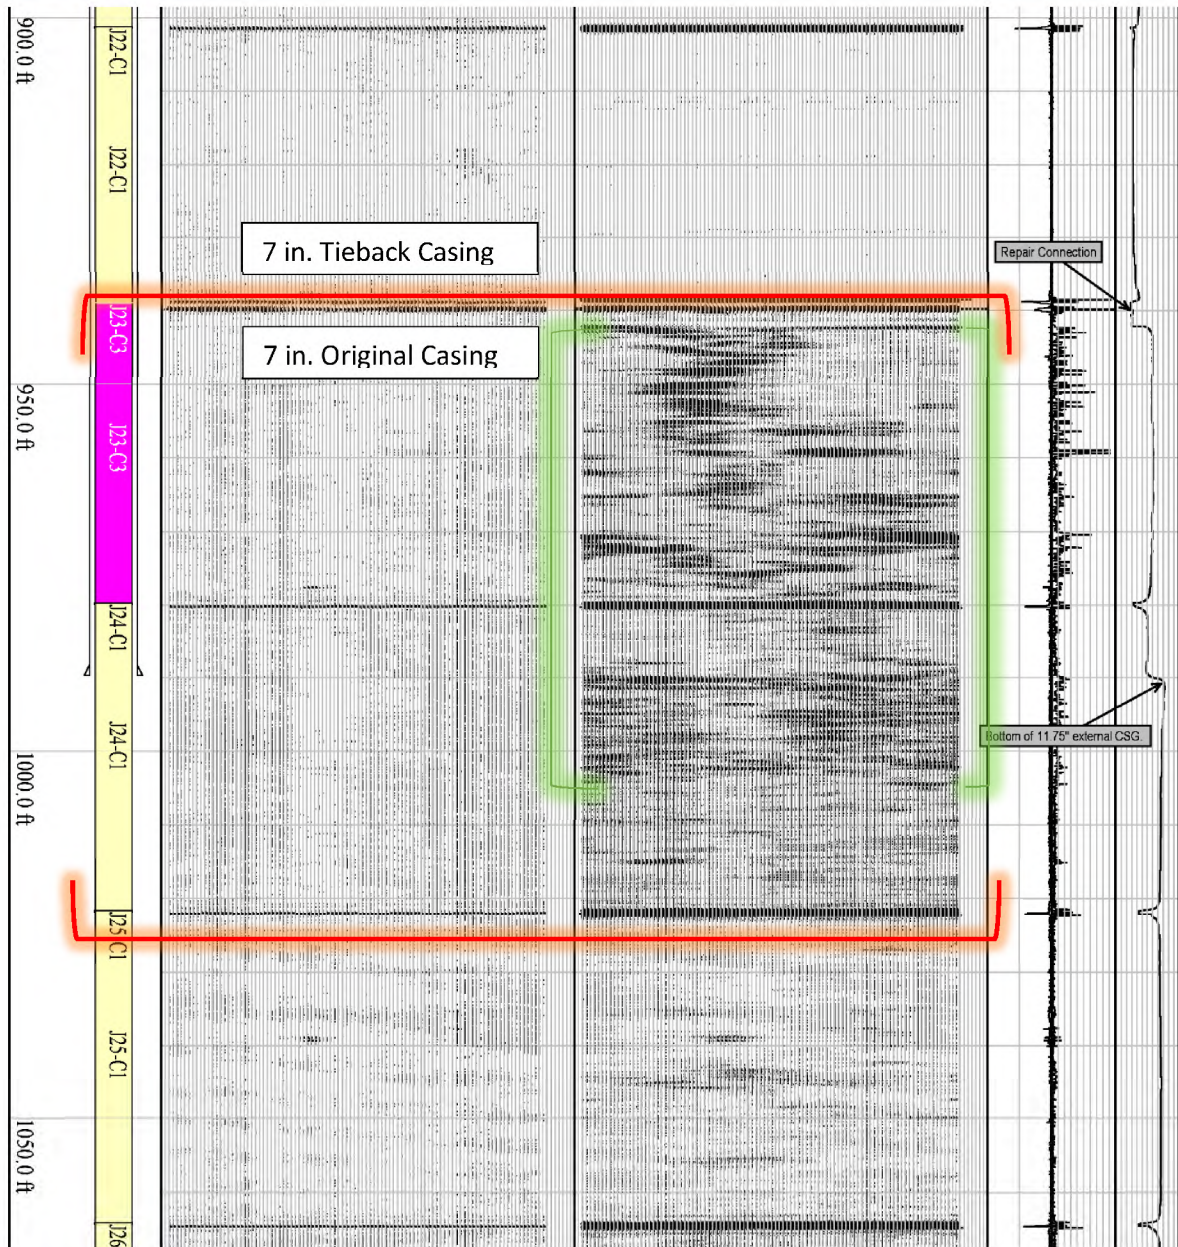
**Figure 15: 7 in. HRVRT Log [9], December 2, 2017, External Corrosion at 939–1,015 ft - Green Bracket, Extracted August 8, 2018 – Red Bracket**

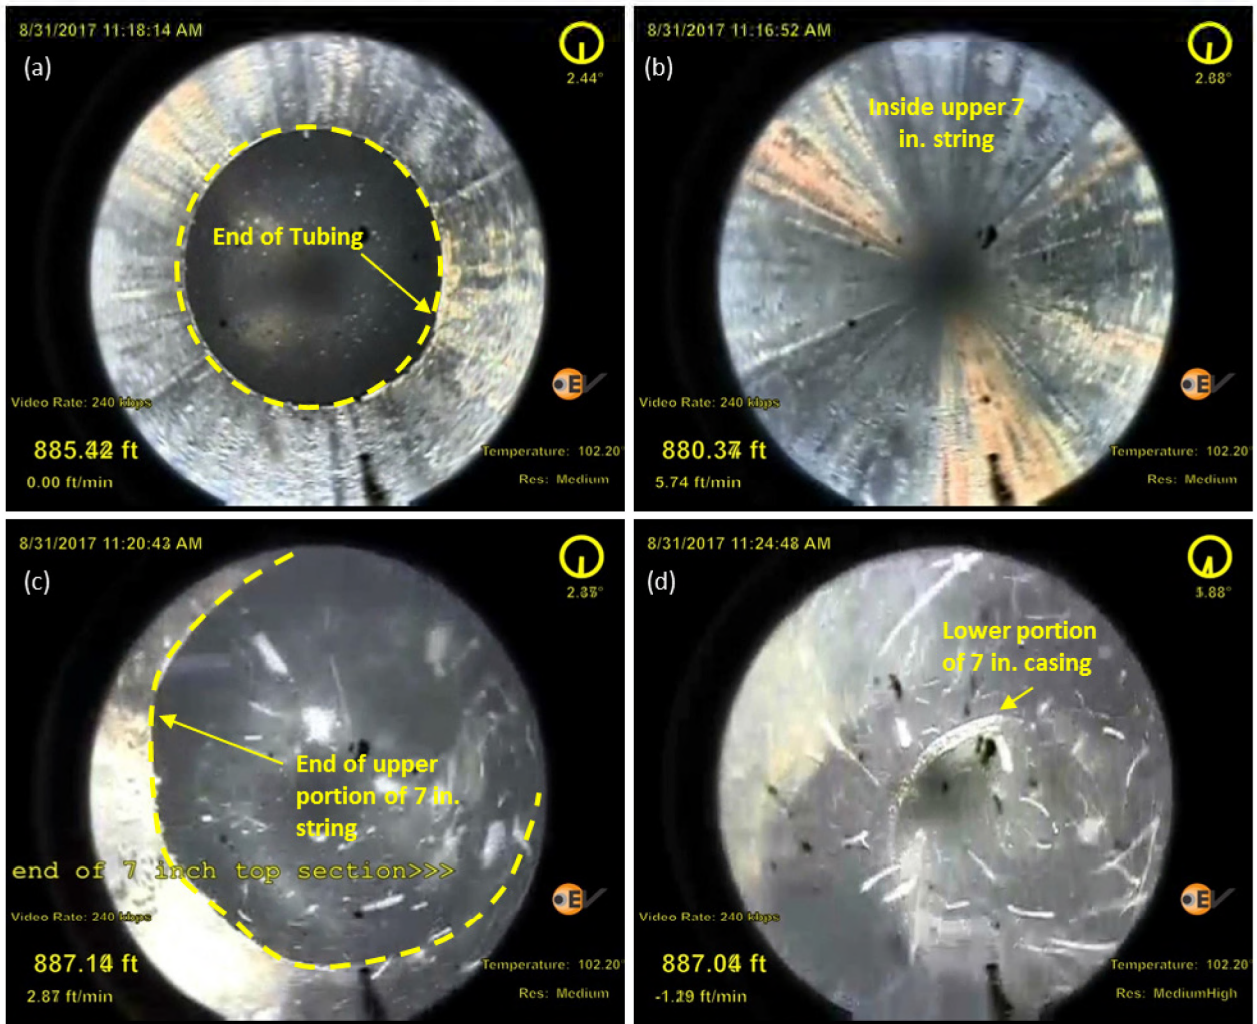
Figure 24: Video Imaging from August 31, 2017, Parted 7 in. Casing

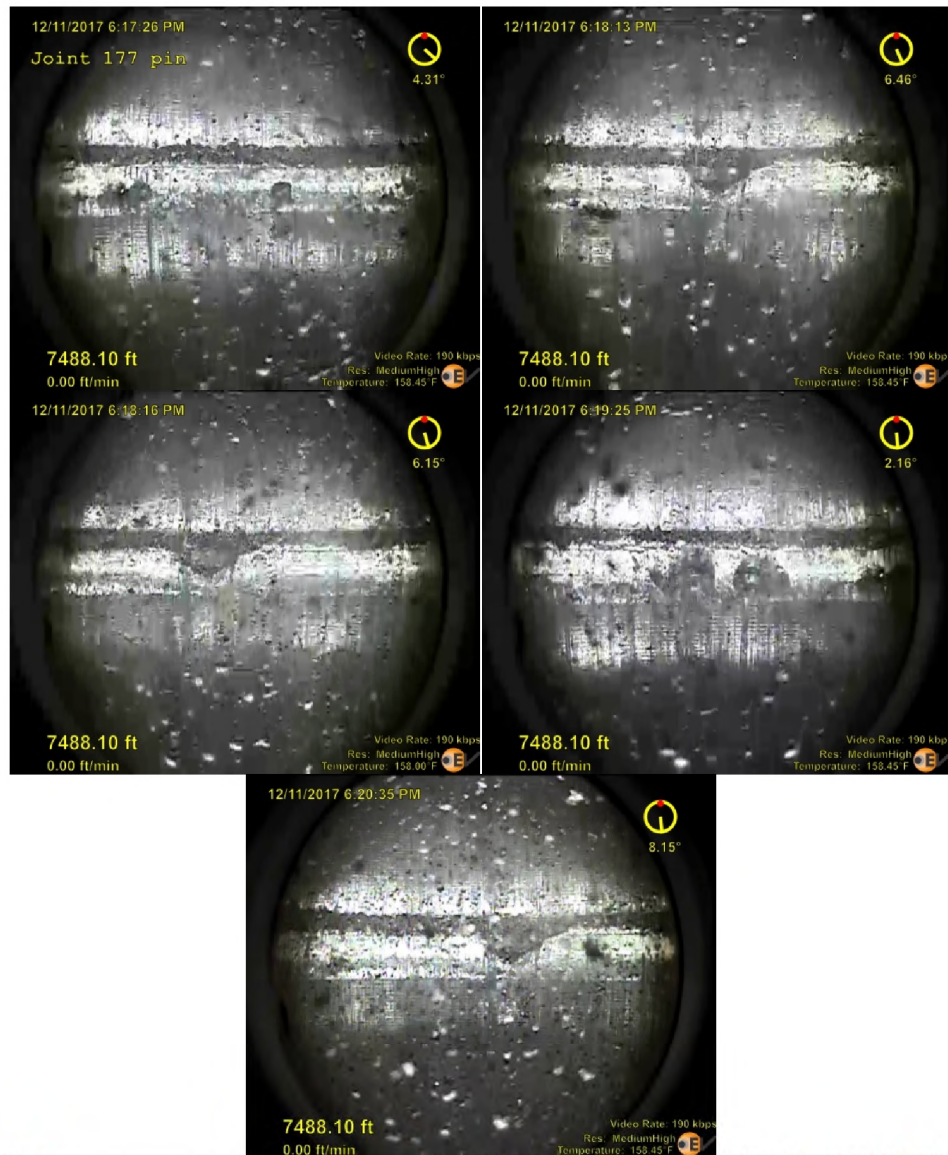
Figure 27: December 11, 2017 EV Camera (Images Above) and December 2 Caliper Log (Bottom), 7 in. Casing Connection 177 at 7,488.1 ft, Minor Gouges

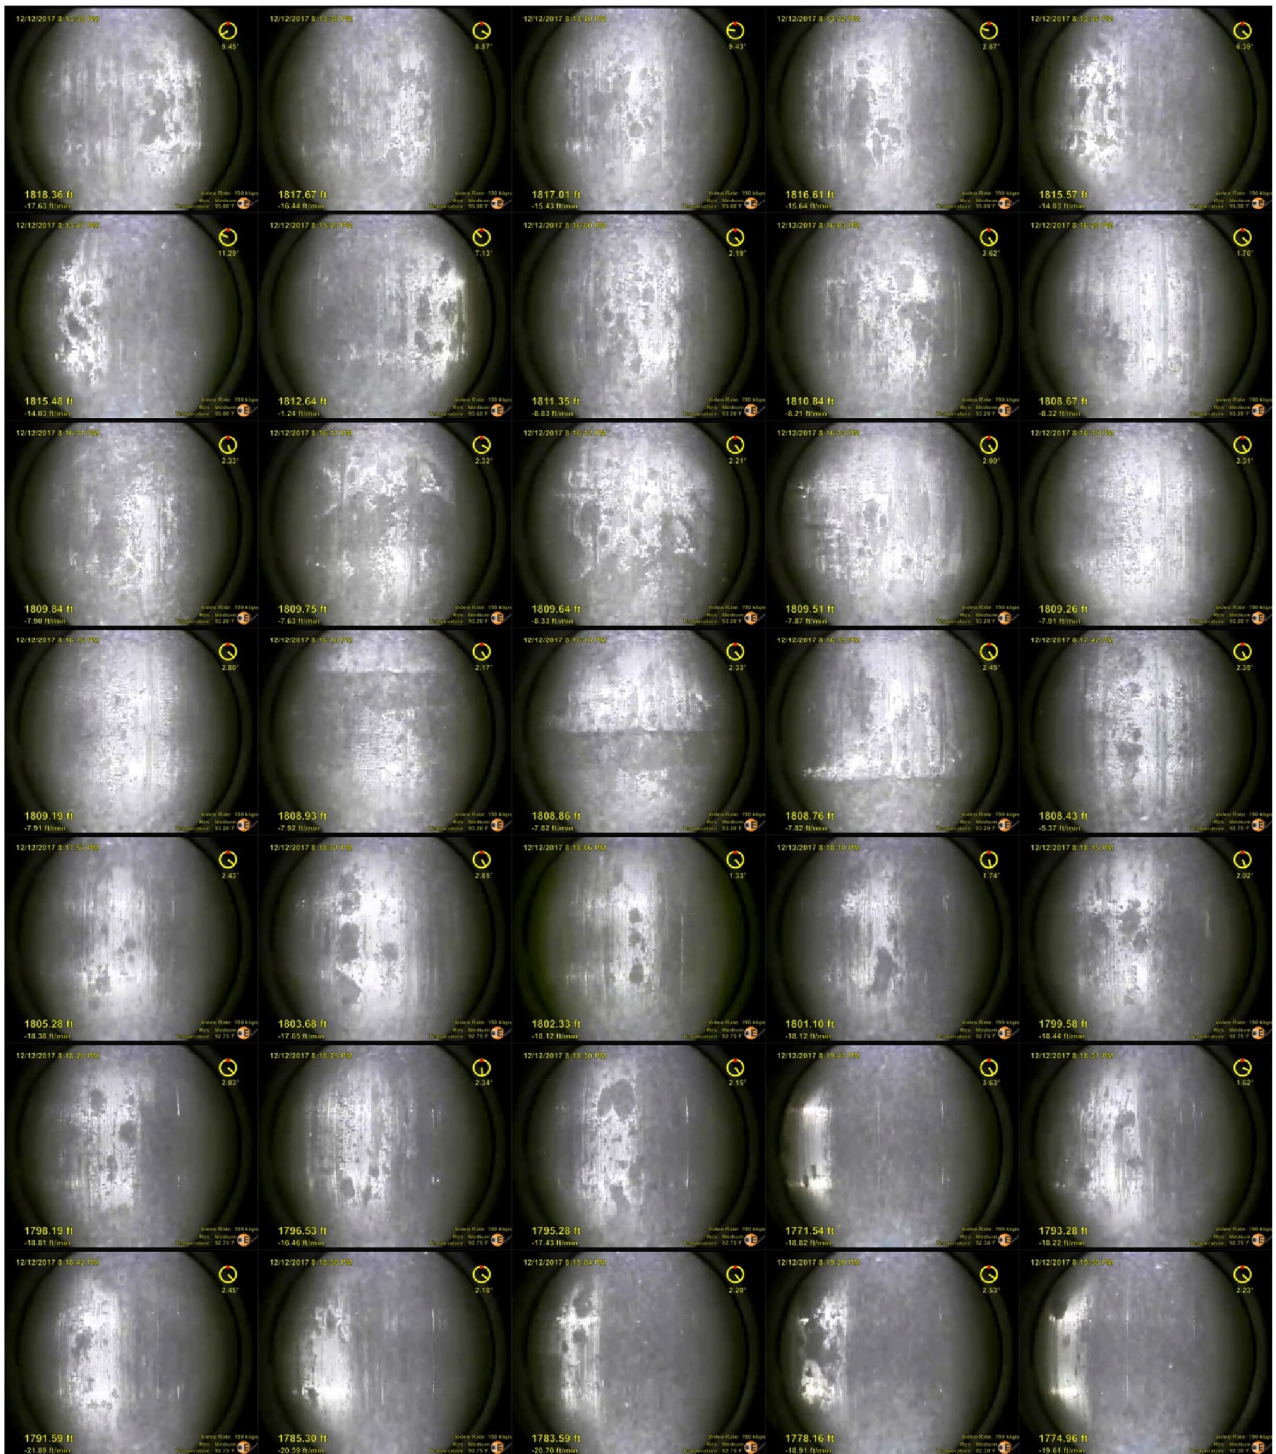
Figure 29: December 12, 2017, EV Camera, Example of Internal Corrosion on 7 in. Casing for 1,818–1,775

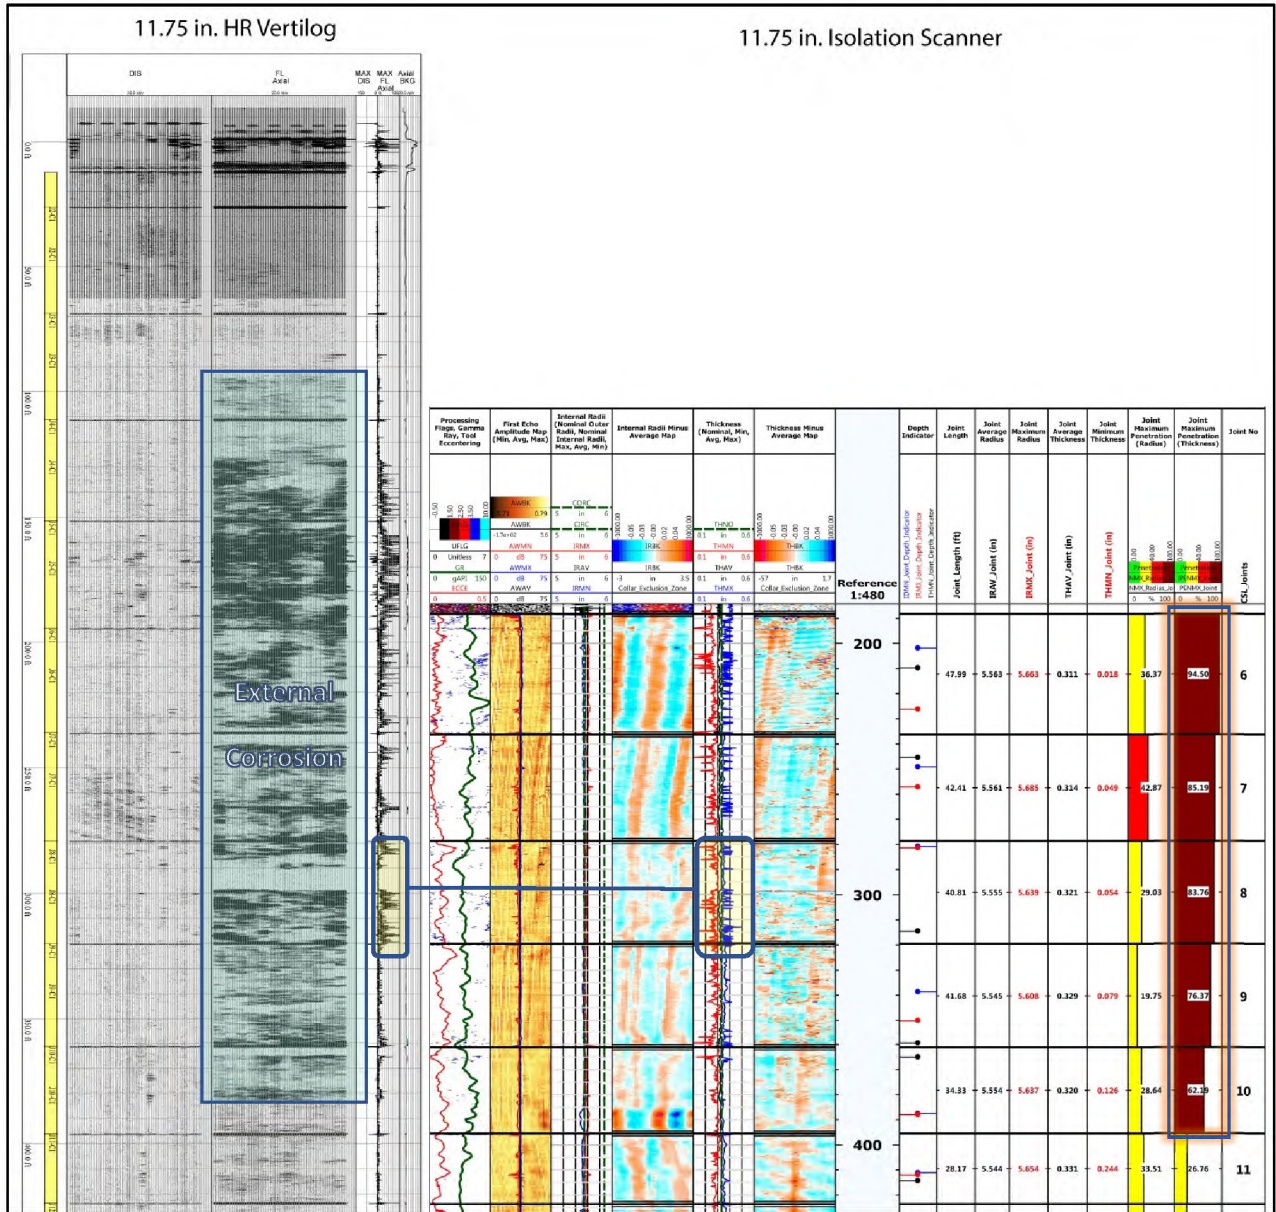
Figure 34: 11 3/4 in. HRVRT [16] and Isolation Scanner [17], External Corrosion Observed (Green Box)

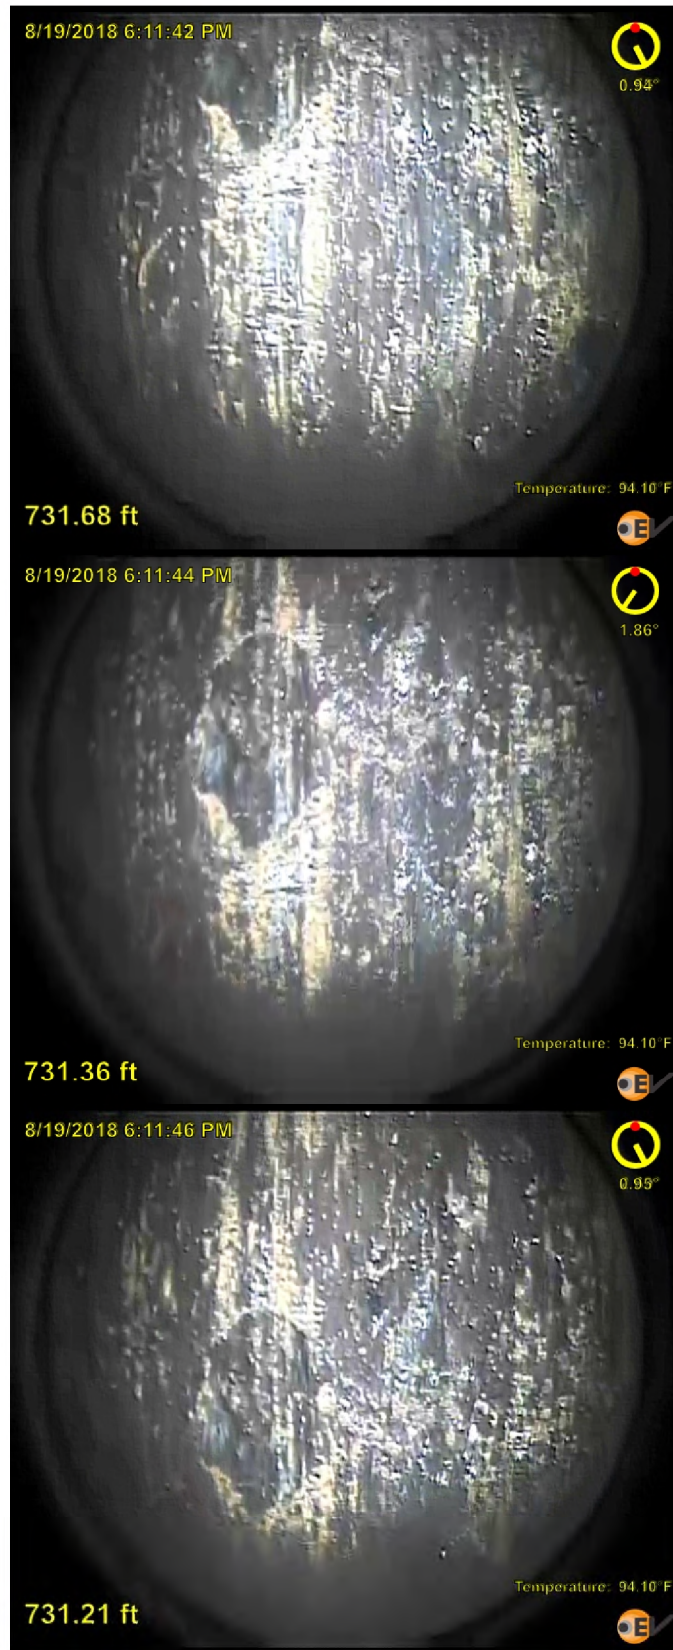
Figure 43: 11 3/4 in. Video Imaging at ~731 ft, Example of Pitting Observed

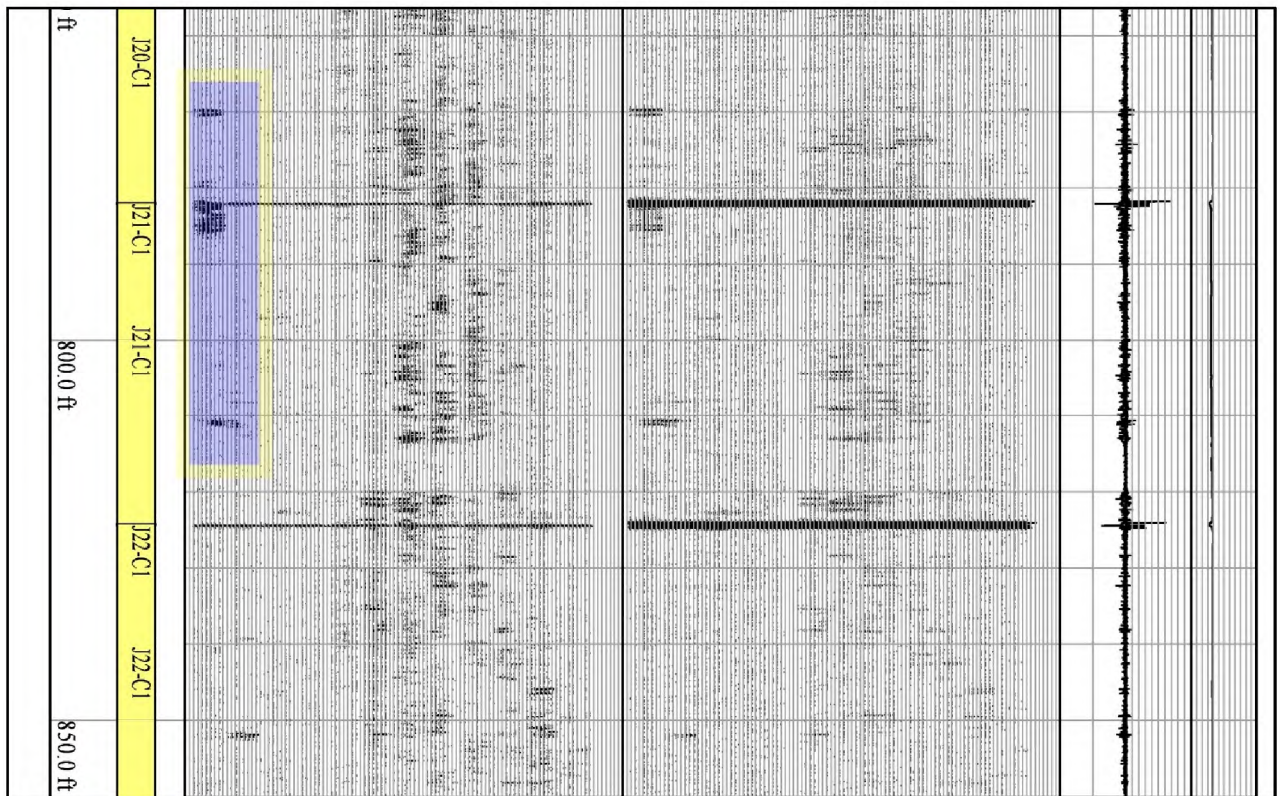
**Figure 44: 11 3/4 in. HRVRT Log [16], Nonrandom Internal Metal Loss (Blue Rectangle)**
