Order Instituting Investigation on the Commission's Own Motion into the Operations and Practices of Southern California Gas Company with Respect to the Aliso Canyon storage facility and the release of natural gas, and Order to Show Cause Why Southern California Gas Company Should Not Be Sanctioned for Allowing the Uncontrolled Release of Natural Gas from Its Aliso Canyon Storage Facility. (U904G).

I.19-06-016 (Filed June 27, 2019)

PREPARED REPLY TESTIMONY OF ROBERT A. CARNAHAN, P.E. ON BEHALF OF SOUTHERN CALIFORNIA GAS COMPANY (U 904 G)

March 20, 2020

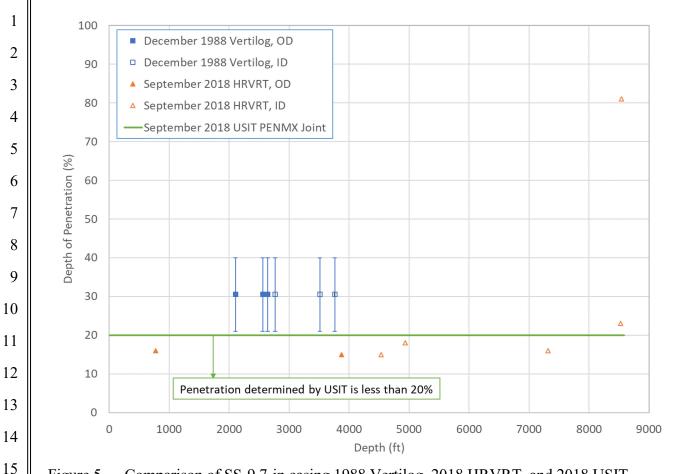
Figure 5. Comparison of SS-9 7-in casing 1988 Vertilog, 2018 HRVRT, and 2018 USIT results. ²⁸ Depth of penetration into the casing is shown on the vertical axis. Depth along the casing into the well is shown on the horizontal axis. Vertilog results are shown as vertical blue lines spanning the range of the identified indication class. USIT did not detect penetration greater than 20%, as indicated by the solid green line. External HRVRT indications are denoted by the solid orange triangles. Internal HRVRT indications are denoted by the open orange triangles.

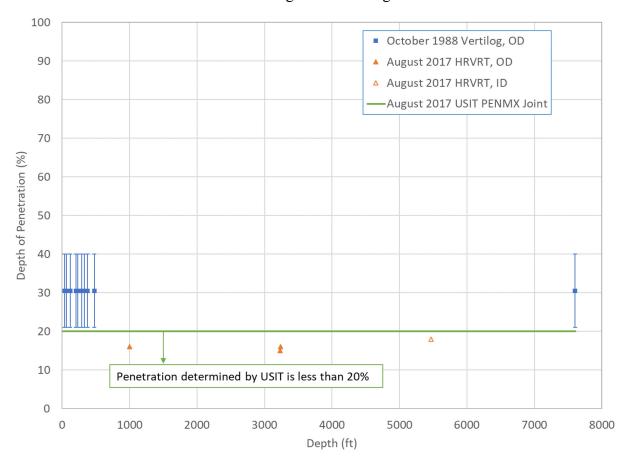
• HRVRT and USIT of the P-46 7-in casing were performed during the 2017 SIMP program and no metal loss features greater than 20% of casing thickness were found, even though the 1988 Vertilog inspection identified ten casing joints as having Class 2 damage. USIT of the Porter 46 7-in casing identified an unspecified anomaly in the range 3970 ft to 3984 ft. The nature of the anomaly was not described, but review of the USIT log suggests the existence of mechanical deformation or damage in this area. No such anomaly was reported by HRVRT. An August 25, 2017 email from SoCalGas to DOGGR stated "After reviewing the P46 log results at

Figure 6. Comparison of P-46 7-in casing 1988 Vertilog and 2017 USIT results.³² Depth of penetration into the casing is shown on the vertical axis. Depth along the casing into the well is shown on the horizontal axis. Vertilog results are shown as vertical blue lines spanning the range of the identified indication class. USIT did not detect penetration greater than 20%, as indicated by the solid green line. External HRVRT indications are denoted by the solid orange triangles.³³ Internal HRVRT indications are denoted by the open orange triangles.

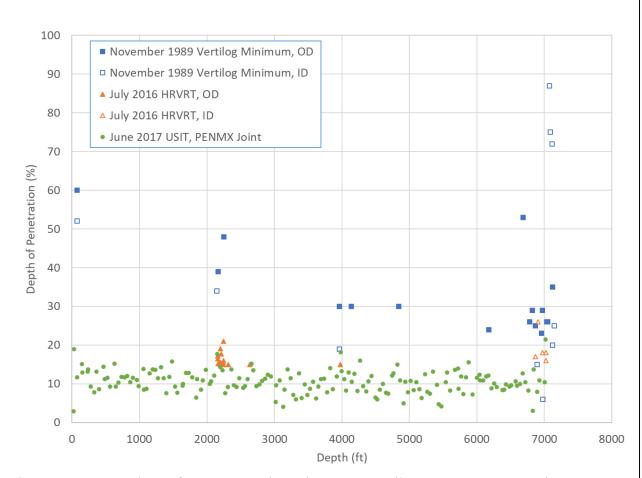
- 4. Vertilog inspection of the FF-35B 8 %-in casing in November 1989 identified multiple Class 2, 3, and 4 indications (Figure 7). The Class 3 and Class 4 Vertilog indications were not corroborated by the 2016 HRVRT and 2017 USIT logs, even though these logs were conducted 27 and 28 years after the Vertilog inspection (Figure 7). HRVRT did not identify external metal loss deeper than 21% of wall thickness and did not identify internal metal loss deeper than 26% of wall thickness. USIT did not identify metal loss greater than 19% of wall thickness, except for an area reported as 21.4% metal loss at 7020 ft depth.

Figure 7. Comparison of FF-35B 8 %-in casing 1989 Vertilog, 2016 HRVRT, and 2017 USIT results. 34 Depth of penetration into the casing is shown on the vertical axis. Depth along the casing into the well is shown on the horizontal axis. Vertilog results are shown as blue squares and USIT results are shown as green circles. External HRVRT indications are denoted by the solid orange triangles. Internal HRVRT indications are denoted by the open orange triangles.

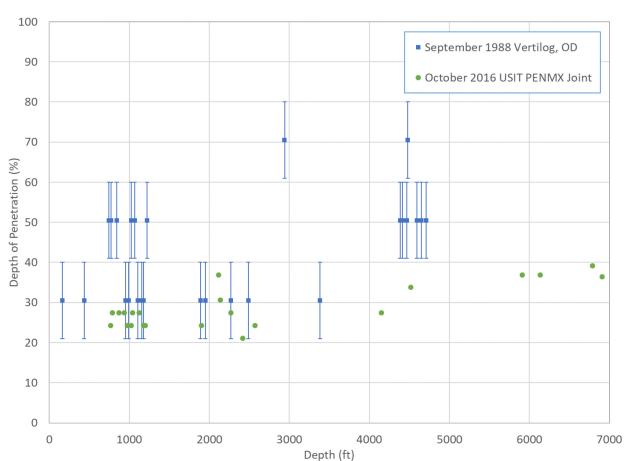
• USIT of the F-4 7-in casing (with the inner-string removed) was performed in 2016 as part of SIMP and no significant corrosion was found in the two areas that had been previously identified as having Class 4 damage based on the 1988 Vertilog inspection.³⁵

Figure 8. Comparison of F-4 7-in casing 1988 Vertilog and 2016 USIT results. ³⁶ Depth of penetration into the casing is shown on the vertical axis. Depth along the casing into the well is shown on the horizontal axis. Vertilog results are shown as vertical blue lines spanning the range of the identified indication class. USIT data showing penetration greater than 20% is represented by the green circles.

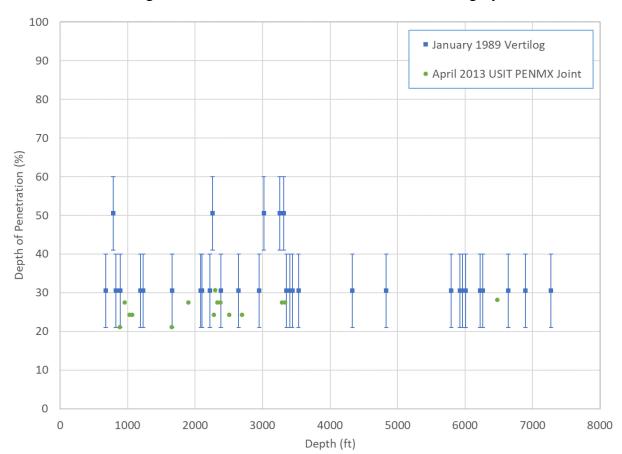
• USIT of the SS-8 7-in casing was performed on 4-24-2013 and no significant corrosion was found in the areas that had been identified by the 1989 Vertilog inspection as having Class 2 and Class 3 damage.³⁷ While the significance of corrosion depends on the depth and size of the defect, generally local metal loss below 50% of wall thickness should not be

considered significant because it does not threaten the integrity of the well. In other words, the 20%-30% wall loss indicated by USIT below is not significant because such loss does not affect the integrity of the well.

Figure 9. Comparison of SS-8 7-in casing 1989 Vertilog and 2013 USIT results.³⁸ Depth of penetration into the casing is shown on the vertical axis. Depth along the casing into the well is shown on the horizontal axis. Vertilog results are shown as vertical blue lines spanning the range of the identified indication class. USIT data showing penetration greater than 20% is represented by the green circles.

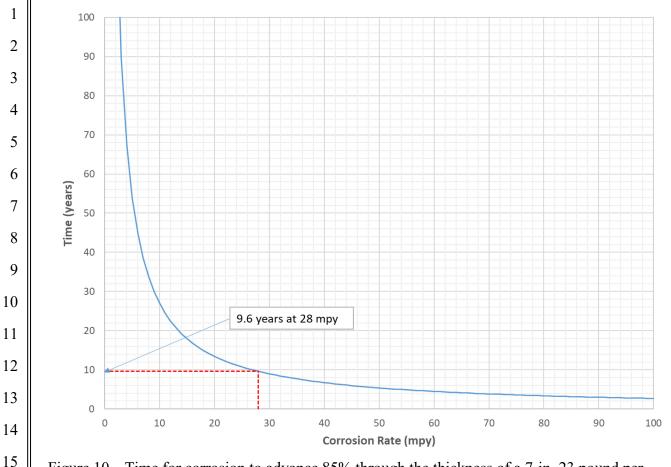
Critically, the grooved, striated appearance of the SS-25 corrosion is consistent with Microbiologically Influenced Corrosion (MIC).⁴⁶ This is important because corrosion associated with MIC typically occurs at rates greater than Blade's estimated corrosion rate range of 5 to 10 mpy. Given the 85% corrosion depth reached in 2015, it is thus likely that any corrosion at SS-25 started many years **after** the circa 1988 Vertilog testing.

Figure 10. Time for corrosion to advance 85% through the thickness of a 7-in. 23 pound per foot casing.

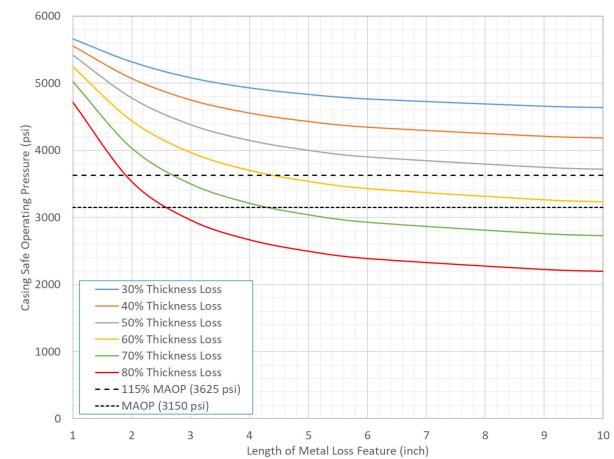
To illustrate, we used the modified B31G method described by ASME B31G to calculate safe operating pressure of corroded 7-in., 23 pound per foot J55 casing, which is the type of casing that was used in the upper portions of the aforementioned seven Vertilog-tested wells at Aliso Canyon (Figure 11).⁵²

Our calculations further show that safe operating pressure for casing with metal loss up to 60% wall thickness (boundary between Vertilog Classes 3 and 4) and 10-in length is above the approximately 3150 psi casing MAOP.

Figure 11. Modified B31G casing safe operating pressure determined for longitudinal metal loss features with depths varying from 30% to 80% of wall thickness and lengths varying from one to ten inches.

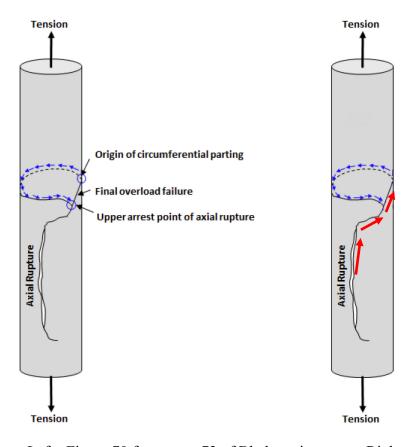
- The 7-in. casing did not have to become cold for the circumferential fracture to occur. The fracture that extended vertically upward from burst area did not require cooling of the material. Similarly, no further cooling would be required for this fracture to change direction and propagate circumferentially.

- There is no mechanical reason for the upward extending vertical fracture to arrest. The stress intensity at the tip of the fracture, essentially the driving force for fracture, was increasing as the fracture became longer.

Figure 12. Left: Figure 70 from page 73 of Blade main report. Right: Corrected Figure 70 with red arrows added, which in addition to existing blue arrows, show actual crack propagation direction. The upper vertical fracture did not arrest abruptly at the location indicated by Blade. The circumferential fracture simply ran into the existing (mostly) vertical fracture and stopped (location of lowest blue arrow).

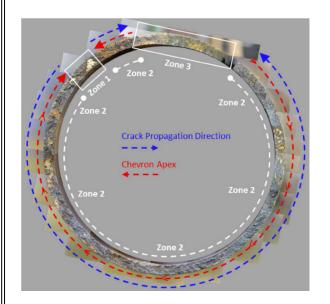
Figure 13. Left: Figure 69 from Blade main report. Right: Corrected Figure 69 showing actual crack growth direction.

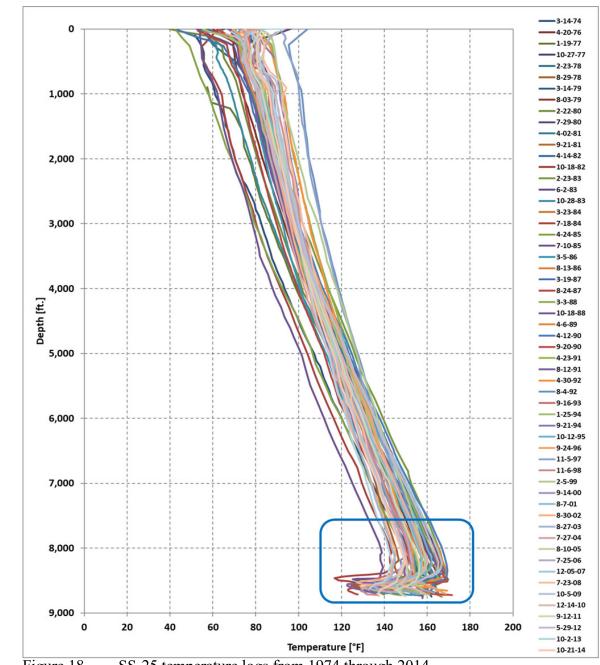
Figure 18. SS-25 temperature logs from 1974 through 2014.

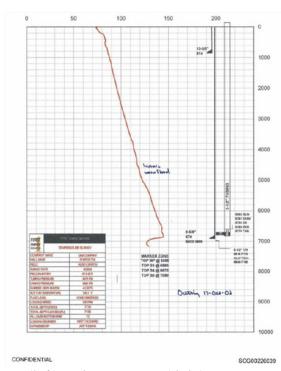
CONFIDENTIAL Figure 20. Temperature logs for Fernando Fee 32A (left) and Porter 72A (right).

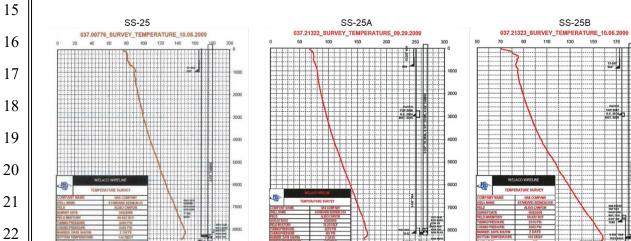
Figure 21. Temperature logs taken in 2009 in wells SS-25, SS-25A, and SS-25B.
