# **Blade Supplemental Report (Vol. 1: Approach)**

Root Cause Analysis of the Uncontrolled Hydrocarbon Release from Aliso Canyon SS-25

Volume 1: Approach

# **Phase 0 Summary**

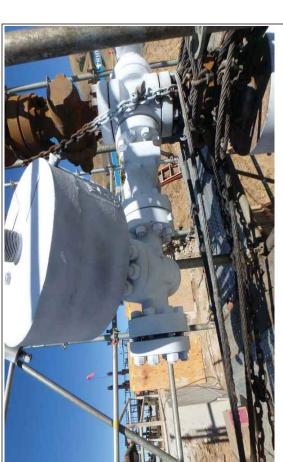
Description: General location of crack-like anomaly found during MPI

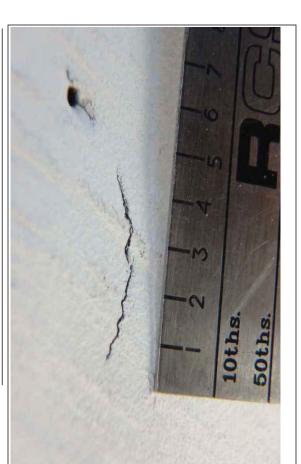
Description: Close-up of crack-like anomaly: horizontal measurement

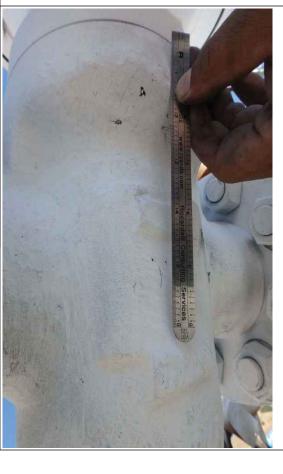
Description: Location of crack-like anomaly

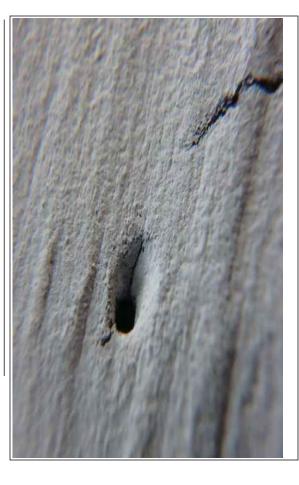
Description: Macro of crack-like anomaly plus adjacent hole

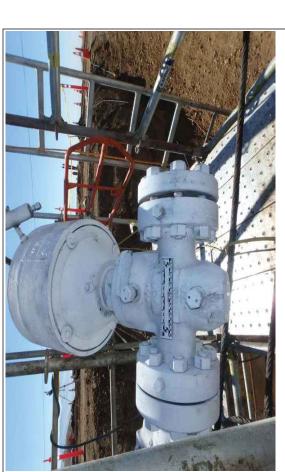
Description: General location of crack-like anomaly

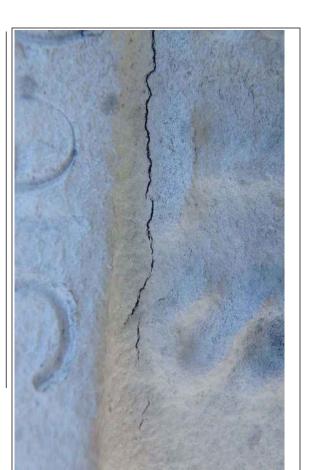
Description: close-up of crack-like within 1st inch

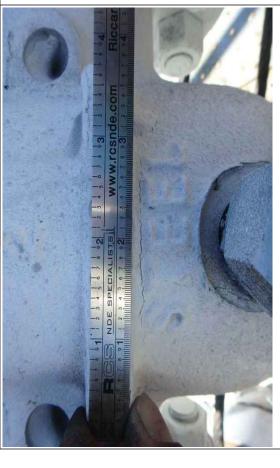
Description: 2.2" crack-like anomaly found

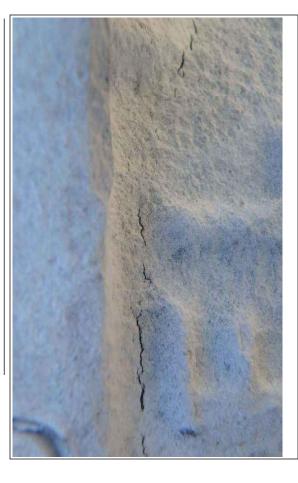
Description: close-up of crack-like within 1st inch

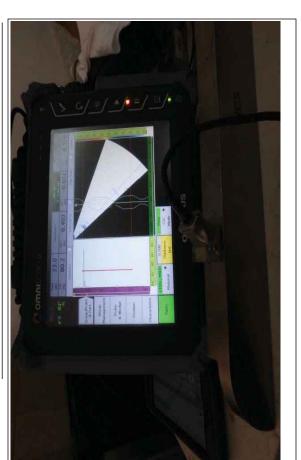
Description: PAUT post-calibration showing .403" depth measurement

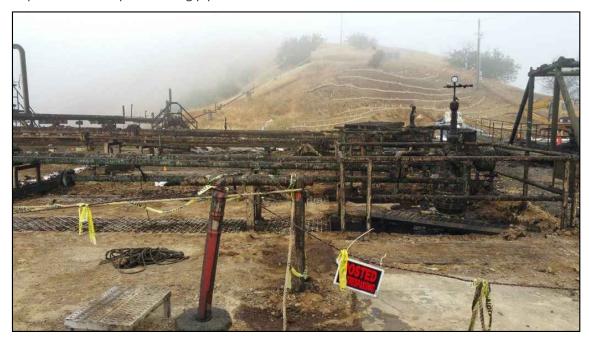
The crater was immediately adjacent to well site infrastructure, which included piping, concrete pipe trenches, and cellars for the adjacent SS-25A and SS-25B wells along with two concrete pipe trenches, which previously serviced SS-25, overhanging the west crater wall. In order to complete the crater excavation, the pipe trenches and their contents had to be safely removed. Figure 21 shows the area of the site prior to clean-up containing pipe trenches and the SS-25A and SS-25B's cellars.

Figure 21: As-found Pipe Trenches Filled with Blowout and Kill-Related Debris

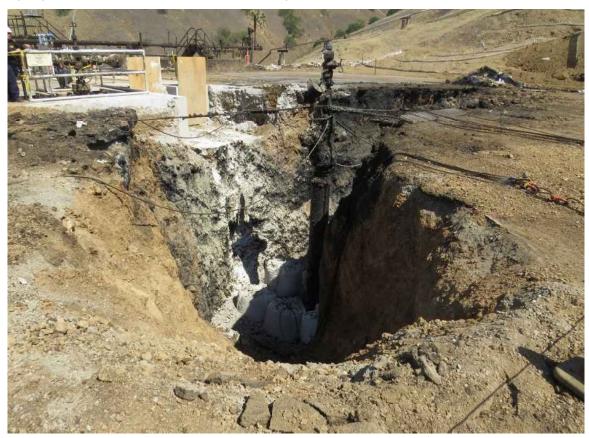
Figure 29 shows the condition of the SS-25 crater prior to excavation. Unsafe site conditions and *visually impacted* soils are readily apparent. The term visually impacted indicates soil readily identifiable as having been exposed to liquids expelled during the SS-25 blowout. Crater excavation was carried out to collect visually impacted soils and increase SS-25 site safety.

Figure 29: Condition of SS-25 Crater Before Excavation

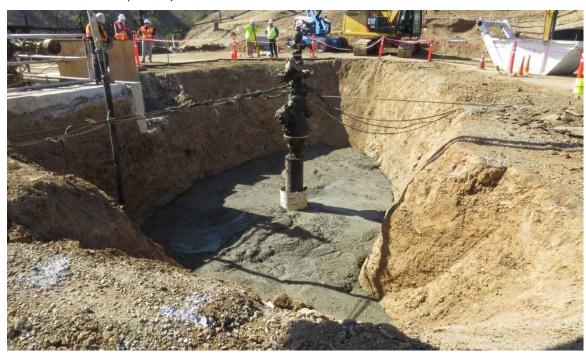
It is clear from Figure 53 that access for personnel to the wellhead for cleaning and NDE was difficult and hazardous. This portion of work in Phase 2 provided safe access to the wellhead and ensured safety of workers while inside the partially backfilled crater.

Figure 53: Hazardous Site Conditions for Personnel Needing Access to the Wellhead

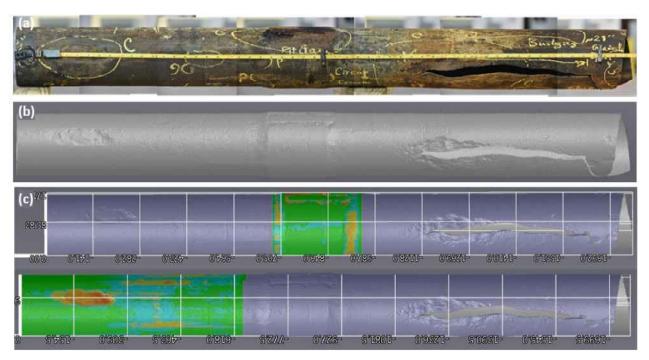
Figure 6: C023A1 (a) Photo, (b) Laser Scan Model, and (c) Corrosion Analysis Results

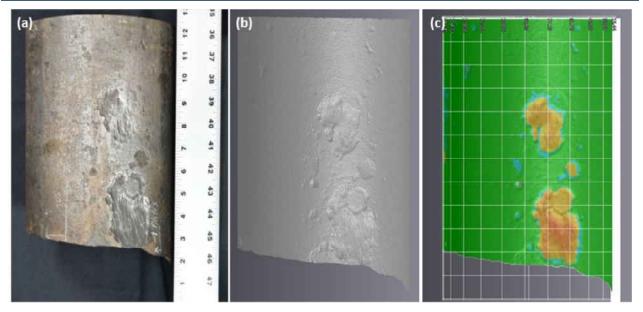
Figure 7: C022B (a) Photo, (b) Laser Scan Model, and (c) Corrosion Analysis Results

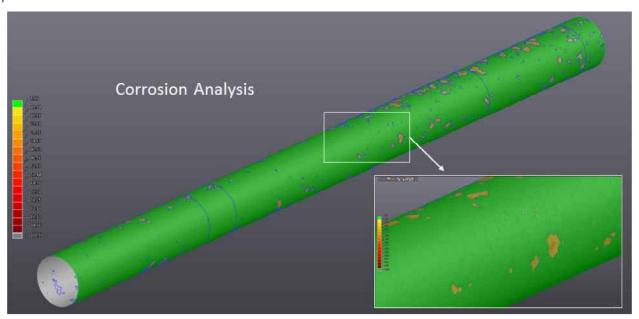
Figure 18: 3D Color Map of Corrosion Analysis Results for C018A

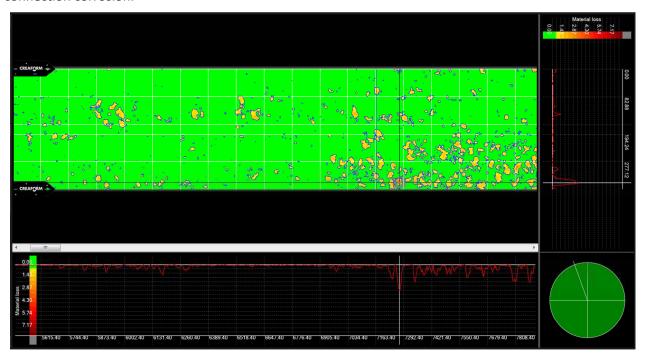
The software provided different views for the analyzed data. Figure 19 shows a 2D color map of the corrosion analysis for a section of joint 18. The 2D maps show the same image as the 3D map flattened to a 2D image. The plots on the bottom and right side of the image show the surface profile at the selected point for the longitudinal and circumferential directions, respectively. The point selected in Figure 19 is the maximum point of the current scan. The 2D plot shown in Figure 19 was the target output for all of the 7 in. casing joints. The corrosion analysis was carried out for each joint body.

Figure 19: 2D Color Map of Corrosion Analysis Results for C018A

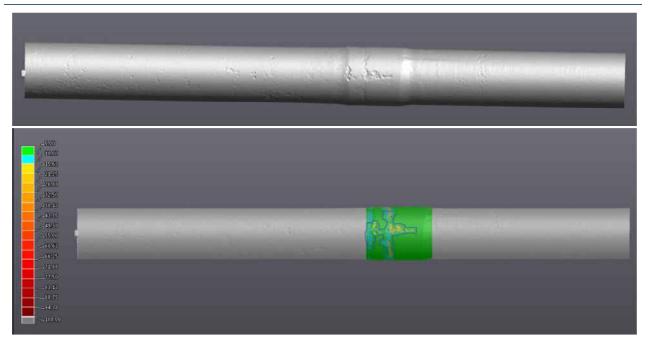
Figure 20 shows the 3D model and corrosion analysis color map for connection 18. Figure 21 shows the corresponding 2D color map. The adjacent pipe body was excluded from the analysis due to the differences in nominal OD. The pipe body was included in a separate analysis. Tapered regions adjacent to the connections cannot be analyzed by the software. These regions were excluded from the analysis.

Figure 20: 3D Model and 3D Corrosion Color Map for Connection 18

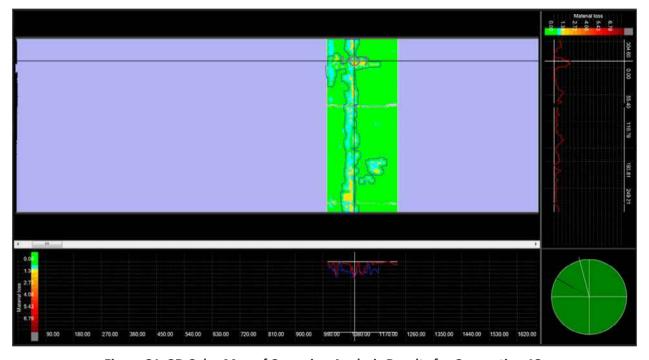
Figure 21: 2D Color Map of Corrosion Analysis Results for Connection 18
