Blade Energy Partners' Response to SED Data Request-58

Response to SED Data Request-58

Blade response to the CPUC Data Request SED 58 related to Vertilog technology and the casing failure in SS-25 from Reply Testimony of Mr. Robert Carnahan on behalf of SoCalGas.

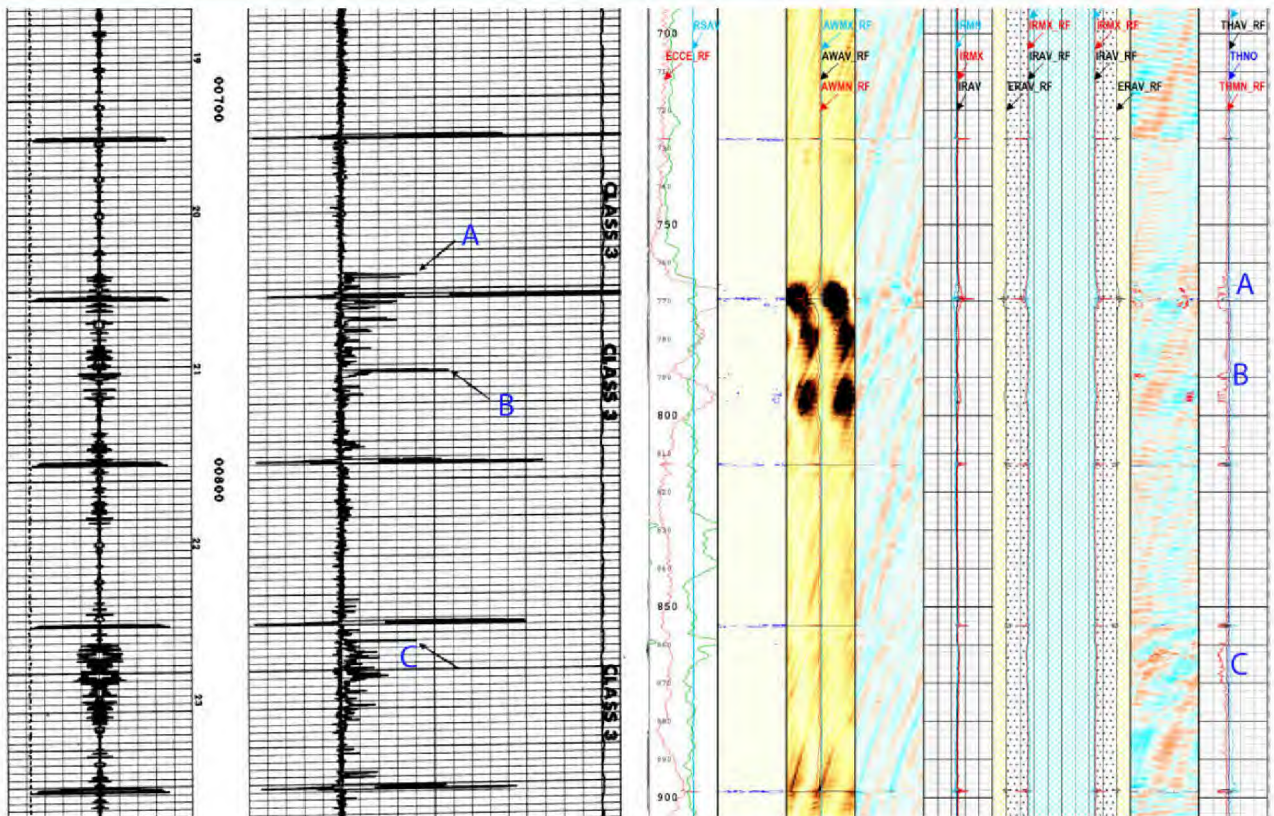
Figure 2: F-4 1988 Vertilog (Left) and 2016 USIT (Right) Comparison

Blade performed an analysis of F-4's 1988 Vertilog as part of the RCA [11] comparing it to the 2016 Ultrasonic Imager (USIT) log. Figure 2 shows these two logs with the Vertilog on the left and USIT on the right. To aid in interpretation from joint to joint, the logs have been adjusted so that the casing connections of each log are aligned. External metal loss is denoted by blue text at A, B, and C on the Vertilog's Flux Leak track, and by the same letter on the USIT's wall thickness track. At A-A, external metal loss is found just above a connection. At B-B, external metal loss is found approximately midway in the joint. At C-C, there is external metal loss below a connection. The point here is the two logs found the same defects.

There was good agreement between the logs at most depths. However, in some cases, the logs did not agree. It should not be assumed that the 2016 USIT log was the more accurate one. In Blade's experience, MFL tools are better at detecting pitting corrosion. In general, it's a flawed concept to compare one log tool to another and automatically claim one is more accurate than the other. Log data has to be compared to truth data (direct measurements of defects) to assess log performance. In today's era, repeatability and reproducibility of pipeline inspection tools are verified independently in pull-through tests (e.g., Pipeline Research Council International Integrity and Inspection projects). Even today, very little data has been published in testing downhole logging tools in controlled environments. An independent comparison of casing inspection logging tools spanning decades does not exist, however, the Vertilog and other casing inspection tools could have been used as an indicator of an issue.

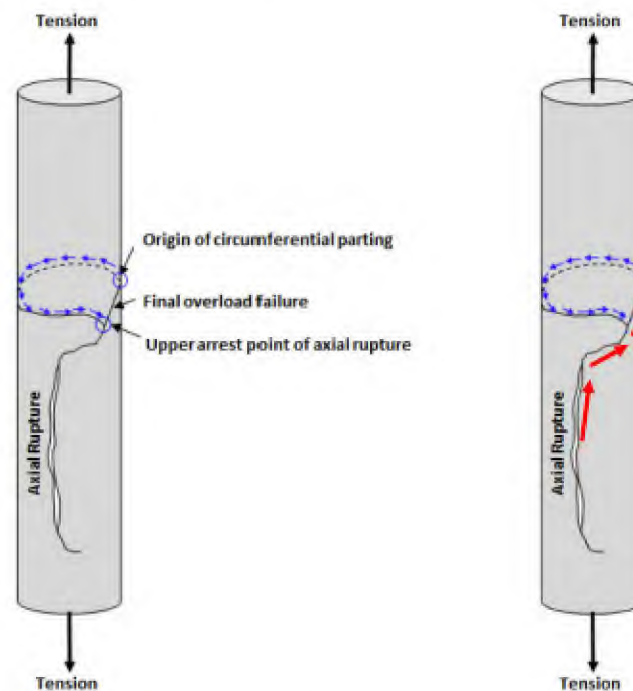
The Blade main report and various supplementary reports assert that the SS-25 7-in. casing's vertical rupture and circumferential parting were two separate events, with the circumferential parting occurring some period of time after the initial vertical rupture, but while the well was still on injection. To the contrary, it is evident the SS-25 7-in. casing vertical rupture and circumferential parting occurred as a single event, as illustrated in Figure 12 and Figure 13, and for the reasons described below:

Figure 12. Left: Figure 70 from page 73 of Blade main report. Right: Corrected Figure 70 with red arrows added, which in addition to existing blue arrows, show actual crack propagation direction. The upper vertical fracture did not arrest abruptly at the location indicated by Blade. The circumferential fracture simply ran into the existing (mostly) vertical fracture and stopped (location of lowest blue arrow).

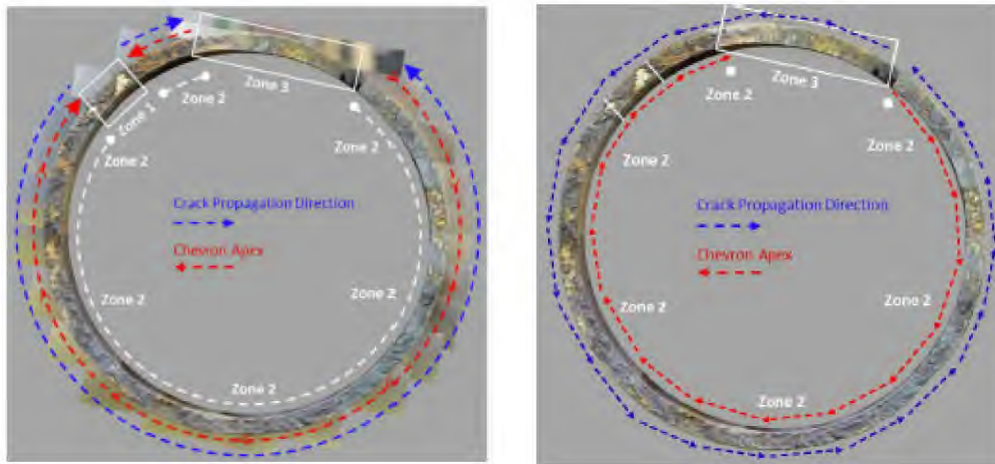
Figure 13. Left: Figure 69 from Blade main report. Right: Corrected Figure 69 showing actual crack growth direction.

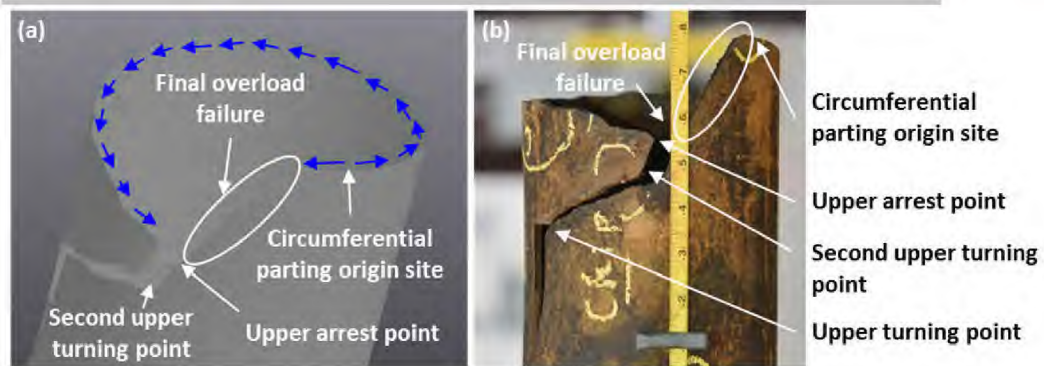
On page 54 in Section 2.4 of Blade's Main Report [9], it clearly states: "Visual and stereoscopic examination of the circumferential parting showed that the failure was not a continuation of the axial rupture, but rather re-initiated near the corner on one side of the parted casing. The origin site was determined based on chevron marks identified on the fracture surface. Figure 47 is a (a) laser scan and (b) image which identifies the upper arrest point, circumferential parting initiation site, and the final overload failure. Figure 48 is stitched stereo images showing the chevron marks and propagation direction of the circumferential parting. These observations indicate that the axial rupture and circumferential parting were two separate events despite their close proximity, and that they are most likely related to each other. This is discussed in more detail later within this section." Figures 47 and 48 are extracted from the Blade Main Report.

Figure 47: (a) Laser Scan and (b) Photo Indicating Circumferential Parting Initiation Site and Final Failure

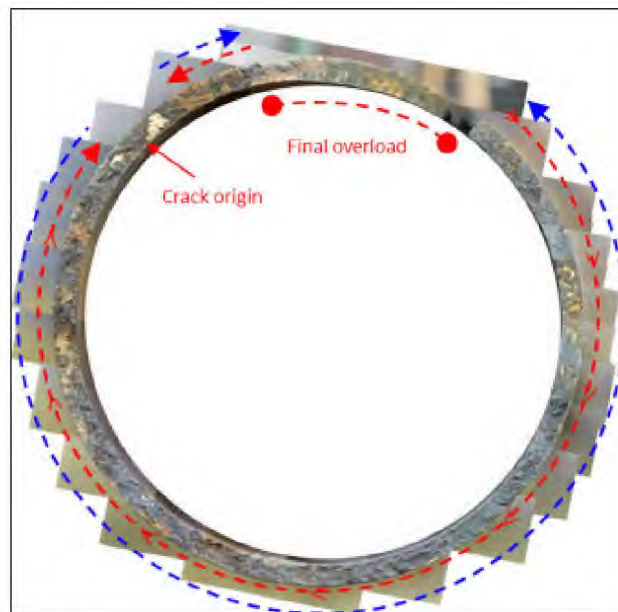
Figure 48: Stitched Images of the Lower Circumferential Parting Fracture Surface

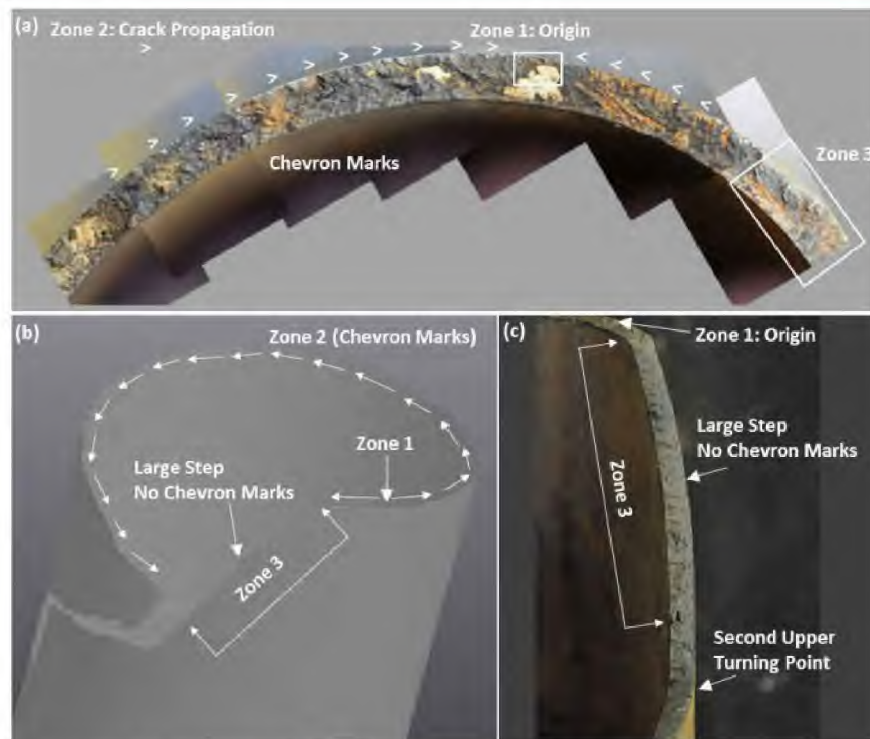
Additional evidence is provided by Blade (Figure 67 on page 71 of Blade's Main report) illustrates the three zones of the circumferential parting. Figure 67 (a) is a stereo image showing the three zones, origin, and the direction of the crack propagation. Figure 67 (b) is a 3D schematic showing the overall circumferential parting steps. Figure 67 (c) is a close-up of the Zone 3 fracture surface, which does not exhibit any chevron marks, thus there is no continuity of the axial fracture.

Figure 67: (a) Stereo Image (b) 3D Schematic of Zones (c) Macro Image of Three Zones

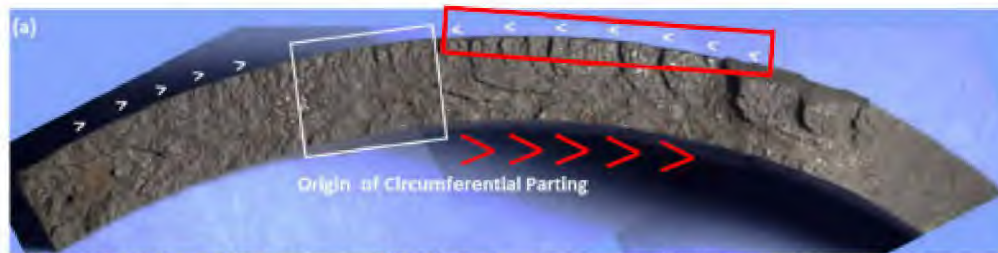
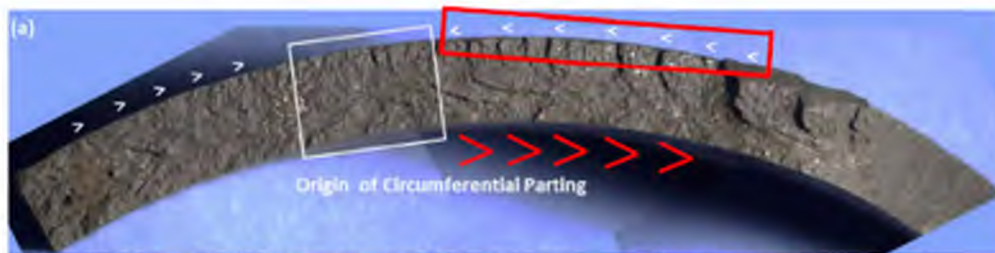
Figure 15. Figure 68 from page 72 of Blade main report. Red rectangle encloses backward chevron marks drawn by Blade. Red chevron marks inserted above are consistent with chevron marks present on the fracture surface. Blade misidentifies the chevron marks as flowing towards the origin. Based on both my physical inspection on February 27-28, 2020, and my analysis of this image, the chevron marks travel to the right, as indicated by the red arrows at the bottom of the figure.

In the caption of Figure 15 below, Mr. Carnahan states "Blade misidentified the chevron marks as flowing towards the origin. Based on both my physical inspection on February 27-28, 2020, and my analysis of the image, the chevron marks travel to the right, as indicated by the red arrows at the bottom of the figure."

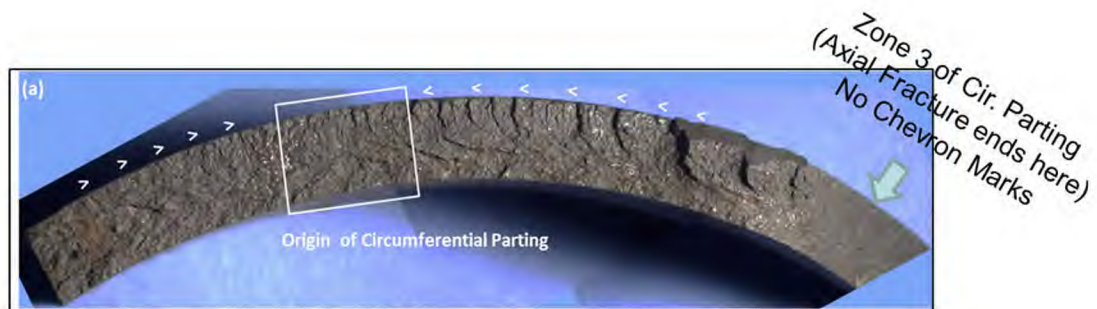
Figure 68 (a), Page 72 Blade Main Report

The figure below (Figure 68 (a), page 72 of Blade Main Report) shows no chevron marks on the final overload rupture. For clarity, we have annotated the upper corner on the right-hand side of the figure with the green arrow) indicating no chevron marks on the final overload failure of Zone 3 of the circumferential parting. On the circumferential fracture surface there is no extension of the axial fracture chevron marks.

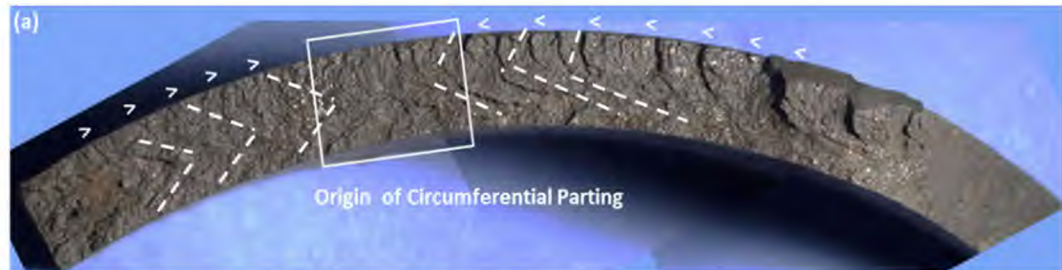
Figure 68 (a), Page 72 Blade Main Report

Blade disagrees with the statement because the visual and stereomicroscopic examinations performed by Blade showed that the apexes of the chevron marks are in the opposite directions around the origin. This is further clarified in Figure 68(a), page 72 of the Blade Main Report below that shows the chevron marks point back towards the origin from either side of the origin. For

clarity, white dashed lines have been added to the figure to outline the chevron marks that point back towards the origin from either side of the origin. This is inconsistent with Figure 16 of Mr. Carnahan's testimony.

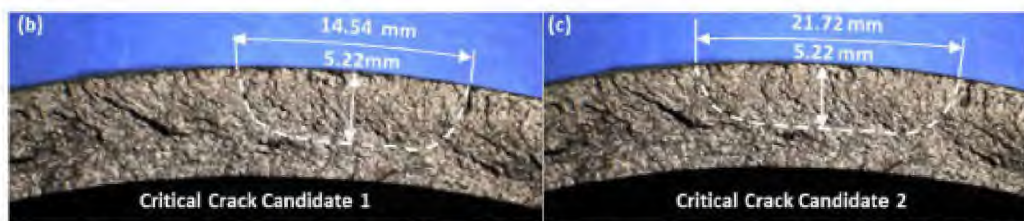
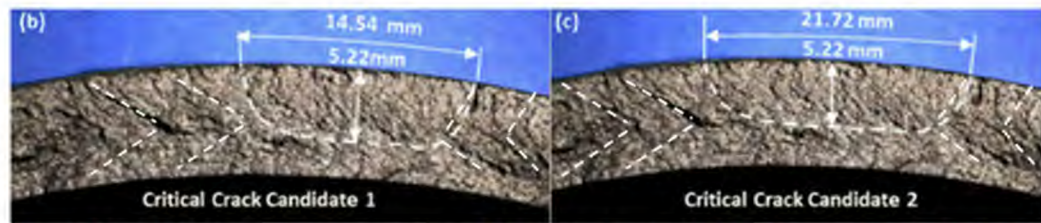
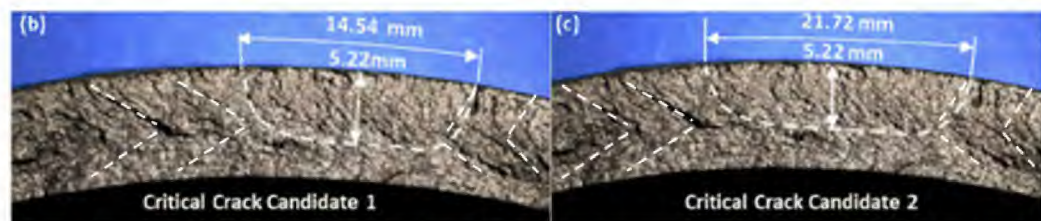
Blade's contention that a separate fracture origin exists on the circumferential portion of the fracture is incorrect (Figure 17). Rather than a fracture origin, this area is merely a continuation of the circumferential portion of the fracture. Fracture surface markings within the hypothesized origin are the same as or similar to those outside of the origin.

Figure 17. There are no features in either of the areas shown in Blade Figures 68b or 68c that suggest the existence of a fracture origin.

An examination of the chevron marks in Figure 17 (i.e., Figure 68 in Blade's Main Report, page 72), showed that the features inside the origin were different from chevron marks outside the origin. The examination identified an area (the origin) that was absent of chevron marks but had chevron marks on either side pointing towards it. For clarity, white dashed lines have been added to outline the chevron marks that point back towards to the origin from either side of the origin. This observation is consistent with the illustration, Figure 14, provided by Mr. Carnahan.

Blade identified the fracture origin of the circumferential parting based on the observed apexes of the chevron marks pointing at the origin, along with the presence of a pre-existing OD oxidized flaw. This was also discussed in Statements 9 and 10. Blade identified two semi elliptical areas as possible critical crack sizes (origin) for the circumferential parting based on thorough examination with the stereo microscope and SEM, one is 14.54 mm long x 5.22 mm deep and the other one 21.72 mm long with the same depth, see pages 71 and 72 of Blade's Main Report and Section 3.3.1 on page 134 of Blade's supplementary report *SS-25 Casing Failure Analysis* for details. Figure 17 provided by Mr. Carnahan in Statement 9 (i.e., Figure 68 in Blade's Main Report, page 72), with added dashed lines to outline the chevron marks), showed that the features inside the origin were different from chevron marks outside the origin. The examination identified an area (the origin) that was absent of chevron marks but had chevron marks on either side pointing at it.

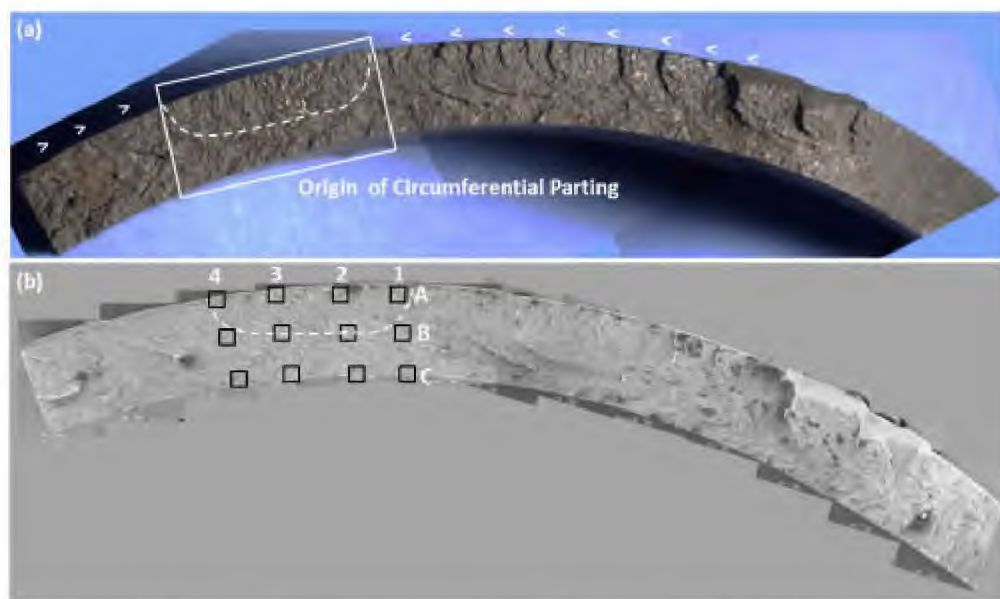
Figure 168: Specimen C023A1A1A (a) Stereo and (b) SEM Images of Zone 1 (Origin) Investigation Areas

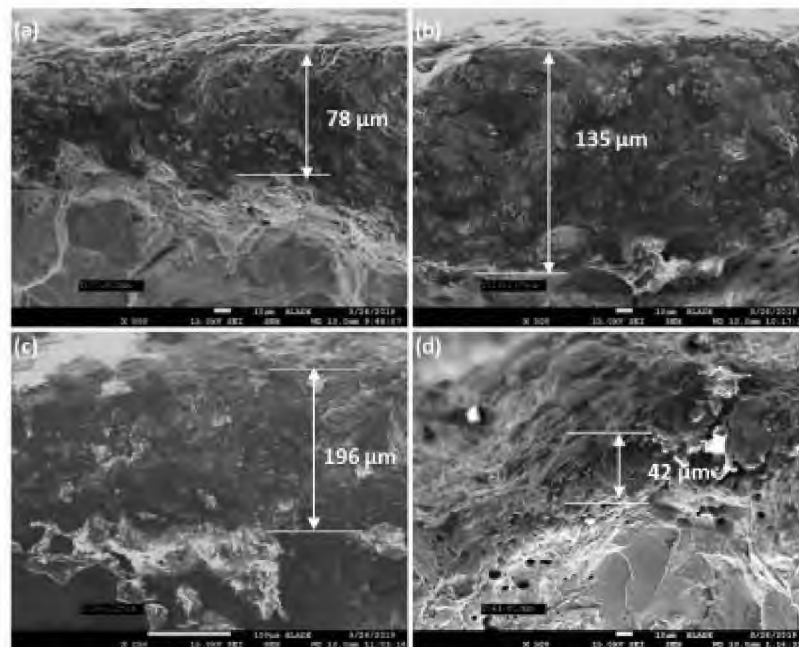
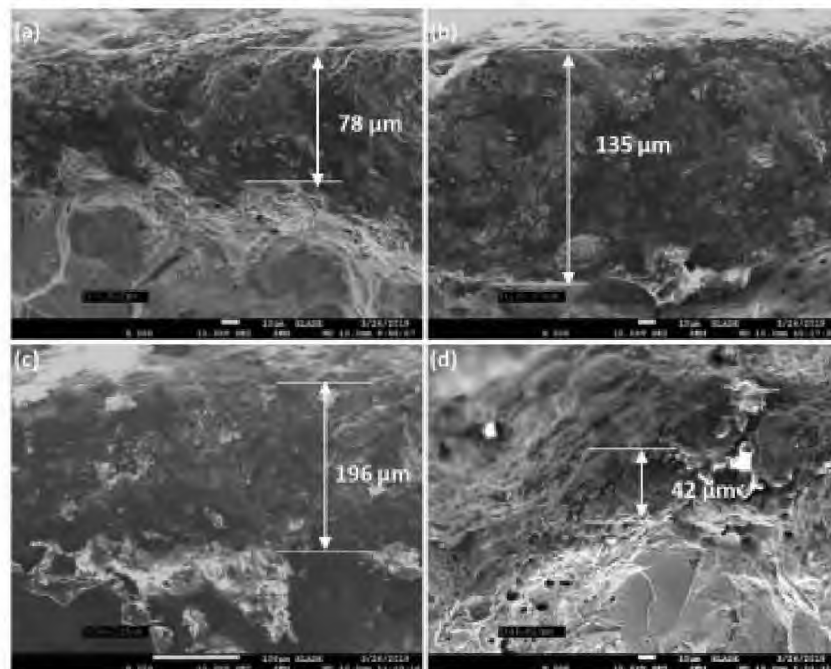
Figure 169: SEM Images of Pre-existing Flaws at (a) 1A, (b) 2A, and (d) 4A Taken at 500X, and (c) 3A Taken at 250X

The SEM images below show the origin was initiated from a crack like surface flaw by cleavage (Figures 169 and 170 on page 141, *SS-25 Casing Failure Analysis* supplementary report).

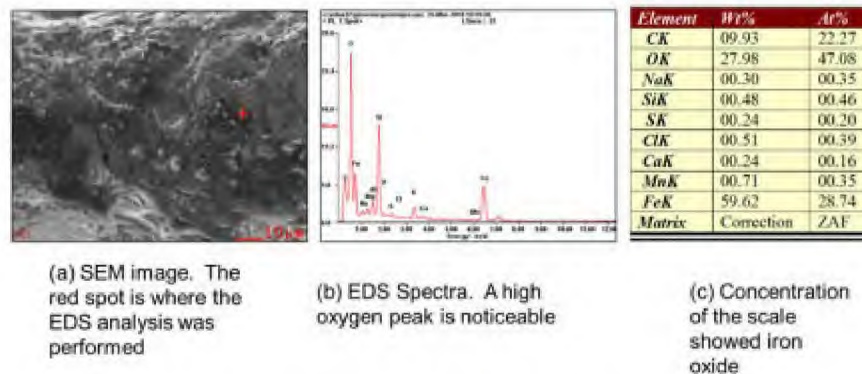
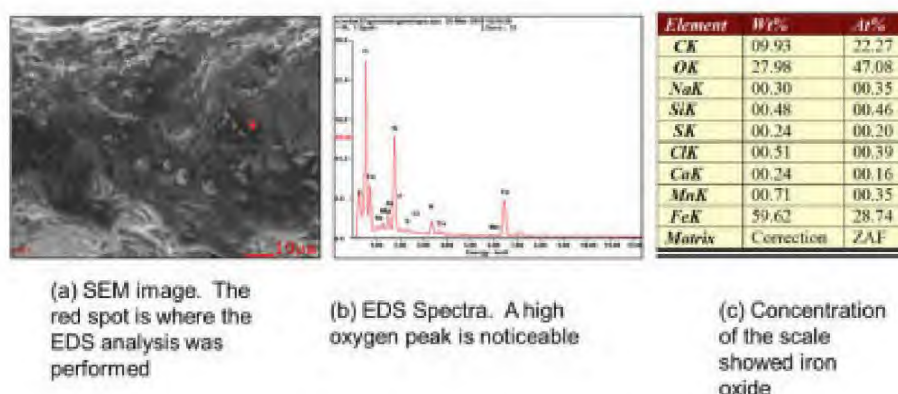
Figure 170: EDS Results for Pre-Existing Flaws

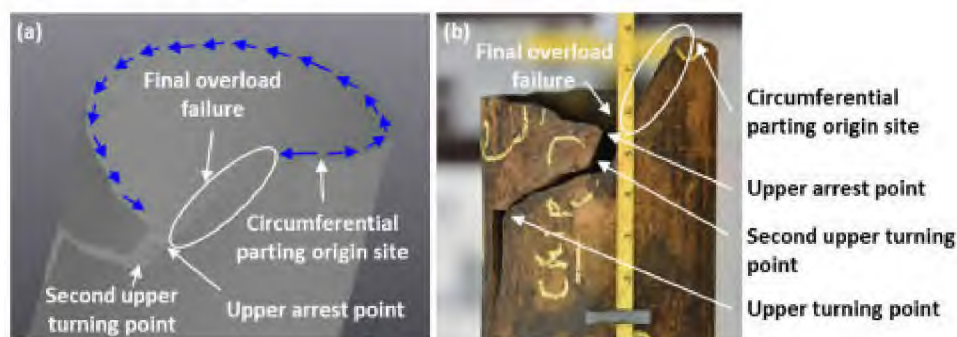
As stated in the supplementary report, Figure 78 (page 76) and Figure 86 (page 81) illustrates the upper (upward) turning point, second upper (upward) turning point, and arrest point. The images show the upper (upward) section of the axial rupture. Figure 87 (page 82) shows the lower (downward) turning and arrest points.

Figure 78: (a) Laser Scan and (b) Circumferential Parting

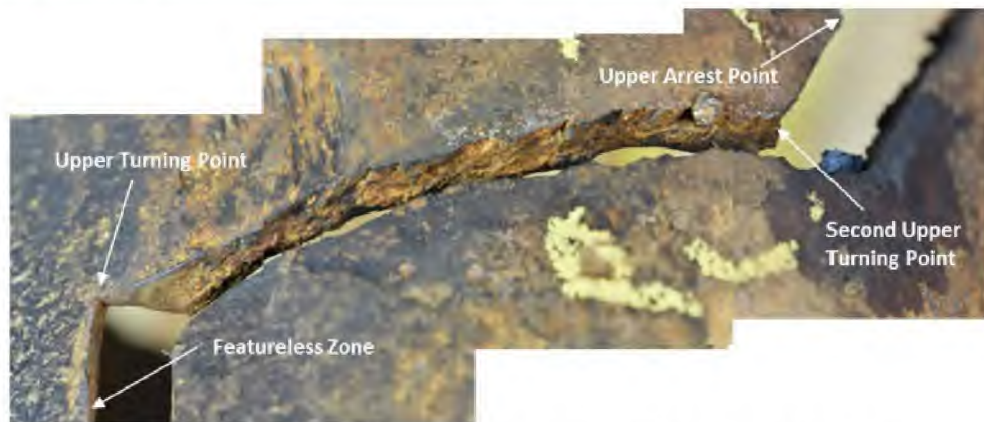
Figure 86: Macro Image of the Two Upper Turning Points and Single Arrest Point

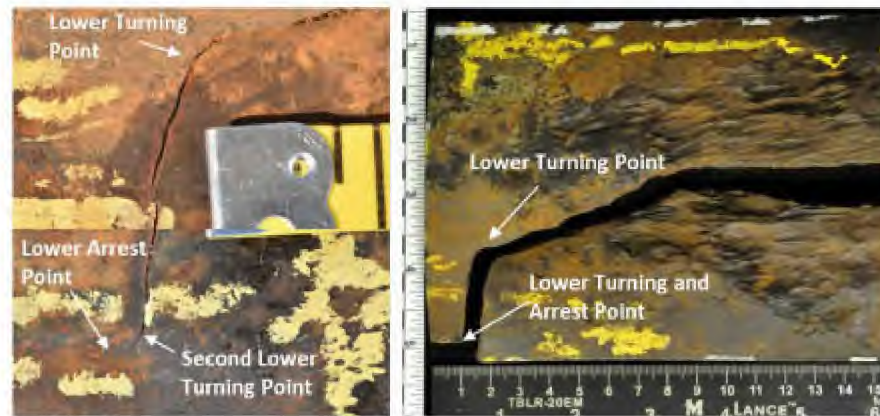
Figure 87: Macro Images of the Lower Turning and Arrest Points

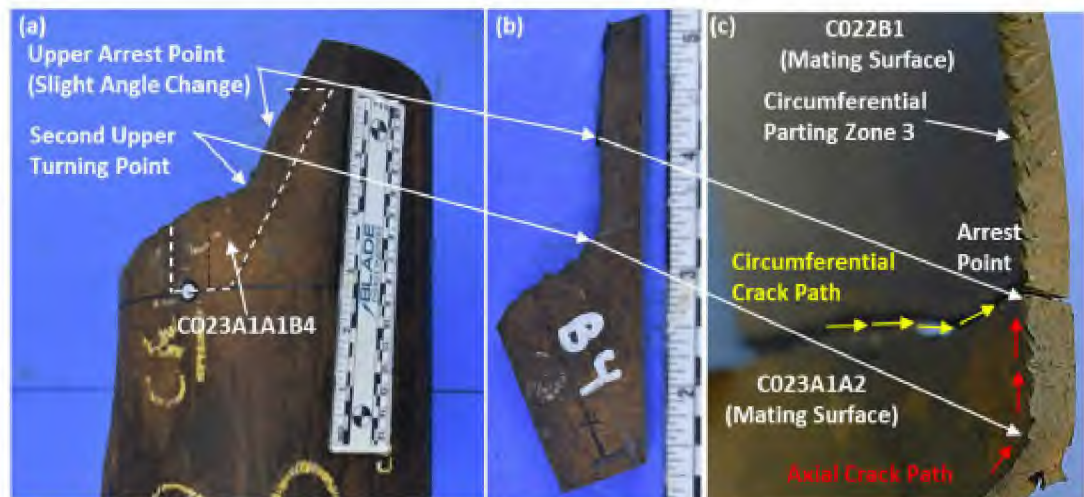
Figure 142: Specimen C023A1A1B4 Extraction

Figure 142 (page 121 in the supplementary report) below shows more detail on the second upper (upward) turning point and upper (upward) arrest area. The upper (upward) arrest area is identified by a slight angle change on the inclined surface. The fracture surface of the upper (upward) arrest area shows no chevron marks because the axial crack was arrested.

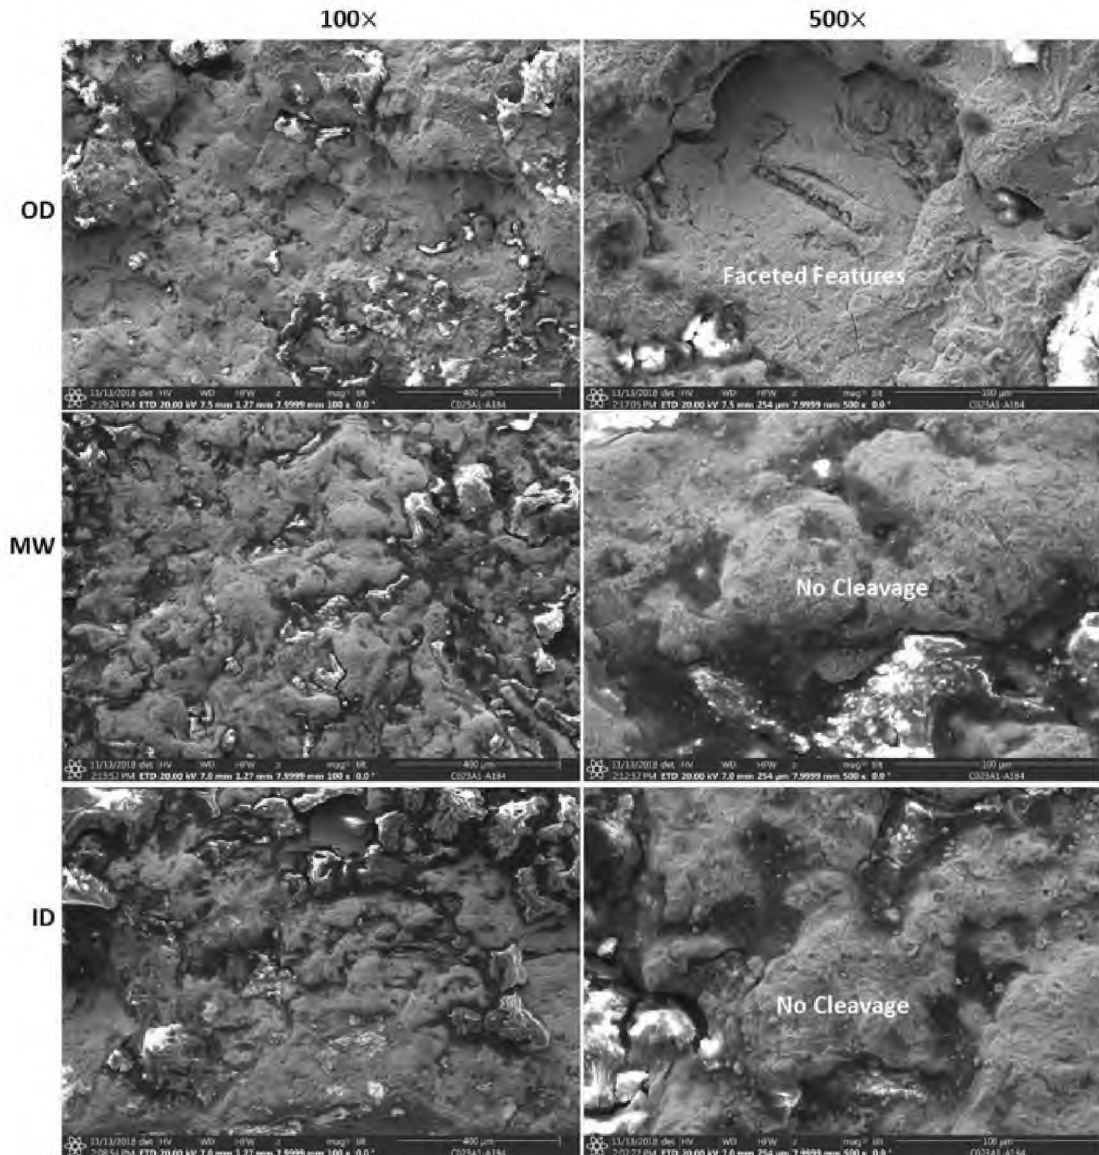
Figure 146 (page 124 of the supplementary report) below are the SEM images of the axial upper (upward) arrest area showing no cleavage facets. There are two observations in the arrest region that support the fact that the crack was arrested. First is the absence of chevron marks observed with a stereo microscope. Secondly, the absence of cleavage facets, observed using a SEM in the same region. Both of these factors support the interpretation that the axial crack slowed down and arrested in this region around a temperature of 80°F. Had the crack propagated per Mr. Carnahan's hypothesis, there should have been chevron marks and cleavage facets in this axial to circumferential transition region, identified as Zone 3.

Figure 146: Specimen C023A1A1B4 A3 Showing OD, MW, and ID at 100x and 500x

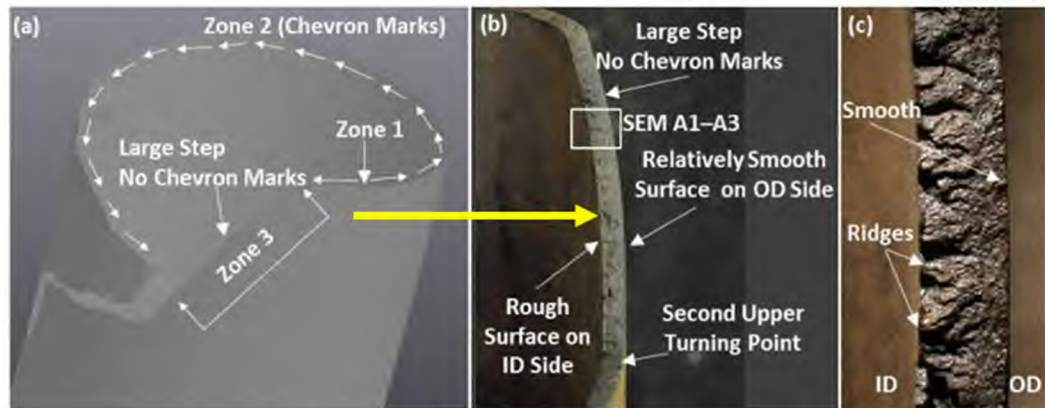
Figure 178 (a) (page 146 of the supplementary report) shows a schematic of Zone 3 of final circumferential parting. The yellow arrow points to Figure 178 (b) and (c) that show macro and stereo images at a higher magnification of Zone 3. The images show a step-like appearance on the

Figure 178: (a) Schematic and (b) (c) Image of Zone 3 (Final Overload Failure)

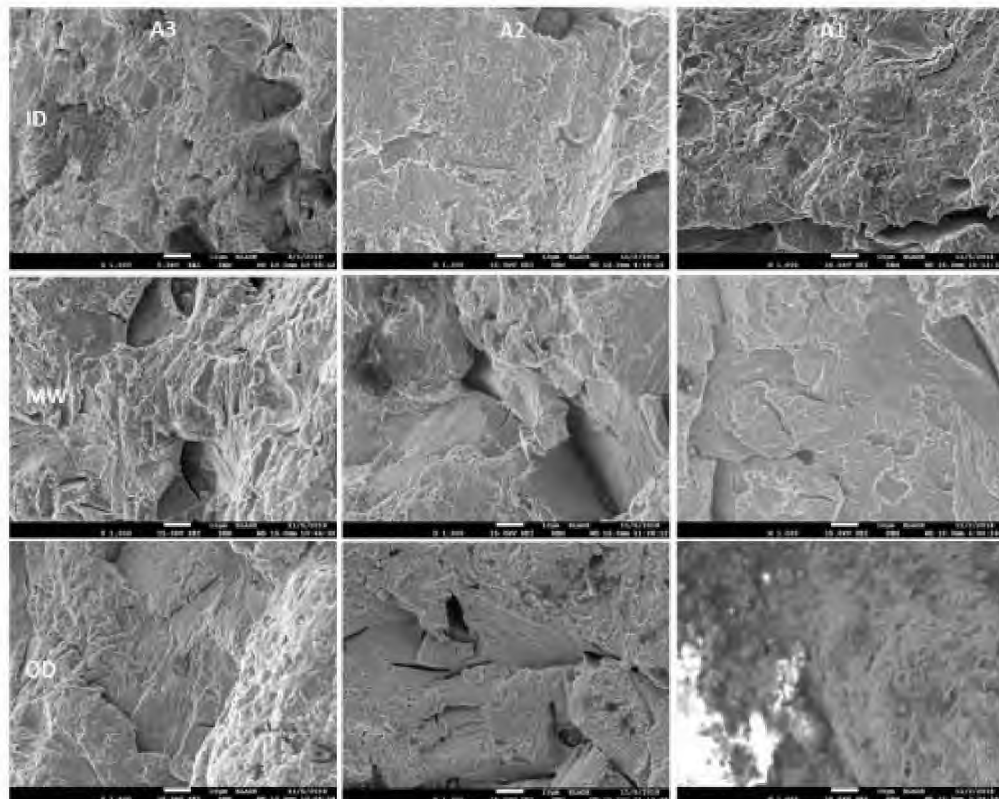
The SEM examination (Figure 180 on page 148 of the supplementary report) showed that the fracture surface near the OD side was mostly cleavage separation, while the ID side showed a mix of cleavage facets and a woody type of plastic deformation. The fracture surface morphology at the mid-wall was a combination of the OD and ID morphologies. This evidence is consistent with the brittle overload failure at temperature below ductile-brittle transition temperature (DBTT).

Figure 180: Fracture Surface Morphologies near the ID, MW, and OD Taken at 1,000X

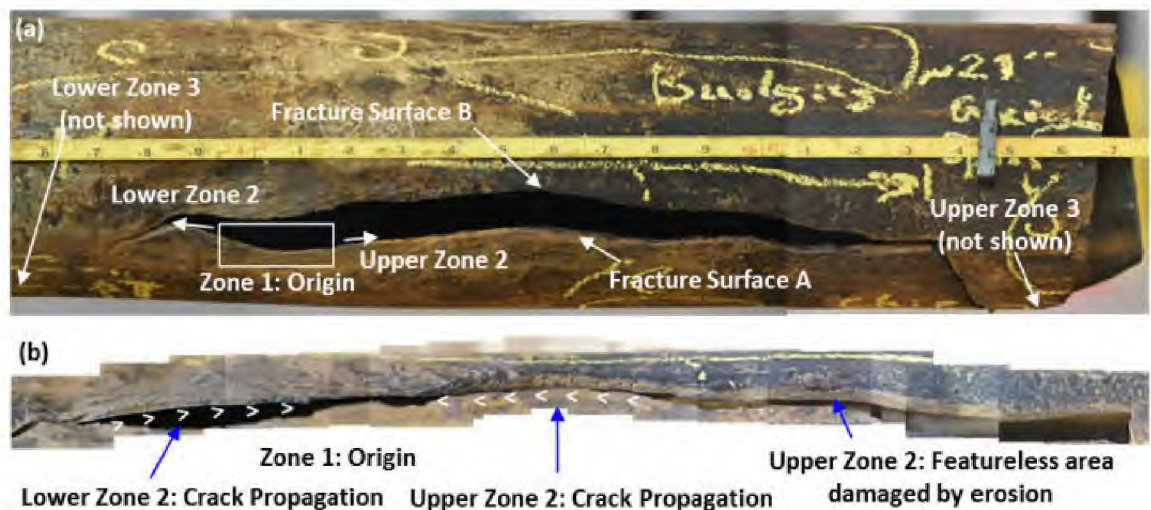
Blade's response to Issue (b): Blade disagrees with Mr. Carnahan's statement that the crack may have arrested at the wall thickness change near the connection. The arrest point was about 9 in. from the start of the change in wall thickness of the casing pin connection, therefore the arrest is not coincident with the wall thickness change. However, Blade does agree that the connection contributed to the lower arrest point. Blade has addressed this issue in its supplementary report *SS-25 Casing Failure Analysis* (Section 3.2.1, page 78). Figure 81 (page 79) shows that the origin was not symmetrically located at the center of the rupture. The non-symmetric location of the origin can be explained by the proximity of the origin to connection 22. The axial crack initiated in Zone 1 and propagated in opposite directions. The lower (i.e., "downward" used by Mr. Carnahan) crack front propagated towards connection 22, which provided additional constraint. Parameters that may contribute to the constraint include connection make up stresses and residual stresses due to local deformation. The upper crack was not influenced by any additional constraint allowing the crack to propagate further before arresting.

Figure 81: (a) Front and (b) Top Views of Fracture Surface B Identifying Zones 1 and 2

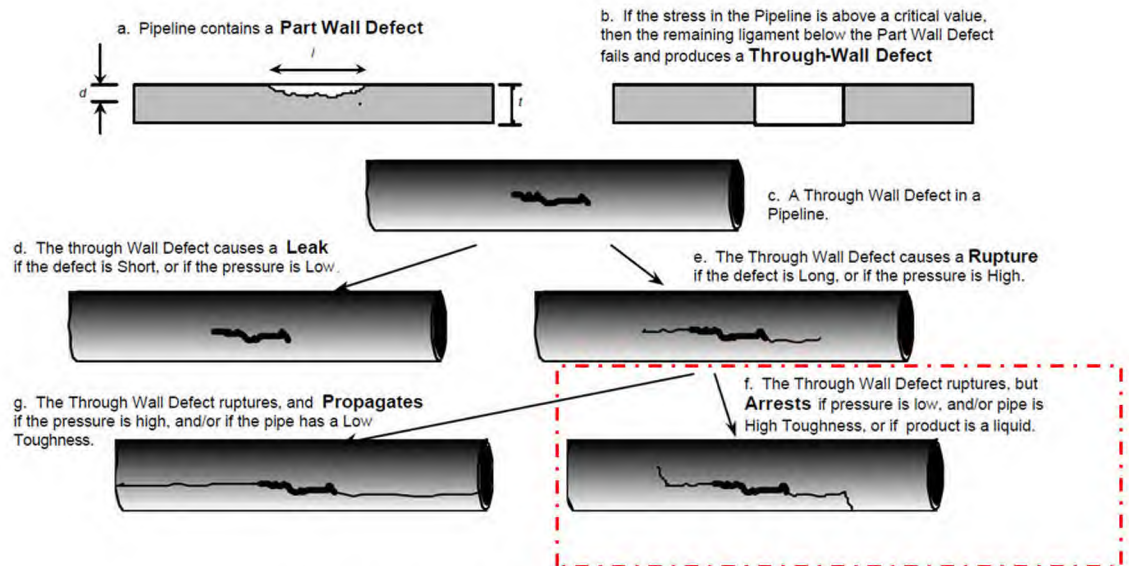
42.6% of actual yield strength, which was a low stress failure, i.e., a low driving force for failure. On the other hand, the temperature at the time of the axial rupture was 80°F. The material exhibited high ductility and toughness. Therefore, this was a low driving force and high resistance failure condition, which falls in the crack arrest category. Therefore, the upward crack would eventually be arrested.

Figure 4: Pipe Failure Process

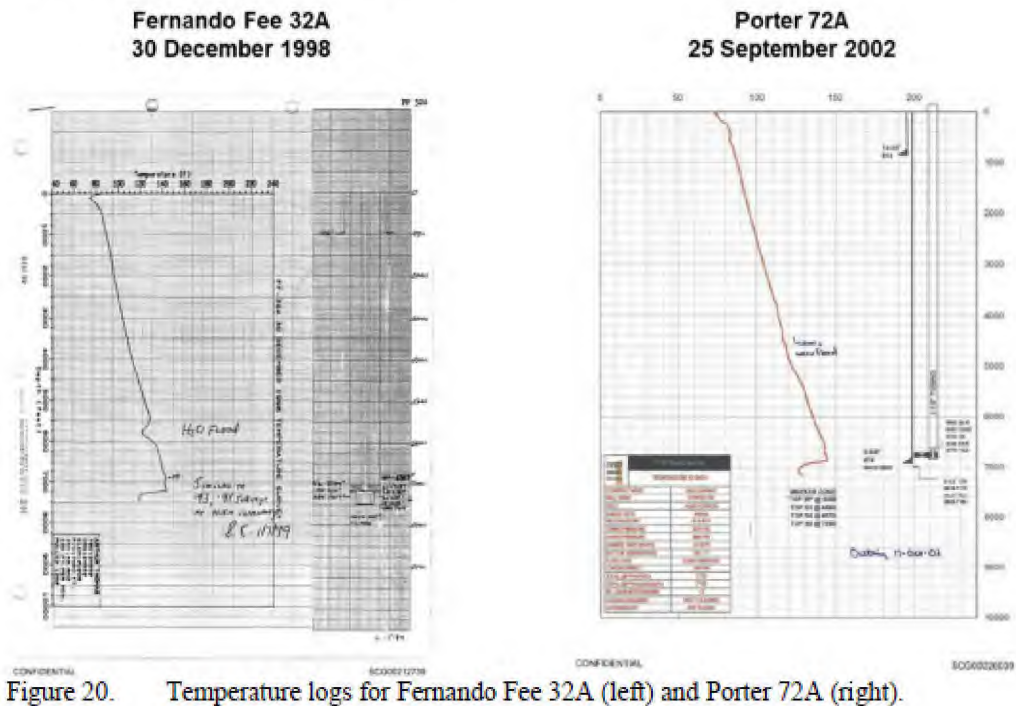
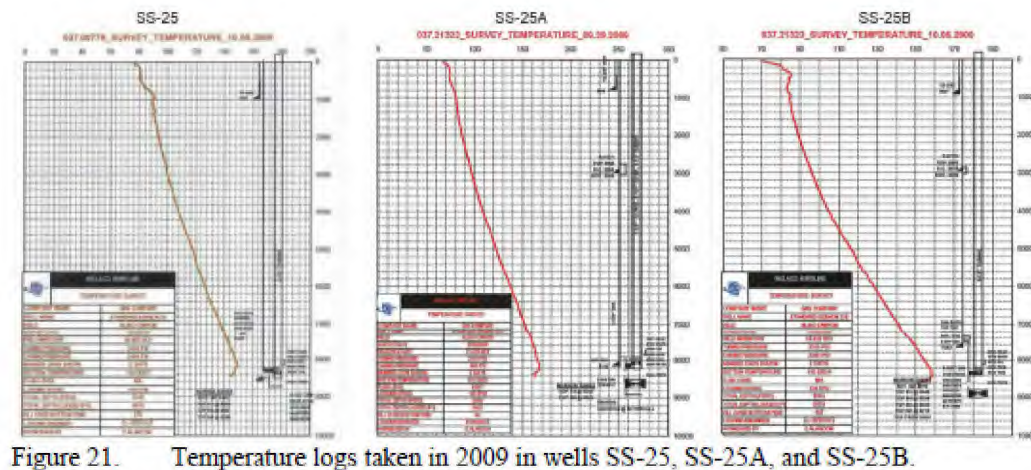
All storage wells at Aliso Canyon exhibit the same or similar cooling at that depth. For example, Figure 20 shows that Fernando Fee 32A and Porter 72A both exhibit cooling at the bottom of the wells, and the same is true for SS-25A and SS-25B (Figure 21).

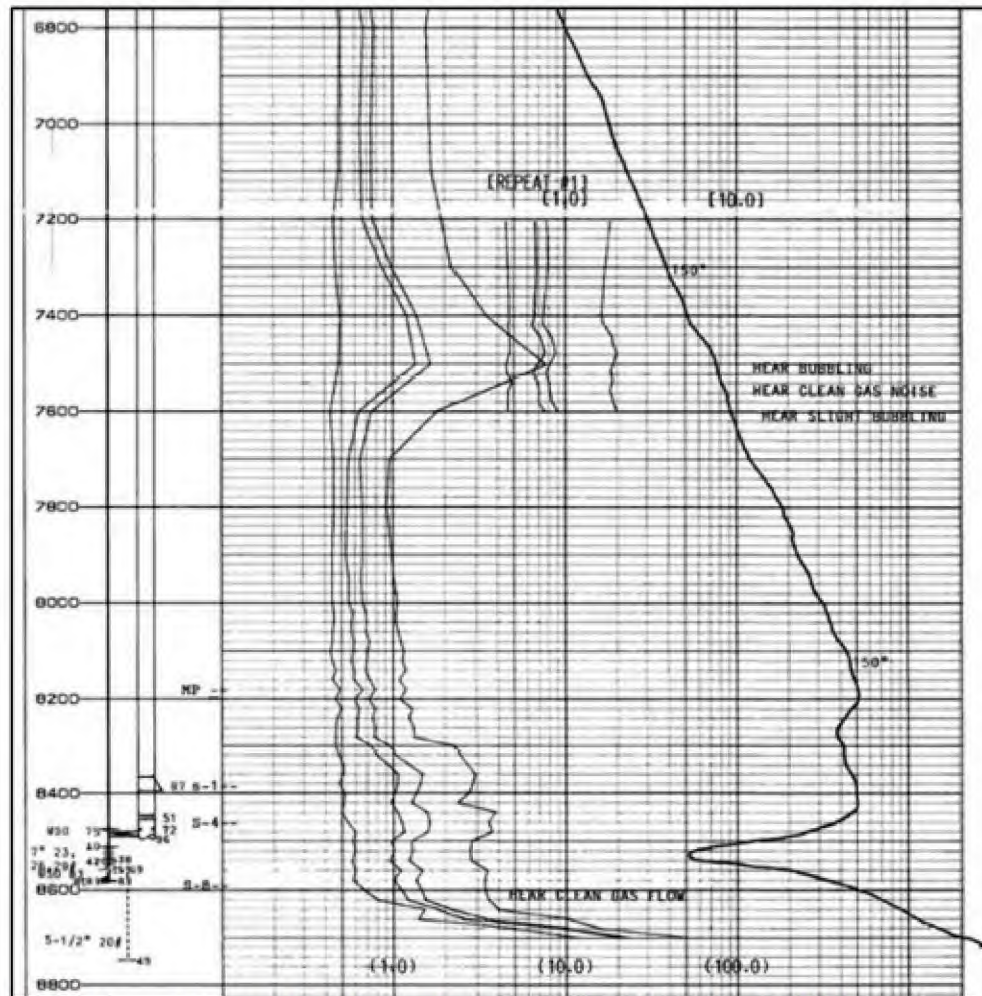
The same six logs also measured noise across all four frequency ranges slightly above the packer and completion equipment at the base of the well, and across the storage formation. Such noise is expected and is associated with movement of gas in the storage formation and through the completion equipment. The 1991 log includes operator comments regarding noise interpreted as "bubbling" at a depth of about 7,500 ft., which is shown in the excerpt of the log in Figure 22. As can be seen in the figure, the noise log was repeated over the depth range of 7,200 ft. to 7,600 ft. and the indicated bubbling noise was not detected.

Figure 22. Excerpt of SS-25 noise log performed on November 11, 1991.
