SCG-02-WP-A

Errata Workpapers (Redline) Supporting the Prepared Direct Testimony of Jordan A. Zeoli, Fidel Galvan, and Travis T. Sera

(Technical – Project Execution and Management, Volume I of VII; Public Version)

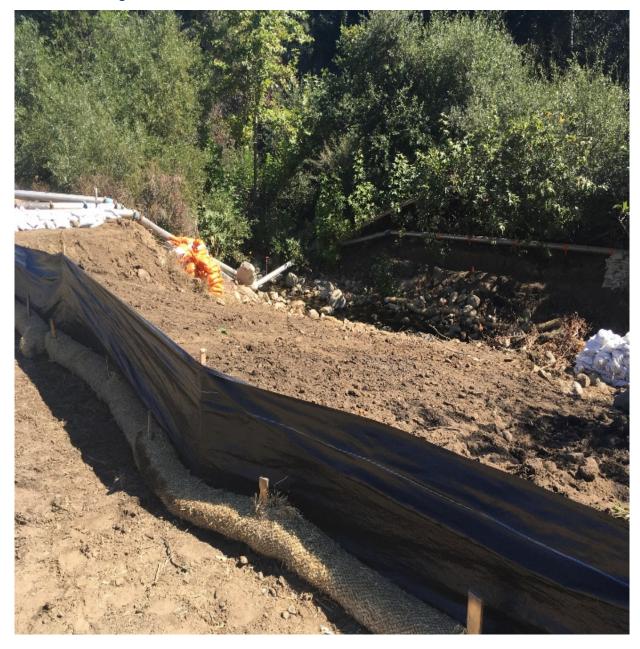
Figure 4: Water Diversion Plan for Direct Examination Site #1
