SED-238
Annual Report
SoCalGas Response to SED Data Request 17 (5)
I.19-06-016
ALJs: Hecht/Poirier
Date Served: March 25, 2021

1990

SOUTHERN CALIFORNIA GAS COMPANY
ALISO CANYON FIELD
ANNUAL REVIEW MEETING
with the
DIVISION OF OIL AND GAS

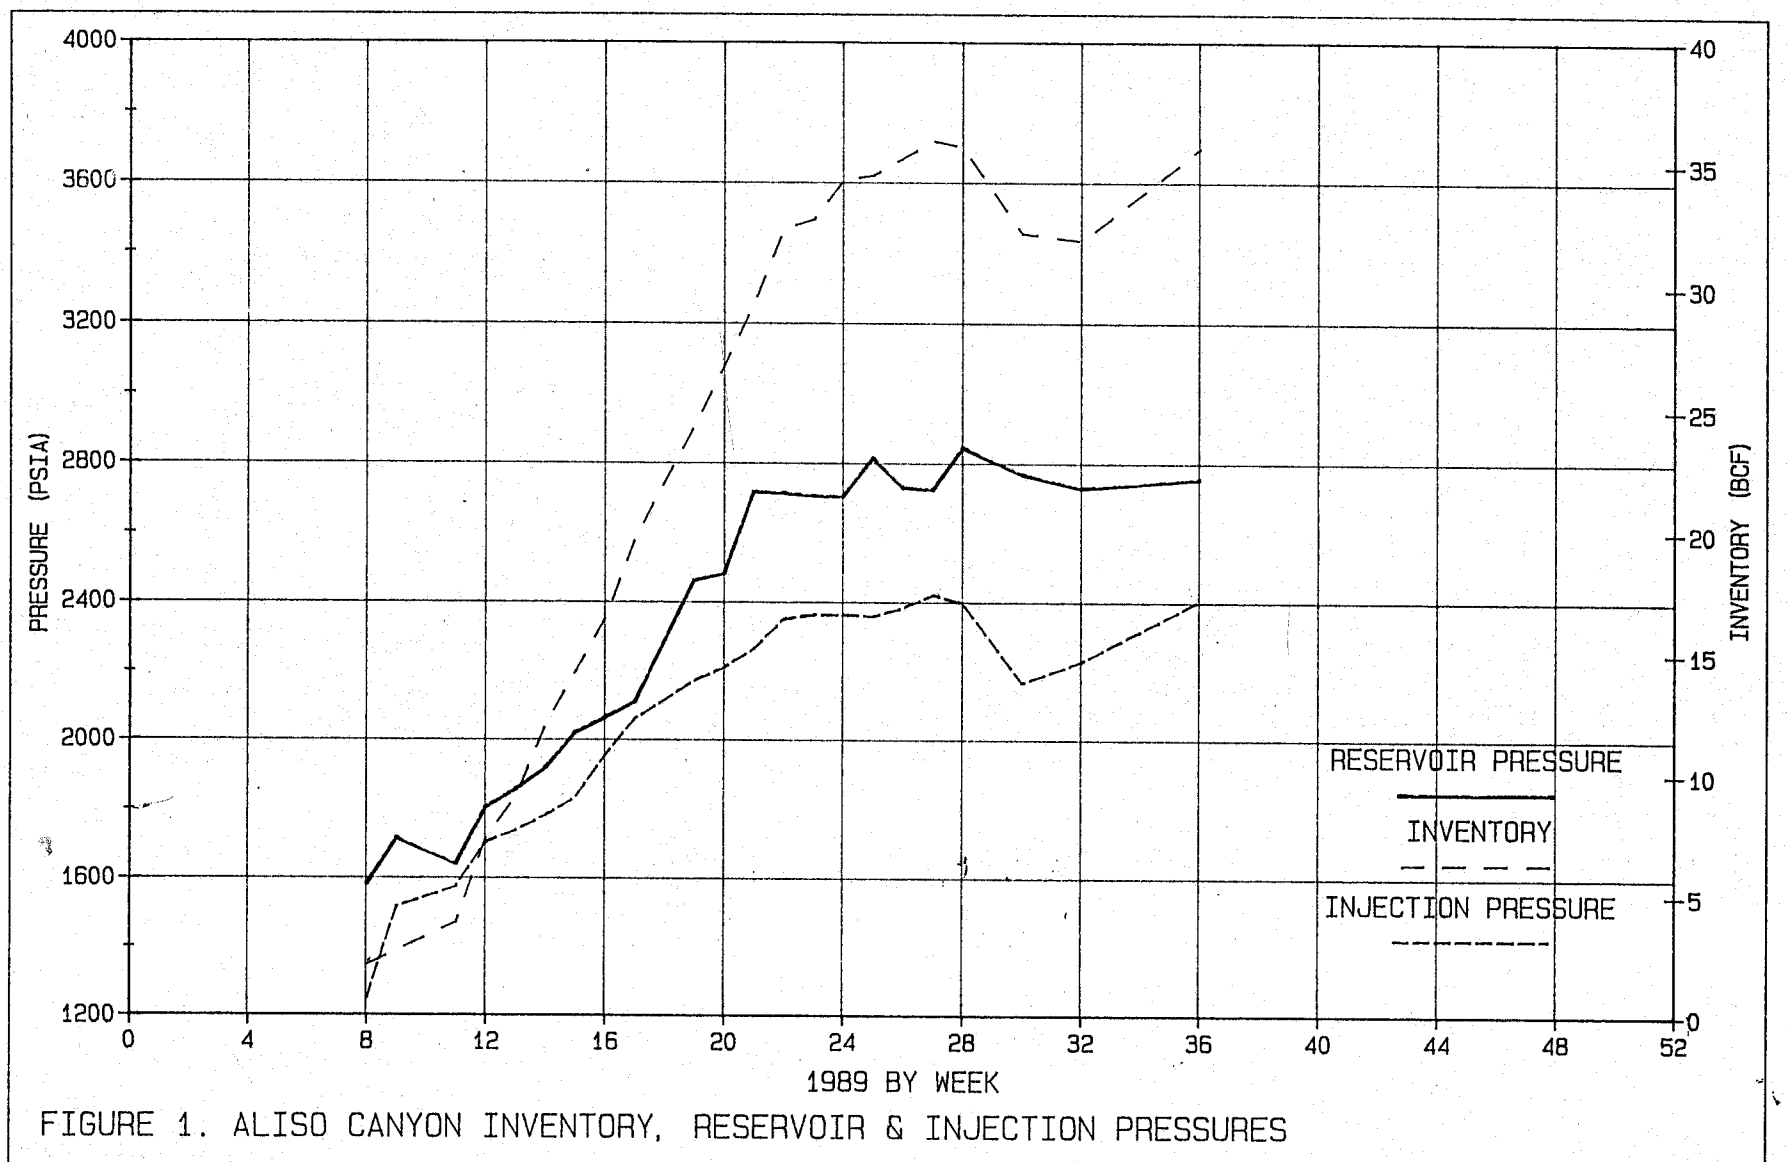
FIGURE 1. ALISO CANYON INVENTORY, RESERVOIR & INJECTION PRESSURES

Figures 1, 2, and 3 show the variation of the average reservoir pressure with inventory for the 1987-1989 injection cycles. The stabilized reservoir pressure is always maintained at less than discovery pressure (3602 psig.)

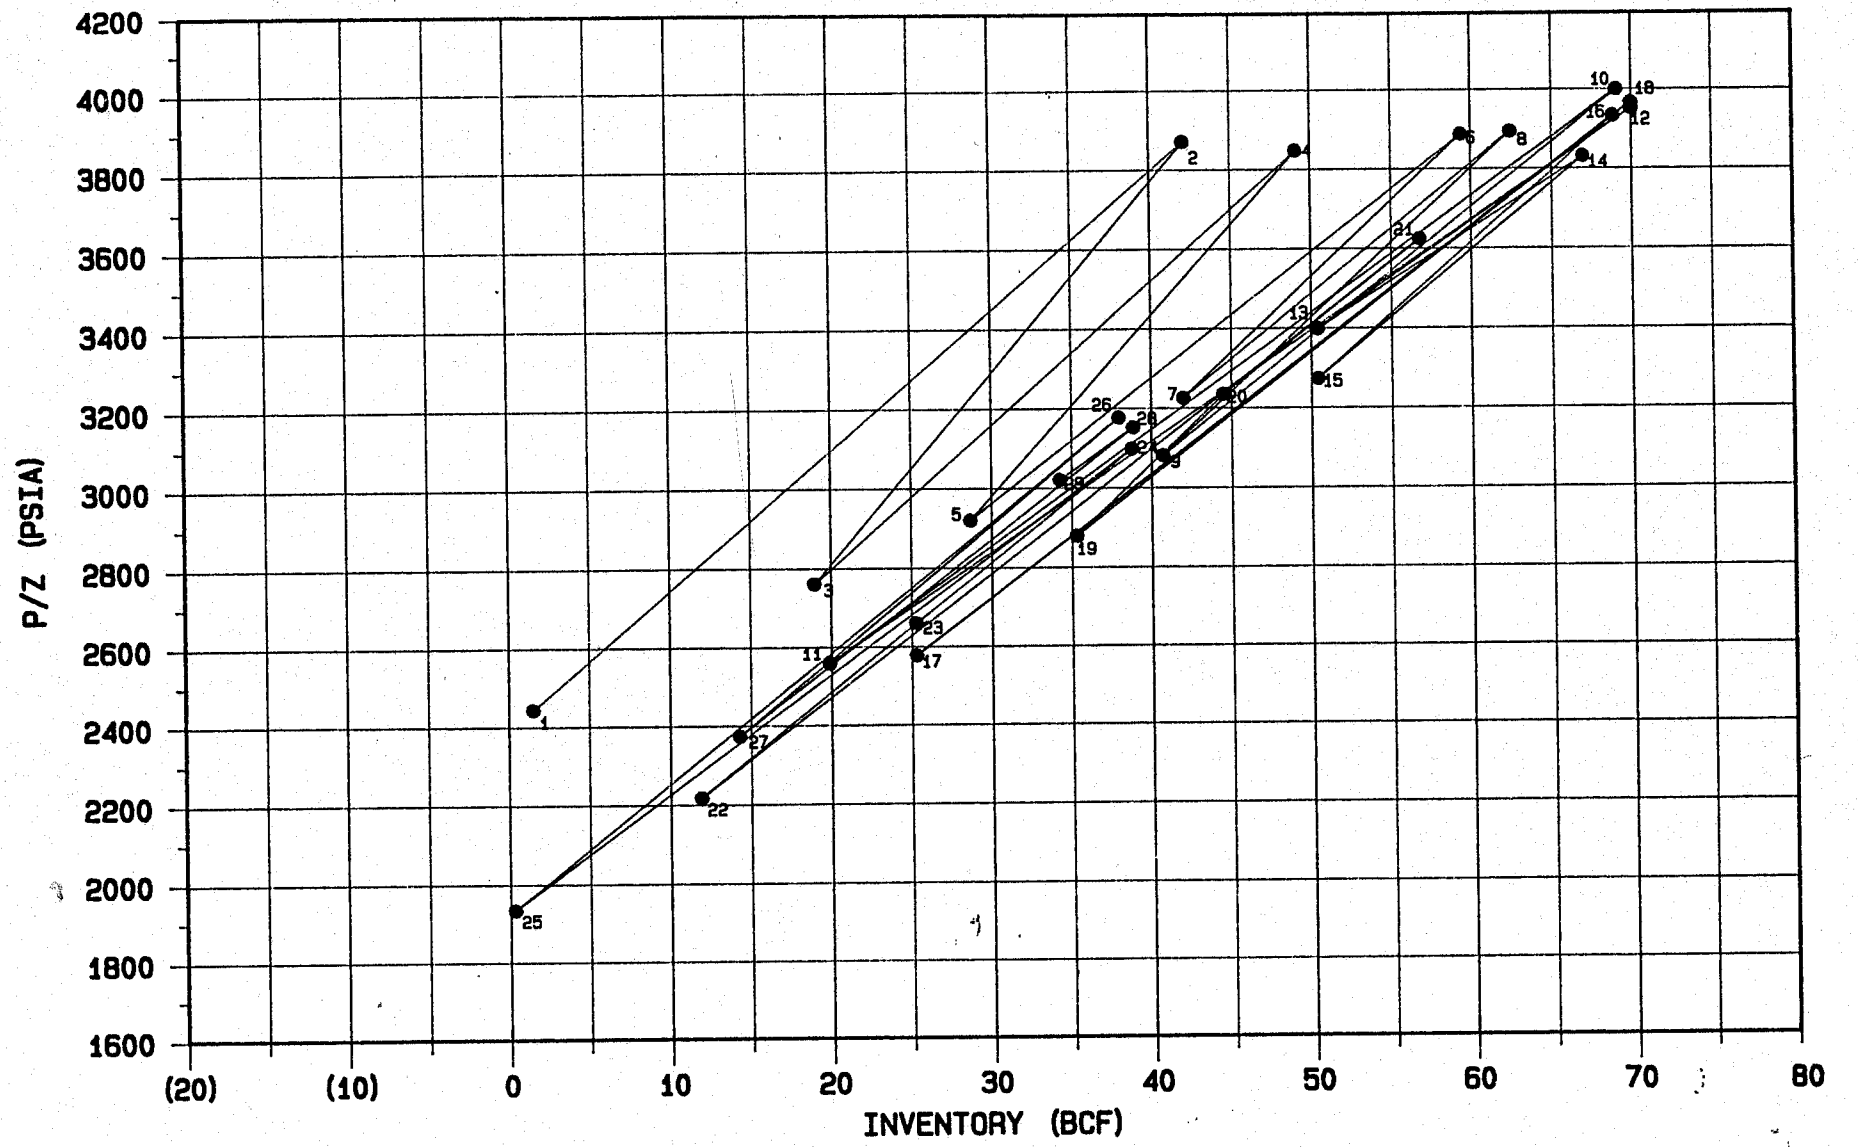
FIGURE 4. ALISO CANYON HYSTERESIS PLOT

Figure 4 is an updated graph of P/Z versus inventory (the data is also listed in Table 2). The shift in reservoir pressures from 1974 to date when plotted versus injected gas content is a combination of the repressurization of low permeability gas cap areas and of gas going into solution in crude oil some distance from the wellbore.

During the past four years the reservoir has not been filled to capacity. As a result the hysteresis curve has shifted to the left. This could be a result of gas coming out of solution or gas coming from tight regions of the reservoir. We have seen no evidence of pressure changes in observation wells penetrating the Ward fault block. We have no observation wells in the sub-Frew block, but with the displacement of 300-400 feet, it is unlikely that any gas moved there. The volumetric weighting of reservoir blocks is used to calculate the current hysteresis curve, Figures 4 and 5.

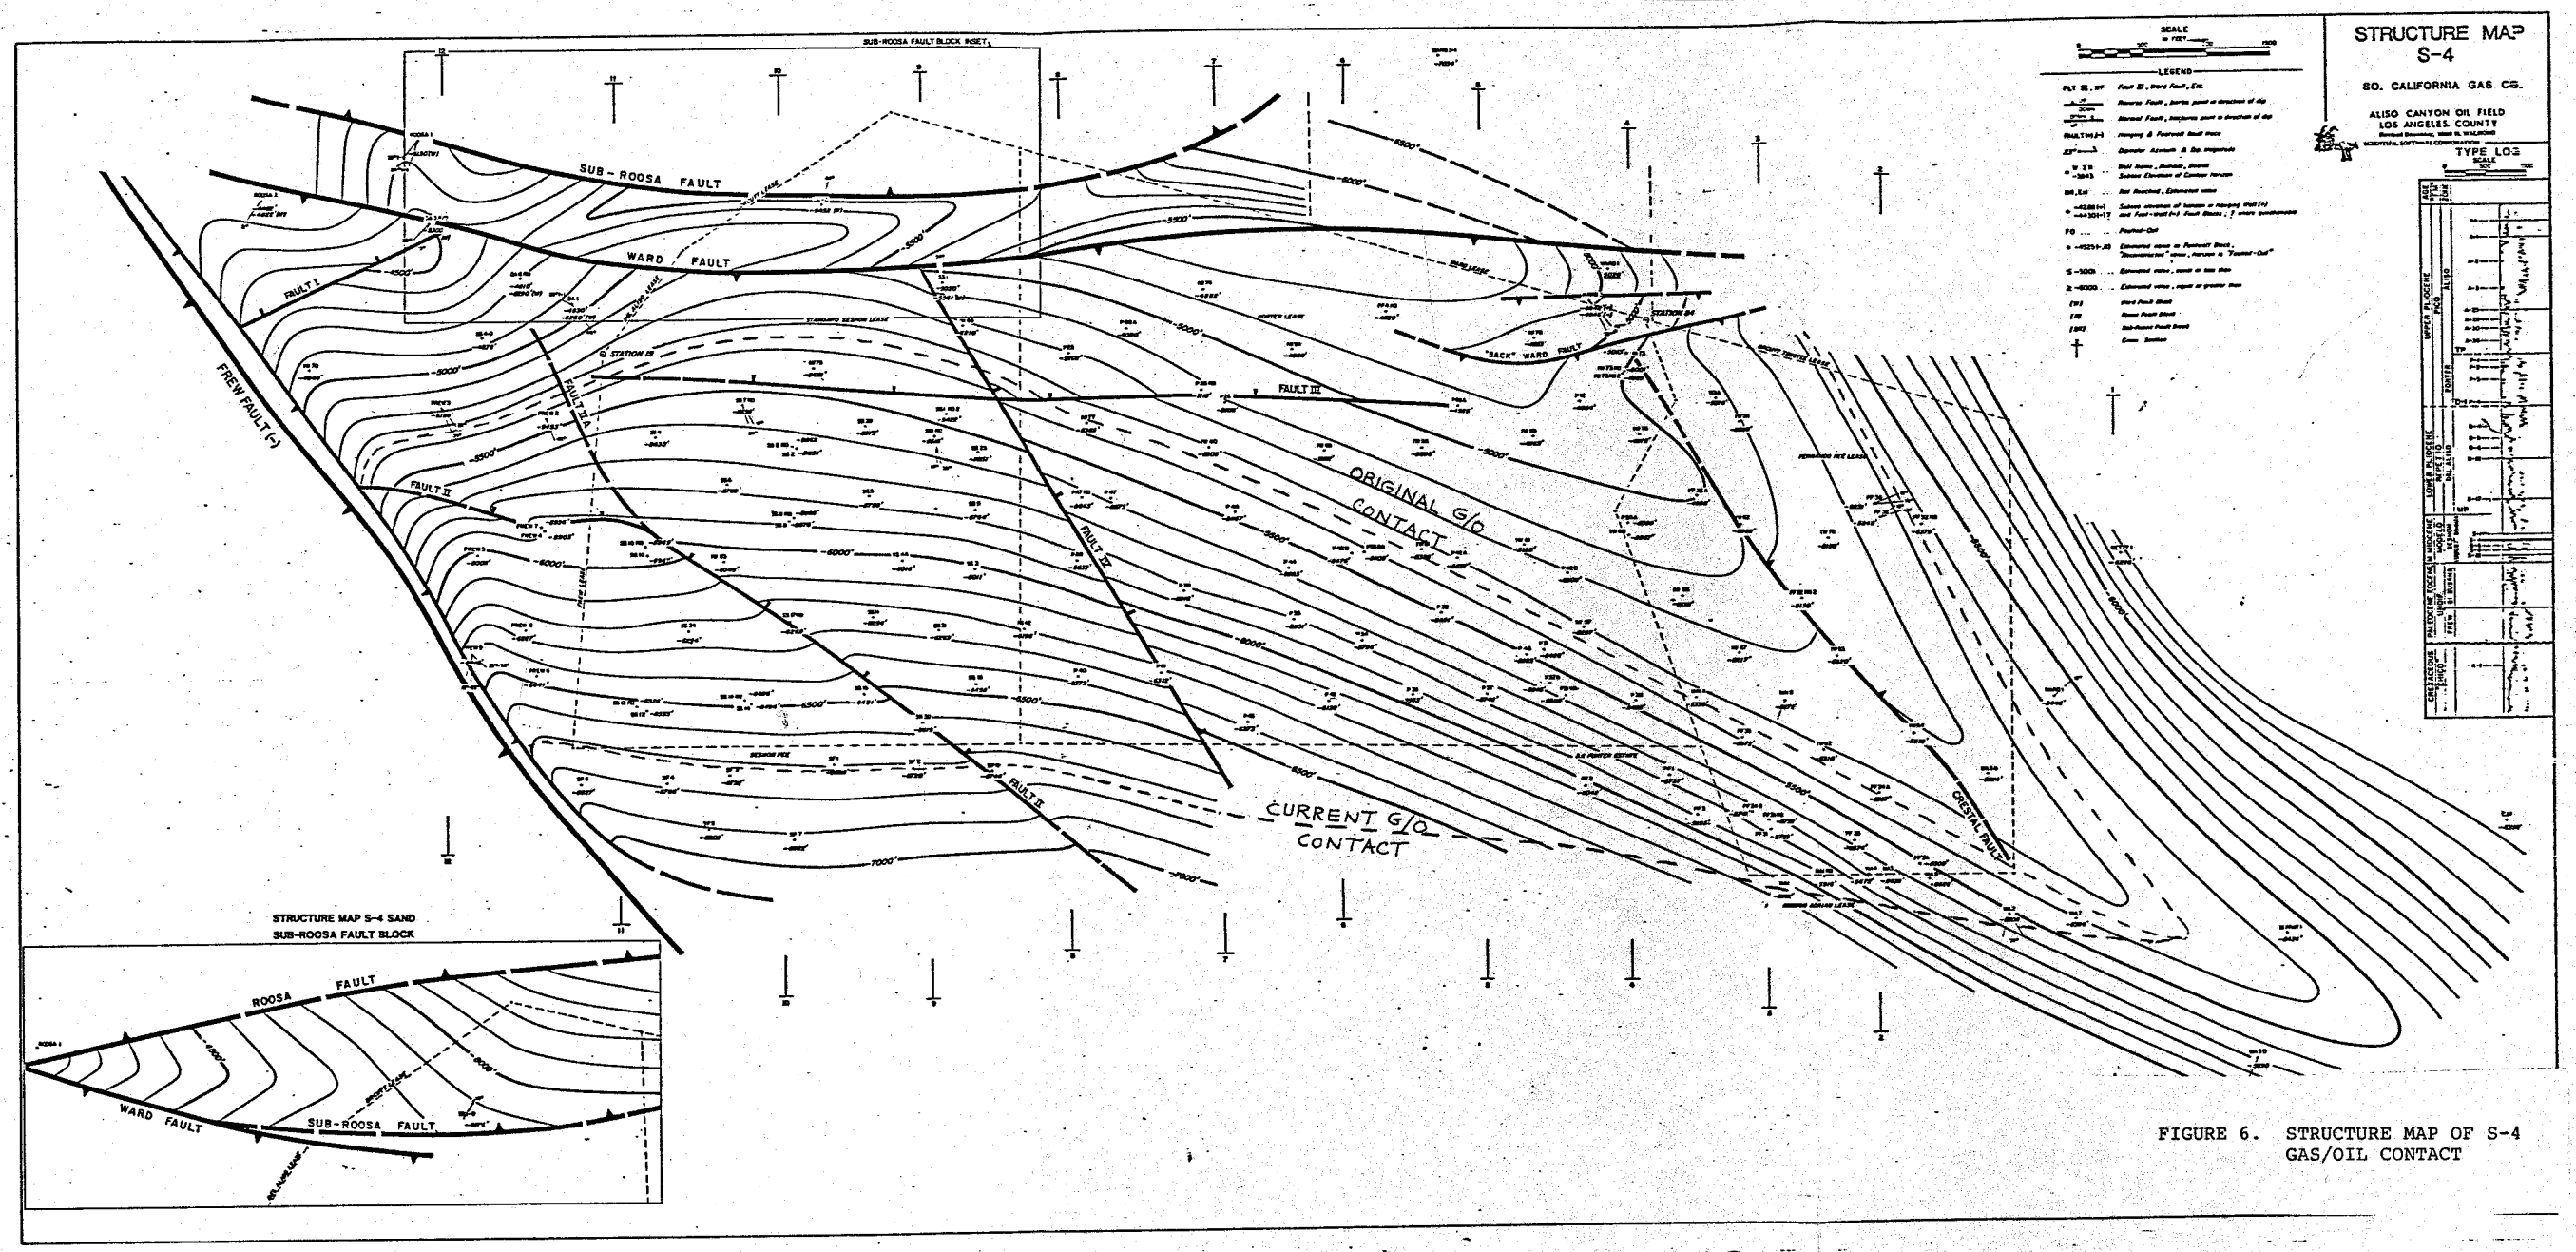
FIGURE 6. STRUCTURE MAP OF S-4 GAS/OIL CONTACT

Figures 6 and 7 show structure maps for the S-4 and S-8 zone tops, respectively. Also shown are the original and best interpretation of current gas/oil and oil/water contacts. There is essentially no oil belt on the east flank which results in a gas/water contact along that flank. Very little changes in fluid contacts have been observed.

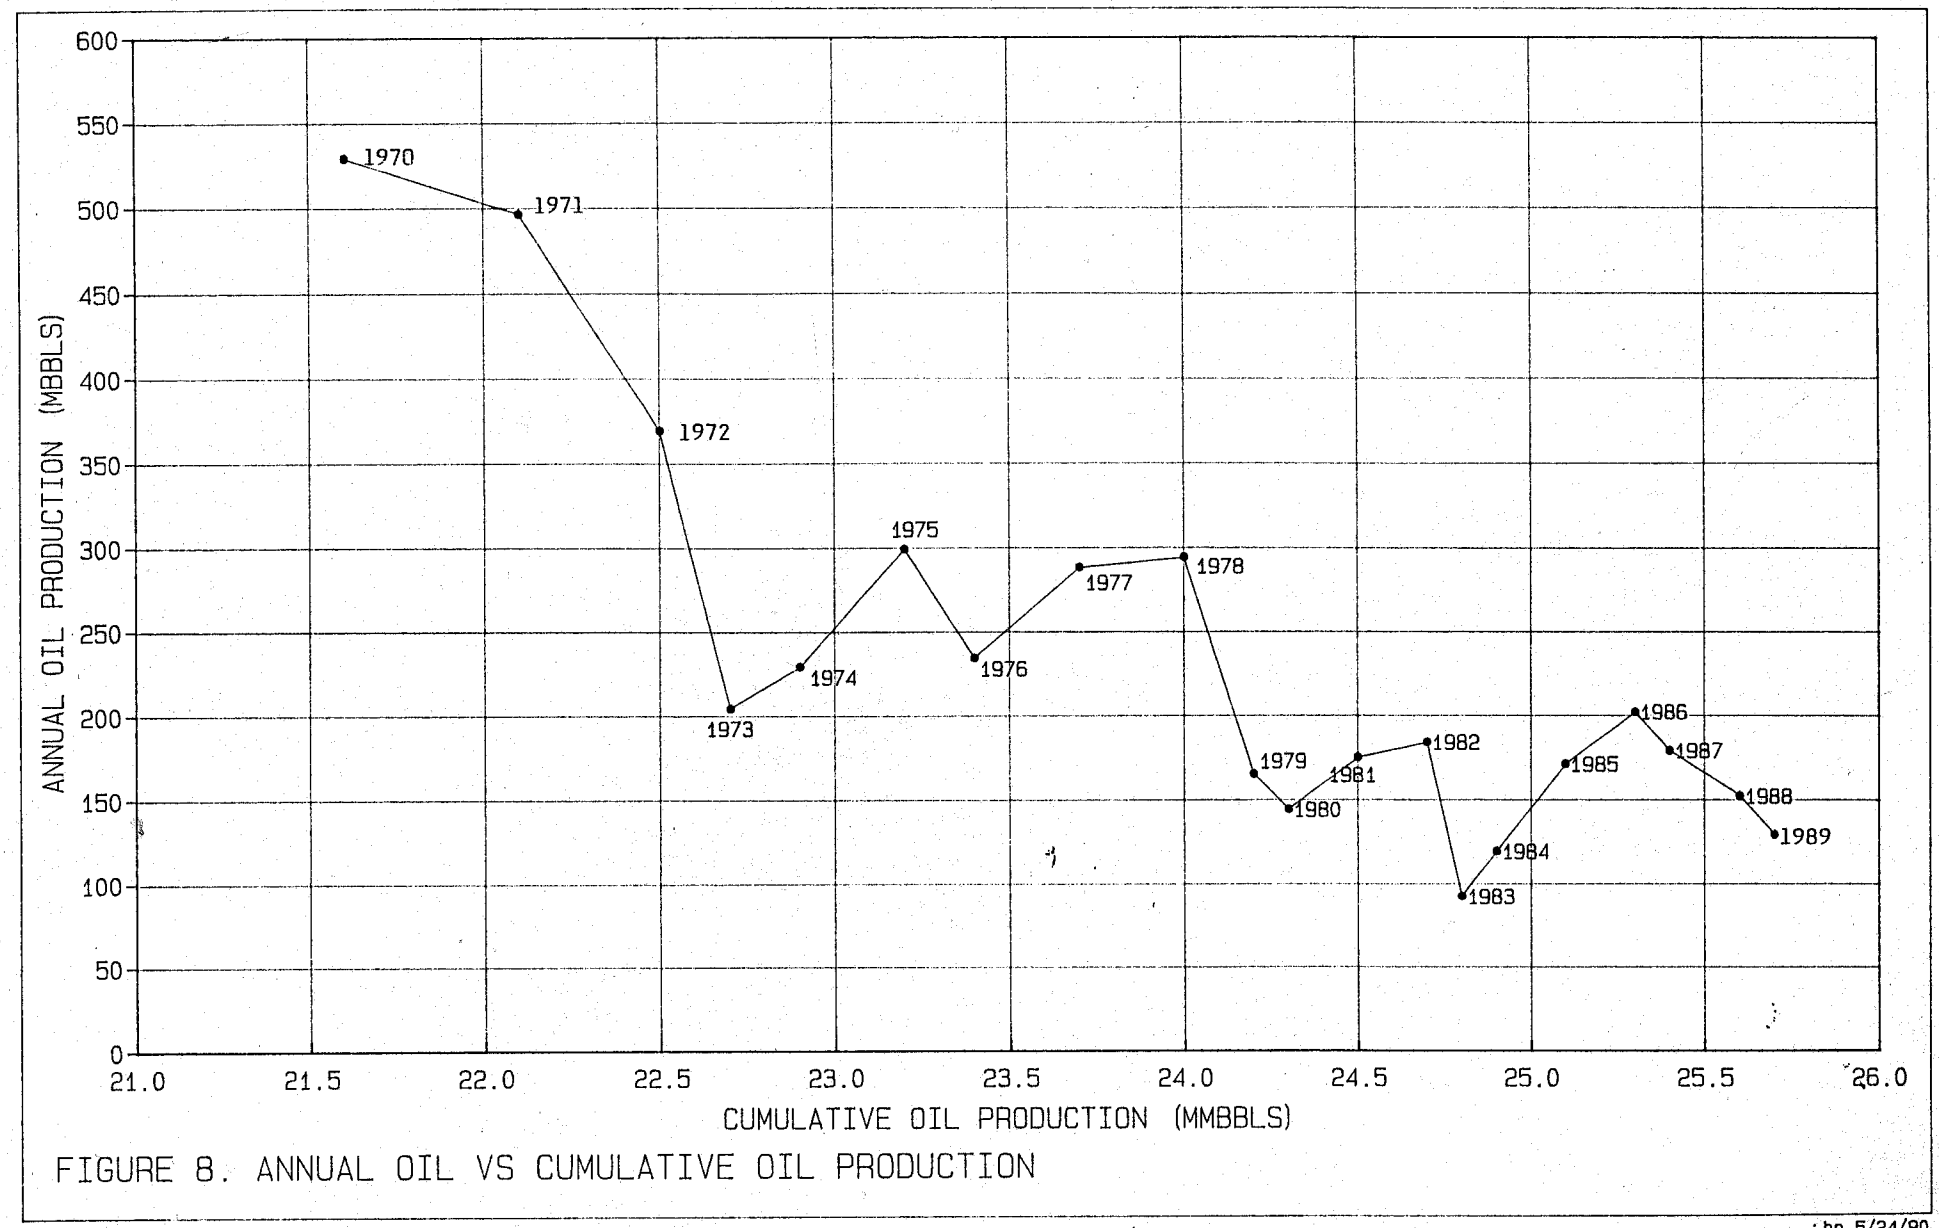
FIGURE 8. ANNUAL OIL VS CUMULATIVE OIL PRODUCTION

Table 3 presents annual oil production figures, starting from 1970 to date. From discovery the cumulative oil production through 1989 was 25,722,878 barrels. Figure 8 shows the annual oil production versus cumulative oil production.

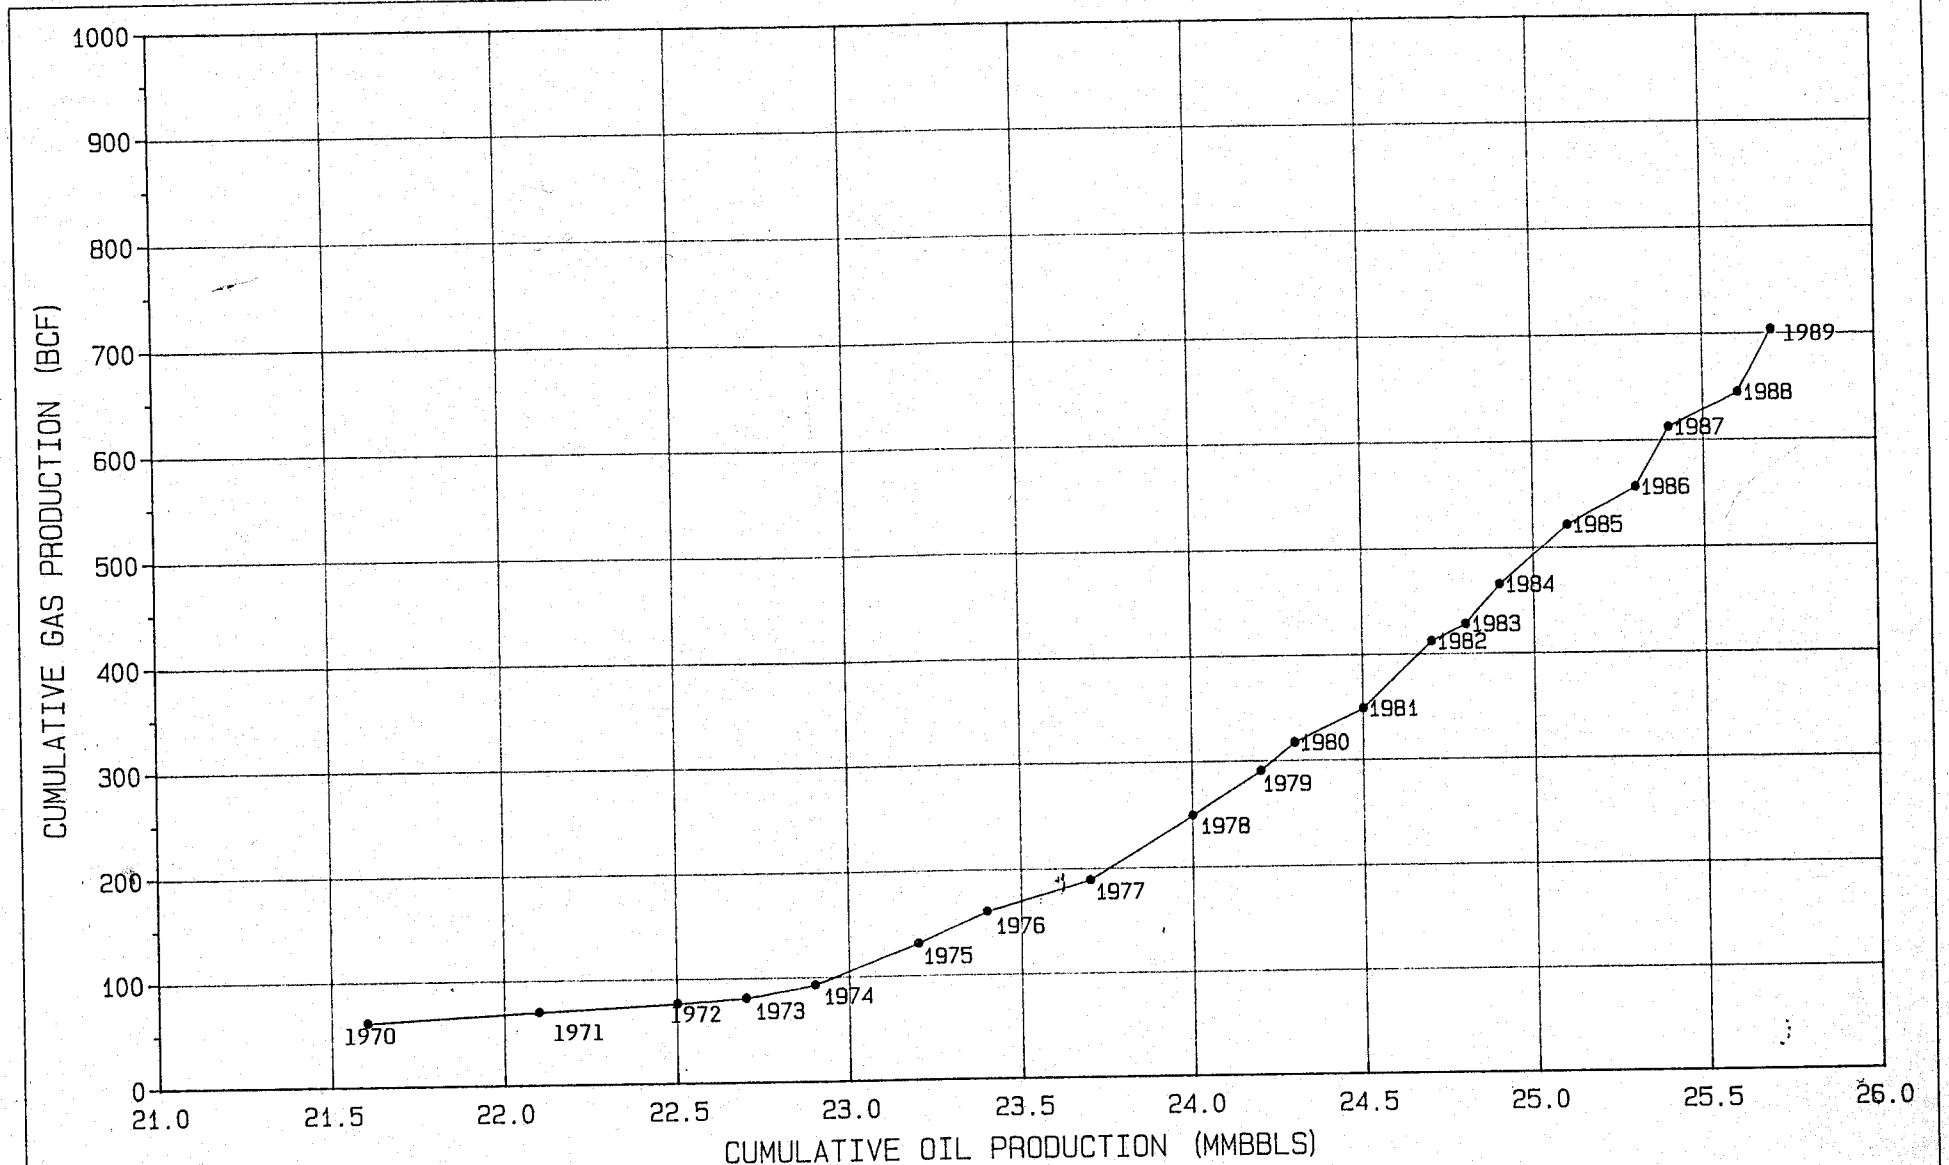
FIGURE 9. ANNUAL CUMULATIVE GAS VS CUMULATIVE OIL PRODUCTION

Figure 9 is a graph of cumulative gas production versus cumulative oil production.

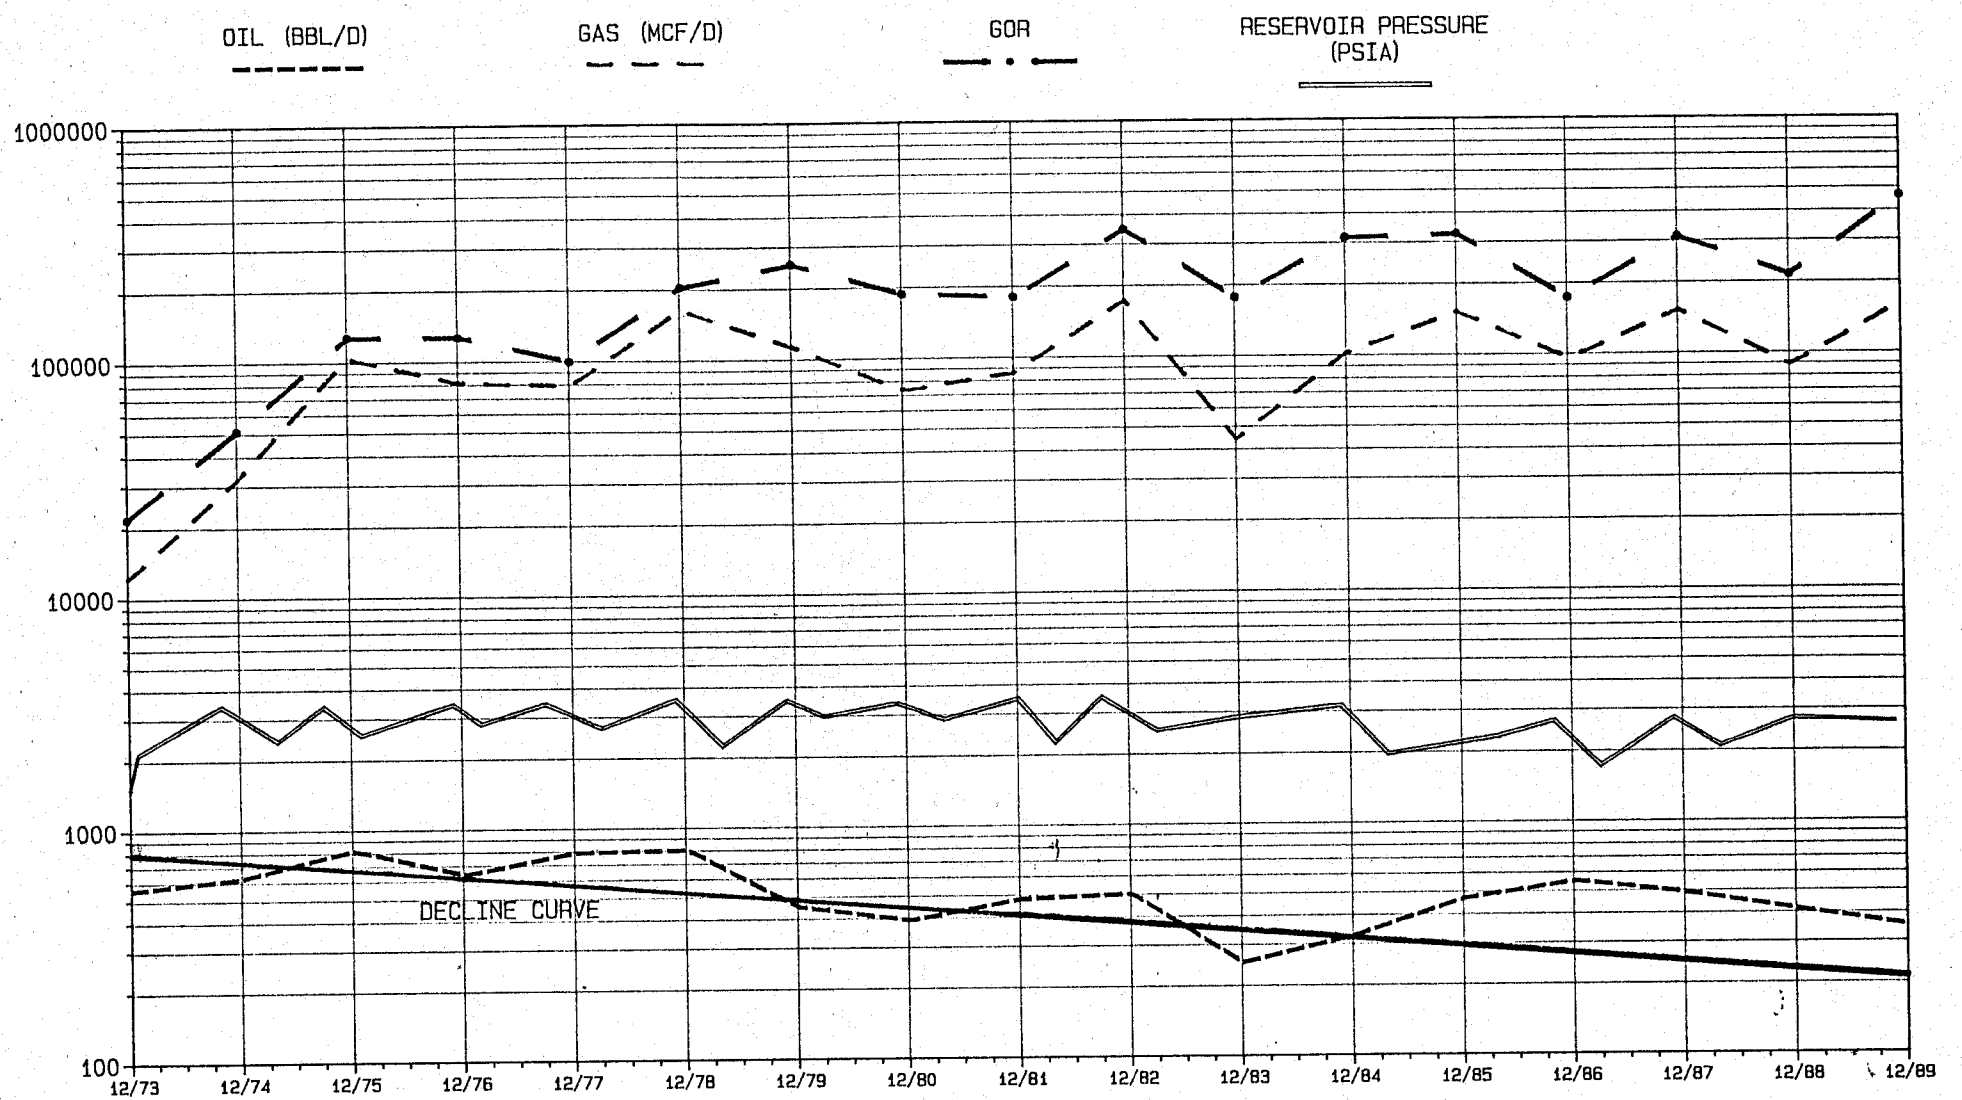
FIGURE 10. ALISO CANYON FIELD PRODUCTION

The performance of the reservoir since 1970 is shown on Figure 10. The plots of annual pressures decline through 1972. The semiannual plot from the start of storage operations illustrates the high and low range of inventory pressures. The estimated recoverable reserves for Aliso Canyon as of 12/31/89 is 770,000 Bbls. A 10% annual decline rate is used for Aliso Canyon oil production estimates.

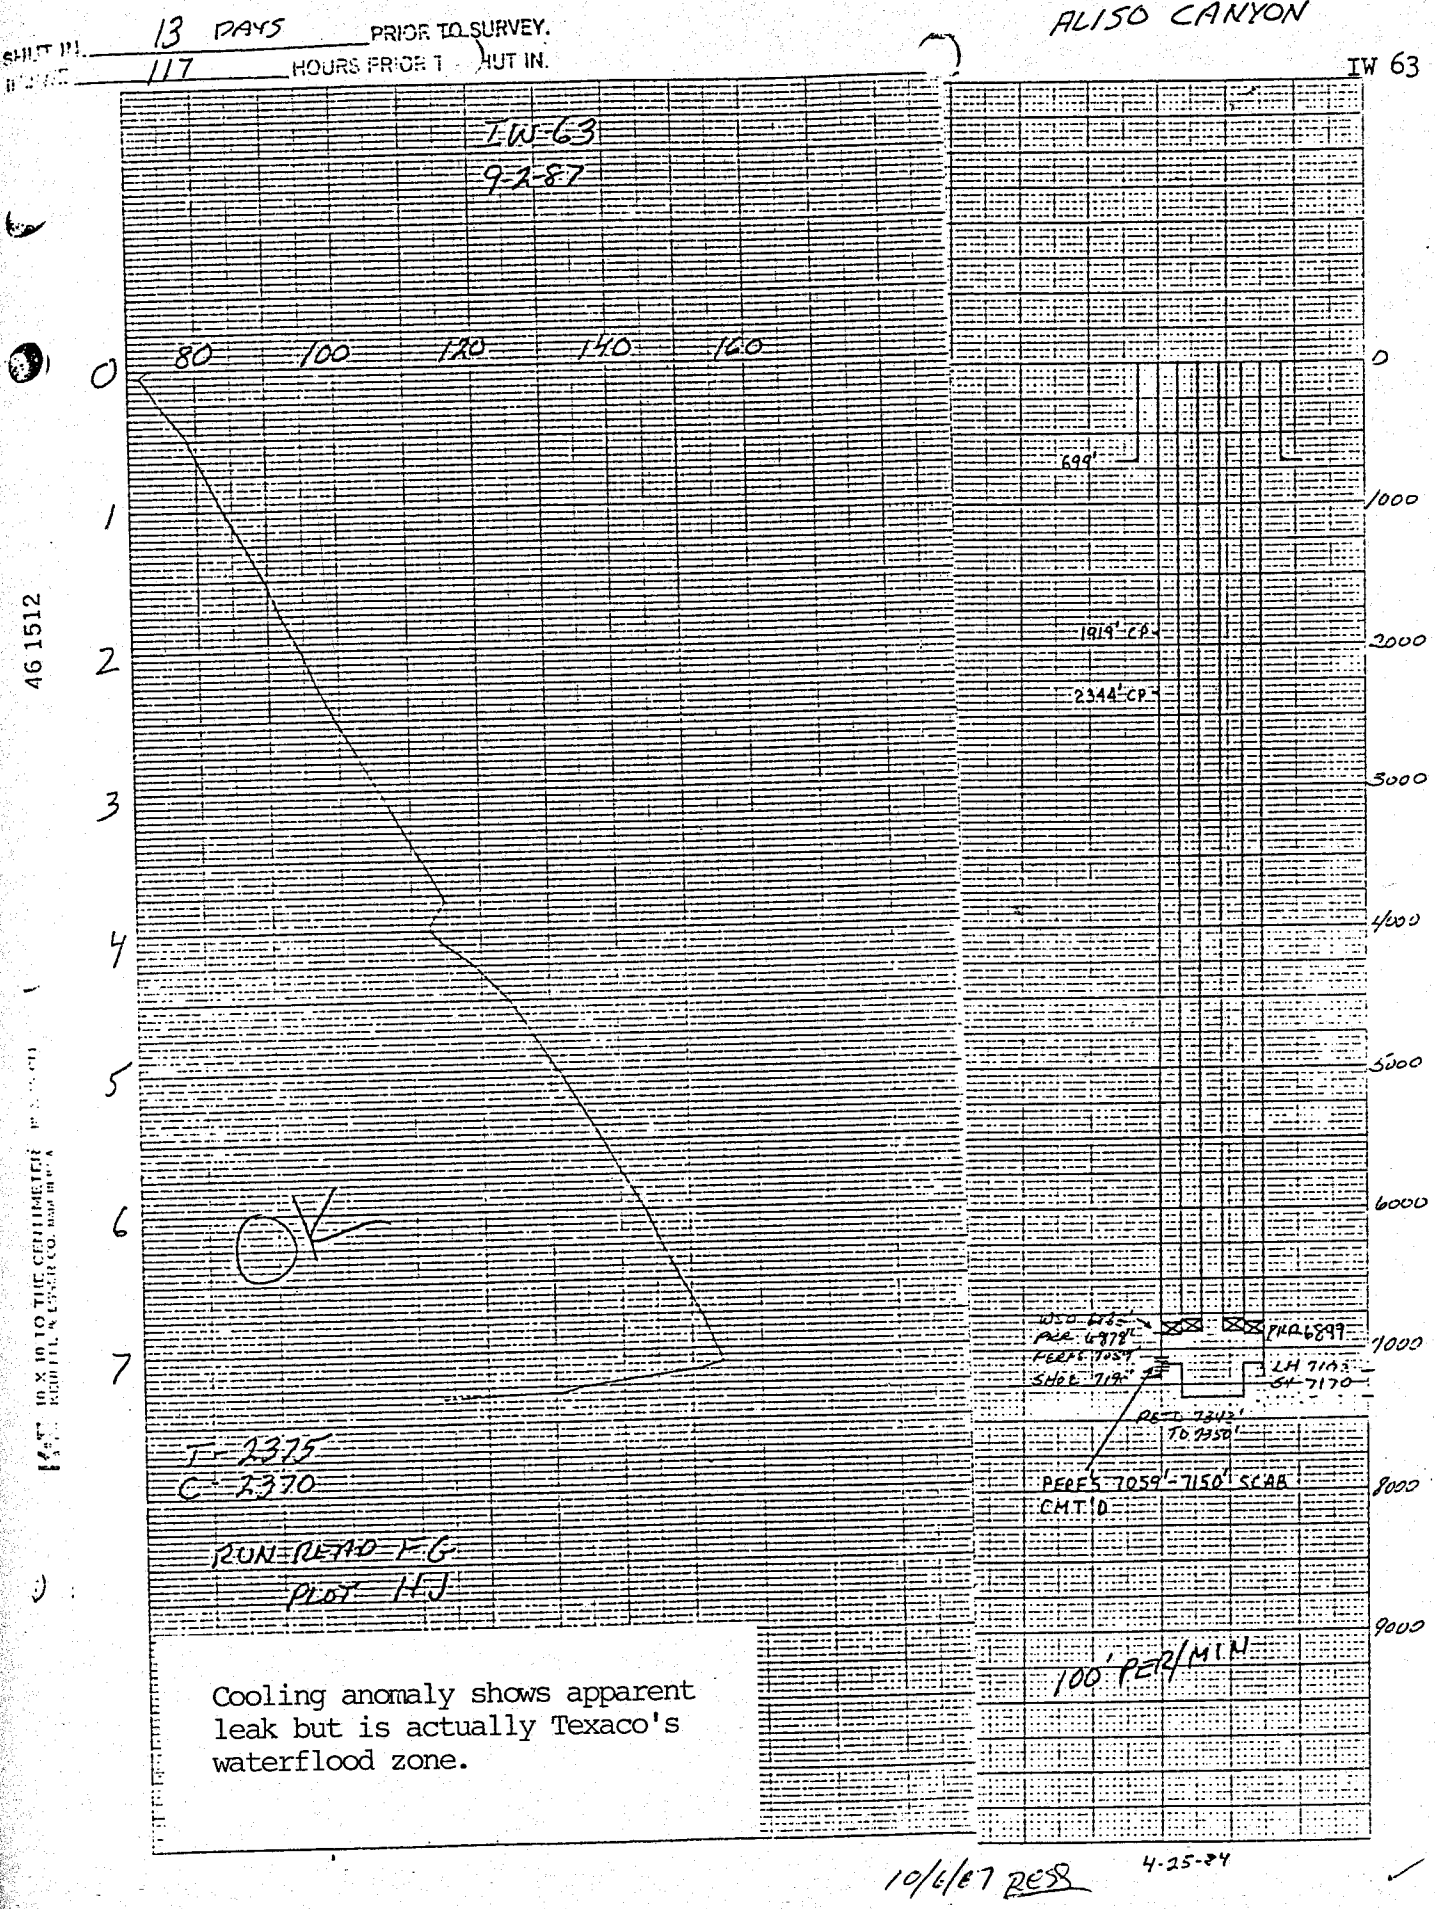
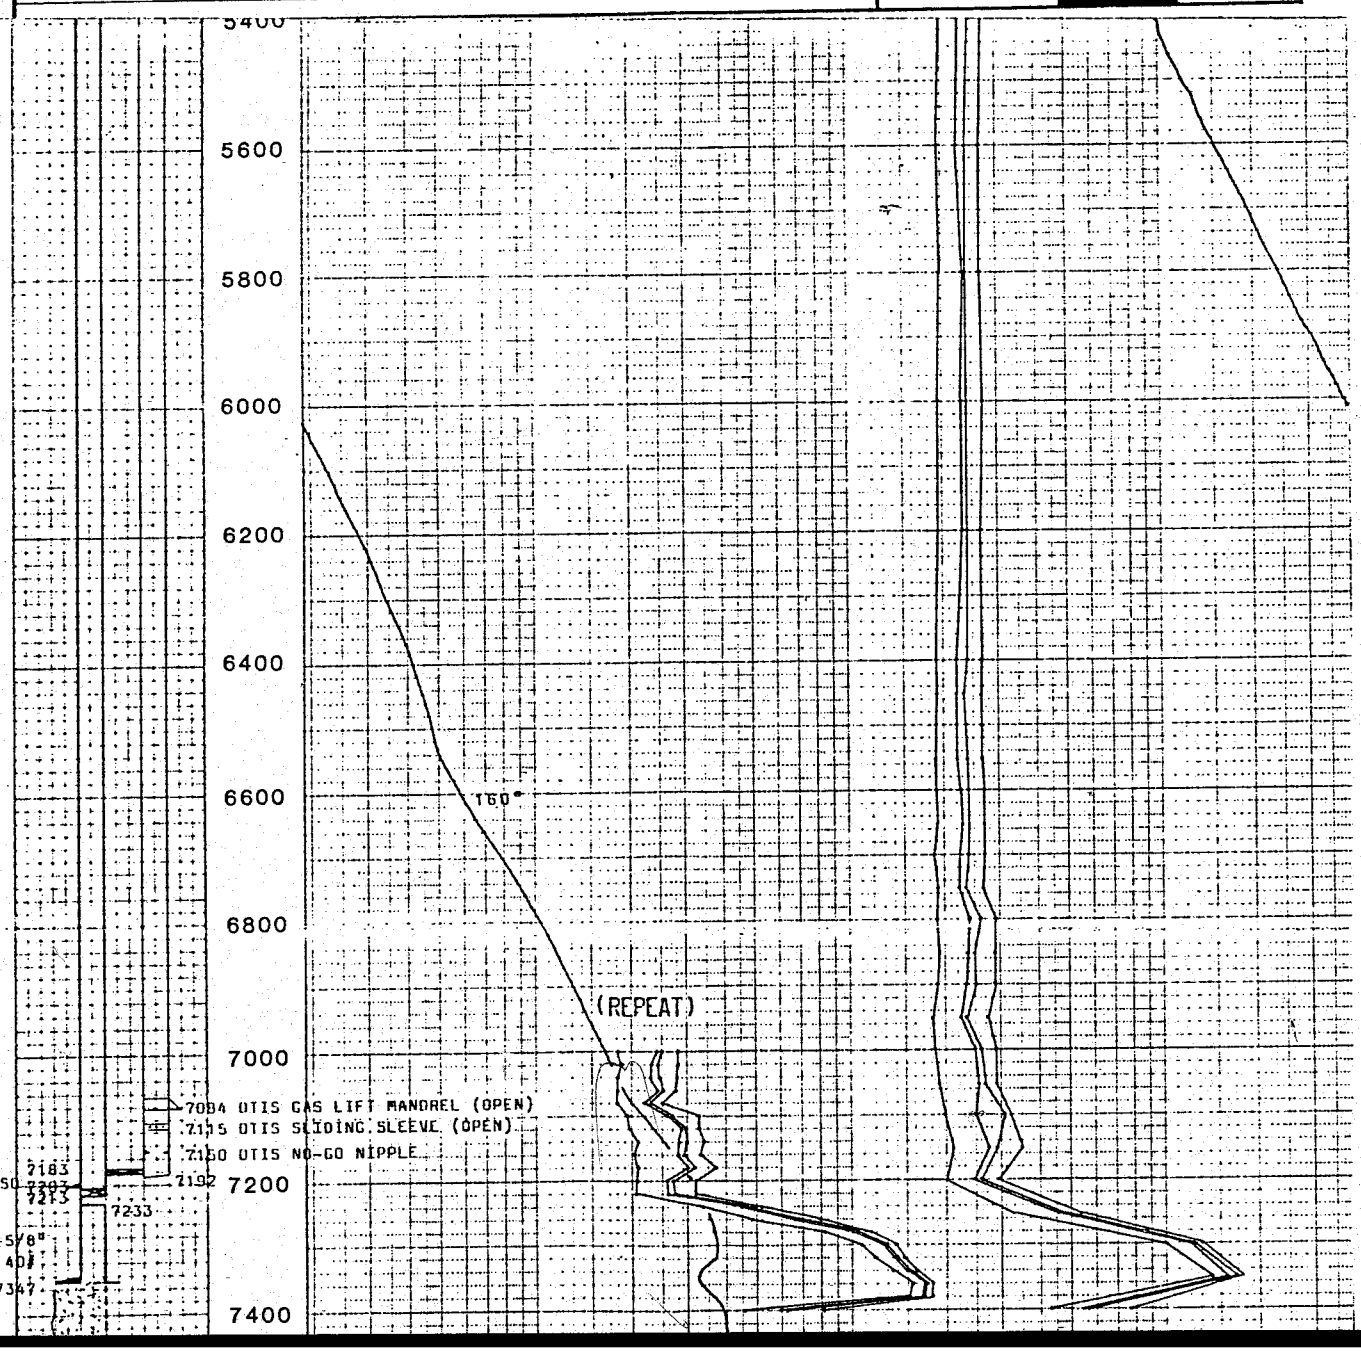
FIGURE 14

RESULTS AND REMARKS: NOISE LOG INDICATES GAS MIGRATION UP TO 7220'.

NO GAS APPEARS TO LEAK PAST THE WSO @ 7203'
