Blade Report

I.19-06-016

Root Cause Analysis of the Uncontrolled Hydrocarbon Release from Aliso Canyon SS-25

May 16, 2019

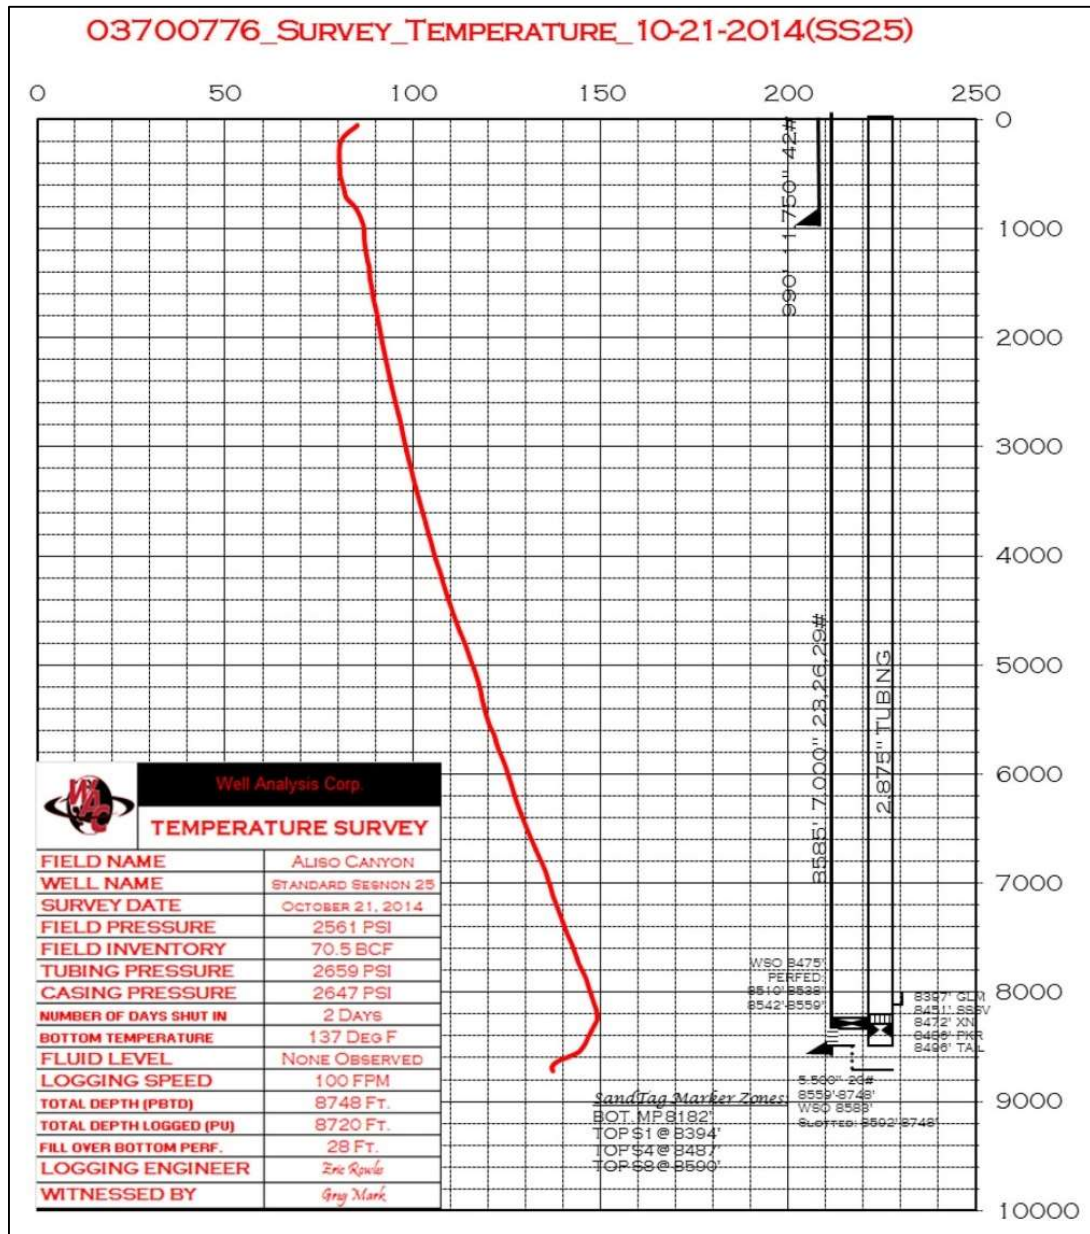
Figure 14: Temperature Survey on October 21, 2014

Figure 14 shows the temperature survey from October 21, 2014, the *last* survey before the incident of October 23, 2015, and shows no anomalies related to casing integrity. A cooling feature was found below approximately 8,200 ft related to gas injection and withdrawal, but it was not related to a casing integrity issue.

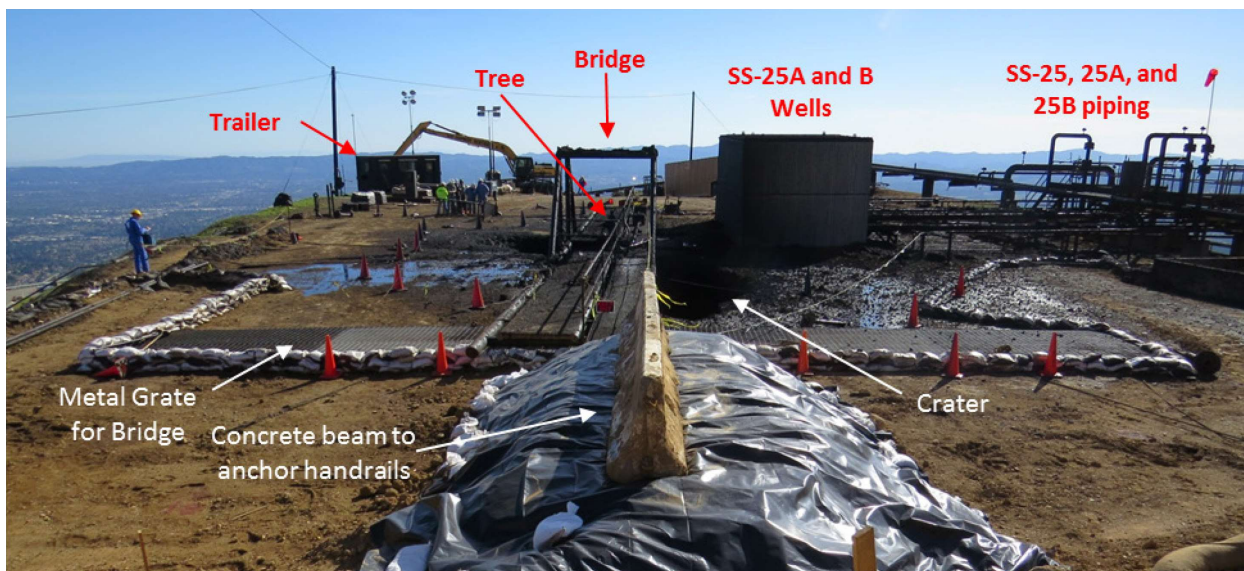
Figure 15: SS-25 Well Site Condition on February 25, 2016

Phase 1 was the first opportunity for the Blade team to observe and document the SS-25 well site. Figure 15 shows one of the initial images taken after the well site was opened to the Blade team. The image shows the SS-25 tree, crater, bridge spanning the crater, SS-25A and SS-25B heat shields, and piping for SS-25, SS-25A, and SS-25B. The majority of the non-permanent items shown in the image were removed throughout Phase 1 or during Phase 2. These items included the trailer, bridge, heat shields, sand bags, cones, and concrete beam.

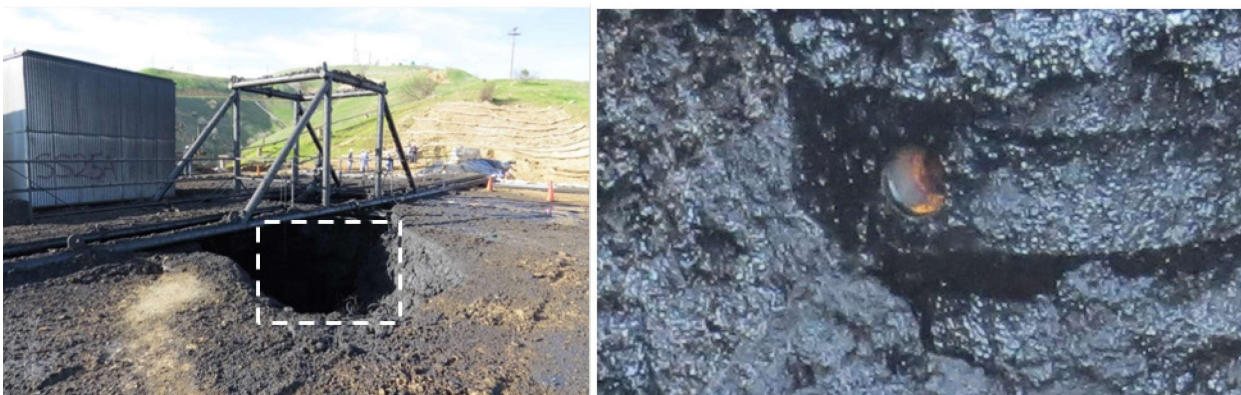
Figure 18: Photos of Missing 11 3/4 in. Casing Valve Taken on February 25, 2016

Figure 18 shows an image of the location of the missing 11 3/4 in. casing annulus valve. The valve backed off during the kill attempts and was not located during the Phase 1 evidence search. The valve most likely ended up at the bottom of the crater with the SS-25 cellar. The cellar collapsed to the bottom of the crater during its formation. A portion of the concrete pad that was attached to the cellar was hanging

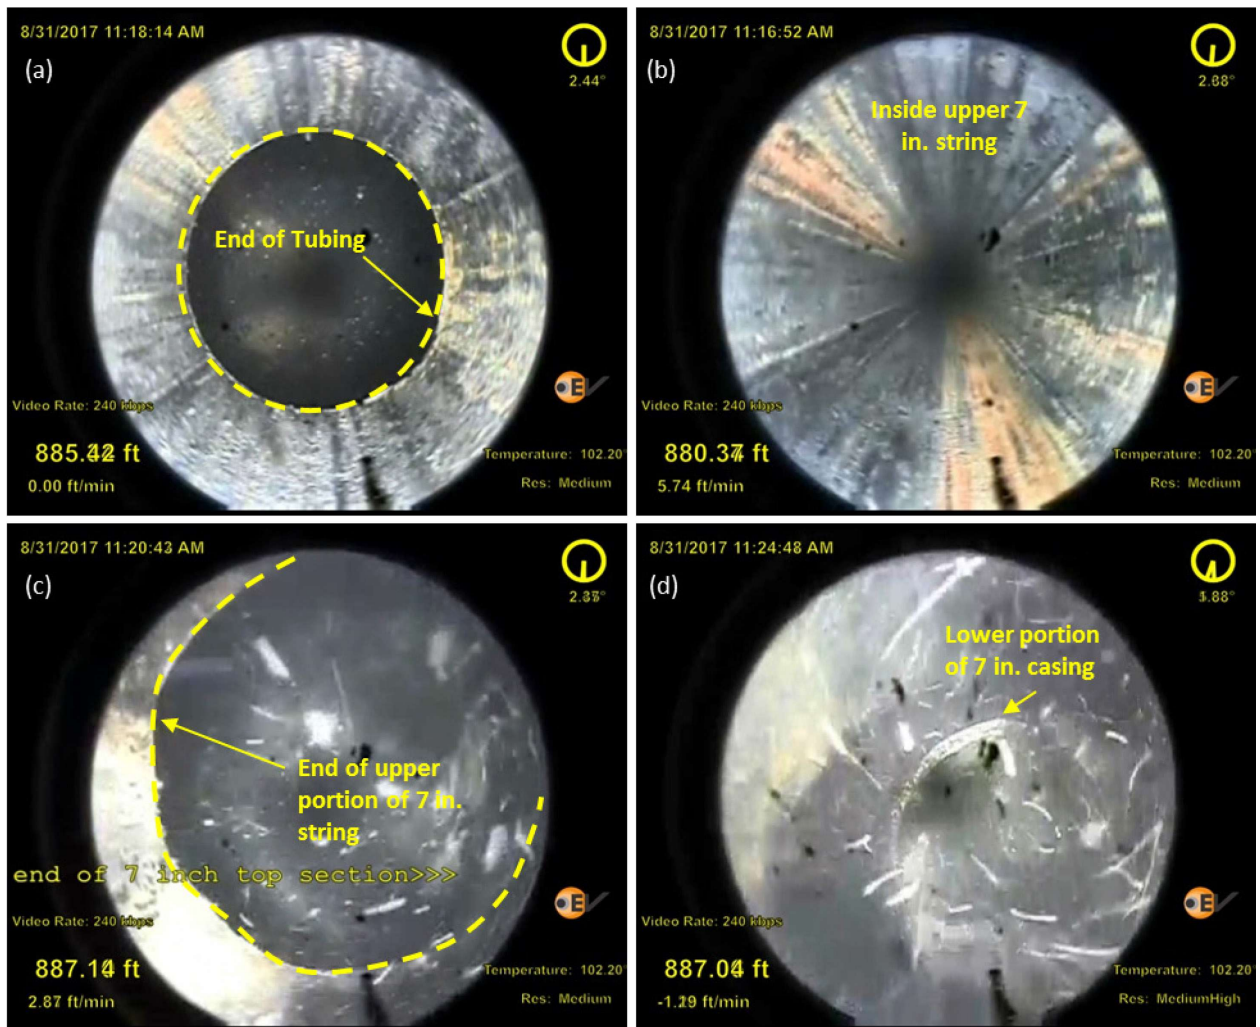
Figure 24: EV Lower Camera Snapshots from August 31, 2017 Showing the Parted 7 in. Casing

Figure 24 shows images extracted during the camera run. Figure 24 (a) shows the end of the tubing, which was set at approximately 885 ft. Figure 24 (b) shows the camera inside the upper 7 in. casing string after exiting the tubing. Figure 24 (c) shows the end of the upper 7 in. casing string. This was the location of the parted 7 in. casing. The camera exited the upper string and looked down at the lower string. Figure 24 (d) shows the lower 7 in. casing string offset from the camera. The lower string was sitting approximately 5 in. below the upper string. The camera runs confirmed that the 7 in. casing was parted and that the lower fish was offset from the upper string.

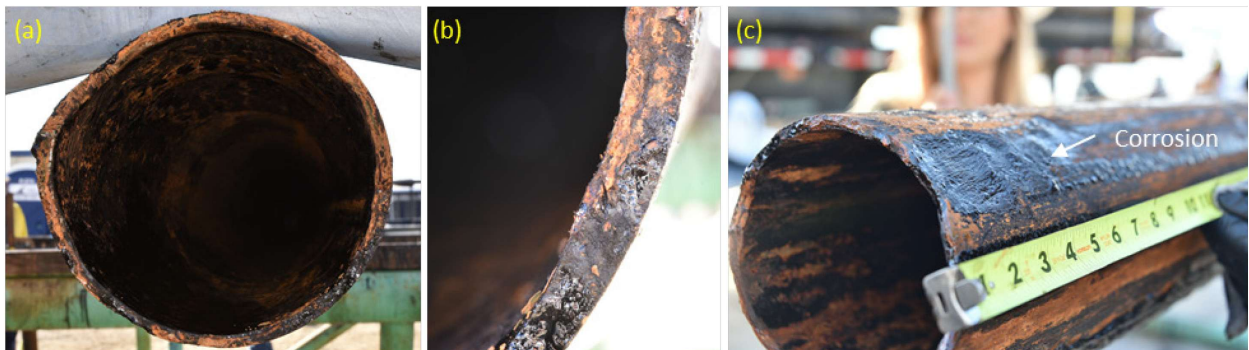
Figure 27: Parted Casing (C022) on the SS-25 Pipe Rack

C022 was extracted on November 07, 2018. C022 contained the upper portion of the circumferential parting identified during logging and visually confirmed with the downhole camera. The circumferential fracture surface was thoroughly examined on the rig floor.

The upper circumferential fracture surface was examined on the SS-25 pipe rack. Figure 27 shows an (a) overall and (b) close-up image of the fracture surface. The images show that the fracture surface was obscured by the presence of oil and scale. The circumferential fracture surface appeared mostly flat with a pointed section that faced the south side of the rig floor. Figure 27 (c) shows corrosion features adjacent to the fracture surface.

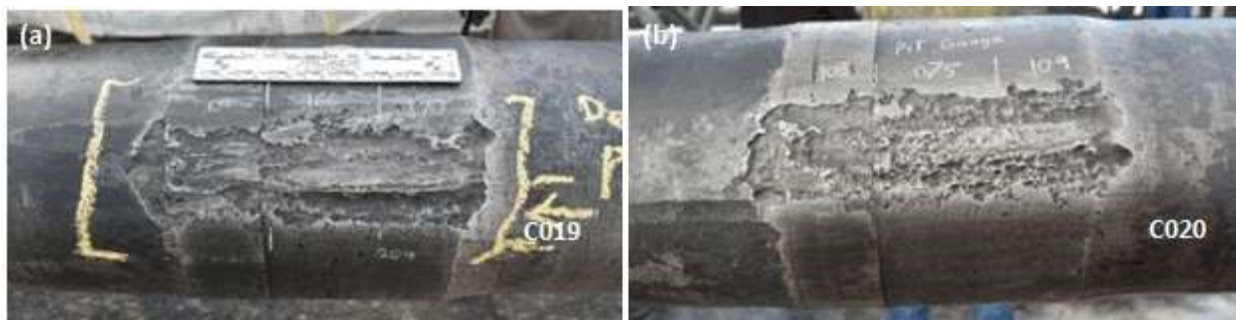
Figure 29: Connection Corrosion on (a) C019 and (b) C020

Shallow metal loss was first identified on the C014 connection and was present on the remainder of the extracted casing pipe bodies and connections. Corrosion was identified on many of the connections below C014 with increasing severity. Figure 28 shows the shallow corrosion on the C014 connection. Figure 29 shows corrosion on the connections for (a) C019 and (b) C020. The corrosion is similar to C014's but more severe.

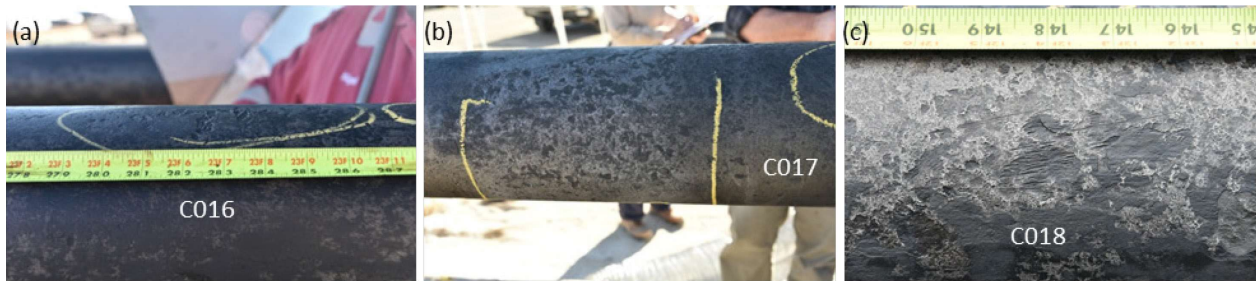
Figure 30: Pipe Body Corrosion on (a) C016, (b) C017, and (c) C018

Corrosion was also identified on the pipe bodies, beginning with C014. Figure 30 shows examples of pipe body corrosion from (a) C016, (b) C017, and (c) C018. Figure 30 (c) shows corrosion with striated grooves slightly angled from the longitudinal axis of the pipe. This type of feature was identified at many locations along the casing below C014. Figure 31 shows examples of corrosion with striated grooves from (a) C018 and (b) C022. Figure 32 shows the largest corrosion feature identified during the PS-20 inspection. The shape and morphology appeared to be consistent with the features found on the connections (Figure 29).

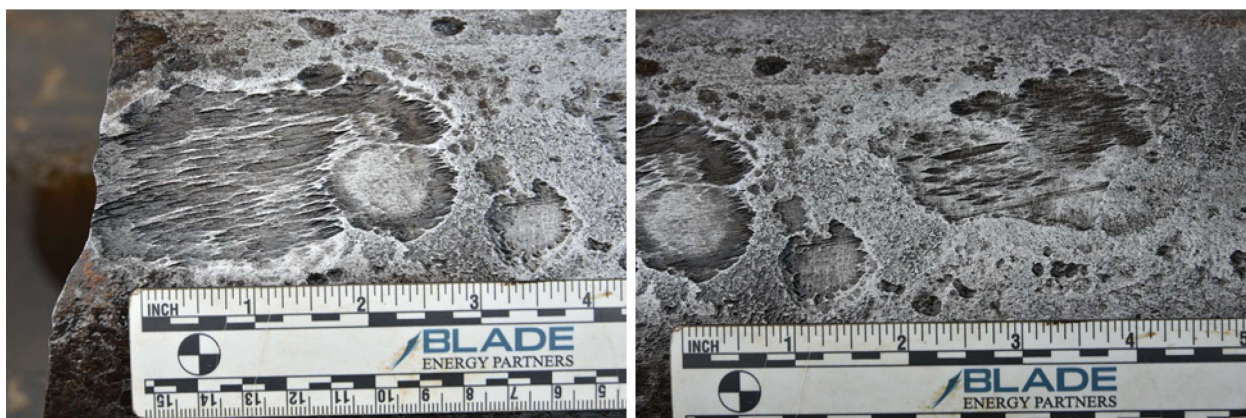
Figure 35: Corrosion with Striated Grooves Adjacent to Fracture Surface

The fracture surface was removed from C022 prior to cleaning and inspection. A cut location approximately 1 ft from the fracture surface was selected, cleaned, and inspected with MPI and UT. An additional cut was made on C022 to remove the connection. Figure 33 shows a diagram of the C022 cut locations. The diagram shows that the section containing the fracture surface was designated C022B after the cuts were executed. Cuts were made using the cold cutter as it had been done on the rig floor. Figure 34 (a) shows cutting joint C022. Figure 34 (b) shows the cutoff piece after cleaning with Sentinel 909. Figure 35 shows the C022B corrosion features adjacent to the fracture surface.

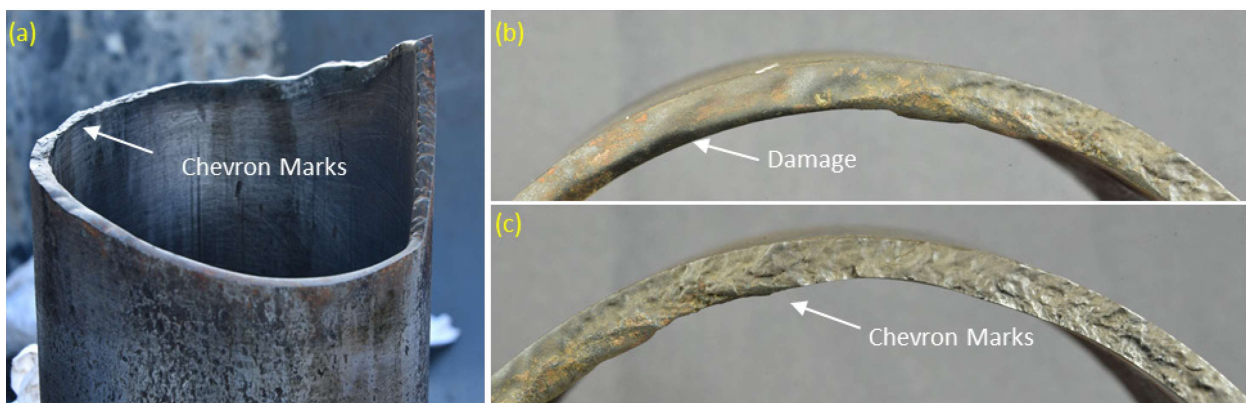
Figure 36: (a) Circumferential Fracture Surface after Cleaning Showing (b) Erosion and (c) Chevron Marks

The fracture surface was examined after being cleaned with Sentinel 909. Most of the fracture surface had been eroded, but chevron marks were visible in some areas. Figure 36 (a) shows the circumferential fracture surface after cleaning with Sentinel 909. Figure 36 (b) and (c) shows close-up images of the fracture surface taken in the field lab after undergoing ultrasonic cleaning.

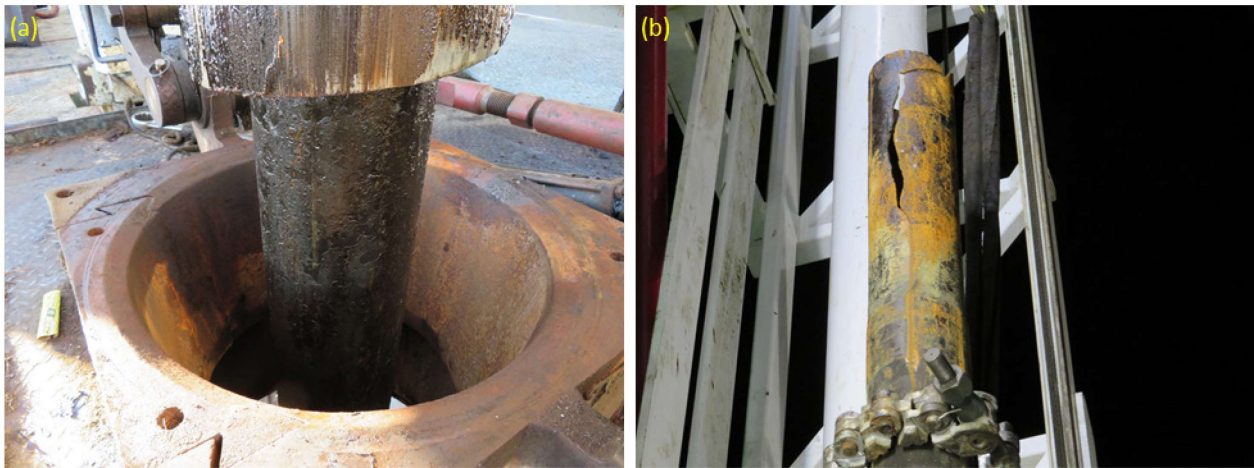
Figure 39: Lower Section of the Parted 7 in. Casing (a) In and (b) Out of the Pawl Tool

Figure 39 shows the fish on the rig floor with the tool (a) engaged and (b) removed. This was the first opportunity to visually examine the fish. The first major observation was that there was an axial rupture below the circumferential parting. C023 was moved from the rig floor to the pipe racks using the crane and a nylon sling. The pipe handler was not used to eliminate damage due to handling. The fracture surfaces were wrapped with VCI and covered for the night. C024 was extracted on November 15, 2017. A 13 ft section (C023A) of C023 was cut on the SS-25 pipe rack using the cold cutter to remove the axial rupture and circumferential parting. The pipe sections (C023A, C023B, and C024) were transported to PS-20 for further inspection. These pipe sections were inspected at PS-20 and preserved in the as-recovered condition for further analysis in Houston, TX. No onsite cleaning was done for these samples.

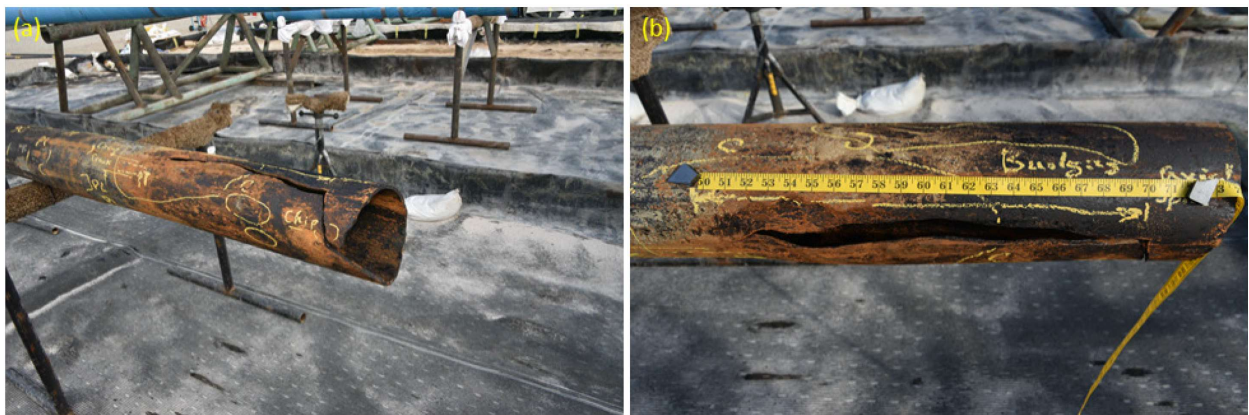
Figure 40: Axial Rupture and Circumferential Parting (C023A)

Figure 40 (a) and (b) show the axial rupture and circumferential parting on the 7 in. casing. The axial rupture was surrounded by a corrosion feature and was located below the circumferential parting. Wall thinning, along with bulging was observed near the middle of the axial rupture. The axial rupture had one lower arrest point away from the circumferential fracture, adjacent to the connection. The upper portion of the axial rupture turns similar to the lower arrest point, but was connected to the circumferential parting by an inclined fracture surface.

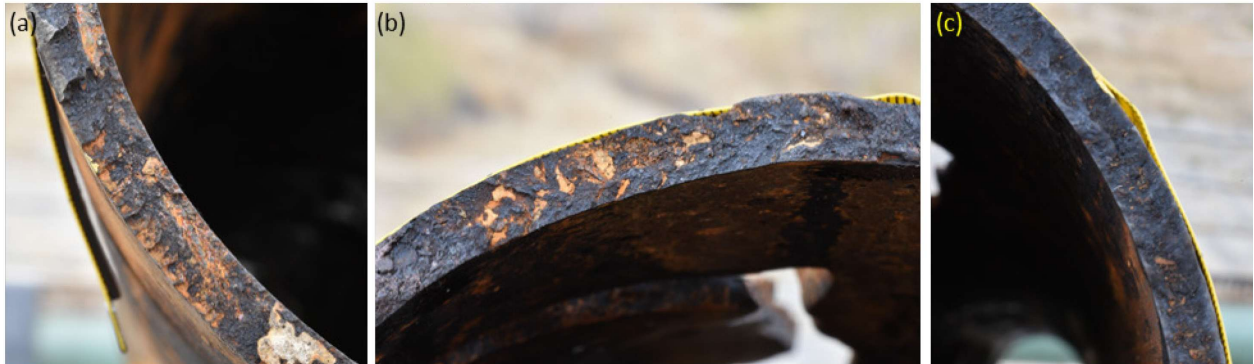
Figure 41: Circumferential Parting Fracture Surface (a) Features, (b) Chevron Marks, and (c) Surface Erosion

The fracture surface was covered with oil deposits and scale products but features were identifiable. Figure 41 (a), (b), and (c) show surface features, chevron marks, and other features, respectively.

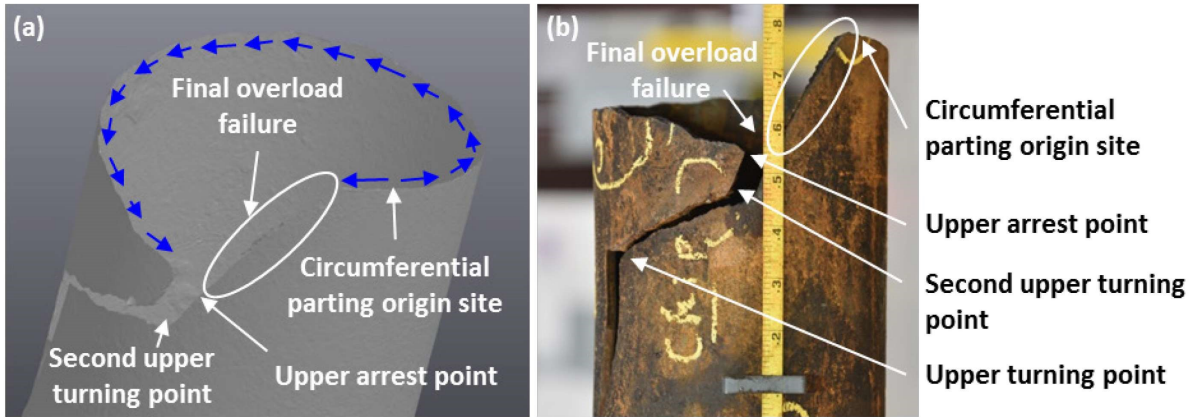
Figure 47: (a) Laser Scan and (b) Photo Indicating Circumferential Parting Initiation Site and Final Failure

Visual and stereoscopic examination of the circumferential parting showed that the failure was not a continuation of the axial rupture, but rather re-initiated near the corner on one side of the parted casing. The origin site was determined based on chevron marks identified on the fracture surface. Figure 47 is a (a) laser scan and (b) image which identifies the upper arrest point, circumferential parting initiation site, and the final overload failure. Figure 48 is stitched stereo images showing the chevron marks and propagation direction of the circumferential parting. These observations indicate that the axial rupture and circumferential parting were two separate events despite their close proximity, and that they are most likely related to each other. This is discussed in more detail later within this section.

The circumferential parting was brittle, which was different from the axial rupture. No evidence of local plastic deformation or overload necking was observed near the fracture surfaces on either side of the circumferential parting.

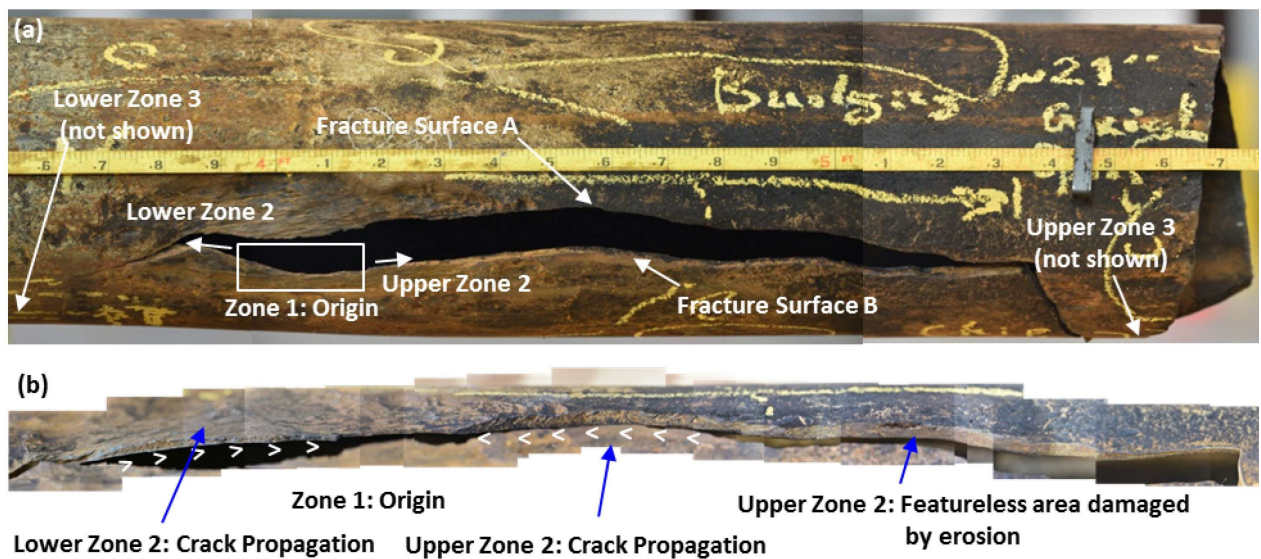
Figure 50: (a) Front and (b) Top Views of Fracture Surface B Identifying the Three Zones

Figure 50 illustrates the three zones of the axial rupture. Zone 1 is a short section of the axial rupture, which was identified by severe wall thinning due to corrosion. Zone 2 extends from the lower and upper boundaries of Zone 1 to the boundary of the lower and upper arrest region. Lower and upper Zone 2 contained chevron marks. However, upper Zone 2 contained a featureless segment created by erosion. Zone 3 contained the lower and upper arrest region. The arrest points in Zone 3 cannot be seen in Figure 50 (a) or (b).

Zone 1 was determined based on the chevron marks in Zone 2. The apexes of the chevron marks generally point towards the origin of a failure. The chevron marks in Zone 2 pointed towards the area with the maximum metal loss. Both observations suggested that this area was the origin of the axial rupture, and it was denoted as Zone 1.

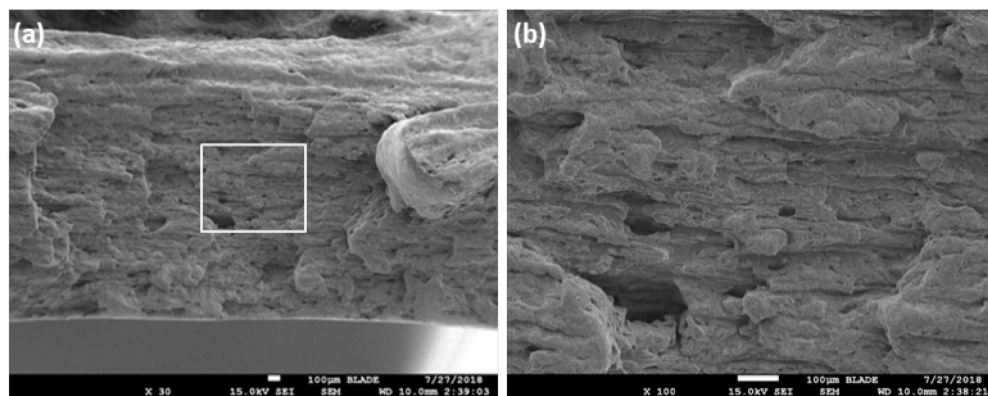
Figure 54: SEM Images of Area 8 Taken at (a) 30x and (b) 100x

C023A1B2C and C023A1B2D were examined with the SEM at several locations and magnifications to identify the fracture mode of the origin (Zone 1). Figure 53 shows the areas of interest (AOI) chosen during the SEM examination. C023A1B2C contained most of the origin and was selected for detailed examination. Figure 54 and Figure 55 are SEM images of two AOIs (A8 and A17) that represent the typical features identified in the origin during the examination. The images show woody-type morphology, deformation markings, possible dimples, and pearlite-like features. Cleavage and grain boundary facets were not observed in any of the AOIs in the origin.

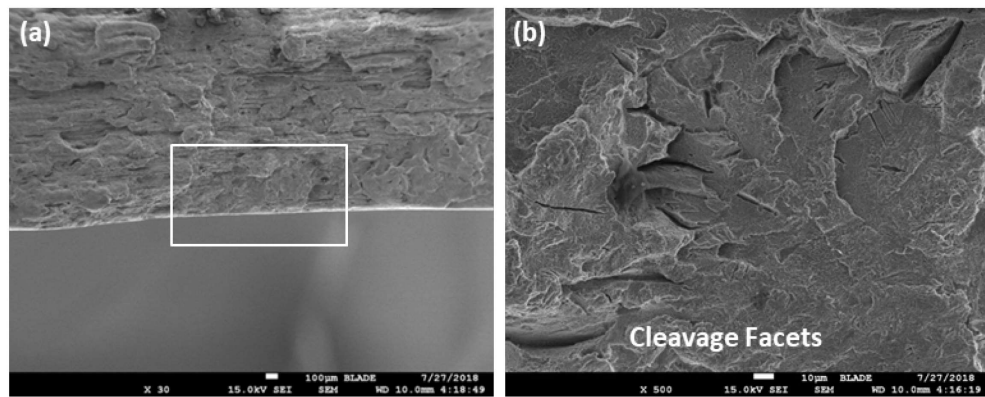
Figure 56: SEM Images of Area 19 Taken at (a) 30× and (b) 500×

A transition from ductile to a ductile–brittle mix was observed beginning at A19 (Figure 53). The transition showed a shift from a woody-type morphology to a mix of woody-type morphology and cleavage. The amount of cleavage facets appeared to increase from location A19 to A27. The observations implied that the speed of the axial rupture was increasing through the transition zone until the crack became fully unstable. Figure 56 is a SEM image from A19 showing the ductile–brittle mixed fracture mode. The images show areas of cleavage facets and deformation markings.

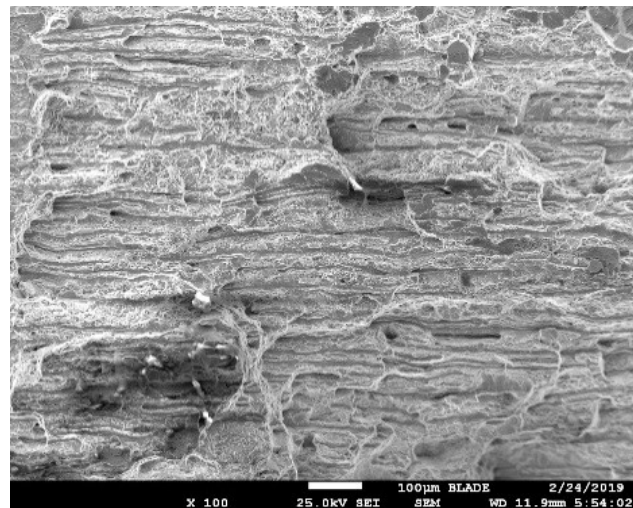
Figure 57: SEM Images of J-R Specimen L4-000 Taken at 100×

The initial examination of the axial rupture suggested that the origin experienced ductile tearing based on the woody-type morphology and deformation markings. The fracture surface produced by J-R ductile tearing tests were used to confirm the ductile tearing observed in the origin. Specimen L4-000 was tested at room temperature, which was comparable to the downhole temperature at the time of the axial rupture. Figure 57 shows SEM images taken at 100× showing the woody-type morphology. Higher magnification images showed the dimpled nature of the surface.

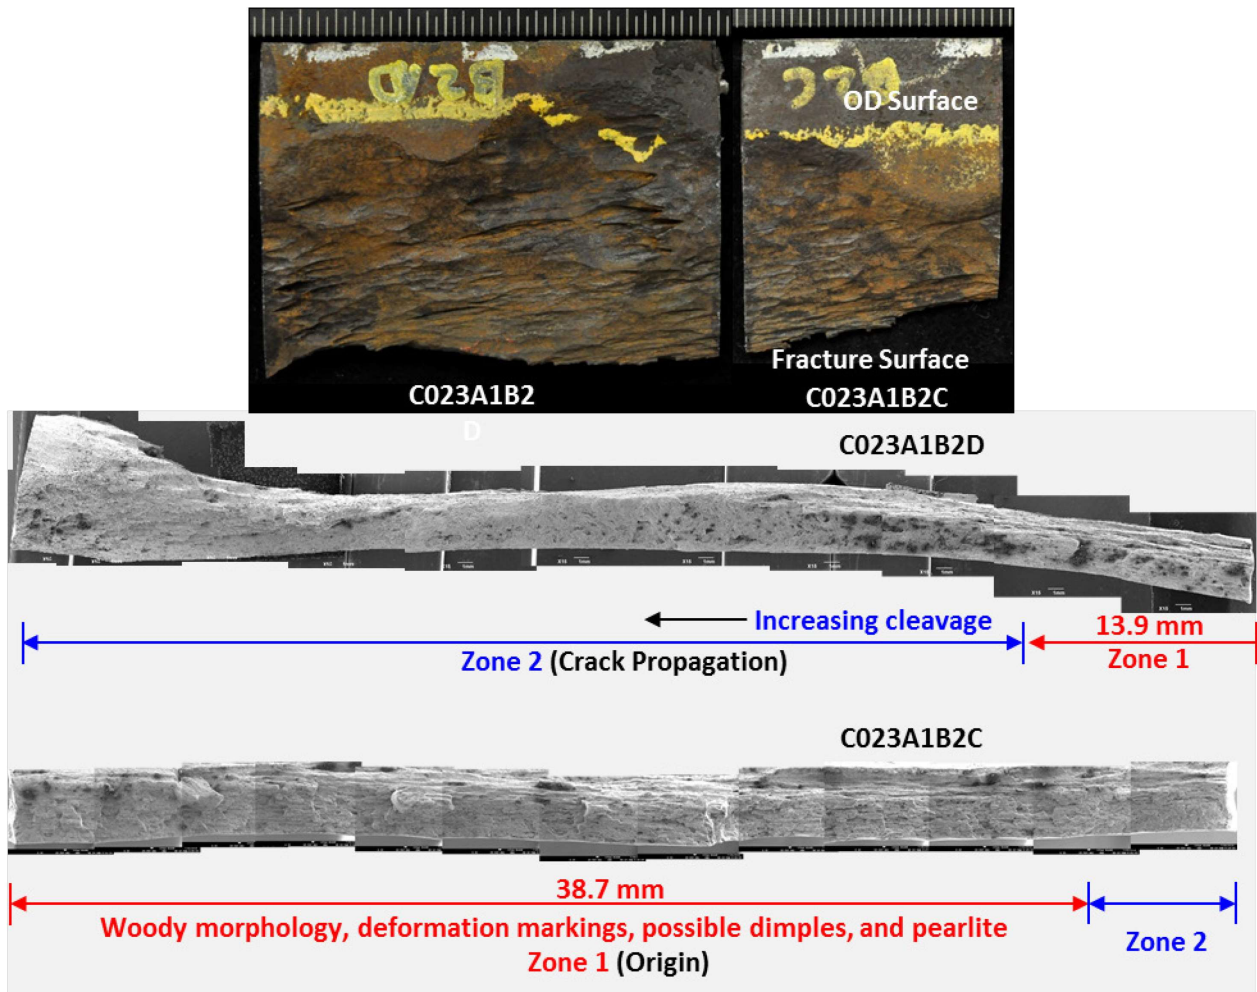
Figure 58: Origin Measurements Based on Micro Definition for C023A1B2C and C023A1B2D

The origin was originally defined based on metal loss measurements and chevron marks identified on the fracture surface. The origin length based on this criterion was measured at 4.8 in. (123 mm). The origin was redefined based on micro-scale features identified on the fracture surface. The micro-scale-based measurement was defined as the length of fracture surface that exhibits fully ductile tearing with no cleavage facets. The origin length based on the new micro-scale definition was 2.13 in. (54 mm). Figure 58 shows the Zone 1 measurements for C023A1B2C and C023A1B2D based on the new origin definition. The origin was measured as 0.55 in. (13.9 mm) and 1.52 in. (38.7 mm) for C023A1B2C and C023A1B2D, respectively. The kerf from the saw cut was approximately 0.06 in. (1.4 mm). The measurements result in a total Zone 1 length of 2.13 in. (54.0 mm). The initial origin length was reduced by more than a factor of two.

The length difference of the origin based on the micro (SEM) and macro (visual) definitions reflects the difference in the role they played for the axial rupture. The micro definition measurement of 2.13 in. represents the initial size of the crack origin. The macro definition measurement of 4.8 in. represents the rapid propagation of the crack as indicated by chevron marks.

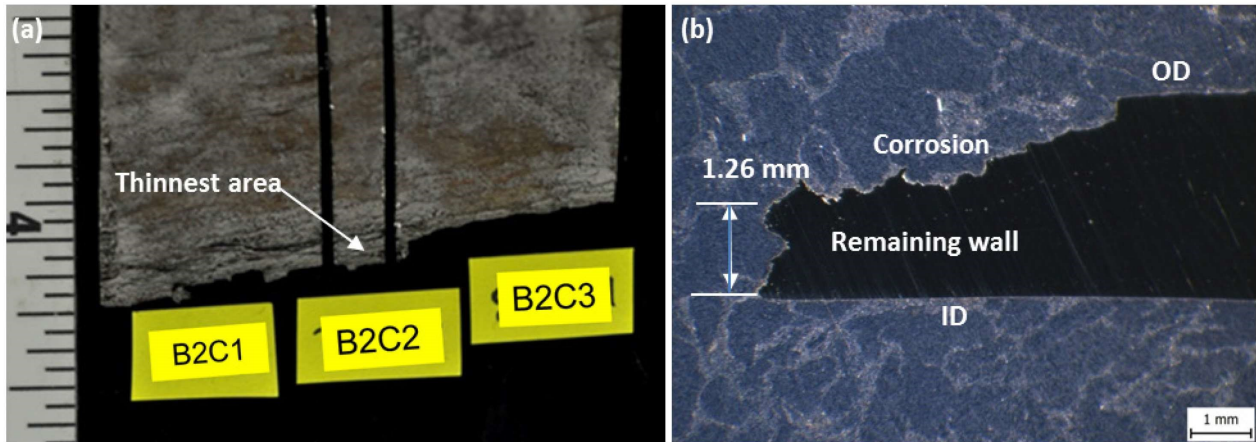
Figure 59: (a) Macro and (b) Metallographic Image of C023A1B2C2 Showing the Remaining Wall

A metallographic cross section was made to accurately measure the minimum remaining wall. The origin specimens (C023A1B2C and C023A1B2D) were visually examined to identify the thinnest area. The selected area was cross-sectioned, mounted, and polished for examination with a microscope. Figure 59 shows the location of the (a) metallographic section of C023A1B2C and the (b) measured remaining wall thickness on the polished specimen. The measured remaining wall was 0.0496 in. (1.26 mm), and the measured wall thickness of the unaffected area was 0.321 in. (8.15 mm). The calculated maximum metal loss, or maximum corrosion depth, was 85% actual wall thickness. The refined measurement of 0.0496 in. was accurate and was used as an input parameter for failure pressure calculations.

Ductile tearing and bulging could have contributed to the remaining wall measurement by ductile deformation. The measured remaining wall would then have been a combination of the original metal loss due to corrosion and thinning caused by the axial rupture. Cross-sections adjacent to the fracture surface were examined to determine if bulging and ductile tearing contributed to the remaining wall thickness measurement. Detailed metallographic examination confirmed that the grains appeared equiaxed and not elongated. Therefore, the remaining wall loss of 85% was caused by metal loss due to corrosion.

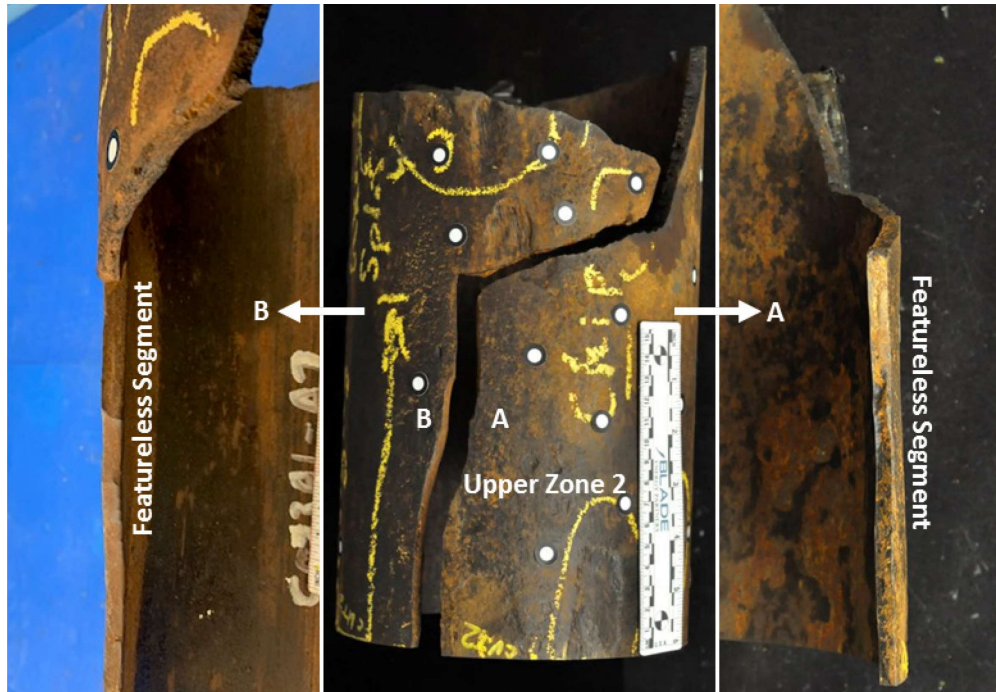
Figure 62: Overview of Upper Featureless Zone

Upper Zone 2 contained a 9 in. long featureless region in addition to a region with chevron marks. The 9 in. featureless region appeared relatively smooth with no visible chevron marks. Visual examination of the featureless region suggested that the fracture surface had been eroded due to escaping gas caused by the axial rupture. Figure 62 shows an overview of Upper Zone 2. Fracture surfaces A and B are mating surfaces of the rupture, which show the Upper Zone 2 featureless segment. Fracture surface A was used to characterize the fracture surface, while B was preserved for future investigations.

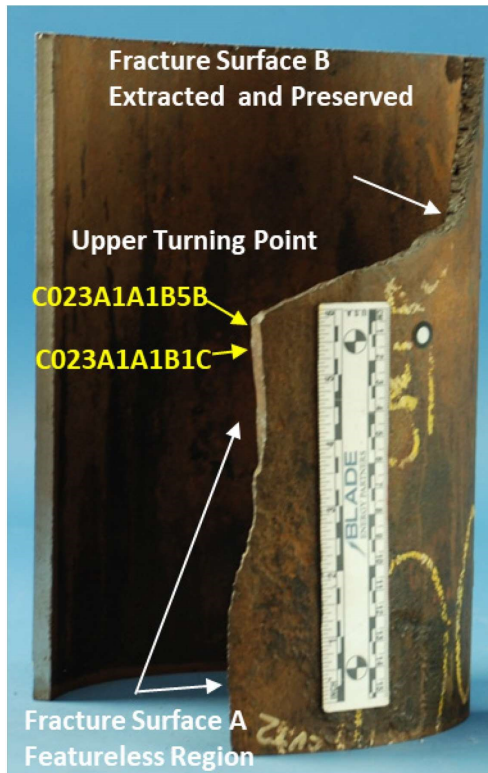
Figure 63: Fracture Surface A Featureless Region of Upper Zone 2

Two specimens were investigated to characterize the Upper Zone 2 featureless region. Figure 63 is a macro photograph of the featureless region. Specimen C023A1A1B5B contained a small section of the featureless zone and the upper turning point. Specimen C023A1A1B1C contained a portion of the featureless zone directly below specimen C023A1A1B5B. Both specimens were examined in detail with the SEM.

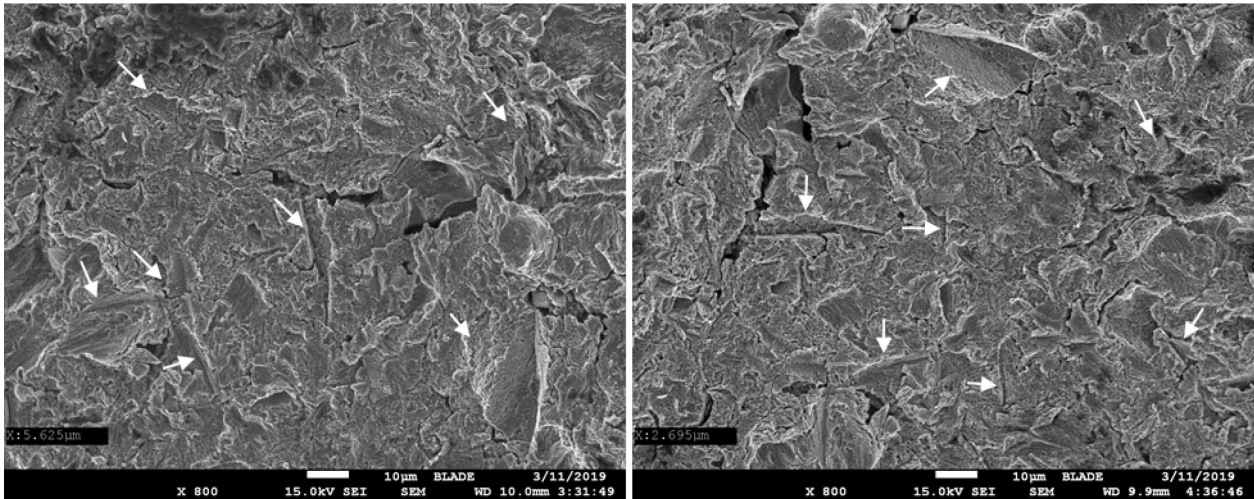
Figure 64: Representative SEM Images of Erosion Marks (White Arrows) Taken at 800×

Specimen C023A1A1B5B was examined first. The specimen was extracted and cleaned ultrasonically in a 1% Citranox solution for six minutes at room temperature. SEM observations revealed an eroded fracture surface with fine erosion marks. Figure 64 shows the representative SEM images of the eroded fracture surface. Erosion marks left on the fracture surface were readily identified at magnifications above 500 \times . Figure 65 shows the measured width distribution of 30 randomly selected erosion marks, which were used to estimate the particle size of the solids in the released gas flow. The results showed that the erosion marks had a maximum measured width of 8 μm , and more than 60% of the erosion marks had measured widths within the range of 4–6 μm . Multiple factors contribute to the width of erosion marks, including solid particle size, hardness, brittleness, speed, and angle of impingement. The particles were assumed to be three times the size of the erosion marks. Based on this assumption, the maximum particle size was 24 μm , and more than 60% of the particle sizes were in the range of 12–18 μm . These observations confirm that the Upper Zone 2 featureless segment was produced by erosion. The observations of specimen C023A1A1B1C were consistent with C023A1A1B5B. Featureless regions were the result of erosion from high-pressure gas with sand particles.

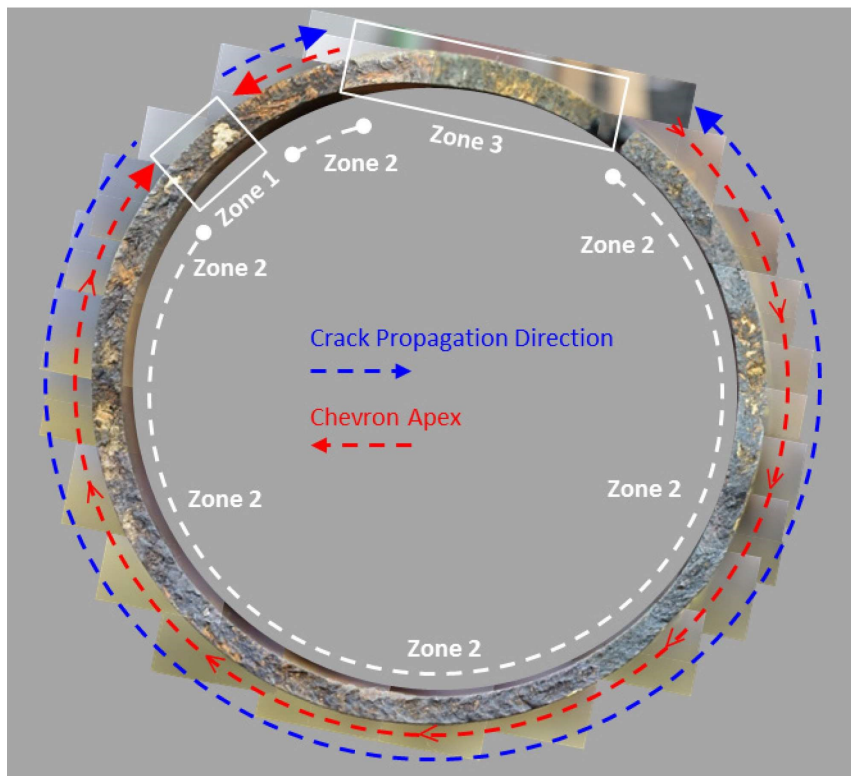
Figure 69: Zone 2 Chevron Marks and Crack Propagation Direction

Zone 2 was characterized by chevron marks with their apexes oriented towards Zone 1 (origin). Figure 69 shows the fracture surface in the non-cleaned condition. The chevron marks are clearly visible on a majority of the fracture surface in Zone 2. Zone 2 is identified by the dashed white circle in Figure 69. The dashed red and blue circles represent the chevron apexes and crack propagation, respectively. Zone 2 began at Zone 1 and arrested at the upper arrest point for the axial rupture. The beginning and end points for Zone 2 are indicated by the white dots at the end of the white circle.

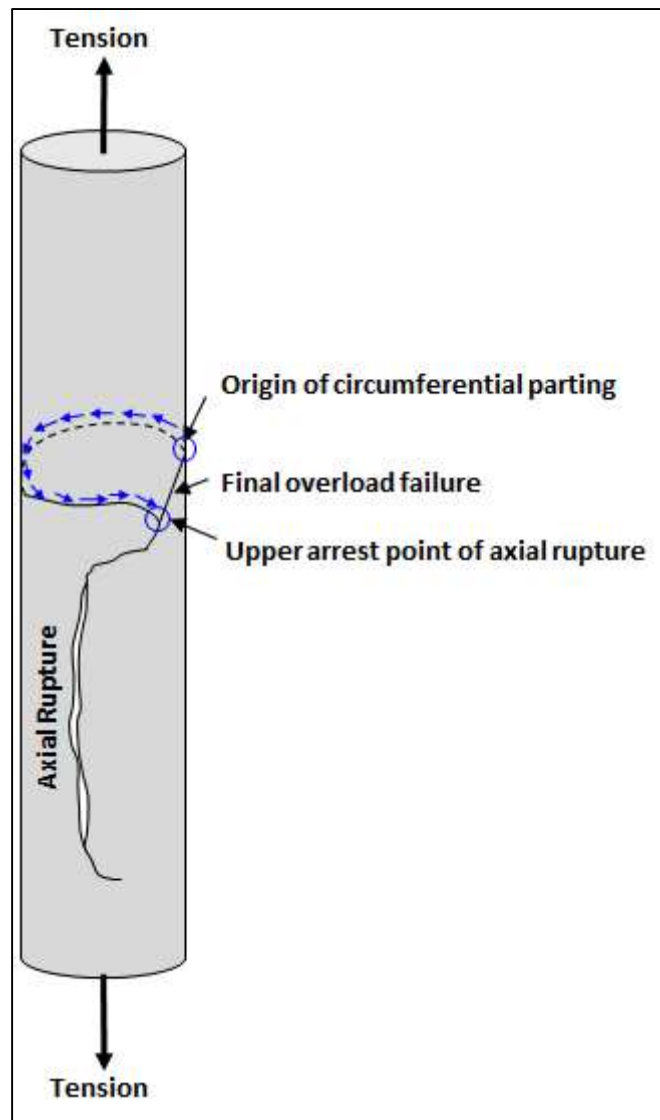
Figure 70: Schematic of the Axial Rupture and Circumferential Parting

the chevron marks produced by the axial rupture. The initiation site and chevron marks produced by the circumferential parting were located approximately 3.7 in. (94 mm) from the upper arrest point of the axial rupture. Figure 70 is a schematic of the crack path for the axial rupture and circumferential parting. The schematic shows how the circumferential parting initiated above the arrest point of the axial rupture. The crack propagated circumferentially until it reached the axial rupture arrest point. The final ligament failed due to the axial load generated by the weight and tension of the 7 in. casing string. The axial rupture and circumferential parting are thought to be two separate events because there was no evidence that the chevron marks from the axial rupture continued into the circumferential parting. The close proximity of the two failures suggests that they are related despite being two separate events.

Observations during the visual examination identified a significant difference between the axial rupture and circumferential parting. The circumferential parting was brittle, unlike the axial rupture, which was characterized by bulging and ductile tearing. The circumferential parting showed no evidence of plastic deformation or necking due to ductile overload. Measurements of the fracture surface were made to confirm this observation. Furthermore, Zone 1 of the circumferential parting was predominantly cleavage.

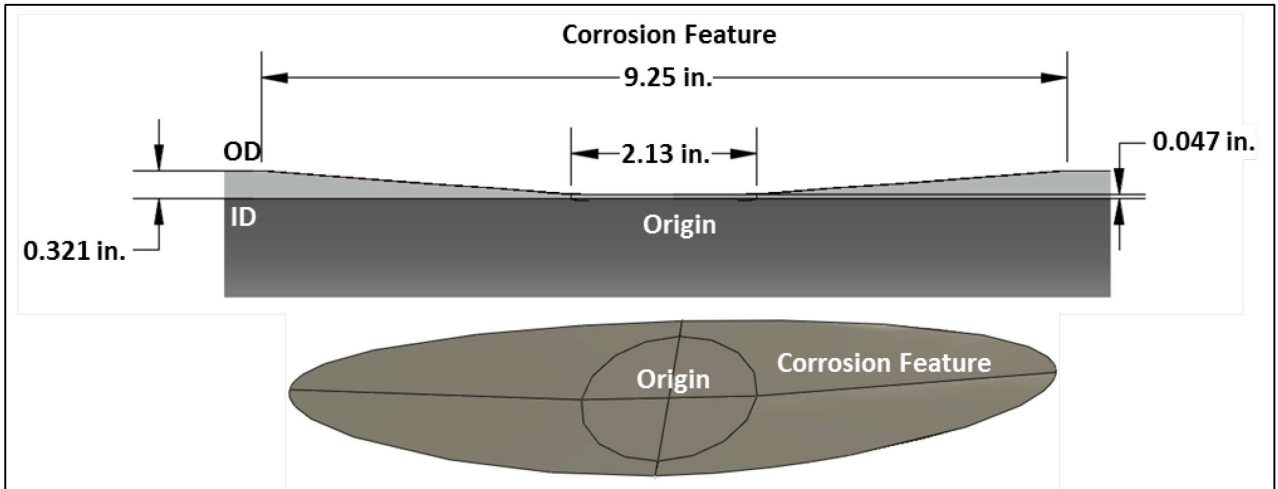
Figure 71: Corrosion Feature Geometry Model 1

Model 1 was a simplified model that focused only on the wall thinning effect (Figure 71). The wall loss of 85% (remaining wall of 0.047 in.) is depicted in the origin that was 2.13 in. The overall corrosion feature was 9.25 in. long.

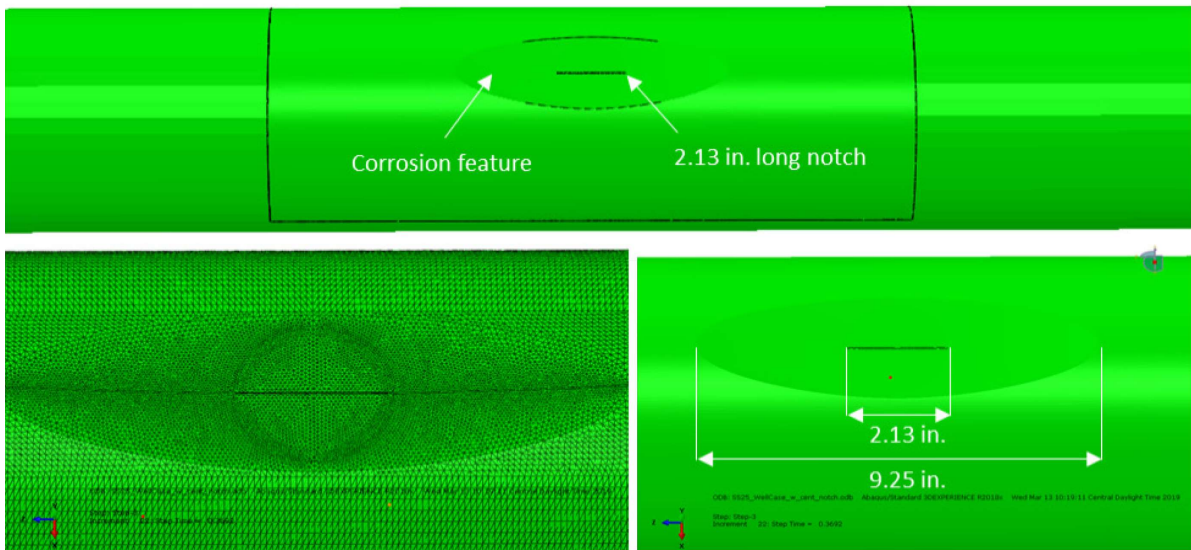
Figure 72: Model 2 Schematic and Mesh for Corrosion Feature and 2.13 in. Notch

Model 2 included a notch that depicted the striated grooves that were observed at the failure locations. The grooves’ dimensions were measured, and the diameter of the notch was noted to be 0.2 mm. However, the small dimensions were beyond the capability of the FE modeling tools; a notch radius of 1.0 mm was used to capture the notch effect of the corrosion grooves. The bottom of the notch was placed at a depth such that the remaining wall was equal to 1.26 mm, which is the same remaining wall as Model 1.

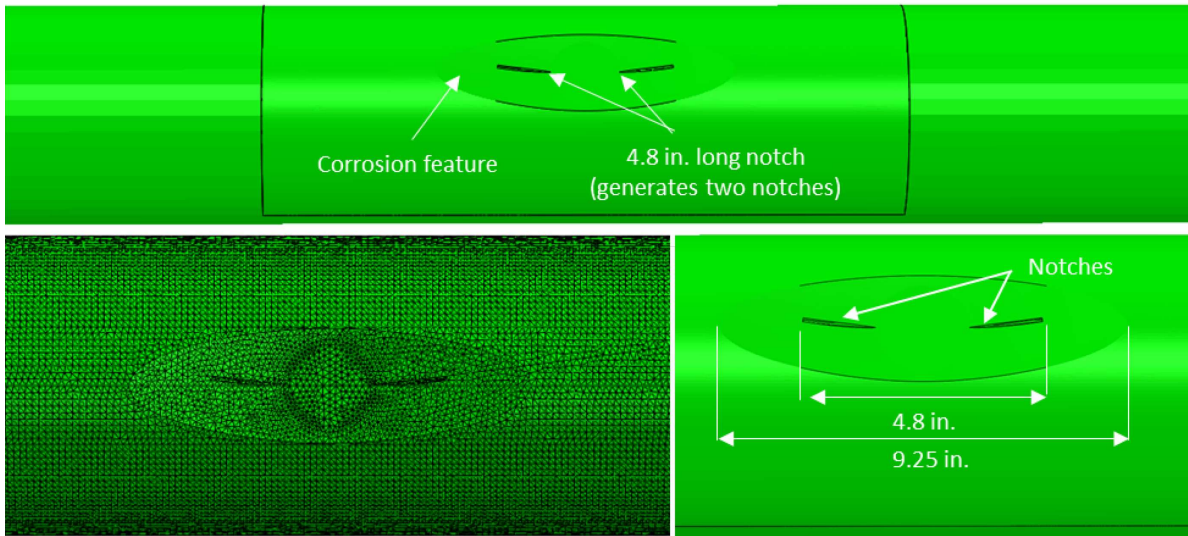
Figure 73: Model 3 Schematic and Mesh for Corrosion Feature and 4.8 in. Notch

Model 3 was designed to introduce the notch effect while maintaining the wall thinning within the ductile tearing region (2.13 in. circular region). The semi-elliptical bowl was modeled in the same way as Model 1. Unlike Model 2, the minimum wall thickness of 1.26 mm was maintained within the ductile tearing zone. A notch was introduced with a length increased to the macro definition of the origin (4.8 in.).
