Blade Report

I.19-06-016

Root Cause Analysis of the Uncontrolled Hydrocarbon Release from Aliso Canyon SS-25

May 16, 2019

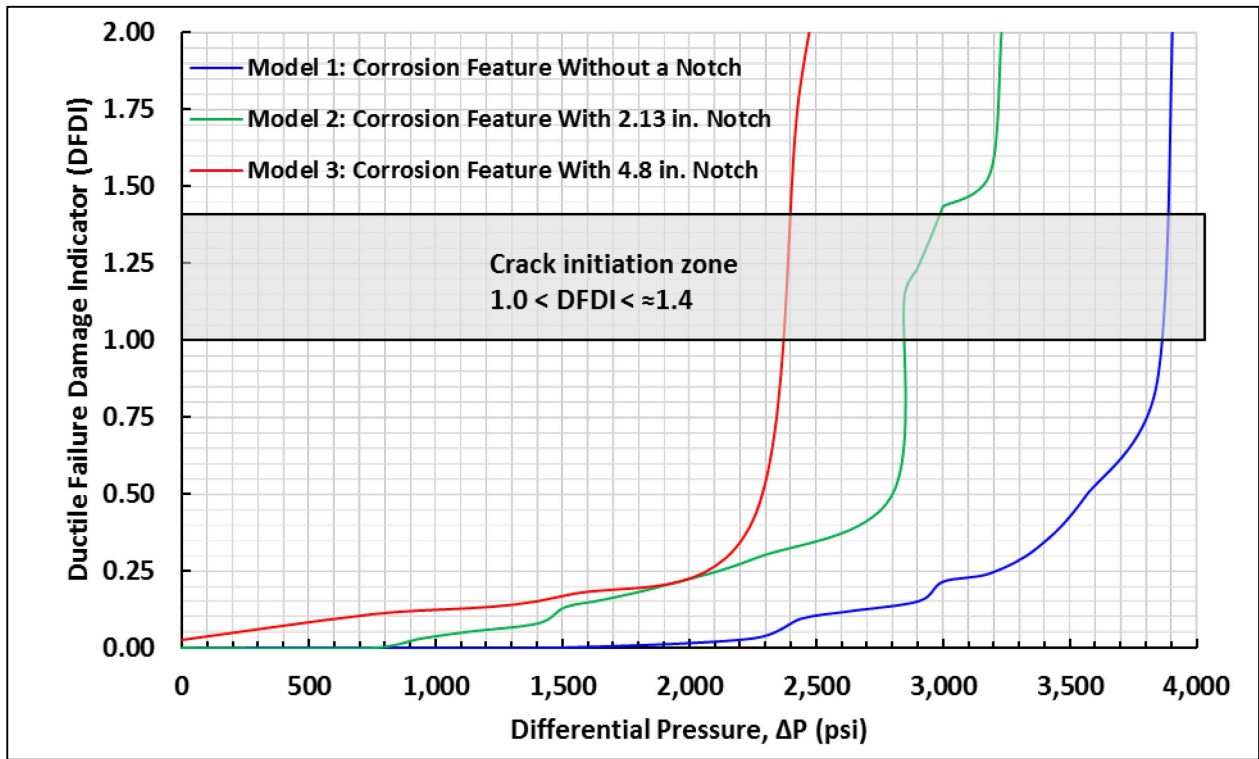
Figure 74: DFDI Evolution with Differential Pressure for Models 1, 2, and 3

A DFDI value of 1.0 was used to determine the differential pressure at which a crack would initiate within the corrosion feature. The DFDI is predicted for the three models as a function of pressure, and Figure 74 shows the results. The DFDI evolution is exponential, which implies the DFDI increases from 1.0 to 1.4 with a small increase in pressure. This implies that the crack initiates and grows by ductile tearing.

Table 5 shows the point of crack initiation in the plastic region when DFDI equals 1. The pure corrosion wall loss model predicts a pressure of 3,850 psi for a crack to initiate in this region. As shown previously in Table 4, the internal pressure on October 23, 2015, reached around 2,700 psi on surface and 2,791 psi at 892 ft. Model 1 schematic of the corrosion is not reflective of the failure scenario. Models 2 and 3 have differential pressures ranging from 2,327 to 2,836 psi, which is in the range of the pressures that existed at 892 ft. Since neither model completely captures the complexity of the failure region due to limitations of the FE modeling, the predicted range of failure pressures is from 2,327 to 2,836 psi. The key finding from the modeling is that the presence of the grooves was an essential element of the failure occurring at 2,791 psi internal pressure.

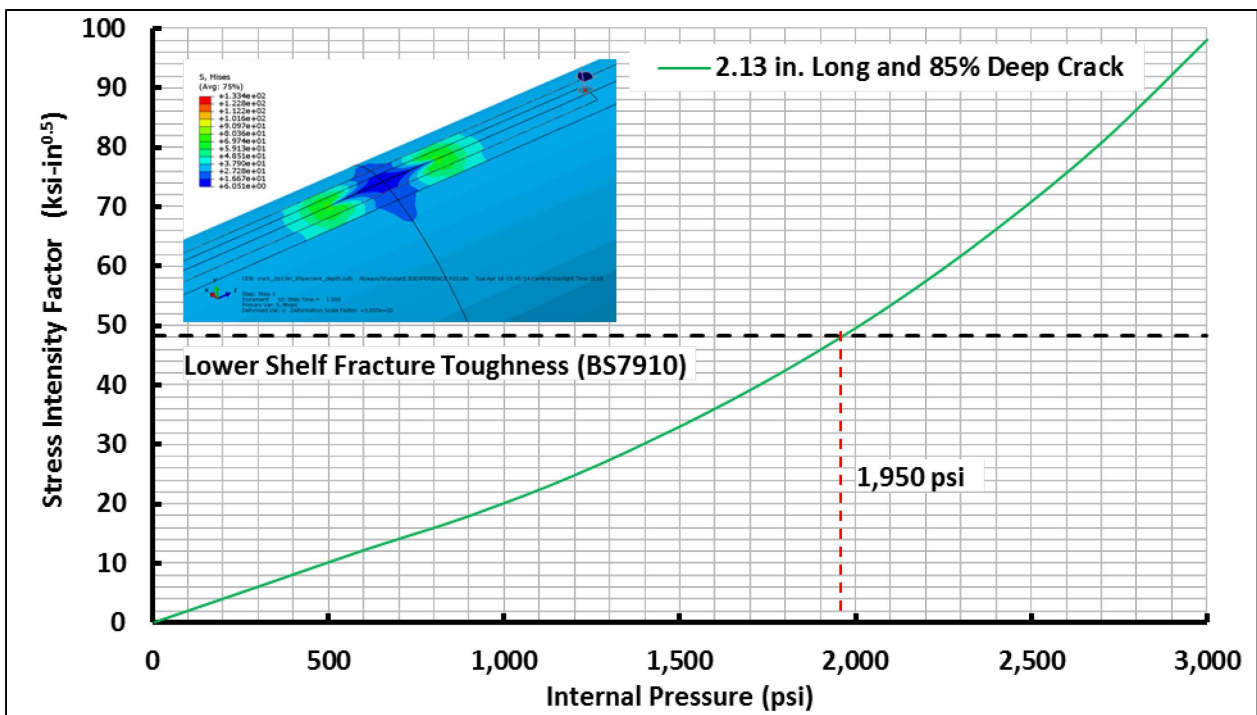
Figure 75: Stress Intensity Factor Evolution with Applied Internal Pressure

Charpy data were used to establish the fracture toughness of this material. The 7 in. casing J55 material exhibited lower shelf toughness properties at temperatures of 75°F (24°C). At room temperature, the average full size Charpy is around 14 J. This Charpy was converted to lower shelf fracture toughness (K_{Ic}) based on equations from BS7910 and equals 48.3 ksi-in^{1/2} shown with a dashed line in Figure 75.

In the FE model of the crack, the crack tip stress intensity factor reaches a value of 48.3 ksi-in^{1/2} equaling the fracture toughness when the internal pressure was approximately 1,950 psi. Figure 75 shows the results of the fracture mechanics analysis. The crack is unstable beyond 1,950 psi at room temperature. The results show that a 2.13 in. long and 85% deep crack would propagate at differential pressures ≥ 1,950 psi. The estimated strain-based failure pressure (2,327—2,836 psi) is above the fracture toughness-based instability pressure (1,950 psi). This shows that once the 2.13 in. crack formed by ductile tearing was unstable.

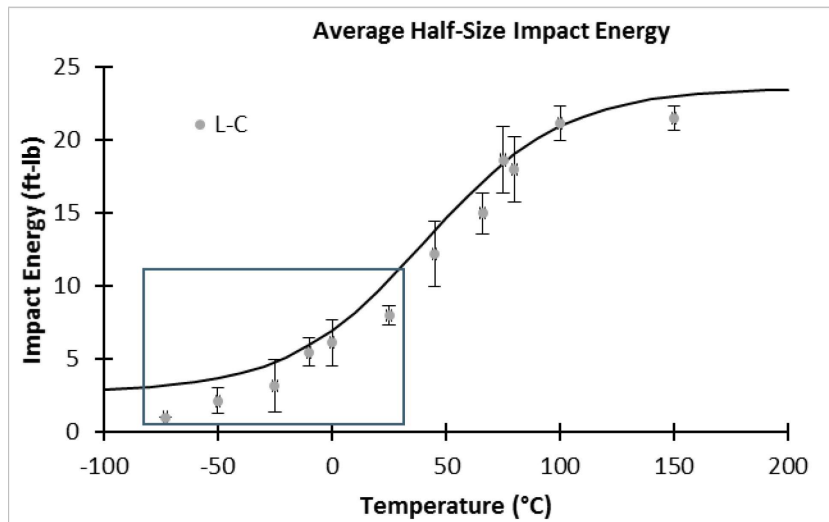
Figure 76: Average Half-Size Charpy Impact Energy vs Temperature for L-C Orientation

The average Charpy impact toughness data measured in the L-C (longitudinal-circumferential) direction as a function of temperature is shown in Figure 76.

The region of interest is the lower shelf that is marked by the box in Figure 76. Fracture toughness has been correlated to Charpy data for the lower shelf based on BS7910, which is shown by the equation below.

The fracture toughness that is estimated for the circumferential parting (Table 6) is correlated to Charpy. Then, from the Charpy data, the temperature is estimated and shown in the last column. The circumferential parting occurred at a temperature that would have ranged from -76°F to -38°F (-60°C to -39°C); the range is defined by the defect dimensions and the fracture mechanics model that is used.

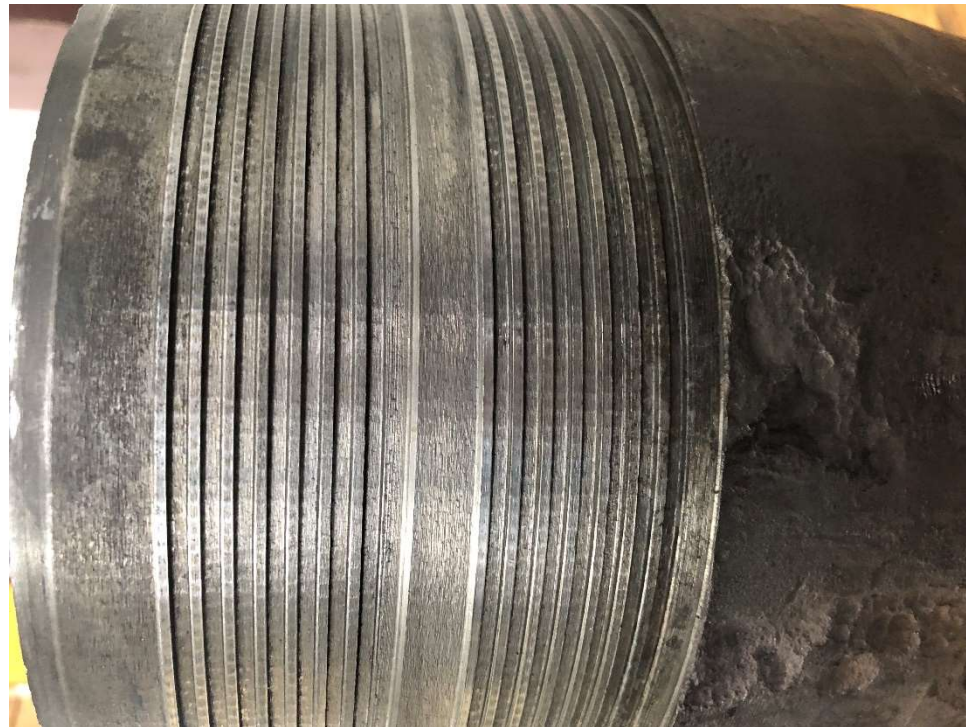
Figure 78: Pin and Box from Leaking Connection C023A1C

The highest leak rates came from C016B and C023A1C, which leaked at 1,120 SCCM (57 scf/D) and 196 SLM (9,967 scf/D) respectively. Connection C023A1C was located in the well 2.3 ft below where the 7 in. casing parted. The remaining seven leaking connections had very low flow rates.

None of the rates were high: there were no indications of any thread erosion as shown in Figure 78. The threads appeared to be in as-machined condition; however, the testing showed that for C021B at 1,000 psi the connection was leaking at more than 4 SCCM, whereas at 3,300 psi the leak rate was 128 SCCM. The leak rates were low and it could be stated that the gas seeped through the connections. The connection testing results were reproducible, implying that the nine connections leaked, albeit at low flow rates. Consequently, the conclusion based on the examination of the threads and the connection testing results was that hydrocarbon gas seeped through some of the connections at low flow rates.

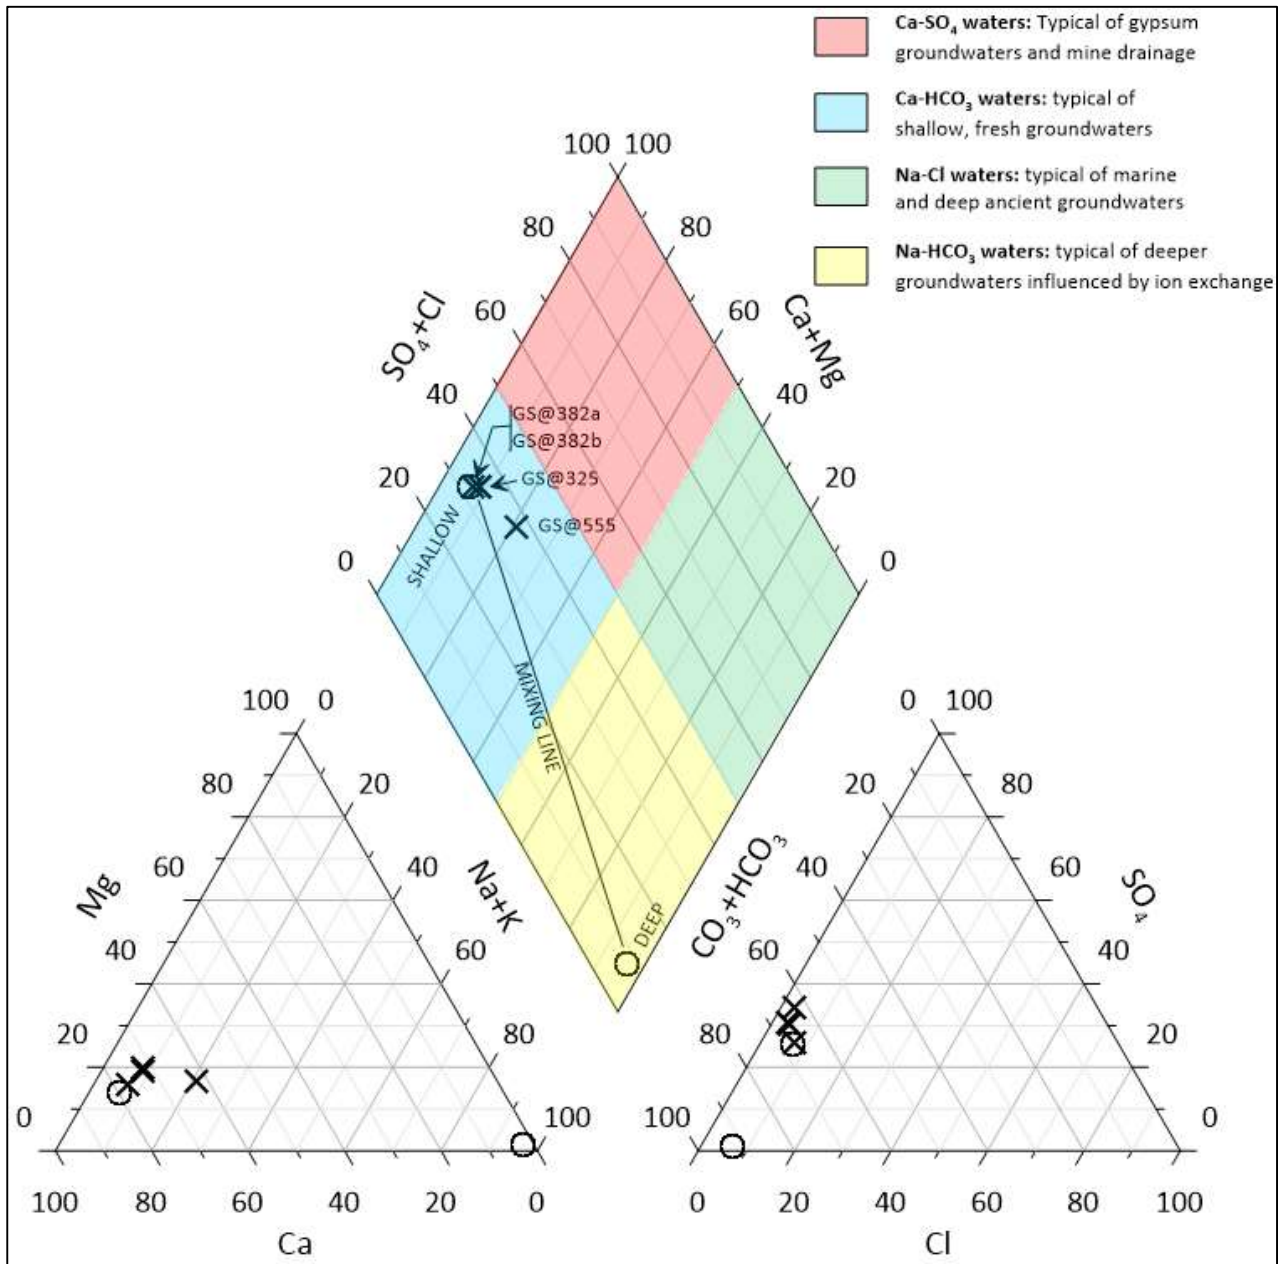
Figure 80: Piper Plots Showing all the Water Analyses

To interpret the water samples, the grab samples that were collected while drilling and the samples collected from the two monitoring wells are depicted on a Piper Plot in Figure 80 [27]. The grab samples compared to the monitoring well samples from shallow depth were identical, which was expected. These waters had calcium cations with bicarbonate. However, the deeper sample was richer in sodium with bicarbonate anions. The cations were different for the shallow versus the deeper water samples.

The difference in the water samples may be due to a mechanism that is discussed in hydrochemical literature known as ion-exchange [28]. The interaction of the water with the clay minerals has been known to result in an exchange of the ion from the water with that adsorbed on a solid. Clays are known to have high ion-exchange capacities when compared to other minerals. As the water permeated deeper into the formation, it would have encountered other clay formations, and the calcium ion would have been replaced by the sodium ion. This mechanism explains the difference in water chemistry between the shallow and deeper samples.

There were distinct shallow (340 to 440 ft) and deeper (900 to 1,000 ft) groundwater with slight differences in water chemistry. This water likely represented the environment in the production casing annulus and outside of the surface casing.

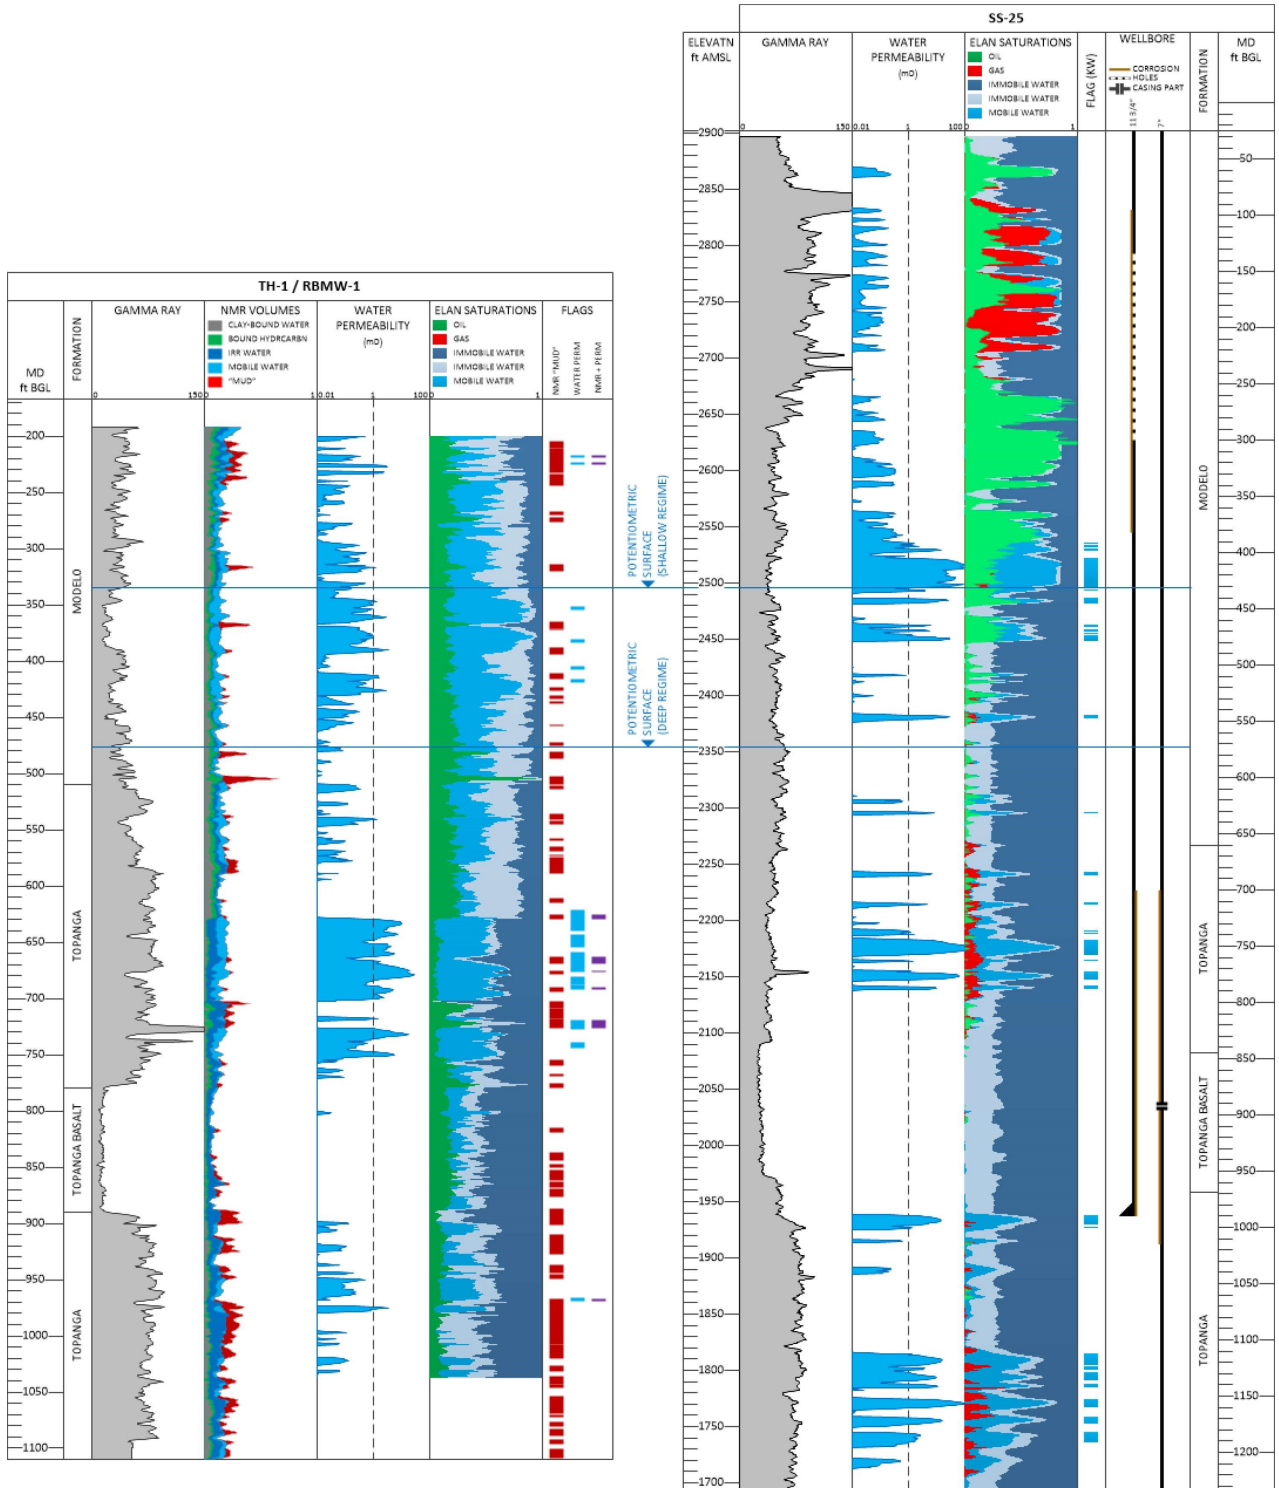
Figure 81: Correlated Geophysical Logs for RBMW-1 and SS-25 Wells

Several geophysical logs were run in both RBMW-1 (on SS-9 site) and the SS-25 well. The primary objective was to locate water zones, if any. Both these logs need to be considered in the interpretation, especially since the formations around the SS-25 wellbore may have been compromised because of the uncontrolled flow and numerous kill attempts. Therefore, RBMW-1 was used to understand the undisturbed subsurface hydrology and compare that to SS-25 (Figure 81).

In the NMR track, the Mud column indicates high-permeability layers, which would be invaded by drilling fluids once the hole is filled to run the NMR logs. Since NMR logs can only be run in open holes, it was not possible to run an NMR log in the SS-25 well. The Modelo formation is above 510 ft in RBMW-1, whereas it is above 660 ft in the SS-25 well. Similarly, above the basalt, the Topanga formation ranges from 510 to 780 ft, whereas in the SS-25 well it ranges from 660 to 845 ft. After the basalt, the Topanga formation starts at 890 ft in RBMW-1 and starts at 970 ft in SS-25.

In summary, Figure 81 suggests that the mobile water is encountered in distinct higher-permeability layers in both Modelo and Topanga formations, but not in the basalt layer. From both logs, the basalt contains no water in SS-25 and RBMW-1. Below the basalt, there is a distinct water zone ranging from 990 to 1,010 ft in SS-25 right at and below the 11 3/4 in. shoe. There is a water permeability streak and mobile water between 990 and 1,010 ft in SS-25. This was likely the source of water that entered the production casing annulus. Further, several shallow high-permeability water layers are observed in both

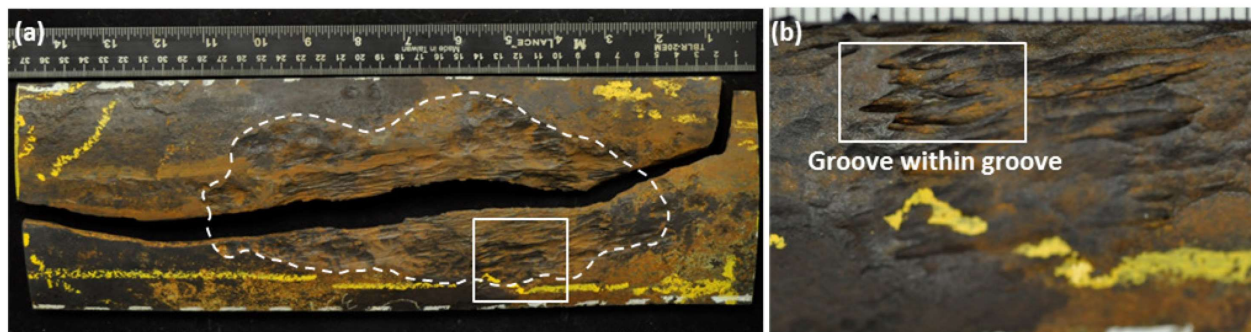
Type I was typical of the failure location and was characterized by striations as shown in Figure 89. These striation features have a groove with a sharp 'V' on each end of the groove. Type I corrosion could be visually identified, and the size of these features varied by location. The striated grooves were noted in all the joints starting from joint 18 onwards; however, none of the connections exhibited this type of corrosion.

Figure 89: (a) Joint 22 Axial Rupture and (b) Type I Feature Showing V-shaped Tips

Type I corrosion at the failure location, as shown in Figure 89, is distinct in nature. The possible cause for such corrosion was assessed and investigated by using morphology, scale, and microbial data.

The axial rupture occurred at the location where the Type I corrosion feature was present (Figure 89). Type I features can be described as a patch of metal loss with striated grooves that are oriented 10 to 15 degrees off longitudinal axes. The grooves contained pointed tips as seen in Figure 89. Some groove tips were present within another groove. The Type I metal loss features were observed as isolated patches along the length of the SS-25 7 in. casing. The maximum wall loss within the patch was 85% of wall. Adjacent to the feature was unaffected metal surface (no metal loss).

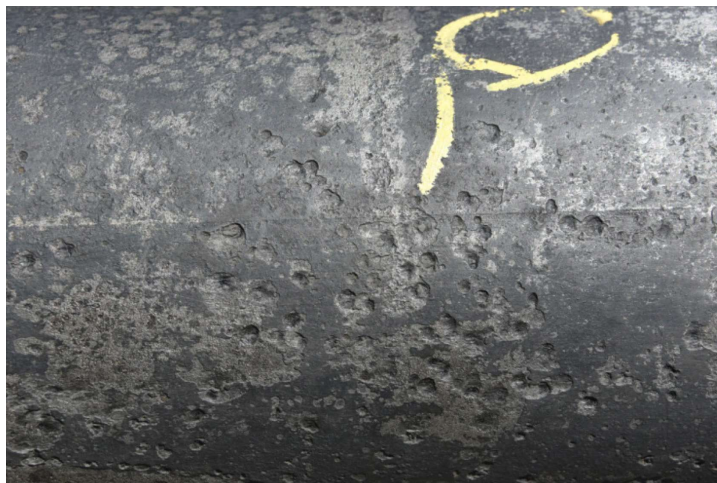
Another type of corrosion that was observed in the joints is classified as a Type II feature as shown in Figure 90. These features were isolated smaller pits, and quite often shallow. These were observed across all of the joints and some connections.

Figure 90: Type II Corrosion—Isolated Small Pits

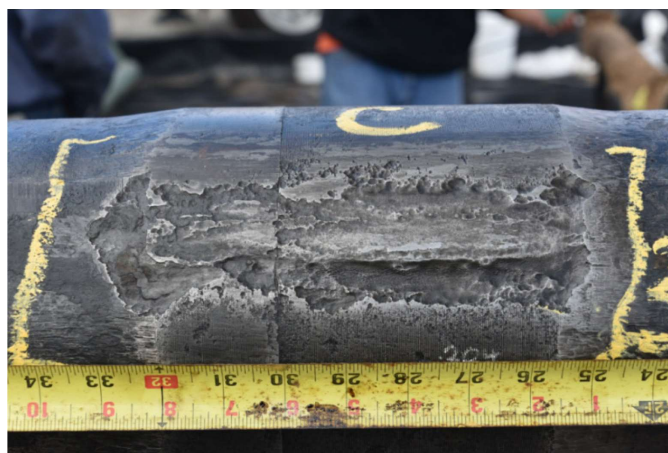
Finally, Type III features appeared as very unusual elongated shapes. Several small scoop-shaped features adjacent to each other are seen within the elongated region as shown in Figure 91. The middle region of Type III feature is not severely attacked by corrosion. Nearly, every connection from connection 16 onwards exhibited Type III, and it was not noted on any of the joints, with one exception (joint 20).

Figure 91: Type III Corrosion feature

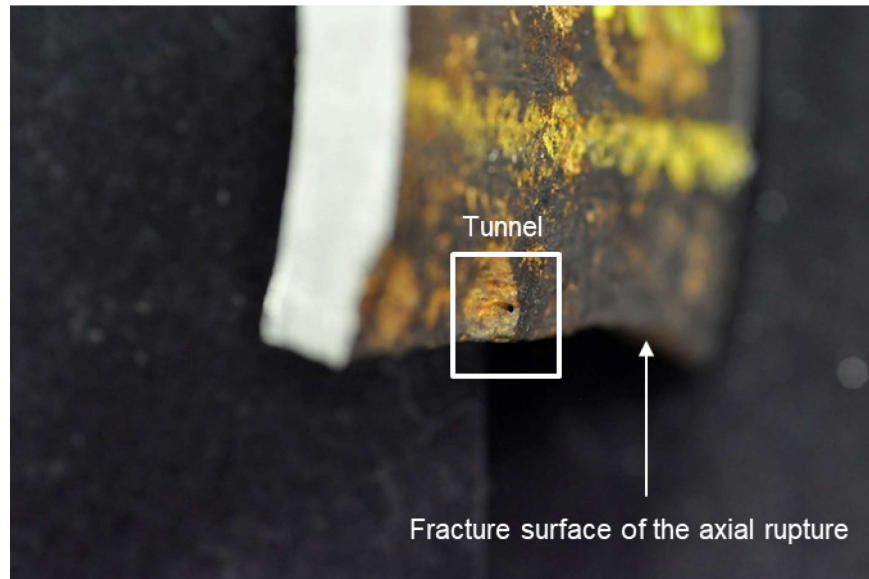
The axial rupture specimen C023A1-B2 from joint 22 had a corrosion patch with striated grooves (Type I corrosion feature). The corrosion patch had a length of 9.5 in. along the longitudinal axis. The specimen was divided into smaller sections to facilitate the SEM investigation of the fracture surface and corrosion features. Specimen C023A1-B2A5 from the axial rupture had a visible tunnel in the groove that was visually identified (Figure 92). The tunnel orientation was parallel to the axial rupture fracture surface. The tunnel penetrated the base metal. Figure 93 shows the magnified image of the tunnel using the SEM image of the same tunnel in Figure 92. Within the tunnel there are scale deposits. Despite the samples being exposed to kill and other fluids since the leak event, the scales and other deposits within these tunnels should have been relatively unaffected.

Figure 92: C023A1-B2A5 Groove Tunnel Adjacent to Axial Rupture Fracture Surface

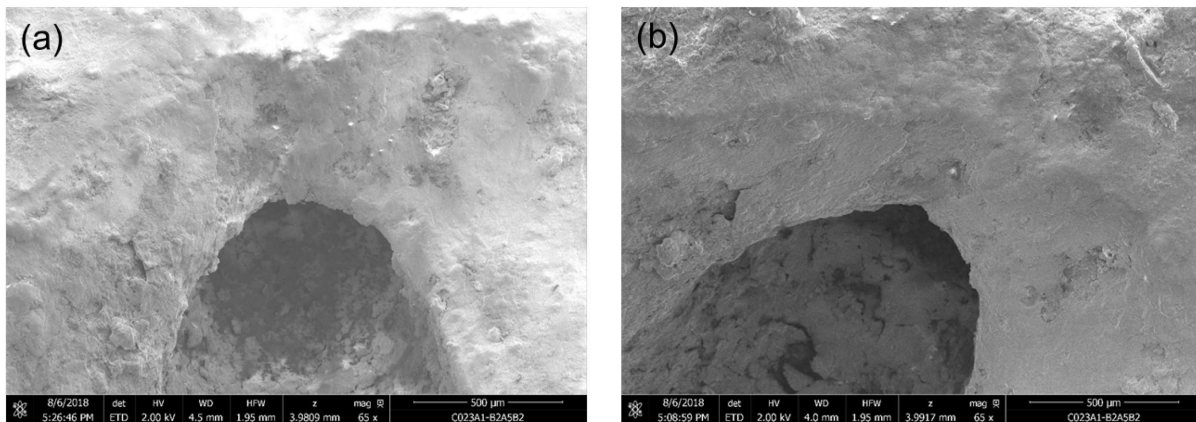
Figure 93: Specimen C023A1-B2A5B2 Tunnel Seen at Different Angles

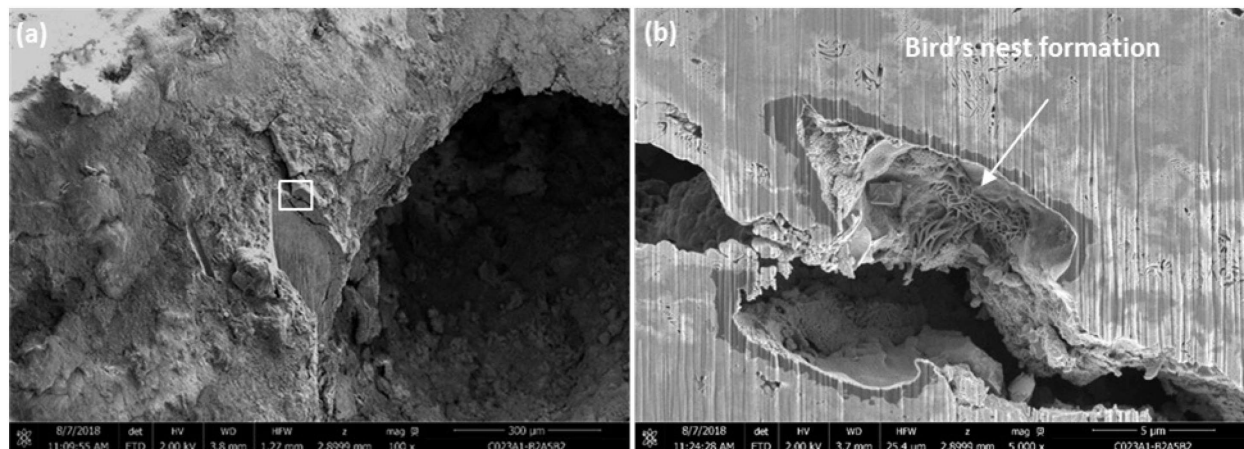
FIB cross-sectioning was done on the wall of the tunnel to look at the deposit morphology on sample C023A1-B2A5B2. Figure 95 shows the corrosion deposit morphology, which looks like the bird’s nest formation. This has been described by various authors who have studied atmospheric corrosion [30] [31] [32]. An EDS analysis revealed that the corrosion deposit contained ≈40 atomic percent (at%) Iron (Fe), 18 at% Carbon (C), 18 at% Oxygen (O), 9 at% Calcium (Ca), 0.2 at% Sulfur (S), and small amounts (<1 at%) of other elements. Another FIB cross section at the tip of the tunnel (Figure 96) reveals the corrosion products that form inside the tunnel. The main elements found with EDS were C (≈60 at%), Fe (≈19 at%), O (≈19 at%), and small amounts of S, K, Mn, Cl, Si, and Al. The corrosion product did not appear to be dense. Several layers of deposits were seen inside the tunnel.

Figure 95: FIB Cross Section of the Tunnel Wall in C023A1-B2A5B2 at (a) 100× and (b) 5,000×

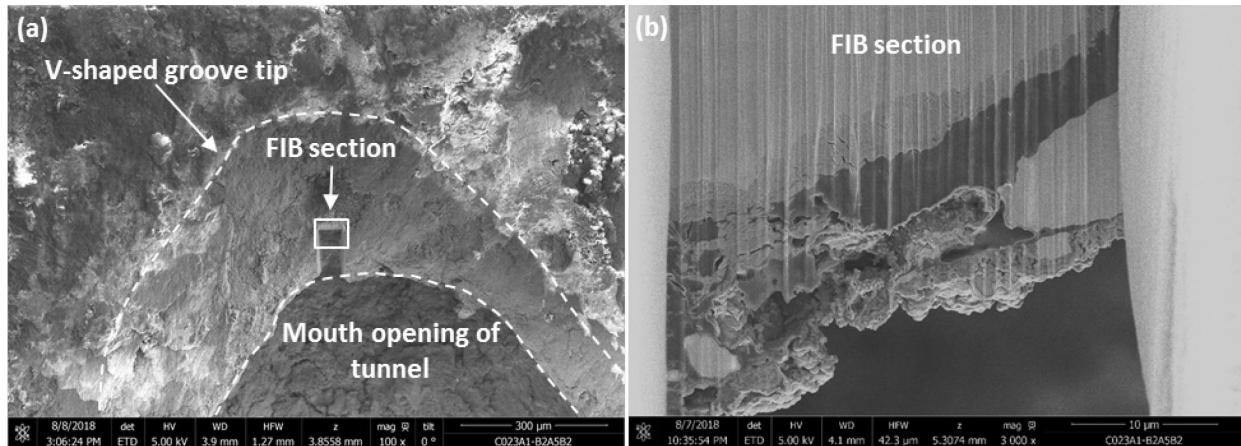
Figure 96: FIB Cross Section of the Tunnel Tip in C023A1-B2A5B2 Viewed at (a) 100× and (b) 3,000×

Further investigation of the area adjacent to the major tunnel identified a smaller tunnel at the initial formation stage. A closer look at the low magnification image in Figure 96 (a) shows a small, darker circular feature (white arrow) that appears to be another tunnel directly above the FIB cross section. Figure 97 shows a high magnification image of the circular feature. Material that appears to be extra-cellular was within the smaller tunnel. EDS analysis showed that the material surrounding the forming tunnel had a high amount of C (≈ 77 at%), with 10 at% Fe, 9 at% O, and 0.6 at% S. The high carbon on the extra-cellular looking material may indicate biological activity related to the formation of the tunnel.

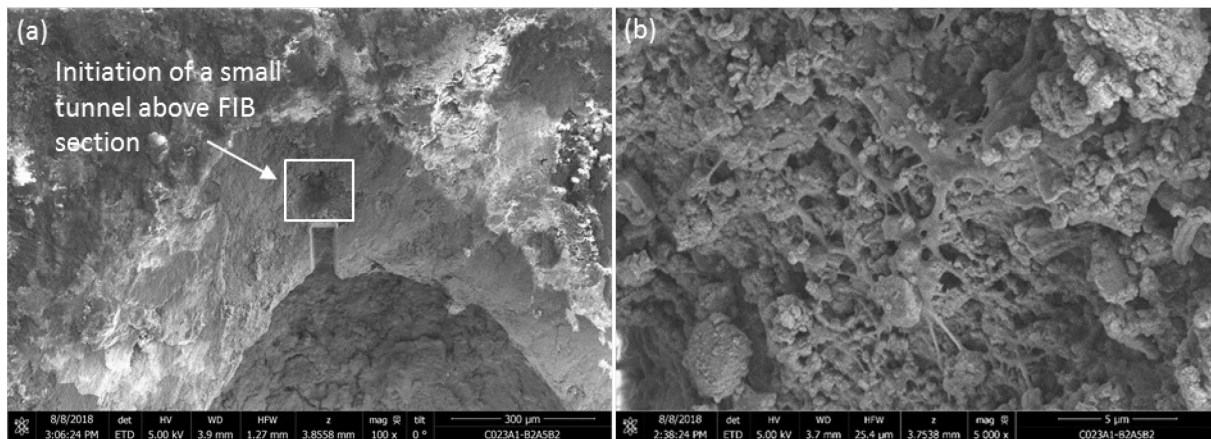
Figure 97: C023A1-B2A5B2 (a) Small Tunnel and (b) Extra-Cellular Looking Material

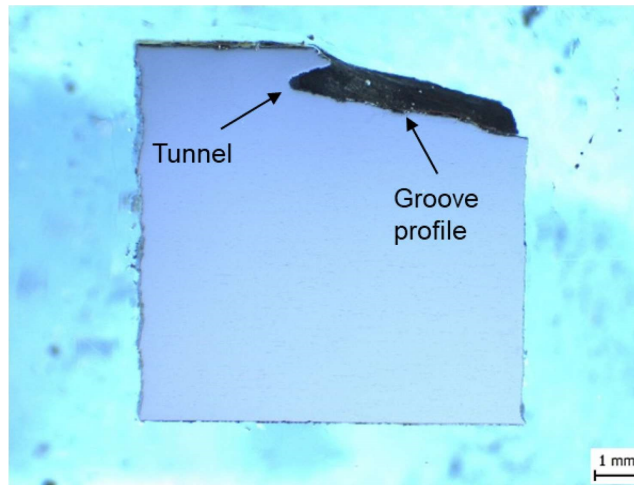
C023A1-B2A5B2A was subjected to a progressive-step wise metallographic sectioning across the major tunnel after the FIB investigation. The sample was mounted in epoxy. Figure 98 shows the groove profile of the depth of the tunnel along the longitudinal axis of the pipe after the second polish. The tunnel has a mouth opening of 0.0197 in. (0.5 mm) and extends 0.0393 in. (1 mm) into the metal. Figure 99 shows that the corrosion deposit at the tip of the tunnel is denser. Lamellar (plate-like) features are visible from SEM high magnification image in Figure 99. The presence of the lamellar cementite provides an anchor to the corrosion products [33]. EDS analysis showed that the corrosion product inside the tunnel was rich in O and C. The analysis also revealed that manganese sulfide (MnS) inclusion was present and surrounded by the corrosion product.

Figure 98: Stereo Microscope Image of C023A1-B2A5B2A

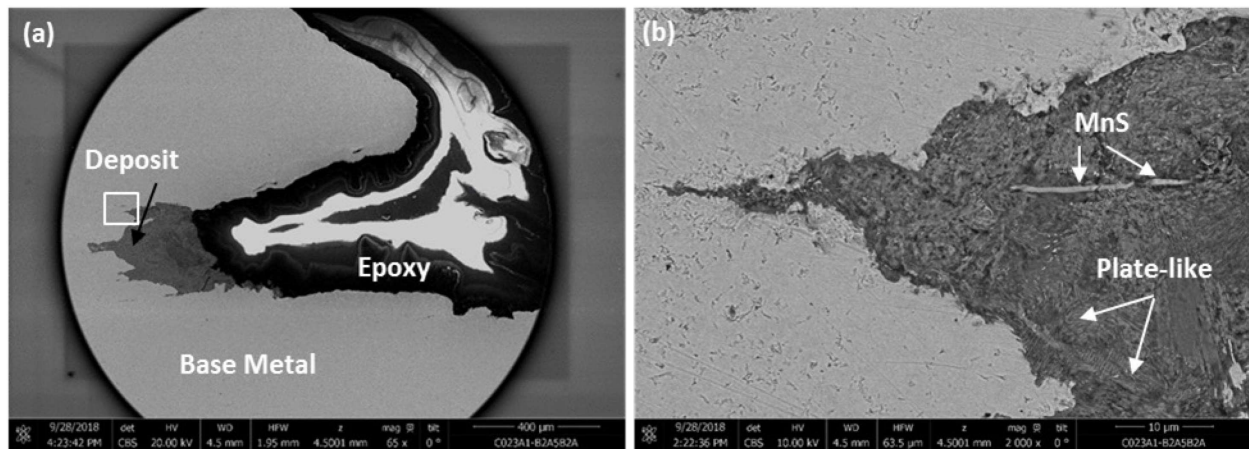
Figure 99: (a) Second Metallographic Cross Section of C023A1-B2A5B2A and (b) High Magnification Image of Corrosion Deposit

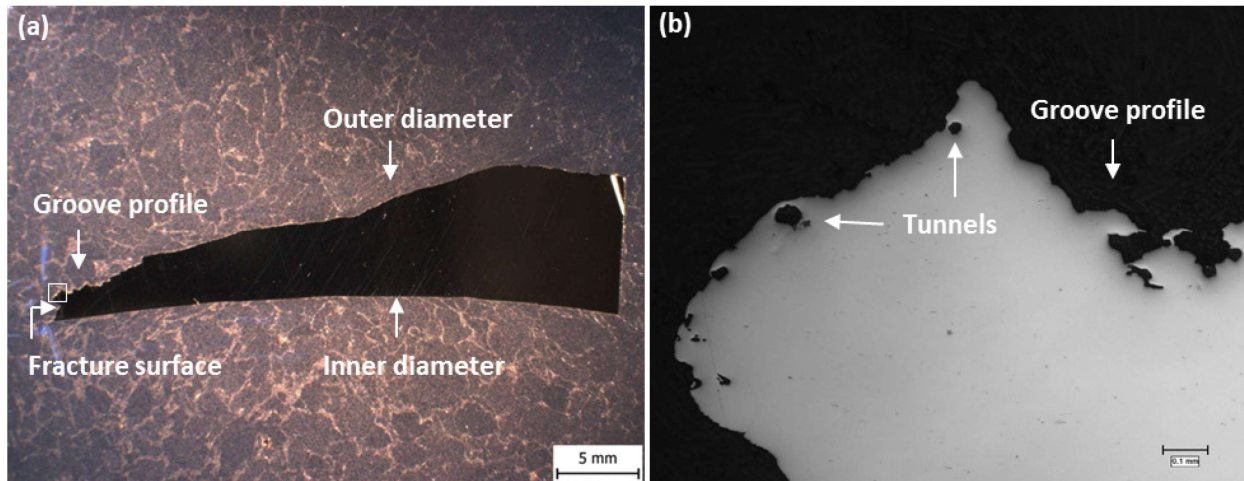
C023A1-B2C2 was extracted from the initiation site of the axial rupture fracture surface. The specimen was mounted in epoxy and polished. Figure 100 shows a cross section of C023A1-B2C2 indicating the presence of tunnels directly below the groove inside of the Type I corrosion feature. The cross section also shows that MnS inclusions are present in the tunnel along with the acicular corrosion deposit. Figure 101 shows the SEM image of the cross section and the sulfur and manganese mapping obtained with EDS. The corrosion products inside the tunnel were not very dense. They were identified as hematite, modified hematite, magnetite, and organic matter using Raman spectroscopy.

Figure 100: (a) C023A1-B2C2 Mounted and Polished and a (b) High Magnification Image Near Fracture Surface

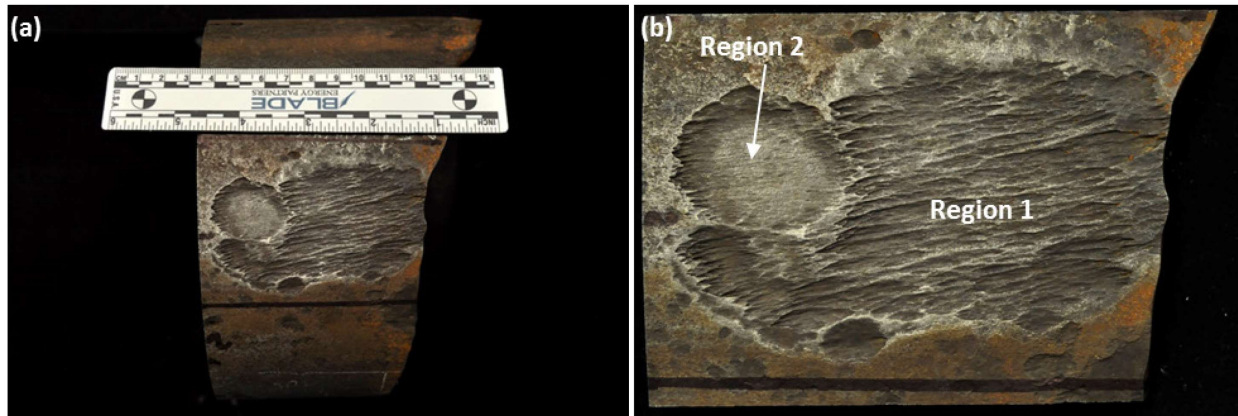
Specimen C022B1 was extracted from the failed joint (joint 22). The specimen was located adjacent to the circumferential parting. The corrosion patch is approximately 3.5 in. long in the longitudinal direction and contained two regions. Region 1 of the corrosion patch has striated grooves that are visible within the entire region. Region 2 of the corrosion patch contains groove tips that are visible on the edge; however, striated grooves are not very visible on the mid region (Figure 102). The crystalline deposits were also observed on the striated grooves. Raman spectroscopy analysis of specimen C022B1 showed presence of carbonate, iron oxide combination, and organic matter. The number of grooves and groove density was quantified in a patch of corrosion, which was then compared to MnS density. There was no relationship between the two; the MnS density was much higher than the groove density. The

Figure 102: (a) C022B1 Specimen Extracted from the 7 in. Casing Adjacent to the Circumferential Fracture; (b) Macroscopic View of C022B1 Specimen After Cutting

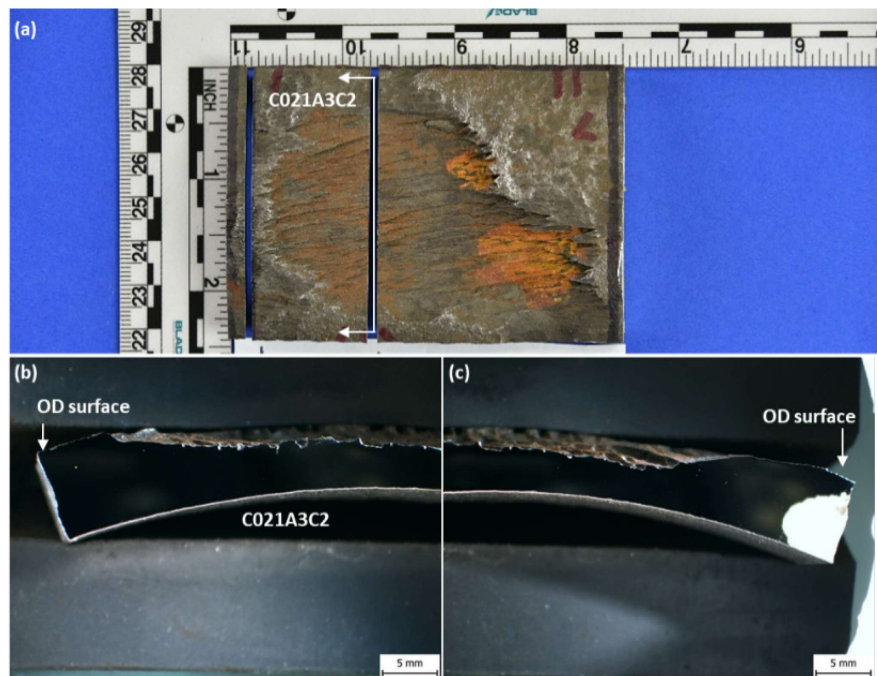
Specimen C021A3C was extracted from joint 21 of the SS-25 7 in. casing. This specimen exhibited a corrosion patch with striated grooves (Figure 103 [b]) approximately 3 in. long along the longitudinal axis. Groove tips were seen within larger groove tips and the striated grooves were visible over the entire corrosion patch. Raman analysis showed the presence of hematite (Fe_2O_3) and an iron oxide combination of hematite (Fe_2O_3), goethite ($\alpha-FeO(OH)$), and ferrihydrite ($Fe(OH)_3$).

Figure 103: (a) C021A3C Pipe Section from 7 in. Casing; (b) and (c) Cross section near center

Specimen C021A3C was sectioned across the striated grooves to investigate the groove profile and tips. Figure 103 (b) and (c) shows the profile of the grooves within the corrosion patch and unaffected OD

surface indicated by arrows. This image shows severe metal loss towards the center of the corrosion patch. Each individual groove contributed to the metal loss profile.

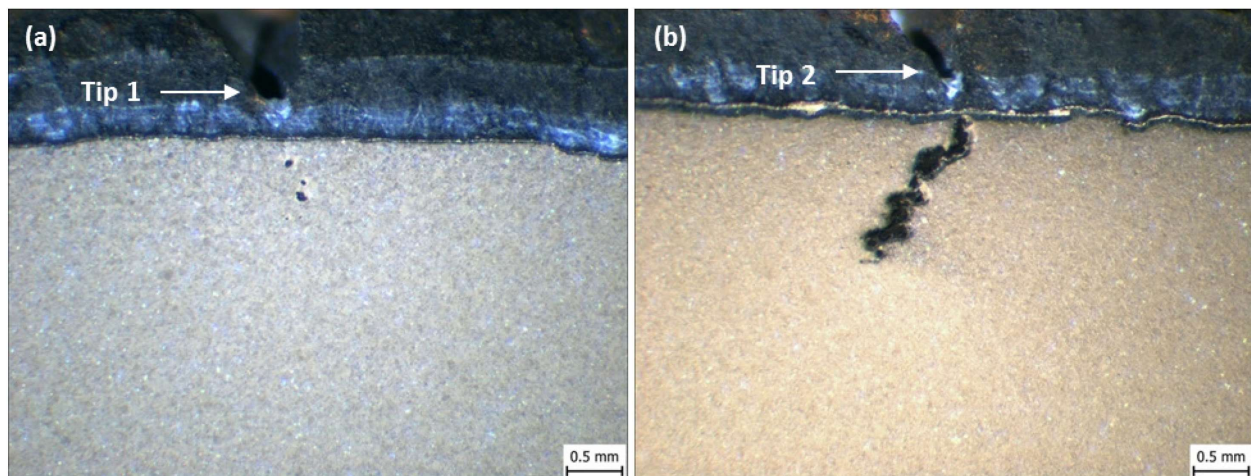
The cross section of specimen C021A3C2 near the groove tips revealed several tunnels underneath the groove tip. C021A3C2 groove tips were cross sectioned 1 mm ahead of the V-shaped groove tips. The dark circles in Figure 105 reveal the presence of several tunnels underneath Tips 1 and 2. Figure 106 are metallographs taken after the polished surfaces were etched of tunnels under Tips 1 and 2. Figure 106 (a) shows that even small tunnels can occur at 850 μm below the OD surface, and in Figure 106 (b) under Tip 2, the tunnels appeared to coalesce into a larger tunnel. A closer look at the tunnel under Tip 1 in Figure 106 (a) shows tunnels of various diameters that are isolated within the ferrite-pearlite microstructure. None of these tunnels appeared to be connected. In contrast to these, under Tip 2, the tunnels appeared to have coalesced into a large tunnel, as shown in Figure 106 (b).

Figure 105: Stereo Microscope Images of Tunnels beneath (a) Tip 1 and (b) Tip 2

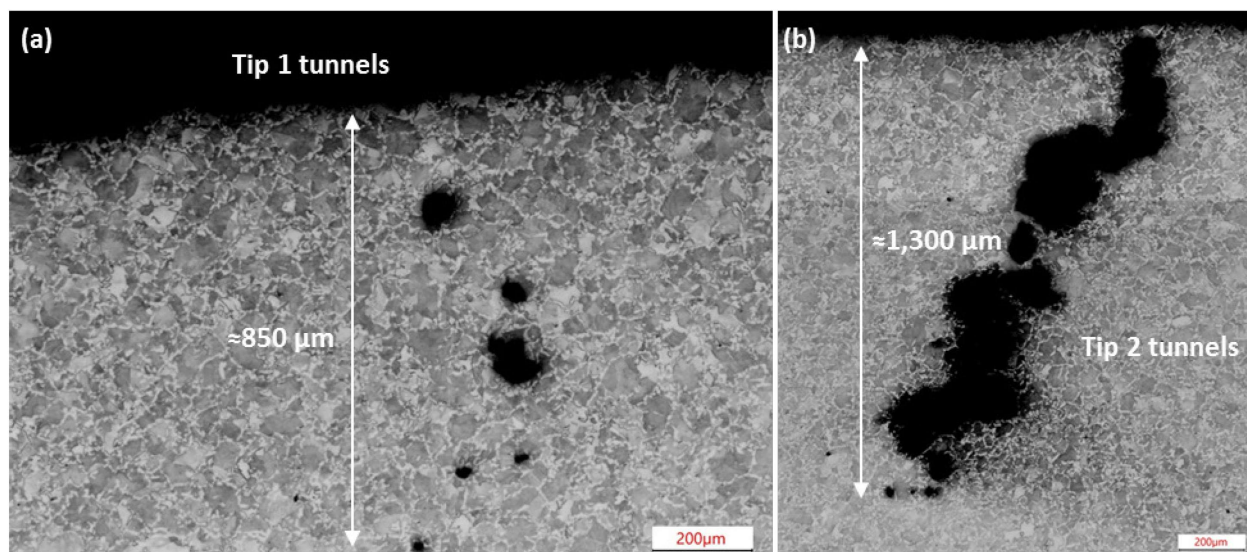
Figure 106: Microstructure Adjacent to Tip 1 and Tip 2 Tunnels

All the tunnels were filled with corrosion product. SEM images taken at higher magnification show the presence of the lamellar feature and MnS inclusion in the corrosion products. EDS confirmed the presence of MnS and showed that the corrosion product was rich in O. The lamella structure was seen both on the etched pearlite (alternating layers of ferrite and cementite) and on the corrosion products). There seemed to be a preferential anodic dissolution of ferrite, leaving the cementite behind.

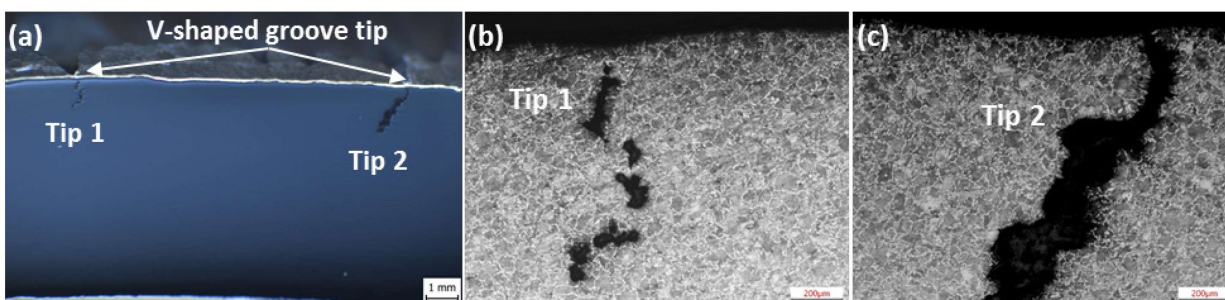
Specimen C021A3-C2 was re-polished, which removed approximately 1 mm of material from the previously-polished surface (Figure 107). Tips 1 and 2 in Figure 107 clearly indicate that the tunnels under Tip 1 grew in size and the tunnels under Tip 2 merged into a larger tunnel. Raman spectroscopy identified organic matter, modified hematite, and magnetite in the corrosion products present in the tunnel.

Figure 107: Specimen C021A3-C2 after Second Polish

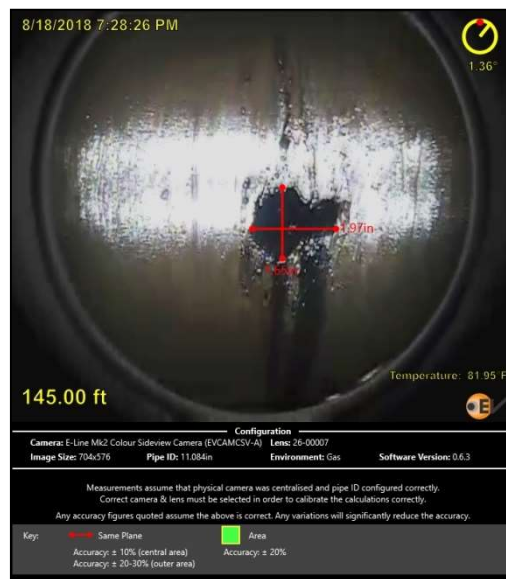
- At shallow depths in the casing, ranging from 90 to 385 ft, there were holes or metal loss indications. The various technologies, including caliper, UCI and HRVRT identified these through wall metal losses. The camera data were consistent with the logging data, and a typical photograph of the hole is shown in Figure 108. A total of 58 holes were identified, with 50 of them in joint 5 at depths ranging from 152.1 to 195.4 ft.

- Some of these approximately 58 holes could have existed prior to the 7 in. casing axial rupture. Many of the holes exhibited sharp corners that may have been more typical of a burst failure, implying that they occurred due to a pressure surge in the surface casing. These holes provided a pathway for the gas to the surface that further complicated the well-control operations. These holes provided a less resistant pathway to the surface, resulting in a higher gas leak rate.

Figure 108: Picture of Hole in 11 3/4 in. Casing with Dimensions from Video Imaging at 145 ft

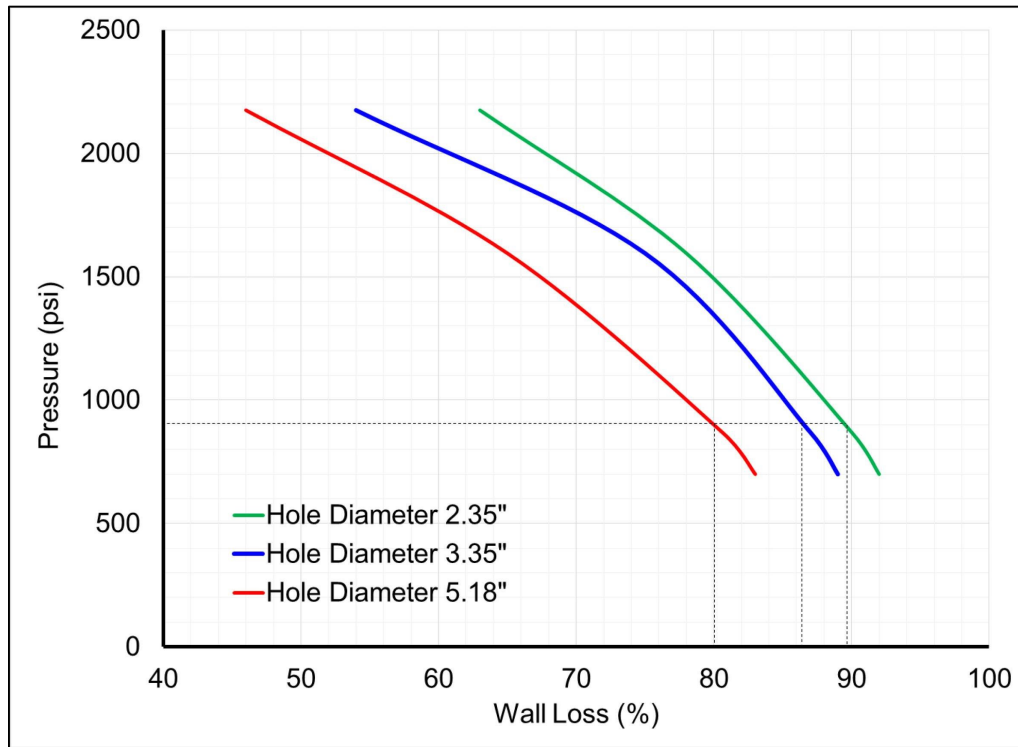
- Failure pressure was estimated using RSTRENG, assuming three different hole diameters and variable wall loss. The results are summarized in Figure 109, which shows that the external corrosion would have resulted in a hole at penetrations ranging from 80 to 90% of wall loss. The holes may have been a consequence of an internal pressure of 800 psi or higher. The pressure in the surface casing annulus surged to 800 psi at one point right after the axial rupture. The holes are likely a consequence of the axial rupture.

Figure 109: RSTRENG Safe Pressure Limit as a Function of Wall Loss

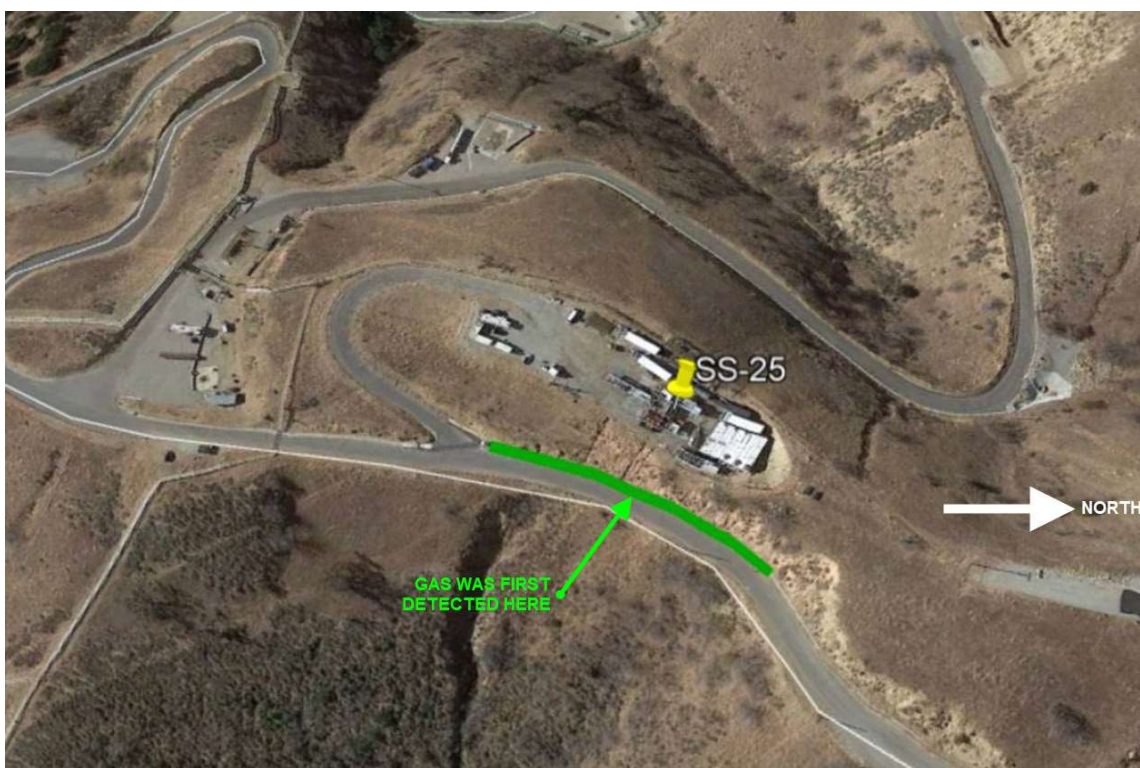
7. Around 7 PM, gas was detected on the main road at the SS-25 site (Figure 110). Personnel were evacuated from the well site, and the road was closed. SoCalGas began mobilizing for well kill operations and started recording wellhead pressures every 30–60 min.
8. A contractor checked and repaired the wellhead seals the next morning (because SoCalGas had initially suspected a wellhead seal leak), but the gas leak continued.
9. SoCalGas proceeded with the first attempt to kill the well (Section 3.4).

Figure 110: Location Where Gas was First Detected on October 23, 2015 [39]
