Blade Report

I.19-06-016

Root Cause Analysis of the Uncontrolled Hydrocarbon Release from Aliso Canyon SS-25

May 16, 2019

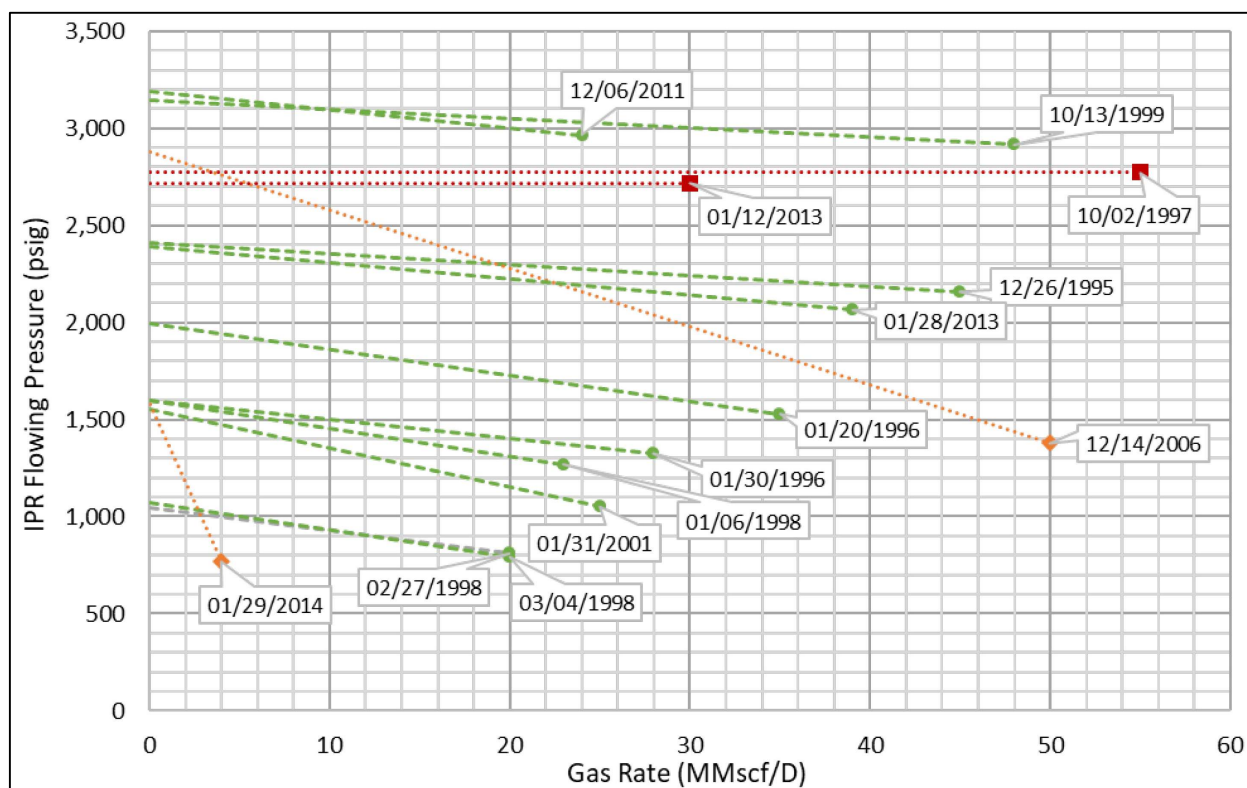
Figure 111 shows the well tests for the previous 20 years on a performance chart. Wellhead pressures (WHP) were converted to bottomhole pressures by using the well model. In the figure, the well test itself is marked as a circle with a line connecting back to the reservoir pressure that was estimated from the provided static shut-in pressure. (As expected, the reservoir pressure varied by month of test according to the yearly cycle of demand.) The colors and symbols are as follows:

- Green dashed lines with green circles indicate well tests that follow a consistent trend and are considered valid.
- Red dotted lines with red squares indicate well tests that have flowing bottomhole pressures greater than reservoir pressure and are thus questionable.
- Orange dotted lines with orange diamonds indicate well tests with excessive drawdowns and are thus questionable.

Figure 111: SS-25 Validation of Well Tests 1995–2015

The questionable test of January 12, 2013 (in red), was re-run on January 28, 2013. The questionable test of January 29, 2014 (in orange), was not re-run; it was the test that was the most recent prior to the leak. Any adjustments based on the January 29 test that were made to any model would have under-predicted deliverability. This most recent test was inconsistent with the tests of the last 20 years.

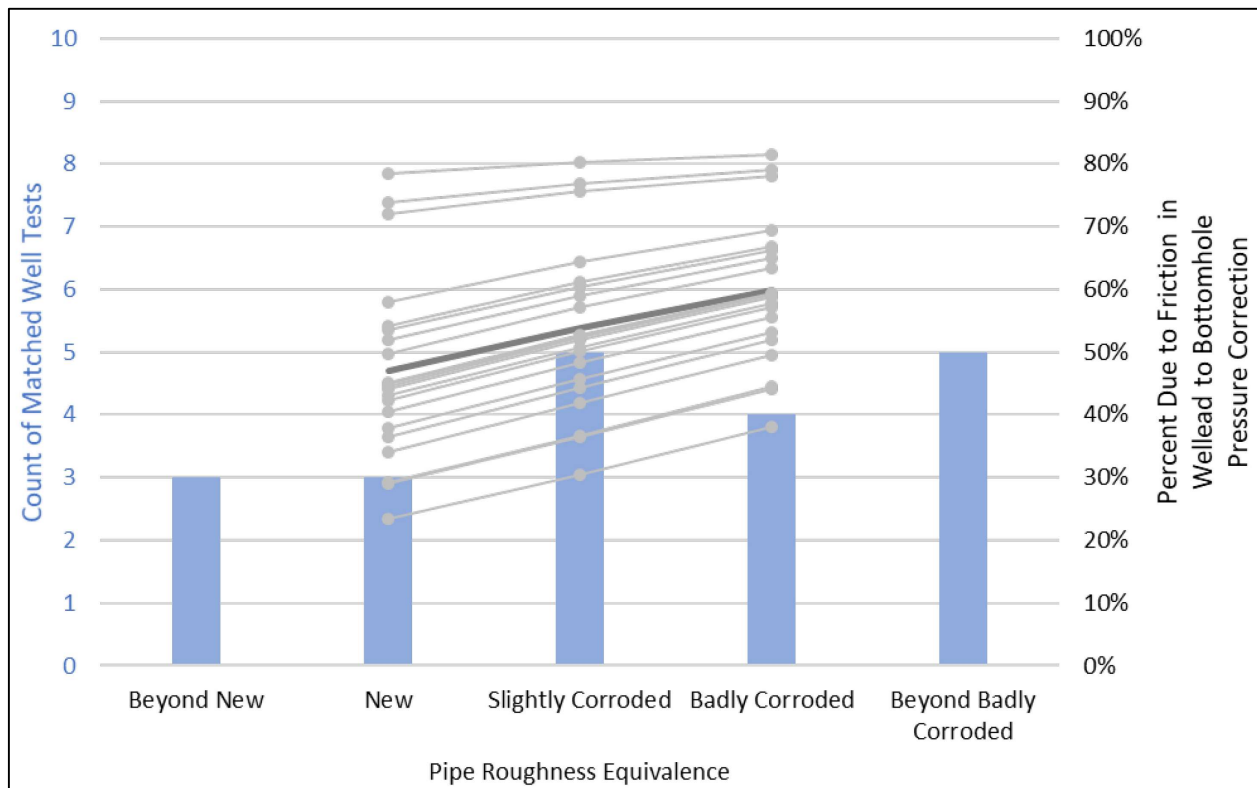
Figure 112 shows the best-estimate pipe roughness for well tests from the last 37 years. The roughness differed from test to test, and friction was significant (it averaged 45 to 60% of pressure loss in the outflow model).

Figure 112: SS-25 Pipe Roughness Study for Well Tests 1980–2015

Because there was sufficient random scatter in the well tests, a best-estimate approach was to assume the presence of pipe roughness in the slightly corroded category. (This was also supported by metal loss logs, which were run after the well was killed.) The scatter in the well tests resulted in uncertainty in the downhole flowing conditions and, consequently, uncertainty in the inflow properties. The best estimates would be statistically averaged estimates. A maximum leak rate could have been calculated by assuming new pipe roughness, for example, to engineer kill attempts.

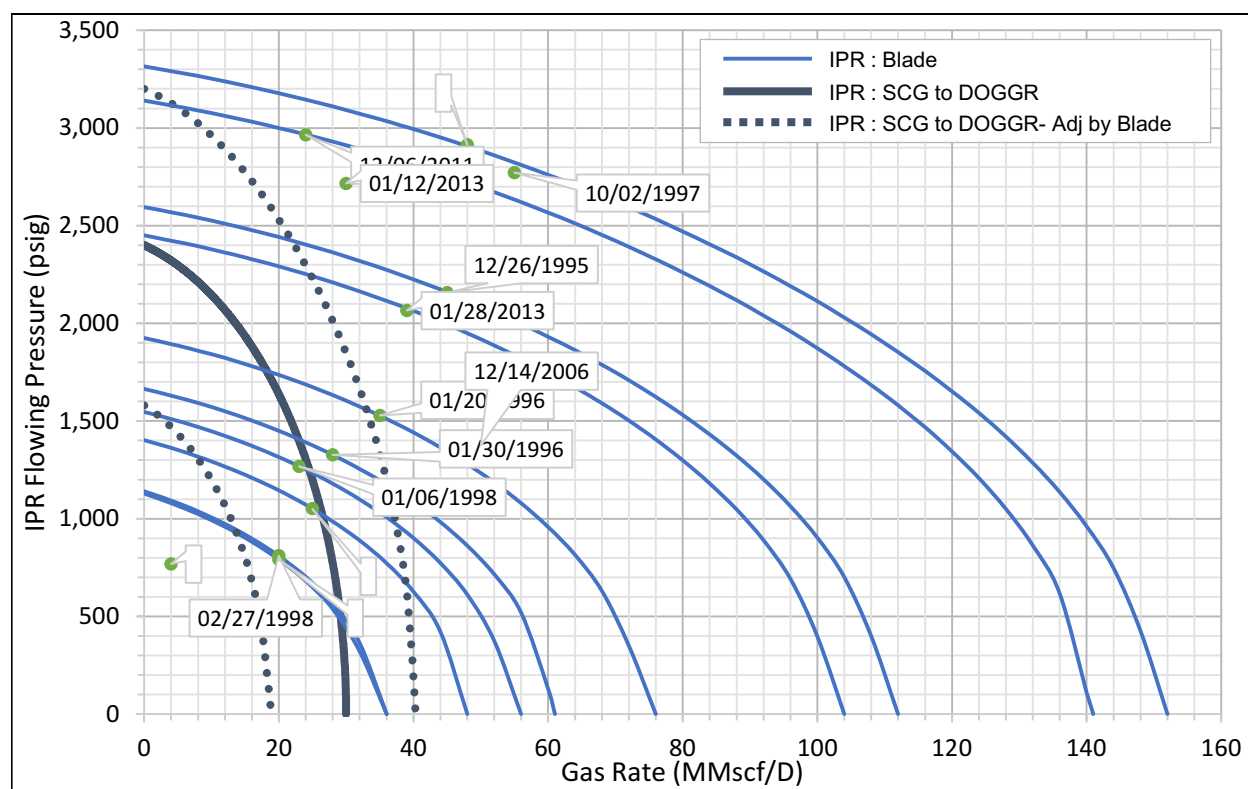
Figure 113 shows the best estimated match of the analyzable flow tests for the last 20 years using the best-estimate properties shown in Table 16. Blade’s inflow performance relationship (IPR) estimates for each well test are plotted as solid, thin blue lines. The model’s drainage area reservoir pressure varied, at the most, 100 psi from the static measured pressure at the time of the test.

Figure 113: SS-25 Match of Well Tests 1995–2015

Blade identified an IPR curve that first appeared in a SoCalGas response to a DOGGR request [40]. This request implied that a national laboratory was modeling the kill attempts on behalf of DOGGR, and DOGGR wanted the laboratory to use the same data that the well-control company was using. This SoCalGas-provided IPR curve is plotted in Figure 113 as a solid, thick navy line.

The SoCalGas IPR did not match Blade’s best-estimate IPR, which was derived from valid well tests. The Blade model could be used to match the SoCalGas IPR by changing the permeability from 80 to 30 md and increasing the gas turbulence to 0.5 (MMscf/D)⁻¹. Blade adjusted the reservoir pressure of the SoCalGas IPR, and this was still not representative of any well test. A more representative IPR obtained from proper modeling of the production well tests would have been a better basis for designing kill attempts.

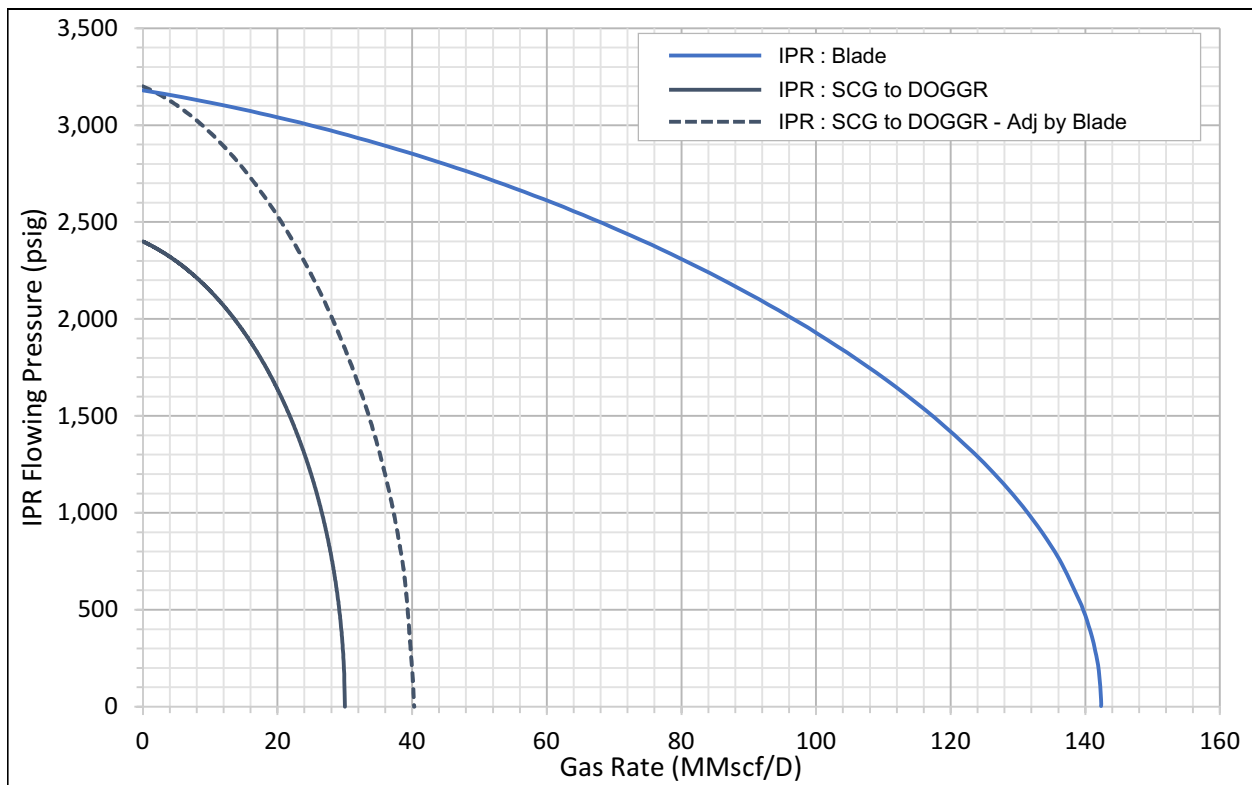
Figure 114 shows Blade’s IPR model as of October 23, 2015, after injection was shut down. It also shows the SoCalGas IPR adjusted to the initial reservoir pressure. That IPR model was not representative of the actual flow; it underestimated the actual leak rate by a factor of 3.4–3.6.

Figure 114: SS-25 IPR Model for October 23, 2015

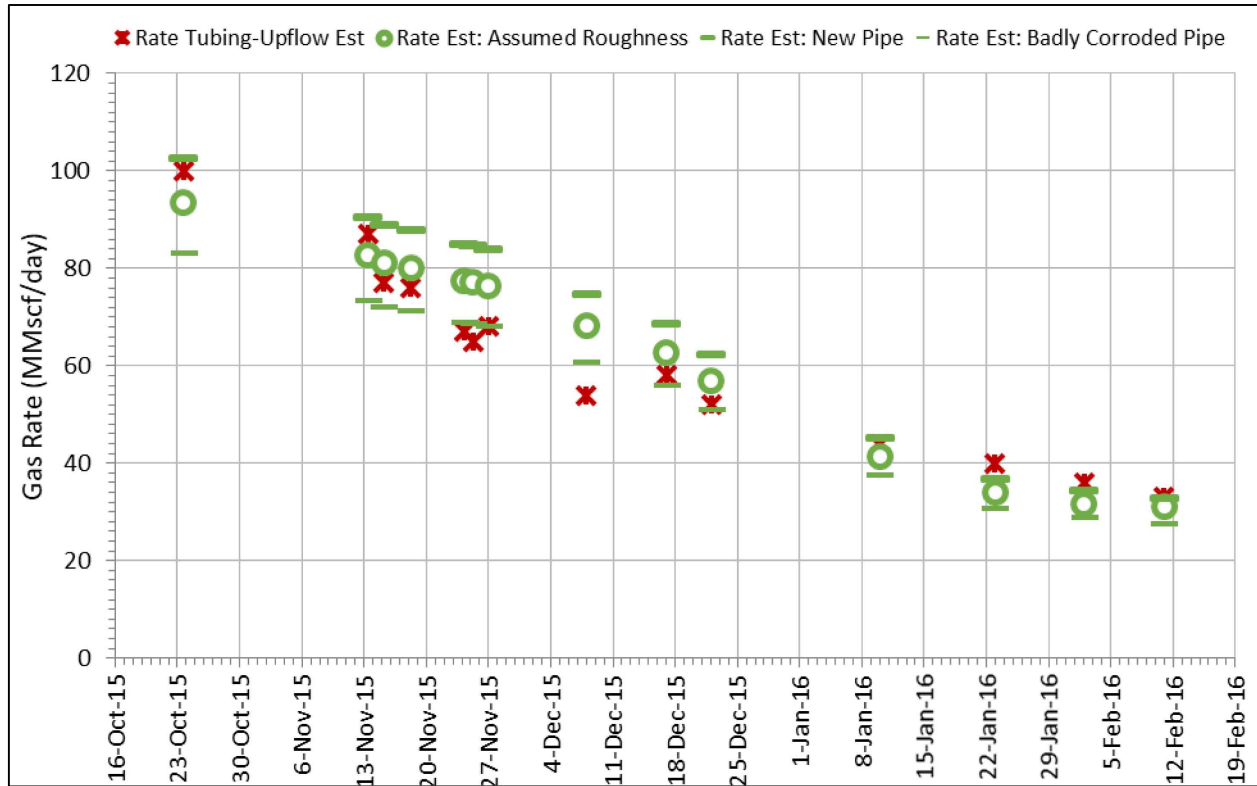
Blade performed such *tubing-upflow only* calculations. Figure 115 compares the results of these calculations (in red) with the more accurate *upflow-inflow* (or IPR) models (in green). The tubing-upflow estimates prior to and after the kill attempts matched the upflow-inflow model for new pipe. This further validated Blade’s IPR model, which was used in reviewing the kill attempt designs. During the kill

attempts, the well flow was more unstable, and the estimates were more scattered. Both methodologies for rate estimates suggested that the first kill should have been designed for at least 93 MMscf/D.

Figure 115: SS-25 Key Rate Estimates using Upflow-Only and Upflow-Inflow Models

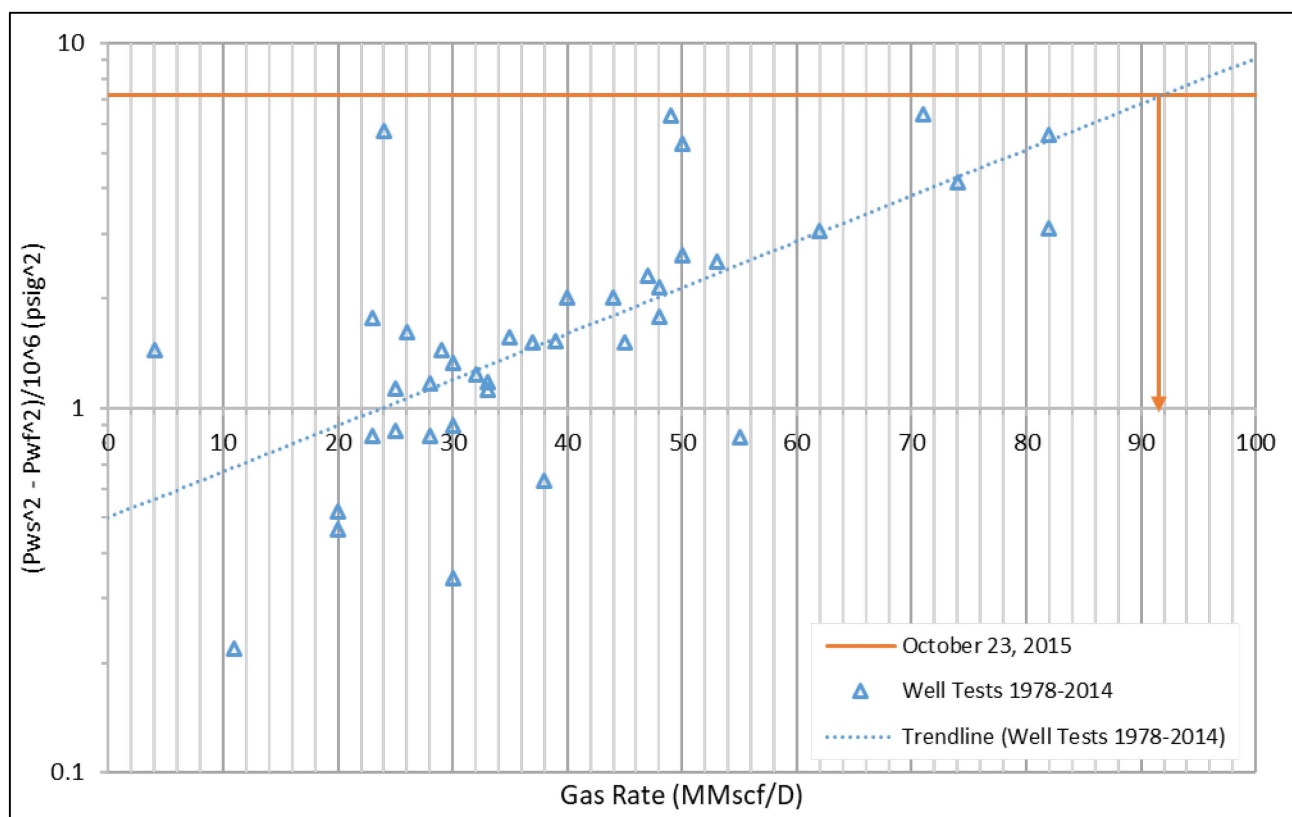
There was a third method available to estimate the leak rate. This is shown in Figure 116, where P_{ws} is the static WHP (i.e., well shut-in or not flowing) and P_{wf} is the flowing WHP upstream of the choke. This process allows the calibration of the well deliverability and the estimation of the well flow rates at various pressure differences. The results are shown in Figure 114; the initial leak rate on October 23 matched the 91 MMscf/D estimated through the more accurate model. SoCalGas did use this method to estimate the leak rate; however, the leak rates were estimated to be ranging from 56 MMscf/D to 62 MMscf/D because the downstream choke pressure was used instead of upstream choke pressure.

The key observation from the PROSPER analysis discussed above is that the gas rates were significantly higher than those estimated during the incident. The higher gas rate could have been correctly estimated using industry-standard flow simulations or other methods using data available at the time of the incident. Additional details regarding the well deliverability modeling and analyses please refer to the supplementary report on SS-25 Nodal Analysis with Uncontrolled Leak Estimation [41].

Figure 116: P-Squared Rate Estimate for October 23, 2015

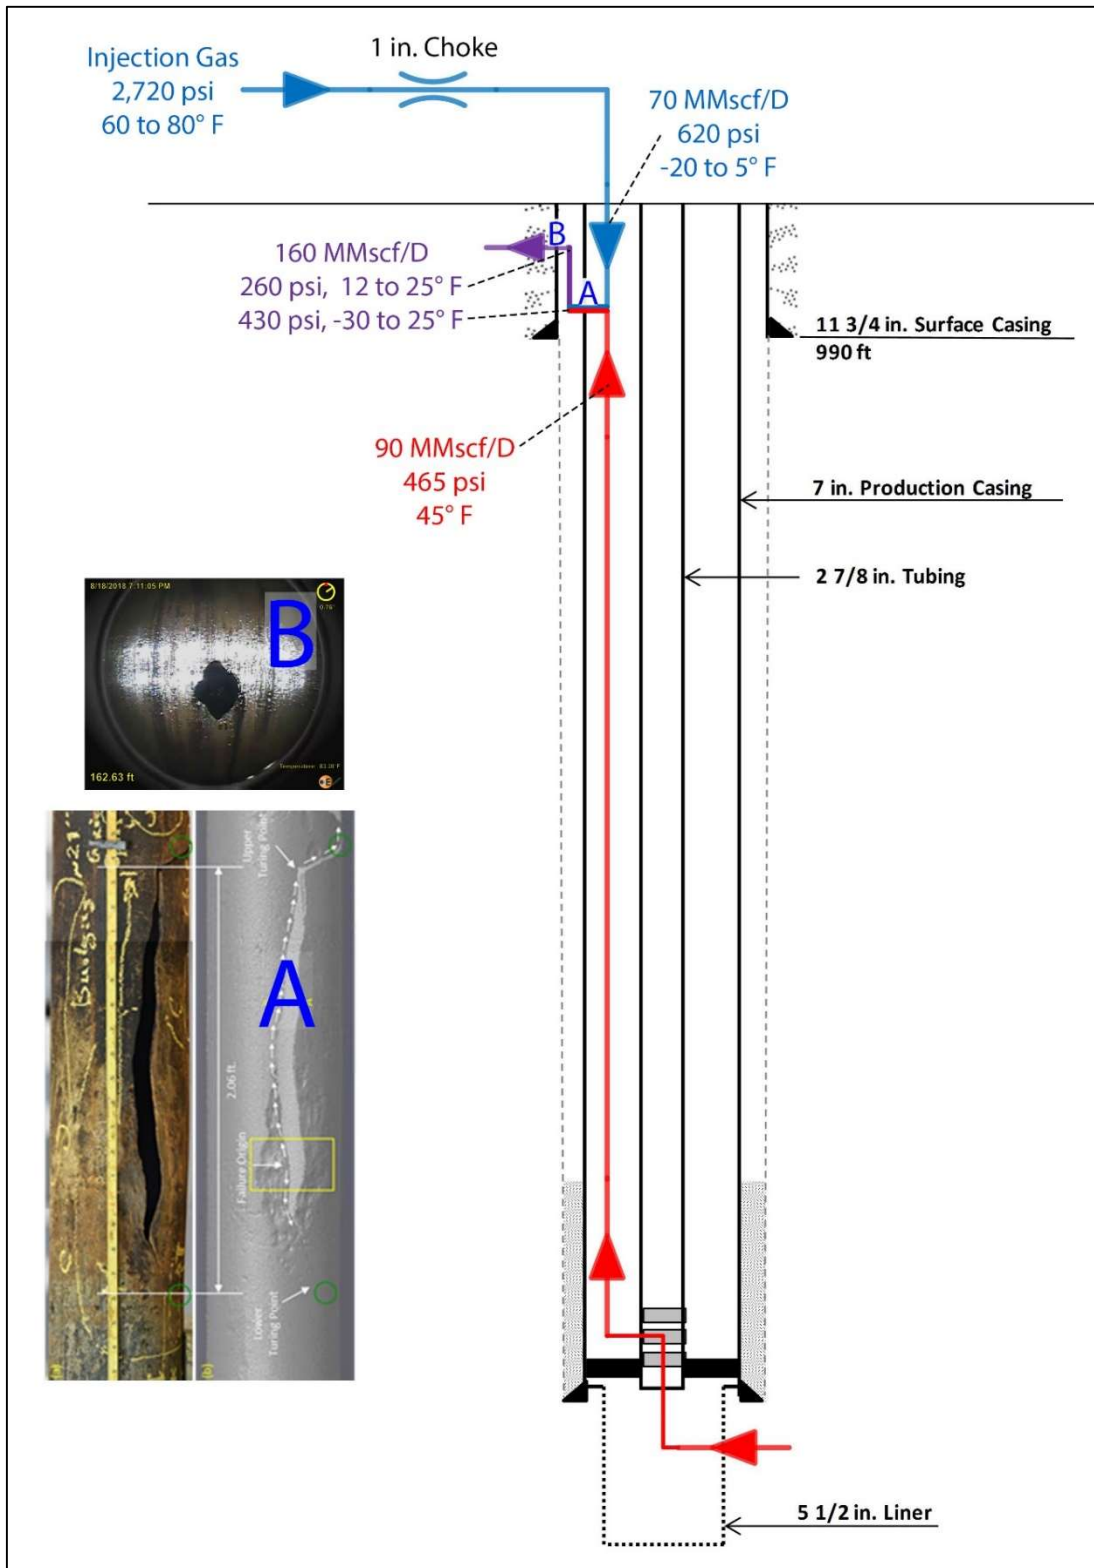
To determine when the 7 in. casing failure occurred, Blade first modeled the flow in SS-25 prior to the shut-in. The problem was solved by using PROSPER. Figure 117 shows the SS-25 well flow problem posed to PROSPER and the pressure, rates, and temperatures that PROSPER calculated. First, focusing on the flow from the wellhead down the 7 in. × 2 7/8 in. production casing annulus to the leak point at 892 ft, the WHP required to drive 70 MMscf/D to 892 ft was 620 psi, and the arrival pressure at this depth was 465 psi. The WHP of 620 psi was too high to cause the SSV to close. In fact, even if the pressure at 892 ft were 260 psi (and it could not have been this low because 260 psi was the pressure at the holes in the surface casing as shown in Figure 117-B), the WHP would still have been about 500 psi. This means that when SS-25 was on injection, even if the 7 in. casing had already failed, the SSV would not have closed. The only time the SSV would have closed would have been when the well was shut in and the 7 in. casing had already failed. This is confirmed by the fact that the SSV closed immediately when SS-25 was shut in on the afternoon of October 23, 2015.

Figure 117 shows that prior to the shut-in of SS-25, the total estimated leak rate at 892 ft. through the production casing was 160 MMscf/D, of which 70 MMscf/D was from the injection system and 90 MMscf/D from the reservoir. This period, however, lasted less than half a day before the leak was detected and the well was shut in.

Figure 117: Summary of the PROSPER Results Prior to Shut-In of SS-25, A-Ruptured 7 in. Casing and B-Hole in the 11 3/4 in. Casing

Metallurgical analysis showed that the 7 in. casing failed in two steps. The first was the instantaneous 2 ft long axial rupture that occurred at ambient temperature. The axial rupture (Figure 117-A) was followed by a low temperature brittle circumferential parting of the 7 in. casing. The parting was brittle and required extremely low temperature (−78°F to −38°F).

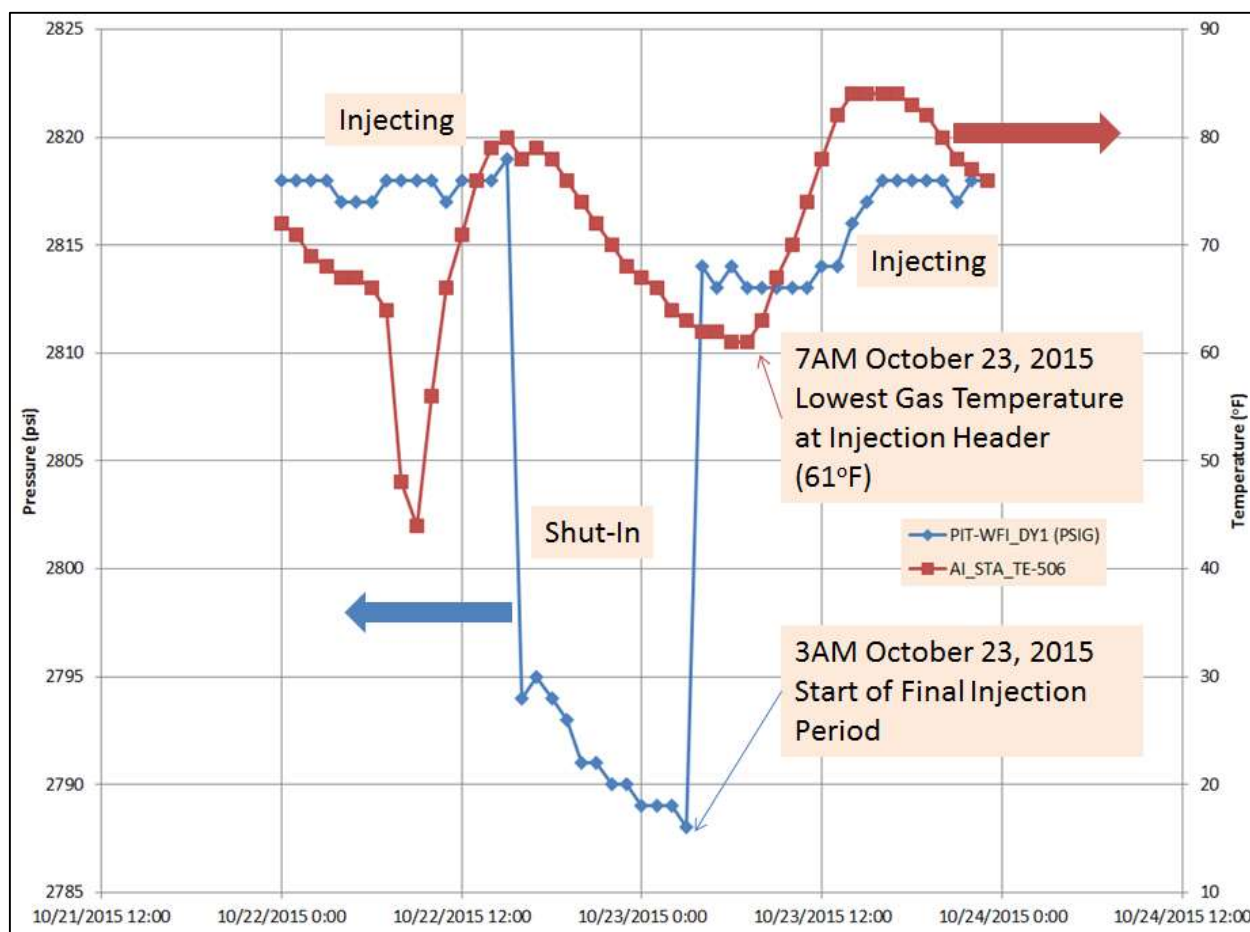
Figure 118 shows the hourly pressure and temperature reading at the compressor station. The pressure gauge, PIT-WFI_DY1, measured the pressure in the trunk line to the western area of Aliso Canyon, which included SS-25. The pressure varied between about 2,815 psi and 2,790 psi. When the pressure was 2,815 psi, SS-25 was injecting. The system was shut in around 3 PM on October 22, 2015; injection was restarted between 3 and 4 AM on October 23, 2015.

Had the 7 in. casing failed during the shut-in period, the pressure reading of PIT-WFI_DY1 would have fallen to as low as 300 psi, the low pressure set point of the SSV. This is because the leak at SS-25 would have drained the gas in the trunk line leading to SS-25 until the SSV closed. Figure 118 shows that PIT-WFI_DY1 during the shut-in period prior to the final shut-in. No anomalously low-pressure reading was observed. The 7 in. casing did not fail during this shut-in period. The 7 in. casing, therefore, must have failed during the final injection period, which started after 3 AM on October 23, 2015.

Figure 118: PIT-WFI_DY1 Hourly Pressure and AI_STA_TE-506 Hourly Temperature Measurements

Such low temperatures however could have occurred prior to final shut-in of SS-25. Figure 118 shows that the temperature at the compressor station was between 60°F and 85°F. SS-25 is about 1,000 ft higher in elevation relative to the compressor station. Therefore, the inlet gas temperatures to the SS-25 1 in. choke were likely several degrees lower. The pressure drop across the 1 in. choke was estimated to be 2,100 psi. Using the 0.56°F/14.7 psi J-T coefficient, this pressure drop corresponded to a decrease in temperature of about 80°F. The outlet temperature of this 1 in. choke therefore ranged from −20 to 5°F. PROSPER estimated that the flow down the 7 in. × 2 7/8 in. annulus led to an additional 8°F temperature

Figure 118 shows that during the final injection period, the lowest temperature measured at the compressor station occurred between 7 and 8 AM on October 23, 2015. Consequently, the gas temperature at the failure location would have been the coldest during this period. This suggests that the circumferential parting likely occurred between 7 and 8 AM. Therefore, the initial axial rupture must have happened sometime prior to the parting but after the start of injection on October 23, 2015.

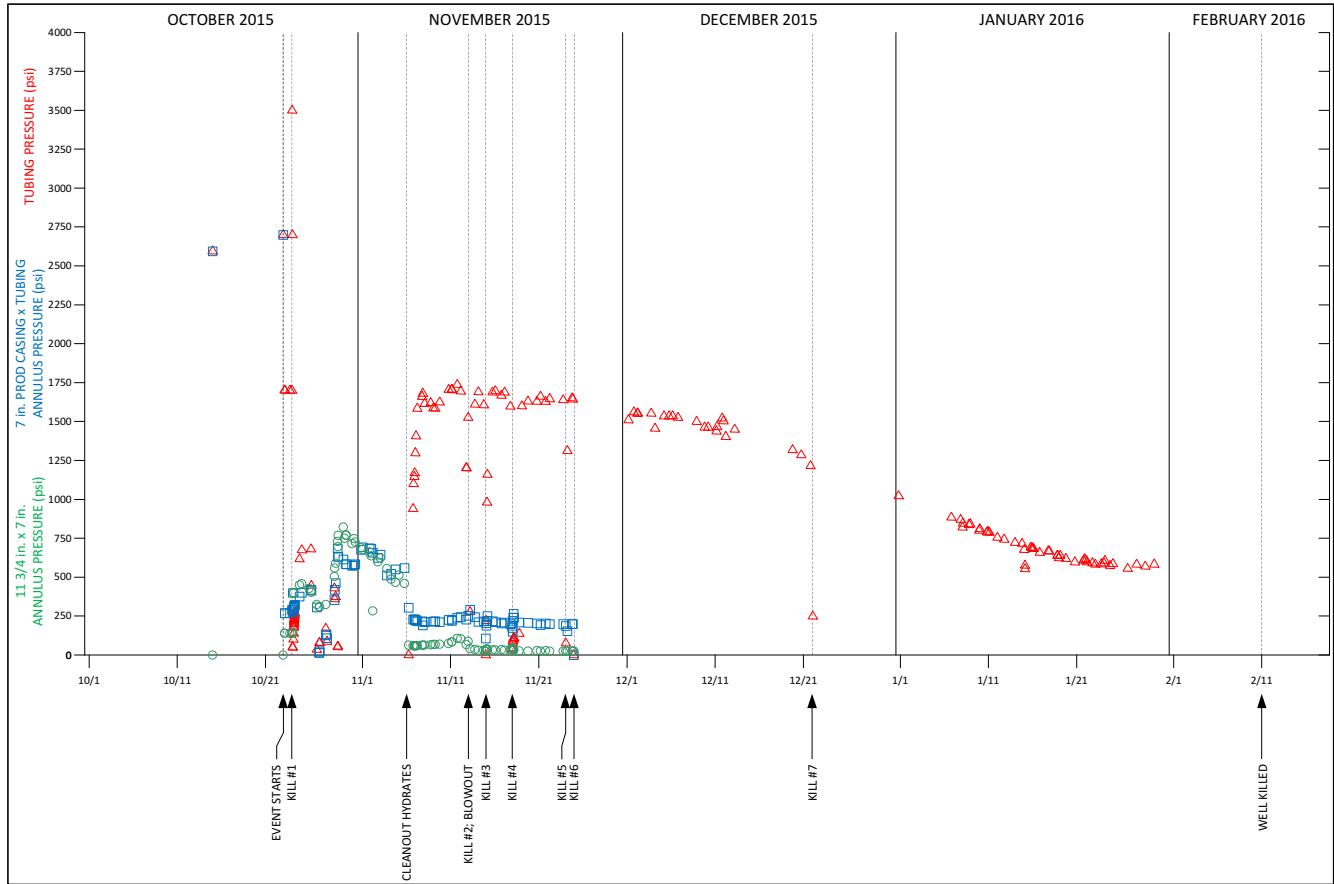
This redirection was important because the surface casing annulus pressure was as high as 800 psi between October 25 and November 6, 2015 (Figure 119). PROSPER estimated that, at these pressures, the temperature of the leaking gas could have reached 60°F . If the bulk of this warm gas had flowed up the 11 3/4 in. x 7 in. annulus, the upper section inside the well would have thawed out significantly, increasing the gas flow to the surface. However, because this did not occur, the upper section stayed cold.

Figure 119: SS-25 Wellhead Pressure Measurements During the Incident

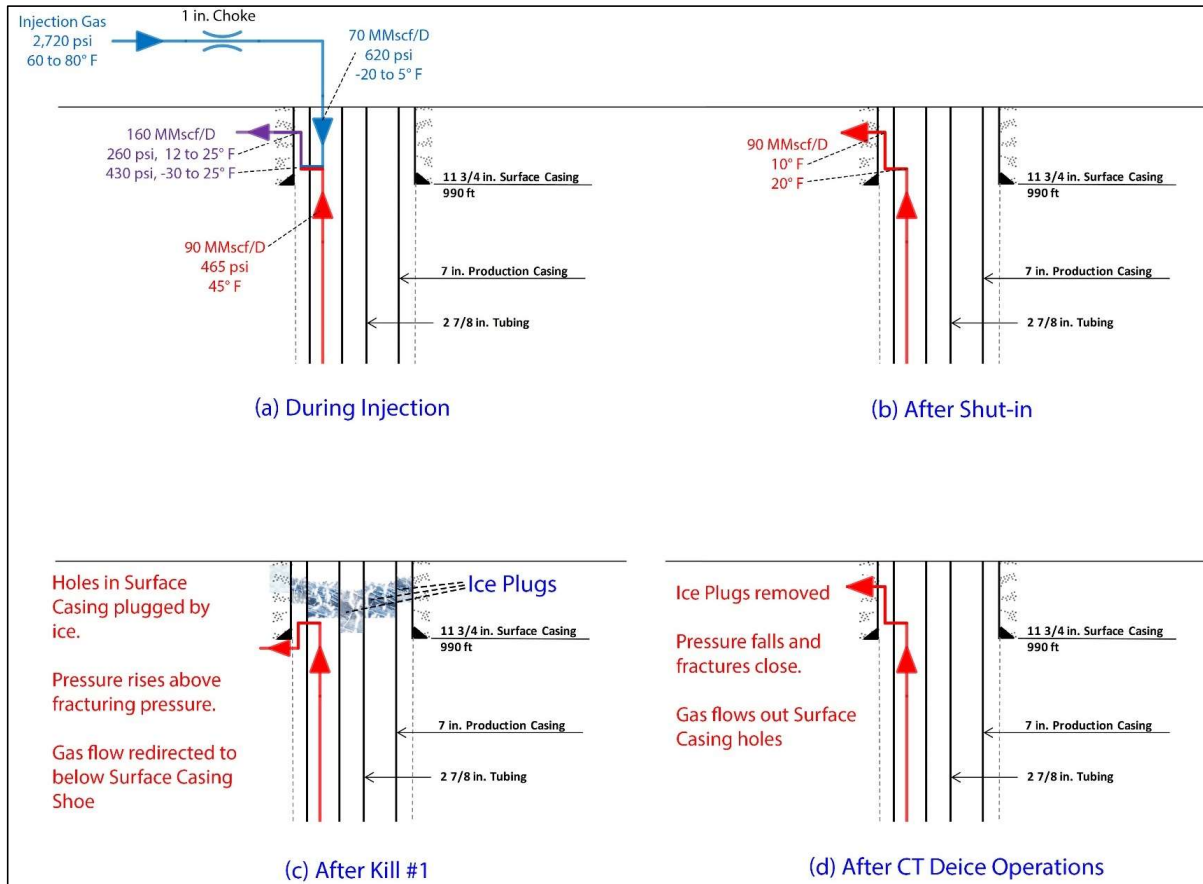
On November 6, 2015, a solution of glycol and 10.8 ppg CaCl_2 was pumped down the tubing and unblocked the pathways, allowing the gas to flow out of the 11 3/4 in. holes again. The pressure in the 11 3/4 in. \times 7 in. annulus fell to 60 psi, which was lower than the initial 140 psi pressure. The kill attempt #1 might have opened up additional pathways for the gas, and the deicing operation might have unplugged them. The DOGGR representative reported that after the deicing operation, the gas leak rate increased substantially [6]. Figure 120 summarizes how the flow paths changed from prior to the shut-in to after the deicing operation.

Figure 120: Summary of the Leak Paths Prior to SS-25 Shut-In to after Deicing Operation on November 6, 2015

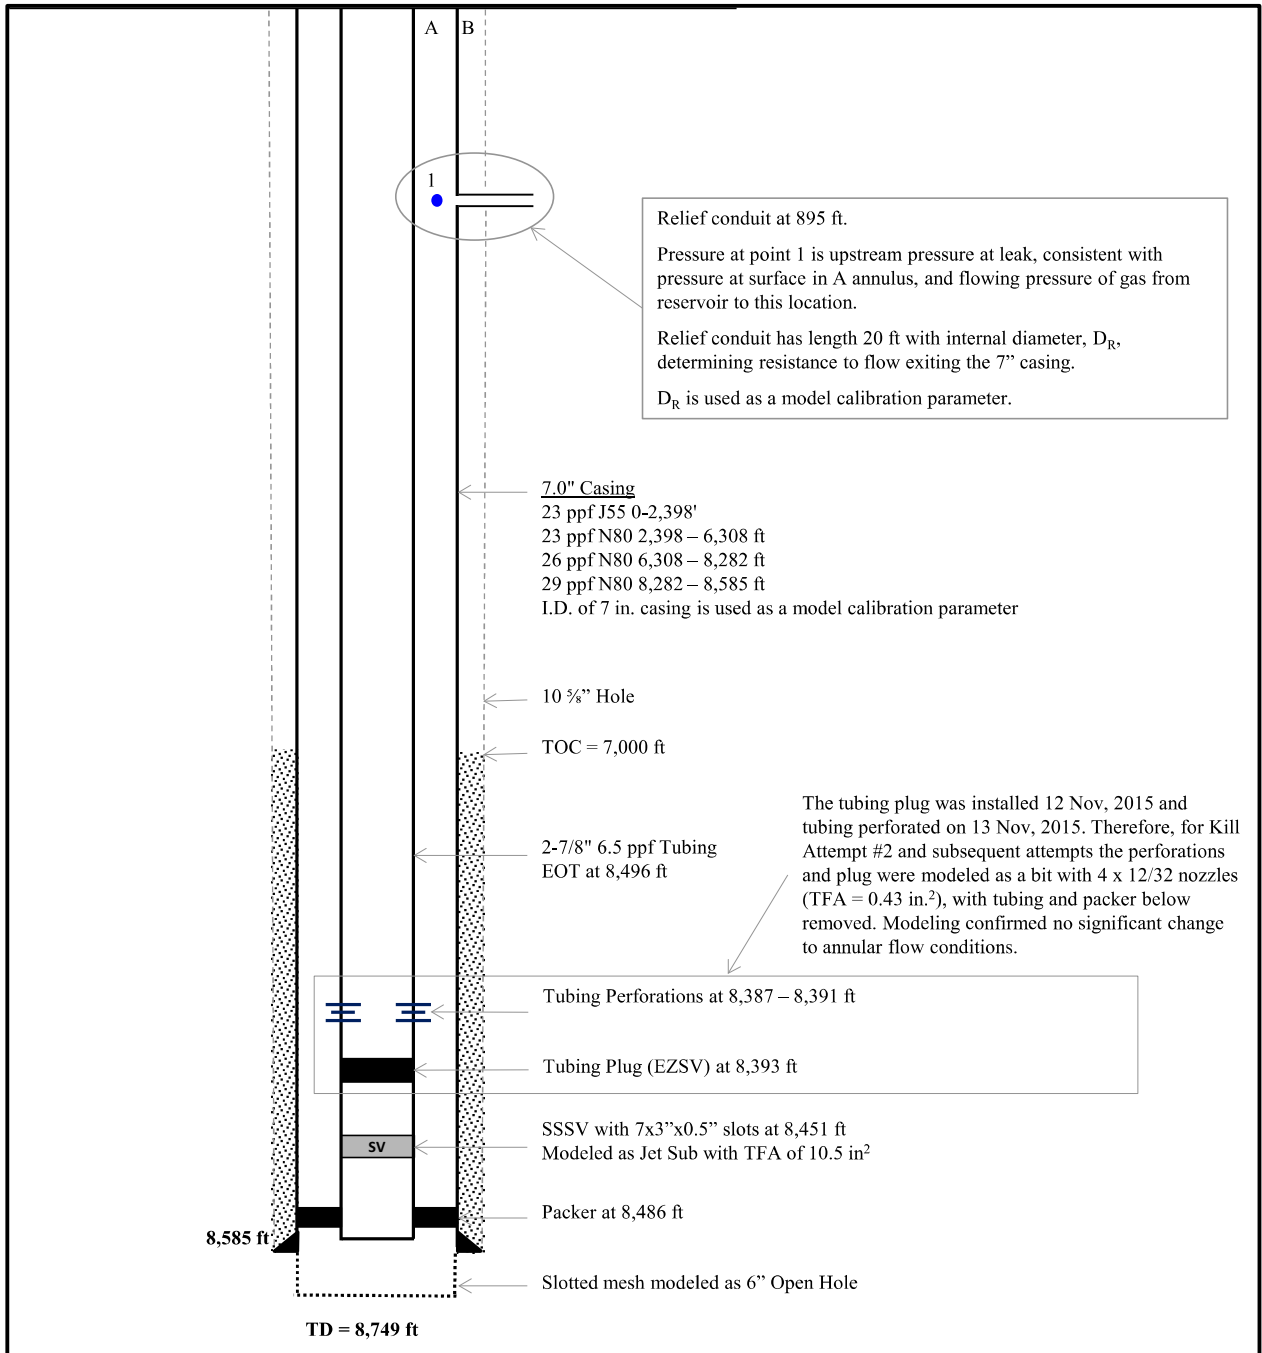
This subsection analyzes why each one of the kill attempts failed and if any of them could have been successful. Blade set-up the SS-25 physical system within the Drillbench Blowout Control software (Figure 121). After shut-in and prior to kill attempt #1 on October 24, 2015, gas had flowed from the reservoir into the bottom of the tubing, entered the 7 in. x 2 7/8 in. annulus via ports near the packer, flowed up the 7 in. x 2 7/8 in. annulus, exited the 7 in. casing through a leak at 892 ft, and finally flowed to the surface through the formation. When the pumping of the kill fluid down the tubing of this physical system was initiated, the influx gas and kill fluid met in the tubing, and the combined flow entered the annulus through the ports.

Prior to kill attempt #2 on November 13, 2015, a plug had been set in the tubing at 8,393 ft, and the tubing had been perforated a few feet above the plug. Within the software, the plug and perforations were represented as a bit with nozzles, forming the equivalent flow area of the perforations. When the pumping of kill fluid down the tubing of this physical system was initiated, the kill fluid entered the annulus via the bit nozzles (perforations) while influx gas flowed up from below. The modeling details and approach are in the *SS-25 Transient Well Kill Analysis* supplementary report [46].

Figure 121: Physical Model as Set up in the Drillbench Blowout Control Model

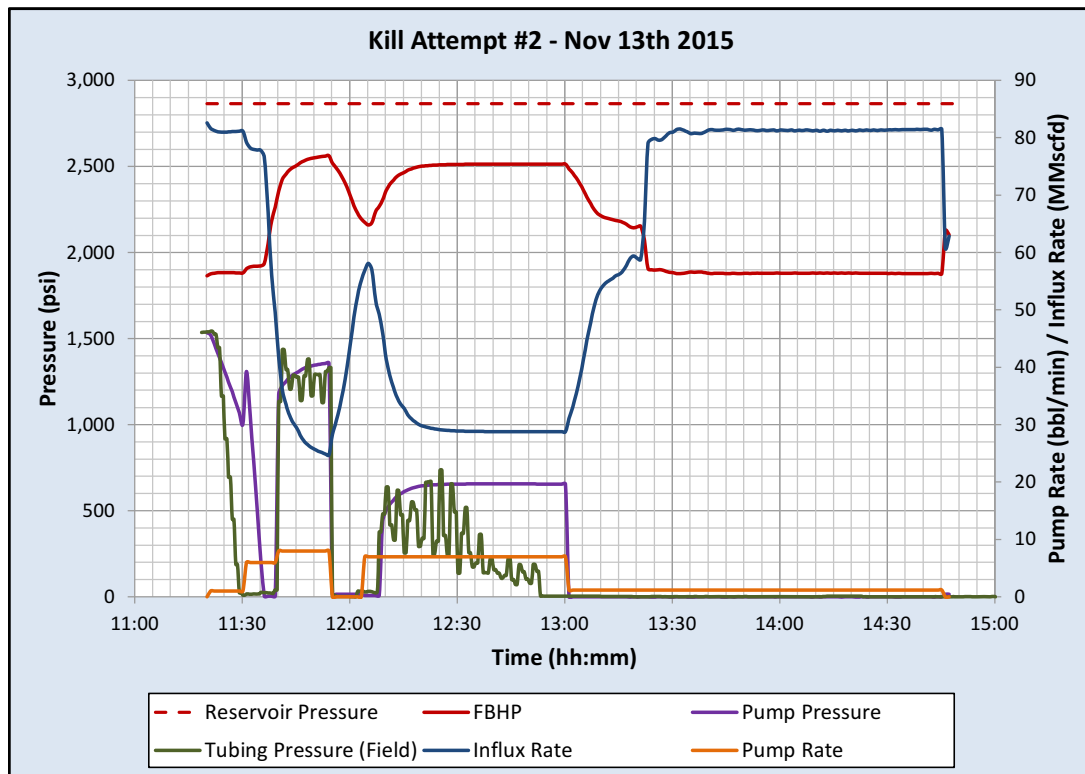
Blade simulated kill attempt #2 in detail (Figure 122). When the FBHPⁱⁱ (flowing bottomhole pressure) (solid red line) is less than the reservoir pressure (dashed red line), the gas will flow from the reservoir into the wellbore as shown by the influx rate (solid navy line). The well is killed if the FBHP is higher than the reservoir pressure so that the influx rate is zero.

Figure 122 shows the results of the kill attempt as it was executed. As kill fluid was pumped into the well, the FBHP (solid red line) increased, and the influx rate (navy line) decreased (between 11:30 AM and 11:55 AM and between 12:05 PM and 1 PM). However, the FBHP did not rise above the reservoir pressure (dashed red line), and the influx rate did not go to zero; therefore, the well was not killed. When the pump was turned off (between 11:55 AM and 12:05 PM) or pump rate (orange line) was reduced (after 1 PM), the FBHP decreased, and the influx rate increased. In fact, between 12:05 PM and 1 PM, both the FBHP and the influx rate stabilized at 2,500 psi and 28–29 MMscf/D; this indicates that the kill attempt was not sufficient to kill the well even if the pumping had continued indefinitely.

Figure 122: Simulation of Kill Attempt #2

At the time of kill attempt #2, the estimated leak rate was 83 MMscf/D. Blade’s analysis indicates that the 9.4 ppg fluid was not dense enough to kill the well at a realistic pumping rate. The well could have been killed by pumping a 12 ppg fluid at 9 bpm or a 15 ppg fluid at 6 bpm (Table 20). (Blade’s analyses assume that kill fluids would have been pumped down the tubing; it would have been impossible to kill SS-25 by pumping down the 7 in. casing.)

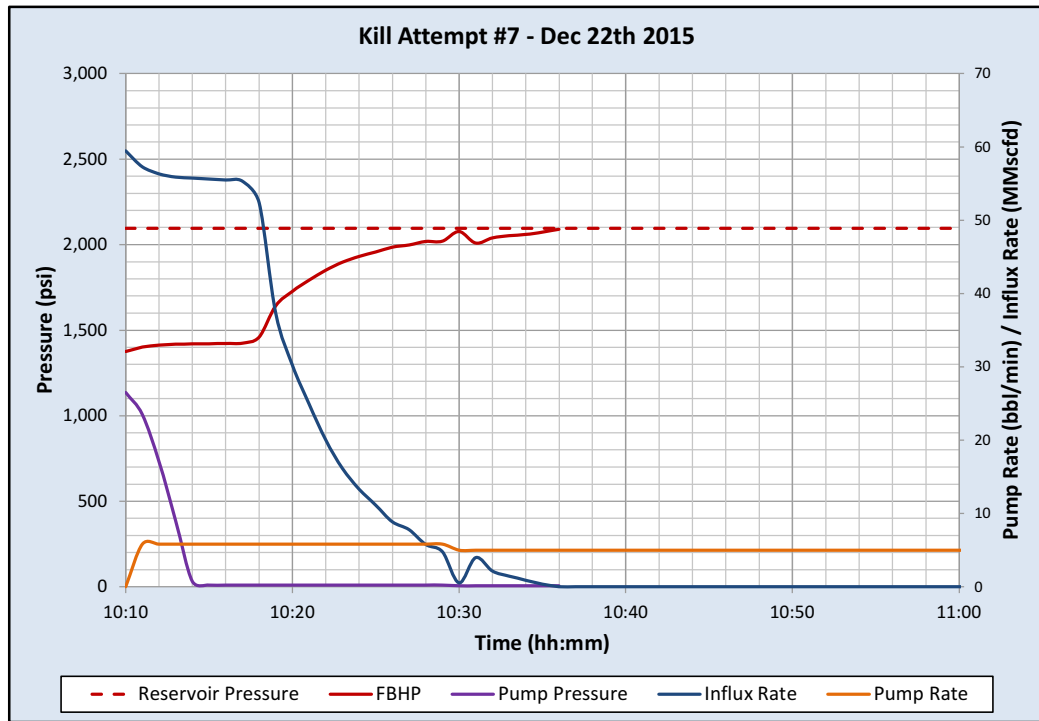
The estimated leak rate was 60 MMscf/D. Results of Blade's simulations are shown in Figure 123. As pumping continued, the FBHP (solid red line) approached the reservoir pressure (dashed red line), and both influx rate (solid navy line) and pump pressure (solid purple line, also WHP) went to zero. This behavior was consistent with what was observed in the field during the kill attempt. At 10:30 AM, the well was just about to be killed, although premature shutdown of the pumps resulted in the FBHP decreasing and the influx rate increasing. Pumping needed to continue for some time after the well had seemed to have been killed to ensure that the well had been effectively killed. This did not happen in the field because the pumps were shut down early. Blade's analysis (Table 25) confirms that the well should have been killed with either 12 ppg fluid pumped at 6 bpm or 15 ppg fluid pumped at 5 bpm.

In conclusion, kill attempt #7 was a "near kill" that failed because the pumping was terminated early due to concern for potential wellhead damage. A contributing factor was the cumulative damage done by previous, unsuccessful kill attempts to the well site and wellhead, which caused this kill attempt to be terminated early.

Figure 123: Simulation of Kill Attempt #7

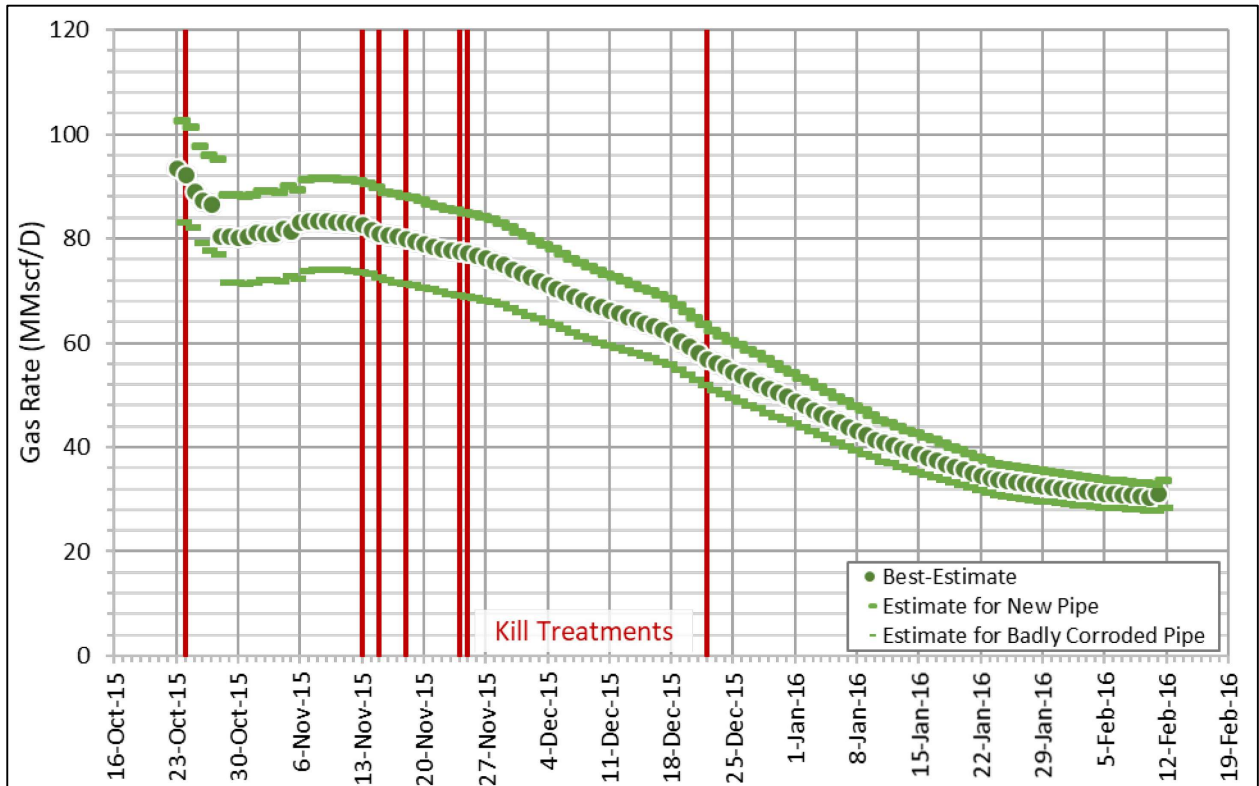
The cumulative gas release volume was estimated using the modeling results. Figure 124 presents Blade’s SS-25 withdrawal rate estimate for the duration of the uncontrolled leak using the PROSPER model described in Section 3.2.1 The kill attempts are shown to highlight the rates that the kill attempts should have been designed to kill. Kill attempt #1 had a discharge rate of 93 MMscf/D, kill attempts #2 to #6 had discharge rates from 83 to 78 MMscf/d, and kill attempt #7 had a discharge rate of 60 MMscf/D. Blade derived the best-estimate rate from data available after the well was killed.

Figure 124: SS-25 Leak Rate Estimate (October 23, 2015–February 11, 2016)

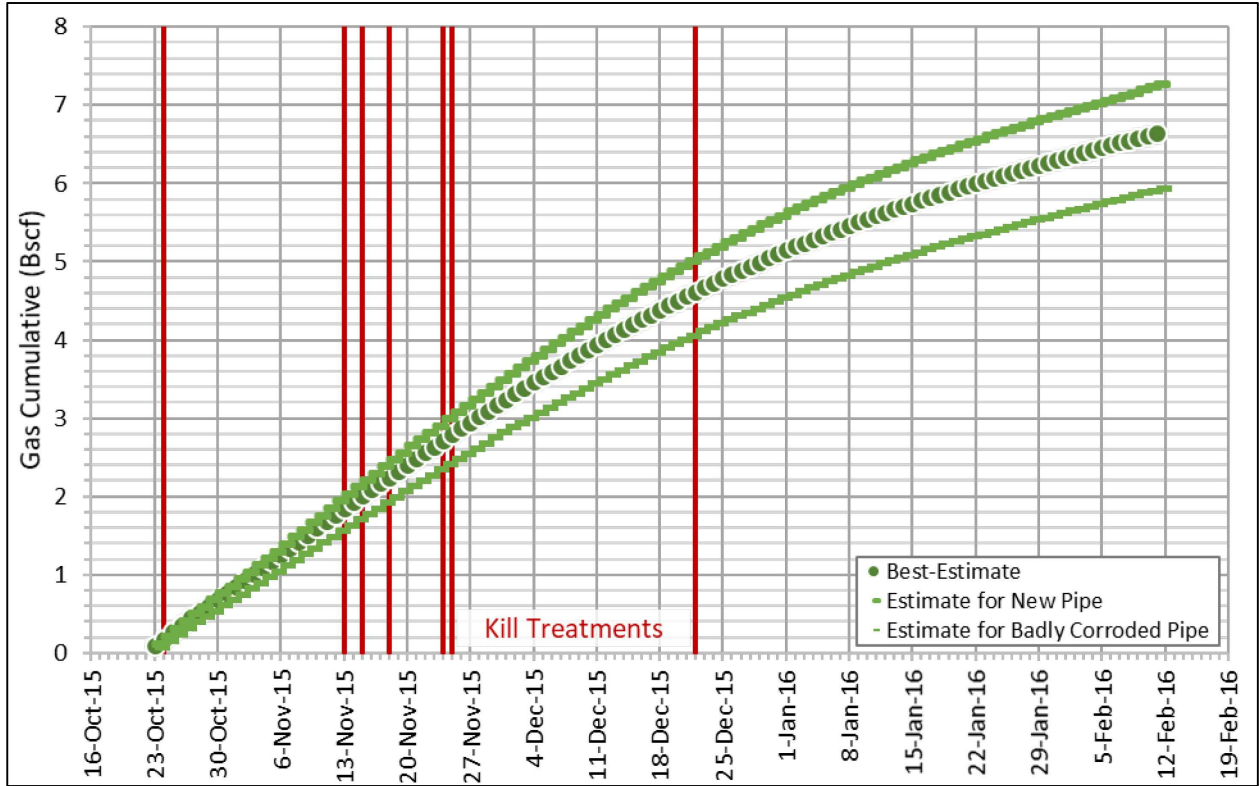
Figure 125: SS-25 Leak Cumulative Estimate (October 23 to February 11)

Figure 125 presents Blade’s SS-25 cumulative leak estimate for the duration of the incident. If the uncontrolled leak had ended by kill attempt #2, the methane discharge would have been less than one-third of the final amount.

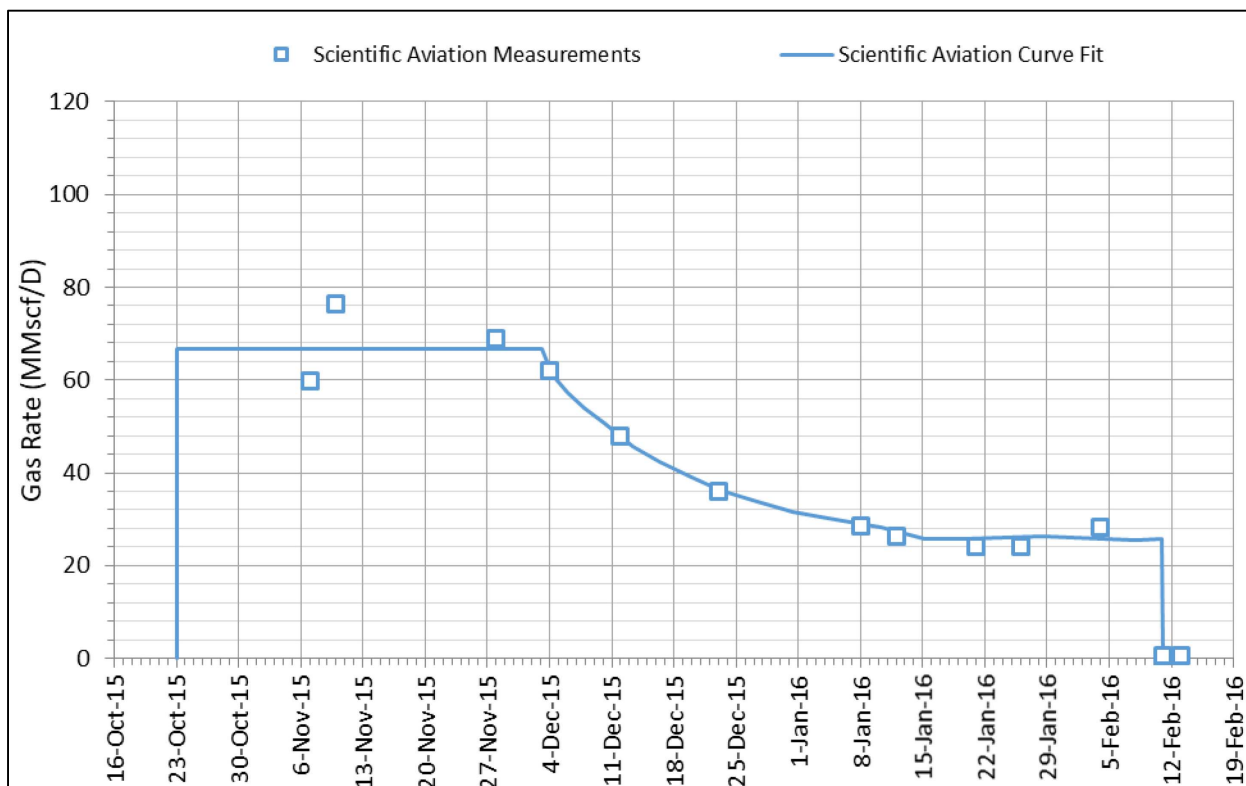
Figure 126: SS-25 Measured Leak-Rate History–Scientific Aviation

CARB derived their estimate following a review of the Scientific Aviation estimate. Scientific Aviation estimated the airborne emissions of the leak by analyzing data gathered by flying a specially equipped aircraft over the leak site [48]. Figure 126 shows the estimated airborne rates (converted from metric tons of methane to standard gas rates using the equation of state model from Blade’s SS-25 PROSPER well model).

Although Scientific Aviation’s plane was nearby for other measurements when the SS-25 leak occurred and mobilized quickly to measure the leak, the initial leak rates were not measured. Also, only airborne hydrocarbons were measured, and this did not necessarily represent the total leak. Hydrocarbons could have dispersed through the fracture matrix and taken an unknown path that delayed emissions to the air. This dispersion and delay were likely to affect the Scientific Aviation measurements.
