Blade Report

I.19-06-016

Root Cause Analysis of the Uncontrolled Hydrocarbon Release from Aliso Canyon SS-25

May 16, 2019

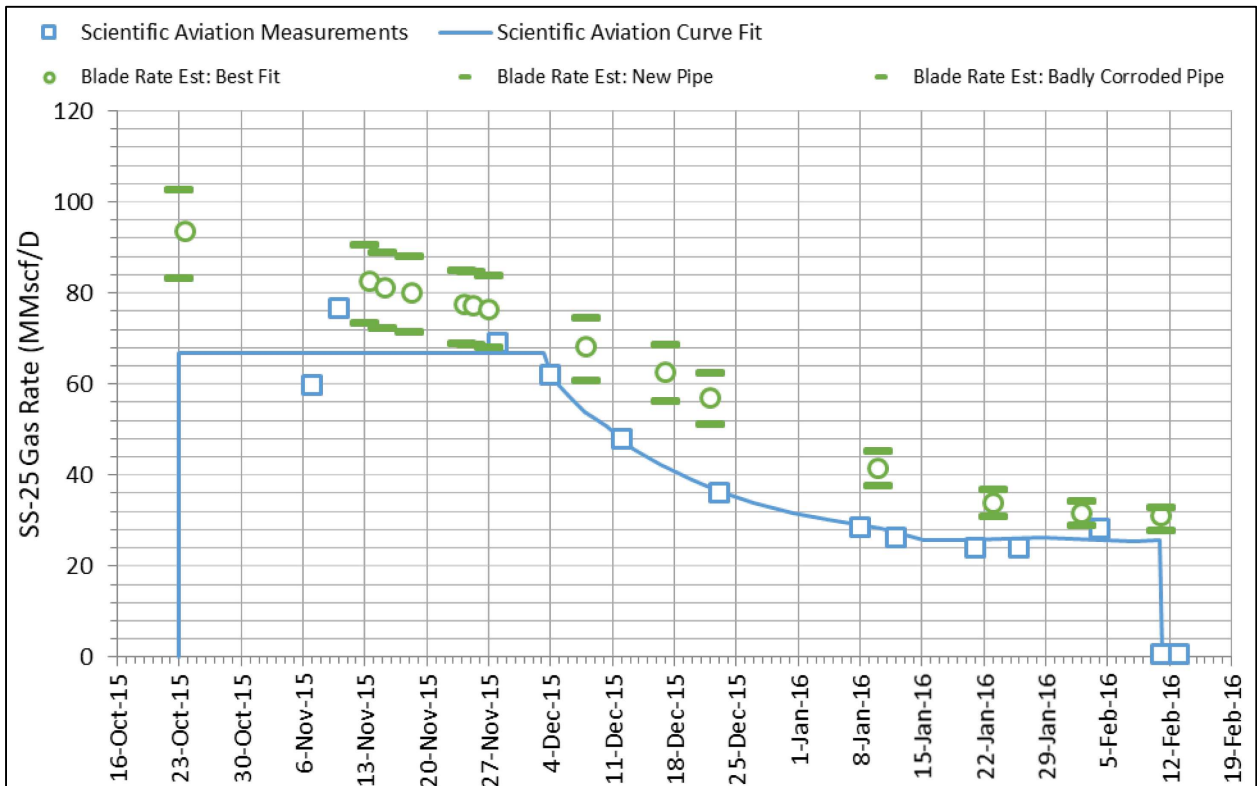
Figure 127: SS-25 Leak-Rate History Comparison—Blade and Scientific Aviation

Figure 127 compares the rates of Scientific Aviation with those of this report. The lower estimated rates, which assumed badly corroded tubing and casing, were the lower limit, and the higher estimated rates, which assumed new tubing, were the upper limit. Pulled production casing and logging after the leak showed evidence of metal loss, corrosion, and scaling. The best rates were from the assumed pipe roughness based on corrosion and scaling and were always just at or above the Scientific Aviation rates. Note that the plateau rate assumed by Scientific Aviation for the six weeks was a result of limited measurements.

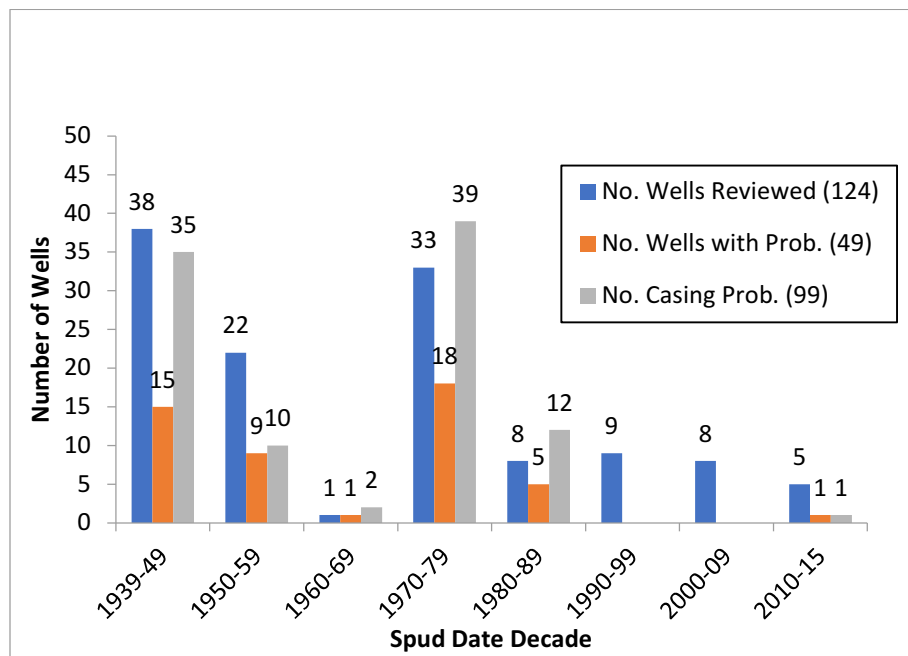
Figure 129: Number of Wells Reviewed, Wells with Failures, and Casing Failures

Figure 129 shows a breakdown of the number of wells reviewed, wells with casing problems, and casing failures by spud date (the start date of the well drilling process) at ten-year intervals. As the plot shows, most of the drilling activity happened in two groups: from 1939 to 1959, when the field was developed for oil and gas production, and from 1970 to 1979, when many of the gas storage wells were drilled.

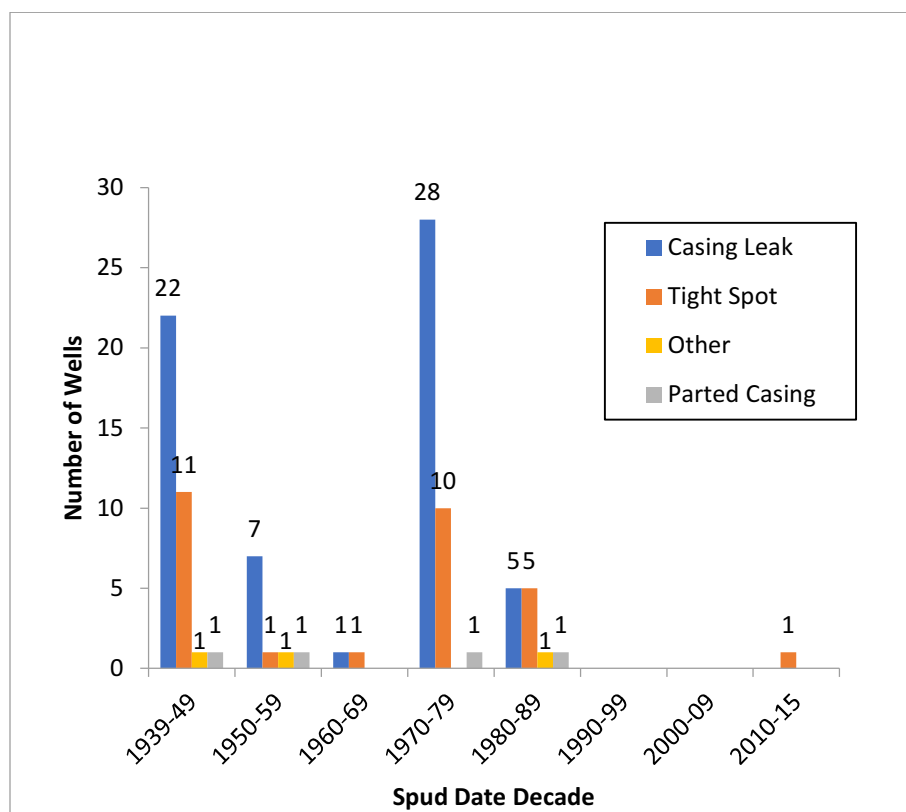
Figure 130: Number and Types of Casing Failures by Spud Date

Figure 130 shows that casing leaks represent the majority of the casing failures.

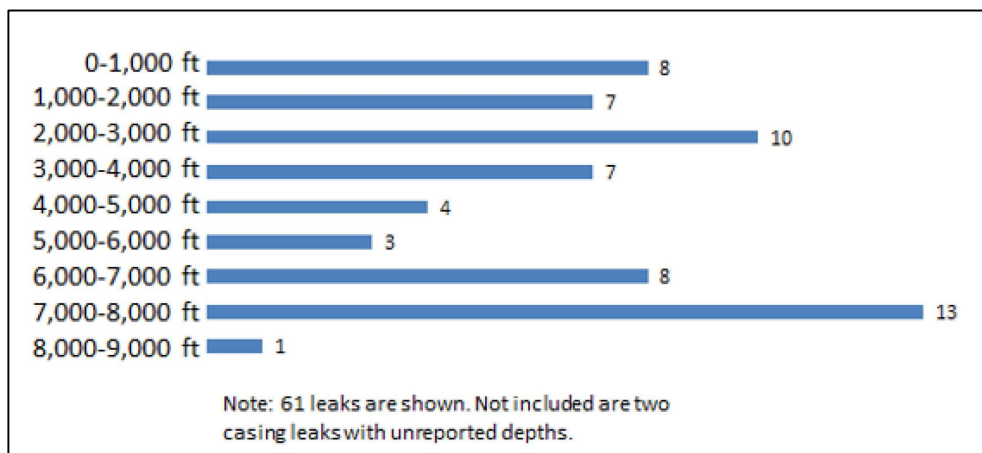
Figure 131: Casing Leak Count by Depth Range

Figure 131 shows the number of casing leaks by depth range. Our analysis shows that:

- 8 of 61 (13%) casing leaks occurred above 1,000 ft, including the one in SS-25.
- 52% of the leaks were between the surface and 4,000 ft with no trend of leak count vs. depth.
- Leaks in the lower part of the well were more numerous from 7,000 ft to 8,000 ft.
- 63 casing leaks occurred in 41 wells for an average of 1.5 leaks per well.

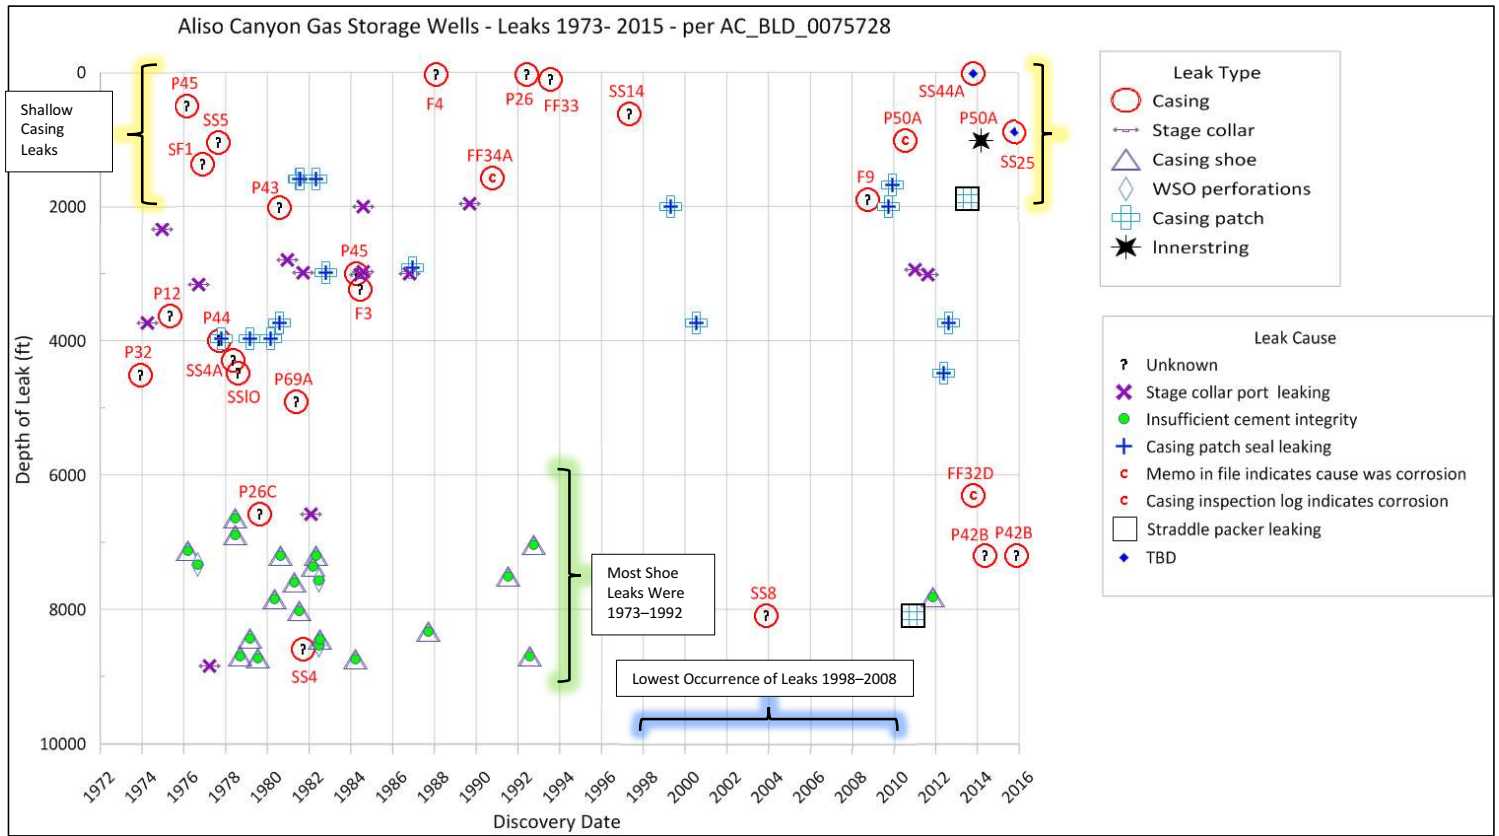
Figure 132: Leaks per SoCalGas Data [51]

Figure 132 shows the data from SoCalGas table graphically by leak discovery date on the x-axis and well depth on the y-axis. There are two legends: one for the leak type and a second one for the leak cause. A few trends are visible. What is apparent is that leaks of any type were most prevalent before the mid-1990s. For the casing shoe leak type, all but one leak occurred before 1992, denoted by a green brace. Although not of high importance to the RCA, numerous leaks in stage collars and casing patches (intended to cover the stage collars) are present. Most relevant to the RCA are the casing leaks denoted by red circles. Denoted within each circle are SoCalGas’s determinations of the leak cause. The ? symbol denotes unknown causes. About half of the casing leaks are shallower than 2,000 ft and denoted by yellow braces. Most of the shallow casing leaks have unknown causes. There does seem to be a reduction in the number of leaks identified from around 1998 to 2008—denoted by a blue brace. We are not entirely sure why this was the case. There were no changes in the SoCalGas Monitoring Program (Appendix A.1).

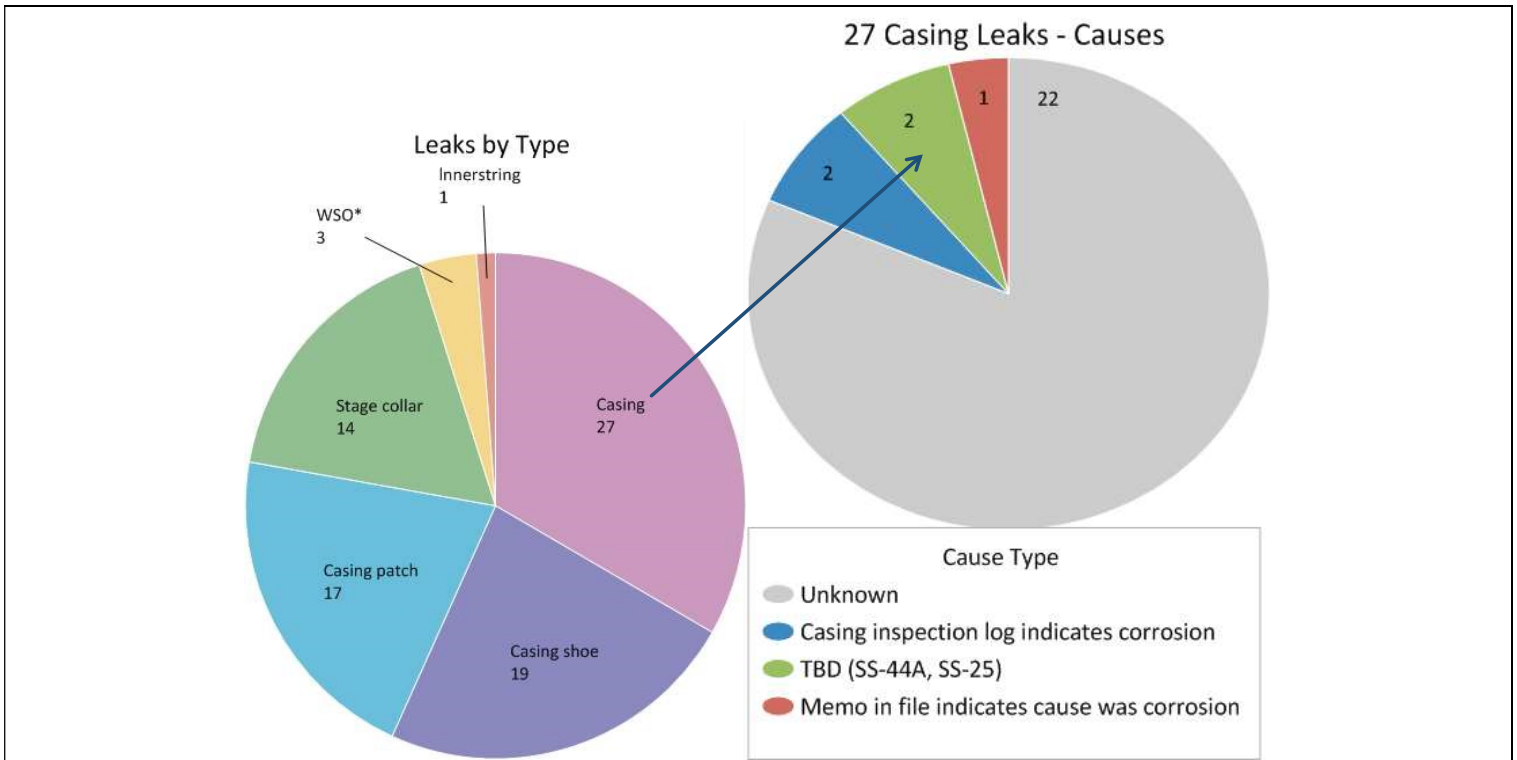
Figure 133: Leaks by Type per SoCalGas [51]

Figure 133 shows two pie charts: The left one shows the casing leak type and the right one shows the casing leak causes. Of the 81 leaks, 27 are casing leaks. The rest of the leak types are stage collar, casing shoe, water shut off (WSO) perforations, casing patch, and inner string, but these are not of interest to the RCA. The stage collar and casing patch leaks are related because casing patches were run to isolate leaks in the stage collars. Of the 27 casing leaks, 22 are of unknown reasons. Three casing leaks are stated to relate to corrosion, and two casing leaks are to be determined (TBD).

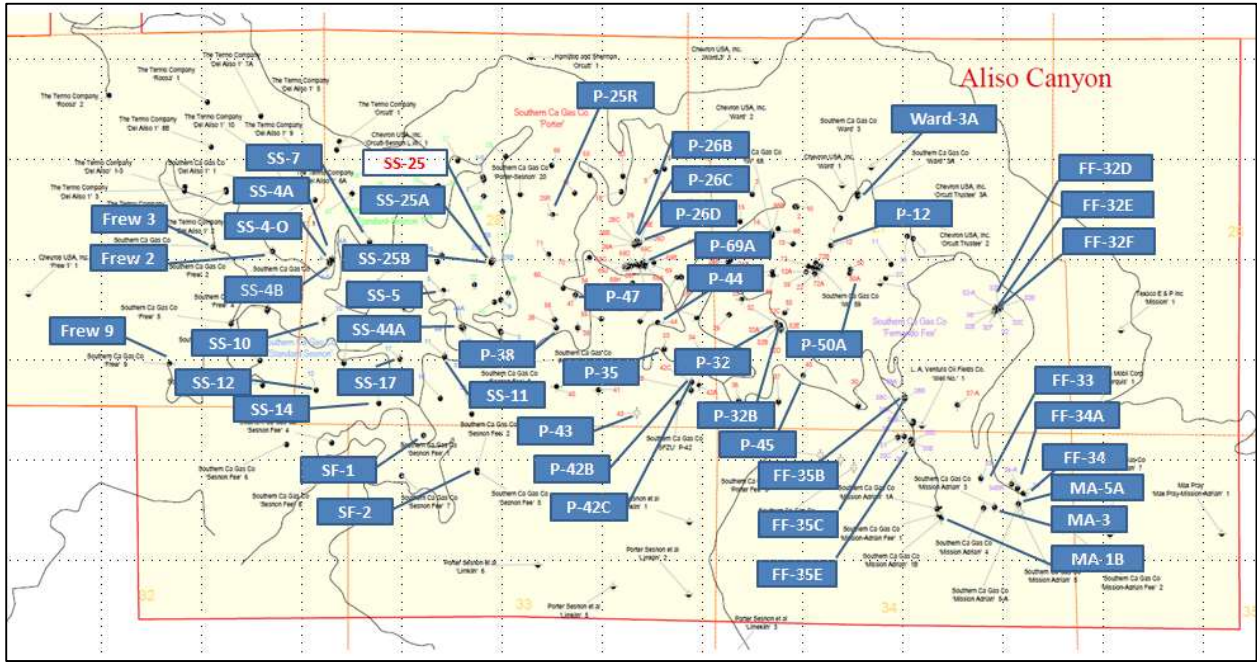
Figure 134: Map of Aliso Canyon showing Wells with Casing Failures

Figure 134 shows the Aliso Canyon wells with casing failures. The distribution of casing failures appears to be field-wide and not concentrated in a specific area of the Aliso Canyon Field. SS-25 is located in the western part of the field.

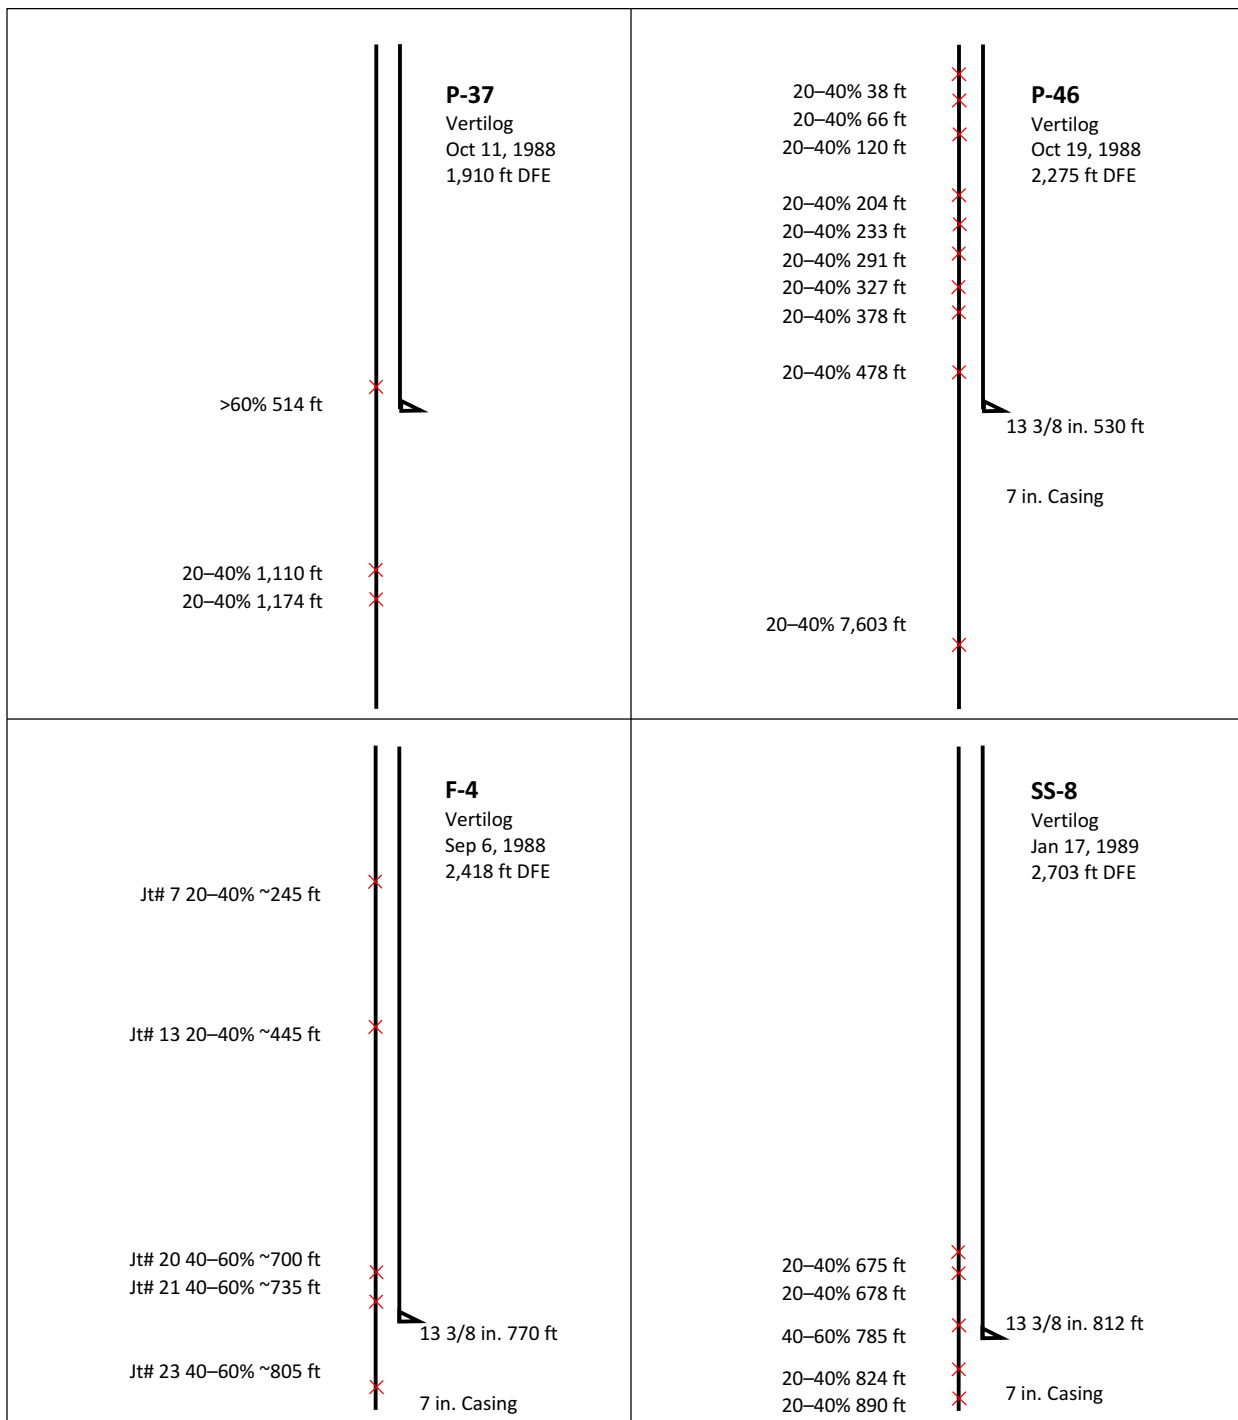
Figure 136: Wellbore Schematics Showing Vertilog Penetration Data

Figure 136 summarizes the percent penetration and depths from the Vertilog inspection results for wells P-37, P-46, F-4, and SS-8 production casings above and immediately below the surface casing shoe. The four wells were inspected in 1988 and 1989. The derrick floor elevation (DFE) above sea level is included and shows the significant variation in surface elevations among the wells. All of these wells had OD indications. P-46 had numerous metal loss indications above the shoe; and all of them had indications shallower than 1,000 ft. The behavior in these wells appears similar to SS-25.

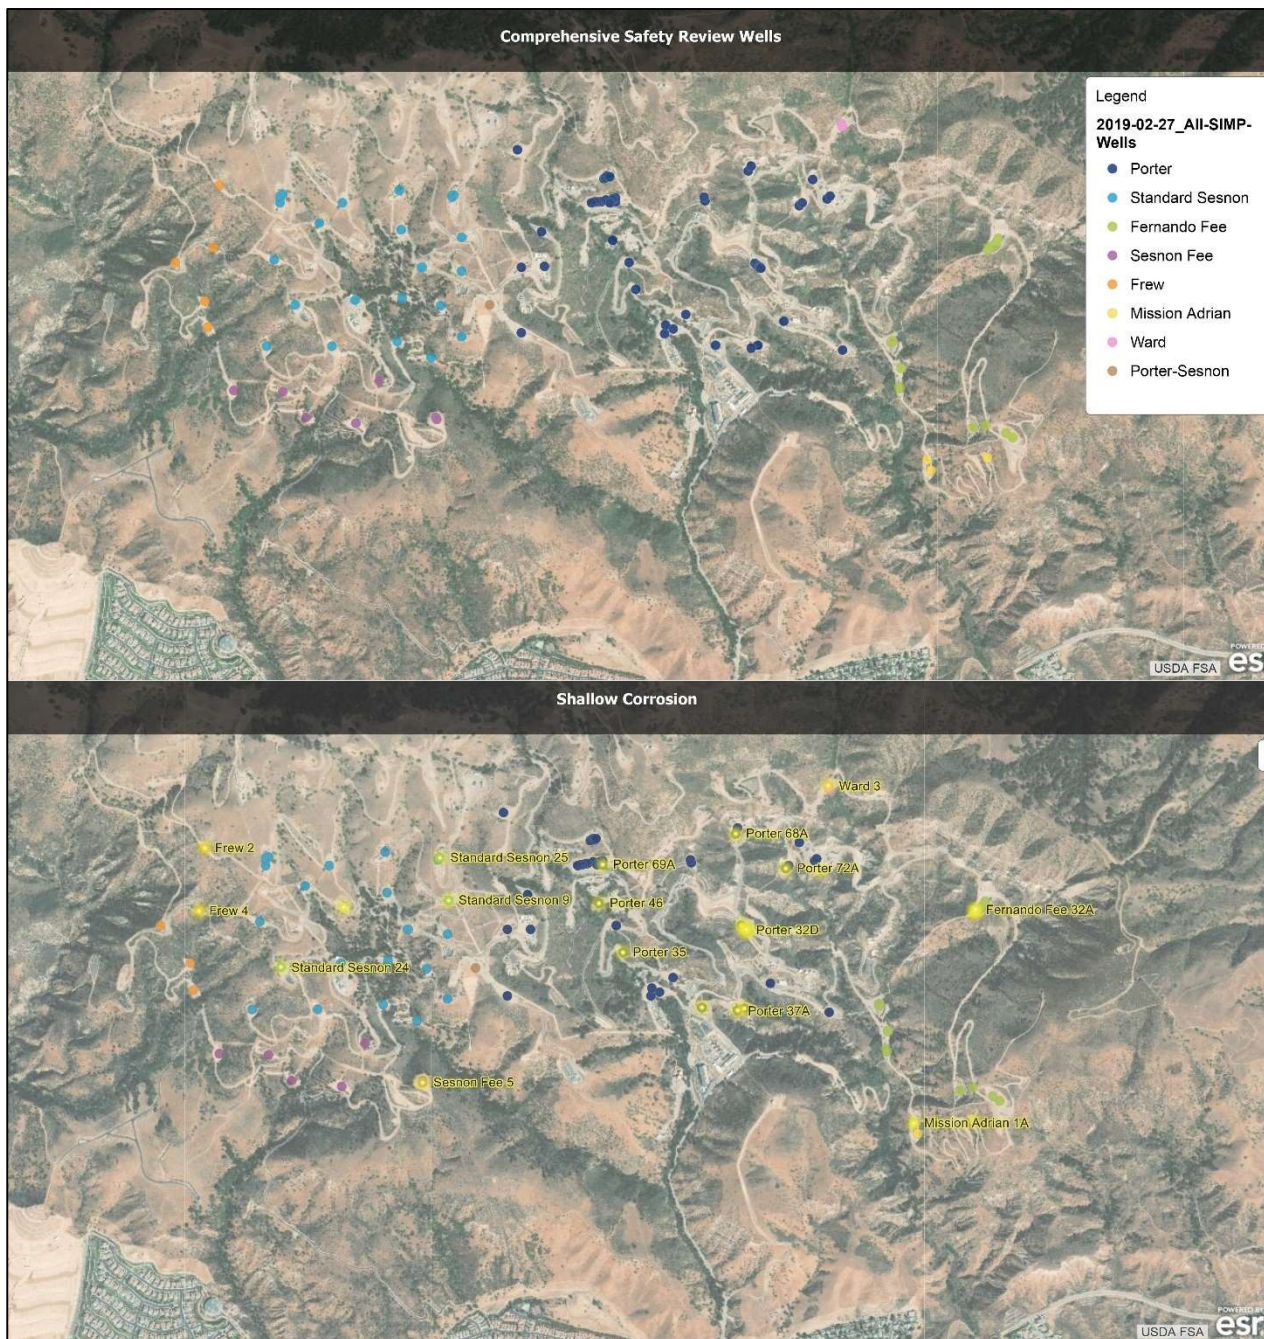
Figure 138: Well Locations with Shallow External Corrosion on Production Casing Excluding SS-25

Figure 138 shows the locations of the 114 comprehensive safety review wells, also known as the SIMP wells, (upper graphic), and the 27 wells with shallow external corrosion on the production casing (lower graphic). These 27 wells are spread throughout Aliso Canyon with no apparent trends.

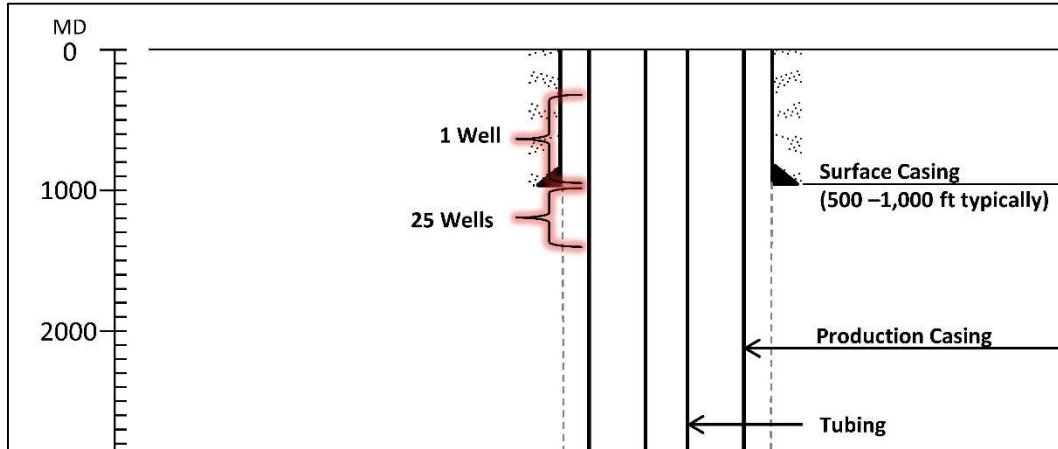
Figure 139: Location of Shallow External Corrosion on Production Casing Not Including SS-25

Figure 139 shows the location of the shallow external corrosion on the production casing for 26 wells. Almost all of the wells had production casing external corrosion present just below the surface casing shoe. One well, P-50A, had production casing external corrosion above the surface casing shoe. SS-25 was not included, but it was the only well that showed shallow corrosion above *and* below the surface casing shoe.

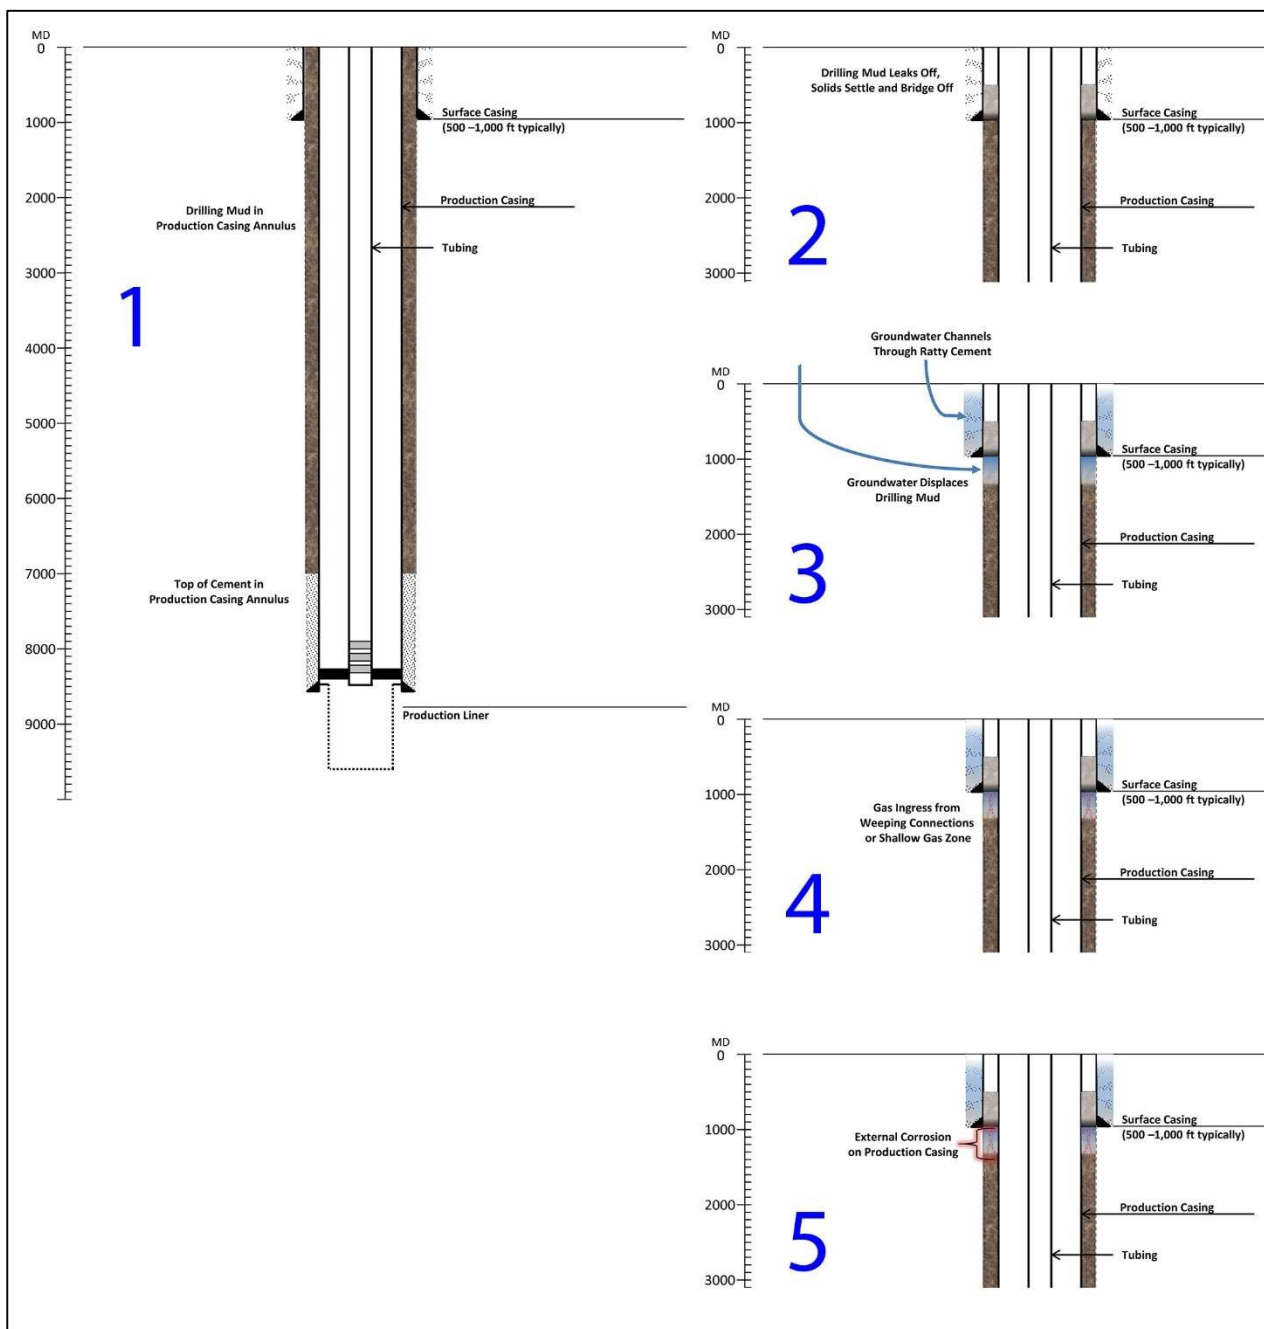
Figure 141: Hypothesis for the Shallow External Corrosion Mechanism

One area of investigation focuses on the location of corrosion near the surface casing shoe. This is common in a number of wells; this suggests a common corrosion mechanism. Figure 141 shows a possible corrosion mechanism supported by some of the observations discussed previously. Using the numbered inset images, the hypothesis is as follows:

5. Corrosion initiated and grew in the aqueous carbon dioxide environment. This process may have been assisted by microbes residing in the groundwater.

The hypothesis described above is consistent with the shallow corrosion observed across the 25 wells. Much of the shallow corrosion, unlike SS-25, was only observed below the surface casing shoe. Further analysis is necessary to develop this hypothesis and appropriately mitigate.

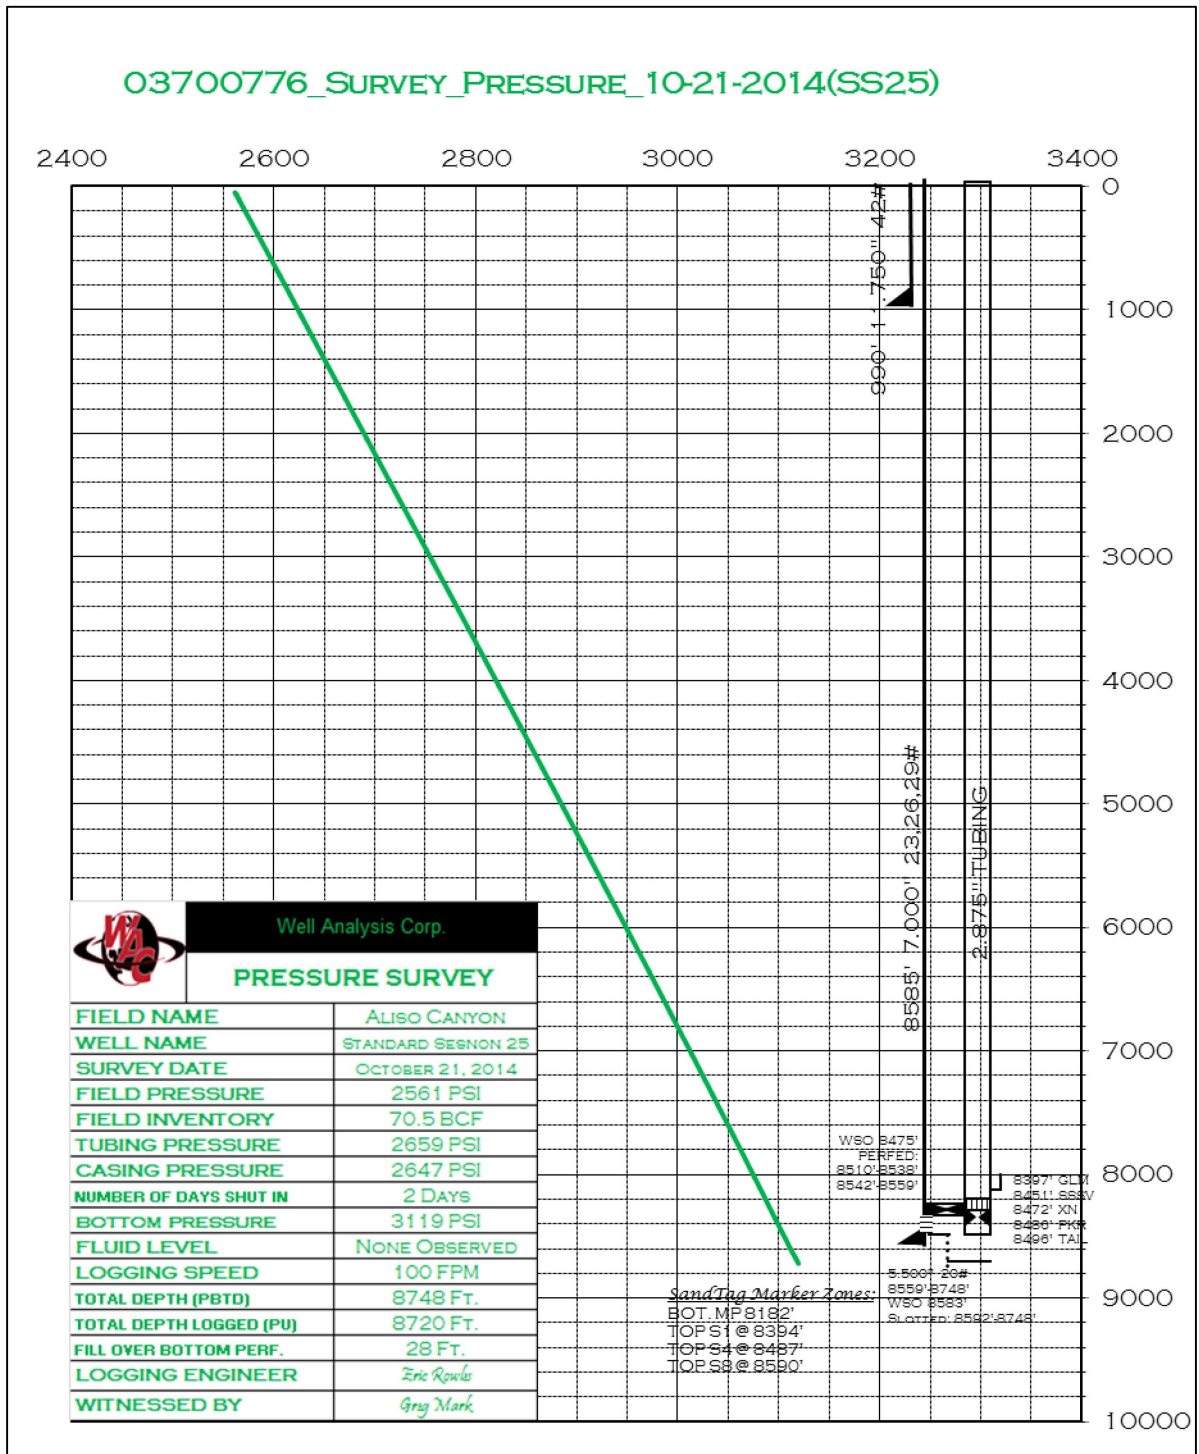
Figure 143: Most Recent SS-25 Pressure Survey, October 21, 2014

Although SoCalGas performed 41 pressure surveys in 41 years, neither the *DOGGR Project Approval Letter* [72] nor the *SoCalGas Gas Inventory-Monitoring, Verification, and Reporting Company Operations Standard Gas Operations* [73] required pressure surveys. Figure 143 shows the most recent pressure survey on October 21, 2014, to 8,720 ft, in which there seems to be a discrepancy; the title block entry for “Tubing Pressure” (2,659 psi) does not match the graphed data, which appears to be between 2,550–2,600 psi. Despite this discrepancy, no pressure anomalies are observed in the graphed data.

Blade’s interpretation of the pressures surveys is that they were not effective in determining the presence or location of a casing leak; small leaks would go undetected. From a casing integrity perspective, pressure surveys differ from pressure tests substantially. In pressure surveys, the well is open to the storage zone, and any gas that escapes into a casing leak is replenished by the storage zone. This is considerably different than a pressure test where all external sources of pressure are isolated. Additionally, the pressures observed during these pressure surveys are the shut-in pressures. The pressure profiles during shut-in are lower than during standard gas injection operations. In other words, pressure surveys are taken at times when the casing is under less pressure than during gas injection.

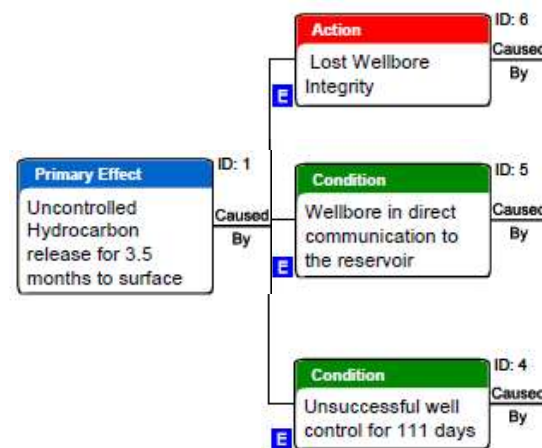
Figure 146: Causes of the SS-25 Incident

There are three causes for the primary effect:

- The well-control efforts took 111 days to stop the reservoir gas from leaking to the surface. Seven attempts were made to stop the gas flowing up through the wellbore by pumping kill fluids down into the well from the surface. These top kill attempts were unsuccessful and, ultimately, a relief well had to be drilled to intersect the SS-25 wellbore at 8,534 ft and bring the gas flow to a stop by pumping kill fluid down the relief well to fill SS-25 with kill fluid from the bottom. If, for example, the first top-kill had been successful, the flow of gas to the surface would have been stopped within days. For example, had a successful well kill occurred by October 26, the cumulative volume leaked would have been 0.4 BCF instead of around 6 BCF.

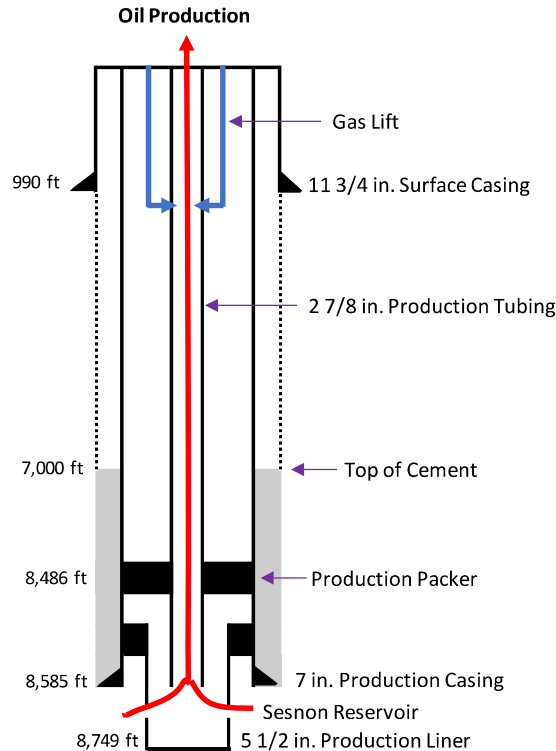
Figure 148: Well Schematic from When SS-25 Was an Oil Well

In 1954, SS-25 was drilled and then completed as an oil producing well. Figure 148 shows that a 7 in. production casing string was run from the surface to 8,585 ft, which was approximately 200 ft into the Sesnon oil reservoir. Below the 7 in. casing, a 200 ft 5 1/2 in. production liner was run across the Sesnon formation. This liner had slots cut along its length. A 2 7/8 in. production tubing string was run inside the 7 in. casing. At the bottom of the tubing string, a production packer isolated the annular space between the tubing and the 7 in. casing. During production the oil flowed from the Sesnon through the slots in the liner, up into the tubing, and up the tubing to the surface. The production packer prevented oil from flowing into the 7 in. x 2 7/8 in. annulus. Thus, the wellbore was in direct communication with the reservoir, allowing the oil to be recovered from the reservoir, which was the objective of the well. Note that the reservoir pressure was not high enough to force the oil all the way to surface. Several gas lift valves were therefore installed in the upper section of the tubing string. This allowed gas to be pumped down the 7 in. x 2-7/8 in. annulus, through the gas lift valves and into the tubing. The gas mixed with the oil making it lighter so that it would flow to the surface.

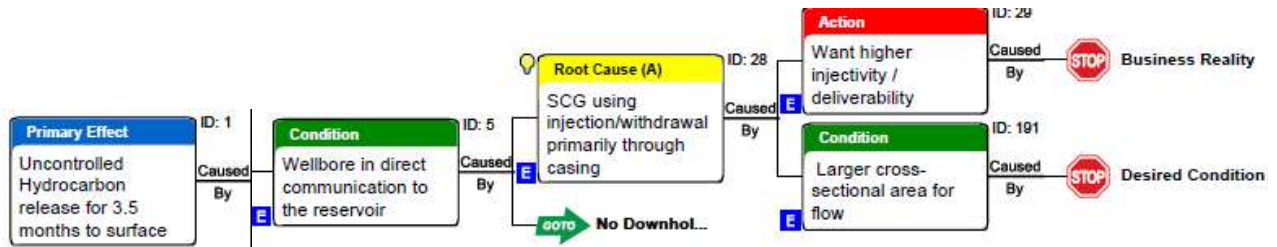
Figure 149: Causes—Wellbore in Direct Communication with the Wellbore

Having the wellbore in direct communication with the reservoir is a business reality. However, as Figure 149 shows, the effects of the incident were complicated by the fact that the well was configured for injection and withdrawal through the tubing and casing. In the 38 years SS-25 was used as a gas storage well, it was mostly used for injection, and most of that was done through the casing. Injecting gas through the casing allowed higher injection and withdrawal rates because it provided a larger flow area (than just the tubing), and a higher rate of gas could be injected through the casing. Maximizing the injection and withdrawal rates at lower pressures through each well is a business reality, reducing the need for additional storage wells. But this had an adverse impact on the wellbore integrity. Another impact of the well configuration was the absence of a functioning downhole annular flow safety system. Such a system had been initially installed but proved to be unreliable, and it was later removed. This is discussed in more detail in Section 5.2.3.

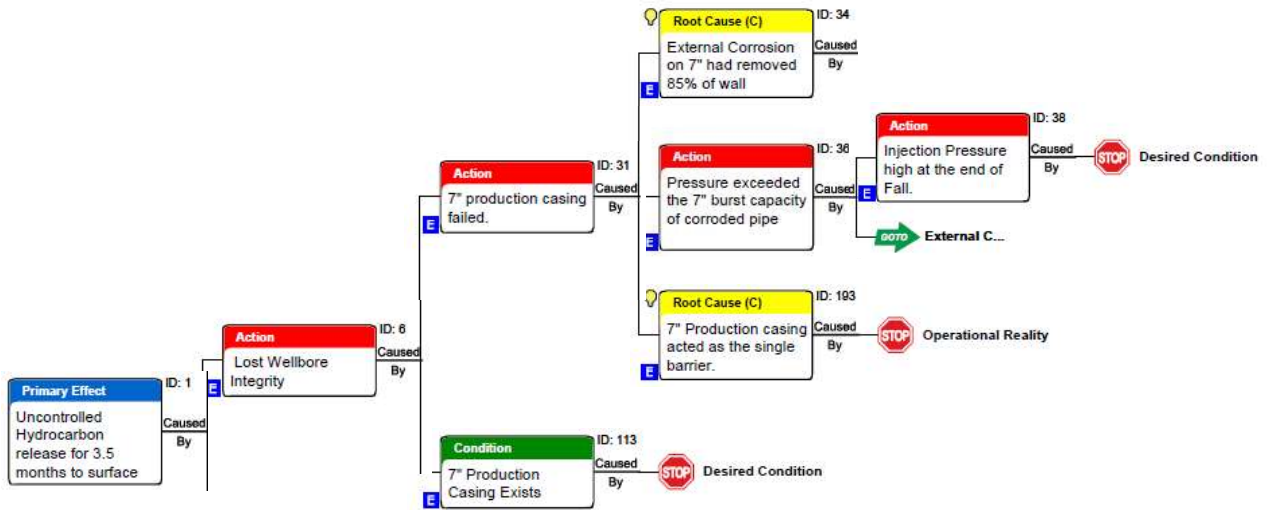
Figure 150: Causes—Lost Wellbore Integrity

At the time of the incident, gas was being injected into the reservoir. Wellbore integrity was lost when the 7 in. casing (which was being used to provide the conduit between the reservoir and the surface) ruptured and parted, allowing the pressurized gas to escape from the wellbore. Figure 150 shows that the following were the causes of the failure:

- The external corrosion on the 7 in. casing had removed 85% of the wall thickness.
- The pressure inside the 7 in. casing exceeded the burst capacity of the corroded casing.
- The 7 in. casing acted as a single barrier.

Rig operations during Phase 3 found that the 7 in. casing had parted at 892 ft. Blade examined the parted sections and found that external corrosion had removed 85% of the wall thickness, which consequently reduced the burst capacity of the 7 in. casing. At the time of the failure, the pressure of the gas being injected into the wellbore was 2,700 psi surface pressure. Blade developed a finite element model of the corroded region where the 7 in. casing failed by using the actual material properties and dimensions of the corroded section. The corroded region included sharp grooves causing a stress concentration that was approximated in the finite element model. The modeling predicted that the corrosion region would fail at a differential pressure between 2,327 and 2,836 psi. This is consistent with an internal pressure of 2,791 psi at the failure location. The surface injection pressure varies throughout the year and was at the highest level for the year. This was normal for the fall months, when more gas is stored for the upcoming winter demand.

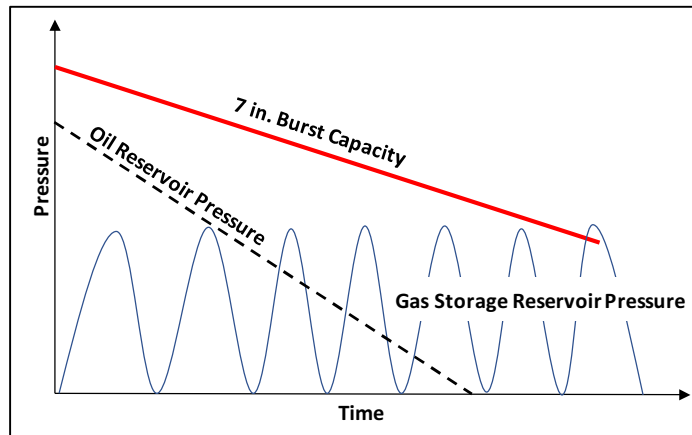
Figure 151: Oil and Gas Storage Reservoir Pressures Compared

Recall that SS-25 was originally designed to be an oil producer in 1954 and was converted to gas storage in 1973, 19 years later. Other wells in Aliso Canyon drilled after 1973 were designed specifically to be gas storage wells. A key difference between the two types of wells is that the reservoir pressure in an oil well decreases gradually over time, whereas the reservoir pressure in a gas storage well does not. An oil well experiences the highest pressures on the first day of production, and pressure then decreases over time. The pressures that gas storage wells are exposed to are cyclic as gas is injected and withdrawn normally on annual cycles (Figure 151). The cyclic pressure levels are approximately the same year after year; the 7 in. casing burst capacity decreased over time because of the effects of wall loss corrosion. A key tenet of ensuring wellbore integrity is that the casing be designed to withstand the pressures it will be exposed to over the complete life of the well.

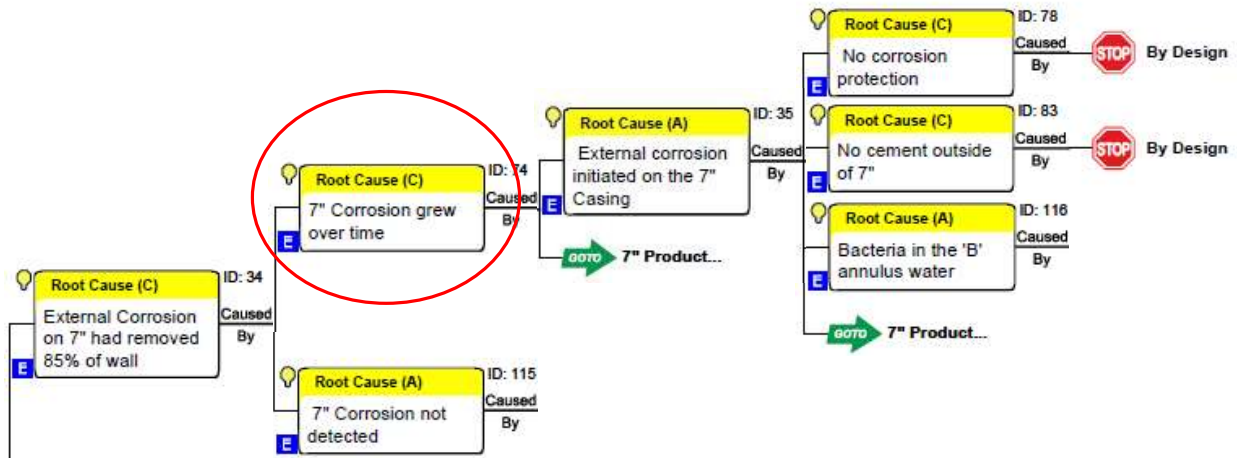
Figure 152: Causes—Corrosion Growing Over Time

Corrosion initiated on the OD of the 7 in. casing and continued to grow over time because there was neither corrosion protection for the OD nor cement outside the casing at 892 ft, and the environment in the 7 in. × 11 3/4 in. annulus was conducive to corrosion (Figure 152). Blade's laboratory analysis of the parted 7 in. casing showed that the wall thickness reduction was caused by microbiologically influenced corrosion (MIC).

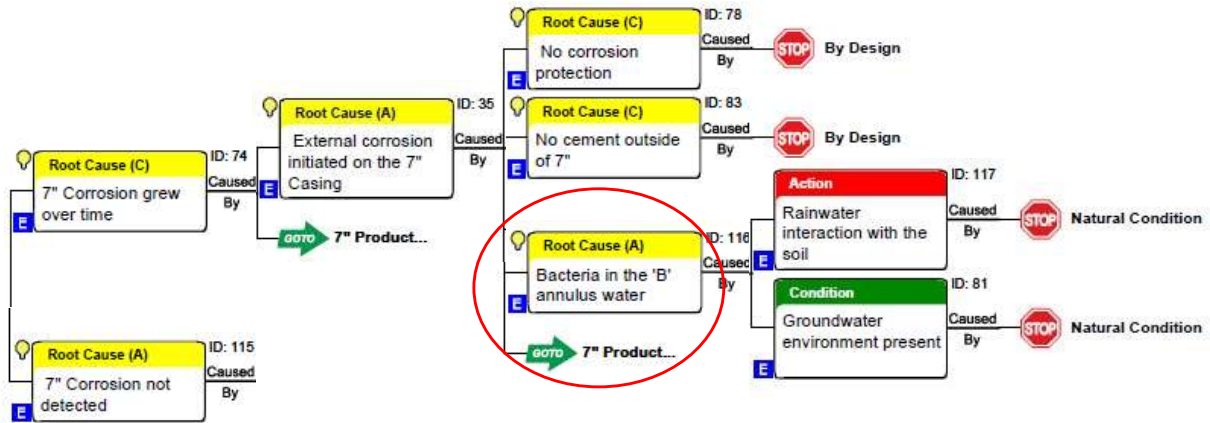
Figure 153: Causes—Annulus Fluid Corrosion Mechanism

The drilling fluid that was left behind the 7 in. casing had a pH ranging from 10 to 12 and would not have caused corrosion. Over time, the drilling fluid leaked off and was displaced by groundwater. The fluid level in the annulus rose and fell with the groundwater level. The groundwater had a microbial environment that resulted in slow corrosion of the OD of the 7 in. production casing (Figure 153).

The metallurgical analyses documented that the failure location had corroded due to MIC. The evidence supporting the interpretation of MIC included metallurgical, scale and corrosion product chemistry, and scale microbial analyses. The metallurgical assessment demonstrated the presence of tunnels, striations and the microbial nature of the corrosion scale. The Raman and XRD analyses demonstrated the predominance of magnetite and modified hematite. The microbial analyses of the scale demonstrated the consistent and predominant presence of methanogen strains that likely caused corrosion. Finally, many of

the 7 in. Speedtite connections exhibited slow leaks, and this seepage of gas likely introduced carbon dioxide, a nutrient for the methanogens.

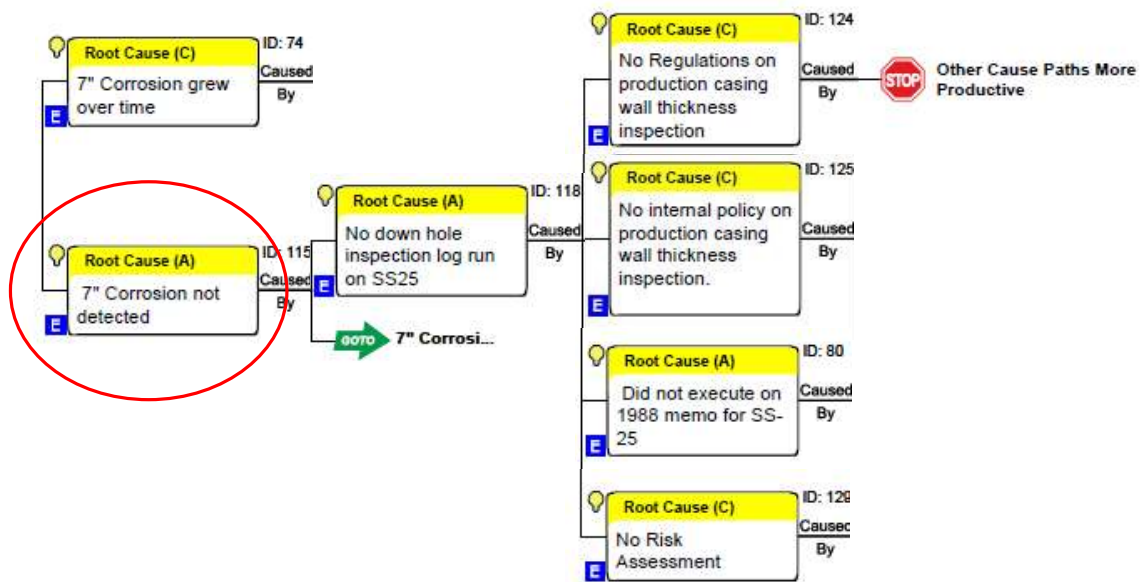
Figure 154: Causes—Corrosion Not Detected

Corrosion was not detected because the 7 in. casing wall thickness had never been inspected; therefore, the fact that the 7 in. casing was undergoing wall loss corrosion was unknown. Various acoustic and electromagnetic based tools can be run in a well with wireline to measure wall thickness along the entire length of a casing or tubing string. These logs were not run in the 7 in. casing because (Figure 154):

- No regulations were in place requiring them at the time.
- No internal SoCalGas policy addressed wall thickness inspections at the time.
- No action from SoCalGas was taken on a 1988 memo recommending that a wall thickness inspection be done at SS-25.
- No risk assessment was performed.

The 2015 DOGGR regulations required periodic MITs, and annual temperature surveys were approved to meet the MIT requirements. Annual temperature surveys and periodic noise logs were run in SS-25 from 1974 to 2014, and no anomalies were found. This type of monitoring program is not capable of detecting corrosion or the growth of corrosion over time (irrespective of whether it is on the ID or OD). The temperature and noise surveys do not measure wall thickness; they will only detect a leak and are consequently after-the-fact, reactive techniques.

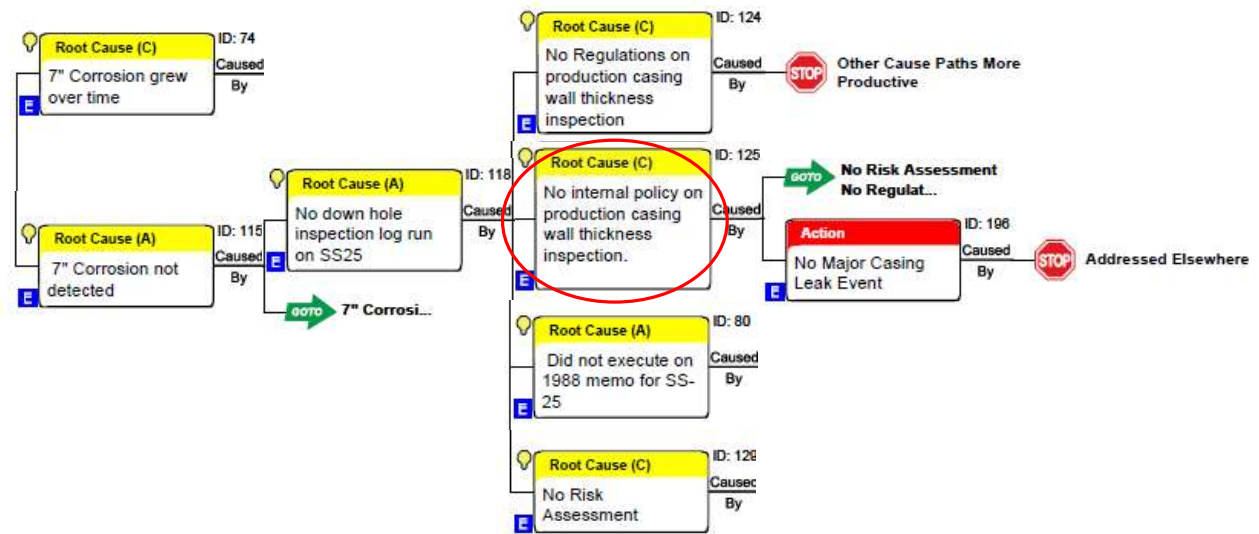
Figure 155: Causes—No Policy on Wall Thickness Inspections

The company assumed that regulatory compliance was being adhered to by running annual temperature surveys per the Aliso Canyon Monitoring Plan and the project approval letter dated 1989 requiring an annual MIT. There were no regulatory requirements for wall thickness measurements to be done. The MIT monitoring system did find casing leaks on other wells in the field, which were successfully repaired or remediated. But again, no failure analysis or risk assessment was ever done on previous wells that had leaks or corrosion. In addition, there had not been an event of similar severity to what happened on SS-25 (Figure 155). Further, since no formal risk assessment was conducted regarding well integrity, wall thickness inspection was not identified as a monitoring technique.
