Blade Report

I.19-06-016

Root Cause Analysis of the Uncontrolled Hydrocarbon Release from Aliso Canyon SS-25

May 16, 2019

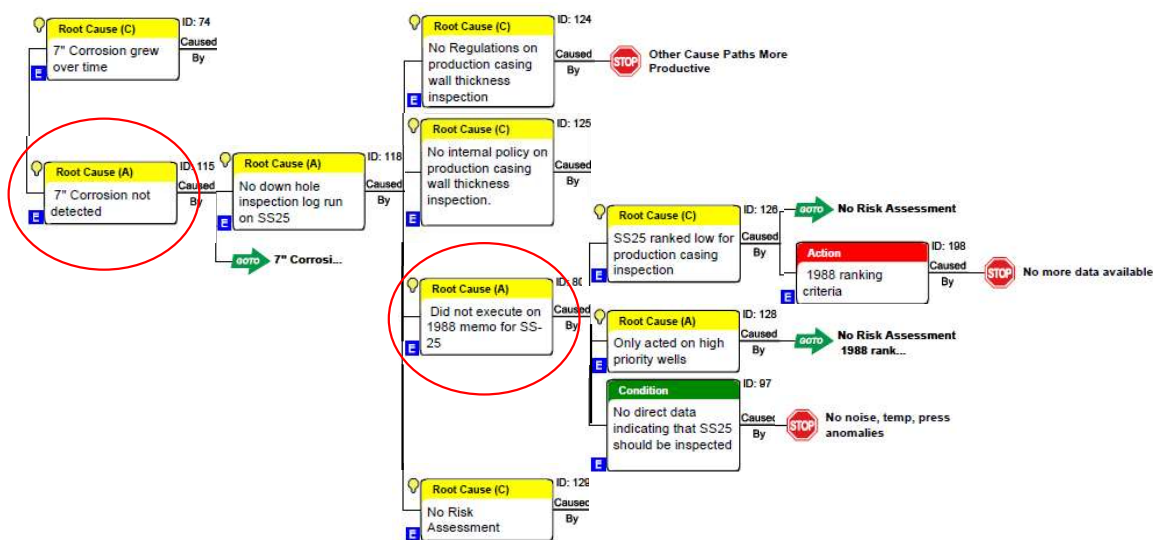
Figure 156: Causes—Not Executing on the 1988 Memo

The 20 wells recommended for a casing wall thickness inspection were originally oil wells completed between 1944 and 1956. The recommendation was to use a Vertilog inspection tool that used magnetic flux leakage measurements to measure casing wall thickness. The recommendation for conducting the survey was approved with the work to be done over the following two years. During that time, 7 of the 20 wells ended up being inspected (5 were high priority, 1 was medium, and 1 had already been scheduled for a workover). The inspection logs showed metal loss, and an inner casing string was run in some of the wells to mitigate the wall loss. However, 13 of the 20 wells were not inspected within the recommended 2-year window. SoCalGas stated that the remaining 13 wells were not inspected because the Vertilog technology available in 1988 “proved to be less effective at identifying casing leaks than the well diagnostic tests that SoCalGas routinely performed on its underground gas storage wells (e.g. annual temperature surveys, noise logs, etc.) [76].” At the time, there were no anomalies or direct evidence from the noise and temperature log monitoring program that SS-25 needed a wall thickness inspection (Figure 156).

A wall thickness inspection provides a leading indicator of possible casing integrity issues. The noise and temperature logs results are trailing indicators because the leak has to already have happened to be detected. Seven of the wells were inspected, and many of them had OD metal loss indications. There was no follow-up investigation of these anomalies. Further, there was no investigation of why these wells exhibited OD corrosion and why the remaining thirteen wells did not require further analyses (the remaining thirteen wells had been ranked as medium and low priority).

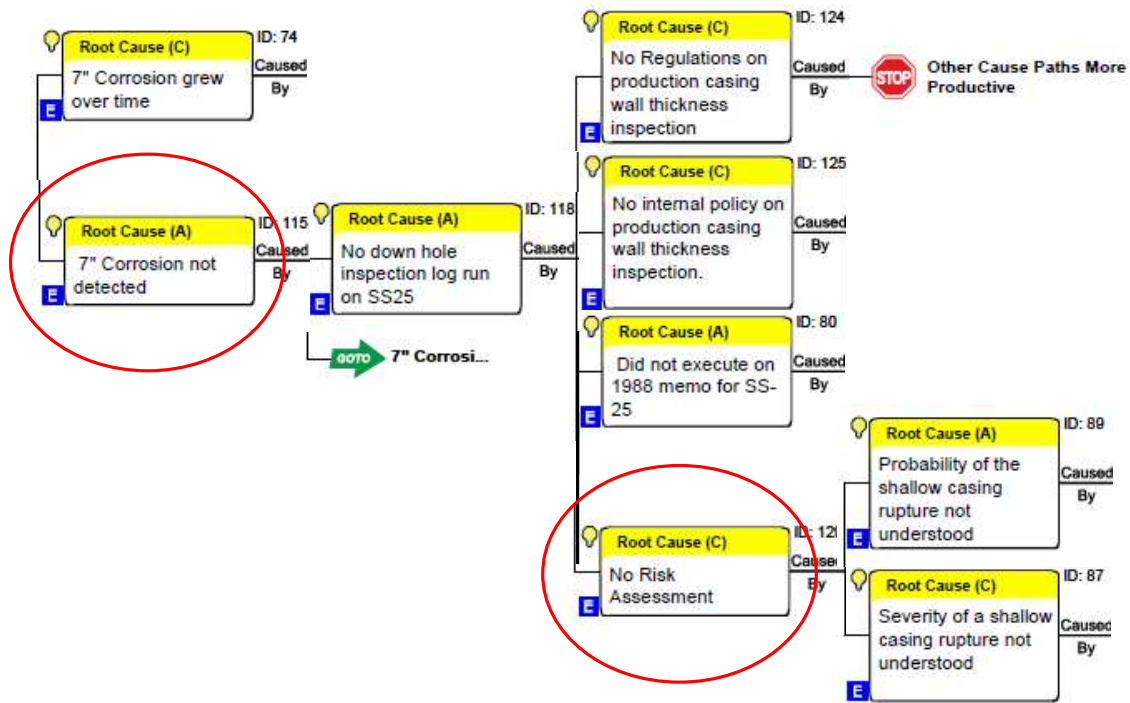
Figure 157: Causes—No Risk Assessment

Despite this, there is no evidence that SoCalGas conducted a formal failure analysis or follow-up risk assessment on any of the casing failures to determine why they occurred. Nor was there an investigation of the reasons for, and the potential consequences of, the corrosion. It is deduced that the reasons for this are because (Figure 157):

- The probability of a shallow casing rupture was not understood
- The severity of a shallow casing rupture was not understood

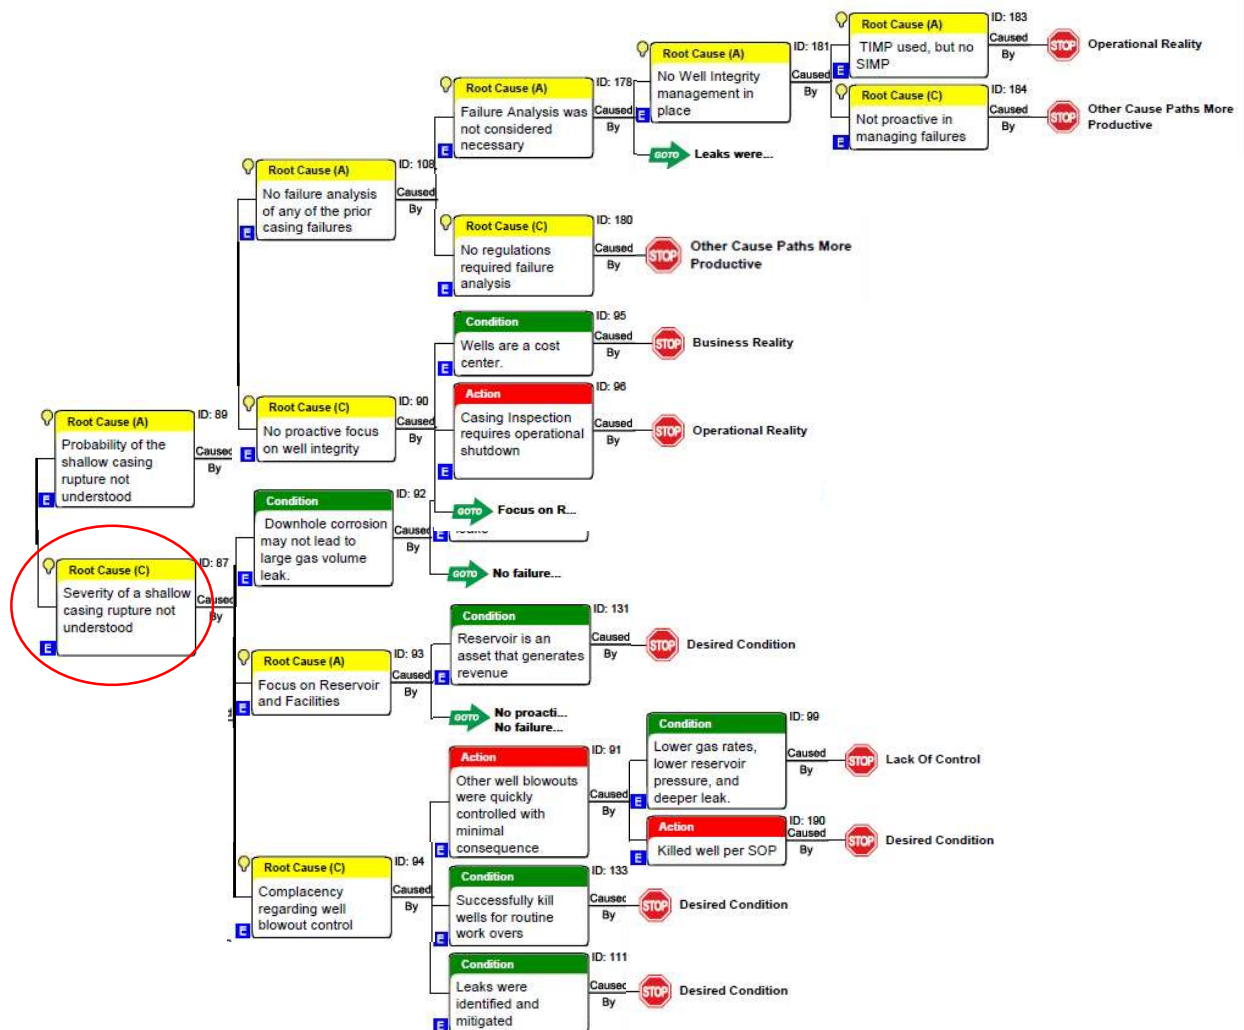
Figure 158: Causes—Probability and Severity of Shallow Casing Rupture Not Understood

The probability of a shallow casing rupture was likely not understood (Figure 158). A key reason for this was that historically, leaks had been detected and were successfully mitigated, but on an individual well basis. The mitigation efforts appeared to be focused on fixing the problem, getting the well back in operation, and then moving on. Also, no regulations required failure analyses to be done. In 2004, the Federal Pipeline and Hazardous Material Safety Administration (PHMSA) began requiring gas transmission companies, including SoCalGas, to develop and implement a Transmission Integrity Management Program (TIMP). In 2006, PHMSA began requiring distribution companies, including SoCalGas, to develop and implement a Distribution Integrity Management Program (DIMP). The concept of an integrity management system is that it proactively identifies potential problems, determines the associated risks, and then implements actions to prevent the problem from occurring or mitigates the risks. There was no equivalent program that involved well integrity, and the response to casing leaks or well failures was reactive instead of proactive. This is consistent with the view espoused by SoCalGas in their 2014 testimony for the 2016 GRC [2] and the lack of formal or informal investigation of casing leaks.

The severity of a shallow casing rupture was likely not understood because there was complacency with respect to well blowout control (Figure 158). The monitoring program had identified casing leaks, which were successfully mitigated. Wells were top-killed for routine workovers or intervention work. The Frew-3 and FF-34A underground blowouts were quickly controlled with minimal consequences—they occurred with a lower reservoir pressure and flow rate, and leaks were deeper when compared to SS-25's. The Sesnon and Frew reservoir properties are generally benign. The temperature is normal, and the reservoir pressure is sub-hydrostatic, that is, the pressure is less than the hydrostatic pressure of water at an equivalent depth. The reservoir gas is not corrosive and consists predominantly of methane with a small amount of CO₂ and no H₂S. Under normal conditions, the wells can be killed with water. Complex well-control techniques or high density kill fluids are not required. Kill operations were therefore fairly straightforward and had become a routine standard operating procedure. Wells do not require constant daily maintenance or observation unlike a compressor or other complex machinery. They can be operated

It also must be acknowledged that downhole corrosion is not unusual and does not automatically lead to catastrophic failures and large gas volume leaks. If monitored accordingly, corrosion can be managed and mitigated, but the causes and associated risks need to be formally evaluated and understood in order to define safe operating limits of a well.

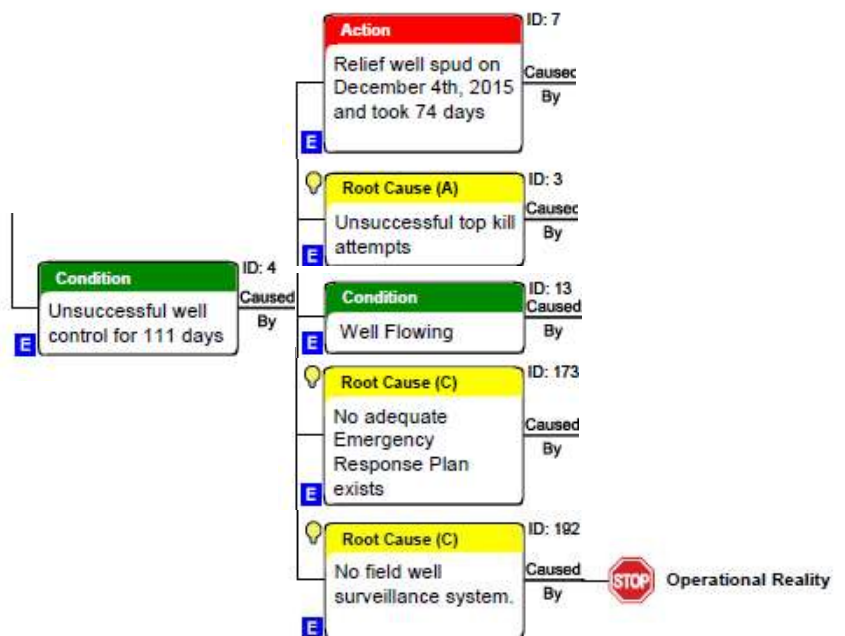
Figure 159: Causes of Unsuccessful Well Control

Seven attempts were made to top kill the well without success. A relief well had to be drilled to intersect SS-25 at 8,534 ft, and kill fluid was pumped down the relief well and into SS-25 from the bottom, which killed the well. It took 111 days to kill the well because (Figure 159):

- The top kill attempts were unsuccessful.
- The well was flowing.
- The emergency response plans were inadequate.
- There was no field well surveillance system.
- The relief well started on December 4, 2015, and took 69 days to complete (74 days including rig up time).

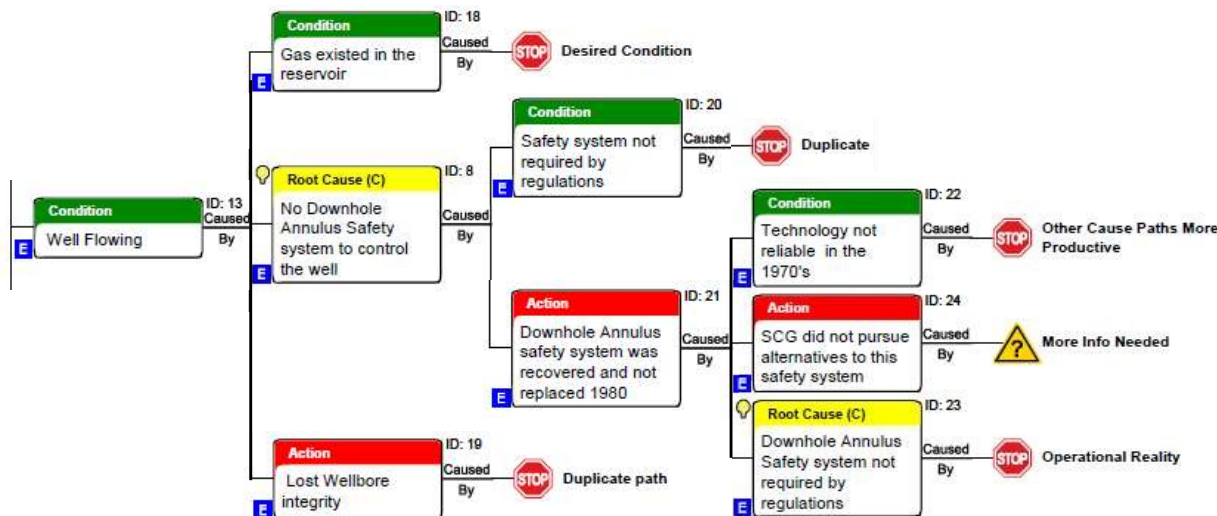
Figure 160: Causes—Well Flowing

The well was flowing because wellbore integrity was lost when the 7 in. casing failed at 892 ft and a downhole annular safety system was not in place to control the well (Figure 160). At the time of the failure, gas was being injected through the casing and into the reservoir. Just after the casing had failed, the injected gas started exiting the well, and gas from the reservoir began flowing up the well and out through the failed casing. Once the leak was discovered, the gas injection was stopped, and the well was shut in at the surface, but gas continued to flow from the reservoir and out the failed area.

A Camco annular flow safety system was installed in SS-25 in July 1976. This system was intended to shut off gas flow in the tubing-casing annulus in the event of a leak in the casing or uncontrolled flow at surface. It was run with the completion tubing and packer and placed deep in the well, above the packer, near the reservoir to provide deep isolation. The safety system was removed and replaced in February 1979. Another attempt was made to repair and test the system in January 1980, when it was concluded that the system did not function as designed. The internal components were then removed, rendering the annular flow safety system inoperable. There are numerous documents in the Aliso Canyon well files indicating problems with this type of safety system. Two systems were tried in various wells in the field; one provided by Camco and the other by Otis. Use of these devices was discontinued in the 1980s,

according to SoCalGas, because they did not work as designed and were unreliable. This is discussed in more detail in the *SS-25 Annular Flow Safety System Review* supplementary report [77].

SoCalGas did not pursue or implement alternatives to the safety system. However, viable deep-set downhole annular safety systems for gas or gas storage wells do not exist even today. Shallow-set systems run in the tubing string that shut off the gas flow in the event of a tubing failure are in common use today, but deep-set annular flow safety systems are not. A shallow-set system would have not prevented SS-25 from flowing either because what failed was the casing and not the tubing. The 2015 regulations did not require a subsurface safety device for non-critical wells.

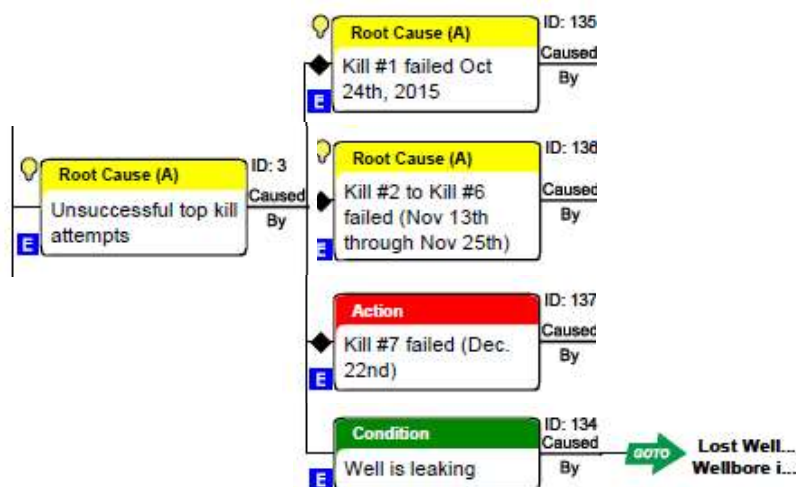
Figure 161: Causes—Unsuccessful Top-Kill Attempts

The leak was detected on October 23, 2015. The first top kill attempt was made on October 24. Because it was unsuccessful, and the well continued to flow; SoCalGas contracted a well-control company to provide technical and operational support. Over the next 39 days, six other top kill attempts were made, all of which were unsuccessful (Figure 161). Table 41 shows the dates of each kill attempt.

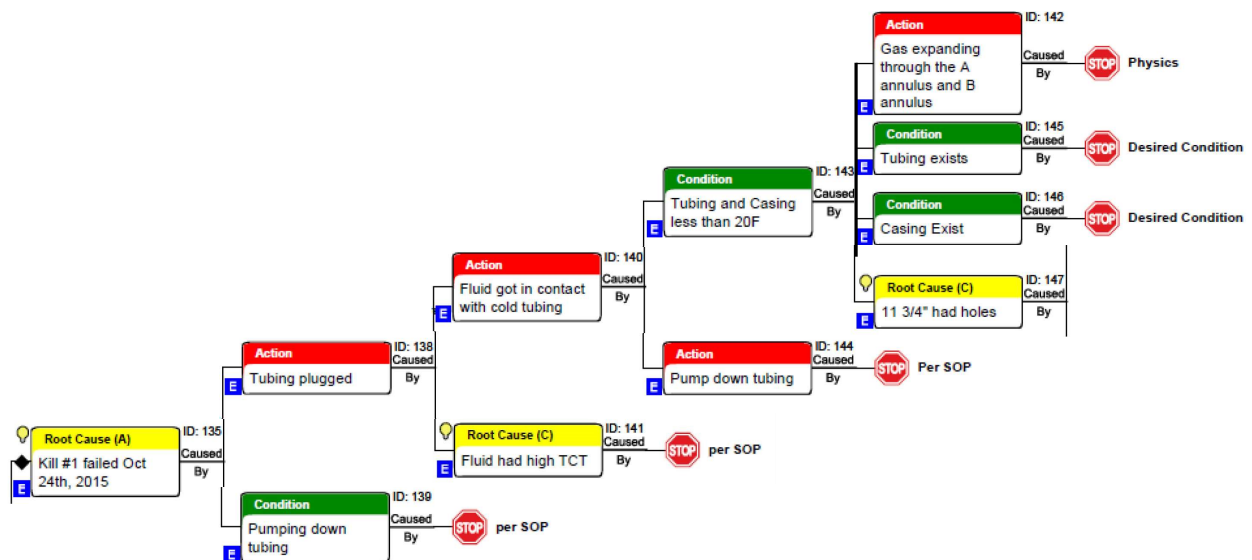
Figure 162: Causes—Unsuccessful Kill Attempt #1

Initially, the nature and depth of the leak were unknown. The plan for the first kill attempt was to pump 10 ppg polymer brine kill fluid down the tubing to stop the flow of gas and to displace the gas in the 7 in. x 2 7/8 in. annulus with kill fluid to finish killing the well. On October 24, after pumping 11.8 bbl of the polymer brine, the pump pressure jumped to 3,500 psi, and pumping was stopped. During this time the pressure in the 7 in. x 2 7/8 in. annulus remained constant at 290 psi, indicating that there was no communication between the tubing and the annulus, and the tubing was plugged. The pumping was then switched over to the 7 in. x 2 7/8 in. annulus. After pumping 89 bbl of brine, gas started to break through to the surface through cracks in the ground around the well and pumping was stopped. These results suggested a wellhead seal leak or a shallow leak in the 7 in. casing existed.

Because of the Joule-Thomson effect, the flowing gas cooled to approximately 20°F by the time it reached the area where the 7 in. casing parted. The cooling of the gas then cooled the tubing causing the brine being pumped down the tubing to freeze and form a plug in the tubing. The freezing happened because TCT of the brine was higher than the temperature of the tubing. TCT is the temperature at which salt begins to precipitate, causing the brine solution to solidify. The first top-kill attempt was therefore unsuccessful because the tubing became plugged, preventing the kill fluid from being pumped down the tubing (Figure 162).

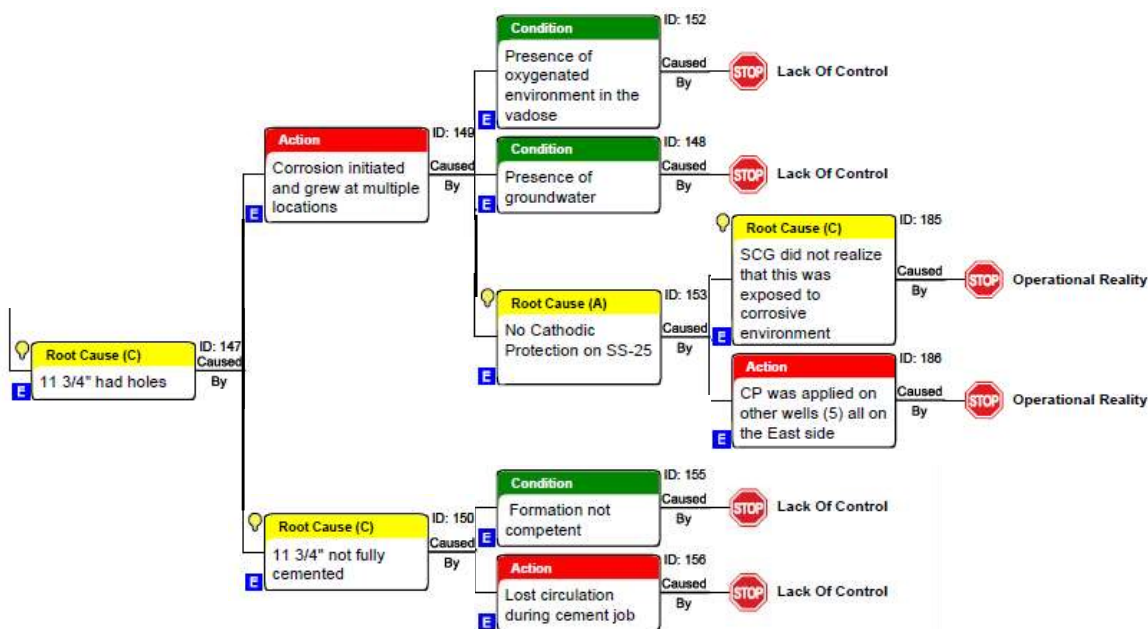
Figure 163: Causes—Holes in 11 3/4 in. Surface Casing

During the Phase 3 evaluation of the condition of the 11 3/4 in. surface casing, holes in the casing were found between 134 and 300 ft. These holes were caused by the escaping gas pressure following external corrosion because the casing was neither fully cemented nor cathodically protected leaving the casing exposed to an environment conducive to corrosion (Figure 163). This environment consisted of the undersaturated vadose zone containing air and some water, from surface to 300–400 ft, and then groundwater in the deeper formations.

Lost circulation occurred at 169 ft when the 11 3/4 in. hole section was originally drilled in 1953. This was because the strength of the formations being drilled is low, as is frequently the case in the first several hundred feet in a well. The hydrostatic pressure of the drilling fluid being used exceeded the formation strength, causing lost circulation. Lost circulation also occurred when the 11 3/4 in. was run and was being cemented so that cement was not circulated to surface. Cement was pumped from the surface, and it was assumed that the annulus around the casing had been filled with cement. However, when cement integrity logs were run in the 11 3/4 in. during the Phase 3 operations, fair cement was only found outside the casing from 606 to 660 ft and from 950 to 985 ft, leaving the majority of the casing exposed (Figure 163). Surface casing cathodic protection had been applied to five other wells at Aliso Canyon, but not to SS-25.

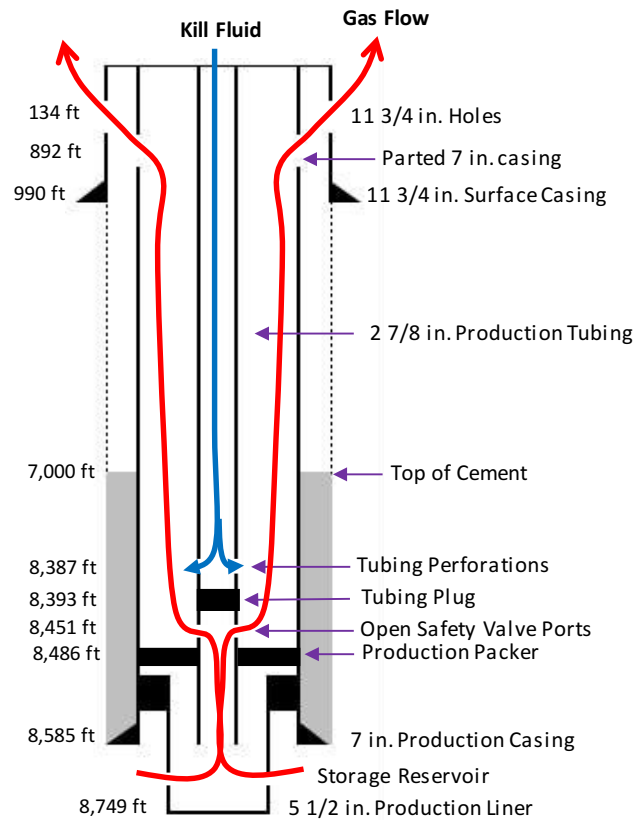
Figure 164: Top-Kill Well Configuration

To kill the well, a column of kill fluid with a hydrostatic pressure higher than the reservoir pressure had to be established in the annulus to stop the gas from flowing; then any gas remaining in the well needed to be displaced out of the well. The height of the column of kill fluid needed would depend on its density. A longer column with a lower density fluid or a shorter column with a higher density fluid would be needed. Kill fluid needed to be pumped down the tubing, out the holes at 8,397 ft, and into the casing where the gas was flowing up the casing. The flowing gas would tend to either blow the kill fluid back up out of the well or dilute it, thereby reducing the fluid density. The right combination of kill fluid density and pump rate and volume would therefore be needed to overcome the effects of the gas flow. Figure 164 shows the well configuration during the top kill attempts.

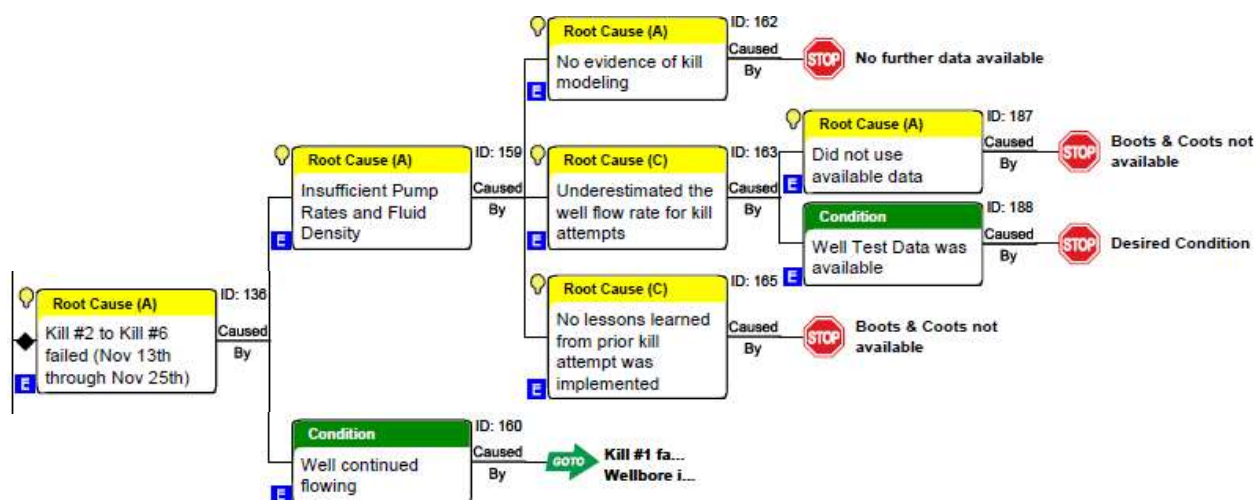
Figure 165: Causes—Unsuccessful Kill Attempts #2 Through #6

Kill attempts #2 through #6 occurred from November 13 through November 25 and were unsuccessful fundamentally because the pump rates and fluid densities used were insufficient to stop the well from flowing (Figure 165). Various combinations of kill fluid densities and volumes were pumped at various rates without success. Gas, oil, and kill fluid were observed flowing to surface through fissures in the ground, and a large crater began to form around the well. Each kill attempt was a variation of the previous one. It appears that lessons from previously unsuccessful attempts were not applied to refine the future attempts. Gas flow rate leaking from the well appeared to be underestimated, based on later kill modeling. There is no evidence that any kill modeling was done to predict the optimum kill fluid density, volume, and pump rates to design kill operations. Models are estimates and have errors,

depending on how much actual data is available and what assumptions need to be made. However, modeling a well kill is the only way to get a reasonable idea of what would be required to kill the well given the complexity of the fluid and gas flow paths, the high gas flow rate, and the shallow leak depth.

The flow rate data is critical to designing a well kill. For example, during kill attempt #2, the Blade estimated flow rate was 83 MMscf/D. The 9.4 ppg kill density fluid could not kill this well; however, 12 ppg at a flow rate of 9 to 10 bbl/min would have gotten the well under control. There is no documentation to indicate that any modeling or analyses were ever performed for kill attempts #2–6. The decisions appeared to be based on the static reservoir pressure and this would be inadequate and inappropriate for designing kills [3]. SoCalGas-provided information suggested that the well-control company was using 30 MMscf/D as the well flow rate [40]. It is unclear whether this information was ever used in any modeling. Flow rate and kill fluid density have to be designed by using established industry modeling tools before preparing an operational plan to ensure the well is killed.

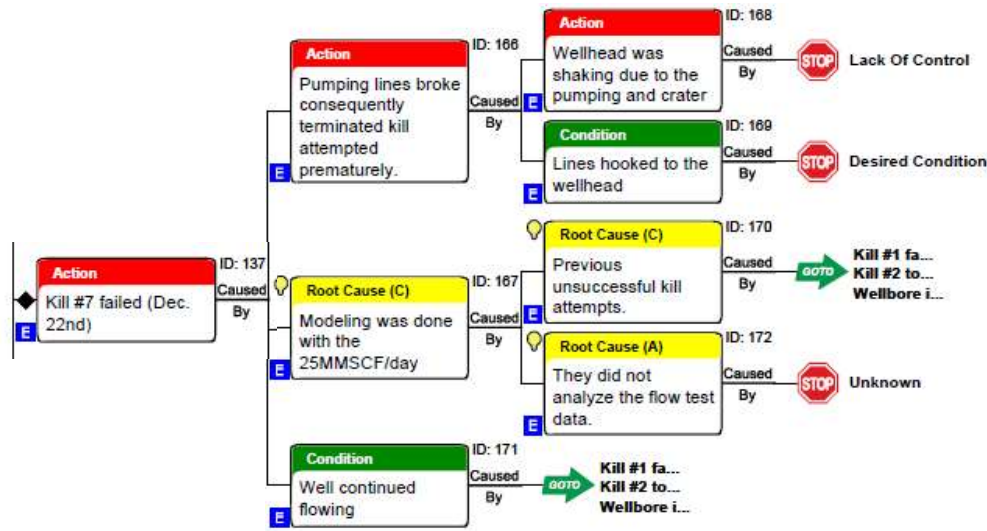
Figure 166: Causes—Unsuccessful Kill Attempt #7

There is data indicating that the design of kill attempt #7 was modeled ahead of time. The well-control company appeared to assume a gas flow rate of around 25–30 MMscf/D, whereas Blade-estimated flow rate was 60 MMscf/D. However, the annulus pressure dropped to 0 psi for a time indicating that the well had likely been killed, but pumping had to be stopped because of severe vibrations of the wellhead. The wellhead movement caused pumping lines to break off, and operations were stopped to prevent damage to the wellhead itself (Figure 166). The inability to continuously fill the well allowed the production zone to resume flowing. No further attempts were made to top kill the well.

The underestimation of the gas flow rate was a deficiency in planning the kill attempts. Flow rate modeling by Add Energy in February 2016 and later by Blade, using the data that were available at the time of the incident, has estimated the gas flow rate to be 80 and 93 MMscf/D, respectively. Records show that the flow rate used for modeling kill attempt #7 was 25 MMscf/D. However, Blade’s estimate for kill attempt #7 was a gas flow rate of 60 MMscf/D.

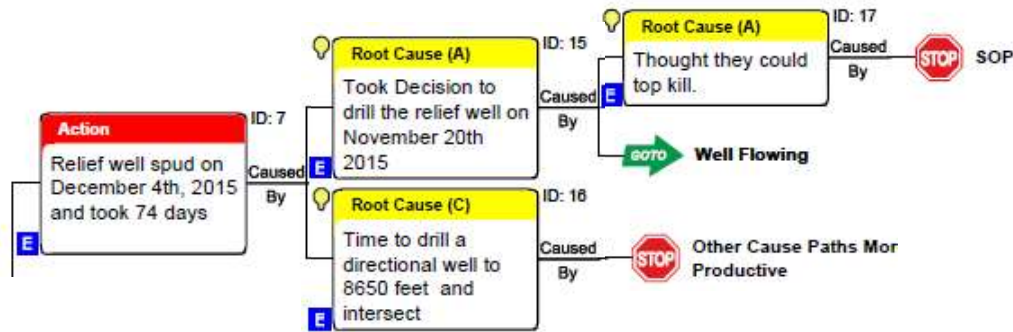
Figure 167: Causes—Relief Well Drilling

The decision to start drilling the relief well was made on November 20, 2015, after four unsuccessful top-kill attempts (Figure 167). The objective of the relief well was to drill down and intersect (i.e., drill into) the SS-25 well at 8,534 ft just below the packer and the top of the 5 1/2 in liner. This would allow kill fluid to be pumped down the P-39A well and into SS-25 near the bottom of the wellbore. The drilling of the P-39A relief well began on December 4, 2015. It took 69 days (74 days including rig up time) to drill down and intersect SS-25. The gas flow was stopped on February 11, 2016, and the well was declared secure on February 18, 2016.

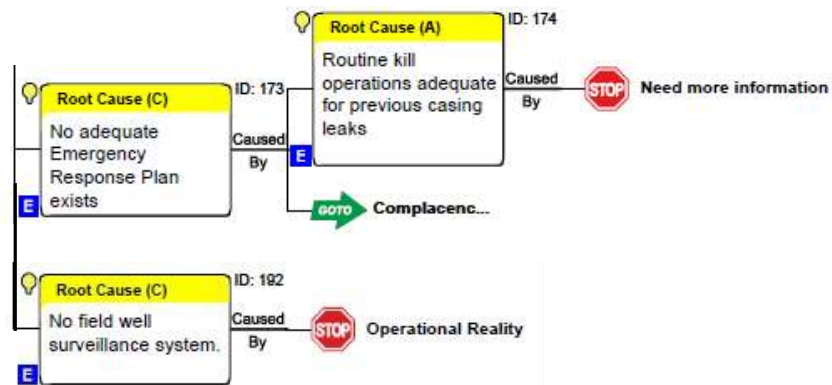
Figure 168: Causes—Emergency Response Plan and Field Surveillance

This suggests that the emergency response plan for this kind of incident was inadequate, and that it was assumed that the routine kill operations were adequate for any scenario (Figure 168). The tubing and casing pressures were measured manually on a weekly basis for all the Aliso Canyon wells. If these pressures had been monitored in real-time with a field surveillance system, then the initial leak in SS-25 would have been detected immediately and injection stopped. This could have prevented the brittle circumferential parting from occurring.

The lack of real-time pressure measurements prevented the immediate identification of the 7 in. casing failure. The constant monitoring of the tubing, production casing and surface casing pressures will provide better insight into operational deviations in all wells. If this type of system had been installed on SS-25, it would have provided insight into the time of the leak, the opportunity to shut in the well immediately, size of the leak, and the extent of the problem. Furthermore, the information could have used during well-control effort improving the chances of an early success.
