**Blade Supplemental Report (Vol. 2: SS-25 Well Failure Causes)**

# Root Cause Analysis of the Uncontrolled Hydrocarbon Release from Aliso Canyon SS-25

May 31, 2019

# SS-25 Casing Failure Analysis

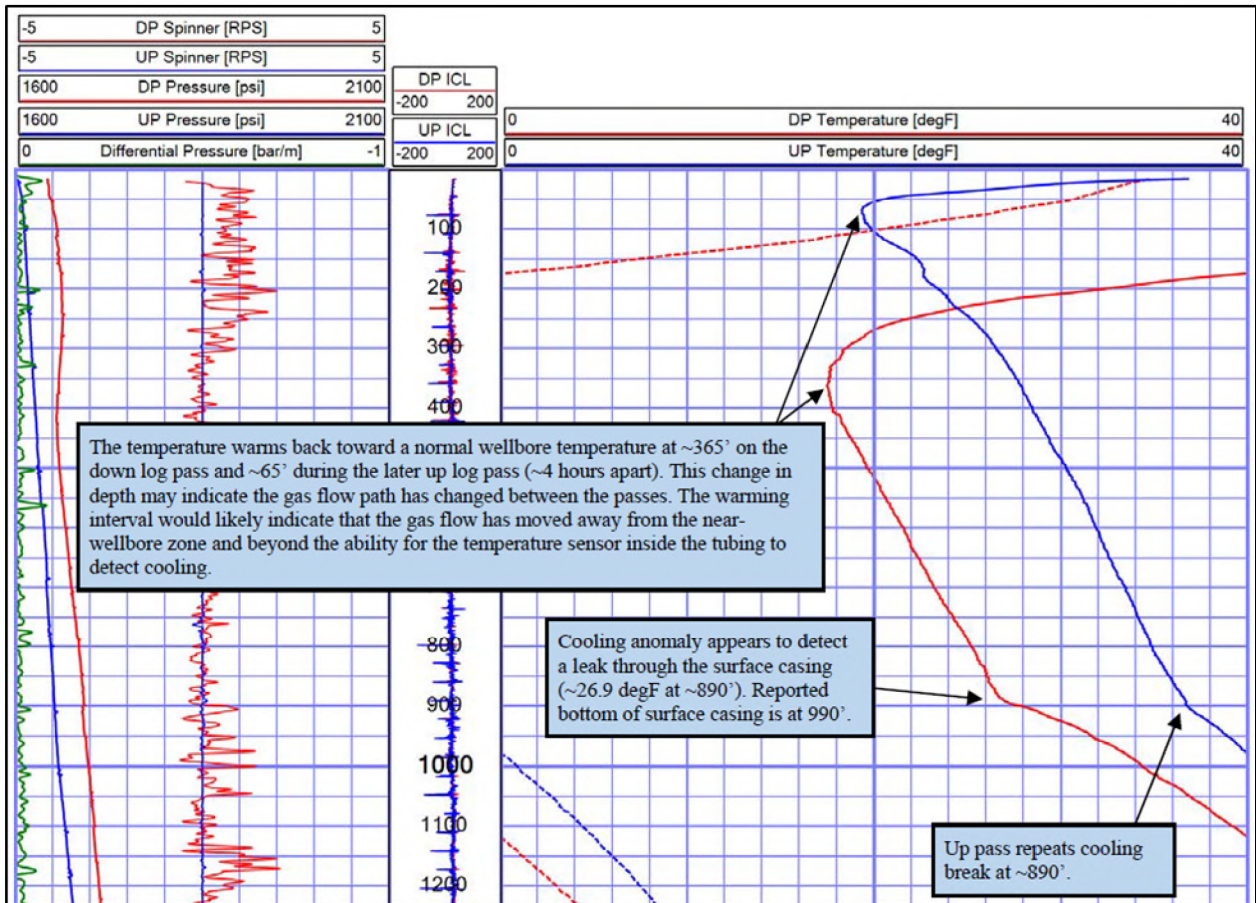
Figure 6: November 08, 2015, Temperature Survey (During Blowout)

The November 08, 2015, log was the first available data set with some indication of a leak location. The 26.9°F temperature reported by the production logs represents an upper bound to the temperature at that location. The temperature was recorded at the ID of the tubing. This suggests that the temperature of the casing at the leak location was colder than the recorded temperature of 26.9°F.

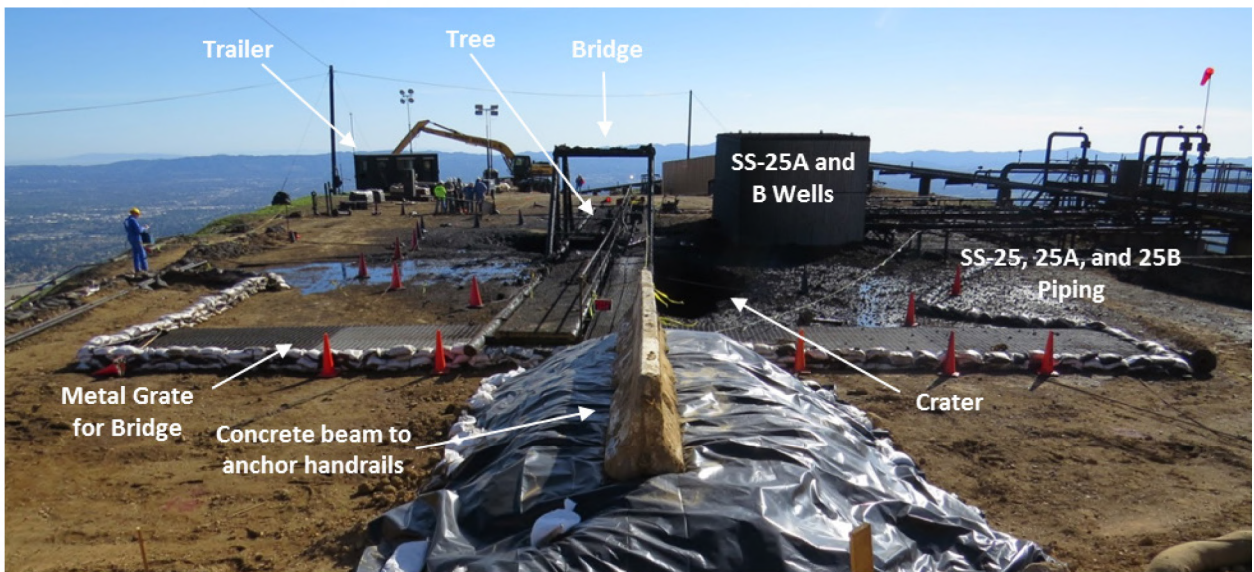
Figure 9: SS-25 Site Condition on February 25, 2016

Phase 1 was the first opportunity for the Blade team to observe and document the SS-25 site. Figure 9 shows one of the first images taken after the site was opened to the team. The image shows the SS-25 tree, crater, bridge spanning the crater, SS-25A and B heat shields, and piping for SS-25, SS-25A, and SS-25B. The majority of the non-permanent items in the image were removed throughout Phase 1 or during Phase 2, and they included the trailer, bridge, heat shields, sand bags, cones, and concrete beam.

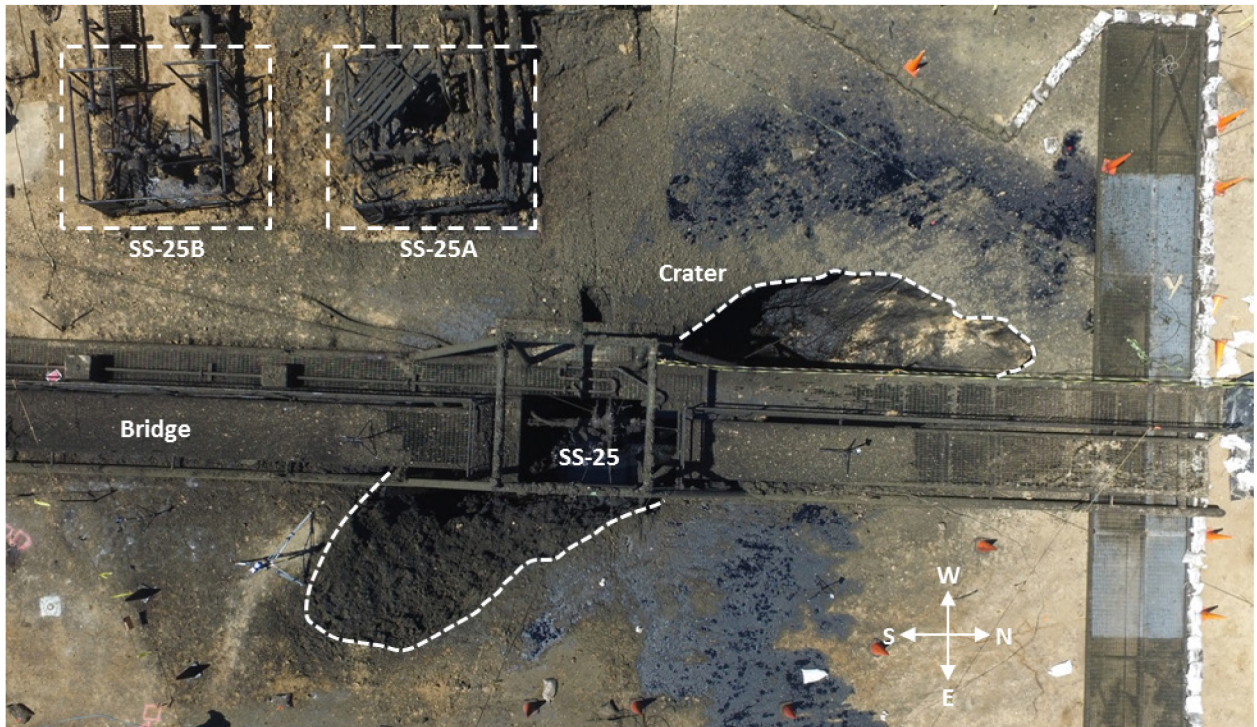
Figure 10: SS-25 Site Top Aerial View Post-Blowout on April 01, 2016

Formation of the crater occurred during the blowout events described in Section 2.1.3. Figure 10 and Figure 11 show aerial photographs of the crater looking down and west, respectively. The images also show the SS-25A and 25B wellheads after removal of the heat shields. The bridge and concrete beam were installed during the kill operations to provide access to the wellhead; it also provided a platform for personnel to connect lines and operate valves. The concrete beam was used to anchor a steel cable handrail.

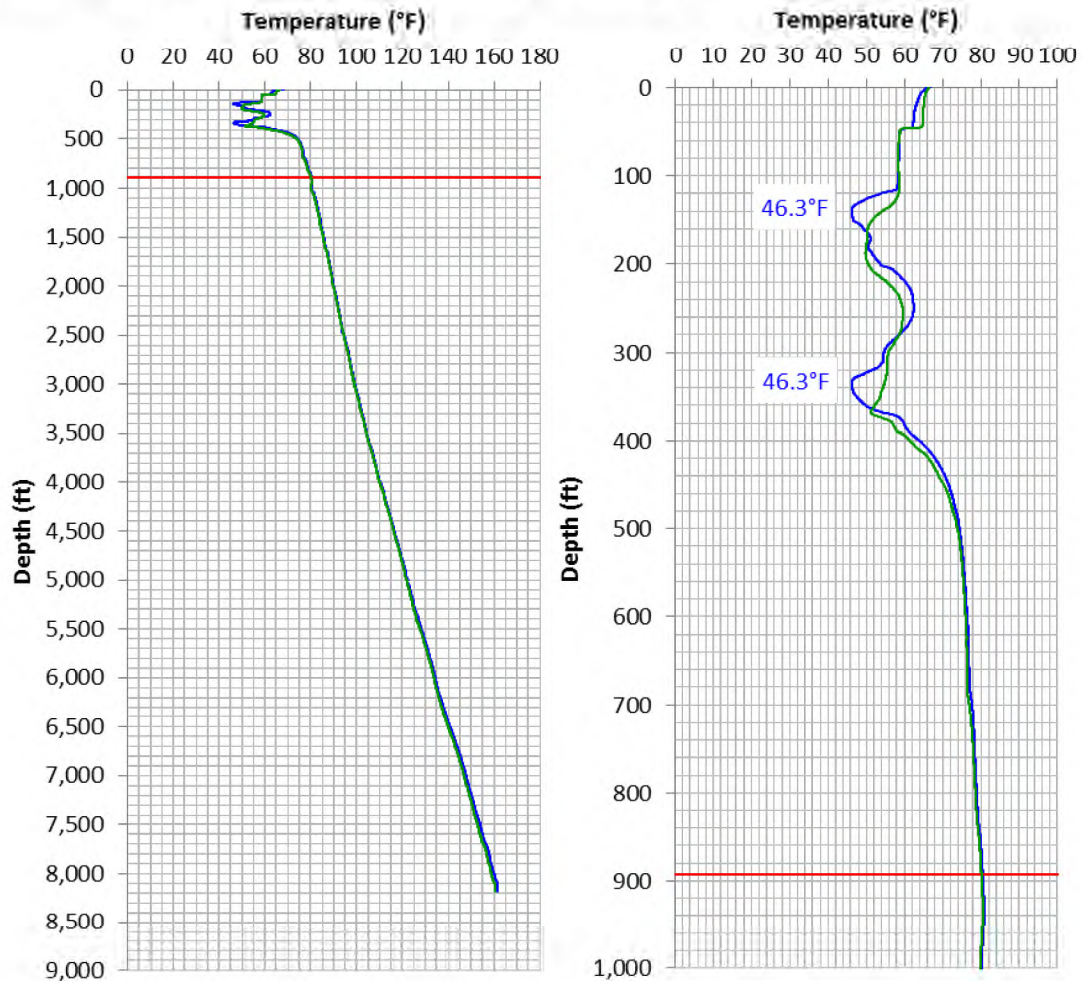
Figure 13: Versa-Line HPT Log Data

The third run was used to collect an accurate temperature profile of the SS-25 well. The temperature profile collected with the Versa-Line HPT was used to accurately profile the cold zone identified during the blowout (Figure 6) and compare with previous temperature logs. Figure 13 shows the temperature profiles for the up and down passes of the HPT log. The profiles show that the 26.9°F temperature recorded by the November 08, 2015, temperature log at the suspected leak location (approximate depth of 890 ft) had warmed to the geothermal gradient. The coldest location recorded by the November 08, 2015, temperature log was 18°F at an approximate depth of 365 ft. That location had an HPT-recorded temperature of 46.3°F, which was colder than the geothermal gradient at that location.

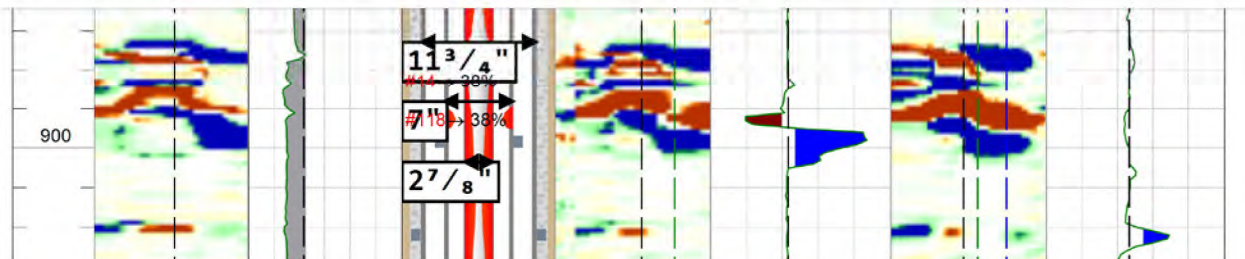
The MID tools detected metal loss at several locations along the length of the 7 in. casing. The most notable location was at 895 ft—Figure 14 shows the MID logs results at this depth; the three color maps represent the near delta (left), medium delta (middle), and far delta (right) responses and correspond to the tubing, 7 in. casing, and 11 3/4 in. casing, respectively. Figure 14 also shows a 38% metal-loss feature on the 7 in. casing. The significant metal-loss feature corresponded with the assumed leak based on the temperature profile from the production log run on November 08, 2015. The log suggested that the 7 in. casing had significant metal loss at that depth. This was the first indication of a significant feature at this location. These data were used to guide future extraction operations.

**Figure 14: MID Results Showing 38% Metal Loss at Approximately 895 ft**

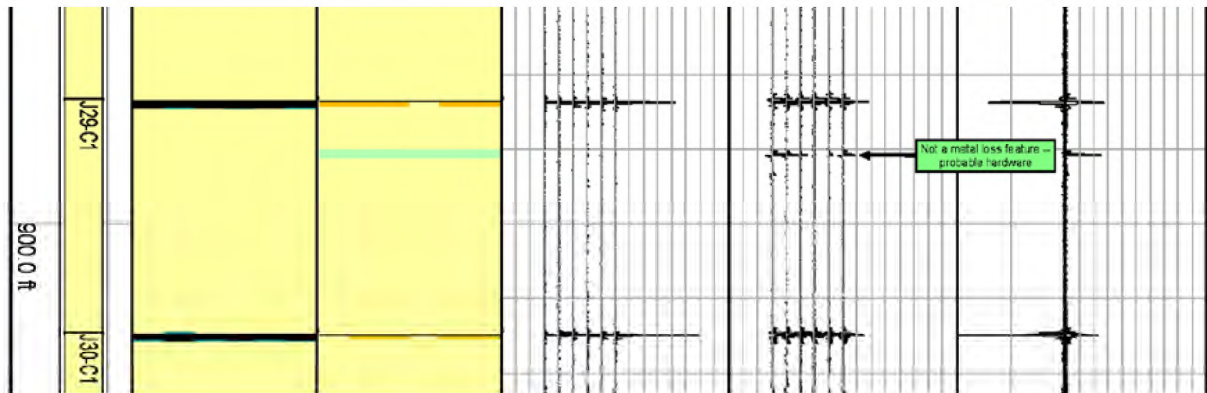
The seventh log was the MicroVertilog (MVRT). An MVRT detects flaws in tubing by observing the flux leakage induced by a permanent magnet as the tool is pulled through the tubing string of interest. The MVRT did not identify any features on the 2 7/8 in. tubing. However, the tool did identify a metal gain at an approximate depth of 890 ft. Figure 15 shows the metal-gain feature on the MVRT log at 890 ft. The MVRT is a single barrier tool, meaning that it cannot detect beyond the string it is run in. However, metal gain can be detected if the barrier that the MVRT is run in is in contact with another barrier. The metal gain detected at 890 ft was interpreted as the 7 in. casing was making contact with the outside diameter (OD) of the 2 7/8 in. tubing. These data contributed to the theory that the 7 in. was parted at this depth and was in contact with the tubing.

**Figure 15: Microvertilog Results at 890 ft**

The tubing logs were critical to the metallurgical investigation—they influenced the decisions during the extraction operations. The HPT, MID, and MVRT logs all had an indication at an approximate depth of 890 ft. The MID and MVRT suggested that the 7 in. behind the tubing might have been parted. These assumptions were used during the planning stages of Phase 3 to minimize the risk of damaging the 7 in. casing at 890 ft when pulling the tubing.

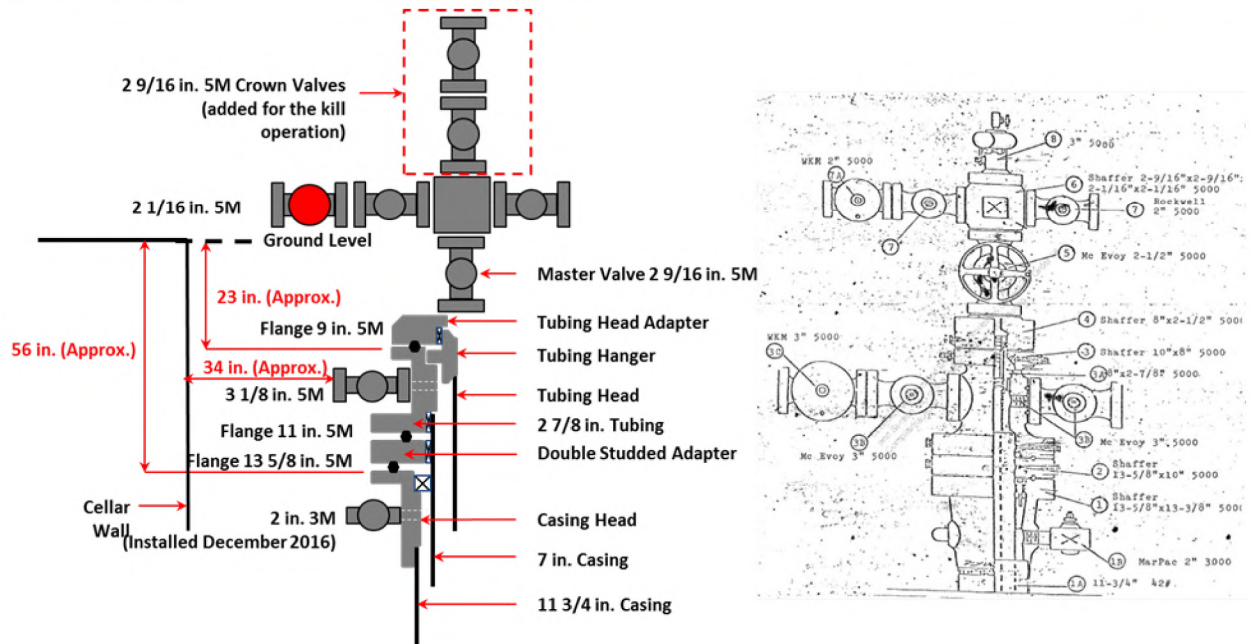
Figure 16: Wellhead Schematic

Figure 16 shows a schematic of the wellhead in the as-found condition. Some components were installed during the kill operations and have been identified in the schematic. The wellhead shifted during Kill Attempt #7 due to the instability caused by the growth of the crater. Wellhead stability was restored using tension cables for support. Figure 17 shows images of the SS-25 wellhead in 2015, and Figure 18 shows images just after the well was killed in 2016. The 2015 images were extracted from a data request provided by SoCalGas. The images were taken in 2015 as part of a survey to evaluate 3D laser technology for Aliso Canyon, and SS-25 was one of the well sites chosen to evaluate the technology. Several viewpoints were selected around the SS-25 site for taking images. Many of them were taken at each location and combined to form a single 360° view from the selected viewpoints. The images in Figure 17 were extracted from two different viewpoints.

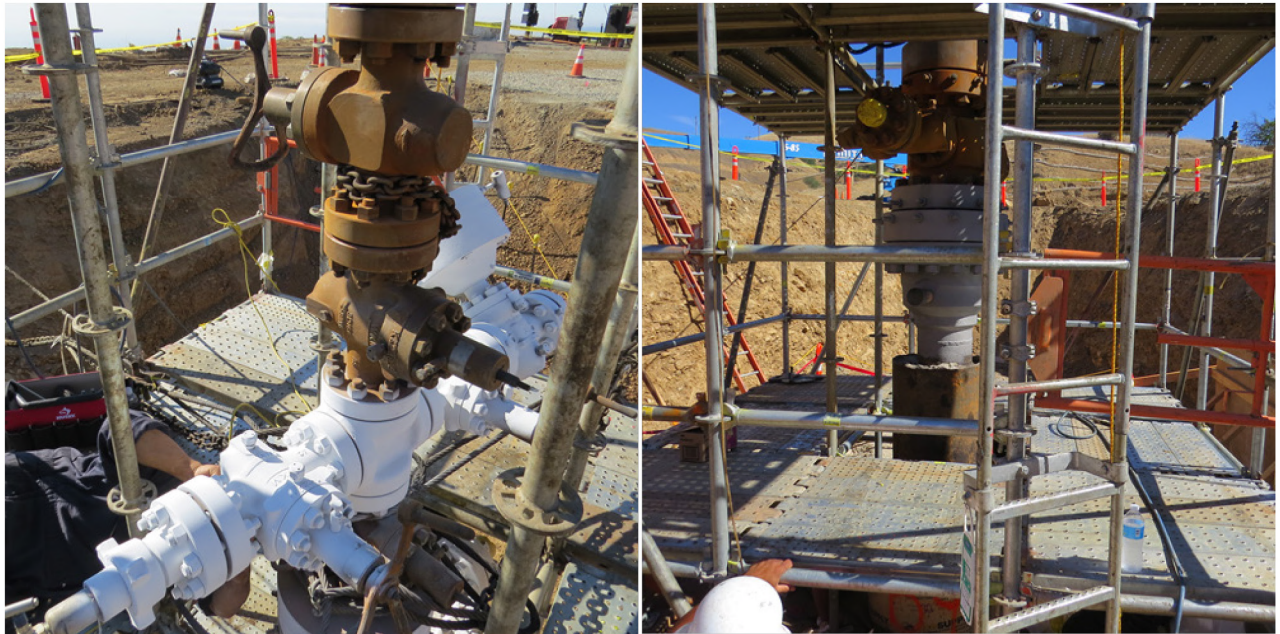
Figure 20: Wellhead Magnetic Particle Inspection

The NDE work began once a satisfactory surface condition was achieved. The goal of the examination was to identify any indications and determine if they were associated with the blowout. Figure 20 shows the condition of the wellhead during the NDE work—the white contrast paint is used for magnetic particle inspection (MPI). The two valves above the flow cross (no contrast paint) were not part of the SS-25 original tree and were not inspected. No indications associated with the blowout were found during the examination.

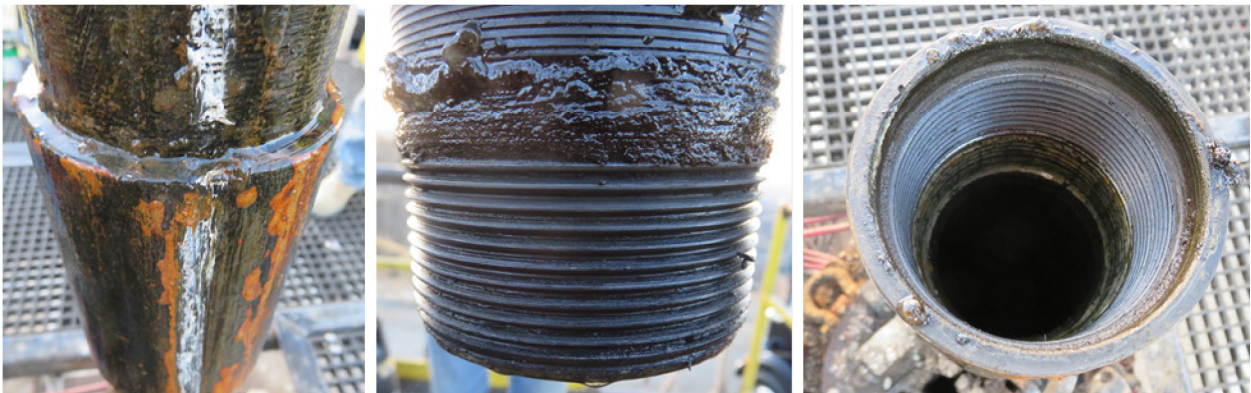
**Figure 23: T155–T156 Connection Before and After Breakout**

The rig floor was the only location where the made-up connections could be inspected. Each connection was inspected before and after breakout. Figure 23 shows the connection between T155 and T156 before and after breakout. The white line in Figure 23 is the orientation mark applied to the joints on the rig

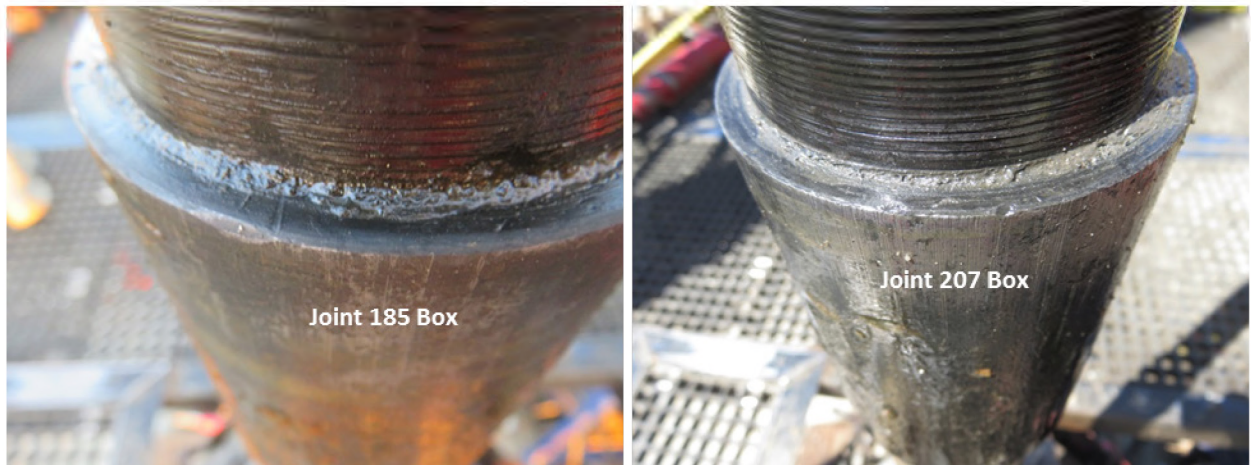
**Figure 25: Minor Mechanical Damage on Box of Joints 185 and 207**

significant features were identified on the rig floor. Most of the observations were of minor mechanical damage to the box. This type of feature was attributed to damage that occurred while running or pulling the tubing. Figure 25 shows examples of the damage noted on the rig floor. Several joints were identified as bent, including joints 40, 80, 112, 116, 147, 158, and 160.

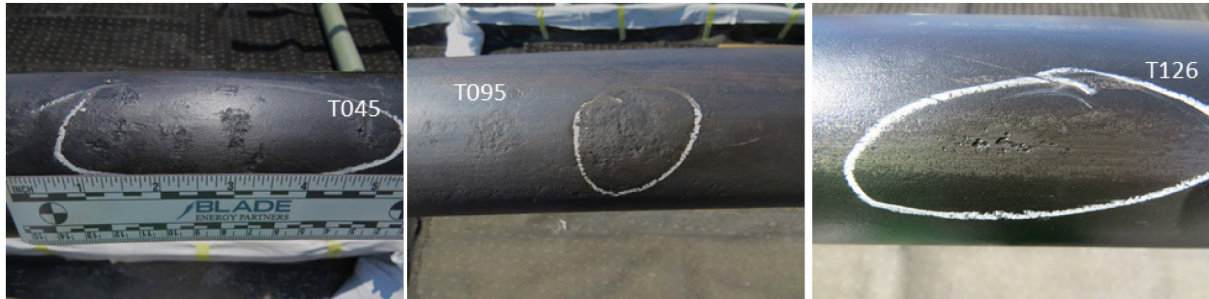
Figure 32: Examples of Minor Metal Loss

Notes were taken and documented on evidence data sheets [14]. The inspection at the PS-20 site identified minor metal loss, bent joints, and minor mechanical damage. The majority of the mechanical damage appeared to be caused by tongs, slips, and other minor damage associated with running the pipe. Significant features were not identified during the tubing inspections. The box and pin were also inspected for damage. Some minor metal loss was observed on the box, and galling was identified in some of the threads. Stamps from the manufacturer were observed on many of the joints, indicating the environment was not aggressive enough to remove the marks. Figure 32 and Figure 33 shows examples of minor metal loss and mechanical damage, respectively. Figure 34 shows examples of manufacturer stamps still visible on the OD surface.

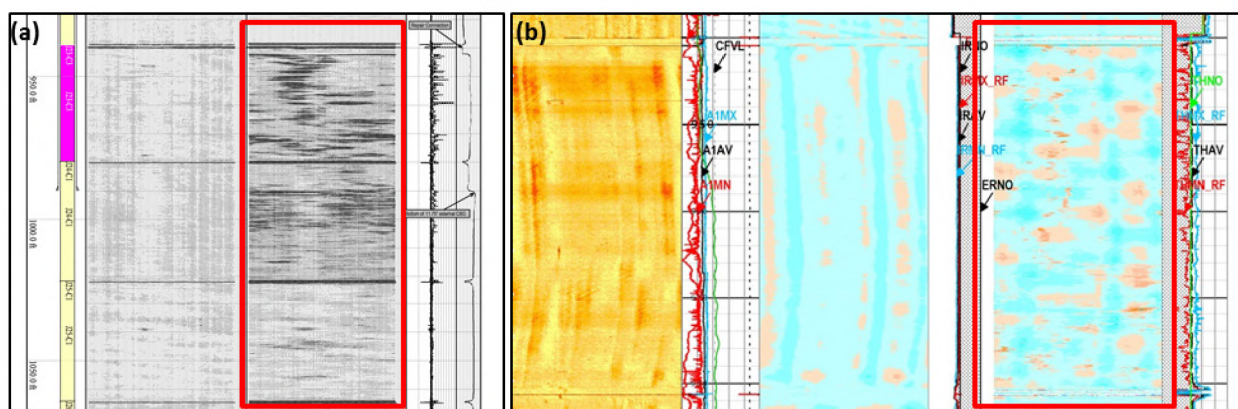
Figure 40: (a) HRVRT and (b) UCI Results Between 939 ft and 1,000 ft Showing External Corrosion

The UCI tool is designed to identify, locate, and quantify casing corrosion. It can identify holes, weight changes, internal and external scale buildup, external metal loss, and damage caused by milling, fishing, or plastic deformation. The UCI tool has a rotating ultrasonic transducer that analyzes signal reflections to provide casing thickness, surface condition images, and small defects on both internal and external casing surfaces. The results were consistent with the HRVRT findings for both the internal and external surfaces. Figure 40 shows a comparison of the HRVRT and UCI results for the OD surface between 939 ft and 1,000 ft. The joints at these depths were eventually extracted, and the OD corrosion was confirmed.

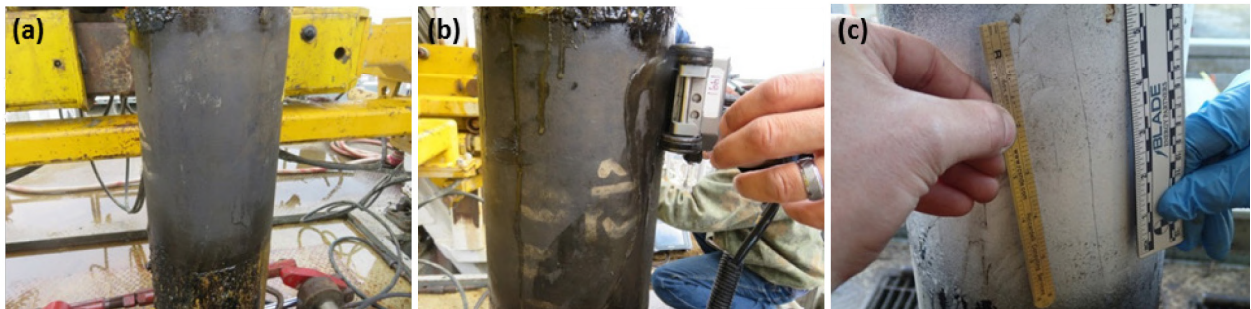
Figure 45: (a) Cleaned Pipe Section for NDE, (b) Ultrasonic Transducer, and (c) MPI Linear Indication

Figure 45 shows the (a) cleaned target cut location and the (b) ultrasonic transducer. Figure 45 (c) shows an example of a linear indication identified by MPI. NDE was performed prior to cutting to ensure the cut did not damage any casing features. Cut locations were moved for C012, C014, C016, C017, and C018 due to the linear indications identified by NDE on the rig floor. The MPI evidence data sheets [16] provide details of the linear indications identified during the rig floor inspection.

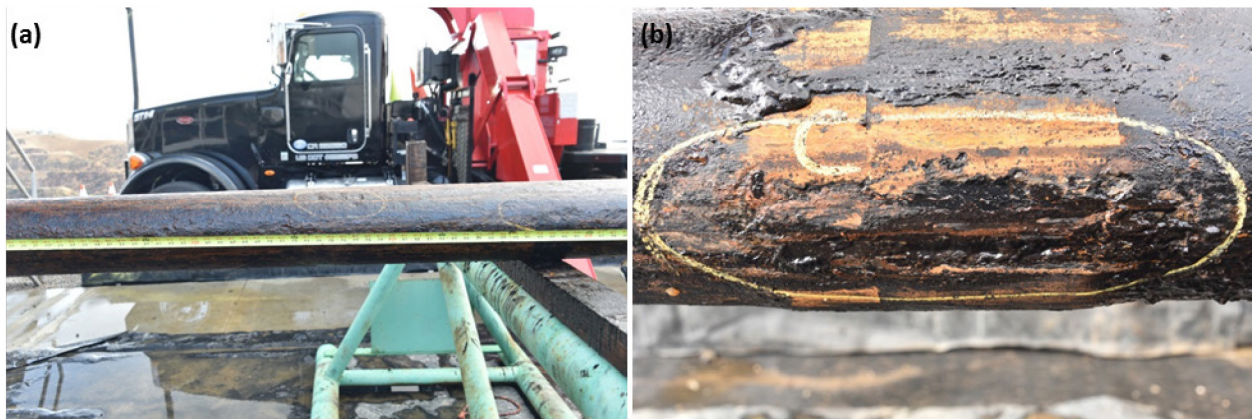
Figure 48: Corrosion Features on C018 (a) Pipe Body and (b) Connection

The casing was inspected in the as-recovered condition on the SS-25 site pipe racks. Samples were taken using the same procedures used for the tubing. (Appendix B contains a list of the samples collected from the 7 in. casing.) C001 through C017 were covered with a tar-like deposit that obscured the OD surface and prevented a detailed inspection; however, minor mechanical damage from extraction, slips, and tongs were noted. Corrosion features were first identified on C018. Figure 48 shows examples of corrosion features identified on the (a) body and (b) connection of C018. Corrosion features were also identified on the remaining joints (C019–C026).

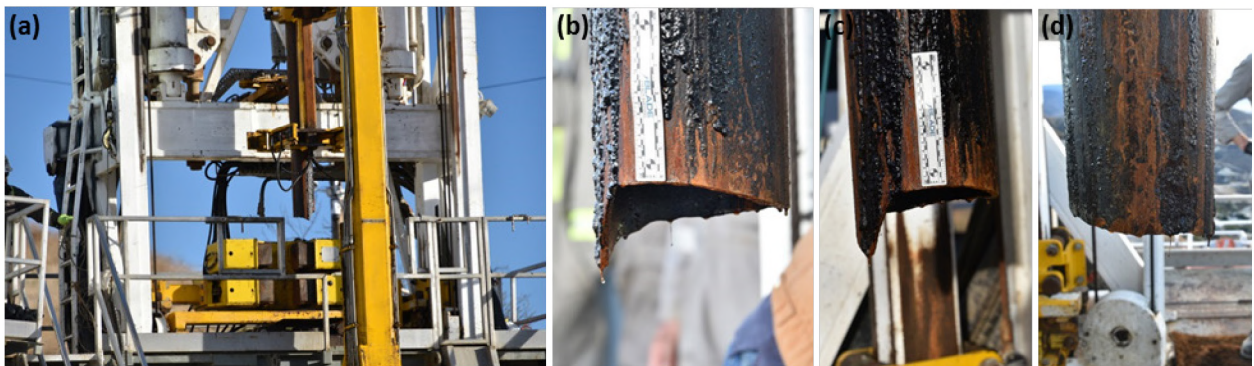
Figure 49: C022 Extraction

C022 was extracted on November 07, 2018, and contained the circumferential parting identified during logging and visually confirmed with the downhole camera. Figure 49 (a) shows the parted casing hanging above the rig floor. Figure 49 (b) through (d) shows the fracture surface above the rig floor. The fracture surface was thoroughly examined on the rig floor and then moved to the pipe rack for further inspection.

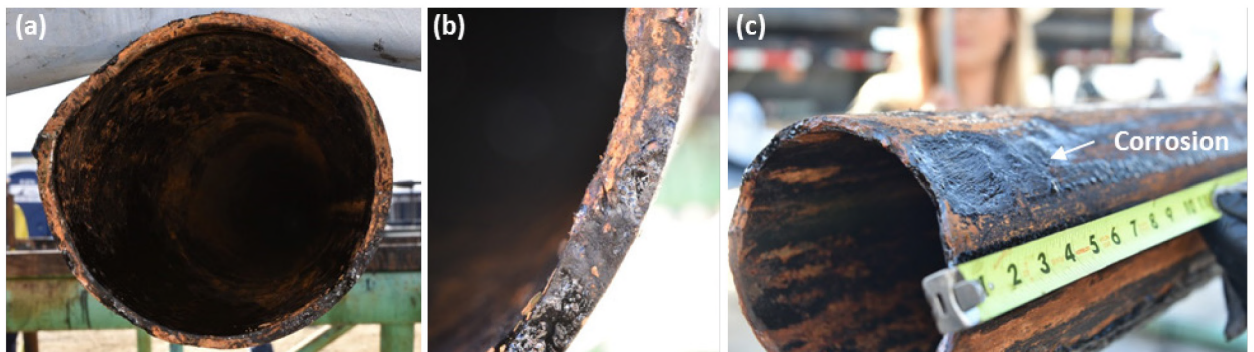
Figure 50: Parted Casing (C022) on the SS-25 Pipe Rack

Figure 50 shows the parted casing on the pipe rack. The fracture surface was obscured because it was covered with oil and scale. The circumferential parting appeared to be mostly flat with a pointed section that faced the south side of the rig floor. Figure 50 shows an (a) overall and (b) close-up image of the fracture surface. Corrosion features adjacent to the fracture were identified (Figure 50 [c]).

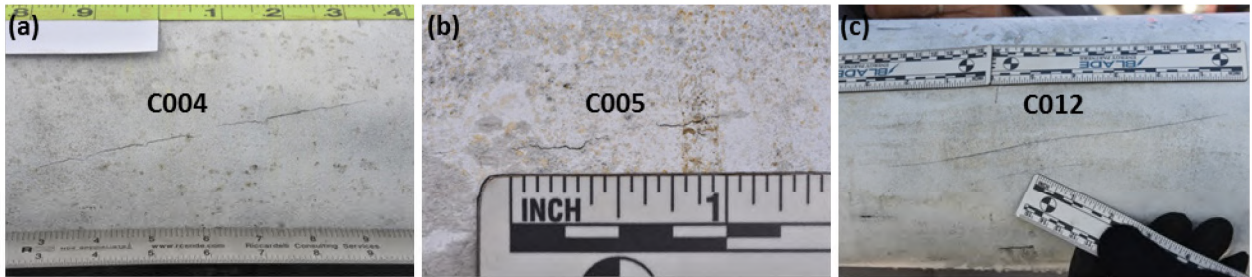
Figure 52: (a) C004, (b) C005, and (c) C012 Linear Indication Identified by MPI

Casing from the upper fish (C001–C022) was examined first. Corrosion features were not noted on C001 through C013; however, minor mechanical damage and linear indications were identified. Linear indications were found on C004, C005, C009, C011, C012, and C013. Figure 52 shows linear indications from (a) C004, (b) C005, and (c) C012. The linear indications were slightly angled with respect to the pipe longitudinal axis.

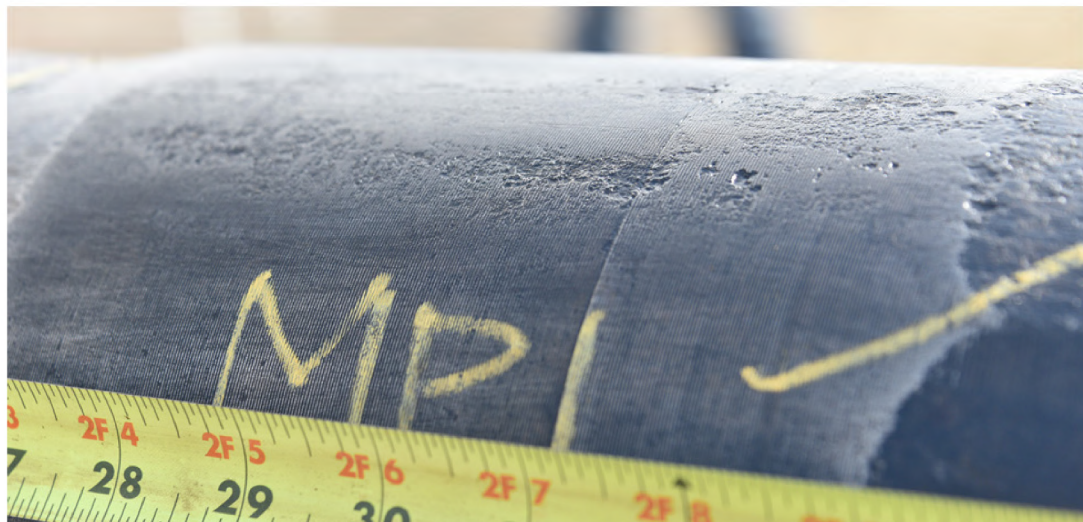
Figure 53: Shallow Metal Loss on Connection C014

Shallow metal loss was first identified on the C014 connection and was present on the remainder of the extracted casing pipe bodies and connections. Corrosion was identified on many of the connections below C014 with increasing severity. Figure 53 shows the shallow corrosion on the C014 connection. Figure 54 shows corrosion on the connections for (a) C019 and (b) C020; the corrosion is similar to C014’s but more severe.

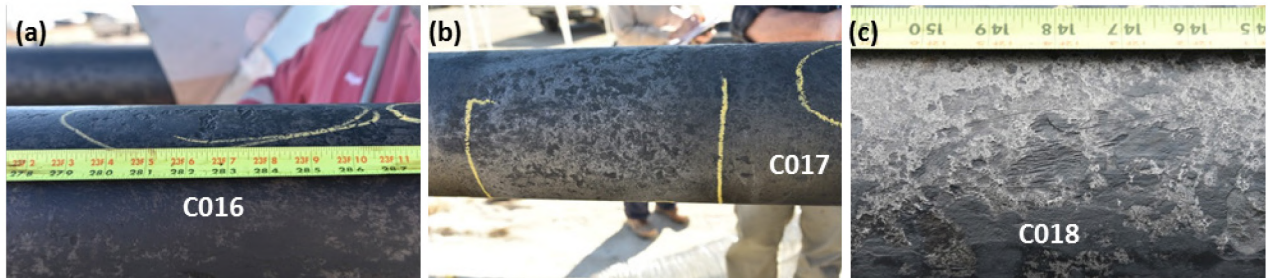
Figure 55: Pipe Body Corrosion on (a) C016, (b) C017, and (c) C018

Corrosion was also identified on the pipe bodies beginning with C014. Figure 55 shows examples of pipe body corrosion from (a) C016, (b) C017, and (c) C018. Figure 55 (c) shows corrosion with striated grooves slightly angled from the longitudinal axis of the pipe. This type of feature was identified at many locations along the casing below C014. Figure 56 shows examples of corrosion with striated grooves from (a) C018

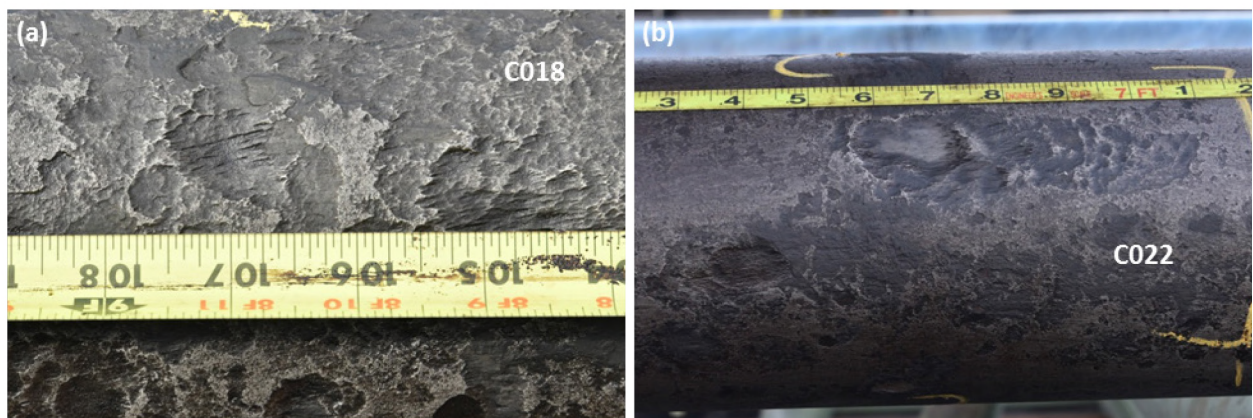
Figure 56: Examples of Corrosion with Striated Grooves from (a) C018 and (b) C022

and (b) C022. Figure 57 shows the largest corrosion feature identified during the PS-20 inspection. The shape and morphology appear to be consistent with the features found on the connections (Figure 54).

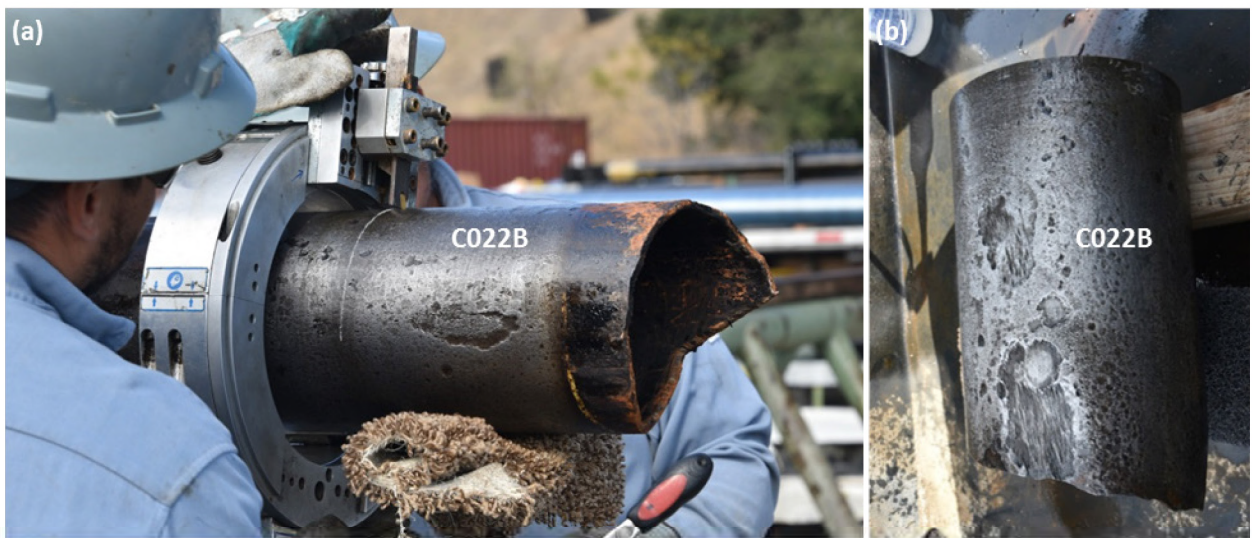
Figure 59: Fracture Surface During (a) Extraction from C022 and After (b) Cleaning with Sentinel 909

The fracture surface was removed from C022 prior to cleaning and inspection. A cut location approximately 1 ft from the fracture surface was selected, cleaned, and inspected with MPI and UT. An additional cut was made on C022 to remove the connection. Figure 58 shows a diagram of the C022's cut locations. The diagram shows that the section containing the fracture surface was designated C022B after the cuts were executed. Cuts were made with the Cameron casing cold cutter the same way it had been done on the rig floor. Figure 59 (a) shows the Cameron casing cold cutter installed on C022. Figure 59 (b) shows the fracture surface cleaned with Sentinel 909. Corrosion features adjacent to the fracture surface after cleaning were clearly visible. Figure 60 shows the C022B corrosion features adjacent to the fracture surface.

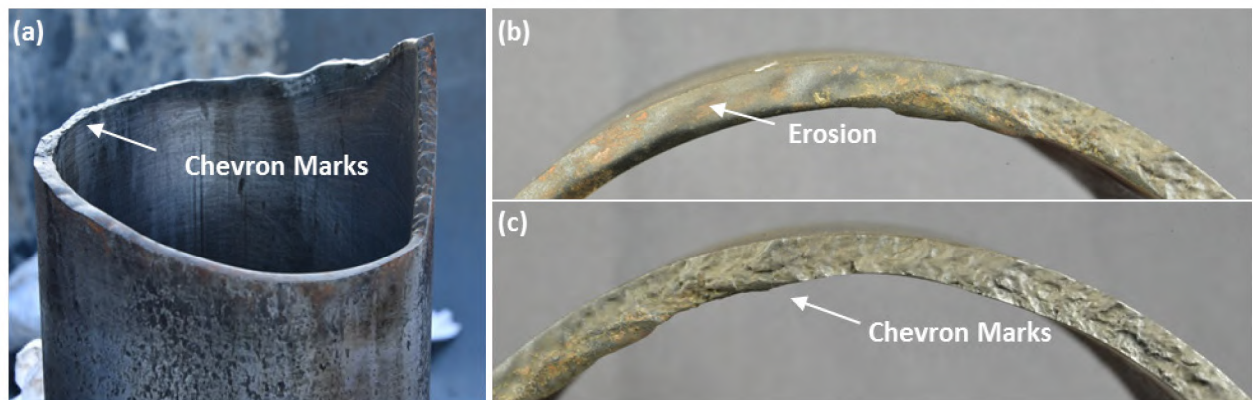
**Figure 61: (a) Circumferential Fracture Surface Showing (b) Erosion and (c) Chevron Marks**

The fracture surface was examined after being cleaned with Sentinel 909. Most of the fracture surface appeared to be eroded; chevron marks were visible in some areas. The eroded fracture surface provided limited information as to the cause of the circumferential parting. Figure 61 (a) shows the circumferential fracture surface after cleaning with Sentinel 909. A field lab was constructed in the trailer at the PS-20 site to provide access to equipment that could assist the field investigation. The field lab included an ultrasonic cleaner, cleaning tools, a stereo microscope, and photography equipment. The fracture surface was cleaned with acetone in a large ultrasonic cleaner. Figure 61 (b) and (c) show close-up images of the fracture surface taken in the field lab after undergoing ultrasonic cleaning. The eroded areas appeared to be smooth and featureless. The chevron marks were visible but also appeared to be eroded.

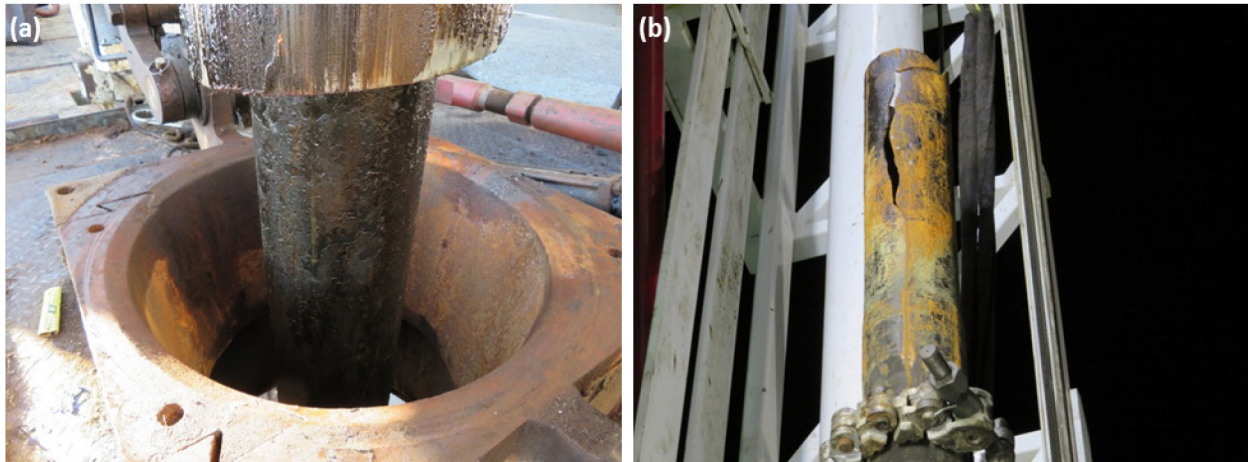
**Figure 62: Lower Fracture Surface (a) In and (b) Out of the Pawl Tool**

C023 was extracted on November 14, 2017, using the pawl tool and a chemical cutter. The casing was cut at approximately 939 ft with the chemical cutter, and the lower fracture surface was extracted. Figure 62 shows the lower fracture surface on the rig floor with the tool (a) over the fish and (b) removed. This was the first opportunity to visually examine the lower fracture surface. The first major observation was the presence of an axial rupture below the circumferential parting. C023 was moved from the rig floor to the pipe racks by using the crane and a nylon sling. The pipe handler was not used in an attempt to prevent damage to the axial rupture and circumferential parting. The fracture surfaces were wrapped with VCI and covered for the night. C024 was extracted on November 15, 2017. A 13 ft section (C023A) of C023 was cut on the SS-25 pipe rack using the Cameron casing cold cutter to remove the axial rupture and circumferential parting. The pipe sections (C023A, C023B, and C024) were transported to the PS-20 site for further inspection. These sections were not subjected to the same protocol at PS-20 as previous

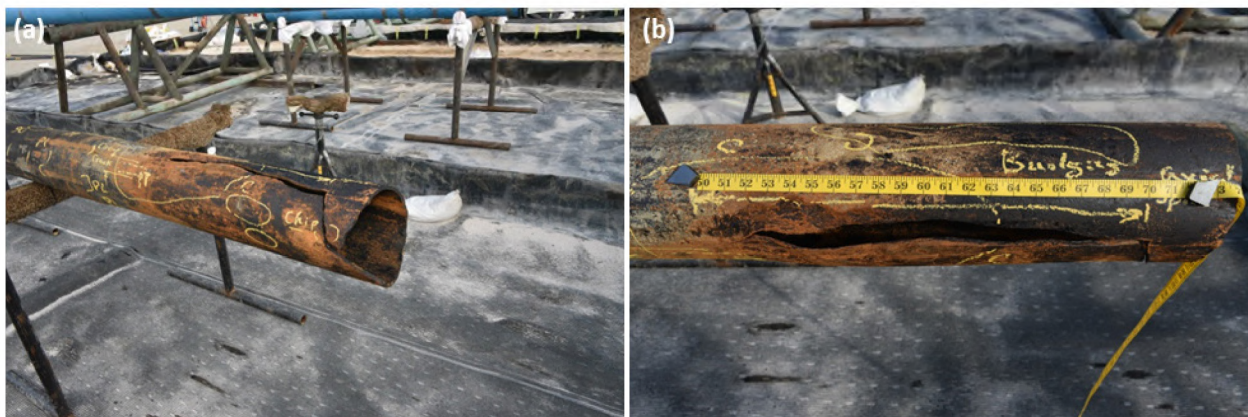
**Figure 63: Axial Rupture and Circumferential Parting at PS-20 (C023A)**

Figure 63 (a) and (b) show the axial rupture and circumferential parting on the PS-20 pipe rack. The axial rupture was located below the circumferential parting and was surrounded by a corrosion feature. Wall thinning was observed near the middle of the axial rupture. Bulging (ductile deformation) was observed adjacent to the axial rupture. The top fracture surface in Figure 63 (b) appeared to be more bulged than the lower fracture surface. The axial rupture had one arrest point away from the circumferential parting, adjacent to the connection. The axial rupture appeared to run towards the connection and eventually turned and arrested. An upper arrest location was not observed. The upper portion of the axial rupture turned similar to the lower arrest point but continued on a path inclined from the pipe axis and was connected to the circumferential parting.

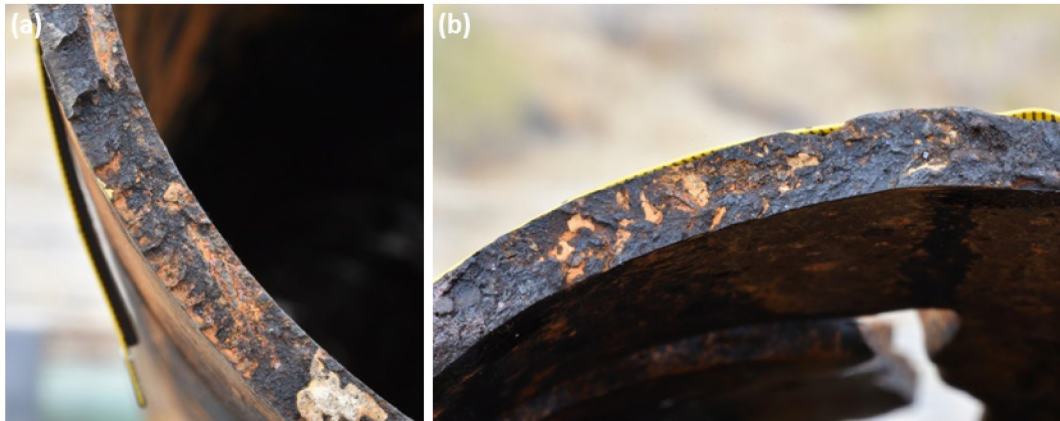
Figure 64: Circumferential Parting Fracture Surface (a) Features and (b) Chevron Marks

The fracture surface was covered with an oil deposit and scale products, but features were identifiable. Figure 64 (a) and (b) show surface features, chevron marks, and other features. C023A was preserved in the as-recovered condition and cut into smaller sections for transportation. A 5.80 ft section (C023A1) containing the axial rupture, circumferential parting, and connection was cut using the Cameron casing cold cutter. Additional cuts were made at the PS-20 site for connection testing and transportation logistics. Figure 65 shows a diagram summarizing the cuts made to C023 and C024.

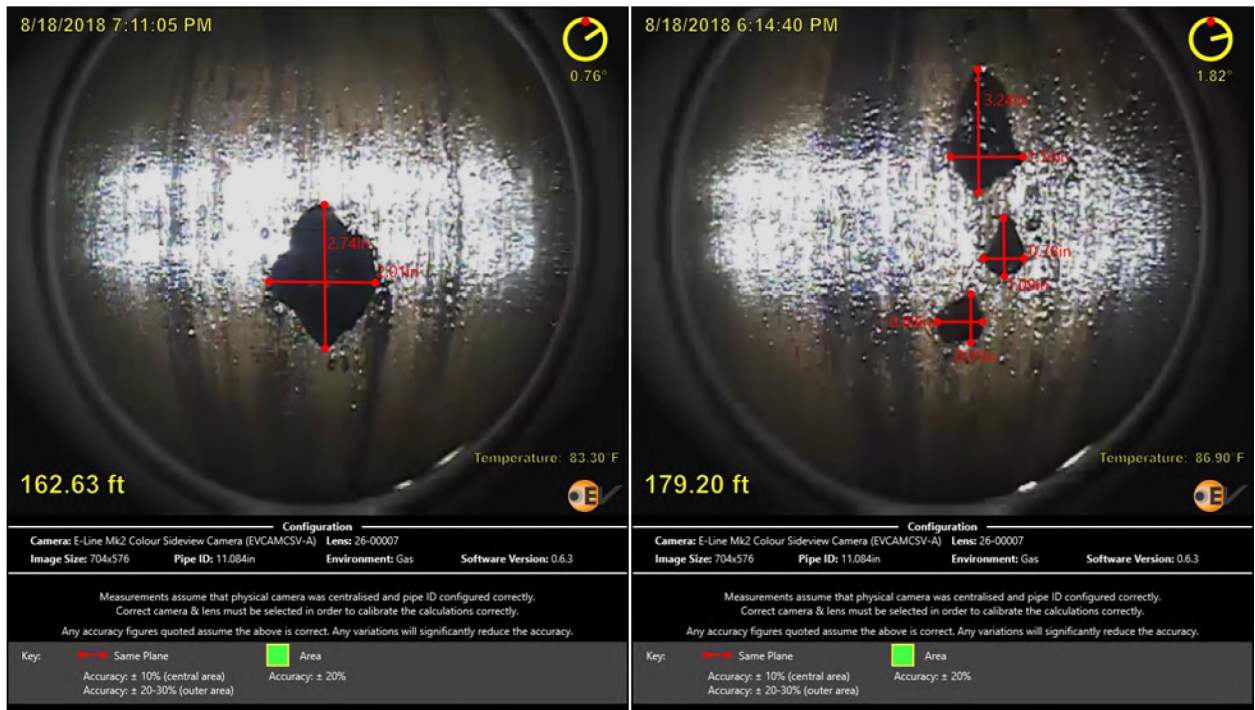
Figure 66: Holes in 11 3/4 in. Surface Casing

The EV camera was the first tool run in the surface casing after extraction of the upper 7 in. casing fish. Section 2.2.5 discusses the EV camera tool. Holes were identified during the camera inspection. Figure 66 shows snapshots of the holes recorded by the camera. The size of the holes was estimated by a software that used images from the camera and the camera parameters to scale the corrosion holes. Several holes were selected for sizing. The minimum and maximum areas measured with the software were 0.15 in<sup>2</sup> and 3.62 in<sup>2</sup>, respectively. The shape of the holes and the surrounding ID suggested that corrosion occurred from the OD to the ID. General corrosion and pitting were not observed on the surrounding ID surface.

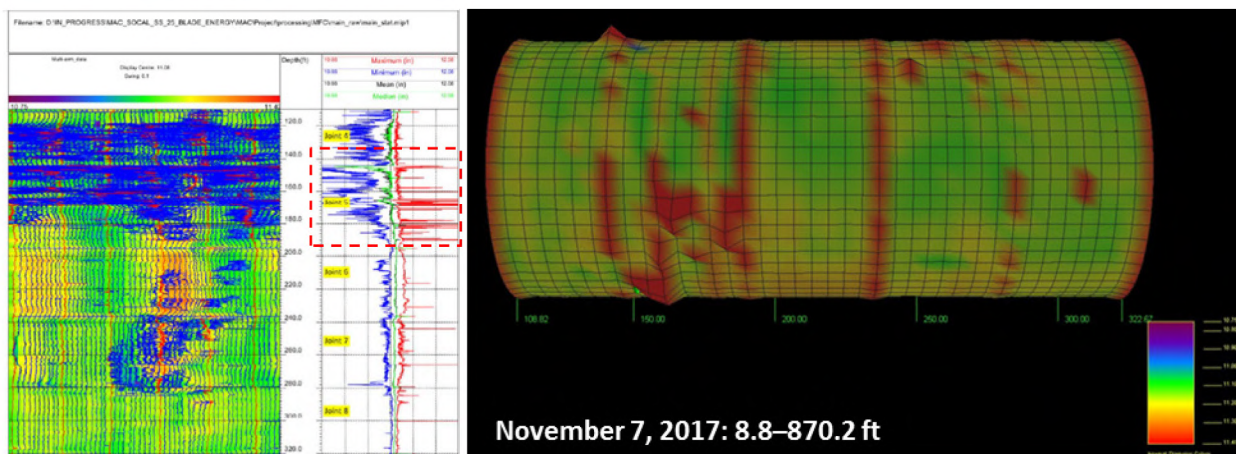
Figure 67: Baker Hughes Caliper Results for 11 3/4 in. Casing Joints 4–8 November 07, 2017

The Baker Hughes 56-Arm Caliper tool was run on the same day from 8.8–870.2 ft. The caliper identified several anomalies, including deformation—ovality, holes, and pitting. Holes were identified between 134 and 300 ft. These findings were consistent with the observations made with the EV camera. Figure 67 shows the caliper log and 3D view for joints 4–8. The dark red peaks in the log and 3D view indicate possible holes in the 11 3/4 in. casing. These were locations where the caliper arm penetrated completely through the casing wall.

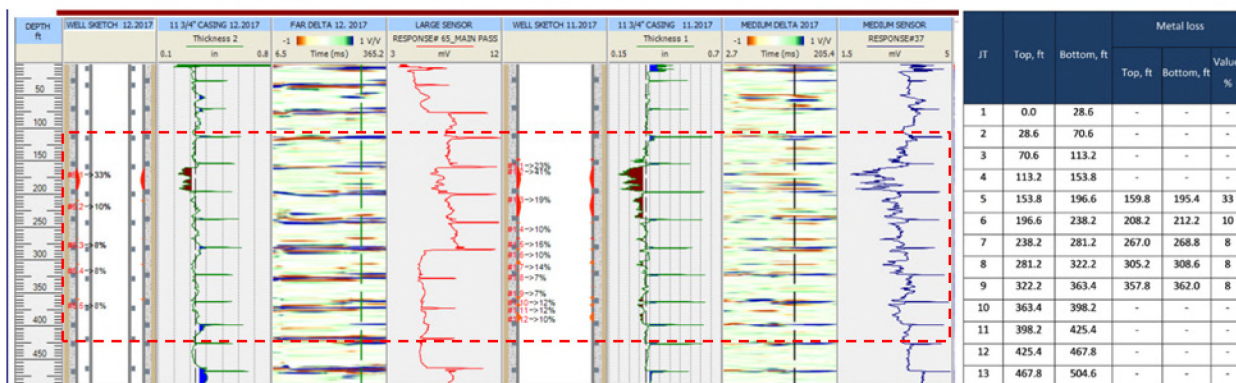
Figure 68: Versa-Line (a) MID-2 and (b) MID-3 Logs for 11 3/4 in. Casing

The Versa-line MID-2 tool was run the following day on November 16, 2017. The MID-2 was used rather than the MID-3 because the first barrier (7 in. casing) was not present. The MID-2 and MID-3 were also run on December 01–02, 2017, after the 7 in. tieback was installed. The MID-3 was used to inspect the surface casing on the second run because the first barrier (7 in. tieback) was present. Both runs identified metal loss on joints 5–9. The most significant metal loss was 33% on joint 5. These findings correspond well with the previous logs that identified holes at these depths. Figure 68 shows the MID-2 and MID-3 results for the surface casing; the table in the figure shows the maximum metal loss detected by the MID-3 for each joint.
