**Blade Supplemental Report (Vol. 2: SS-25 Well Failure Causes)**

# Root Cause Analysis of the Uncontrolled Hydrocarbon Release from Aliso Canyon SS-25

May 31, 2019

# SS-25 Casing Failure Analysis

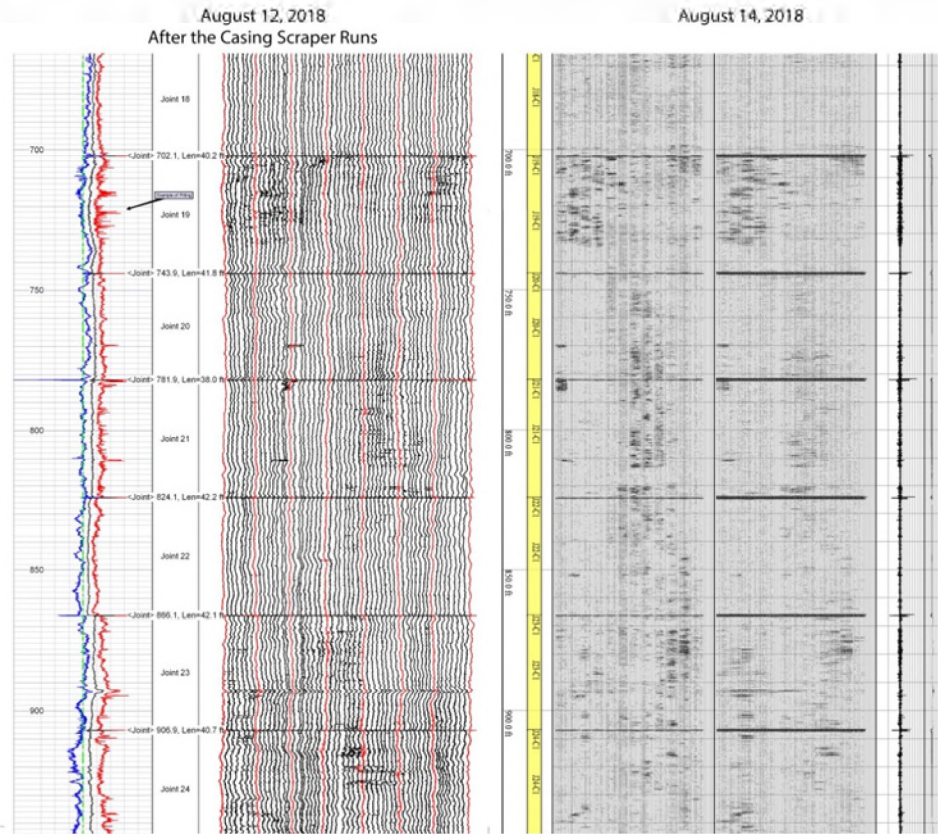
Figure 69: Caliper and HRVRT Logs for 700–990 ft

The caliper and HRVRT log runs in the 11 3/4 in. casing identified internal metal loss beginning at approximately 700 ft and extending to the shoe (joints 18–25). The corrosion had a scattered distribution and non-uniform depths. Figure 69 shows results from the caliper and HRVRT logs. The corrosion identified by these logs was correlated to the corrosion features identified on the OD of the 7 in. casing

pipe body (Section 5.1) and connections (Section 6.1.2). The camera run on August 18–19, 2018, visually confirmed corrosion on the ID surface of the 11 3/4 in. casing. Figure 70 shows an example of the ID corrosion observed on the 11 3/4 in. casing. The corrosion appeared to be similar to the corrosion associated with the axial rupture of the 7 in. casing.

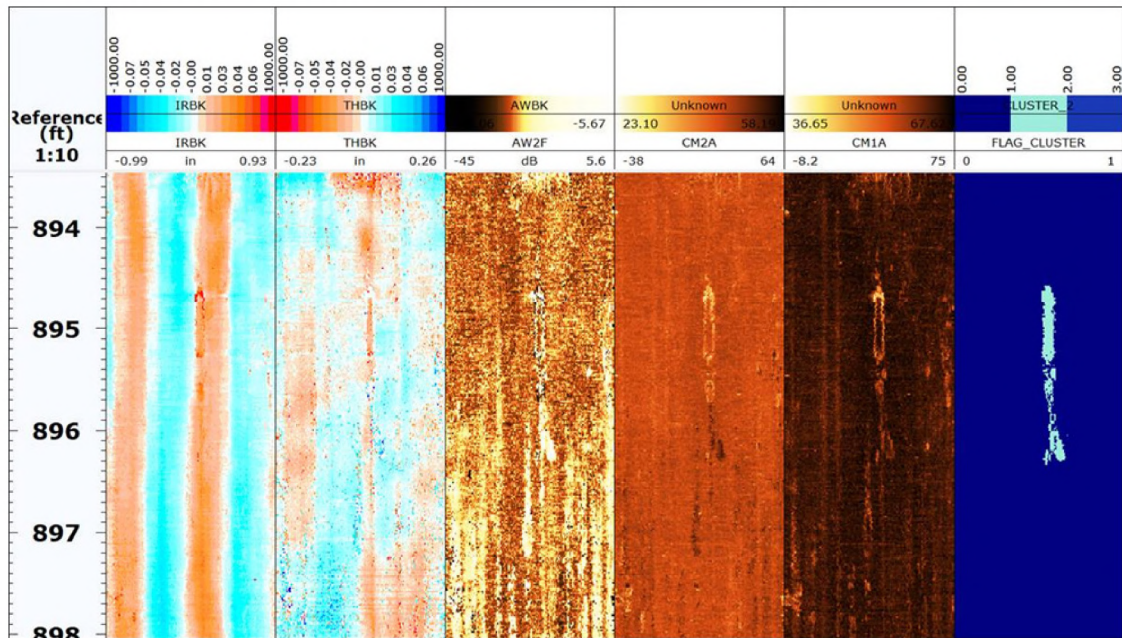
Figure 71: UCI Log of 11 3/4 in. Longitudinal Feature in 11 3/4 in. Casing Resembling 7 in. Rupture

The caliper and UCI logs identified two features that appeared to be associated with the axial rupture and the circumferential parting. The UCI log identified a 21 in. long feature with an average width of 1.8 in. and a maximum penetration of 48% (Figure 71). The axial feature appeared at a similar depth as the axial rupture. Interpretations of the log suggest the feature was related to erosion during the blowout. The caliper log (Figure 72) identified a circumferential feature at a similar depth to the circumferential parting. This feature was also interpreted as erosion during the blowout. The erosion associated with these features is consistent with the erosion identified on the axial and circumferential fracture surfaces during the metallurgical investigation. Section 3.2.5 describes the observation and analysis associated with the axial rupture fracture surface erosion.

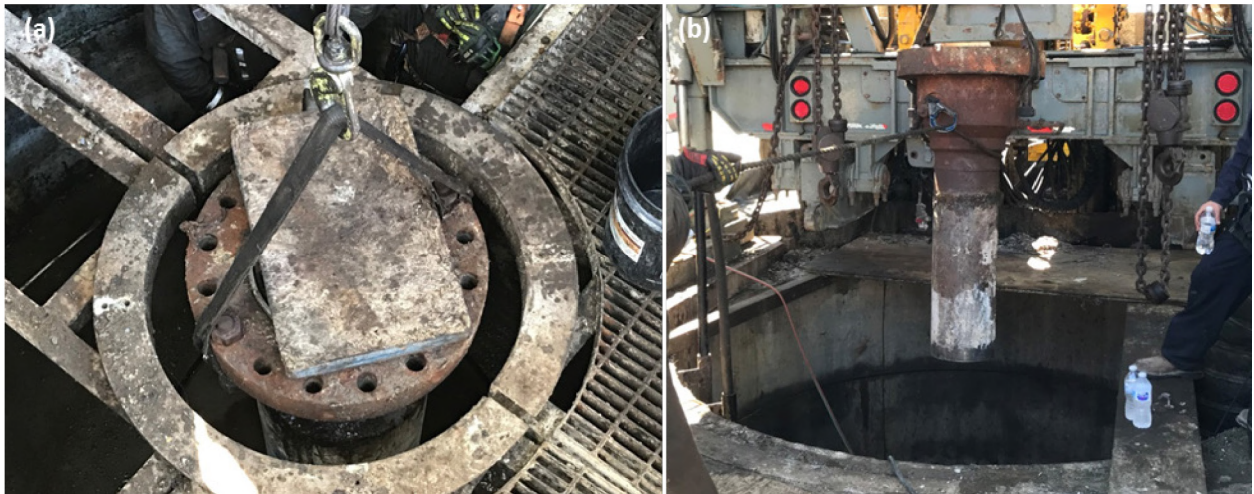
Figure 73: 11 3/4 in. Casing Extraction

The 11 3/4 in. casing was not extracted due to operational challenges, which posed a risk to damaging the evidence. The 11 3/4 in. casing was partially cemented at the top and bottom of the string, and this would make extraction challenging. Extracting the 11 3/4 in. casing string would most likely damage most of the evidence during the extraction process. Blade determined that the evidence collected during the 11 3/4 in. logging was sufficient, given that the string did not directly contribute to the 7 in. casing failure. The casing head and approximately 3 ft of the 11 3/4 in. casing were removed from the well on September 10, 2018, and released to Blade as part of the RCA. Figure 73 shows images of the removal of the casing head and 11 3/4 in. casing material. The following steps were used to extract the casing head and 11 3/4 in. casing material:

The 11 3/4 in. casing material was identified as W006B and was shipped to Houston, TX, for the metallurgical investigation. The material was used for mechanical testing, which is discussed in Section 7.2.

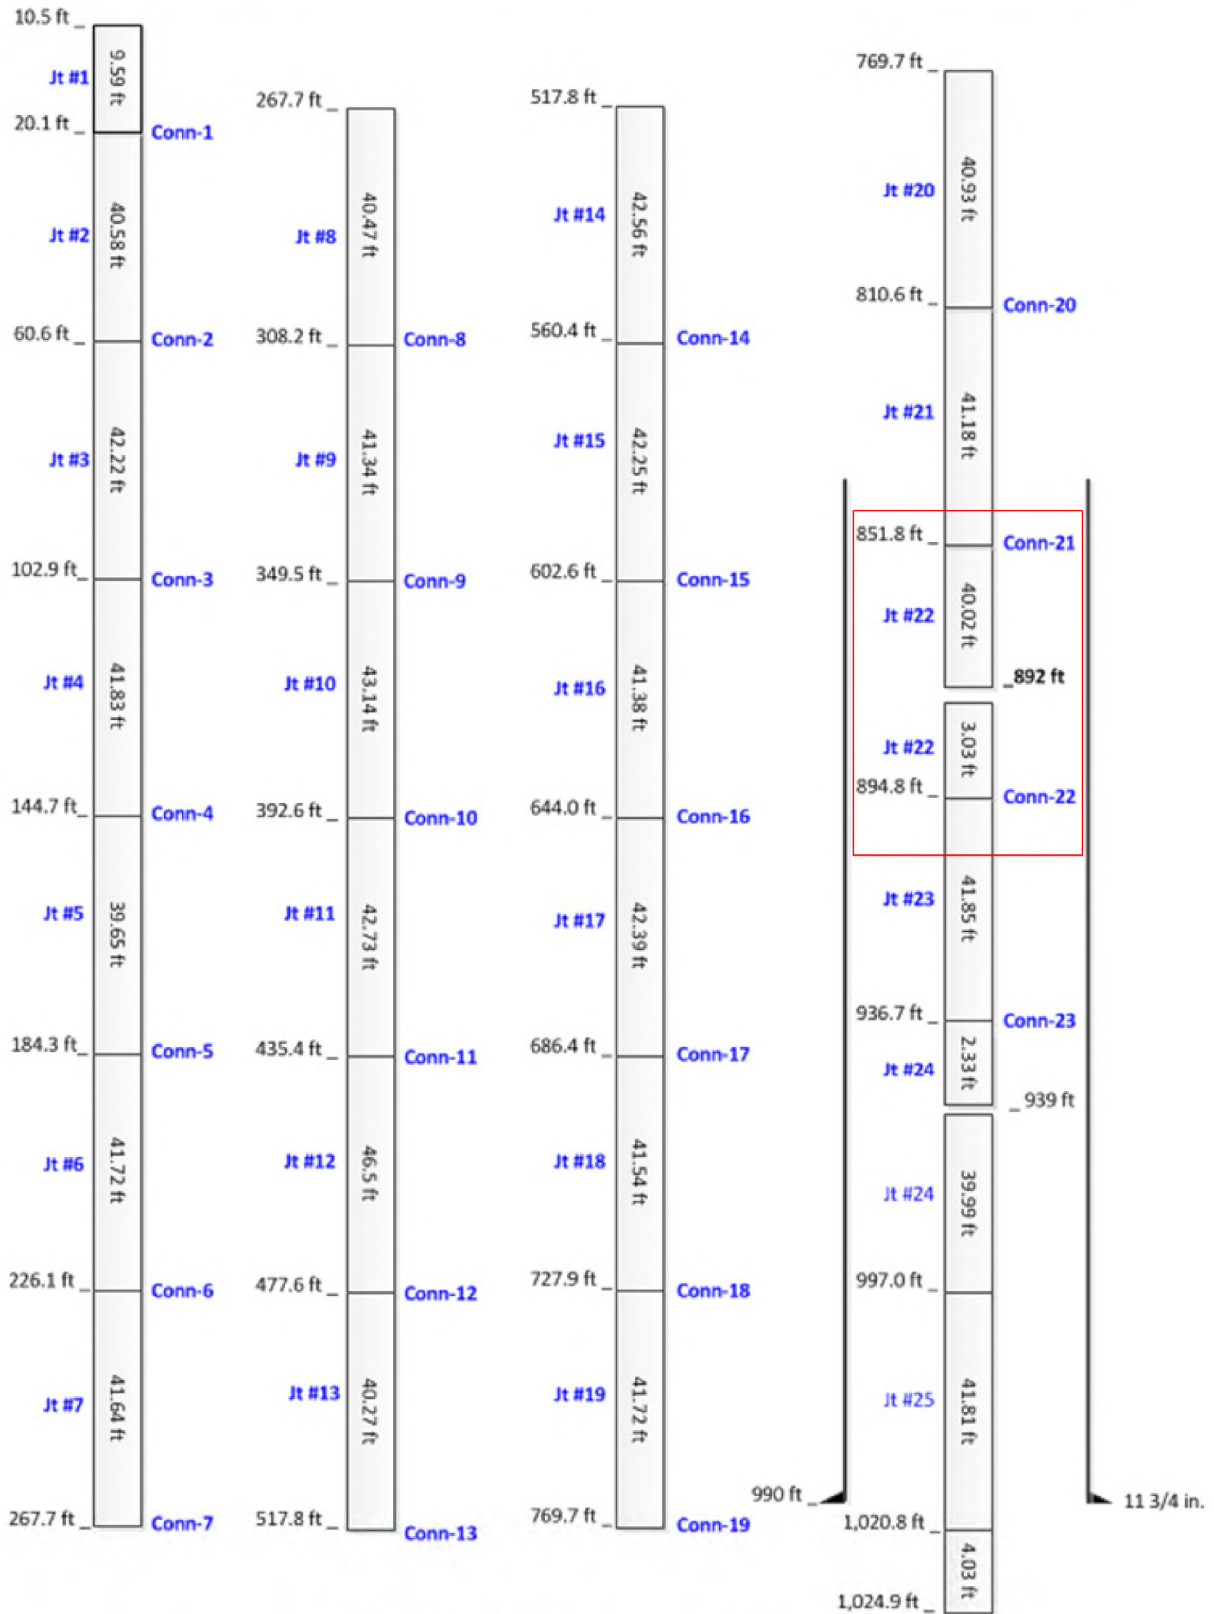
Figure 74: SS-25 7 in. Casing String Schematic

The 7 in. casing extraction confirmed the findings of the EV downhole camera, which identified a fully parted casing at an approximate depth of 887 ft WLM. The top and bottom fracture surfaces of the parted casing (joint 22) were recovered. The lower parted casing (upward-facing fracture surface) was 2.80 ft away from connection 22. Visual examination of the lower parted casing showed a 2 ft long axial rupture that had merged with the circumferential fracture. Section 2.2.5 discusses the EV downhole camera findings. Section 2.2.6 describes the extraction and field examination of the fracture surfaces.

Figure 74 shows the 25 joints recovered from the well and indicates the location of the parted casing. It also shows the official depths used by Blade. These depths are based on consolidation and verification from downhole tools and physical measurements. The official depth for the parted casing is 892 ft as shown in the schematic. Figure 75 shows the field photographs taken during extraction with a diagram of the parted casing and axial rupture. The image shows the failed casing oriented as it was in the well, with the axial rupture below the circumferential parting.

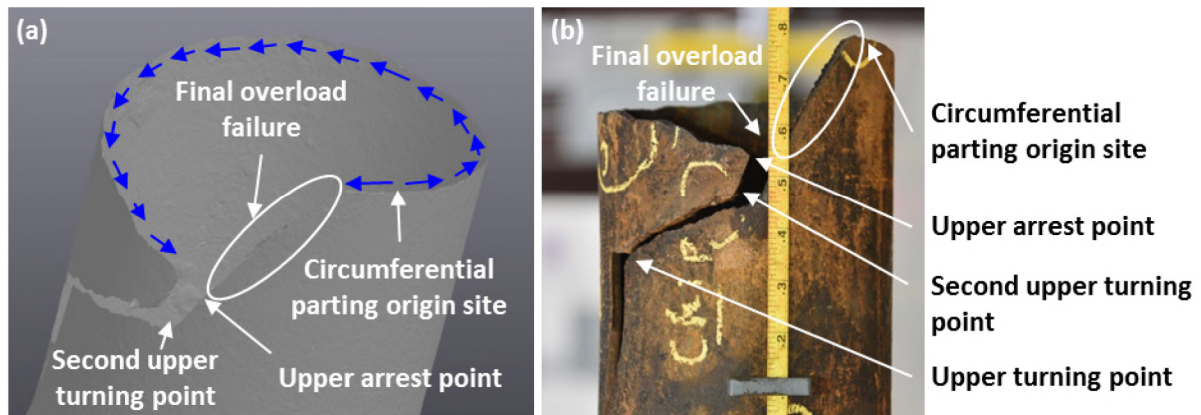
Figure 78: (a) Laser Scan and (b) Circumferential Parting

Visual and stereoscopic examination of the circumferential parting showed that the failure was not a continuation of the axial rupture, but it had rather re-initiated near the corner on one side of the parted casing. The origin site was determined from the chevron marks identified on the fracture surface. Figure 78 shows a (a) laser scan and an (b) image that identify the upper arrest point, origin of the circumferential parting, and final overload failure. The stitched stereo images in Figure 79 show the chevron marks and propagation direction of the circumferential parting. These observations indicate that the axial rupture and the circumferential parting were two separate events despite their close proximity, and that they were most likely related to each other.

The circumferential parting was brittle, which was different from what had been observed with the axial rupture. There was no evidence of local plastic deformation or overload necking for both of the circumferential fracture surfaces. The previously discussed evidence and the detailed metallurgical investigation presented later in this section suggest that the circumferential parting of the 7 in. casing was a consequence of the axial rupture. The suggested failure sequence for the axial rupture and circumferential parting is as follows:

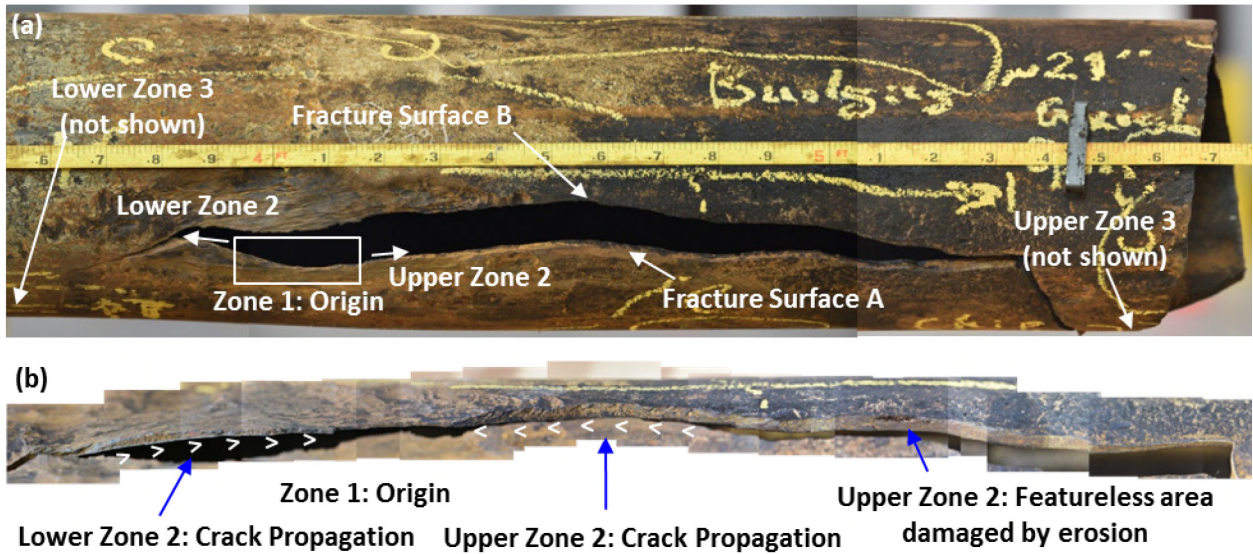
Figure 81: (a) Front and (b) Top Views of Fracture Surface B Identifying Zones 1 and 2

Figure 81 illustrates the three zones of the axial rupture. Zone 1 is a short section of the axial rupture that was identified by severe wall thinning due to corrosion. Zone 2 extends from the lower and upper boundaries of Zone 1 to the boundary of the lower and upper arrest region. Lower and Upper Zone 2 contained chevron marks. However, Upper Zone 2 also contained a featureless segment created by erosion. Zone 3 is the lower and upper arrest regions. The arrest points in Zone 3 cannot be seen in Figure 81 (a) or (b).

Zone 1 was initially determined based on the chevron marks in Zone 2. The apexes of the chevron marks generally point towards the origin of a failure [20] [21]. The chevron marks in Zone 2 pointed towards the area with the maximum metal loss. Both observations suggested that this area was the origin of the axial rupture and was denoted as Zone 1. Figure 82 is a close-up image of fracture surface B and shows the apex of the chevron marks in Zone 2 pointing towards the origin of the axial rupture.

Figure 81 shows that the origin was not symmetrically located at the center of the rupture. The non-symmetric location of the origin can be explained by the proximity of the origin to connection 22. The axial crack initiated in Zone 1 and propagated in opposite directions. The lower crack front propagated towards connection 22, which provided additional constraint as opposed to the pipe body. The additional constraint assisted with arresting the crack at approximately 1 ft from the connection. The upper crack was not influenced by any additional constraint allowing the crack to propagate further before arresting.

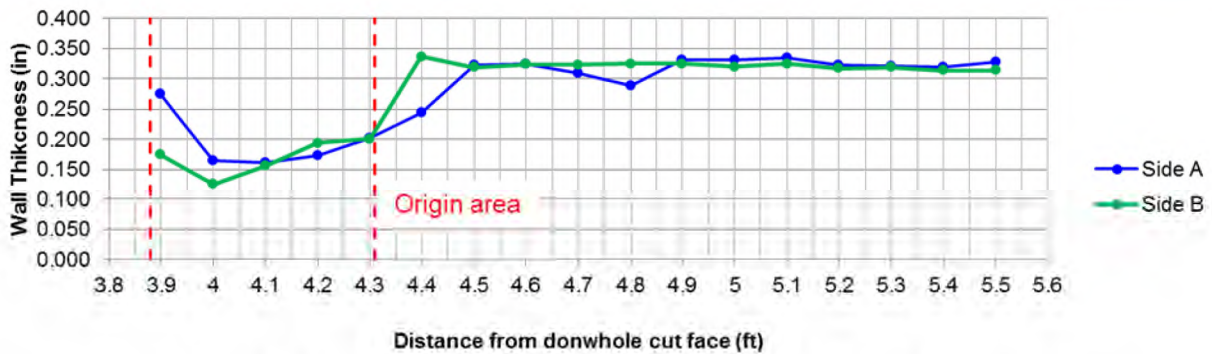
Figure 83: Remaining Wall Thickness Measurements of Axial Rupture

The size of the origin was originally measured with a tape measure for length and an ultrasonic thickness probe for depth. The measured length of the axial rupture origin was 4.8 in. (123 mm), based on chevron marks. The minimum remaining wall thickness measured with the thickness probe was 0.126 in. This was a rough approximation due to the limitations of the ultrasonic thickness probe. The size of the probe prevented taking measurements that were directly adjacent to the fracture surface. The probe also averaged the measurement over the probe area.

Figure 83 shows a plot of the remaining wall thickness as a function of axial position along the fracture surface. The origin for the axial position was taken as the downhole cut below connection 22. The cut face was flat, which allowed for consistent axial measurements regardless of circumferential orientation. The average wall thickness of the pipe was 0.303 in. The measured minimum remaining wall thickness was 0.126 in. The estimated maximum metal loss based on the measured remaining wall thickness and AWT was 0.177 in. (58.4% AWT).

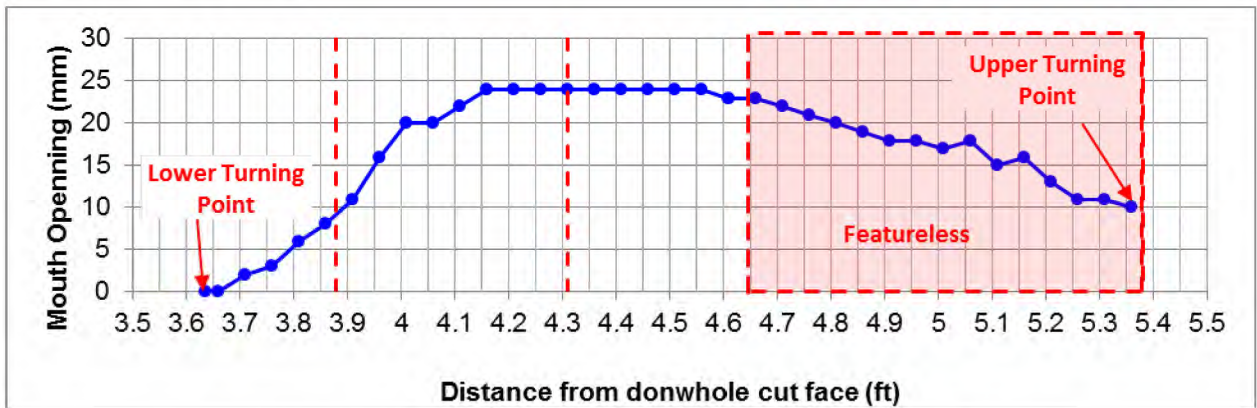
Figure 85: Plot of Fracture Surface Mouth Opening Versus Axial Position

The axial lengths measurements for fracture surfaces A and B were 20.7 in. and 20.58 in., respectively. The profile lengths measurements for A and B were 28.12 in. and 31.50 in. The differences in length between the profile and axial lengths for fracture surfaces A and B were 7.42 in. and 10.92 in., respectively. The length values suggest that bulging (plastic deformation) occurred during the axial rupture.

Figure 85 shows measurements of the fish mouth opening plotted versus axial position. The opening measurements were converted into an estimated opening area that is equivalent to a 4.5 in. x 4.5 in. square or a 5.1 in. diameter hole. The significant plastic deformation of the 7 in. casing material is consistent with the estimated casing temperature of 80°F.

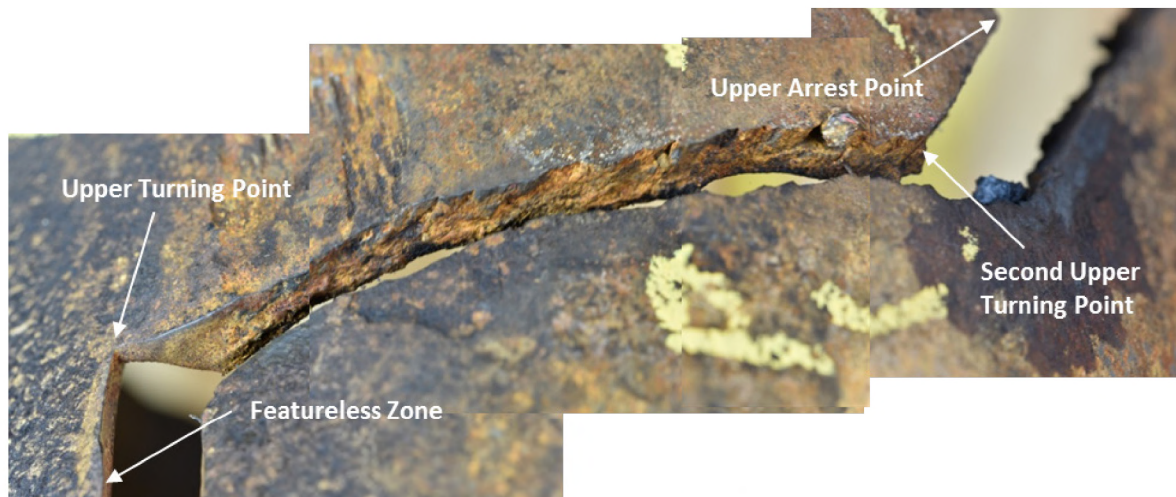
Figure 86: Macro Image of the Two Upper Turning Points and Single Arrest Point

Zone 3 was taken as the fracture surfaces in the arrest point regions. The lower portion of the crack had a well-defined turning and arrest point. The crack terminated after changing directions twice and arrested just beyond the second lower turning point. The lower arrest point was contained within a tight crack tip. The upper portion of the crack also changed directions twice, with the second change occurring 50° from the longitudinal pipe axis. The circumferential parting connected to the upper arrest point, and the final overload failure completely parted the casing. The upper arrest point was not contained within a tight crack tip at the time of recovery. Figure 86 shows the upper turning point, second upper turning point, and arrest point. The image clearly shows Zone 3 for the upper section of the axial rupture. Figure 87 shows the lower turning and arrest points.

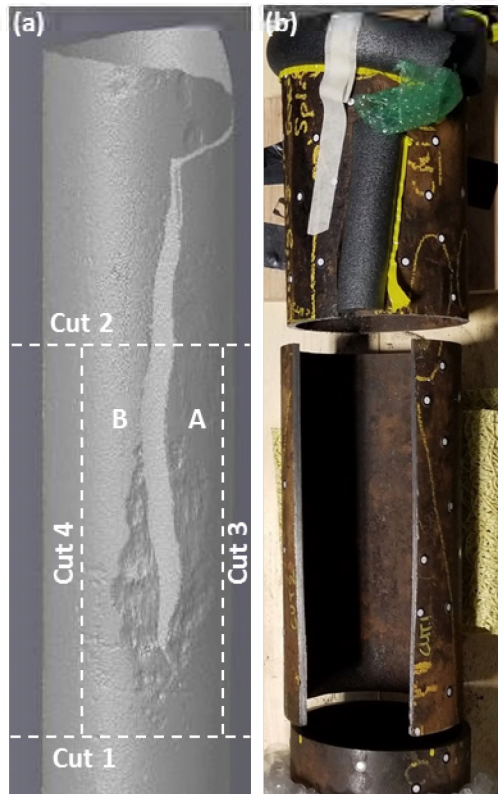
Figure 88: (a) Schematic and (b) Image of the Cut Locations for the Axial Fracture Surfaces

The length of the fracture surfaces had to be reduced for cutting and handling purposes. A 14 in. long section of the fracture surface was chosen for extraction and detailed examination. Four cuts were made to extract the 14 in. section of the fracture surfaces. Figure 88 (a) shows a schematic of C023A1 with the four cut locations identified. Figure 88 (b) shows C023A1 after the fracture surface extraction. Cut 1 was located through the featureless area in the upper portion of Zone 2 (above Zone 1). This location was chosen to minimize the amount of information lost by the cut. The area was damaged due to erosion, which means that the relevant information had already been compromised. The cut was designed to reduce the length of the axial rupture and remove the circumferential parting from the rest of C023A1.

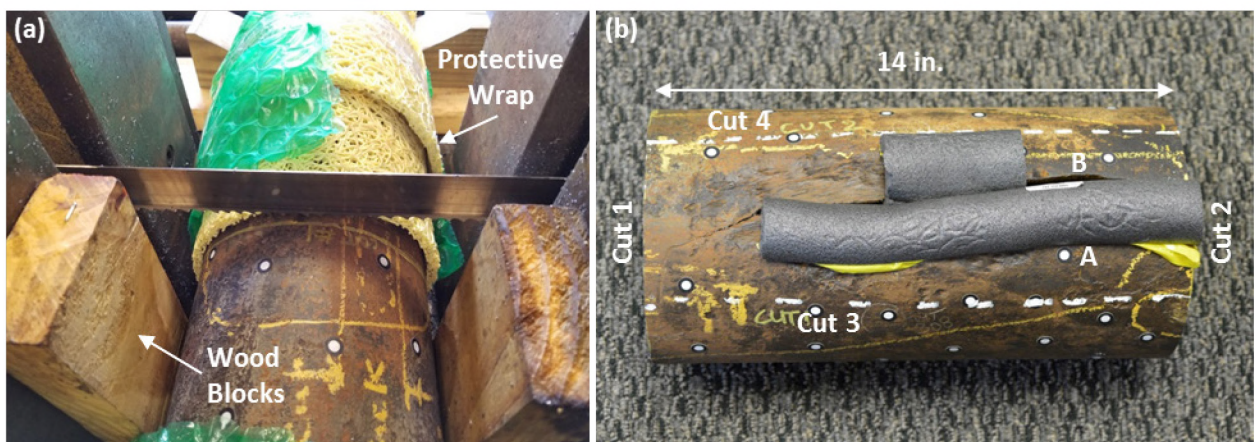
Figure 89: (a) Dry Saw Cut Example and (b) Fracture Surfaces After Cuts 1 and 2

Cut 3 extracted fracture surface A. Cut 4 was longitudinal and extended from cut 1 to cut 2. Cut 4 extracted fracture surface B. Figure 89 (a) shows an example of the dry saw cuts with protective padding around the critical areas of C023A1 and the wooden blocks used to protect C023A1 from metal-to-metal contact.

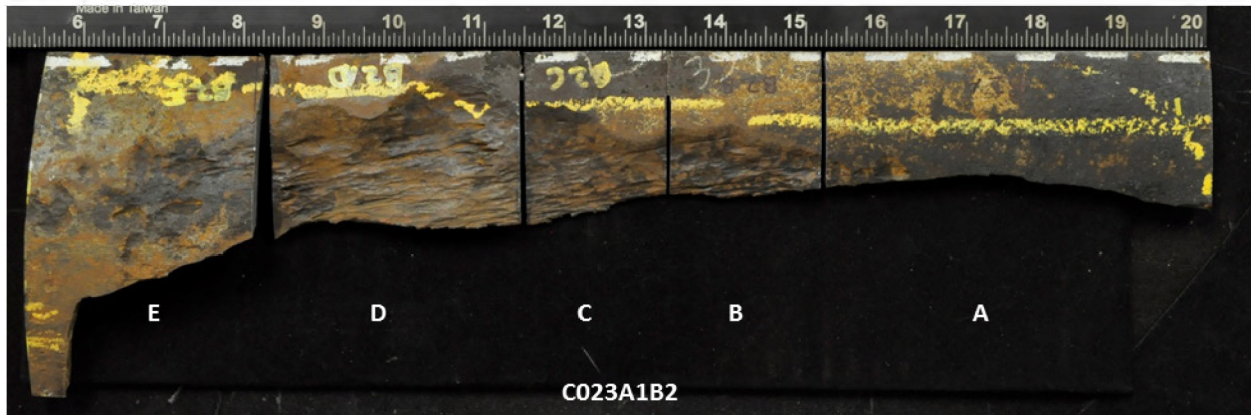
**Figure 90: Five Specimens Cut from C023A1B2 for Fractographic Study**

Fracture surface B was chosen for a detailed examination and analysis. It was cut into five smaller specimens (Figure 90). The cut locations were determined based on the fracture surface features and size limitations imposed by the SEM. Specimen identification was based on JSNs as outlined in the

metallurgical protocol [1] and described in the Phase 4 summary report [7]. Fracture surface B was denoted as C023A1B2. Two specimens (C023A1B2B and C023A1B2D) were chosen for detailed examination to determine the fracture mode for Zone 1 (origin). These samples were chosen because they contained the entire origin and a small portion of Zone 2 (crack propagation). Fracture surface A was preserved.

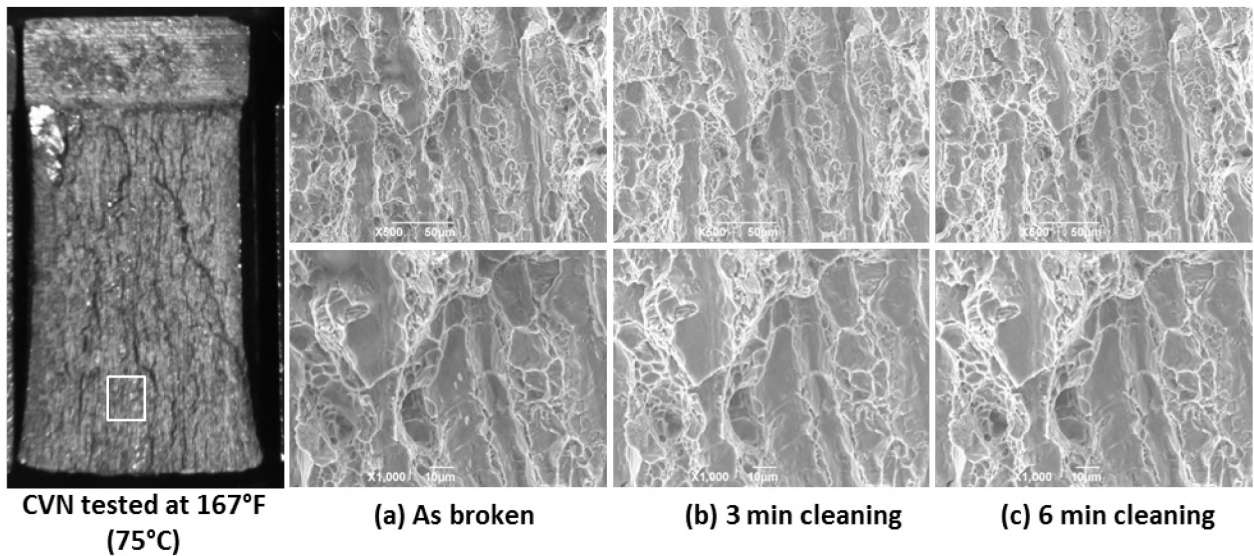
Figure 91: Cleaning Procedure Tests on Charpy V-Notch Specimen

Freshly produced fractures surfaces from Charpy V-notched (CVN) specimens were used to verify the cleaning procedure. These specimens were grade J55 steel from casing material extracted from the SS-25 well. The SEM examination of the fracture surface after cleaning found no resolvable attack at magnifications up to 1,000×. Figure 91 is a comparison of the fracture surface before and after cleaning and clearly demonstrates no attack from up to 9 minutes of ultrasonic cleaning in 1% Citranox solution. The results showed that the cleaning procedure was safe to use on the fracture surface specimens.

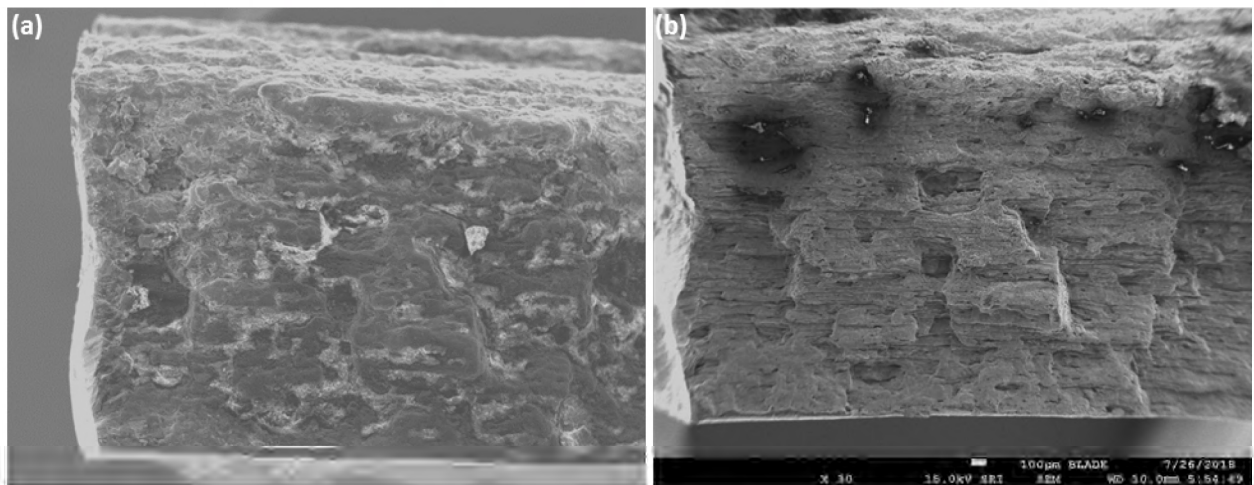
Figure 92: SEM Images of Specimen C023A1B2C (a) Before and (b) After Cleaning

The effectiveness of the cleaning procedure was also tested on a specimen from the origin of the axial rupture (C023A1B2C). The specimen was examined before cleaning and after 3 minutes of ultrasonic cleaning in a 1% Citranox solution. Figure 92 shows the fracture surface (a) before and (b) after cleaning at a magnification of 30×. Most of the corrosion scales, deposits, and contaminants were effectively removed from the fracture surface. The woody-type morphology was clearly seen on the cleaned surface, confirming the effectiveness of the cleaning procedure. The Charpy and fracture surface tests showed that cleaning times up to 9 minutes could be used, if required, with minimal damage to the fracture surface.

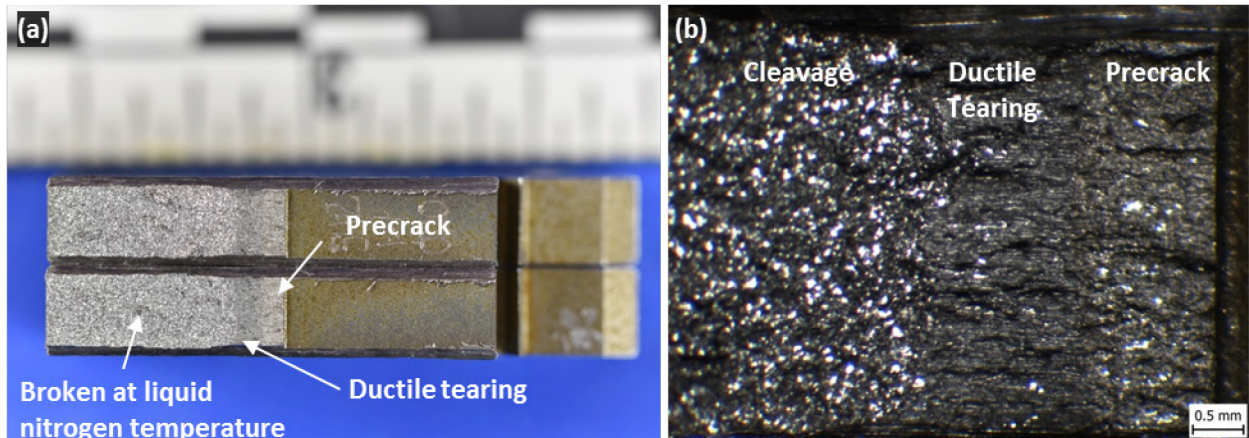
**Figure 93: (a) Macro and (b) 25× Stereo Image of J-R Specimen L4-000**

One specimen (L4-000) was selected for fractographic examination to determine ductile tearing characteristics for the grade J55 7 in. casing material. Specimen L4-000 was tested at room temperature, which was comparable to the estimated downhole temperature at the time of the axial rupture. Figure 93 shows a (a) macro image of the J-R specimen and a (b) stereo image taken at 25× showing the pre-crack, ductile tearing, and cleavage zones. The pre-crack was created prior to testing to initiate a crack in the notch. Ductile tearing occurs during the J-R testing, and cleavage occurs when the specimen is broken at liquid nitrogen temperature. The ductile tearing zone shows the same woody-type morphology shown in Figure 92. The ductile tearing zone was examined with the SEM to identify relevant characteristics.

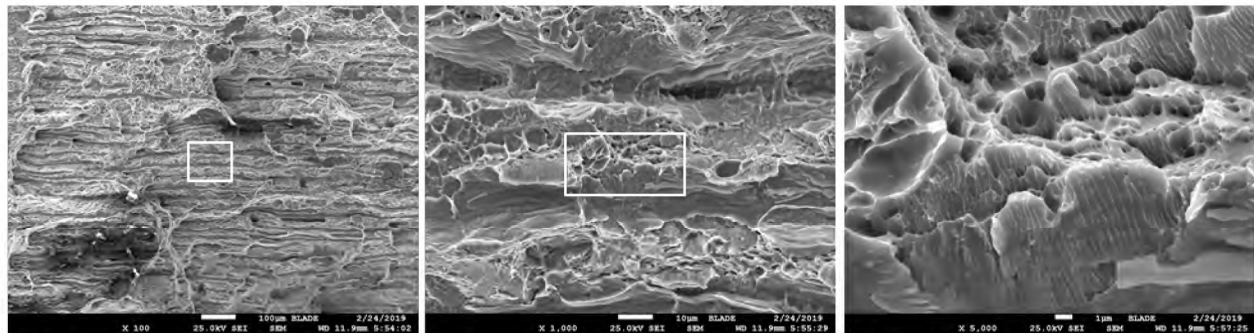
**Figure 94: SEM Images of J-R Specimen L4-000 Taken at (a) 100×, (b) 1,000×, and (c) 5,000×**

Figure 94 shows the SEM images taken at (a) 100×, (b) 1,000×, and (c) 5,000×. Figure 94 (a) shows the same woody morphology observed in the stereo image and in the SEM images of C023A1B2C. Figure 94 (b) shows dimples, deformation markings, and pearlite, which are confirmed at 5,000× in Figure 94 (c). Pearlite is a two-phased lamellar (layered) structure composed of alternating layers of ferrite (87.5 wt%) and cementite (12.5 wt%). Results from the examination show that ductile tearing can reveal pearlite. This finding is important for understanding the micro mechanism for the initiation of the axial rupture. It is apparent that the presence of pearlite on the fracture surface is one of the fractographic components of ductile tearing. The appearance of pearlite is often associated with corrosion because the ferrite is attacked, exposing the layered structure.

**(a) Woody type morphology at 100× (b) Dimples, deformation markings, and pearlite at 1,000× (c) Pearlites and dimples at 5,000×**

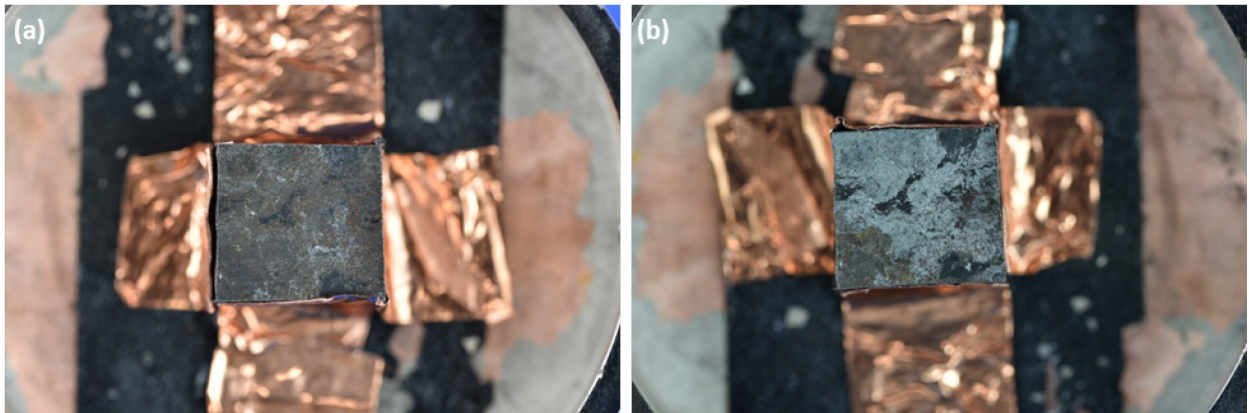
**Figure 95: Joint 22 Corroded OD Specimen C022A1A1C3D (a) Before and (a) After Cleaning**

The axial rupture had been exposed to fluids in the 11 3/4 in. × 7 in. annulus for over two years before extraction. Corrosion could have played a role in exposing pearlite on the fracture surface. A corroded specimen from the OD surface of joint 22 was examined to determine the effects of the 11 3/4 in. × 7 in. annulus environment to the grade J55 material. Specimen C022A1A1C3D was examined before and after ultrasonic cleaning for 3 minutes in a 1% Citranox solution. Figure 95 shows the specimen (a) before and (b) after cleaning. The images show that the cleaning effectively removed most of the OD corrosion product.

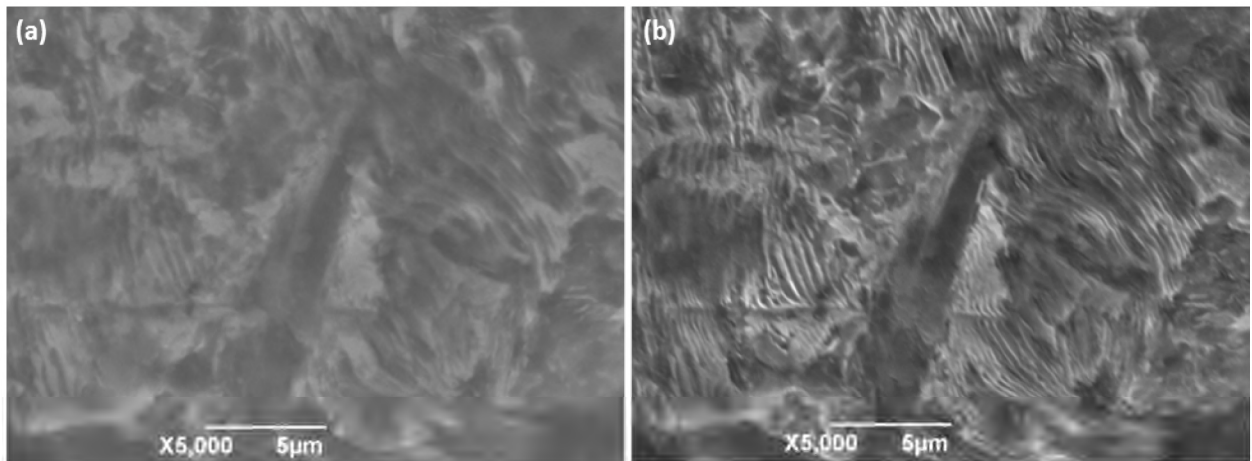
**Figure 96: C022A1A1C3D SEM Images Showing Pearlite Features (a) Before and (b) After Cleaning**

Figure 96 shows the SEM images at 5,000 $\times$  (a) before and (b) after cleaning. The results show that the pearlite features are present before and after cleaning but appear to be more pronounced after cleaning. The results from the J-R ductile tearing examination and the OD surface corrosion testing show that the pearlite features can be revealed by ductile tearing but may have been enhanced by corrosion from exposure to fluids in the 11 3/4 in.  $\times$  7 in. annulus for over 2 years.

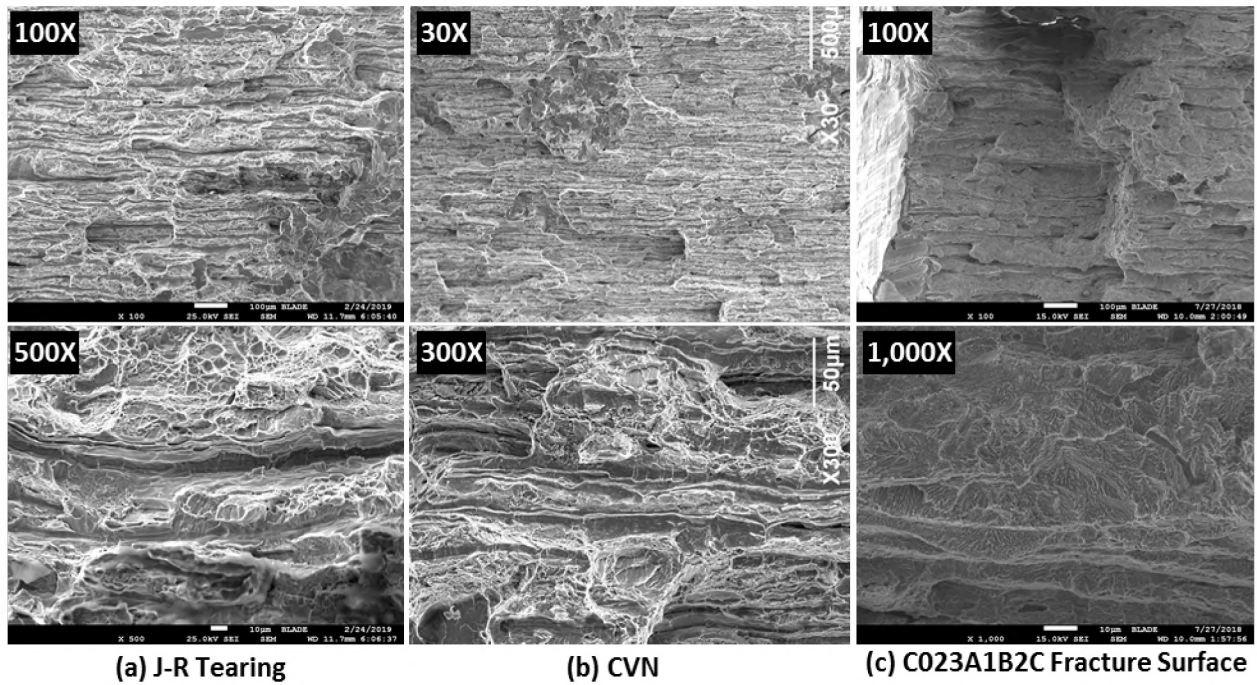
Figure 99: SEM Images Comparing Fracture Surfaces from (a) J-R Tearing, (b) CVN, and (c) C023A1B2C

Figure 99 shows a comparison of the woody-type morphology produced by the J-R testing at room temperature, the CVN testing at the upper shelf temperature (167°F [75°C]), and the origin of the axial rupture. J-R and CVN specimens were selected from the same orientation as the axial rupture. The woody-type morphology was the characteristic feature of ductile tearing along the longitudinal direction of the grade J55 7 in. casing steel. A woody-type morphology is caused by the presence of coarse and elongated MnS inclusions [24]. Section 7.1.5 discusses the microstructure of the 7 in. casing steel and shows the presence of the MnS inclusions.

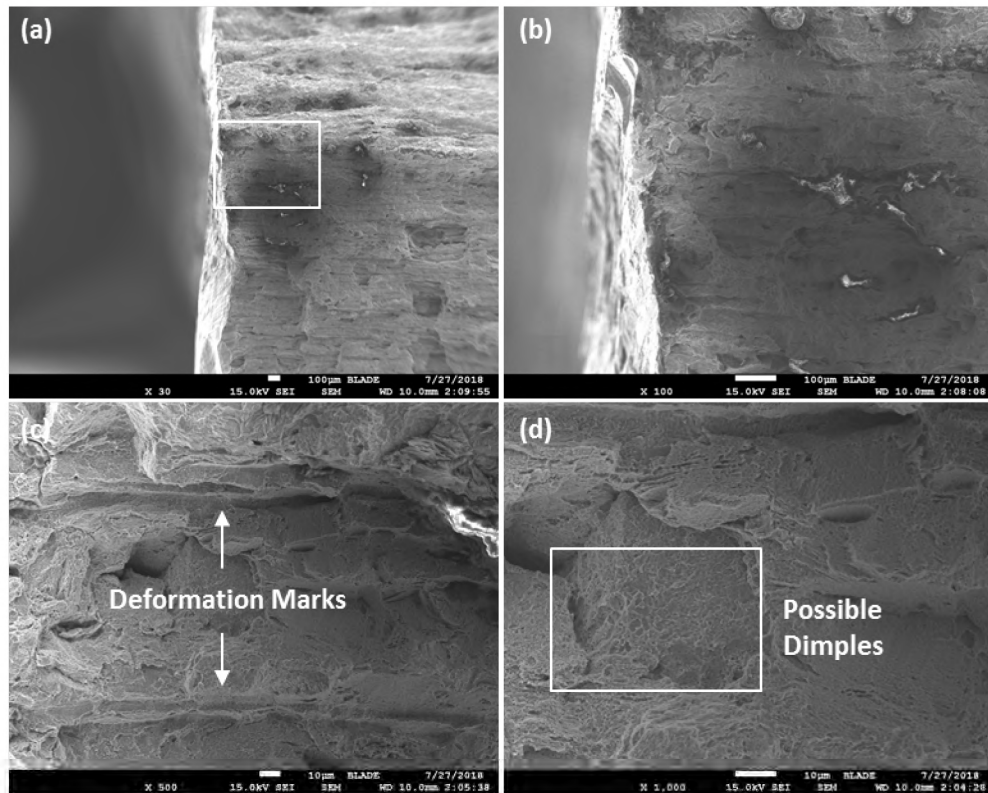
Figure 100: SEM Images of Area 3 Taken at (a) 30 $\times$ , (b) 100 $\times$ , (c) 500 $\times$ , and (d) 1,000 $\times$

C023A1B2C contained most of the origin and was selected for detailed examination. Twenty-seven AOIs were examined with the SEM. Figure 100 to Figure 104 shows the SEM images of five AOIs (A3, A4, A8, A10, and A17) selected to represent the typical features identified in the origin during the examination.

The images show the woody-type morphology, deformation markings, possible dimples, and pearlite-like features due to corrosion.

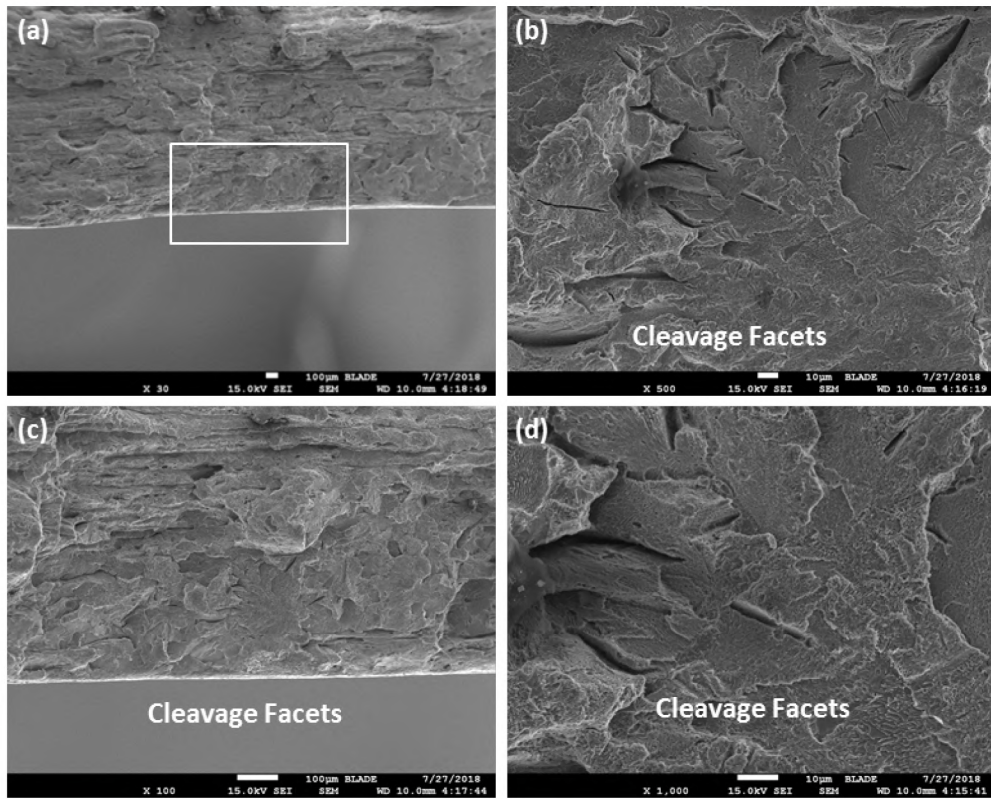
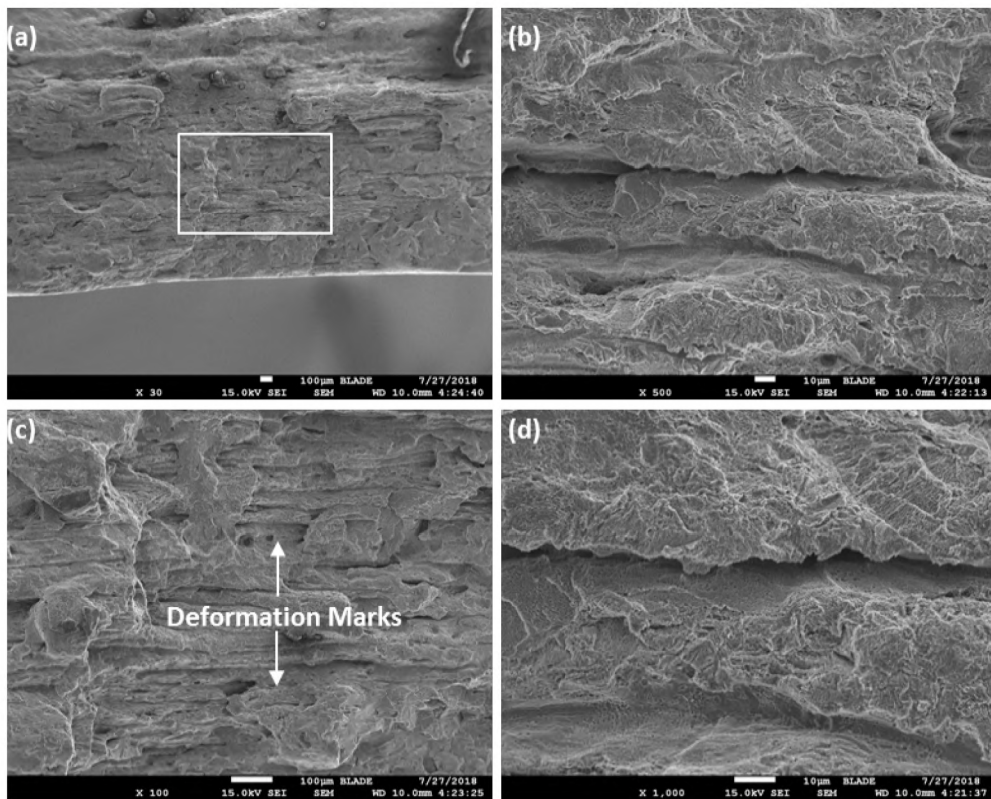
A transition from ductile to a ductile-brittle mix was observed beginning at C023A1B2C A19 (Figure 98). The transition showed a shift from woody-type morphology to a mix of woody-type morphology and cleavage. The number of cleavage facets appeared to have increased from location A19 to A27. The observations implied that the speed of the axial rupture was increasing through the transition zone until the crack became fully unstable. Figure 105 and Figure 106 show SEM images from A19 and A20 with the ductile-brittle mixed fracture mode. The images show areas of cleavage facets and deformation markings.

Figure 105: SEM Images of Area 19 Taken at (a) 30×, (b) 100×, (c) 500×, and (d) 1,000×

Figure 106: SEM images of Area 20 Taken at (a) 30×, (b) 100×, (c) 500×, and (d) 1,000×

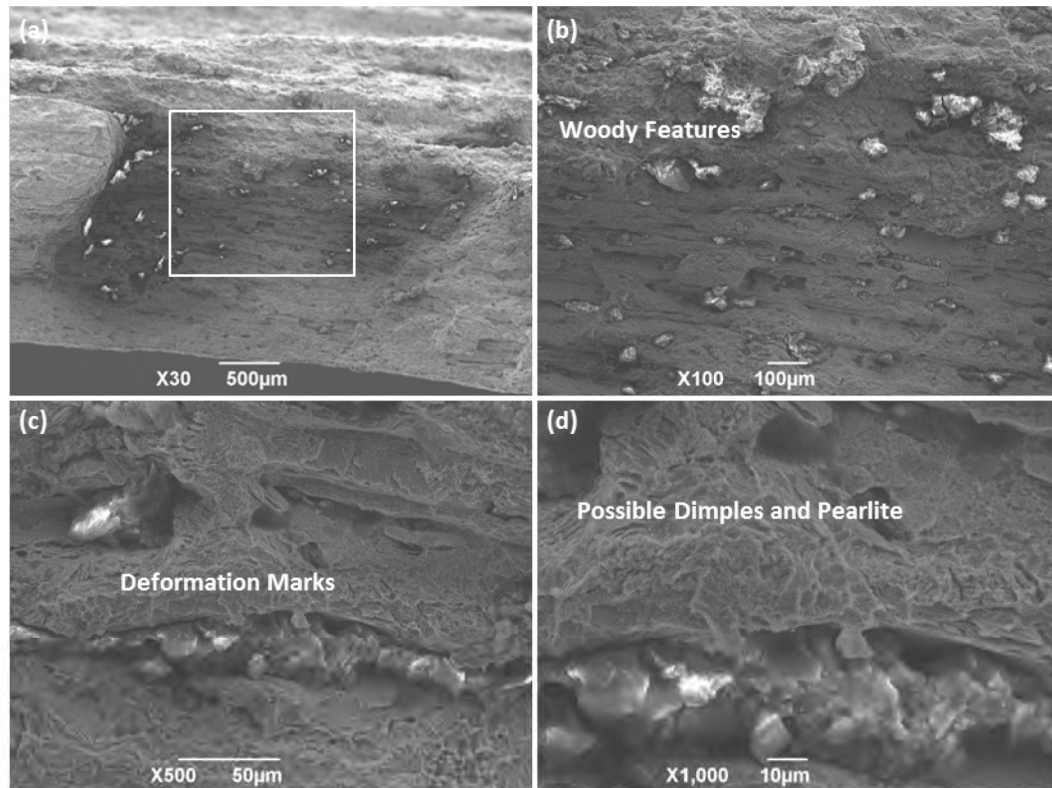
Many AOIs from specimen C023A1B2D were examined with the SEM. C023A1B2D was primarily composed of Zone 2 with a small area identified as Zone 1. Ductile features were observed in locations to the right of A30 (Figure 98). Locations to the left of A30 showed a ductile-brittle fracture mode with cleavage surrounded by deformation marks. Figure 107 shows the morphology for A30. These observations suggest that the length of the origin could be refined and measured between the transition zones identified on fracture surfaces C023A1B2C and C023A1B2D. Section 3.2.3 discusses the refining of the origin based on the observations made in this section. Figure 108 shows A37 (to the right of A30), which contained deformation marks.

**Figure 108: C023A1B2D SEM Images of A37 Showing Woody-Type Morphology and Deformation Marks without Cleavage Facets**
