**Blade Supplemental Report (Vol. 2: SS-25 Well Failure Causes)**

# Root Cause Analysis of the Uncontrolled Hydrocarbon Release from Aliso Canyon SS-25

May 31, 2019

# SS-25 Casing Failure Analysis

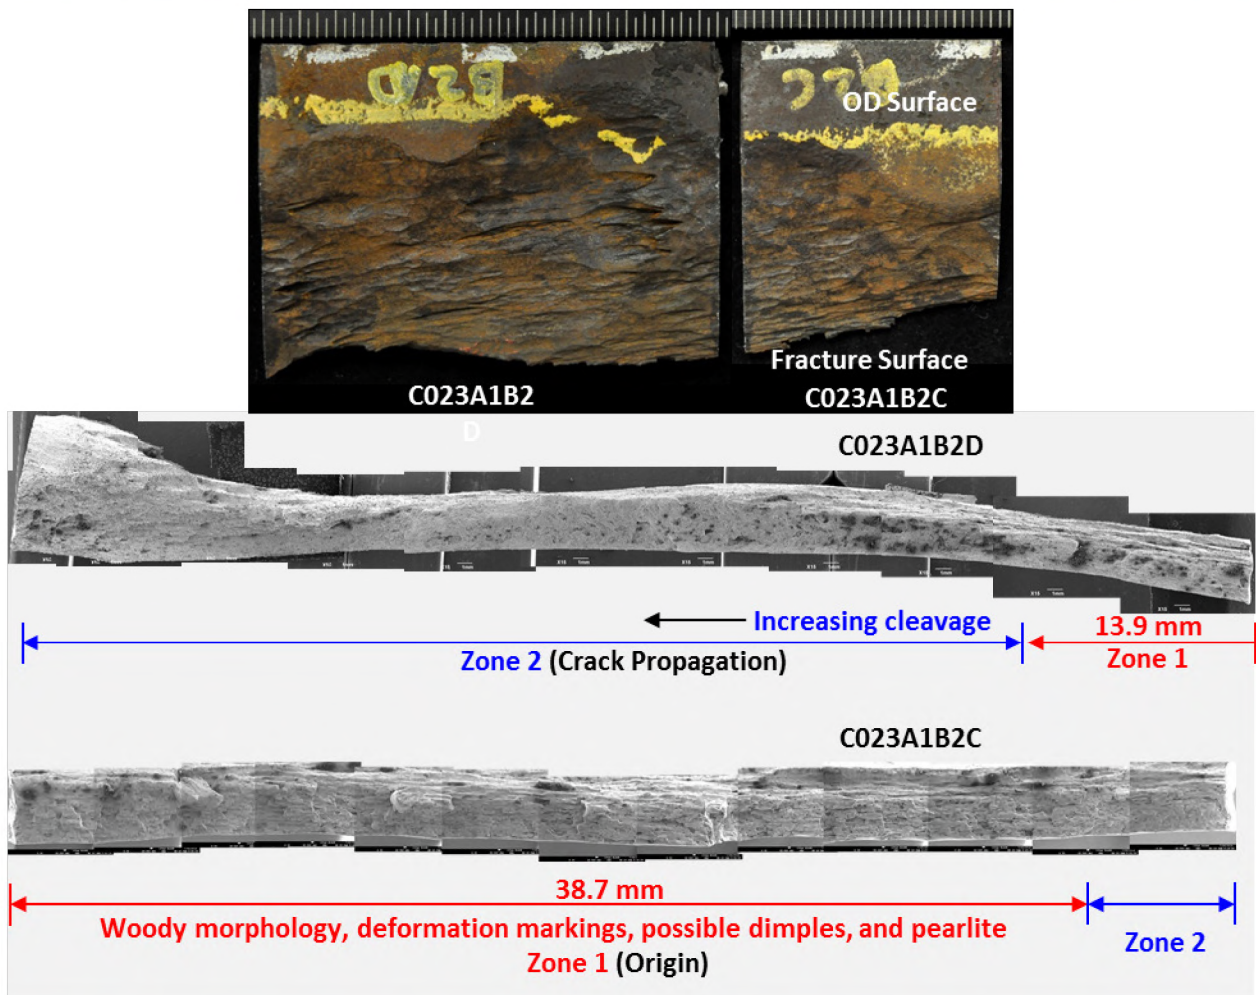
The origin was initially defined based on the metal loss measurements and chevron marks identified on the fracture surface. The origin length based on this criteria was measured at 4.8 in. (123 mm). The origin was redefined based on the micro-scale features identified on the fracture surface. The micro-scale-based measurement was defined as the length of fracture surface that exhibited fully ductile tearing without cleavage facets. The origin length based on the new micro-scale definition was 2.13 in. (54.0 mm). Figure 109 shows the Zone 1 measurements for C023A1B2C and C023A1B2D based on the new origin definition. The origin measurements for C023A1B2C and C023A1B2D were 0.55 in. (13.9 mm) and 1.52 in. (38.7 mm), respectively. The band saw cut removed approximately 0.06 in. (1.4 mm) of material. The measurements resulted in a total Zone 1 length of 2.13 in. (54.0 mm). The initial origin length was reduced by more than a factor of 2. Section 3.2.2 describes the observations from the SEM images that set the basis for redefining the origin length.

The length difference of the origin based on the micro (SEM) and macro (visual) definitions may reflect the difference in the role they played for the axial rupture. The micro definition measurement of 2.13 in. represents the initial size of the crack origin. The macro definition measurement of 4.8 in. represents the rapid propagation of the crack as indicated by the chevron marks.

**Figure 109: Origin Measurements Based on Micro Definition for C023A1B2C and C023A1B2D**

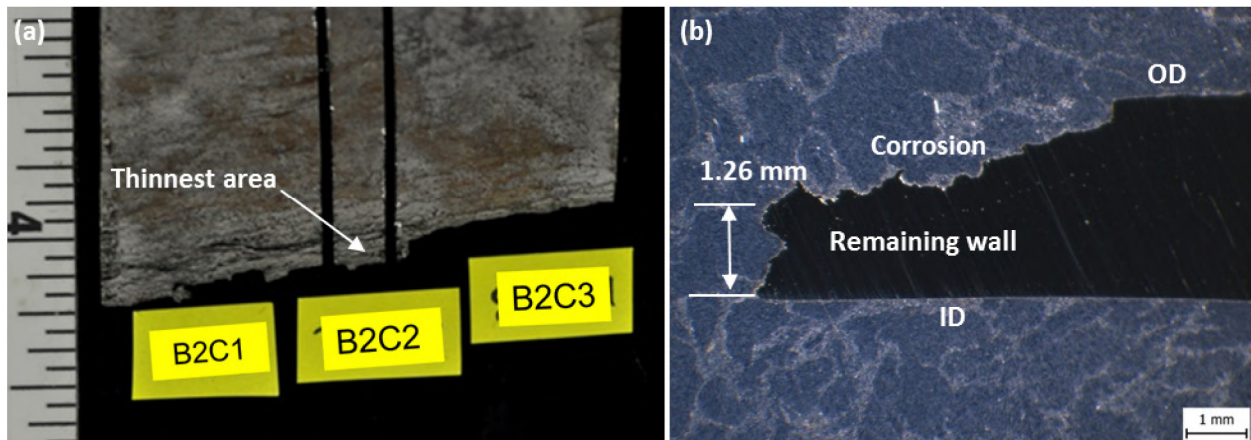
The maximum corrosion depth (metal loss) of the origin was originally measured with an ultrasonic thickness probe. Limitations with the probe prevented an accurate measurement of the maximum corrosion depth. A metallographic cross section was made to accurately measure the minimum remaining wall. The origin specimens (C023A1B2C and C023A1B2D) were visually examined to identify the thinnest area. The selected area was cross-sectioned, mounted, and polished for metallographic examination. Figure 110 shows the location of the (a) metallographic section of C023A1B2C and the (b) measured remaining wall thickness on the polished specimen. The measured remaining wall is 0.0496 in. (1.26 mm), and the measured wall thickness of the unaffected area was 0.321 in. (8.15 mm). The calculated maximum metal loss, or maximum corrosion depth, was 85% AWT. The comparison of the original measurement of 0.126 in. (3.2 mm) with the refined measurement of 0.0496 in. shows a significant error as was expected. The refined measurement of 0.0496 in. was accurate and was used as an input parameter for failure pressure calculations.

**Figure 110: (a) Macro Image and (b) Micrograph of C023A1B2C2 Showing the Remaining Wall**

Two specimens (C023A1B2C2 and C023A1B2C3) were examined for elongated grains. C023A1B2C2 (Figure 110 [b]) was used to determine the refined remaining wall measurement. The same specimen was etched to examine the grain structure perpendicular to the axial rupture orientation. C023A1B2C3 was a specimen adjacent to C023A1B2C2 and was selected to be examined for its microstructure parallel to the axial rupture. A small specimen was extracted from C023A1B2C3 adjacently to the fracture surface. The objective was to section it as close to the fracture surface as possible. A diamond saw was used to make a precise cut with limited material loss (0.5 mm). Figure 111 shows (a) C023A1B2C3 prior to the extraction of the specimen and the (b) mount after the specimen was cut. Figure 112 and Figure 113 show the microstructure for the circumferential (C023A1B2C2) and longitudinal (C023A1B2C3B) cross sections etched with 3% nital. The grains appear equiaxed and are not elongated. The findings suggest that the measured remaining wall loss of 85% was caused by metal loss due to corrosion.

The minimum remaining wall thickness was measured from a cross section through the thinnest area of the corrosion feature. Figure 110 (b) shows the metallographic section and the thinnest remaining wall measurement of 0.0496 in. (1.26 mm). This value was used for the thickness of the inner circle region (origin). Figure 182 shows the model of the corrosion feature with the origin identified. The image shows the corrosion feature positioned within the pipe such that the remaining wall matched the minimum value measured from the metallographic cross section. The remaining wall thickness gradually increased from the inner circle (0.0496 in. remaining wall) to the outer boundary of the corrosion feature (0.321 in. remaining wall) based on the semi-elliptical bowl profile. The semi-elliptical bowl with the inner circle (corrosion feature) was modeled as a solid object and was subtracted from the pipe body to obtain the geometry shown in Figure 182. This model is referred to in this section as Model 1 (corrosion feature without a notch).

Notch geometry was estimated from the grooves shown in the metallurgical cross section of the thinnest region (Figure 110 [b]). The measured radius of the notch was approximately 0.2 mm in diameter. This radius was beyond the capabilities of an FEA due to the global meshing requirements. A notch radius of 1.0 mm was chosen to simplify the mesh and to approximately capture the notch effect. The notch was placed in the central circular region of the semi-elliptical corrosion feature. The bottom of the notch was placed at a depth such that the remaining wall was equal to 1.26 mm, which is the same remaining wall as Model 1. The entire corrosion feature was raised by 1.0 mm to ensure the bottom of the notch coincided with the minimum remaining wall for Model 1. The length of the notch was sized to match the length of the origin 2.13 in. (origin length). This model is referred to in this section as Model 2. Figure 183 shows the 3D schematic and mesh for the Model 2 corrosion feature with the 2.13 in. notch. The modeling assumptions for Model 2 were made to satisfy the following two objectives:

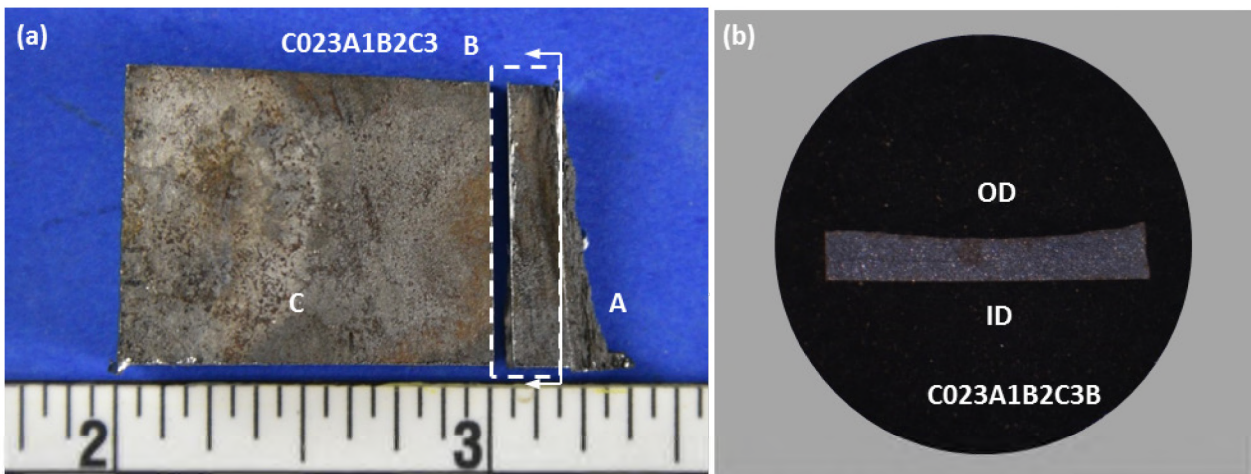
**Figure 111: (a) C023B2C3 Section Layout and (b) Resulting C023B2C3B Mount**

Ductile tearing and bulging could have contributed to the final remaining wall by ductile deformation. The measured remaining wall would have then been a combination of the original metal loss due to corrosion and thinning caused by the axial rupture. Cross sections adjacent to the fracture surface were examined to determine if bulging and ductile tearing contributed to the remaining wall thickness measurement.

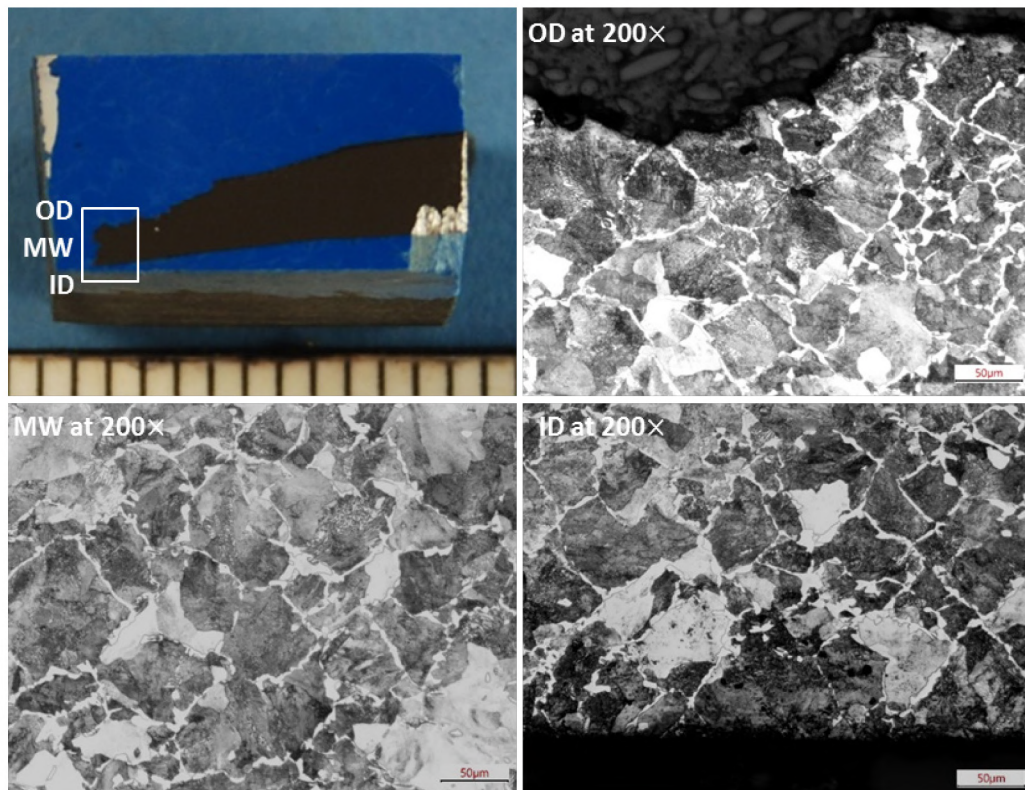
Figure 112: Micrographs of Equiaxed Grain Shape at Thinnest Area Taken at 200X

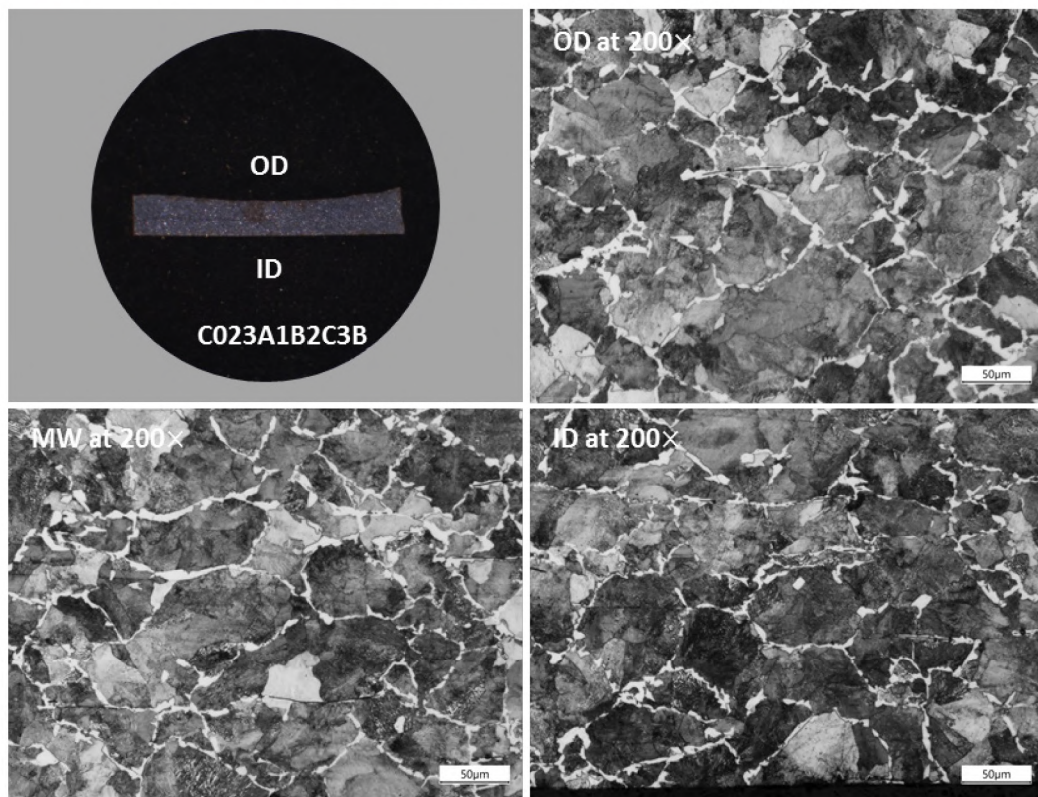
Figure 113: C023A1B2C3B Micrographs of Equiaxed Grain Shape Taken at 200X

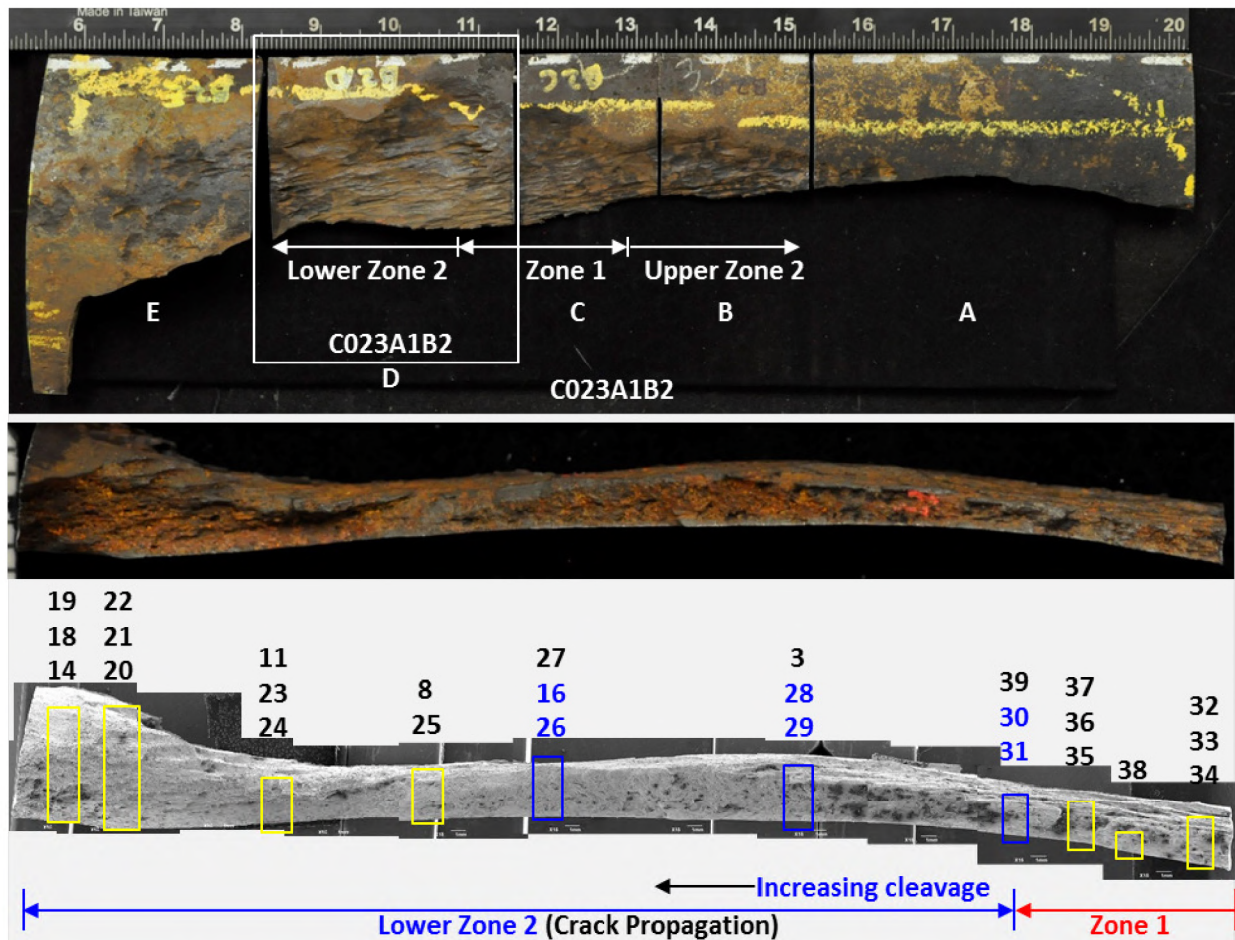
Figure 114: Specimen C023A1B2D Lower Zone 2 SEM Investigation Areas

Zone 2 was separated by Zone 1 (origin) into two segments referred to as Upper and Lower Zone 2 in reference to the zones' relative position in the SS-25 well. Figure 114 shows the separation of Lower and Upper Zone 2. Specimen C023A1B2D in Lower Zone 2 was examined first in detail. Figure 114 shows the non-cleaned (macro) and cleaned (SEM) C023A1B2D fracture surface. Both specimen conditions were examined with the SEM. Only the results from the cleaned examination are discussed in this section. Figure 114 shows the areas investigated with the SEM.

The SEM examination showed a mixed fracture mode that consisted of cleavage (brittle) and microvoid coalescence and dimples (ductile). The amount of cleavage increased with distance from the origin but decreased as the crack approached the lower turning point. Figure 115 through Figure 117 show typical SEM images taken from three locations in Lower Zone 2 (indicated by the blue boxes in Figure 114).

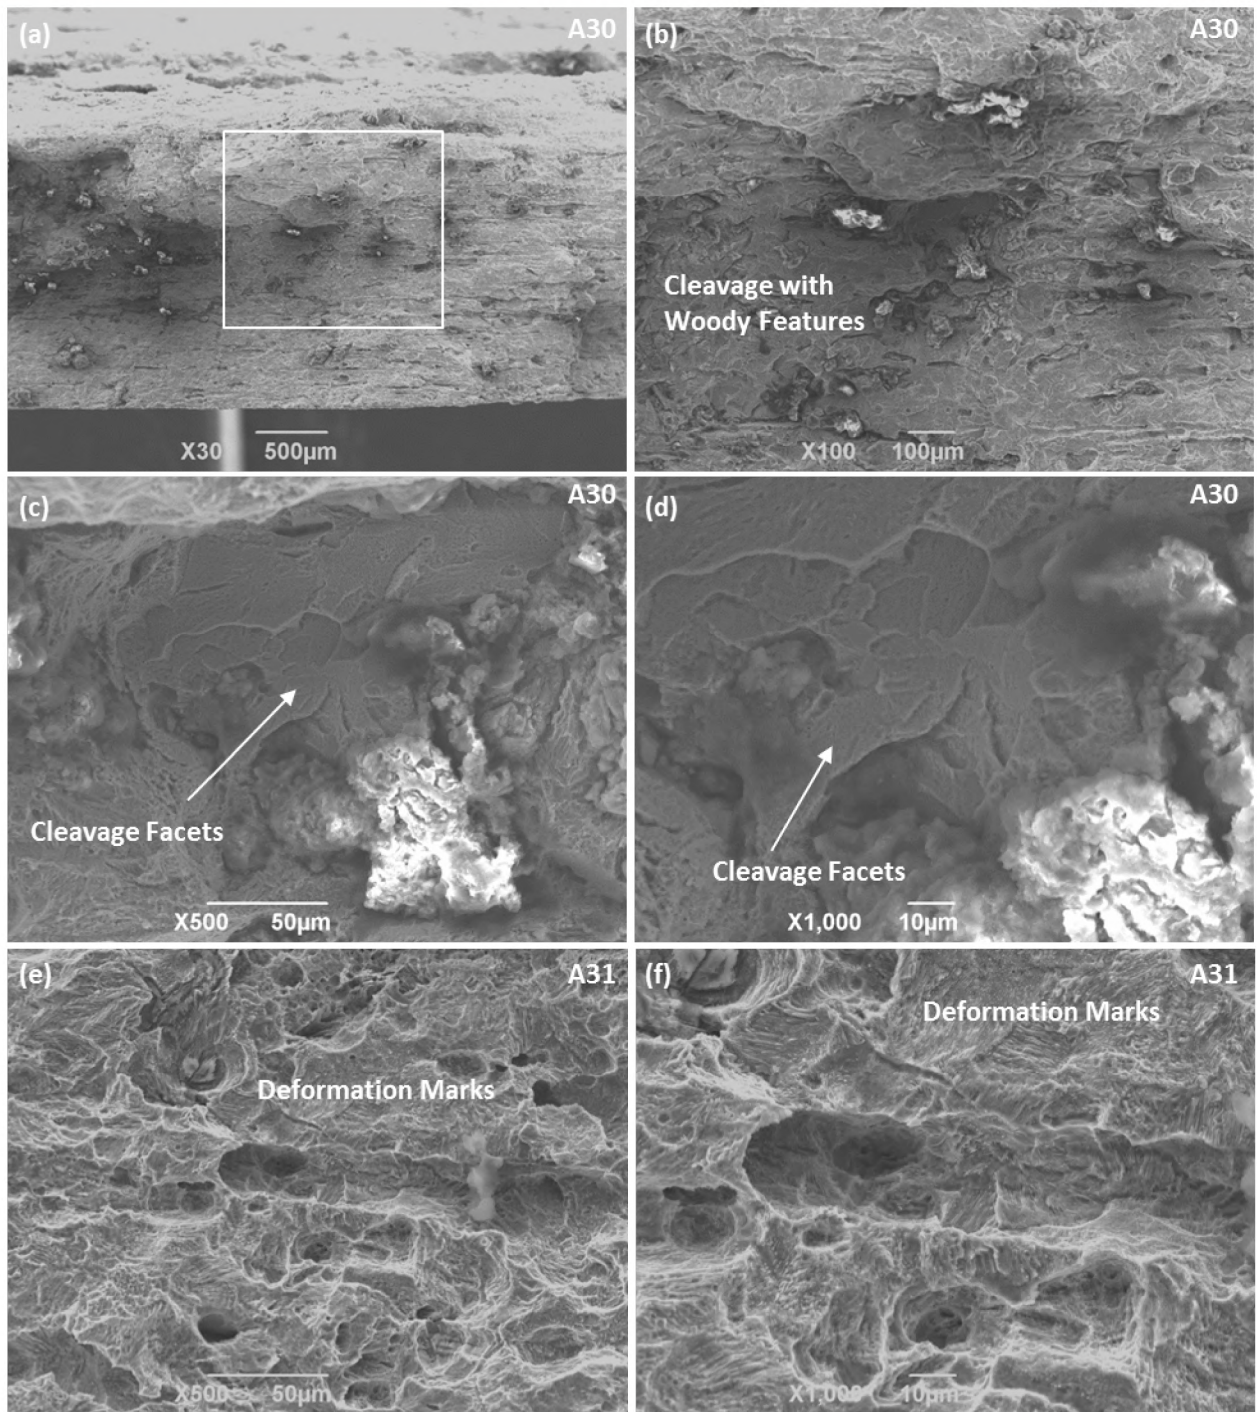
Figure 115 shows SEM images of A30 and A31, located at the mid-wall (MW) and the ID of the fracture surface, respectively. These areas were located directly below Zone 1 (origin). Figure 115 (a) and (b) show SEM images of A30 at 30 $\times$  and 100 $\times$ . The 100 $\times$  image shows cleavage mixed with woody features. Figure 115 (c) and (d) show SEM images of a cleavage facet taken at 500 $\times$  and 1,000 $\times$ . Figure 115 (e) and (f) show SEM images of deformation marks at A31 near the ID taken at 500 $\times$  and 1,000 $\times$ . The images show a mix mode fracture in Lower Zone 2.

Figure 115: SEM Images from Locations A30 and A31 Showing Mixed Fracture Mode

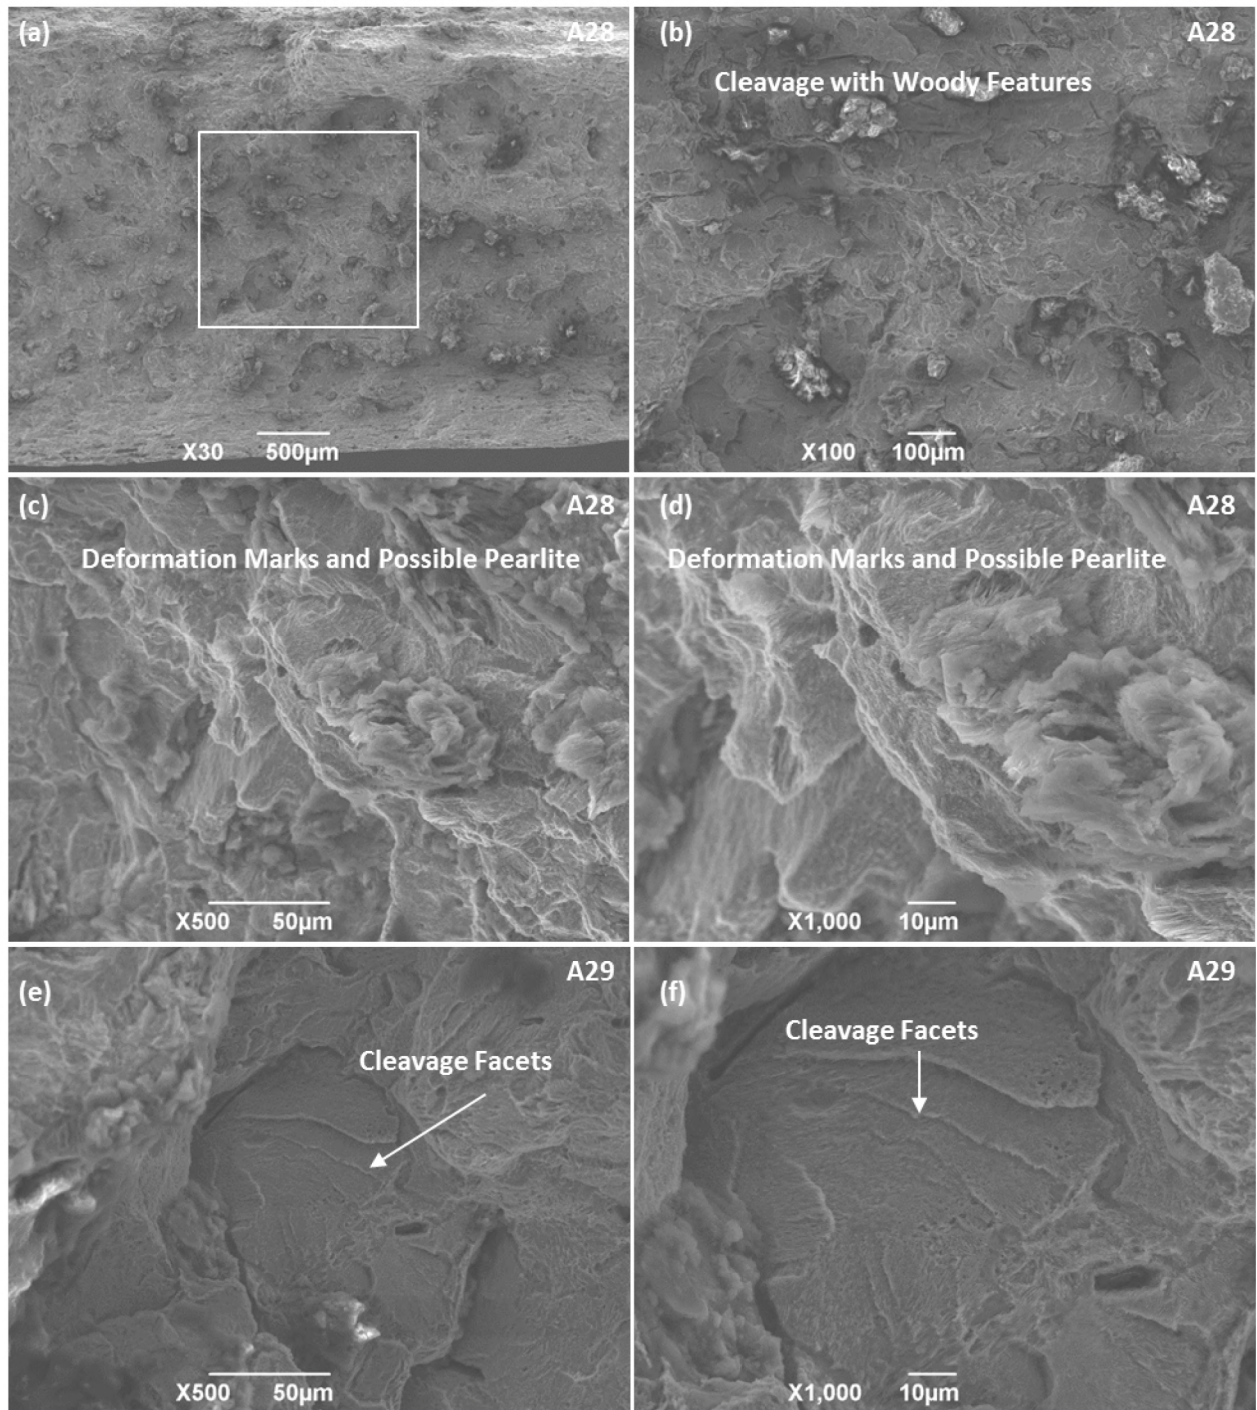
Figure 116 shows SEM images of A28 and A29, located at the MW and ID of the fracture surface, respectively. These areas were located below A30 and A31, which were farther from the origin towards the lower turning point. Figure 116 (a) and (b) show SEM images of A28 at 30 $\times$  and 100 $\times$ . The 100 $\times$  image shows cleavage mixed with woody features that are consistent with the observations of A30. Figure 116 (c) and (d) show SEM images of deformation marks and possible pearlite taken at 500 $\times$  and 1,000 $\times$ . Figure 116 (e) and (f) show SEM images of cleavage facets at A29 near the ID taken at 500 $\times$  and 1,000 $\times$ . The observations of A28 and A29 were consistent with the observations of A30 and A31.

Figure 116: SEM Images from Locations A28 and A29 Showing Mixed Fracture Mode

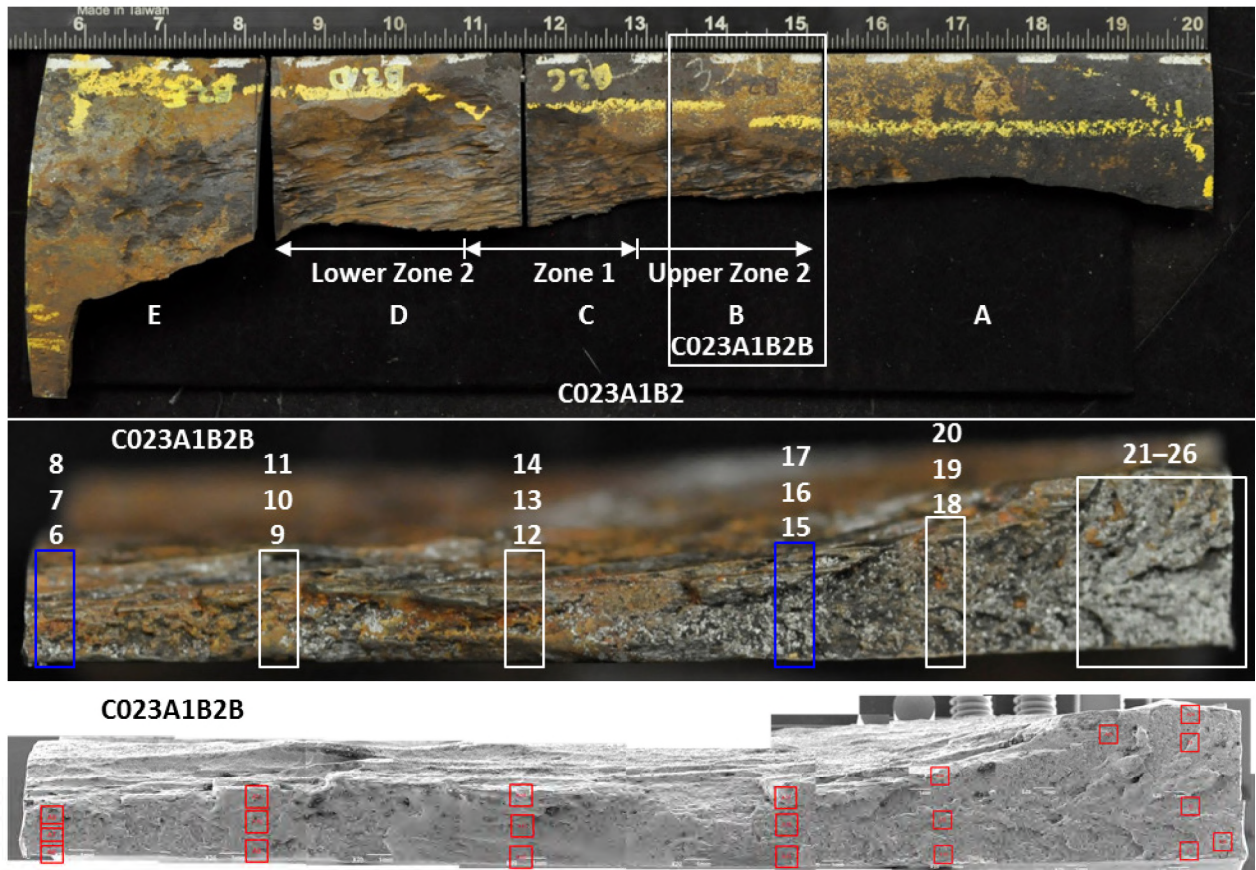
**Figure 118: Specimen C023A1B2B Upper Zone 2 SEM Investigation Areas**

Upper Zone 2 was also examined with the SEM. Specimen C023A1B2B was selected for a detailed examination of Upper Zone 2 with the SEM. Figure 118 shows the non-cleaned (macro) and cleaned (SEM) C023A1B2B fracture surface. Both specimen conditions were examined with the SEM. Only the results from the examination of the cleaned fracture surface are discussed in this section. Figure 118 also shows the areas investigated with the SEM. The observed micro mechanism for crack propagation was a mixed fracture mode consisting of cleavage and dimples. Figure 119 and Figure 120 show typical SEM images from two locations in Upper Zone 2 (indicated by the blue boxes in Figure 118). The micro structure for Upper Zone 2 appears to be similar to Lower Zone 2.

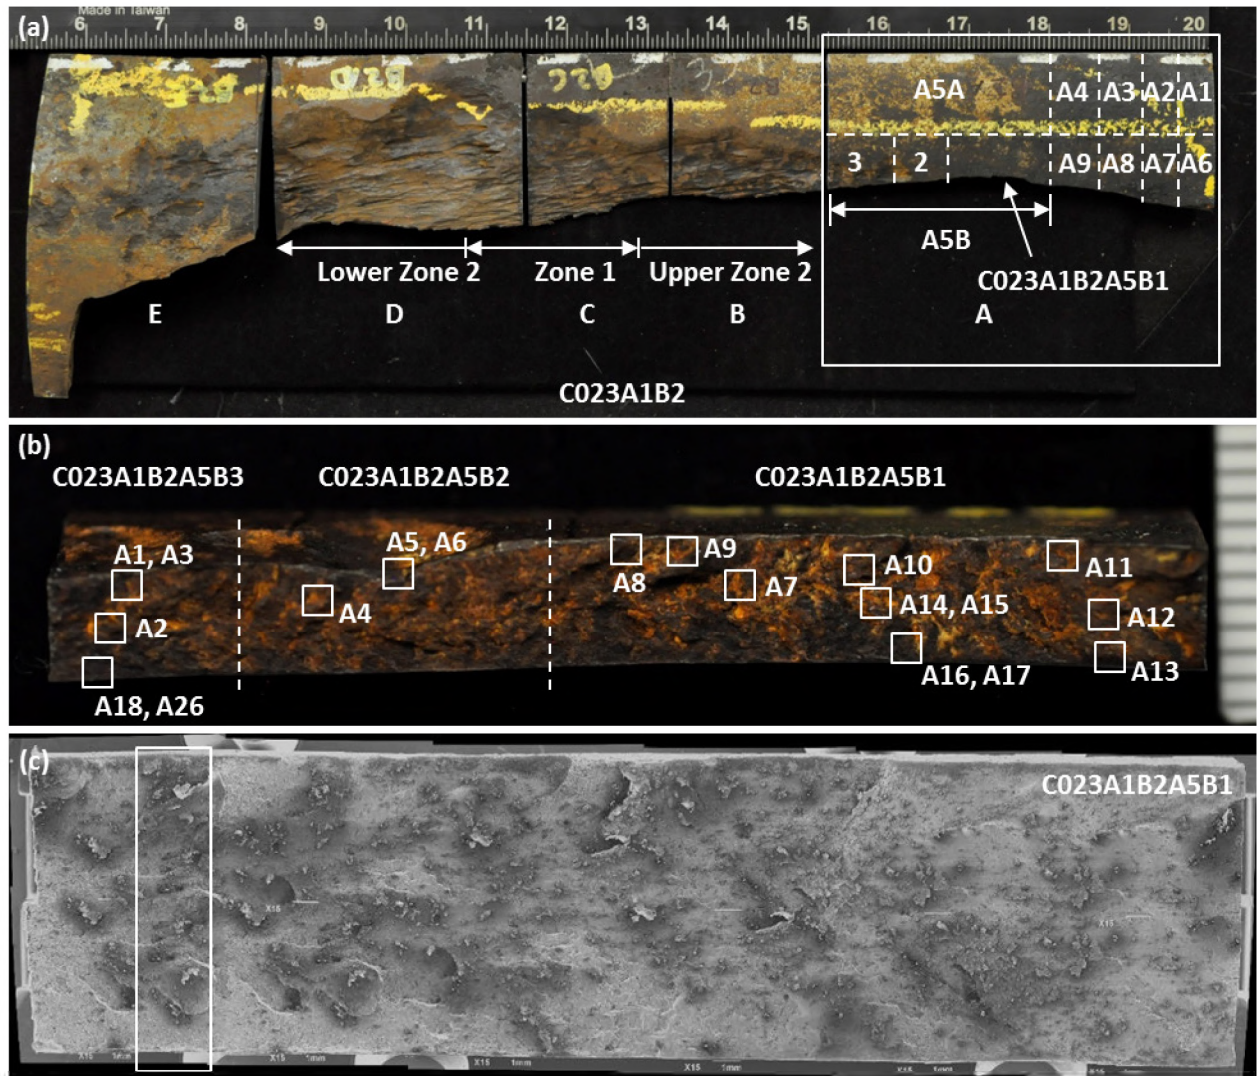
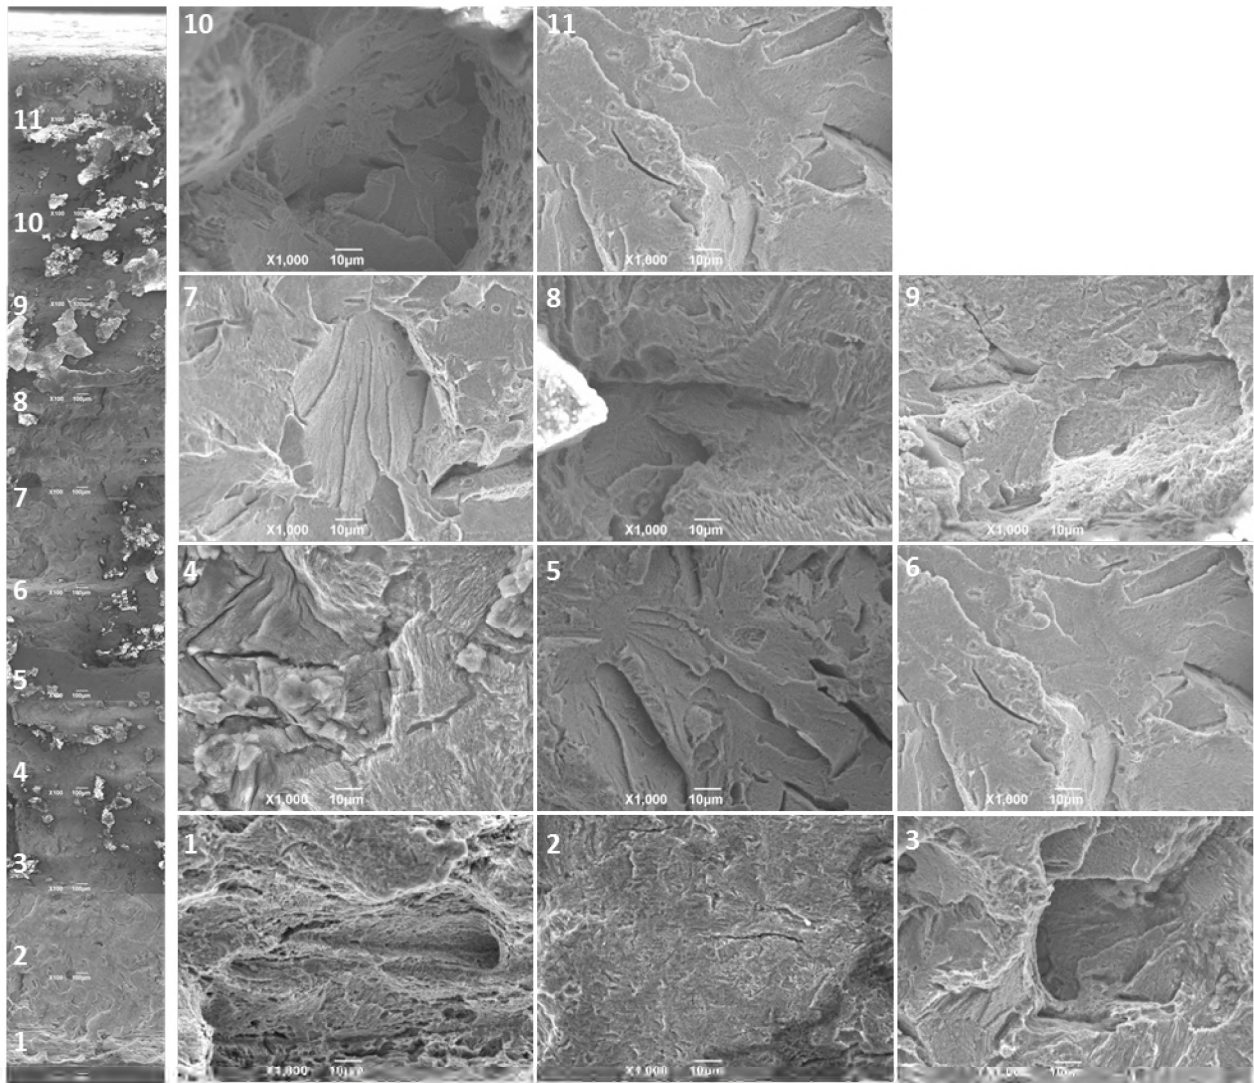
Specimen C023A1B2A was also examined with the SEM. Specimen C023A1B2A consisted entirely of Upper Zone 2 fracture surface. The specimen was cut into several smaller specimens to accommodate the size restrictions imposed by the SEM stage. Specimen C023A1B2A5B3 was examined with the SEM in detail. Figure 121 (a) shows the extraction location for specimen C023A1B2A5B1. Figure 121 (b) shows C023A1B2A5B in the non-cleaned condition prior to extracting specimen C023A1B2A5B1 for cleaning and SEM investigation. Figure 121 (c) shows an SEM image of specimen C023A1B2A5B1 in the cleaned condition. The SEM images were taken from the ID to the OD at 1,000× and stitched together to form a complete cross section of the fracture surface. Figure 122 shows the stitched SEM images. Cleavage facets with dimples and plastic deformation marks were observed throughout the cross section. The observations confirm a mix mode fracture in Upper Zone 2 (crack propagation). These findings are consistent with Upper Zone 2’s specimen C023A1B2B and Lower Zone 2’s specimen C023A1B2D.

Figure 121: Specimen C023A1B2A5B1 Extraction Location and SEM Investigation Areas

Figure 122: Specimen C023A1B2A5B1 SEM Images from ID to OD

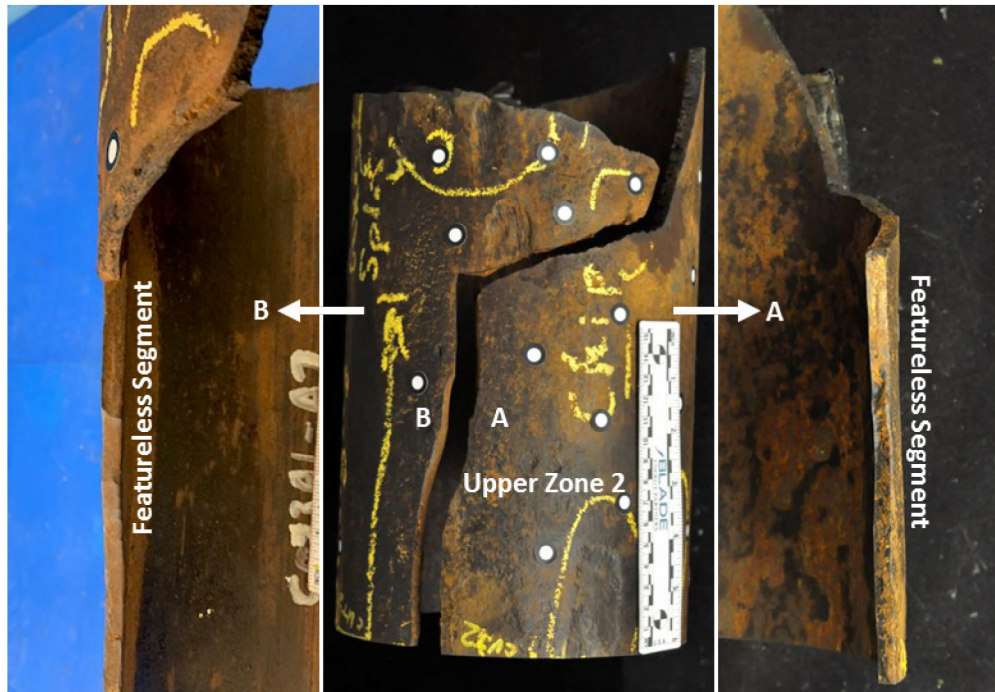
Figure 123: Overview of Upper Featureless Zone

Section 3.2.1 indicated that the upper portion of Zone 2 (crack propagation) contained chevron marks and a 9 in. long featureless region that was not present in Lower Zone 2. The 9 in. featureless region appeared to be relatively smooth with no visible chevron marks. Visual examination of the featureless region suggested that the fracture surface had been eroded by escaping gas caused by the axial rupture. This section discusses the detailed micro examination performed on the featureless region of the upper portion of Zone 2.

Figure 123 is an overview of the upper portion of Zone 2. Fracture surfaces A and B are the mating surfaces of the rupture that show the Zone 2 featureless segment. Fracture surface A was used in the examination, while fracture surface B was preserved.

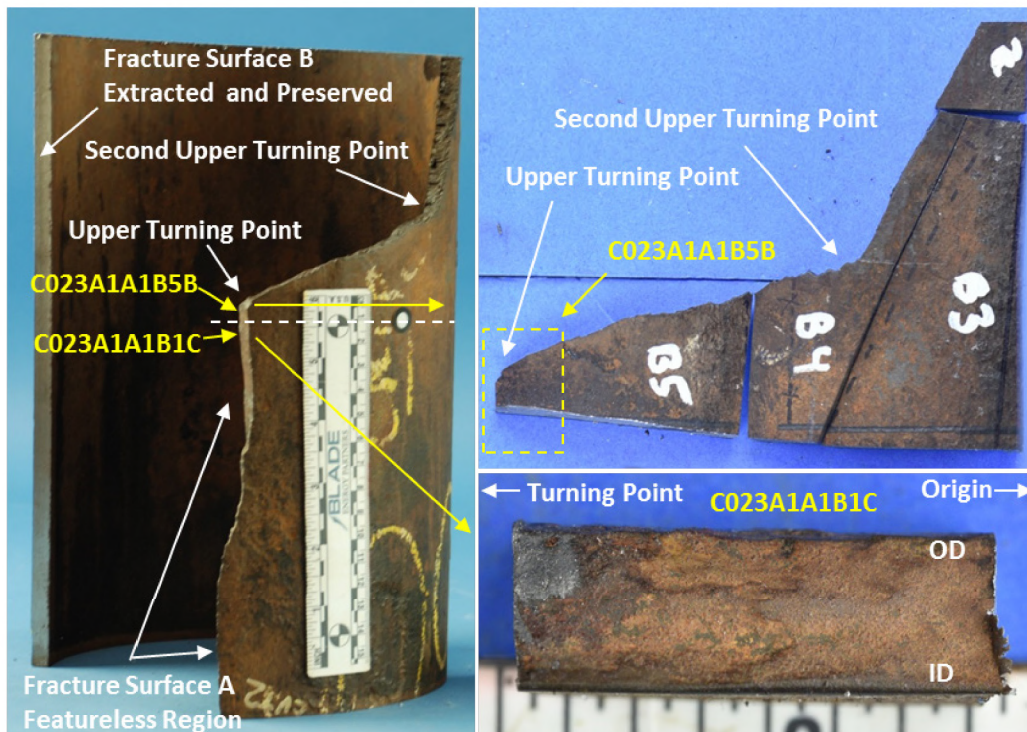
Figure 124: Fracture Surface A Featureless Region of Upper Zone 2

Two specimens were investigated to characterize the Upper Zone 2 featureless region. Figure 124 shows a schematic with the specimen locations. Specimen C023A1A1B5B contained a small section of the featureless zone and the upper turning point. Specimen C023A1A1B1C contained a portion of the featureless zone directly below specimen C023A1A1B5B. Both specimens were examined with the SEM.

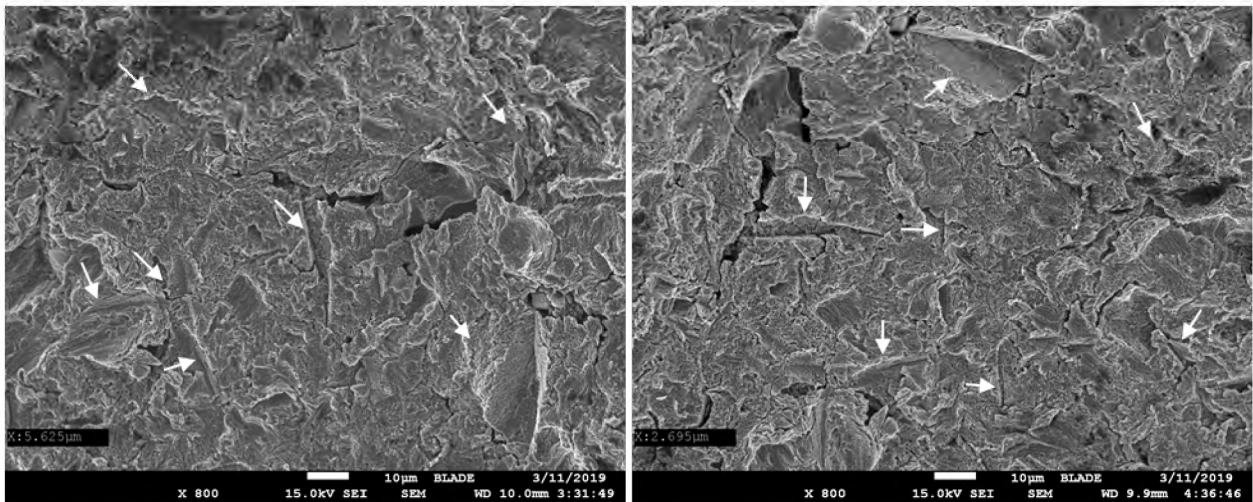
Specimen C023A1A1B5B was examined first; it was extracted and cleaned ultrasonically in a 1% Citranox solution for 6 minutes at room temperature. SEM observations revealed an eroded fracture surface with fine erosion marks. Figure 125 shows the representative SEM images of the eroded fracture surface. Erosion marks left on the fracture surface were readily identified at magnifications above 500 $\times$ . Thirty randomly selected erosion marks were measured to estimate the particle size of the solids in the released gas flow. Figure 126 shows the measured width distribution of the 30 randomly selected erosion marks. The results showed that the erosion marks had a maximum measured width of 8  $\mu\text{m}$ , and more than 60% of the erosion marks had measured widths within the range of 4–6  $\mu\text{m}$ .

Multiple factors may contribute to the width of erosion marks, including solid particle size, hardness, brittleness, speed, and angle of impingement. A factor of 3 was used to estimate the particle size based on the width of the erosion marks. Based on this assumption, the particles had a maximum size of 24  $\mu\text{m}$ , and more than 60% of the particle sizes were in the range of 12–18  $\mu\text{m}$ . These observations confirm that the featureless segment of Upper Zone 2 was affected by erosion.

Figure 125: Representative SEM Images of Erosion Marks (White Arrows) Taken at 800 $\times$

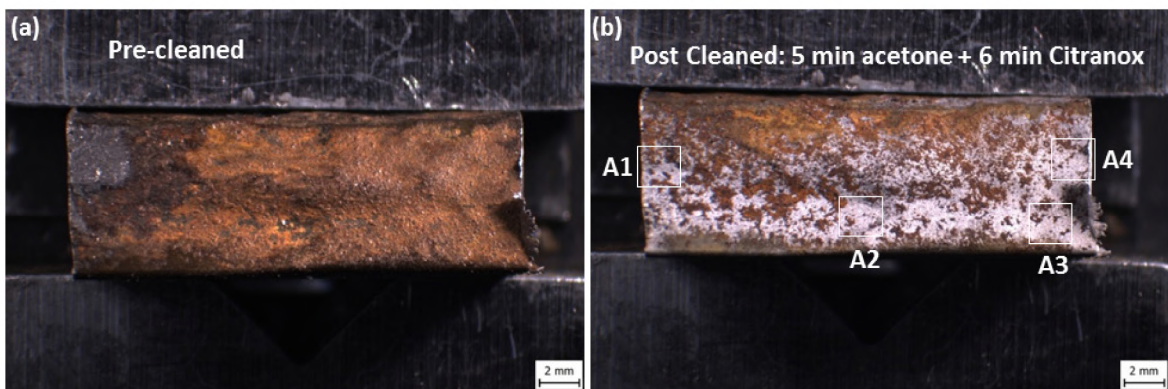
Figure 127: Specimen C023A1A1B1C (a) Before and (b) After Cleaning

Specimen C023A1A1B1C was also located in the featureless segment of Upper Zone 2. Figure 127 shows the specimen in the (a) non-cleaned and (b) cleaned conditions. Figure 127 (b) shows the four areas examined with the SEM. A1 was the closest to the previously examined specimen C023A1A1B5B (adjacent to upper turning point). A2–A4 were progressively lower (towards visible chevron marks in Zone 2) on the

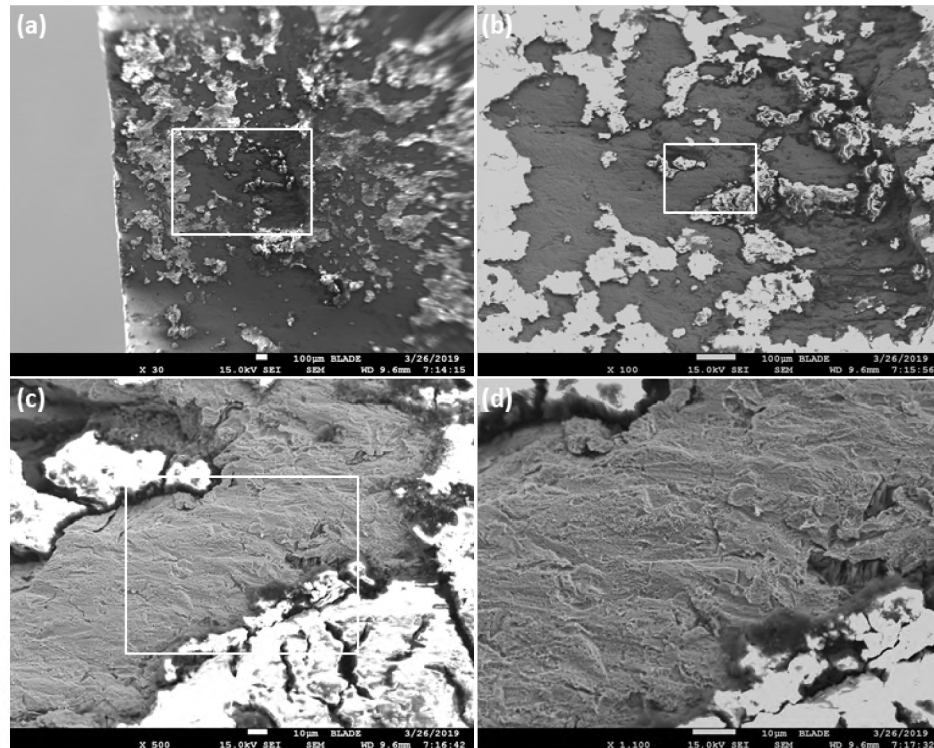
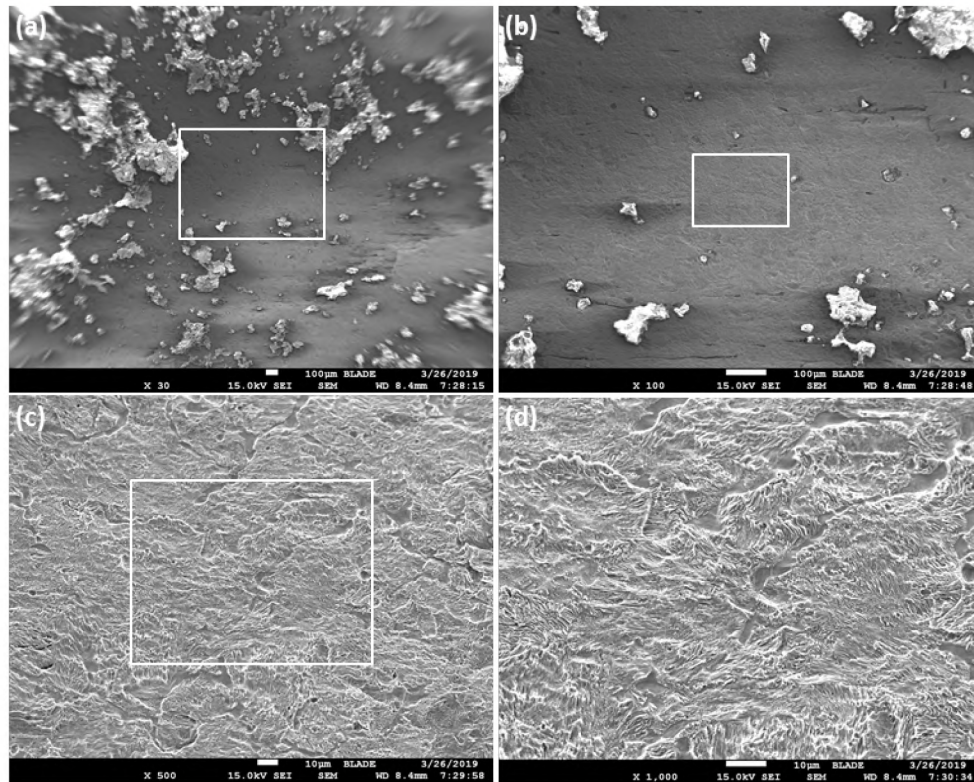
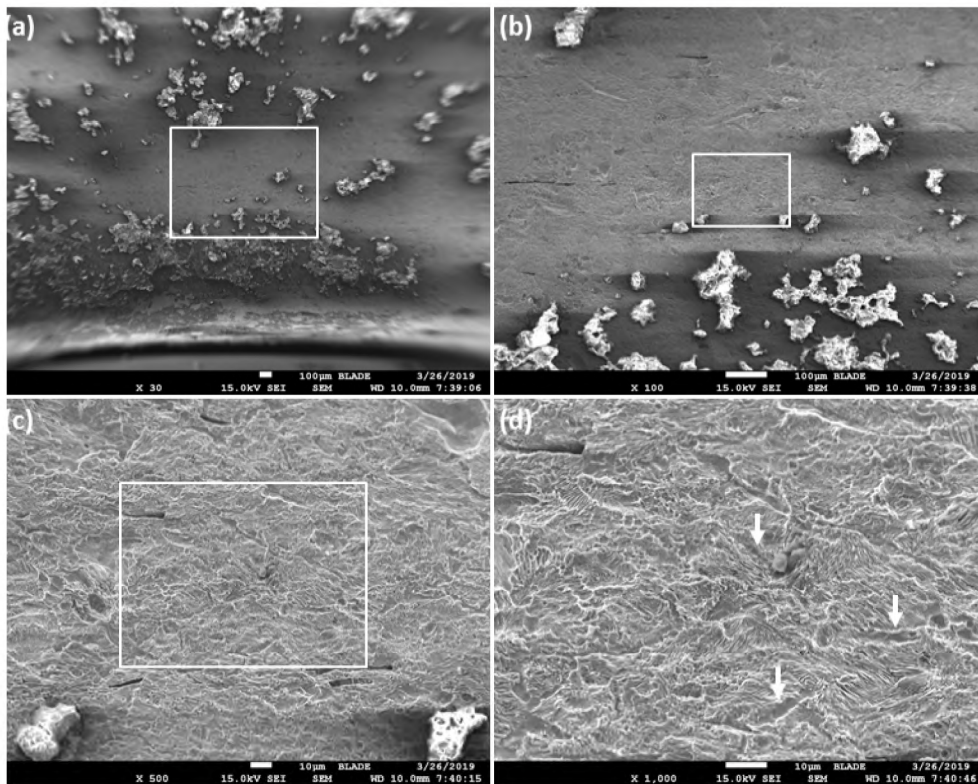
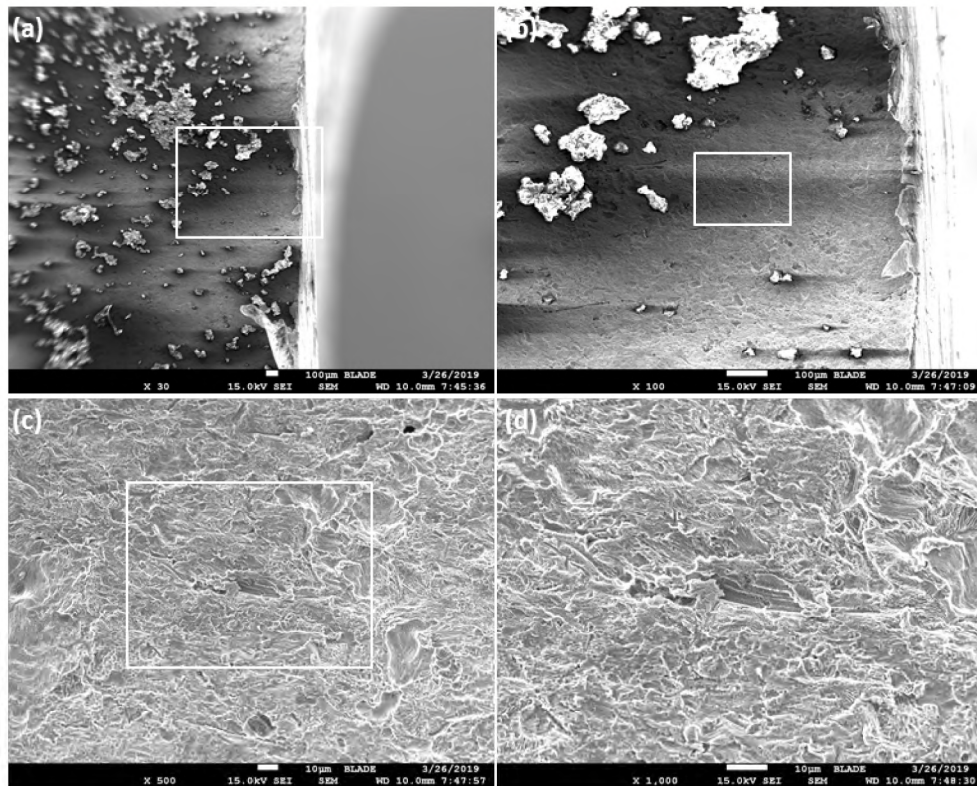
specimen. Figure 128 through Figure 131 show representative SEM images of specimen C023A1A1B1C. The SEM images show some erosion marks as was observed with the previous specimen. The fracture surface that revealed the pearlite microstructure appeared to be corroded. The marks appeared to be less defined due to the corroded surface.

These observations are consistent with the observations from the previous specimen. The observations from both specimens from the featureless segment of Upper Zone 2 confirmed that the featureless segment was a result of erosion-corrosion produced by the high-pressure gas release after the axial rupture. The erosion marks are fine, with sizes on an order of magnitude less than 8  $\mu\text{m}$ , which is not visible to the naked eye. Therefore, the surface morphology of the segment appeared to be smooth and featureless. These findings are consistent with the log interpretation in Section 2.2.7, which identified erosion features.

Figure 128: SEM Images of A1 Erosion Marks Taken at (a) 30 $\times$ , (b) 100 $\times$ , (c) 500 $\times$ , and (d) 1,100 $\times$

Figure 129: SEM Images of A2 Erosion Marks Taken at (a) 30×, (b) 100×, (c) 500×, and (d) 1,000×

Figure 130: SEM Images of A3 Erosion Marks Taken at (a) 30×, (b) 100×, (c) 500×, and (d) 1,000×

Figure 131: SEM Images of A4 Erosion Marks Taken at (a) 30 $\times$ , (b) 100 $\times$ , (c) 500 $\times$ , and (d) 1,000 $\times$
