**Blade Supplemental Report (Vol. 2: SS-25 Well Failure Causes)**

# Root Cause Analysis of the Uncontrolled Hydrocarbon Release from Aliso Canyon SS-25

May 31, 2019

# SS-25 Casing Failure Analysis

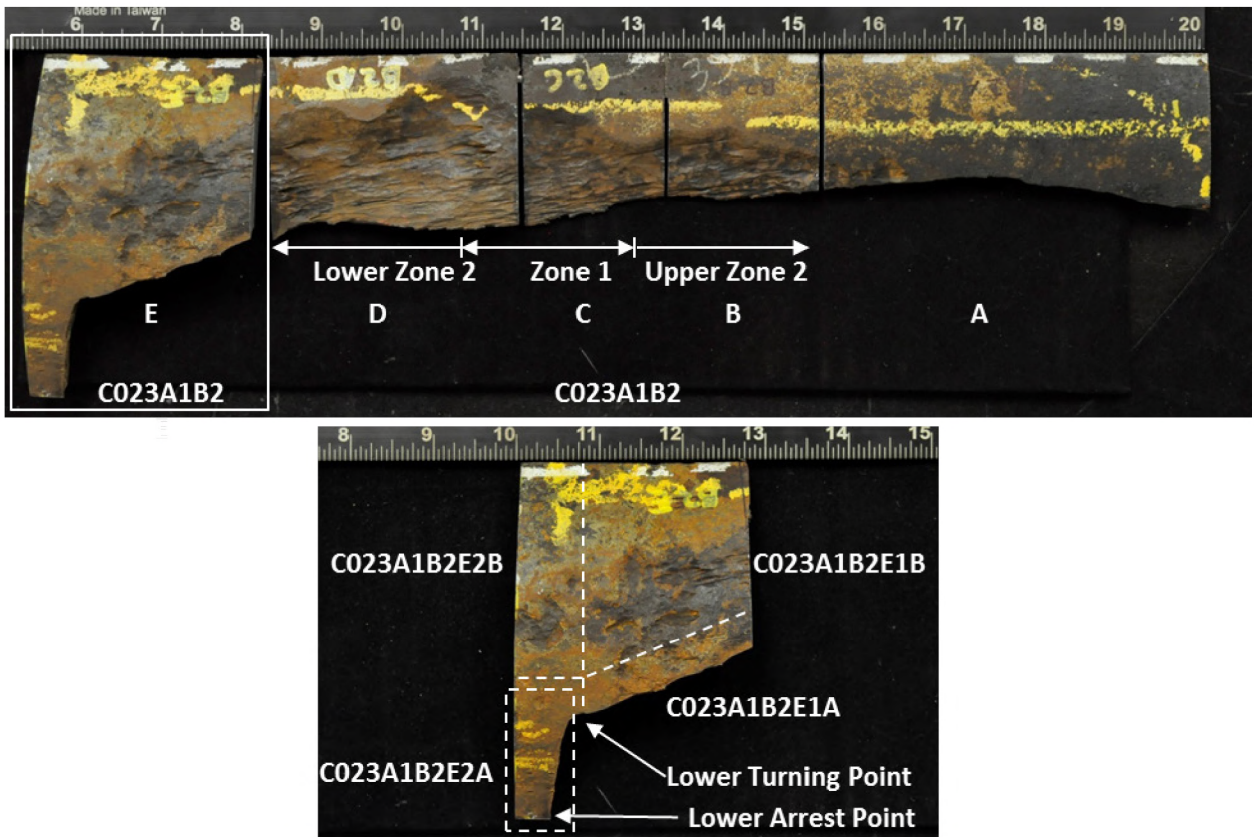
Figure 132: Specimen C023A1B2E2A Extracted from C023A1B2E

The lower arrest region is presented first. Characterization of Lower Zone 3 included the fracture surface from the lower turning point to the lower arrest point. Specimen C023A1B2E was selected for a detailed SEM investigation of the lower arrest region. The specimen was cut into smaller specimens due to the size limitations imposed by the SEM chamber. Figure 132 shows the cut locations for specimen C023A1B2E. Specimen C023A1B2E2A was examined with the SEM. The specimen contained the lower turning point, second lower turning point, and lower arrest point. All three areas were investigated as part of the Lower Zone 3 characterization. Figure 133 shows SEM images of C023A1B2E2A (a) before and (b) after cleaning. The specimen was ultrasonically cleaned with acetone for 6 minutes followed by a 1% Citranox solution for 6 minutes. Chevron marks were visible after cleaning, and this is consistent with the Upper Zone 3 observations.

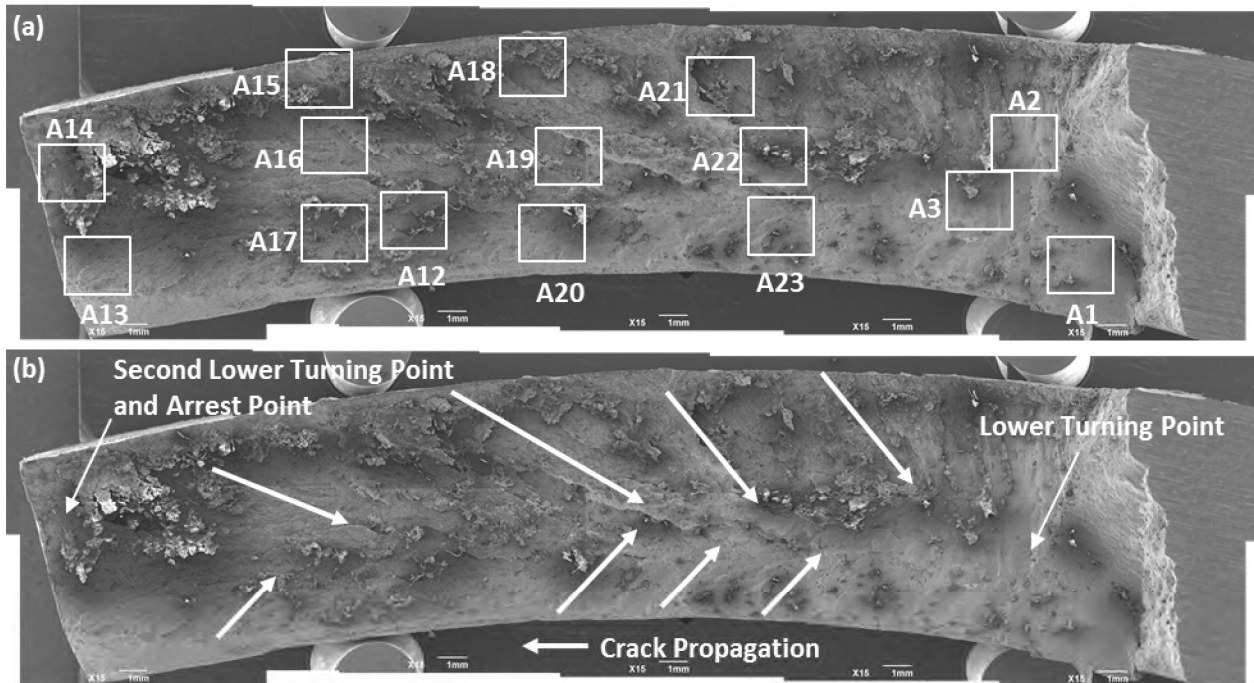
Figure 133: SEM Images of C023A1B2E2A (a) Before and (b) After Cleaning

Several areas were investigated with the SEM (Figure 133). Figure 134 through Figure 136 show SEM images of A1–A3, located at the lower turning point. The fracture surface appeared to be relatively smooth and flat at low magnifications but faceted with some deformation marks when viewed at higher magnifications. Typical cleavage facets were not observed. This observation could be due to the fact that the original cleavage structure had been corroded away.

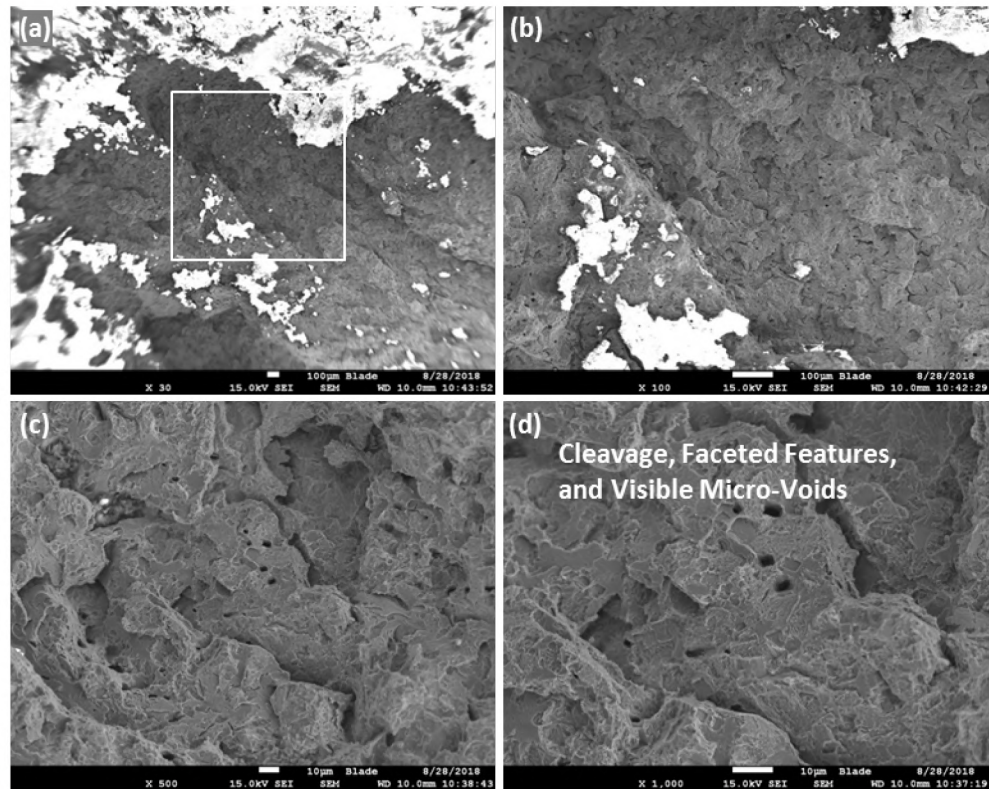
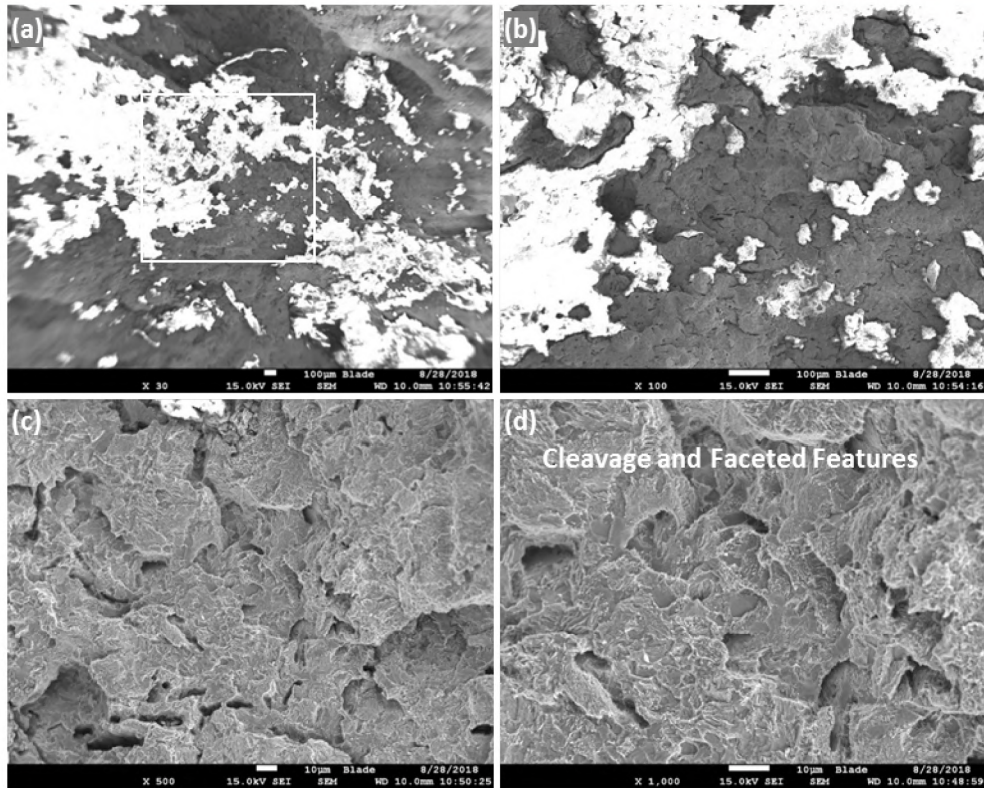
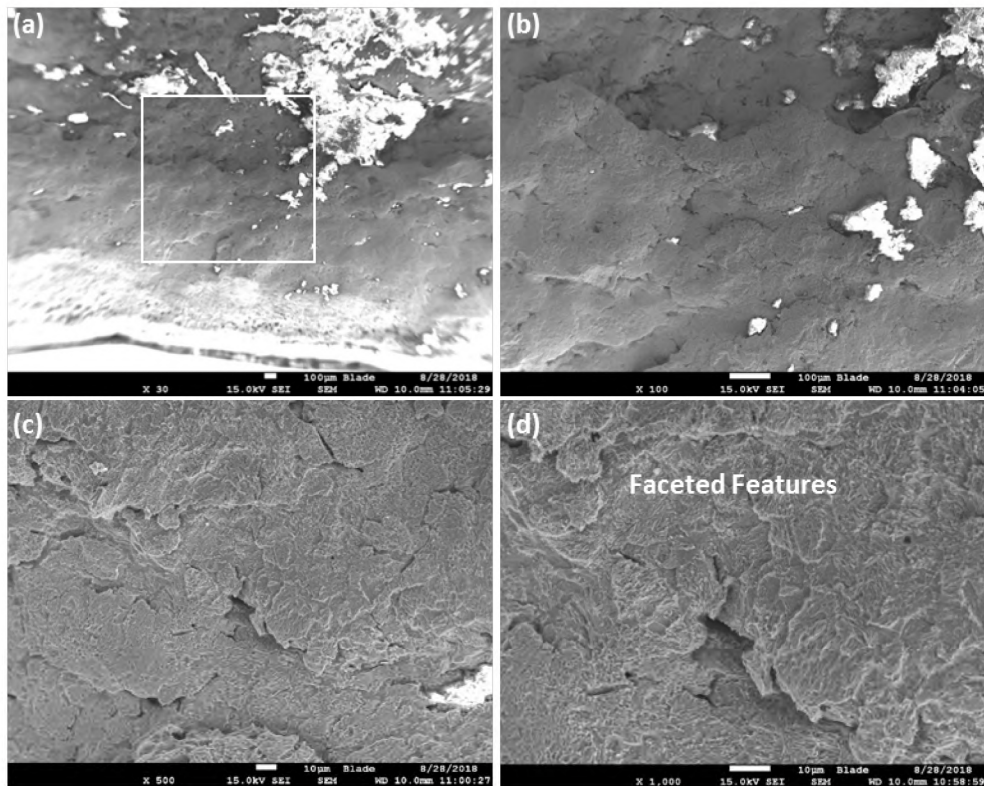
Figure 137 through Figure 139 show SEM images of A18–A20, which are from the mid-section between the lower turning point and arrest area. The fracture surface appears to be relatively smooth and flat at low magnifications. The fracture surface appears to contain faceted features and small amounts of cleavage at higher magnifications. The OD side of the fracture surface contains microvoids that were associated with inclusions (and confirmed with EDS). The MW and ID fracture surfaces did not contain similar microvoids. The cause for this difference is unclear.

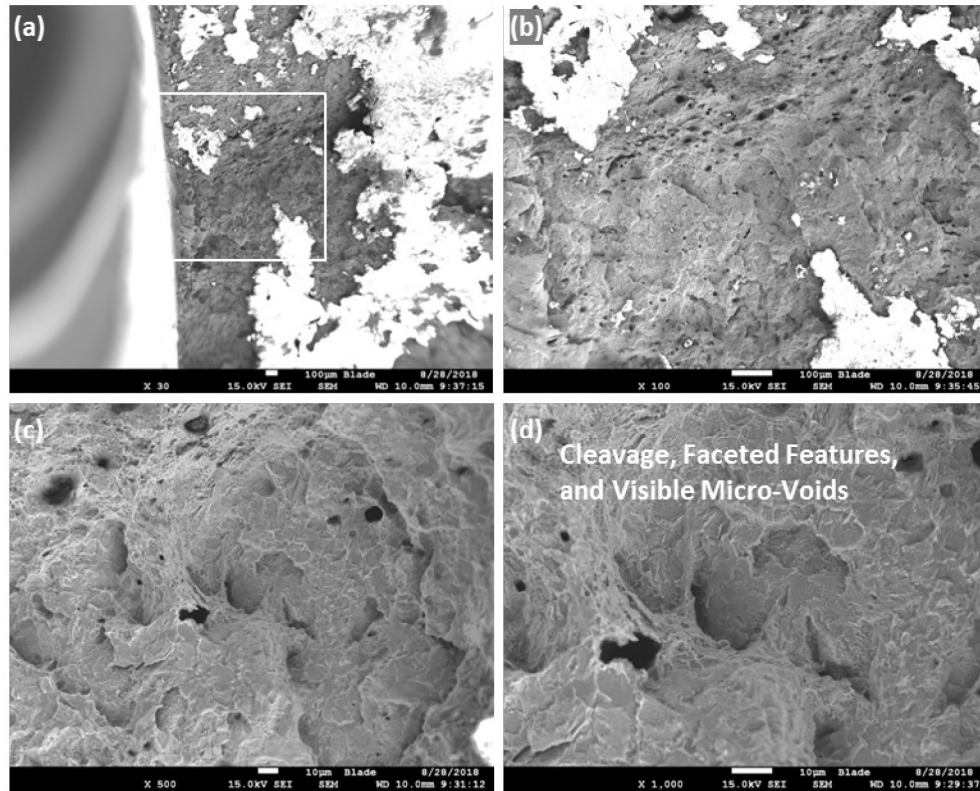
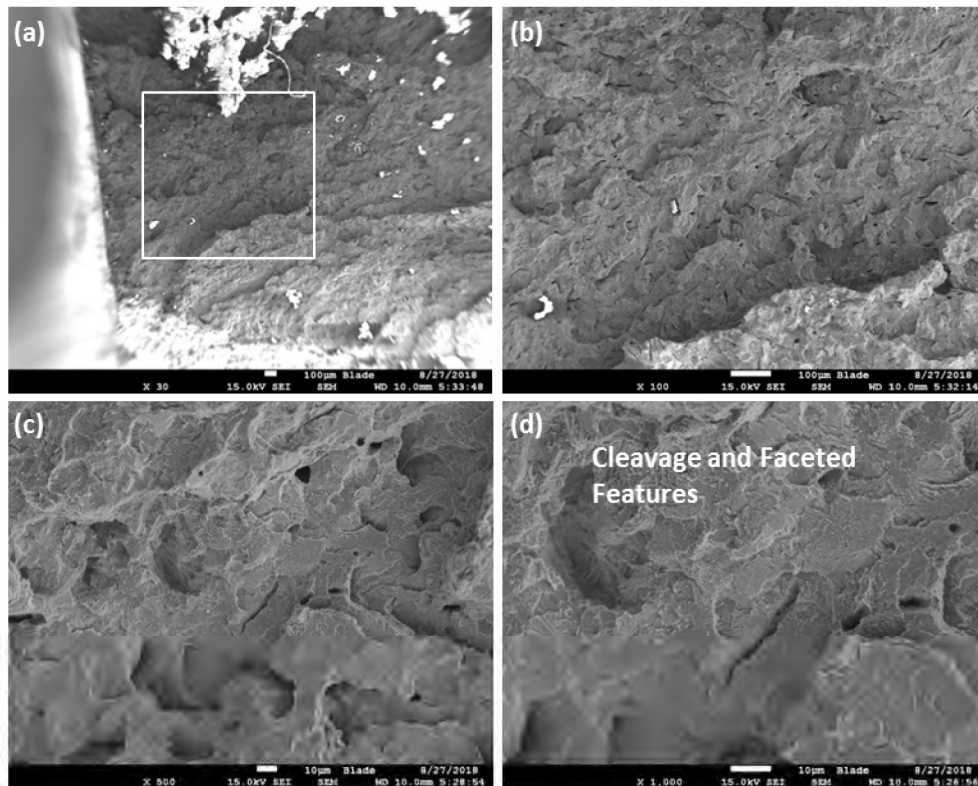
Figure 140 and Figure 141 show SEM images of A13 and A14. The fracture surface also appears relatively smooth and flat at low magnifications. The fracture surface appears to contain faceted features and cleavage at higher magnifications. The OD fracture surface contains microvoids that were associated with inclusions (confirmed with EDS). The MW and ID fracture surfaces did not contain similar microvoids. The cause for this difference is unclear.

The fracture surface morphology in the region between the lower turning point and the arrest point (Lower Zone 3) is different from Zone 2. The fracture surface appeared to have less cleavage separation and more faceted features and microvoids. The reason for this difference may be associated with a change in crack propagation speed.

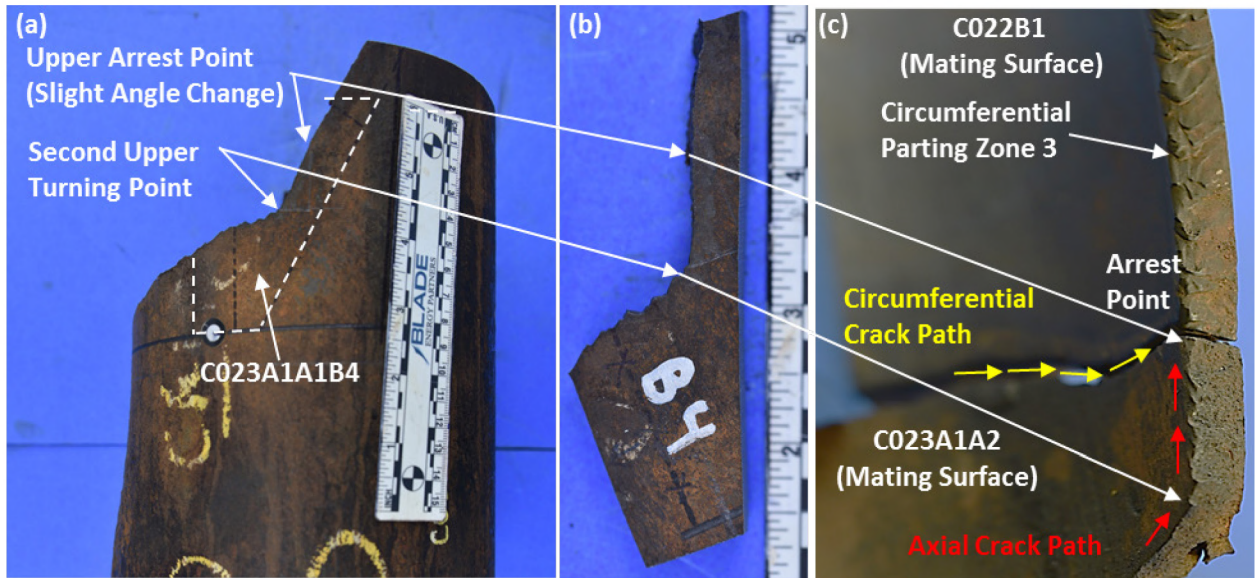
Figure 142 (a) shows the extraction location for specimen C023A1A1B4 and (b) shows specimen C023A1A1B4 after extraction. Specimen C023A1A1B4 contained the second upper turning point and upper arrest point. The upper arrest point was defined on C023A1A1B4 by a slight angle change on the inclined surface. Figure 142 (c) shows the mating surface to C023A1A1B4. The arrest location on the mating surface was clearly defined by the paths of the axial and circumferential fractures.

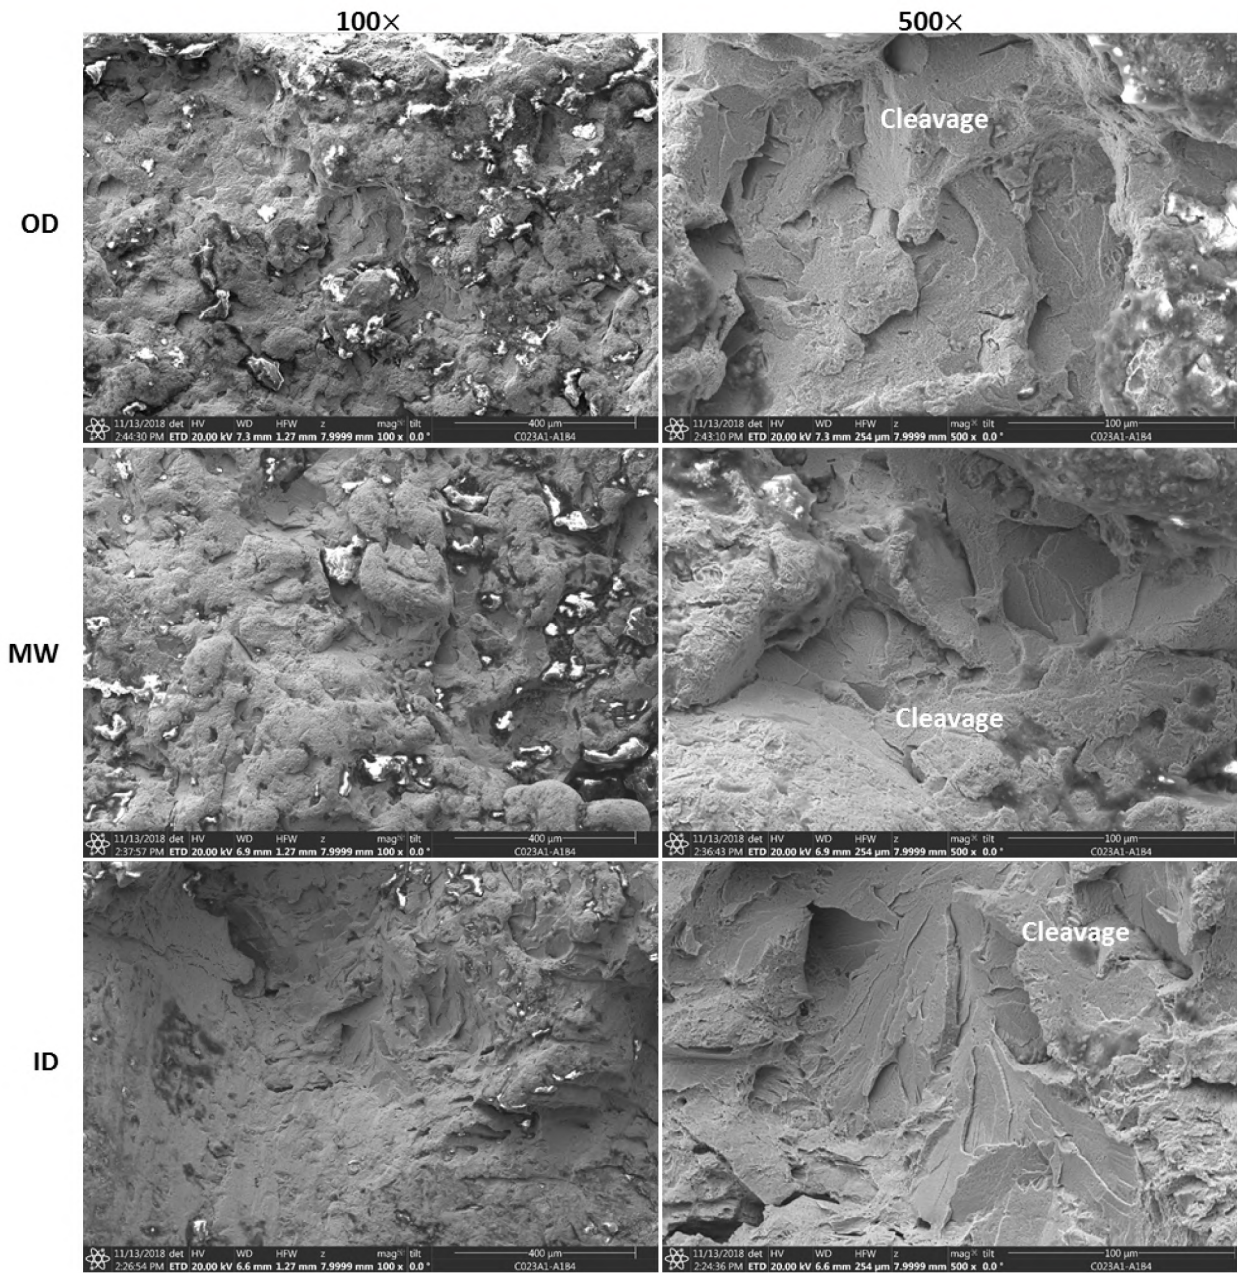
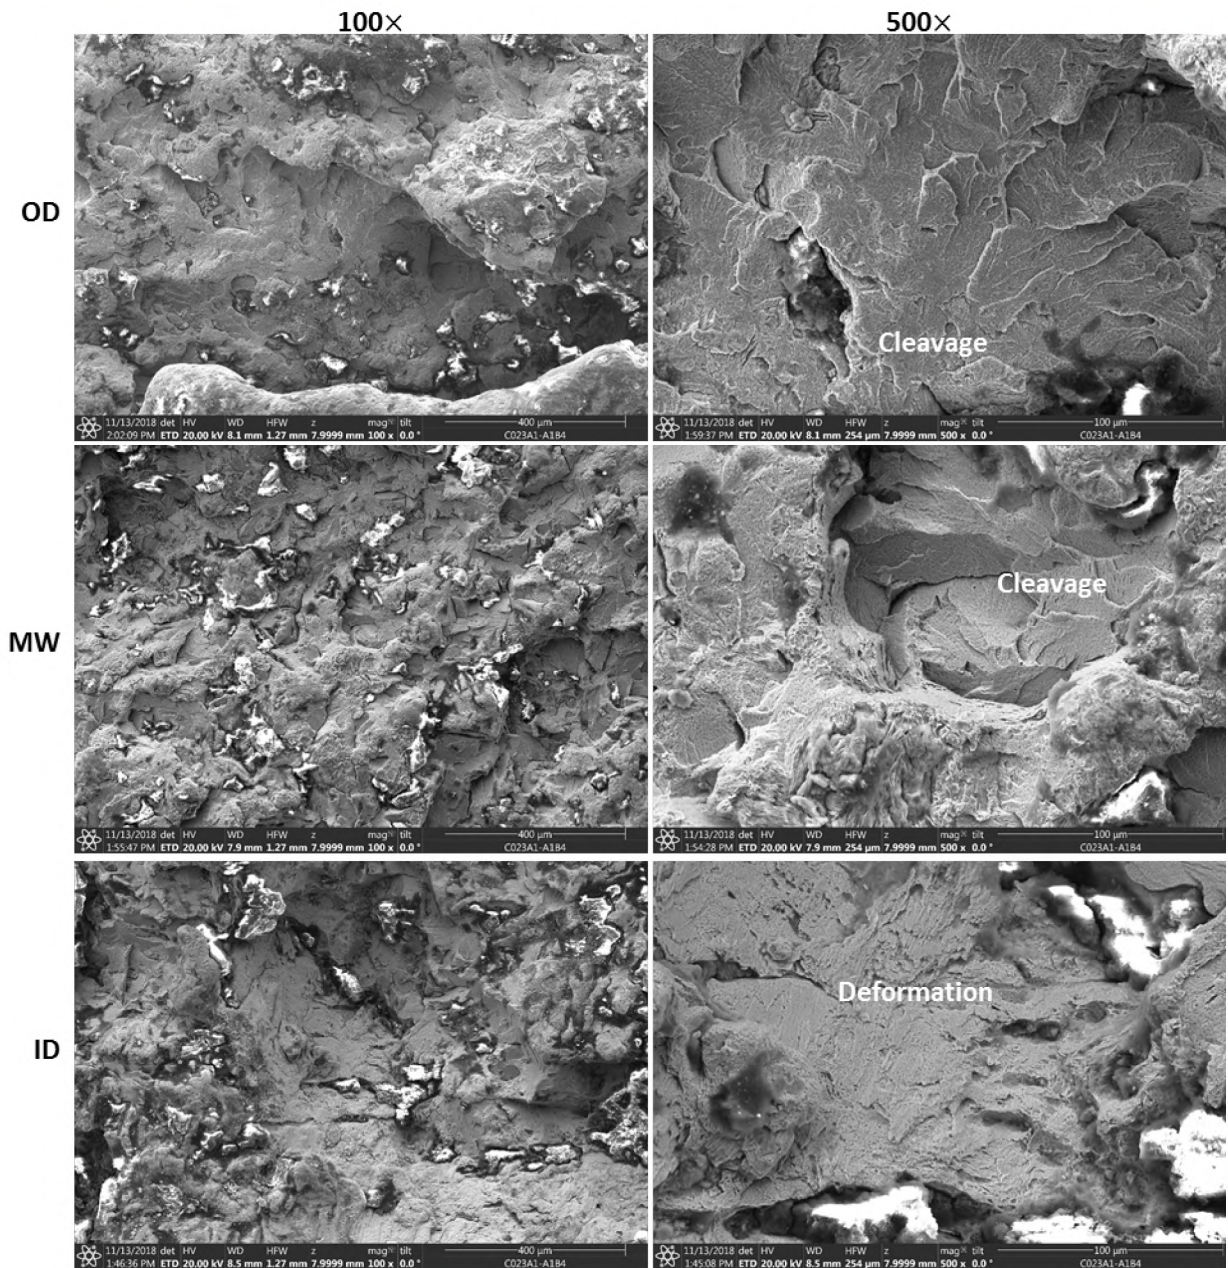
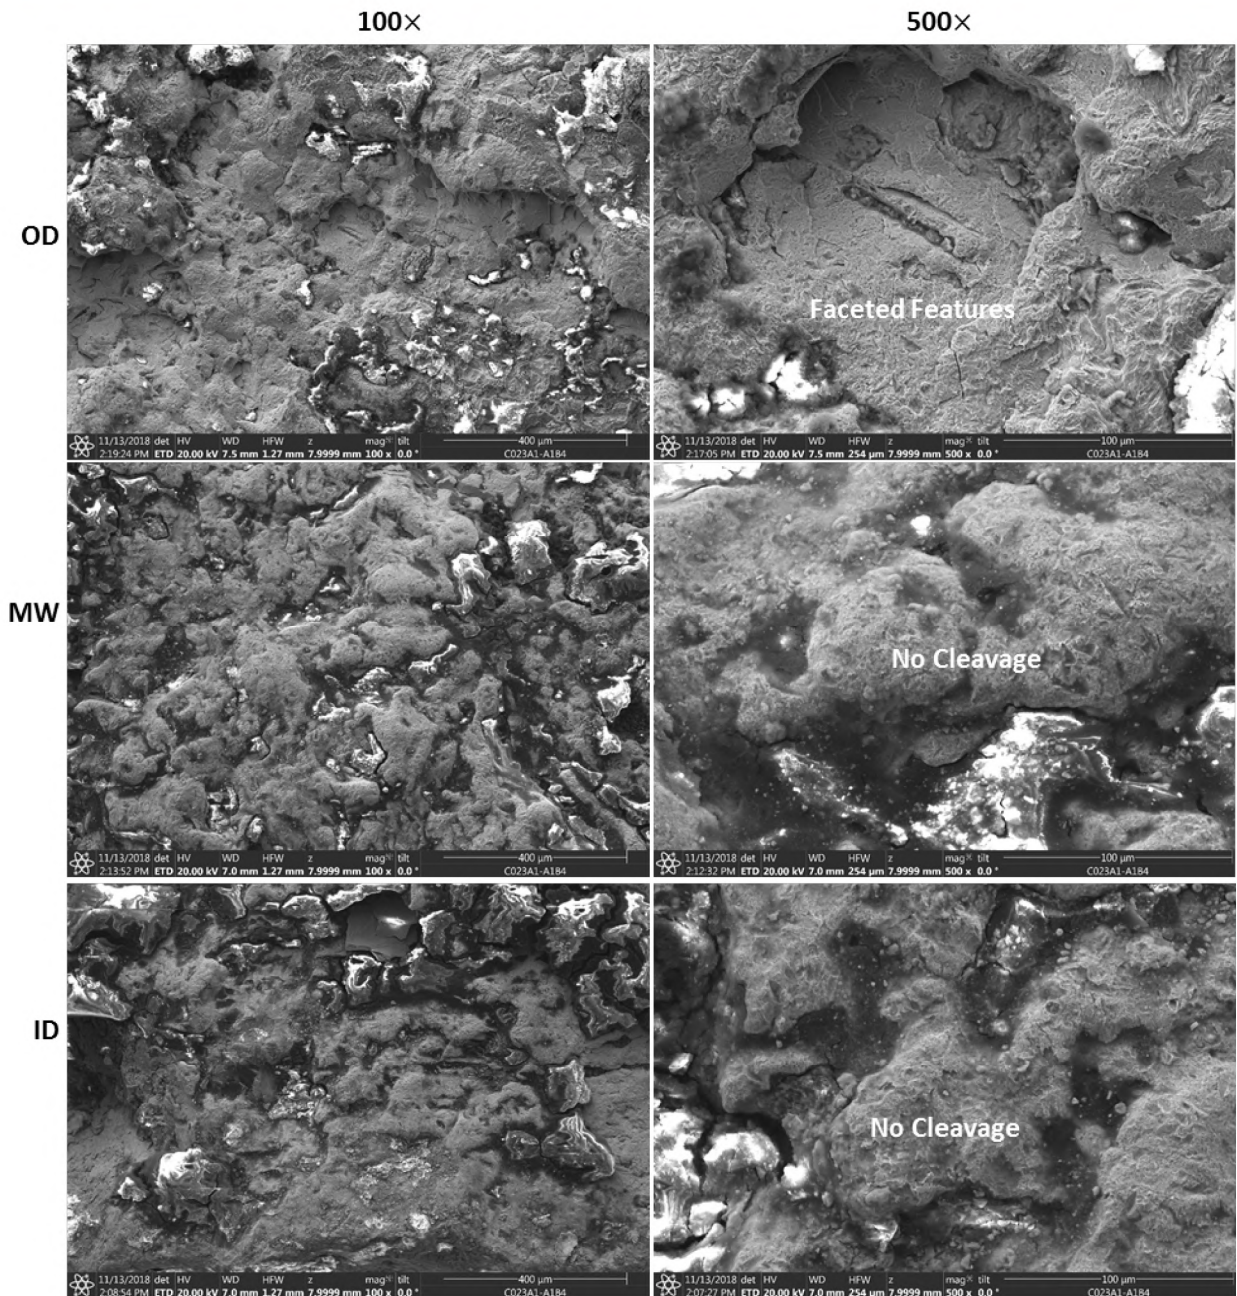
Figure 144 through Figure 146 show SEM images from areas above (A4), below (A2), and near (A3) the arrest region. The OD, MW, and ID of Area A4 (above arrest region) contained mostly cleavage features. The OD and MW of Area A2 (below arrest region) contained mostly cleavage features while the ID contained deformation marks. The OD of Area A3 (arrest region) contained some faceted features. The MW and ID appeared ductile and did not contain cleavage. The observations show a clear transition between A2 and A4, with A3 representing the arrest region, which is most likely associated with a change in crack propagation speed.

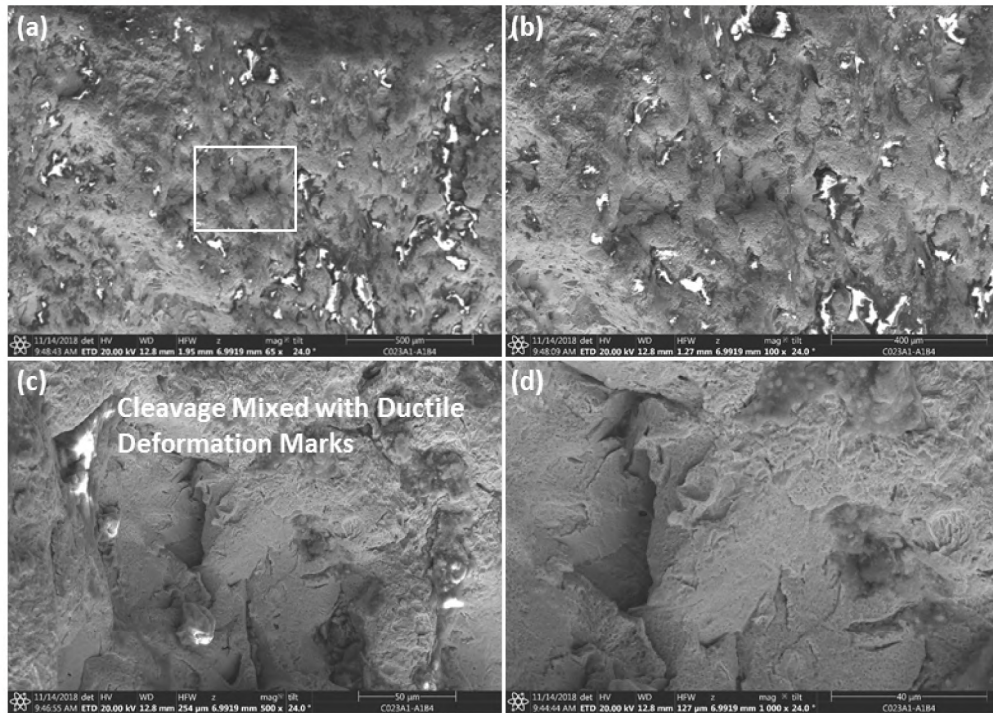
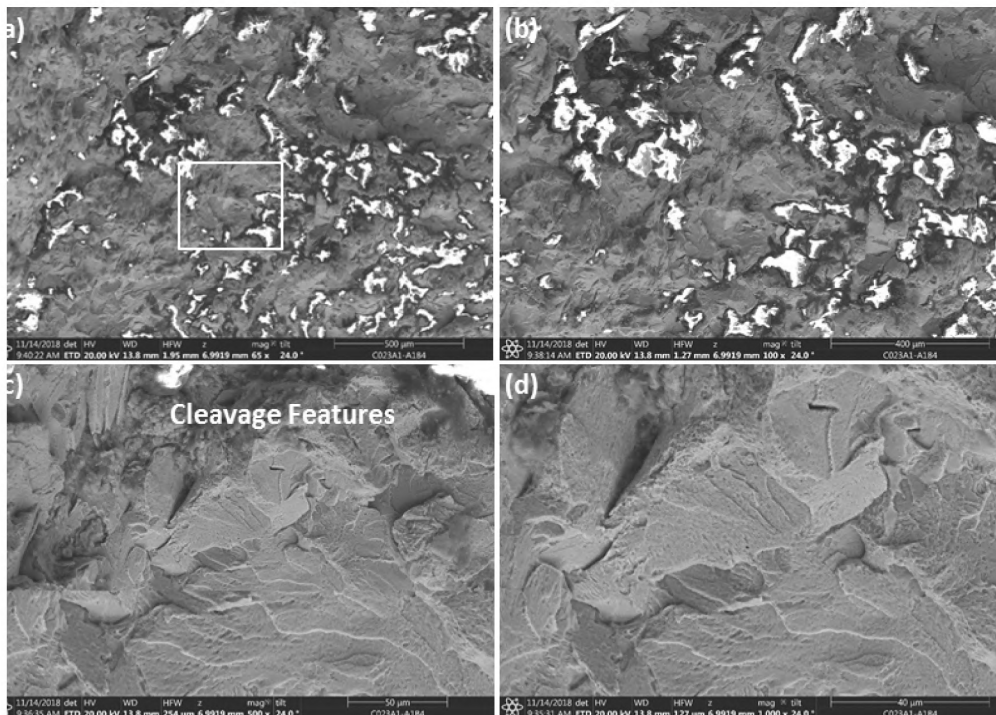
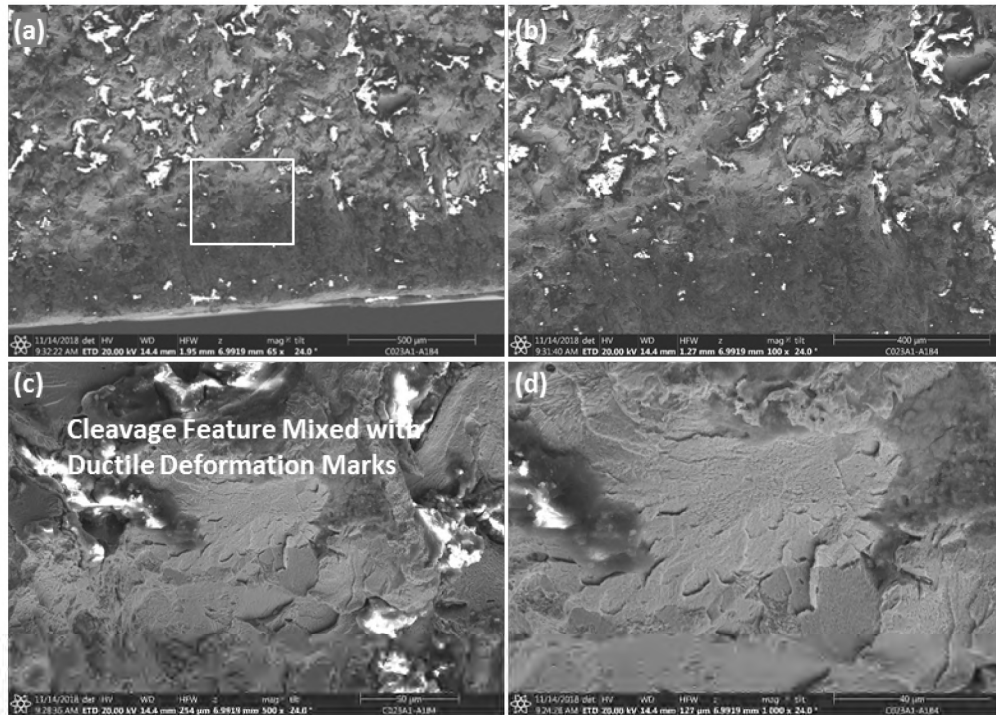
Figure 148 through Figure 150 show SEM images of the OD, MW, and ID for A7, respectively. Area A7 was located between the first and second upper turning points. The fracture surface appears relatively rough on the OD side as compared to the ID. The OD fracture surface was composed of mixed cleavage facets with deformation marks (Figure 148). The MW and ID fracture surfaces were predominantly cleavage separation when viewed at higher magnifications (Figure 149 and Figure 150).

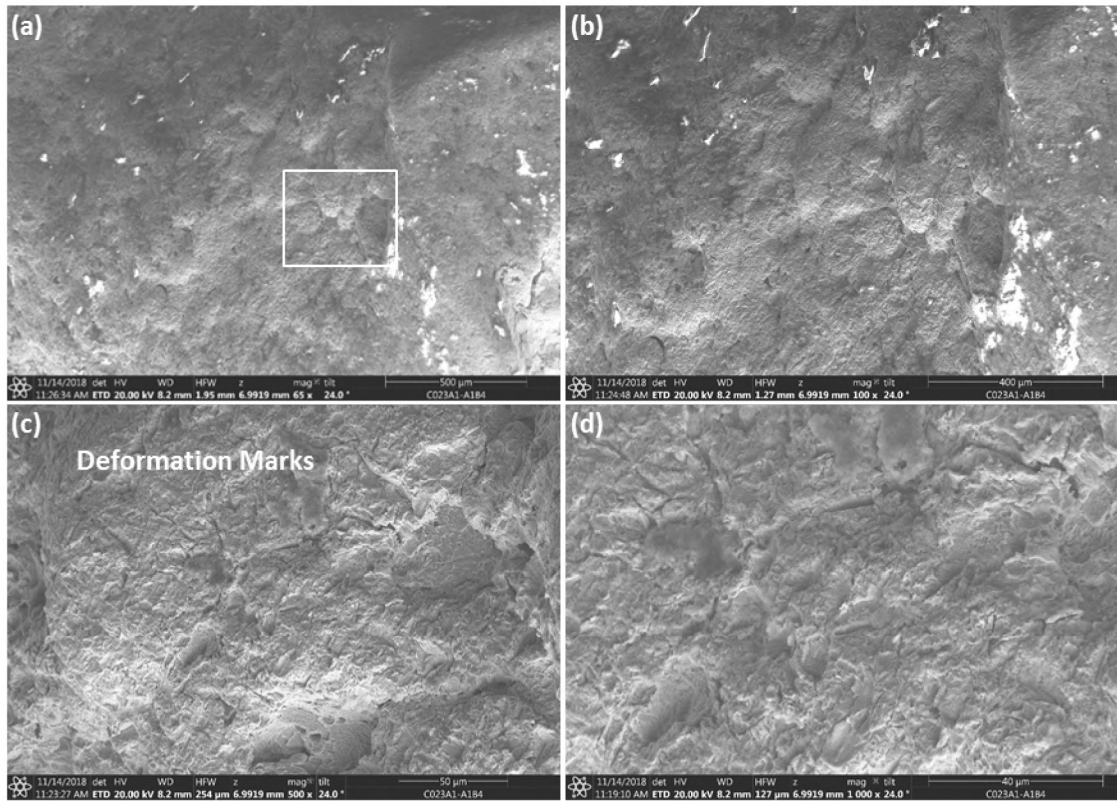
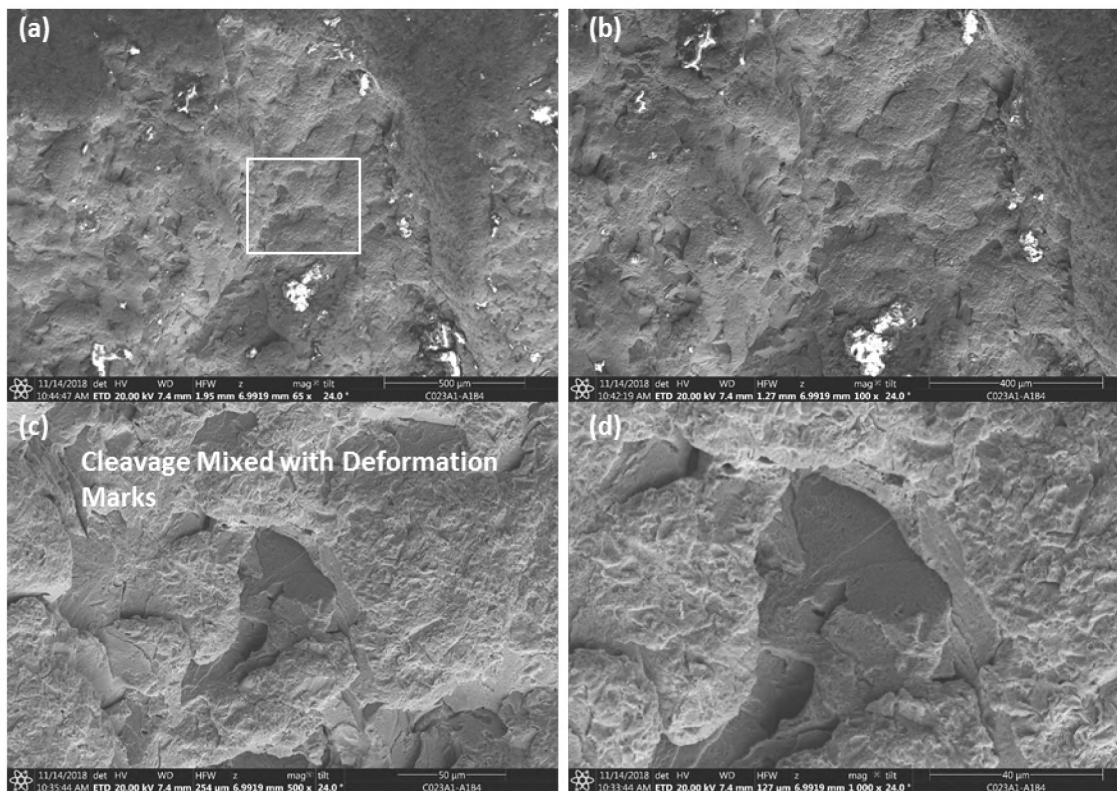
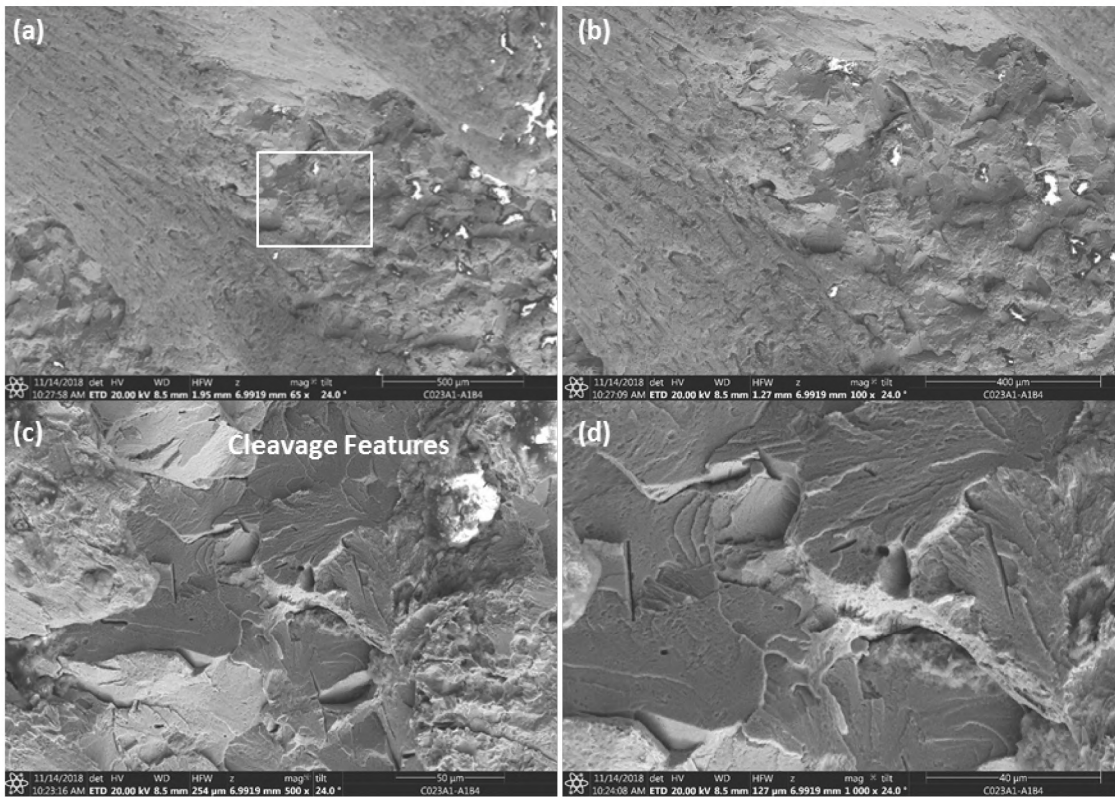
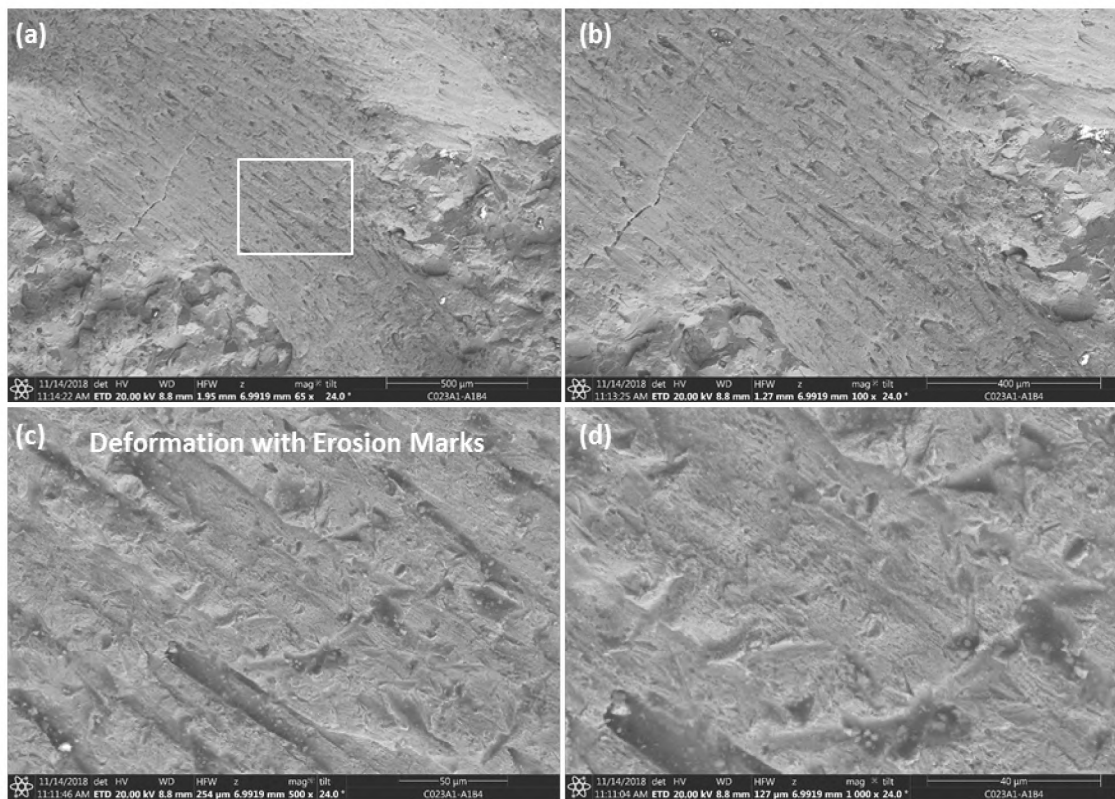
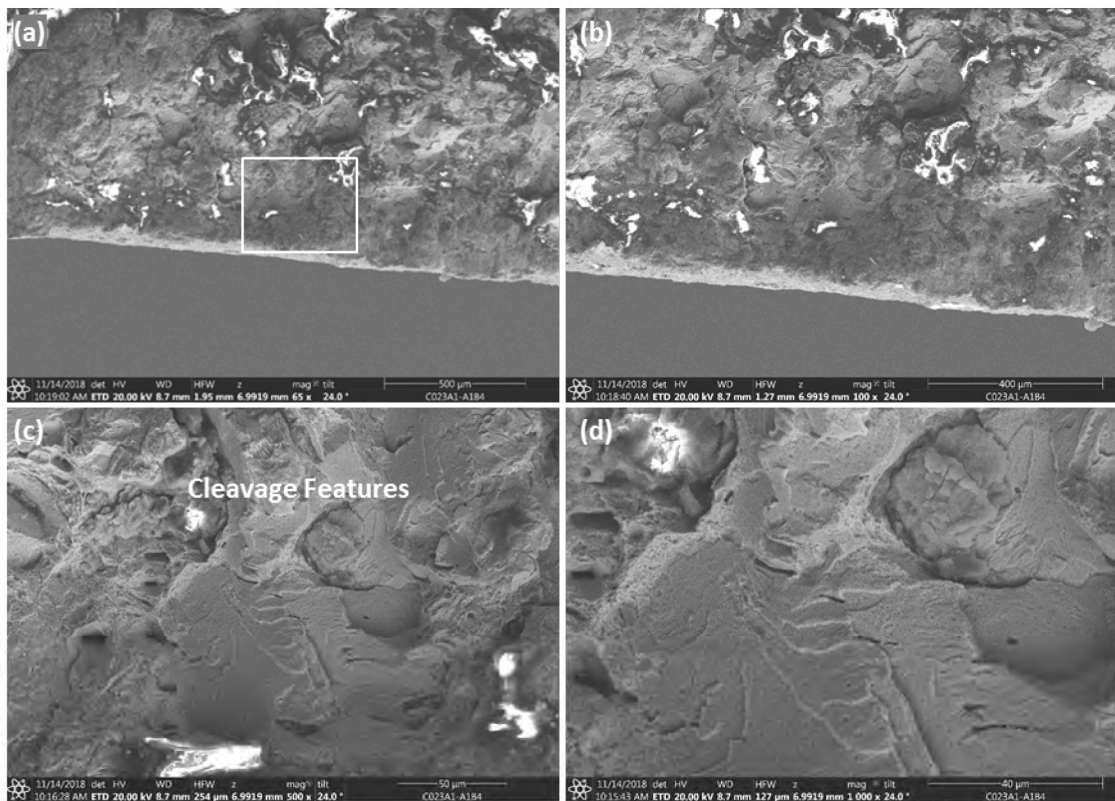
Figure 151 through Figure 155 show SEM images of the OD, MW, and ID of Area A9. Area A9 was located at the second upper turning point. The OD fracture surface appeared relatively rough (Figure 151 and Figure 152) and was a mix of small amounts of cleavage facets and deformation marks. Similar fracture surface morphology was observed in the MW (Figure 153); some erosion marks were also observed (Figure 154). The ID fracture surface contained more cleavage separation (Figure 155).

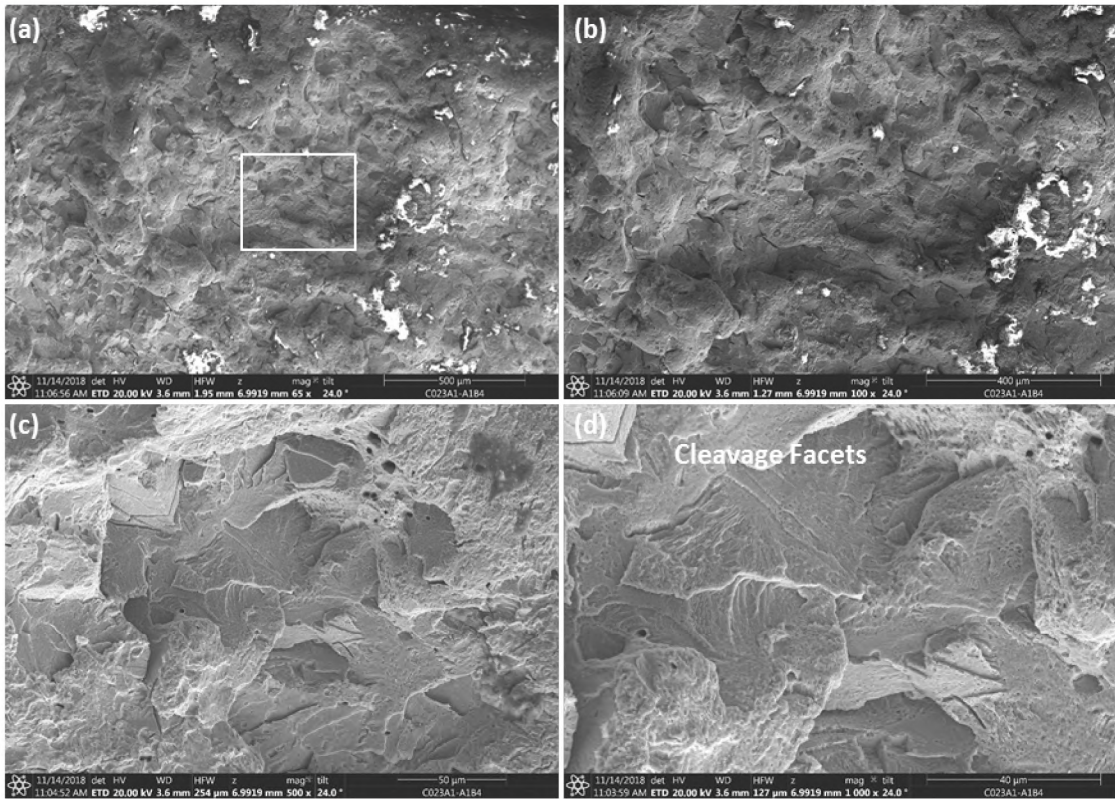
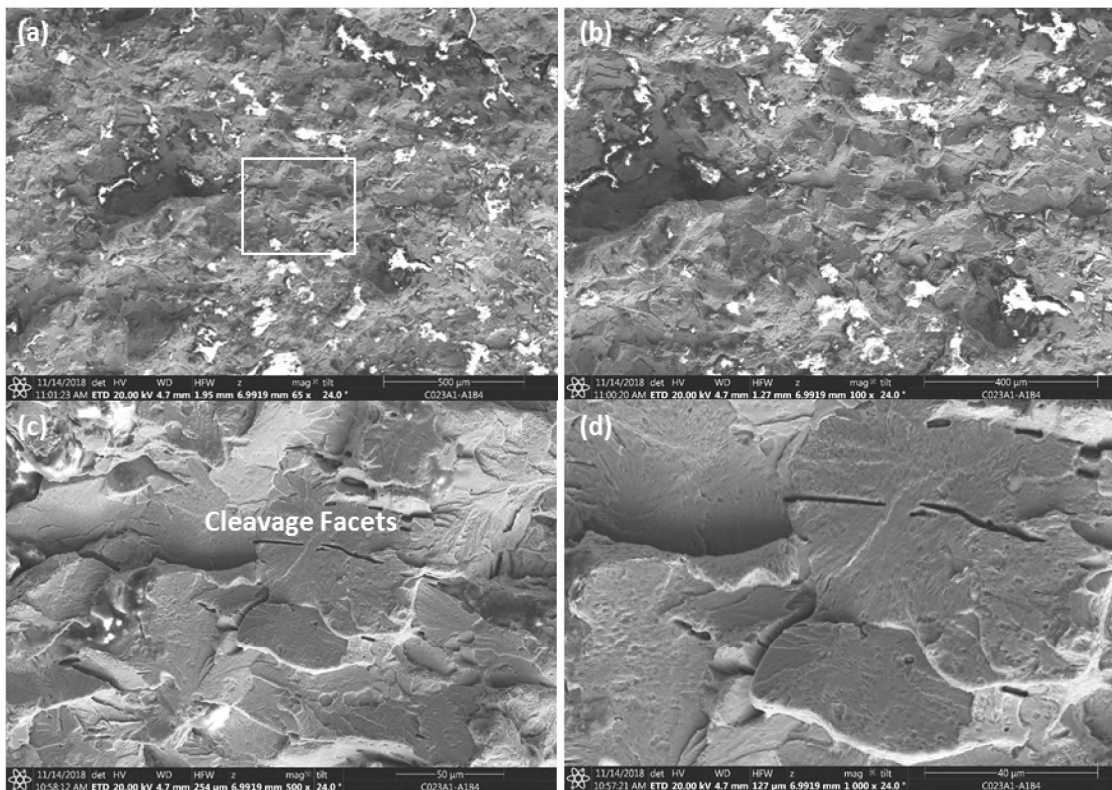
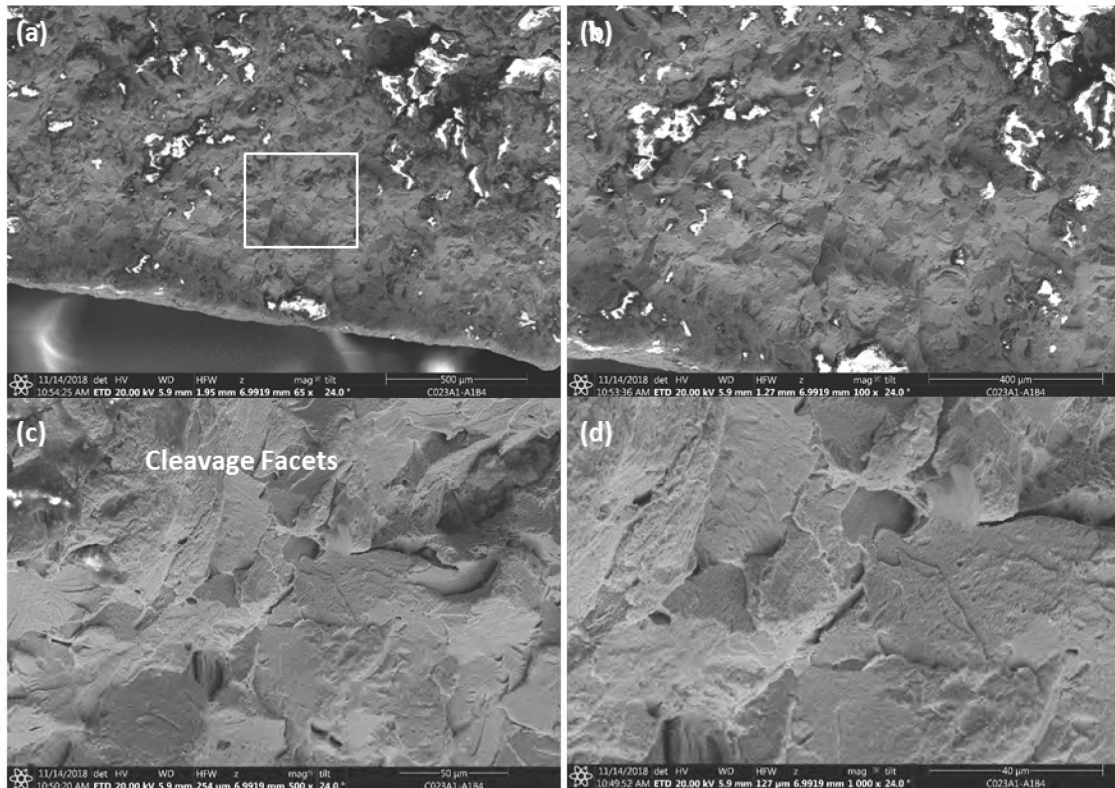
Figure 156 through Figure 158 show SEM images of the OD, MW, and ID of Area A10, respectively. Area A10 was located above the second upper turning point towards the upper arrest region. There was no resolvable difference in surface roughness between the OD and ID. The micro-fractographic morphology is similarly composed of mixed cleavage facets with deformation marks. More cleavage separation was observed at the MW and ID areas (Figure 157 and Figure 158).

The micro-fractographic morphology observed in the area adjacent to the second upper turning point consisted of cleavage facets and deformation marks. The OD fracture surface appeared rougher than the ID side, and this is consistent with more ductile deformation. There is no clear evidence of faceted features as observed at the lower arrest area.
