**Blade Supplemental Report (Vol. 2: SS-25 Well Failure Causes)**

# Root Cause Analysis of the Uncontrolled Hydrocarbon Release from Aliso Canyon SS-25

May 31, 2019

# SS-25 Casing Failure Analysis

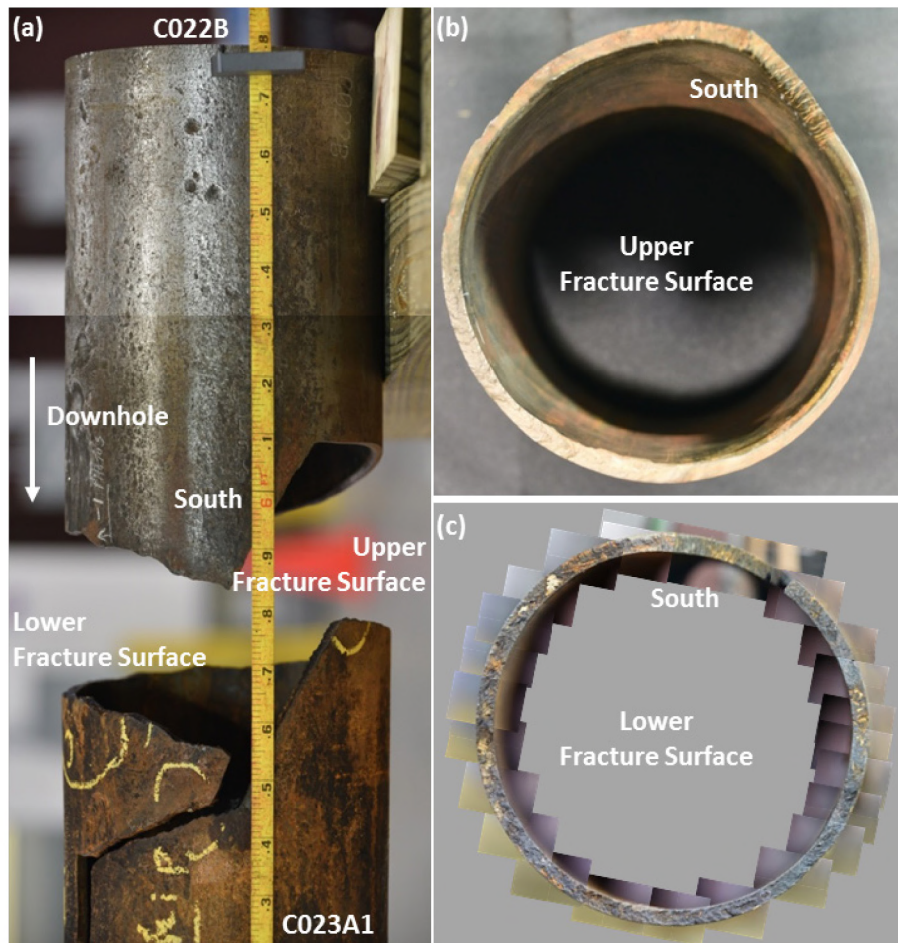
The upper fracture surface was facing down after the parting; it had been severely eroded by the high-pressure gas that had escaped from the reservoir. The lower fracture surface was facing up during the blowout and appeared to be well preserved. Figure 159 (a) shows the lower and upper fracture

surfaces during the examination. The specimens are oriented in the same position as they were in the well. The pointed section of C022B was identified as the south-facing side of the pipe on the rig floor. Figure 159 (b) shows the erosion to the upper fracture surface. Remnants of chevron marks were visible in some areas of the fracture surface. Most of the surface appeared to be smooth and featureless. Figure 159 (c) shows the condition of the lower fracture surface during the examination. The chevron marks are more visible and well defined when compared to the upper fracture surface. The lower fracture surface had no indications of erosion. It was later confirmed by stereo and SEM examinations that erosion was not present.

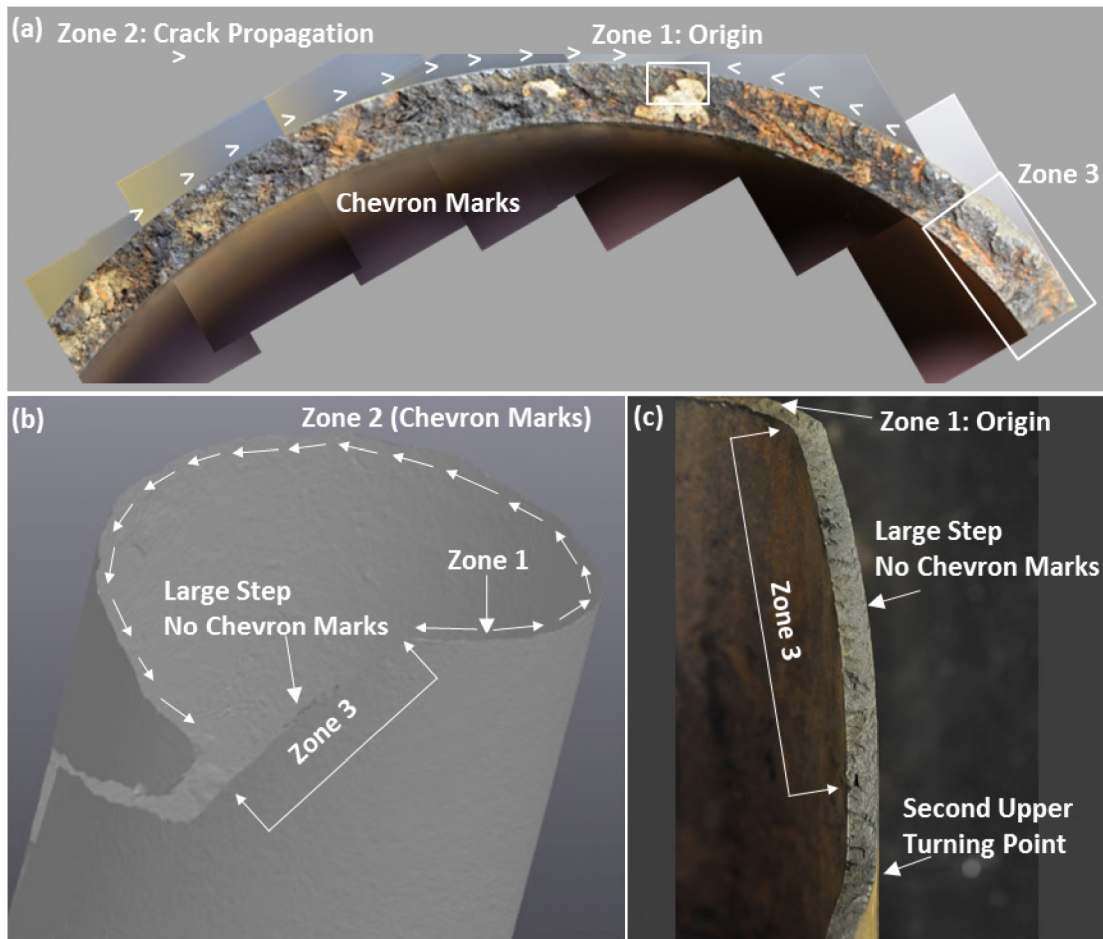
Figure 160 illustrates the three zones of the circumferential parting. Figure 160 (a) is a close-up image of the lower circumferential parting with the three fracture zones identified. Figure 160 (b) is a schematic showing the location of the three zones and the crack propagation direction. Figure 160 (c) is a close-up image of the Zone 3 fracture surface.

Zone 3 was the large, inclined step between the two circumferential crack tips produced by the spiral crack path. The fracture surface of Zone 3 was rough and did not contain chevron marks. The observations suggest that the fracture surface was not produced by a running crack but by an overload of the remaining ligament.

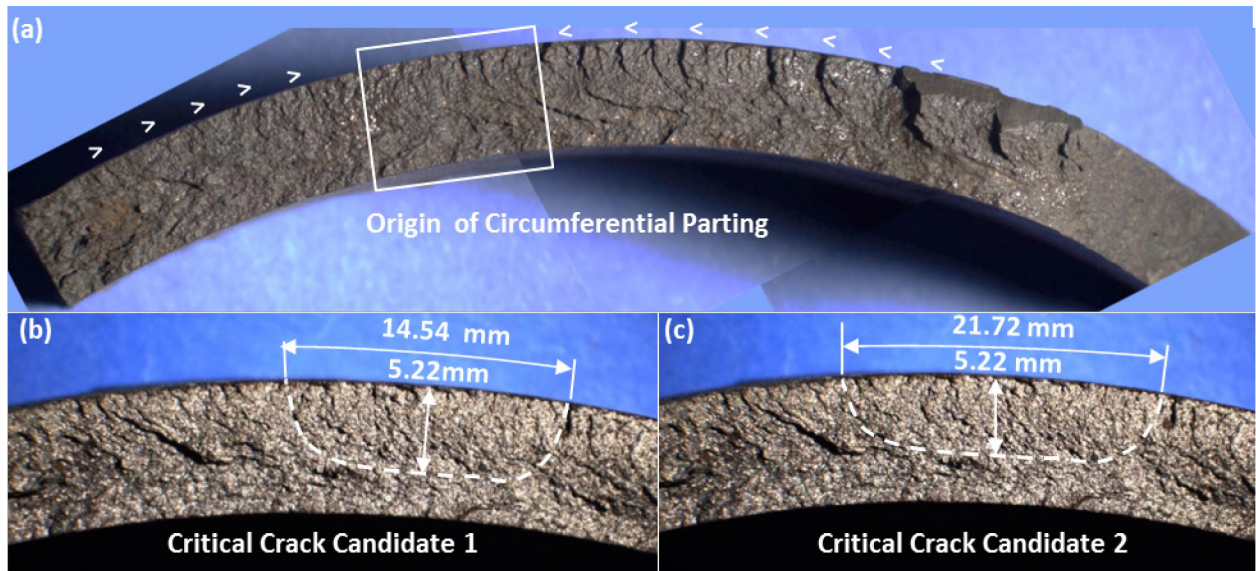
Zone 1 was identified based on the chevron marks that were observed on the fracture surface. An initial area was identified as a possible origin site based on visual and stereoscopic examinations. The proposed origin site was thoroughly examined with the stereo microscope and SEM to determine the origin size. Two semi-elliptical areas were identified as possible critical crack sizes (origin) for the circumferential parting. The first critical crack candidate was 14.55 mm long and 5.2 mm deep. There was uncertainty in identifying the fine chevron marks adjacent to the origin. A second critical crack candidate was identified, which extended just beyond the first critical crack candidate. The second critical crack candidate was 21.72 mm long and 5.22 mm deep. Figure 161 (a) shows the origin area for the circumferential parting. Figure 161 (b) and (c) show the location and sizes of the critical crack candidates.

Additional clarification and verification are required when there is uncertainty in the critical crack size. Temperature was used to verify the critical crack sizes for the circumferential parting, which is discussed in Section 4.3. The results showed that the estimated temperature at the time of the circumferential parting was between  $-60.4^{\circ}\text{C}$  and  $-56.8^{\circ}\text{C}$  for the first critical crack candidate (14.53 mm). The estimated temperature for the second critical crack candidate (21.72 mm) was between  $-40.1^{\circ}\text{C}$  and  $-39.1^{\circ}\text{C}$ . The failure temperature predicted by the thermal model [11] was  $-34^{\circ}\text{C}$ . Both candidates were consistent with the thermal model prediction; however, the second critical crack candidate resulted in a closer temperature prediction.

Section 3.3.1 discusses how the circumferential parting originated from one of two possible critical crack candidates. The first crack candidate had a length of 14.54 mm and a depth of 5.22 mm. The other candidate had a length of 21.72 mm and a depth of 5.22 mm. Figure 161 shows macro images of the critical crack candidates. The sizes of the crack candidates were based on visual and stereoscopic observation of the chevron marks. In this section, the sizes of the critical crack candidates were validated by estimating the material conditions at the time of the circumferential parting. The following were the methods used for the investigation:

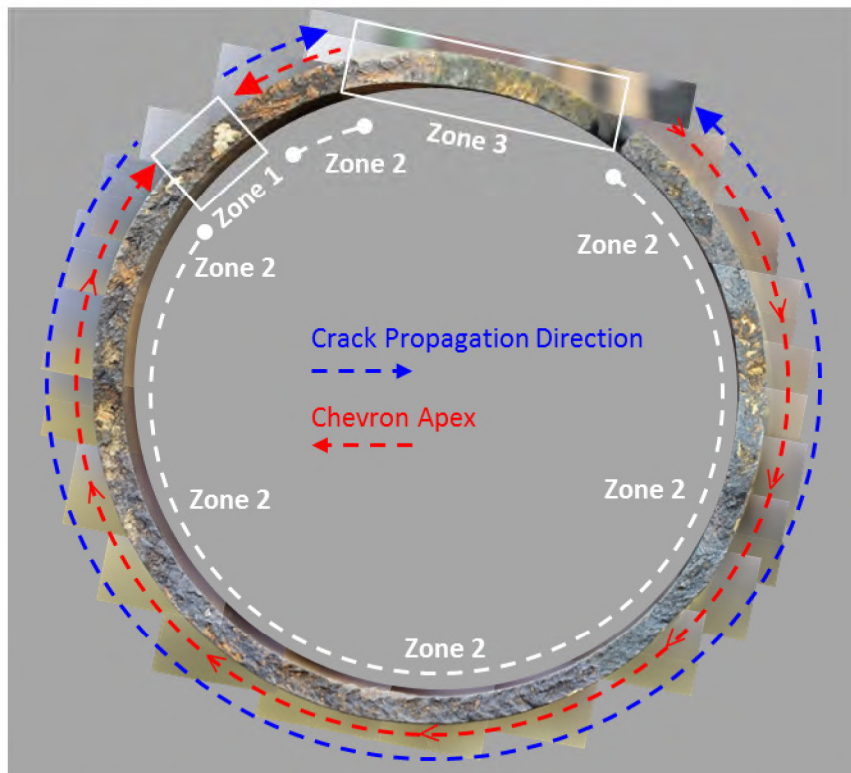
Zone 2 was characterized by chevron marks, and their apices were oriented towards Zone 1 (origin). Figure 162 shows the fracture surface in the non-cleaned condition. The chevron marks are clearly visible on the majority of the fracture surface in Zone 2, identified by the dashed white circle in Figure 162. The dashed red and blue circles represent the chevron apices and crack propagation, respectively. Zone 2 began at Zone 1 and arrested at the upper arrest point for the axial rupture. The beginning and end points for Zone 2 are indicated by the white dots at the end of the white circle.

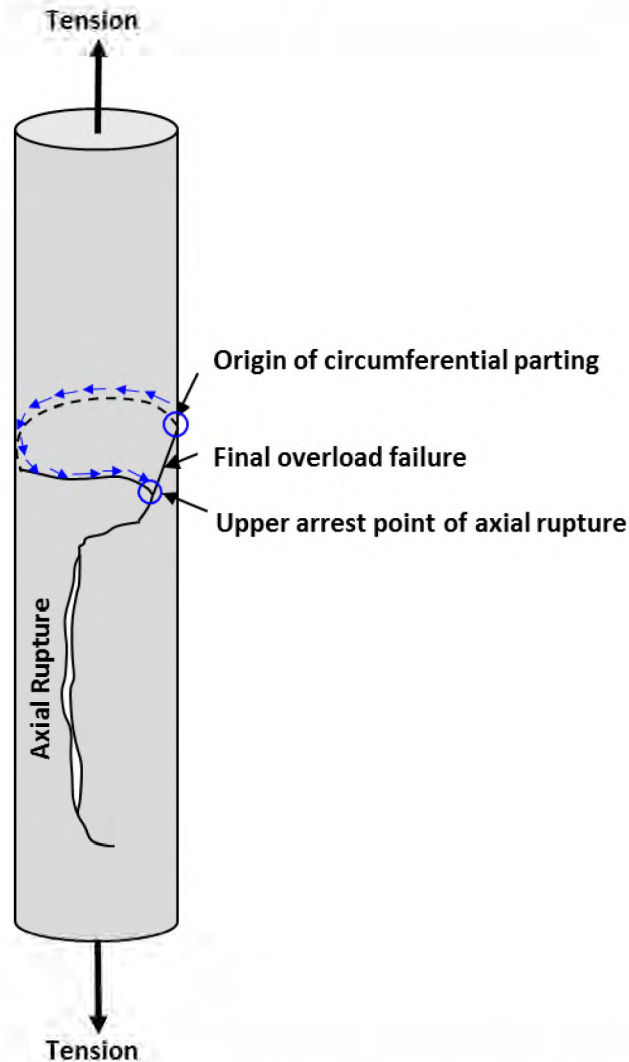
Additional detailed visual and stereoscopic examination showed that the circumferential parting was not an extension of the axial rupture. Chevron marks produced by the circumferential parting did not follow the chevron marks produced by the axial rupture. The initiation site and chevron marks produced by the circumferential parting were located at approximately 3.70 in. (94 mm) from the upper arrest point of the axial rupture. Figure 163 is a schematic of the crack path for the axial rupture and circumferential parting. The schematic shows how the circumferential parting initiated above the arrest point of the axial rupture. The crack propagated circumferentially until it reached the axial rupture's arrest point. The final ligament failed due to the axial force generated by the weight of the 7 in. casing string. The axial rupture and circumferential parting are thought to be two separate events due to a lack of evidence that the chevron marks from the axial rupture continued into the circumferential parting. The close proximity of the two failures suggests that they are related despite being two separate events.

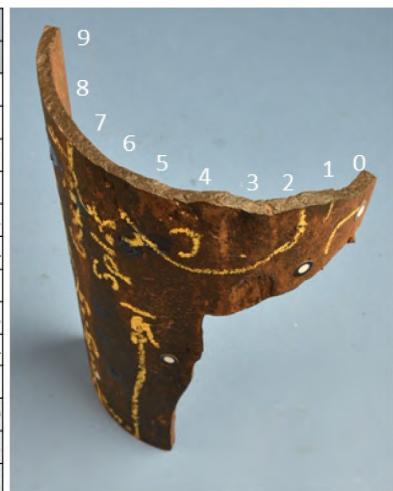
The measurements were taken after most of the SEM work had been completed. The lower fracture surface had been cut into multiple specimens. Three specimens (C023A1A2, C023A1A2A, and C023A1A1) were selected to cover most of the lower fracture surface. Figure 165 shows the results for specimen C023A1A2. Measurements of the fracture surface were taken with the caliper at nine equally spaced locations. The wall thickness was measured with the thickness probe at the nine locations directly below the fracture surface. Locations 5 and 8 were not measured due to corrosion on the OD surface. The results show that the maximum reduction in wall thickness was 0.009 in. with an average wall thickness difference of 0.000 and -0.002 in. for runs one and two, respectively.

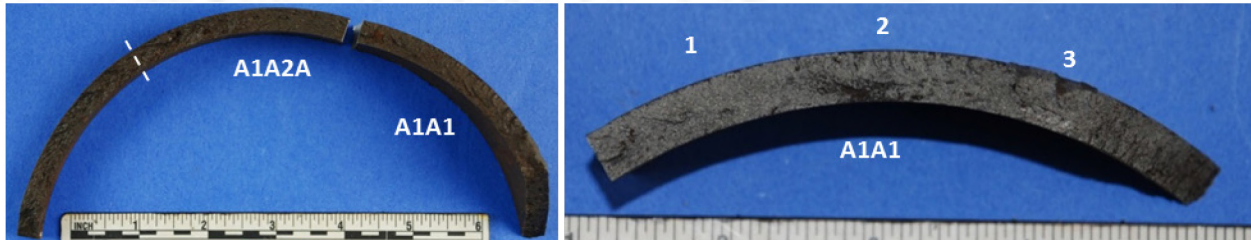
Figure 166 shows the results for specimens C023A1A1 and C023A1A2A. Measurements were taken at four locations from each specimen. Wall thickness measurements were taken at the cut face of the specimen with the caliper. The results show that the maximum reduction in wall thickness was 0.007 in. with an average of -0.001 in. These values are within the error range of the measurement technique and suggest minimal to no ductility associated with the circumferential parting.

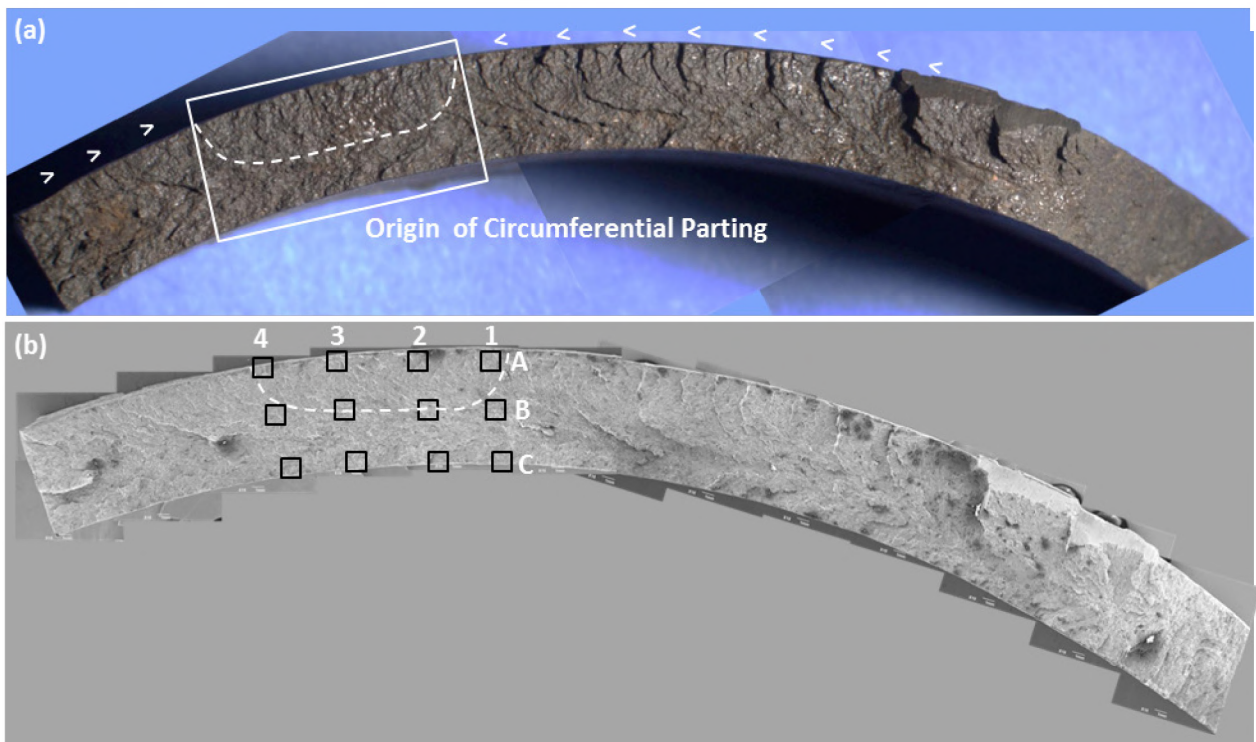
**Figure 168: Specimen C023A1A1A (a) Stereo and (b) SEM Images of Zone 1 (Origin) Investigation Areas**

To prevent contamination, all cuts were made without coolant. Care was taken to protect all fracture surfaces and features during the cutting process. Specimen C023A1A1A, which contained the origin for the circumferential parting, was cleaned by using the same procedures described in Section 3.2.2. Figure 168 (a) shows stitched stereo images of the fracture surface after it was ultrasonically cleaned in a 1% Citranox solution for three minutes. Figure 168 (b) shows stitched SEM images of the same cleaned fracture surface. The black boxes show the locations for the detailed SEM examinations. Zone 1 was examined in a grid with numbers representing columns and letters representing rows. Row A was located at the OD side of the Zone 1 fracture surface. Row B and C were located at the MW and ID of Zone 1, respectively.

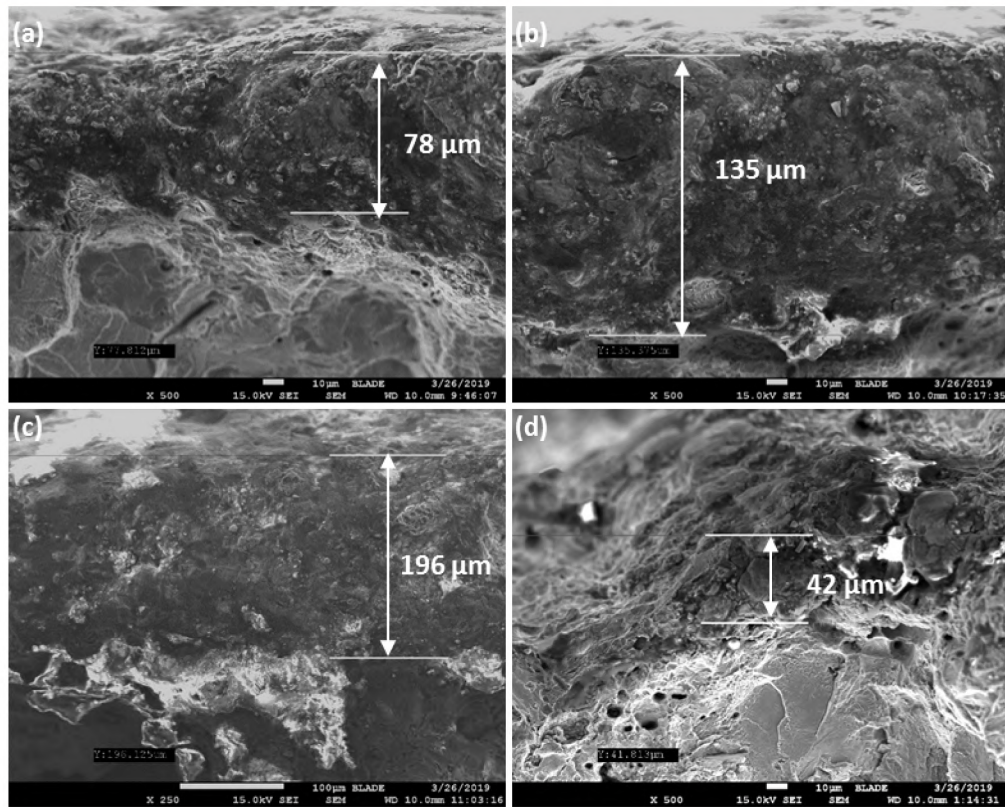
Figure 169: SEM Images of Pre-existing Flaws at (a) 1A, (b) 2A, and (d) 4A Taken at 500X, and (c) 3A Taken at 250X

The SEM examination of Zone 1 identified a pre-existing, crack-like flaw on the OD side of the origin. Figure 169 shows SEM images of the crack-like flaw on the OD surface. The crack-like flaw was shallow, with a measured maximum depth of 196  $\mu\text{m}$ . Figure 170 shows an EDS analysis indicating that the surface of the flaw was severely oxidized by a scale that had not been removed during cleaning. The adjacent fracture surface was easily cleaned and clearly showed cleavage facets. This observation suggests that the flaw existed prior to the circumferential parting. The OD surface flaw may have promoted brittle cracking from the origin of the circumferential parting, even though the flaw was shallow.

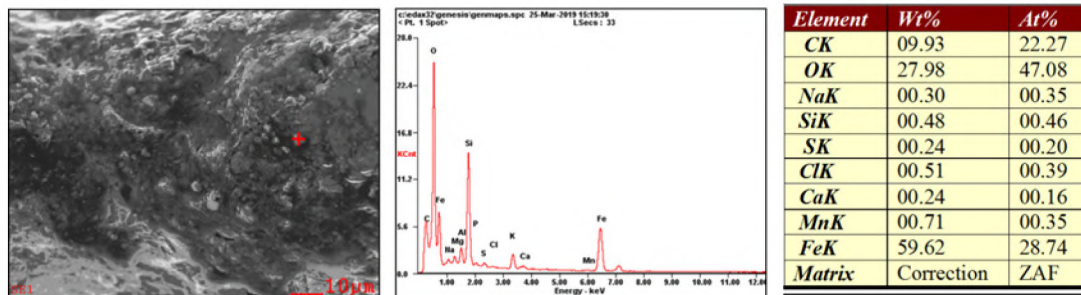
Figure 170: EDS Results for Pre-Existing Flaws

(a) SEM image. The red spot is where the EDS analysis was performed

(b) EDS Spectra. A high oxygen peak is noticeable

(c) Concentration of the scale showed iron oxide

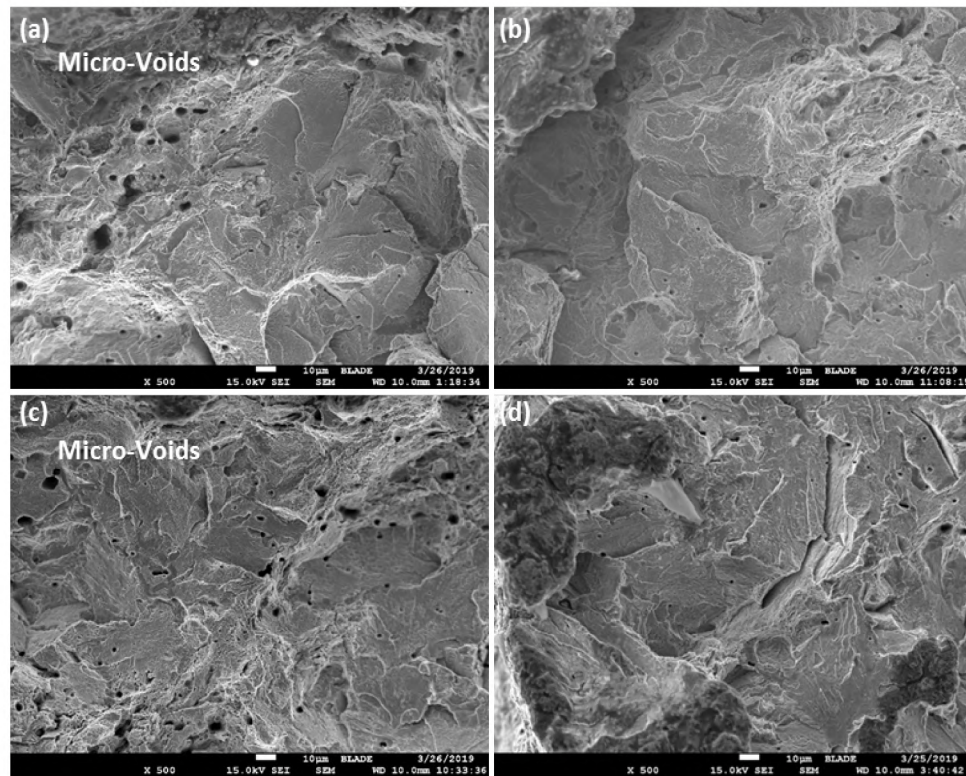
Figure 171: SEM Images of C023A1A1A Areas (a) 1A, (b) 2A, (c) 3A, and (d) 4A Taken at 500×

Further detailed SEM examination identified that the fracture mode of the origin was characterized by cleavage with a small number of microvoids (Figure 171). The small amount of microvoids is associated with inclusions in the material. Similar features were also observed along the edge of the origin (Figure 172).

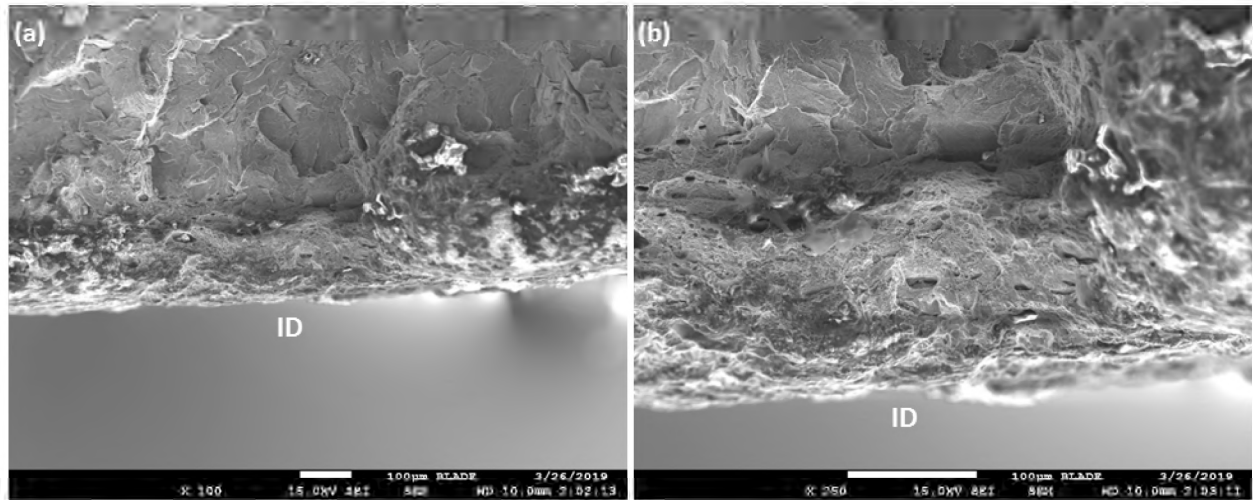
**Figure 173: C023A1A1A ID Fracture Surface Morphology Taken at (a) 100× and (b) 250×**

No noticeable changes in the fracture mode were observed outside of the origin, except for an area close to the ID. Deformation marks were observed on the fracture surface of Zone 1 near the ID. The deformation is thought to be associated with a small shear lip. Figure 173 shows the typical fracture surface morphology observed near the ID surface.

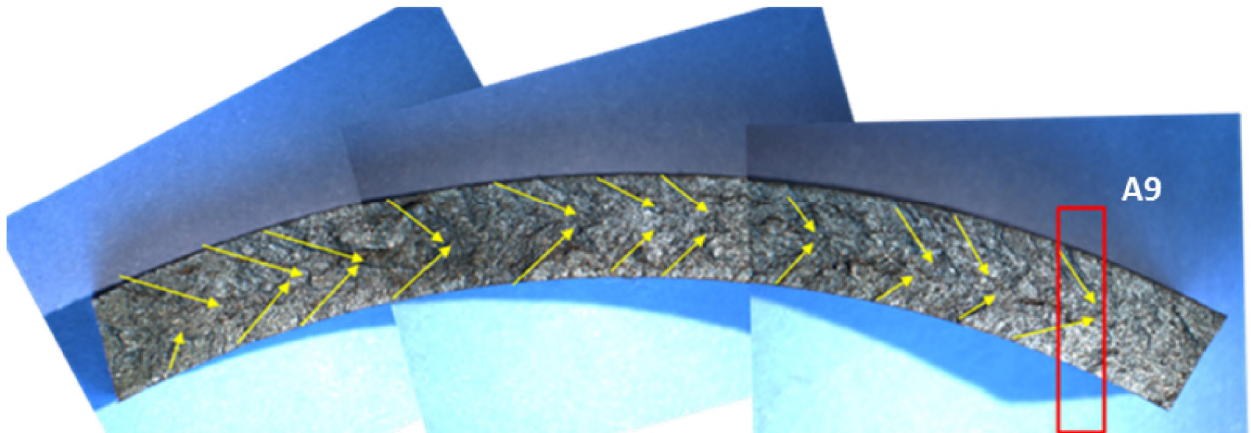
Figure 174: Specimen C023A1A1A2A Showing Fine Chevron Marks and Representative SEM Location

Cleavage separation was the predominant micro mechanism for Zone 2 (crack propagation). Most of the circumferential fracture surface was characterized by fine chevron marks. Fine chevron marks indicate that the limited micro-plastic deformation occurred in the steps between the cleavage planes. Macro-plastic deformation, such as necking, did not occur as discussed in Section 3.3.1. These observations are consistent with brittle fracture of mild steels at temperatures below the DBTT [19] [20].

Figure 174 shows stitched stereo images of C023A1A1A2A with the chevron mark orientation and the SEM examination location. Many locations were examined with the SEM, and the same micro mechanism was observed at each location, but only one set of the representative fracture morphology is shown here. Figure 175 through Figure 177 show the morphology for the OD, MW, and ID for Area A9. The SEM images show cleavage features through the thickness of the circumferential fracture surface. This was consistent with all examined locations.

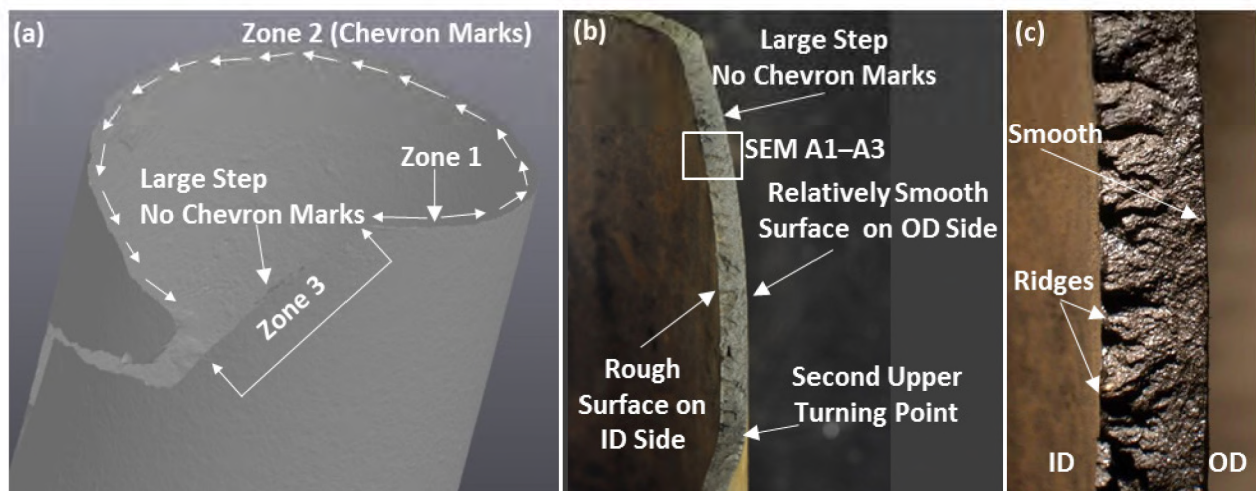
Figure 178: (a) Schematic and (b) (c) Image of Zone 3 (Final Overload Failure)

Figure 178 (a) shows a schematic showing the location of Zone 3. Figure 178 (b) and (c) show macro and stereo images of Zone 3. The images show a step-like appearance on the ID side of the fracture surface. The OD side of the fracture surface appears to be smooth. The SEM examination showed that the fracture surface near the OD side was mostly cleavage separation, while the ID side showed a mix of cleavage facets and a woody type of plastic deformation. The fracture surface morphology at the MW was a combination of the OD and ID morphologies.

The observed mixed fracture mode near the ID was consistent with the rough surface observed on the ID side of the fracture surface (Figure 178 [c]). The ridge-like appearance is associated with multiple initiation sites at different levels during tearing. Figure 179 and Figure 180 show representative SEM micro-fractographic features of the overload failure as indicated by the white box in Figure 178 (b). The micro mechanism was predominantly cleavage separation due to failure at low temperatures. Some degree of plastic deformation was observed on the ID side of the fracture surface. The change in surface condition from the ID to the OD suggests that the final overload failed from the ID (rough) to the OD (relatively smooth).

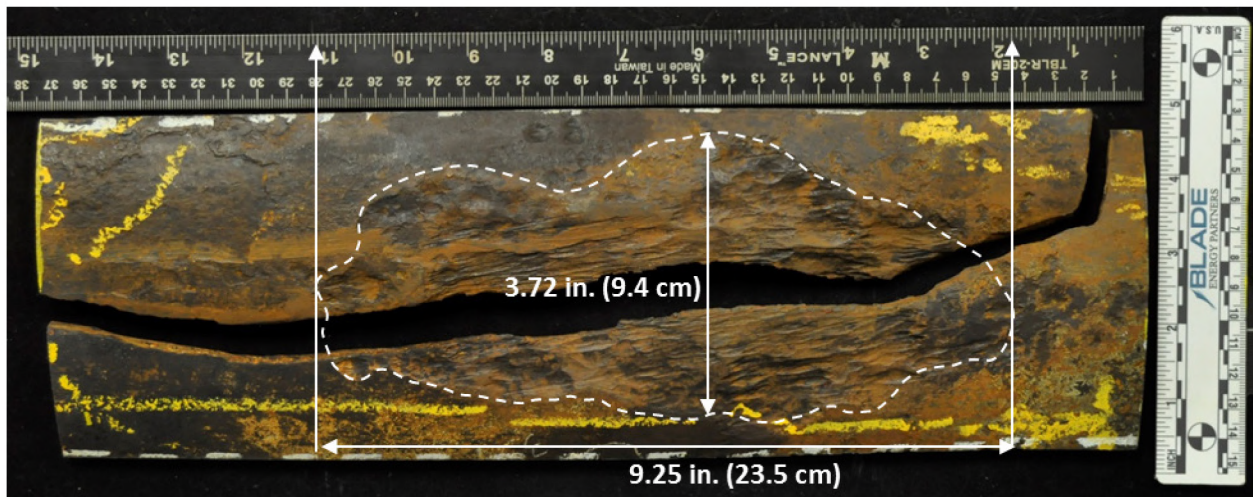
Figure 181: Corrosion Feature Dimensions at the Rupture Location (892 ft)

The first task for constructing the FEA was to model the 7 in. casing segment and corrosion feature. The corrosion feature size was approximated from scaled images. Figure 181 shows the corrosion feature and estimated axial and circumferential dimensions. The feature had a length of 9.25 in. (23.5 cm) and a width of 3.72 in. (9.4 cm). The measurement of the wall thickness of the pipe body was 0.321 in., and it was measured by using a UT wall thickness probe at locations away from the corrosion feature. The yellow

dotted line in Figure 181 represents the corrosion feature boundary where the wall thickness returned to the measured pipe body value of 0.321 in.

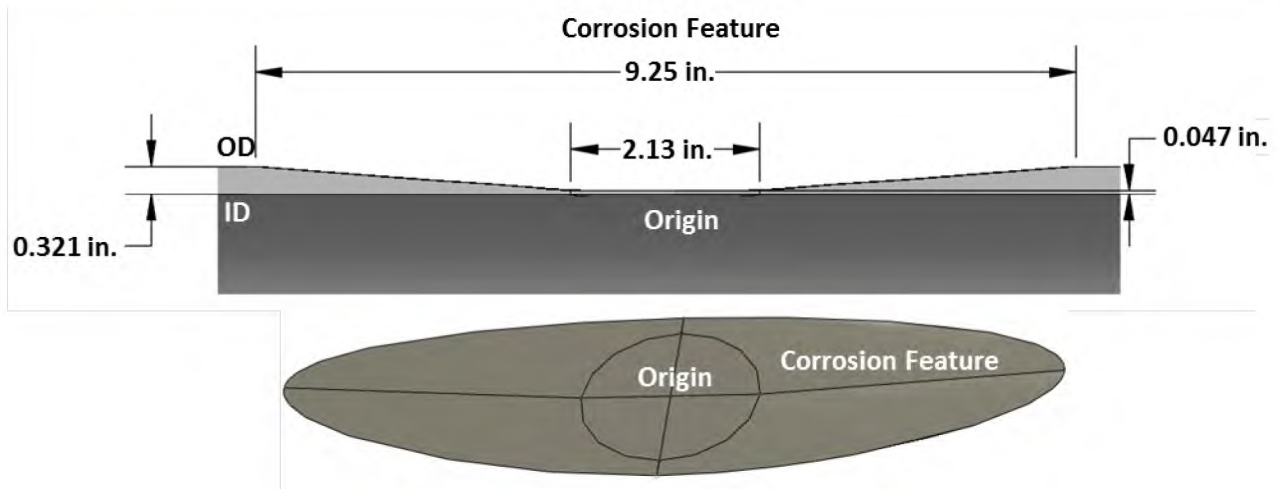
**Figure 182: Corrosion Feature Geometry**

The minimum remaining wall thickness was measured from a cross section through the thinnest area of the corrosion feature. Figure 110 (b) shows the metallographic section and the thinnest remaining wall measurement of 0.0496 in. (1.26 mm). This value was used for the thickness of the inner circle region (origin). Figure 182 shows the model of the corrosion feature with the origin identified. The image shows the corrosion feature positioned within the pipe such that the remaining wall matched the minimum value measured from the metallographic cross section. The remaining wall thickness gradually increased from the inner circle (0.0496 in. remaining wall) to the outer boundary of the corrosion feature (0.321 in. remaining wall) based on the semi-elliptical bowl profile. The semi-elliptical bowl with the inner circle (corrosion feature) was modeled as a solid object and was subtracted from the pipe body to obtain the geometry shown in Figure 182. This model is referred to in this section as Model 1 (corrosion feature without a notch).

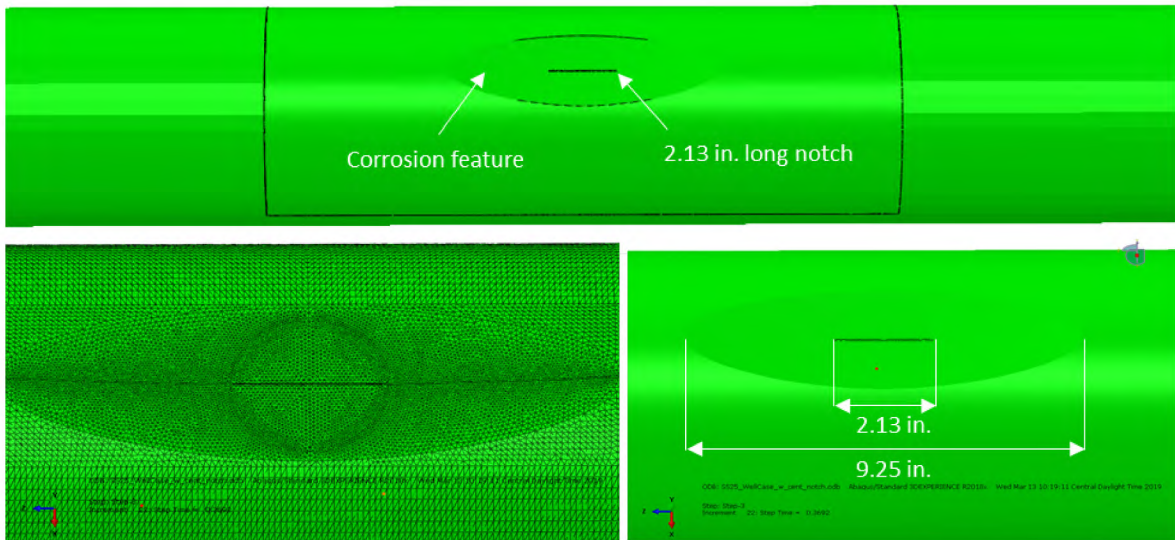
**Figure 183: Model 2 Schematic and Mesh for Corrosion Feature and 2.13 in. Notch**

Figure 183 shows the raised corrosion feature, which had the effect of reducing the total volumetric metal loss. The presence of the notch introduced a stress concentration in the thinnest section of the corrosion feature, which had the effect of reducing the estimated failure pressure. However, the reduced volumetric metal loss would have had an opposing effect of increasing the estimated failure pressure.

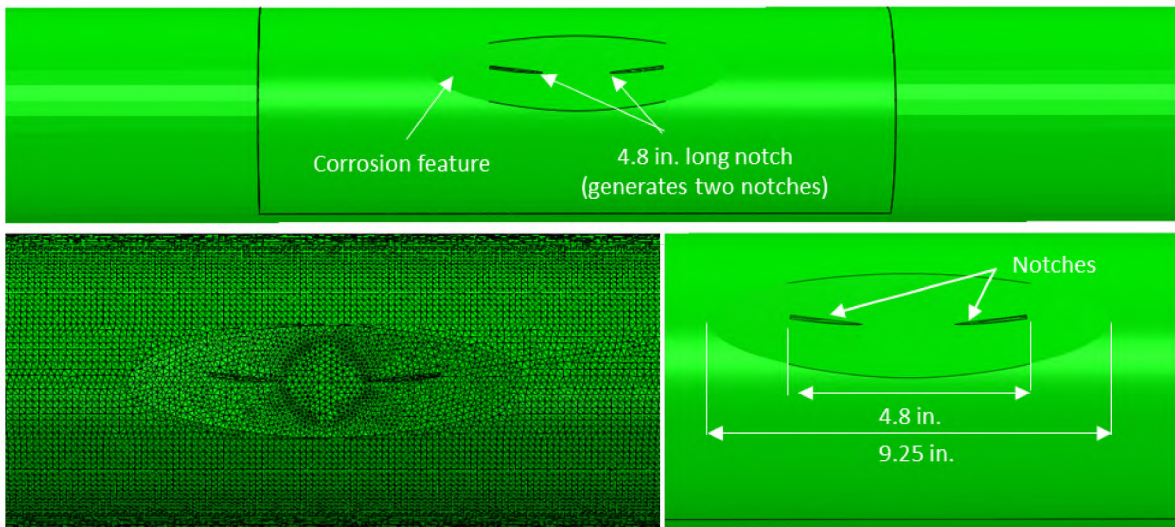
**Figure 184: Model 3 Schematic and Mesh for Corrosion Feature and 4.8 in. Notch**

A third model was designed to introduce the notch effect while maintaining the wall thinning within the ductile tearing region (2.13 in. circular region). The semi-elliptical bowl was modeled in the same way as Model 1. Unlike Model 2, the minimum wall thickness of 1.26 mm was maintained within the ductile tearing zone. A notch was introduced with its length increased to the macro definition of the origin (4.8 in.). Section 3.2.3 defines the macro definition of the origin as the length of the fracture surface between the chevron marks. The notch was positioned so that the deepest point was tangent to the circular ductile tearing region. Placement of the 4.8 in. long notch had the effect of creating two notches adjacent to the ductile tearing region. This model is referred to in this section as Model 3. Figure 184 shows the Model 3 notch geometry and position relative to the corrosion feature.

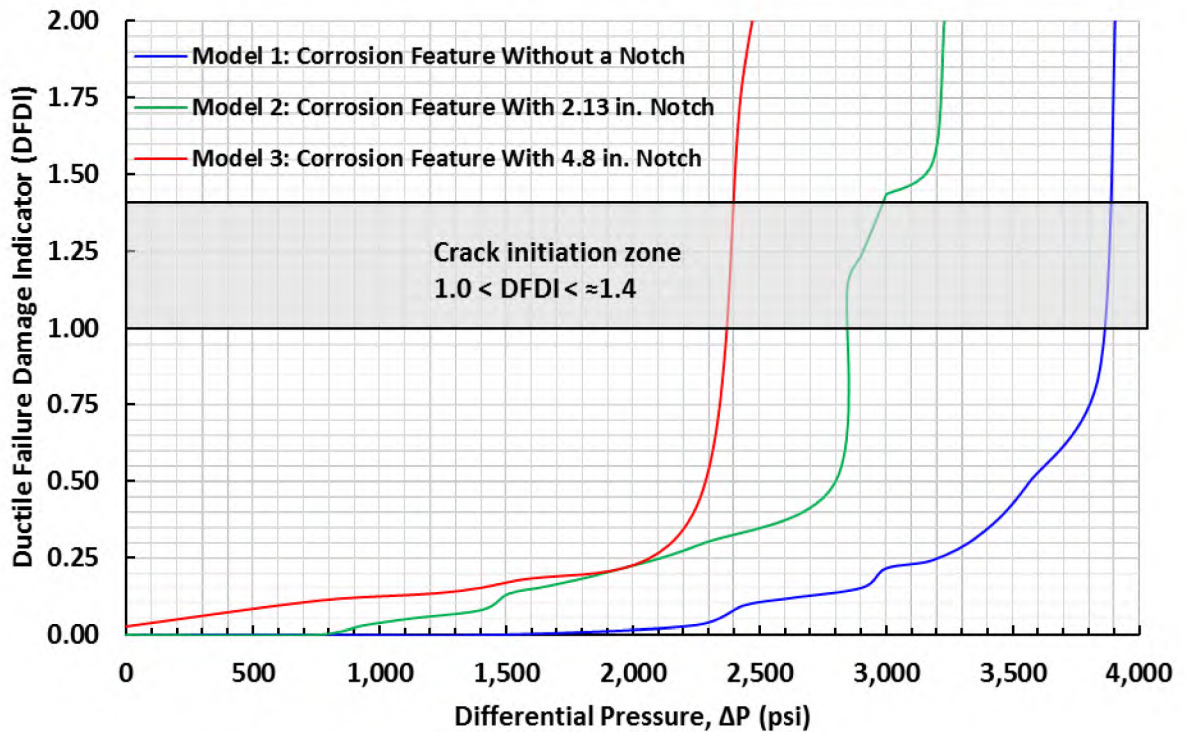
Figure 187: DFDI Evolution with Differential Pressure for Models 1, 2, and 3

Models 1, 2, and 3 were analyzed with the loads and boundary conditions described in Section 4.1.3. Differential pressure was applied to the interior surface of the pipe geometry, and the stress and strain states of the models were analyzed. DFDI was computed at all elements and nodes and was compared to the failure criteria of DFDI = 1.0. Figure 187 shows the DFDI evolution with differential pressure at the edge of the notch, supposedly the most critical location of the pipe model. The DFDI evolution was exponential, which means that the DFDI increased from 1.0 to 1.4 with a small increase in pressure, which suggests that a crack could initiate and grow by ductile tearing.

The stress state for Model 1 was the least severe of the three models. The point of crack initiation occurred at an approximate pressure of 3,850 psi. The corrosion feature (i.e., semi-elliptical bowl) was raised for Model 2 by 1.0 mm, which reduced the volumetric metal loss due to corrosion. The point of crack initiation for Model 2 was approximately 2,836 psi. Model 3 increased the length of the notch to 4.8 in. and maintained the corrosion feature geometry from Model 1. Introduction of the notch geometry

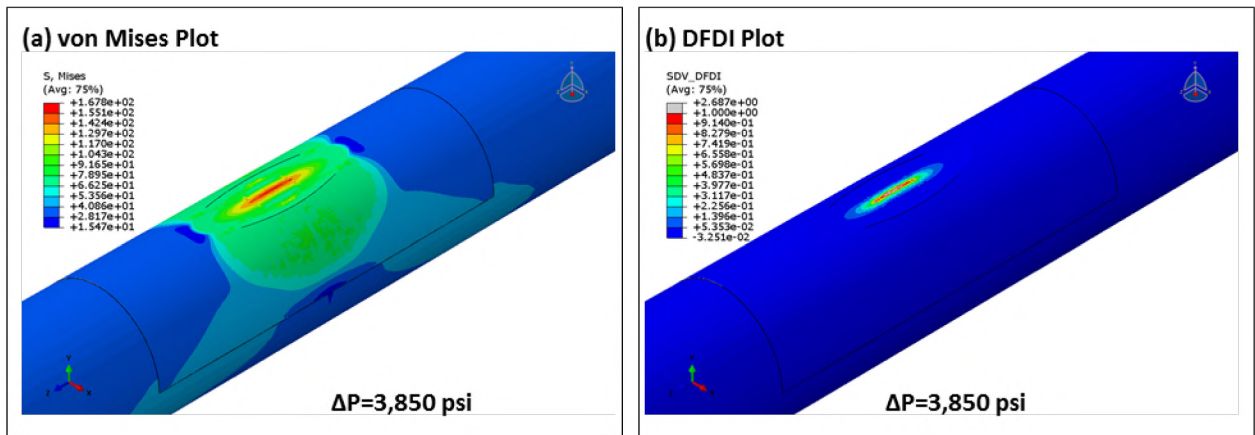
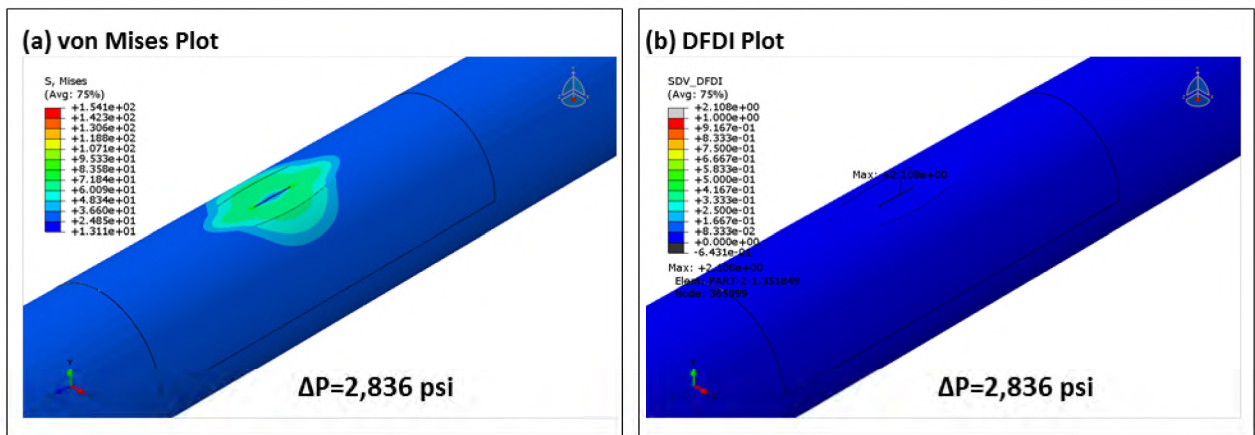
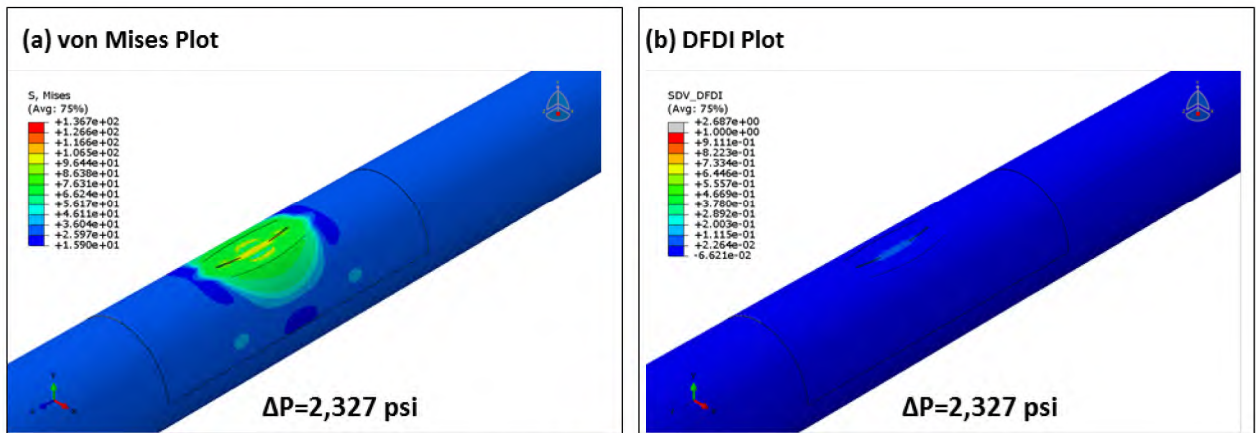
The von Mises and DFDI plots for Models 1, 2, and 3 are shown in Figure 188, Figure 189, and Figure 190, respectively. The figures illustrate that the ductile tearing region has a high stress state and a localized region with a DFDI > 1.0.

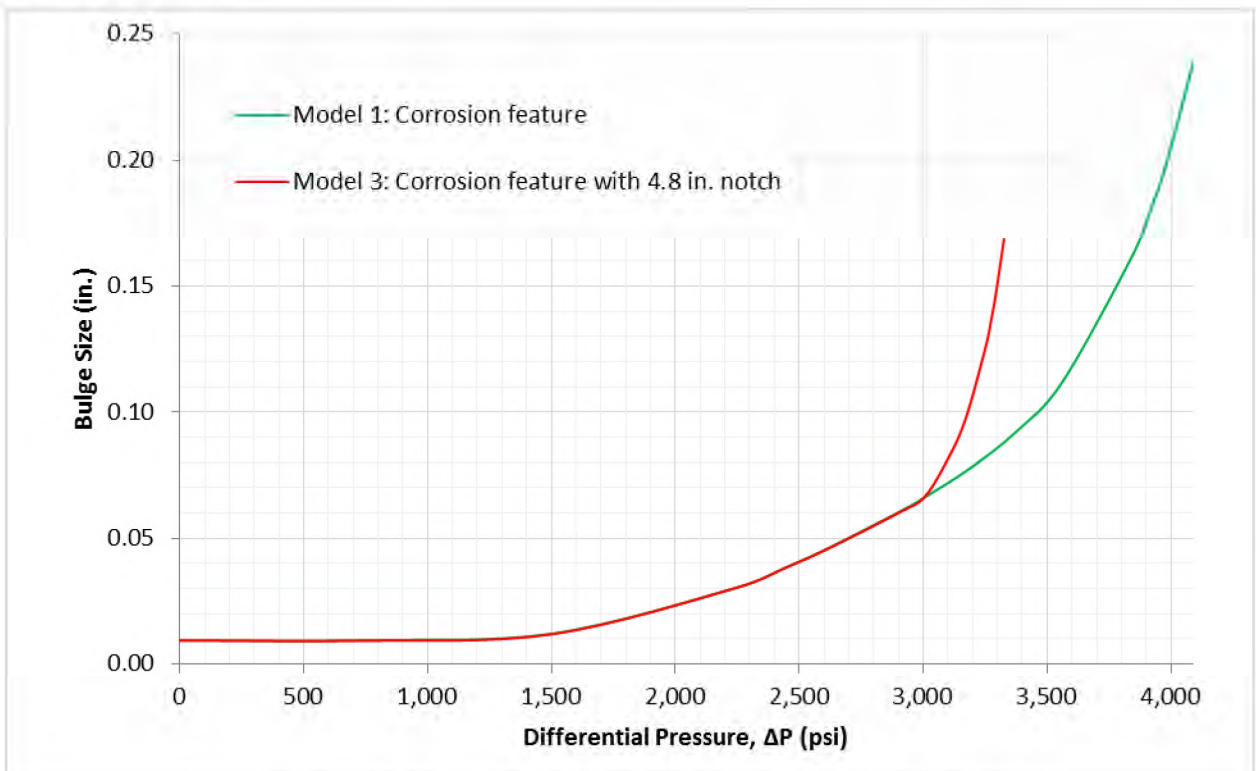
Figure 191: Pipe Bulge at the Center of the Corrosion Feature

3D pipe models cause radial expansion with increased internal pressure. Localized regions near the corrosion feature have a significantly lower wall thickness and bulge considerably with the increasing pressure. Figure 191 illustrates the maximum bulge at the center of the corrosion feature for Models 1 and 3. Model 3 showed a bulge of approximately 0.17 in., as shown in the displacement contour (Figure 192). The bulge in Model 3 (4.8 in. notch) is higher than in Model 1 (no notch). Model 2 (2.13 in. notch) showed bulging below Models 1 and 3 due to the increase in remaining wall. Model 2 was not included in the plot. The plots in Figure 191 show that the bulge increased exponentially once the crack initiation stage (DFDI >1.0) was reached. These results further support that the ductile tearing occurred after the crack had initiated.

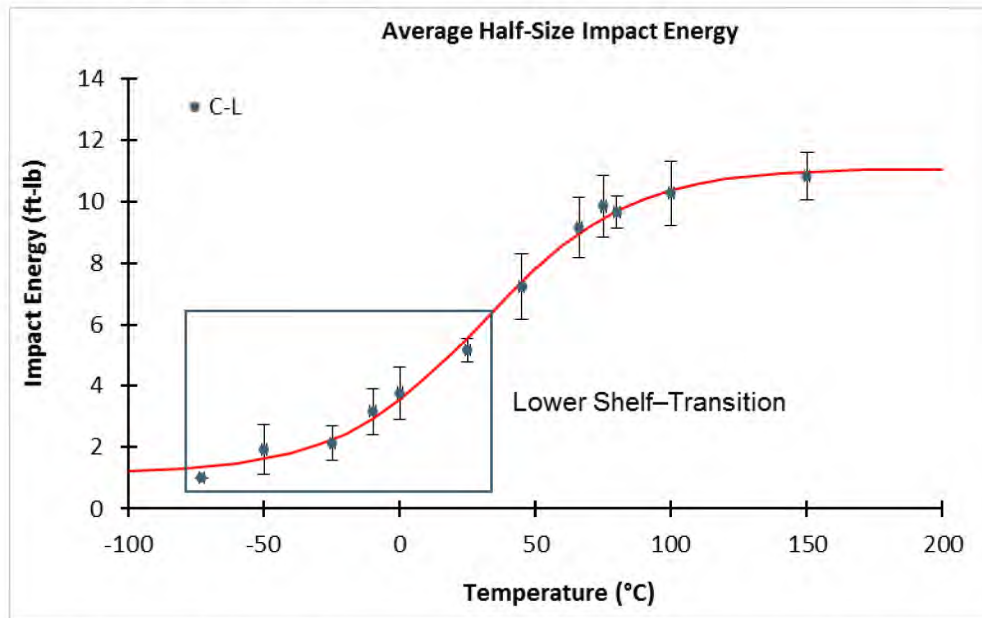
Figure 194: Average Half-Size Charpy Impact Energy Versus Temperature for C-L Orientation

Table 7 shows the half-size impact energies, converted full-size impact energies, and estimated  $K_{mat}$  values for the points within the box in Figure 194. Half-size Charpy impact energies were converted to full-size by multiplying them by a factor of 2 [27]. The goal of the conversion was to estimate the fracture toughness of the grade J55 material based on the orientation and temperature of the axial rupture. This corresponds to the C-L orientation and a temperature of 80°F (26.7°C). The closest test temperature was 25°C, which gave an estimated  $K_{mat}$  value of 48.3 ksi-in<sup>1/2</sup>.

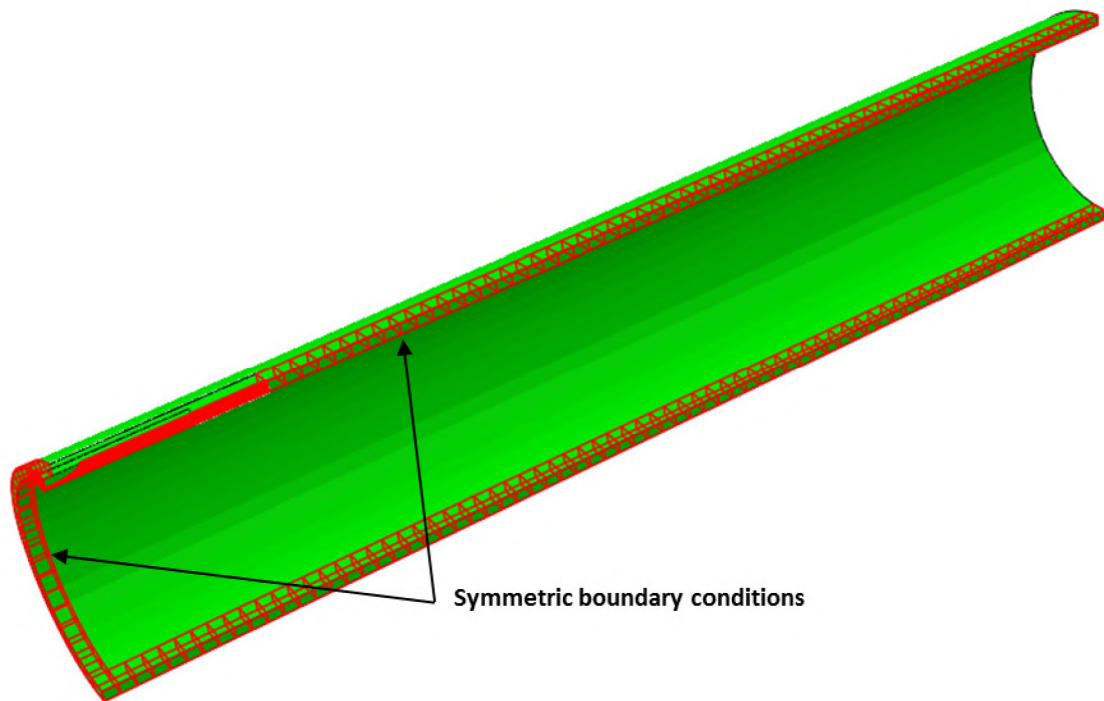
**Figure 195: Symmetric Boundary Conditions**

The mesh at the crack front was used to accurately obtain the stresses and strains surrounding the crack tip. Symmetric boundary conditions were used to simplify the model. The boundaries were applied on symmetric surfaces and corresponded to the pipe axes. Figure 195 shows the boundary conditions for the model. Stress intensity factors were computed at the crack front using the surrounding nodes. Values from the third or fourth contours were considered appropriate and are plotted at various pressures in Figure 196.
