**Blade Supplemental Report (Vol. 2: SS-25 Well Failure Causes)**

# Root Cause Analysis of the Uncontrolled Hydrocarbon Release from Aliso Canyon SS-25

May 31, 2019

# SS-25 Casing Failure Analysis

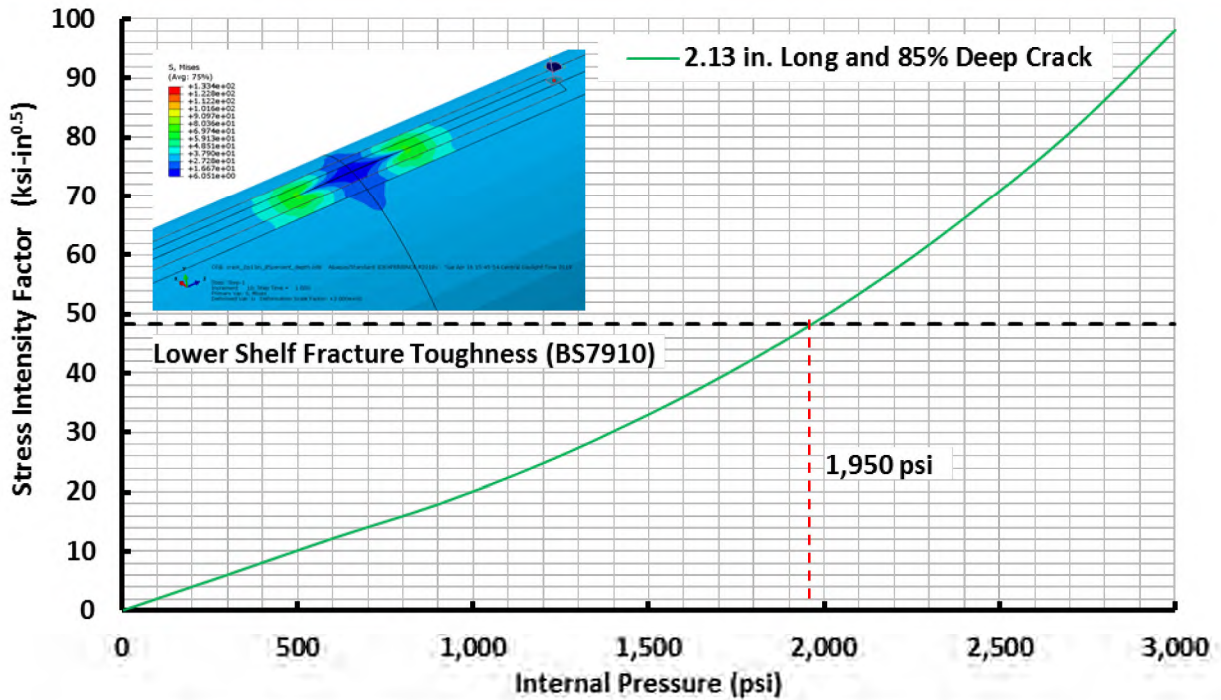
Figure 196: Stress Intensity Factor Evolution with Applied Internal Pressure

The stress intensity factor for the crack model reached a value of 48.3 ksi-in<sup>1/2</sup> when the internal pressure was approximately 1,950 psi. Figure 196 illustrates that the crack was unstable beyond an internal pressure of 1,950 psi. The results show that a 2.13 in. long and an 85% deep crack would have propagated at differential pressures  $\geq 1,950$  psi. The estimated strain-based failure pressure (2,327–2,836 psi) was above the fracture toughness-based instability pressure (1,950 psi). This shows that as soon as the 2.13 in. crack formed by ductile tearing, it became unstable.

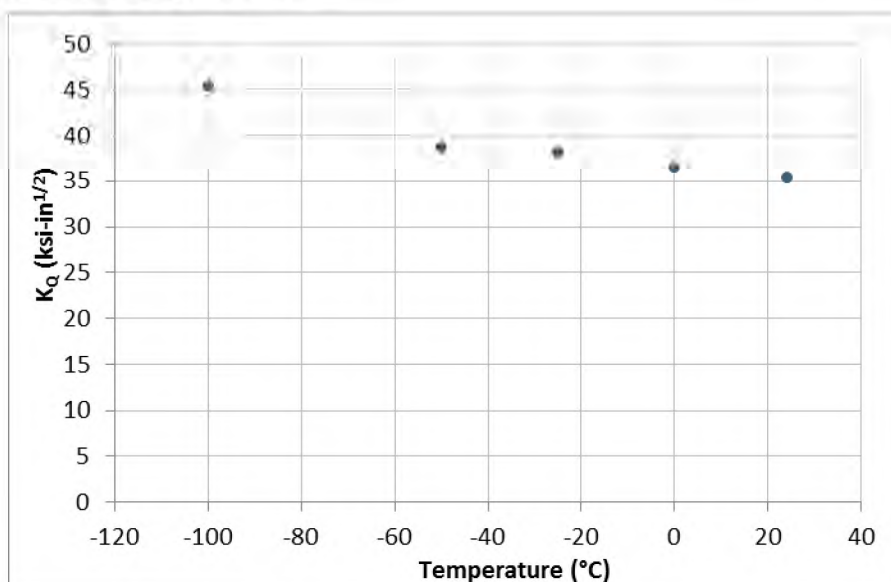
Figure 197:  $K_Q$  Versus Test Temperature

The tests did not meet  $K_{IC}$  requirements due to the small size of the specimens, dictated by the 7 in. casing dimensions. However, the tests did provide conditional  $K_Q$  values per ASTM E399. Figure 197 shows a plot of  $K_Q$  vs. test temperature. In general,  $K_Q$  should decrease with temperature, which is the opposite of what is observed in Figure 197. The discrepancy in trend, which can be attributed to the small specimen size, prevented the use of the  $K_Q$  values.

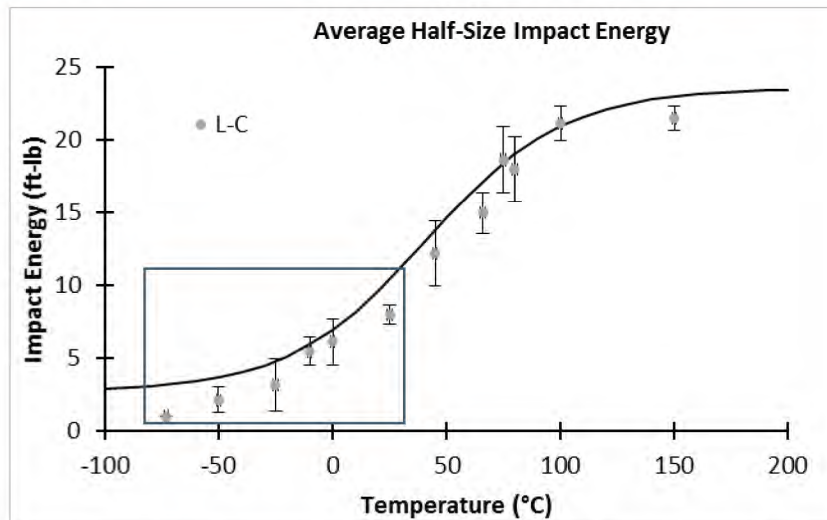
Figure 198: Average Half-Size Charpy Impact Energy Versus Temperature for L-C Orientation

The lower bound relations for lower shelf and transitional behavior were chosen to convert the CVN impact energies into fracture toughness. Figure 198 shows a plot of the average half-size impact energy vs. the temperature for the specimens from all the 25 extracted casing joints. The lower bound relations for lower shelf and transitional behavior provide a conversion for a wide range of steels on the lower shelf and in the transition region. The lower bound, lower shelf conversion gives the fracture toughness values given by Eq. 6 [30].

Regression analysis was used to fit the general DBTT equation (Eq. 21) through the average half-size impact energy data (Figure 198 [black line]). The results from the regression are shown in Eq. 14.

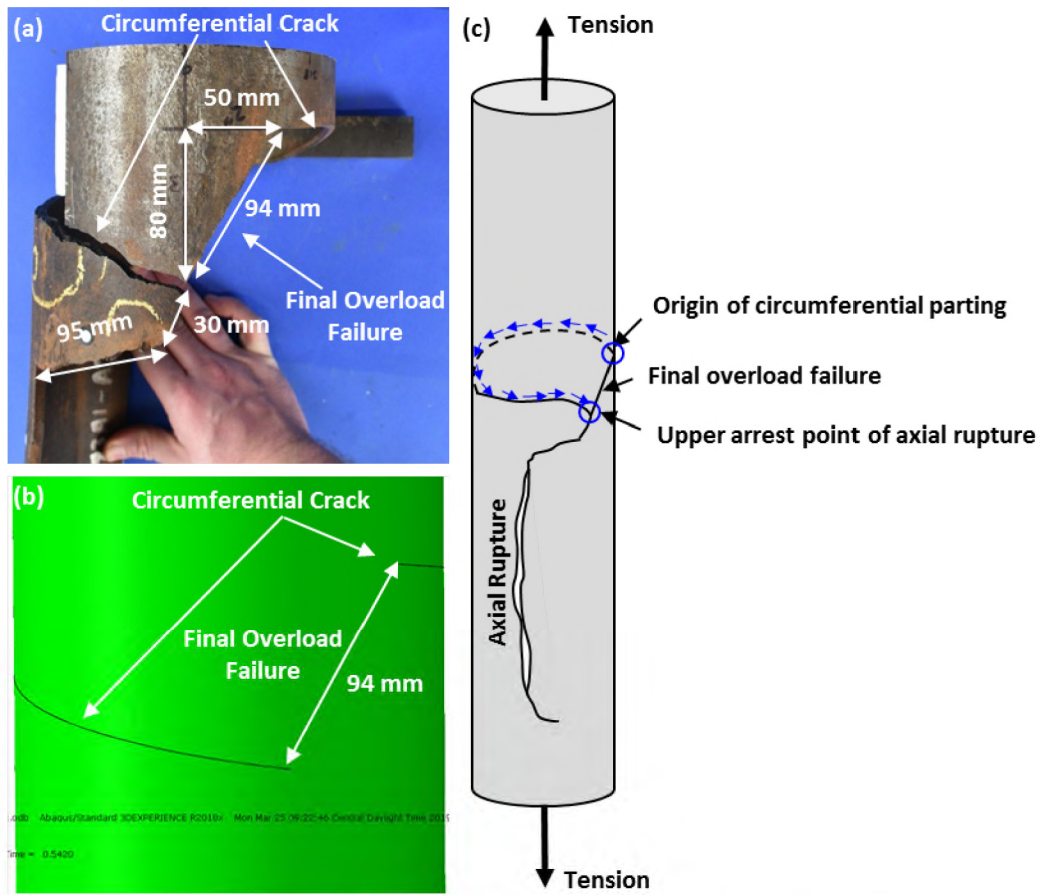
**Figure 199: Final Overload Schematic and Dimensions**

The final overload failure occurred after the axial rupture and circumferential cracking events. An FEA was used to determine if the remaining ligament could support the weight of the 7 in. casing string. Figure 199 shows a schematic of the failure sequence and relevant dimensions for the final overload. Figure 199 (a) shows that the circumferential and axial distances between the upper arrest point of the axial rupture and the circumferential parting initiation site was 50 mm and 80 mm, respectively. The linear distance between the two points was 94 mm at approximately 32° from the longitudinal axis of the pipe.

The circumferential crack was modeled as a helical crack, with the arrest points positioned to match the 7 in. casing. Figure 199 (b) shows the FE model with the helical crack. The pipe was modeled as a 100 in. long 7 in. OD cylinder with a wall thickness of 0.321 in., as was done with the axial rupture models in Section 4.1. One end of the pipe was constrained to restrict movement in all directions. A maximum axial force of 236.5 klb was applied to the opposite end of the pipe. The tensile force at the failure location of 892 ft was taken from Table 5.

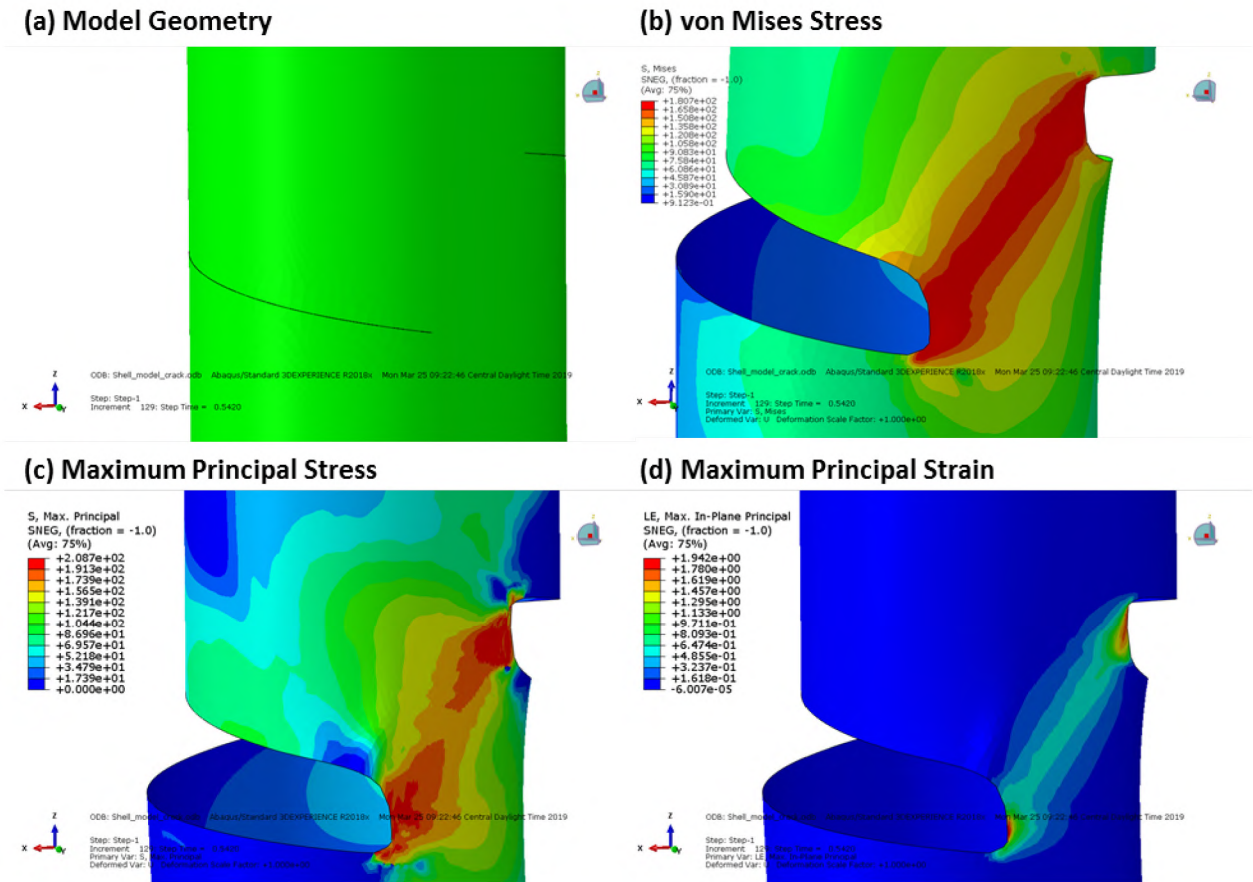
Figure 200: Geometry and FEA Results of the Final Overload Failure

The pipe model failed to converge beyond an axial force of 128 klbf (54% of the total axial force). A high stress of approximately 180 ksi was observed at both ends of the circumferential crack. Figure 200 shows the various contour plots from the FEA at 54% of the total axial force. High stresses and the model instability at 54% of the total axial force suggest that the remaining ligament could not withstand the tensile force and would tear, causing the final overload failure. This observation is in agreement with the failure sequence described in Section 3.1.

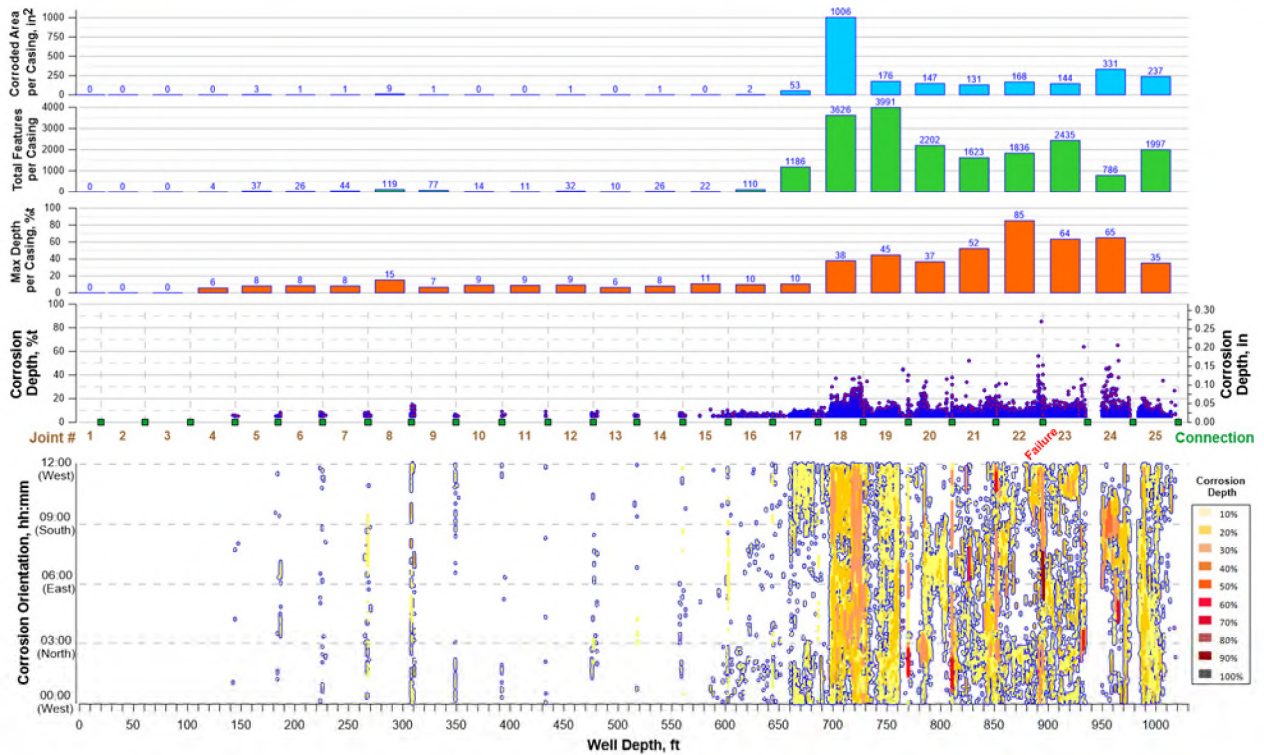
Figure 201: 7 in. Casing OD Corrosion Distribution for Joints 1 to 25

Figure 201 shows the laser scan results for joints 1–25. The map shows that the OD corrosion began around joint 15, and this is consistent with the field observations (connection 14). Furthermore, the color map shows a distinct zone of severe corrosion beginning at 700 ft. Features were identified on the connections and adjacent 3 ft section of pipe above joint 15; however, the pipe bodies did not contain any features. The connections and adjacent 3 ft section of pipe body were not blasted. Features identified in this region were most likely associated with the non-blasted surface condition and handling marks rather than corrosion. Both the visual examination and laser scan data suggested the inexistence of notable corrosion above connection 14.

The color plot shows feature depth as a function of well depth and circumferential orientation. The corrosion was present around the entire OD circumference and did not appear to have a preferential orientation.

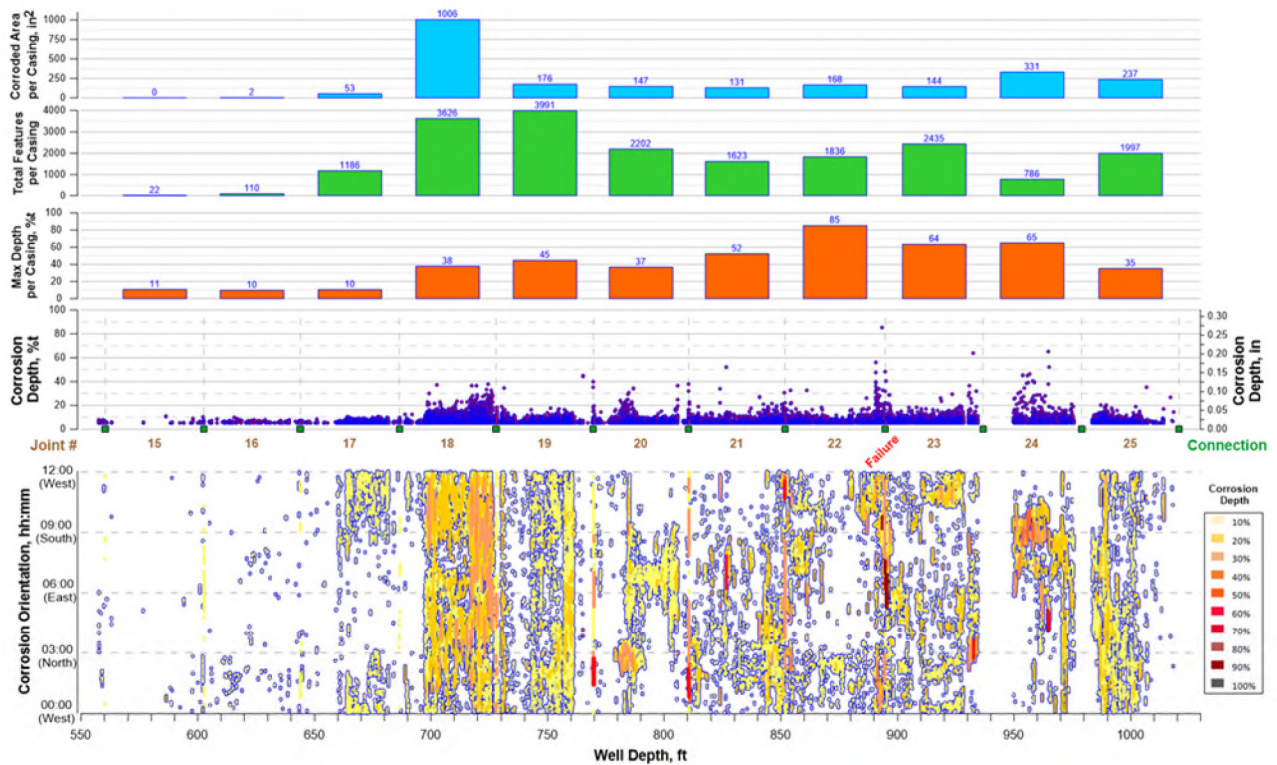
Figure 202: 7 in. Casing OD Corrosion Distribution for Joints 15 to 25

Figure 202 shows the laser scan results for joints 15–25. The plot above the 2D color map shows the maximum corrosion depth measurement at each well depth location. The abscissa is depth in feet and the ordinate is corrosion depth in percent NWT. The secondary axis on the right side of the plot shows the corrosion depth in inches. The plot reinforces the trends observed in the 2D color map. A spike in the maximum corrosion depth was observed at joint 22 near connection 23. This spike represents the corrosion associated with the axial rupture. This location is identified in the plot by the dark red region in the 2D color map.

The three remaining plots from bottom to top are bar graphs showing max depth, feature count, and corroded area for each joint, respectively. The max depth bar plot shows that joints 21–24 contained features greater than 50% NWT. The feature count bar graph shows how many features were identified for each joint. Joints 18 and 19 contained the most features with counts between 3,000 and 4,000. Feature counts are influenced by clustering parameters within the software. The same clustering parameters were used for all pipe body and connection scans so that the results could be compared. The maximum calculated density was 0.36 features/in<sup>2</sup>, based on the count (4,000 features), nominal dimensions, and joint length for joint 19.

The corroded area bar graph shows the summation of all the corrosion feature areas for each joint. Most of the joints had measured corroded areas of 350 in<sup>2</sup> or less. The maximum value of 1,000 in<sup>2</sup> occurred at joint 18 and is equivalent to a 9% area coverage.

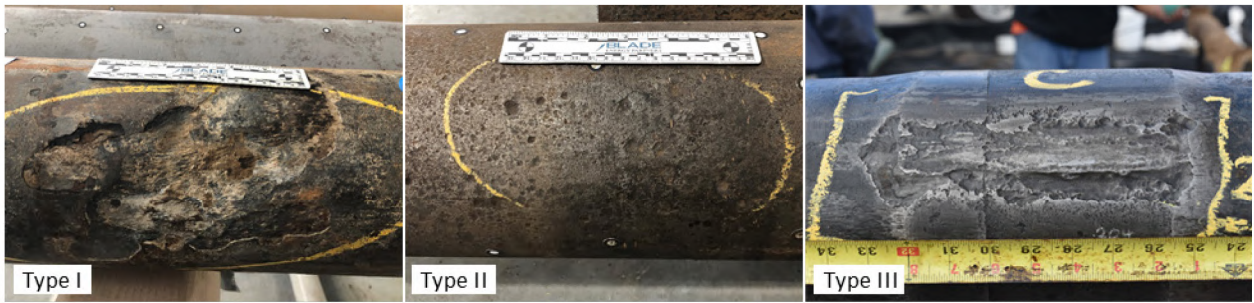
Figure 203: Types I, II, and III Corrosion Features

A visual examination was conducted, and three corrosion feature types were identified based solely on morphology (Type I, II, and III). Figure 203 shows examples of each of the following feature types:

- Type I:
  - Characterized by striated grooves with V-shaped tips
  - Typical of joints below 700 ft
  - Associated directly with the axial rupture in joint 22
- Type II:
  - Characterized as corrosion without striated grooves with an appearance similar to general corrosion and pitting
  - Occurred in most joints beginning at joint 15
  - Not associated with the axial rupture
- Type III:
  - Characterized as rectangular-shaped corrosion with little to no attack in the middle region
  - Occurred mostly on connections except for one large feature identified on joint 20
  - Not associated with the axial rupture

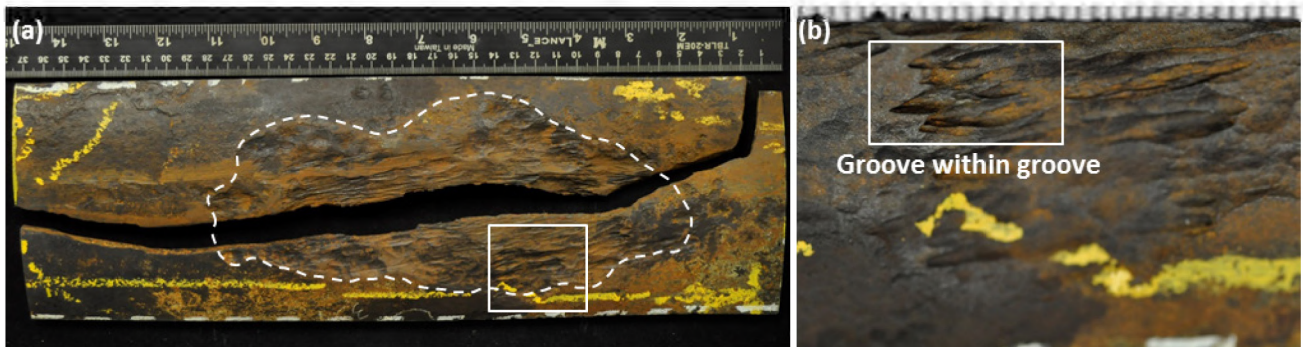
Figure 204: (a) Joint 22 Axial Rupture and (b) Type I Feature Showing V-Shaped Tips

The axial rupture was caused by a Type I corrosion feature. The feature was 9.25 in. long and 3.72 in. wide and contained striated grooves. Severe wall thinning was observed near the center of the feature. Type I features were observed in many of the joints below 700 ft. Figure 204 (a) shows the Type I feature associated with the axial rupture. Figure 204 (b) shows the V-shaped tips typical of Type I corrosion and small striated grooves within larger striated grooves (groove within groove).

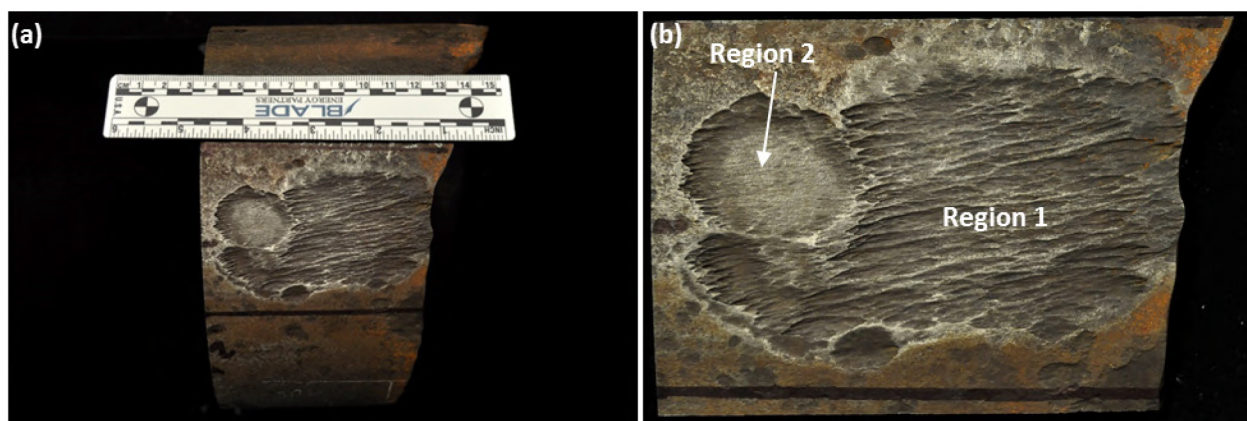
**Figure 205: (a) Specimen C022B1 from Circumferential Parting Showing (b) Regions 1 and 2**

Specimen C022B1, adjacent to the circumferential parting (Figure 205 [a]), was extracted from the failed joint (joint 22). The corrosion patch was approximately 3.5 in. long in the longitudinal direction and contained two regions. The first region had striated grooves that were present throughout the entire region. The second region contained groove tips along the outer boundary but was relatively flat in the mid-region.

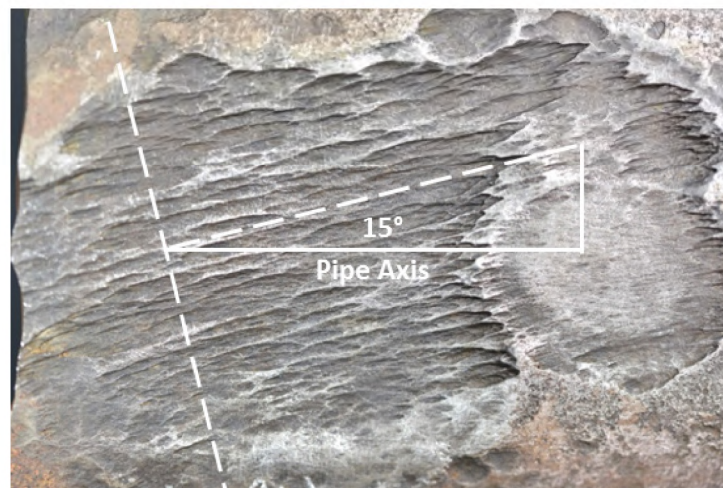
**Figure 207: Striated Groove Orientation for Specimen C022B1**

Most of the striated grooves were oriented at 0–15° from the longitudinal axis of the casing (Figure 207). The reason for this phenomenon is unclear. Literature on the subject is limited but suggested that striations could be the result of preferential attack of longitudinally oriented microstructural features, pearlite stringers, coring, and stressed regions. Striations are typically associated with MIC but can be caused by other mechanisms [34] [35].

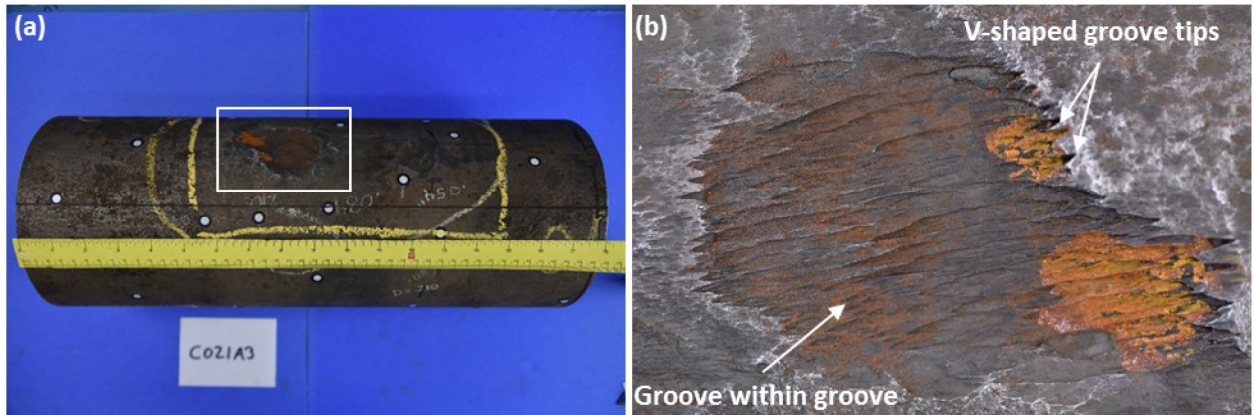
Figure 208: (a) Specimen from Joint 21 and (b) Type I Corrosion Feature

Specimen C021A3C extracted from joint 21 of the 7 in. casing has a corrosion patch with similar morphology as specimen C022B1 (Figure 208). The corrosion patch was approximately 3 in. long in the longitudinal direction and contained striated grooves present throughout the entire feature similar to the first region of C022B1 (Figure 205 [b]). Figure 208 [b] shows grooves within grooves, which is typical for Type I corrosion features.

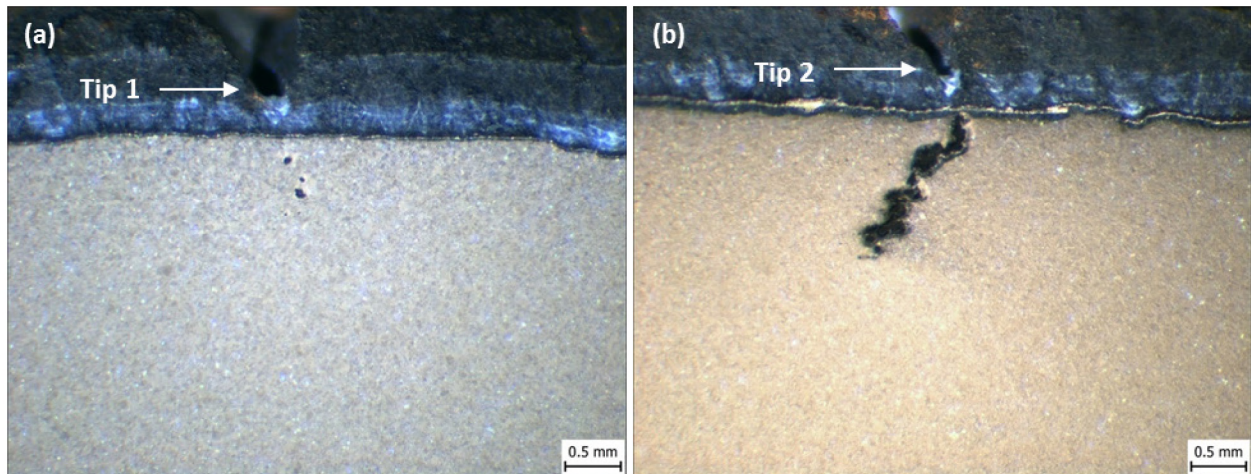
Figure 211: Stereo Microscope Image of (a) Tip 1 and (b) Tip 2

Figure 210 (a) shows the location of a transverse cross section for C021A3C that was made approximately 1 mm ahead of the V-shaped groove tips. Figure 210 (b) identifies two large groove tips designated as tips 1 and 2. Tunnels were observed beneath both groove tips (Figure 210 [c]). Figure 211 (a) and (b) are micrographs of groove tips 1 and 2 after etching with 2% nital. The micrographs clearly show tunnels as black regions ahead of the groove tips. Figure 212 (a) and (b) are metallographs of groove tips 1 and 2 taken at 50 $\times$ . The metallographs show multiple tunnels occurring as deep as 1,300  $\mu\text{m}$  below the OD surface. The inner structure of the tunnels could not be examined due to the limitations of the metallographic microscope. A detailed examination of the tunnels was conducted with the SEM.

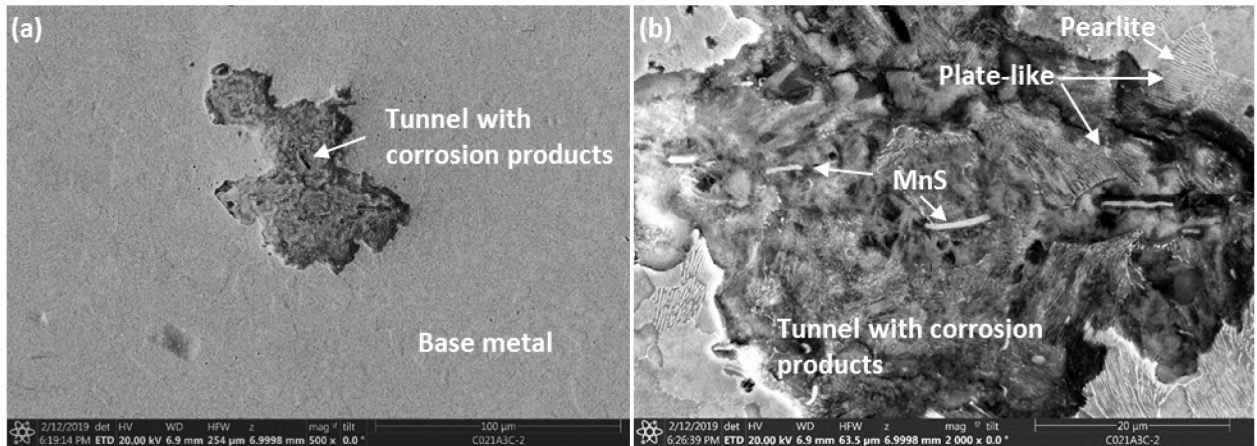
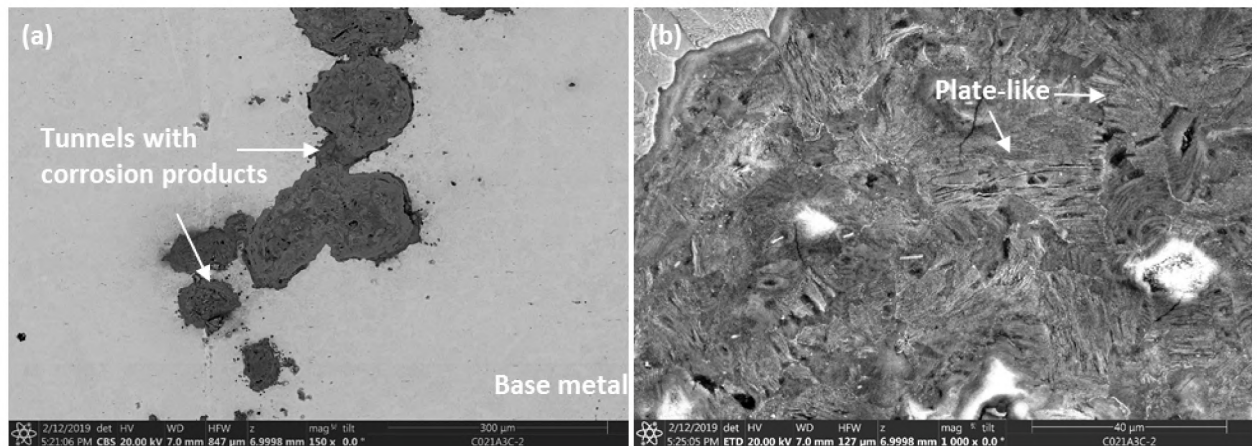
Figure 213 and Figure 214 show SEM images of the tunnels in the C021A3C2 cross section. Corrosion products were present in the tunnels. Figure 215 shows an EDS color map of the corrosion product. The EDS results indicate high levels of oxygen (27–54 at%) and carbon (24–50 at%). The SEM image and EDS maps also show remnants of the original MnS inclusions and plate-like cementite ( $\text{Fe}_3\text{C}$ ) within the corrosion product. There seemed to be a preferential anodic dissolution of ferrite leaving the cementite behind [37]. The presence of the lamellar cementite provided an anchor to the corrosion products [37].

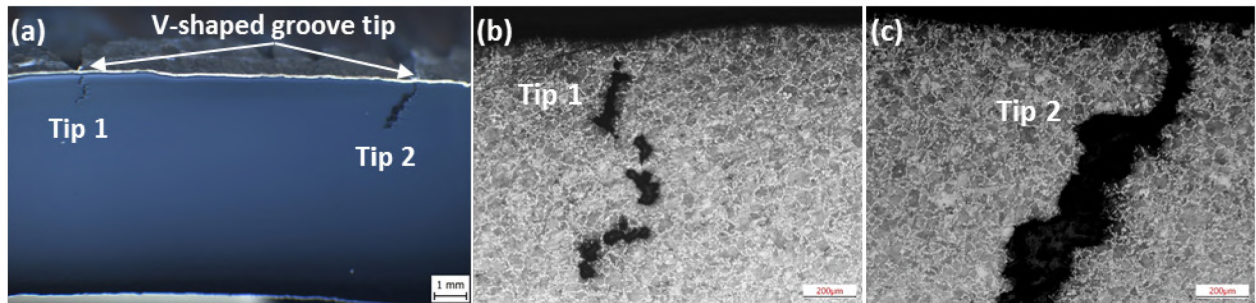
Figure 216: Specimen C021A3C2 after Second Polish

Figure 216 (a) shows the cross section of tips 1 and 2 after re-polishing. The tunnels under tip 1 increased in size and in depth from the OD surface.

Figure 216 (b) and (c) show metallographs of tips 1 and 2 after etching with 2% nital. The tunnels under tip 2 also increased in size and coalesced into a larger tunnel. Raman spectroscopy identified organic matter, modified hematite ( $\text{Fe}_2\text{O}_3$ ), and magnetite ( $\text{Fe}_3\text{O}_4$ ) in the corrosion products in the tunnel. Figure 217 shows the Raman spectra for the corrosion product in the tip 2 tunnels [38].

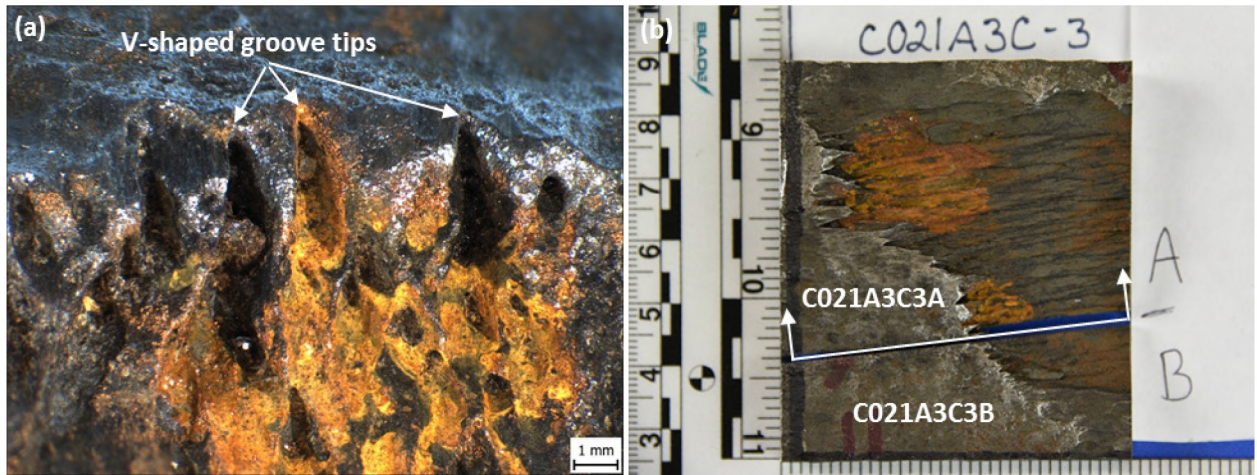
Figure 218: Specimen C021A3C3 (a) V-pointed Groove Tips and (b) Cross Section Location

A longitudinal cross section was made parallel to the long axis of the striated grooves to reveal the V-shaped groove tips in detail. The primary objective of the cross section was to confirm the presence of tunnels and determine their profile. Figure 218 (a) shows the distinct V-shaped groove tips that were the target for the longitudinal cross section. Figure 218 (b) shows specimen C021A3C3 and the cross section location. Figure 219 shows stereo images of the C021A3C3A cross section. The images show that tunnels penetrated longitudinally into the base metal.

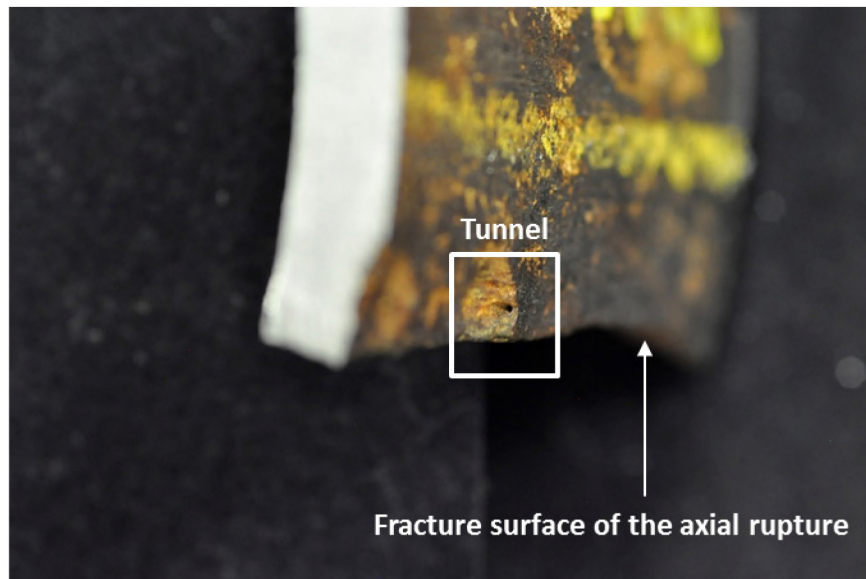
Figure 220: C023A1B2A5 Groove Tunnel Adjacent to Axial Rupture Fracture Surface

Specimen C023A1B2A5 was extracted from the Type I corrosion feature associated with the axial rupture (joint 22). Visual examination of the specimen identified a tunnel adjacent to the axial fracture surface. Figure 220 shows a macro image of the tunnel. This was the only example of a tunnel that was observed by visual examination. Figure 221 (a) shows a low magnification SEM image of the same tunnel as viewed from the top. The tunnel was metallographically cross-sectioned in the longitudinal direction to show the groove profile (Figure 221 [b]). The tunnel had a mouth opening of 0.5 mm and penetrated 1 mm into the base metal.

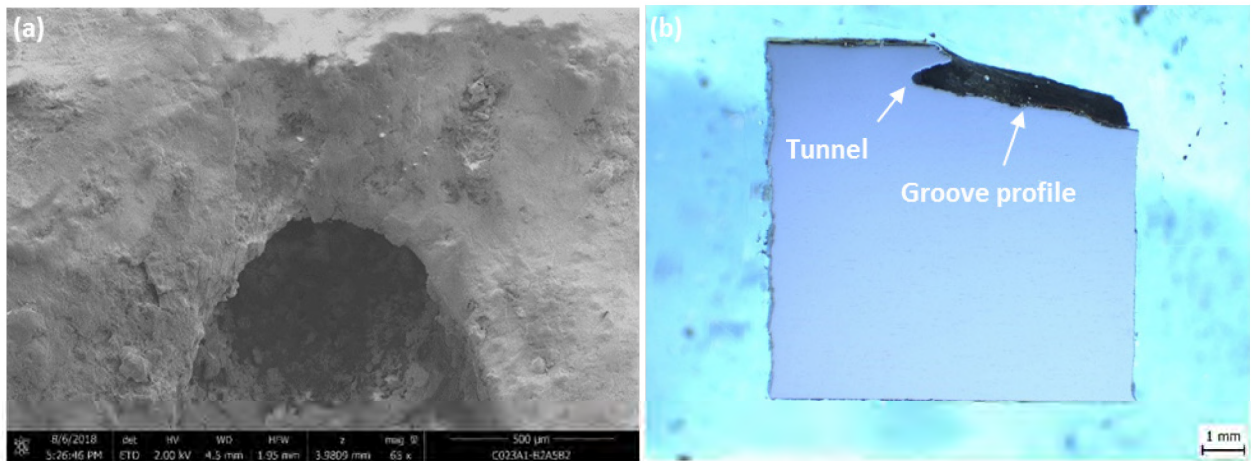
Figure 221: Specimen C023A1B2A5B2's (a) SEM Image and (b) Metallographic Section Showing Tunnel

C023A1B2A5B2A (Figure 221 [b]) was mounted in epoxy, polished, and examined in incremental steps after the FIB investigation. Figure 221 (b) is an image of the specimen after the final polish. Figure 227 shows backscatter images of the cross section after the first polishing step.

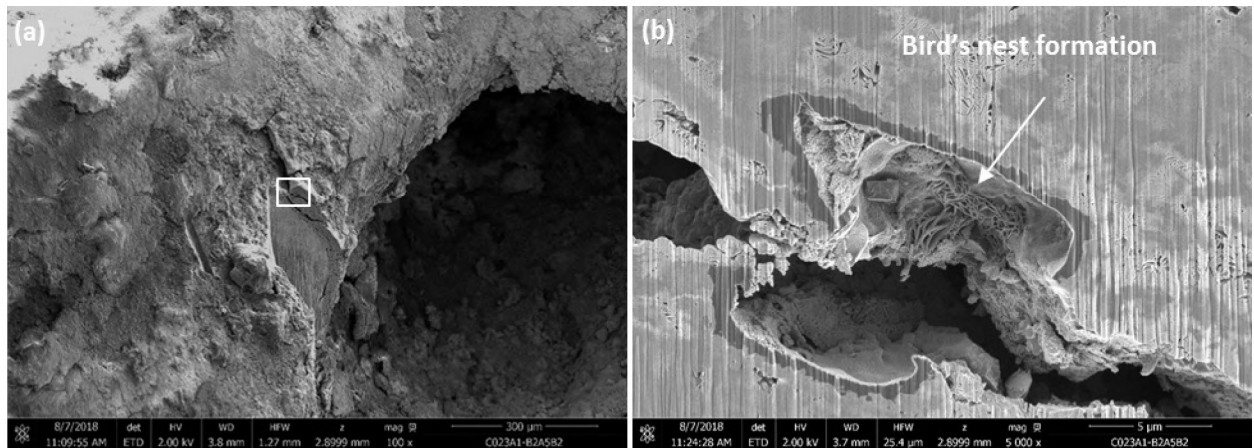
Figure 223: FIB Cross Section of the Groove Wall in C023A1B2A5B2 at (a) 100 $\times$  and (b) 5,000 $\times$

Specimen C023A1B2A5B2 (extracted from C023A1B2A5 [Figure 220]) was initially sectioned for a detailed analysis using FIB followed by metallographic cross sectioning (C023A1B2A5B2A). The groove wall was cross-sectioned using FIB to look at the deposit morphology. Figure 223 shows a bird's nest formation within the corrosion deposit, as described by various authors [39] [40] [41]. The bird's nest formation is typical of atmospheric corrosion of carbon steel [39].

EDS analysis shows that the corrosion deposit contains approximately 40 at% Fe, 18 at% C, 18 at% O, 9 at% Ca, 0.2 at% S, and small amounts (<1 at%) of other elements. Another FIB cross section at the groove tip (Figure 224) reveals corrosion products that formed just inside the mouth opening of the tunnel. The corrosion product does not appear to be dense. Several layers of deposits were seen inside the tunnel. Figure 225 shows Fe, C, and O EDS color maps of the FIB section. EDS found approximately 60 at% C, 19 at% Fe, 19 at% O, and small amounts of S, K, Mn, Cl, Si, and Al.

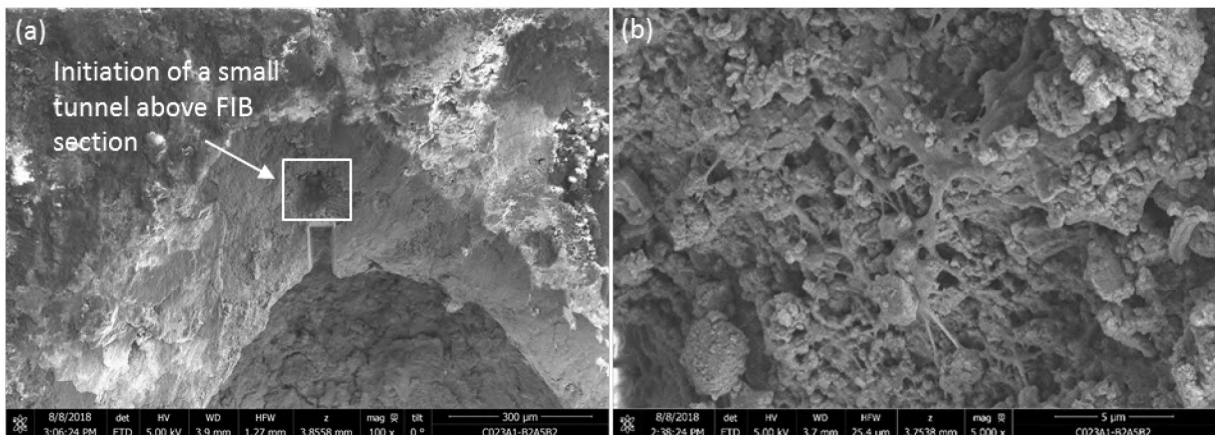
**Figure 226: (a) Small Tunnel and (b) Extra-Cellular-Like Material**

Figure 226 (a) shows a small, darker circular feature (white box) directly above the FIB section (in the V-shaped groove tip). The circular feature was interpreted as being a small tunnel in its initial stages of forming. Figure 226 (b) shows a high magnification image of the forming tunnel. There is extra-cellular-like material [42] surrounding the forming tunnel. EDS analysis of the area containing the extra-cellular-like material showed high amounts of C ( $\approx 77$  at%), with 10 at% Fe, 9 at% O, and 0.6 at% S. High amounts of carbon may suggest the presence of organic material. The organic matter could have come from different sources, such as microbiological activities, kill fluids, oil, and the surrounding formation.

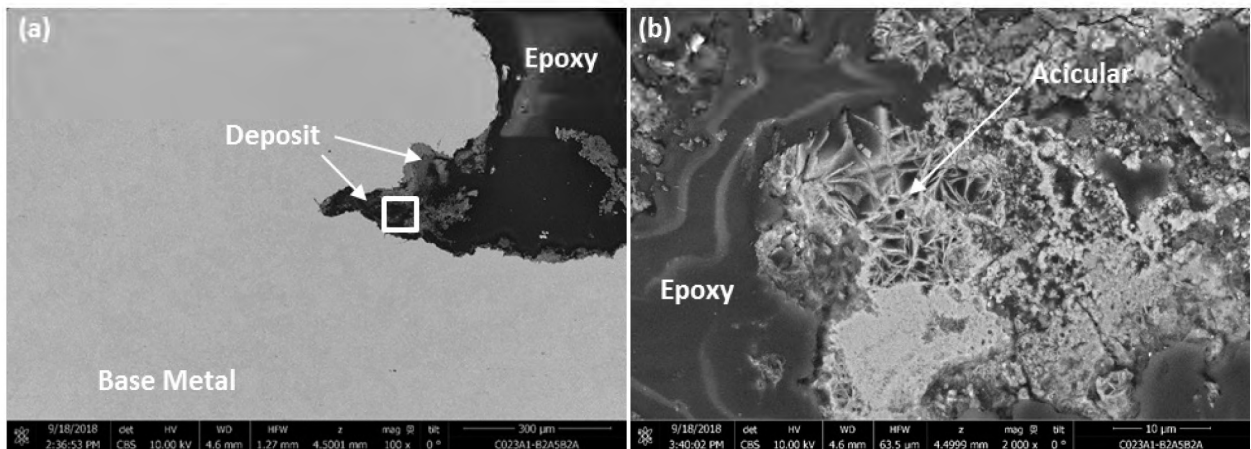
Figure 227: (a) Metallographic Cross Section of C023A1B2A5B2A and (b) High Magnification Image of Corrosion Deposit Inside the Tunnel

Figure 227 (b) shows that the corrosion deposit inside the tunnel is not compact or dense but has some acicular features. A bird's nest formation similar to Figure 227 (b) was observed [39] [40] [41]. EDS analysis of the corrosion product identified high amounts of C (60 at%), Fe (20 at%), and O (17 at%) with trace amount of S and Cl. Raman spectroscopy confirmed the presence of modified hematite ( $Fe_2O_3$ ), magnetite ( $Fe_3O_4$ ), and organic matter inside the tunnel.

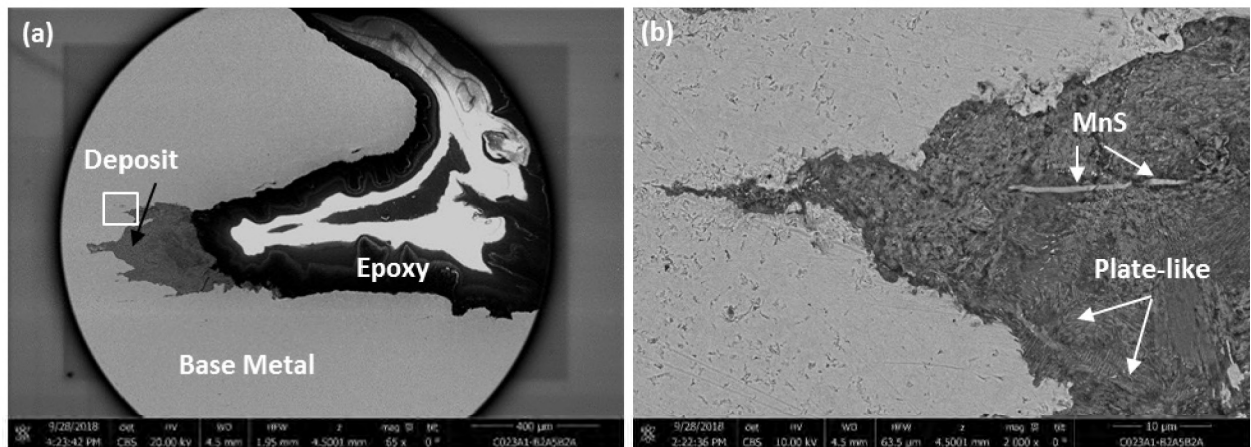
Figure 228: (a) Second Metallographic Cross Section of C023A1B2A5B2A and (b) High Magnification Image of Corrosion Deposit

Figure 228 shows a corrosion deposit at the tip of the tunnel after the final polish. The corrosion deposit appears denser than what was observed after the first polish. Lamellar (plate-like cementite) features similar to Figure 213 (b) are visible from the high magnification backscatter images (Figure 228). EDS analysis shows that the corrosion product inside the tunnel was rich in O and C. The analysis also revealed that MnS inclusions were present and surrounded by the corrosion product.

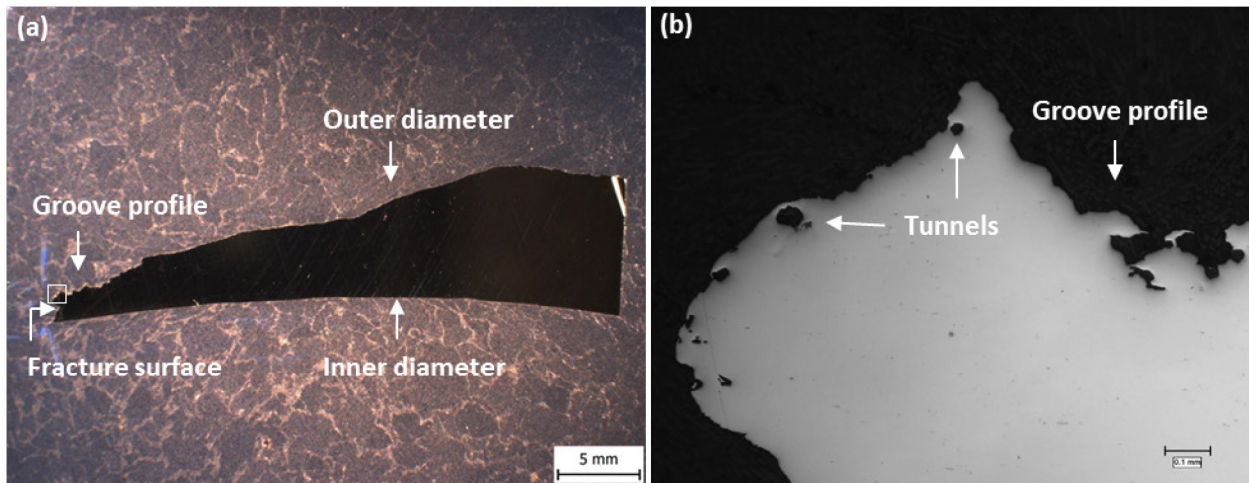
Figure 229: Metallographic Images of C023A1B2C2

C023A1B2C2 was extracted from the initiation site of the axial rupture. The specimen was mounted in Bakelite and then polished. Figure 229 shows the presence of tunnels directly below the groove in the Type I corrosion feature. The cross section also shows an acicular corrosion deposit in the tunnel with remnants of MnS inclusions. Figure 230 shows the SEM image of the cross section and the sulfur and manganese mapping obtained with EDS. The corrosion products inside the tunnel are not very dense. Raman spectroscopy identified the corrosion products as hematite ( $\text{Fe}_2\text{O}_3$ ), modified hematite ( $\text{Fe}_2\text{O}_3$ ), magnetite ( $\text{Fe}_3\text{O}_4$ ), and organic matter.

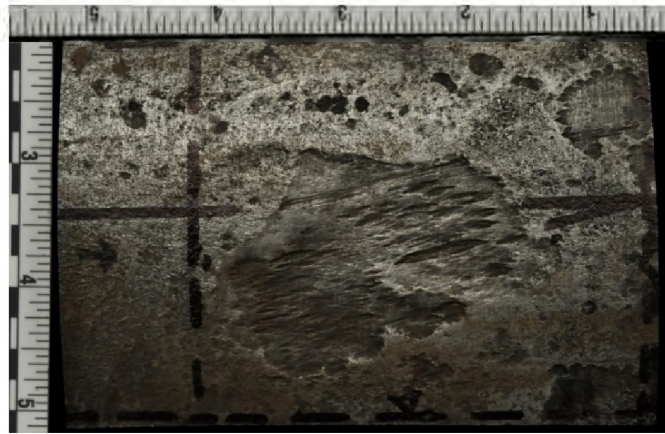
Figure 231: Specimen C022B2A5

Figure 230: (a) SEM Image of Tunnel with Acicular Deposit and EDS Color Maps for (b) S and (c) Mn Specimen C022B2A5 (Figure 231) was extracted from joint 22 and has a Type I corrosion feature with a length of 2.5 in. along the longitudinal axis. The specimen was subjected to the FIB cross section. The specimen was ultrasonically cleaned in acetone prior to the FIB cross section. Globules are seen mostly inside the groove tips. High magnification imaging of the globules shows details of the globular structure

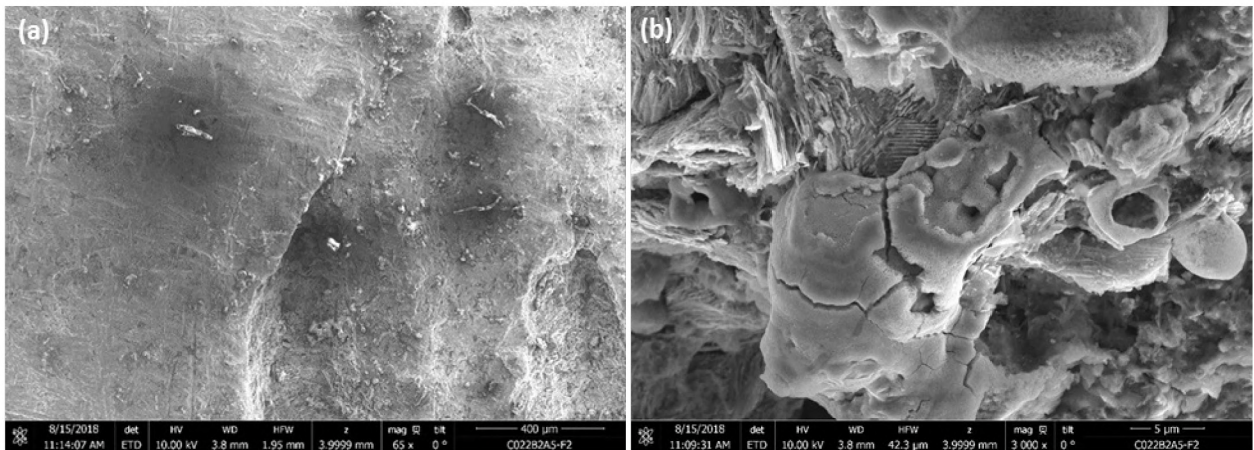
Figure 232: (a) Top View of Groove Tip and (b) High Magnification Image of Globule Cluster

(Figure 232). The FIB cross section of the globule shows that features that look like bird's nest formation, as described by some authors [39] [40] [41], are present inside the globules (Figure 233). These globules are high in C ( $\approx 50$  at%), Fe ( $\approx 40$  at%), and O ( $\approx 10$  at%). Raman spectroscopy confirmed the presence of modified hematite ( $\text{Fe}_2\text{O}_3$ ), magnetite ( $\text{Fe}_3\text{O}_4$ ), iron oxide combination, and organic matter [38].

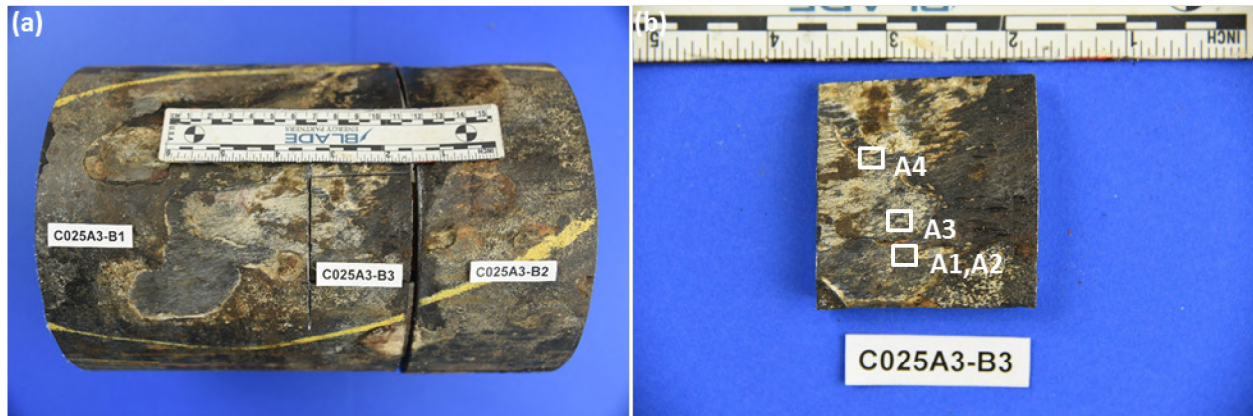
Figure 234: Specimen C025A3B Sample (a) Layout and (b) Areas of Investigation

Specimen C025A3B3 was extracted from a specimen (from joint 24 [Figure 234]) with a large (> 5 in. diameter) corrosion patch. The striated grooves were visible but were covered with what appeared to be white deposits. The white deposits were rich in Ca (10-20 at%), O (30-50 at%), C (20-30 at%), S (2-10 at%). White deposits were also seen in Area 3 (Figure 235), while globules were prominent in Area 4. Raman analysis showed the presence of gypsum ( $\text{CaSO}_4 \cdot \text{H}_2\text{O}$ ) on the surface of specimen C025A3B3 Area 1. Modified hematite ( $\text{Fe}_2\text{O}_3$ ), barite ( $\text{BaSO}_4$ ), and carbonate were identified in Area 1, while barite ( $\text{BaSO}_4$ ), carbonate, and organic matter were found on the surface of Area 4.
