**Blade Supplemental Report (Vol. 2: SS-25 Well Failure Causes)**

# Root Cause Analysis of the Uncontrolled Hydrocarbon Release from Aliso Canyon SS-25

May 31, 2019

# SS-25 Casing Failure Analysis

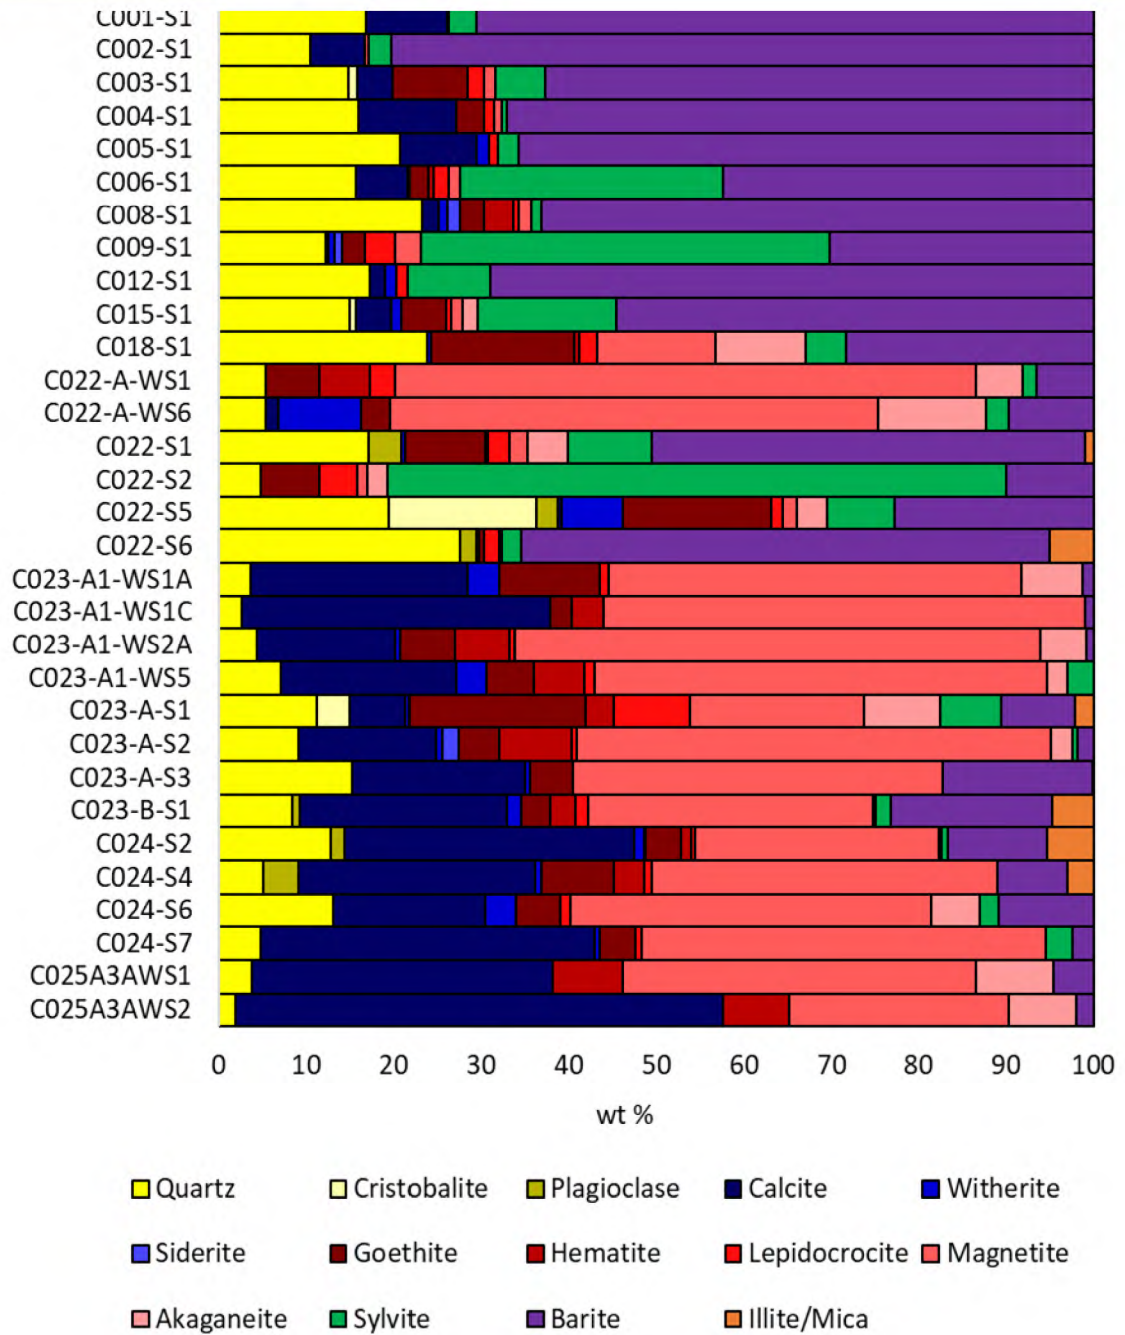
Figure 236: XRD Weight Percentages Before Adjustment

Figure 236 shows the XRD weight percentages of the compounds present in the scale samples collected from C001–C025. It can be seen that barite ( $\text{BaSO}_4$ ) and sylvite ( $\text{KCl}$ ) dominate the weight percentages of the compounds, which were most likely contaminants from the kill fluids. Blade adjusted the weight percentages by removing barite ( $\text{BaSO}_4$ ) and sylvite ( $\text{KCl}$ ) to obtain the graphs shown in Figure 237.

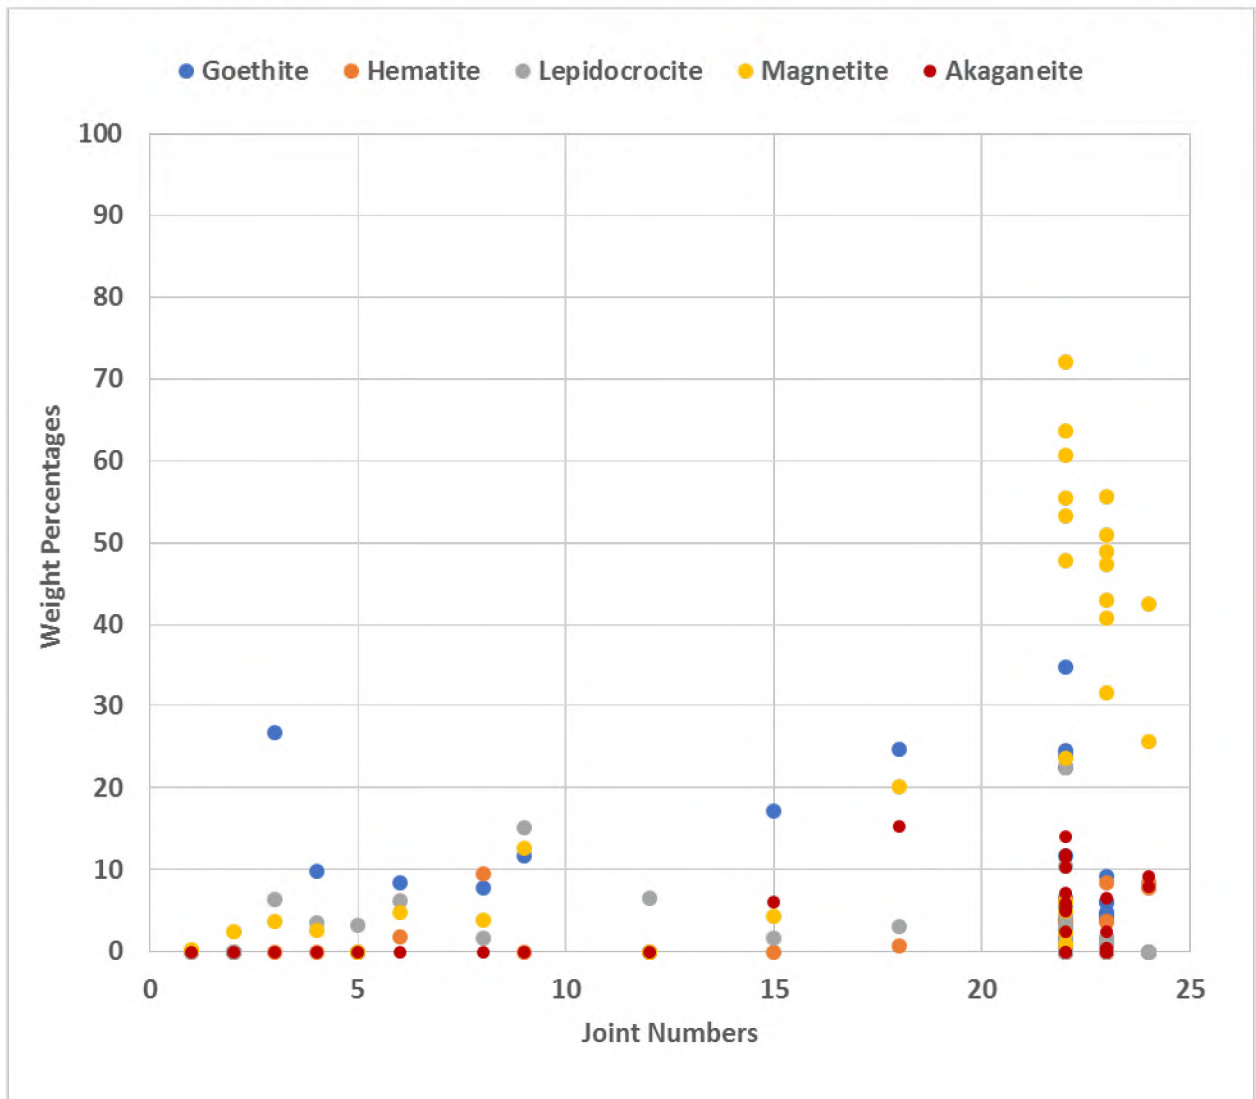
**Figure 238: Weight Percentages of Iron Oxides Present in Scale Samples from C001–C025**

Figure 238 shows a plot of the recalculated weight percentages of iron oxides and iron hydroxides identified in the scale samples for C001–C025. The figure shows that the amount of magnetite ( $\text{Fe}_3\text{O}_4$ ) in the scale samples was higher for joints in the lower portion of the well. In general, scale collected from joints at shallow depths contained higher percentages (>5%) of goethite [ $\alpha\text{-FeO(OH)}$ ] and lepidocrocite

[ $\gamma$ -FeO(OH)], while scale samples collected from deeper locations contained more (>20%) magnetite ( $\text{Fe}_3\text{O}_4$ ). The change in the dominant corrosion product may indicate a possible change in environment.

Magnetite ( $\text{Fe}_3\text{O}_4$ ) is commonly formed in environments with less oxygen. C018–C025 had an adjusted weight percent greater than 20% for magnetite ( $\text{Fe}_3\text{O}_4$ ). These observations suggest a possible change in environment between the upper and lower portion of the extracted 7 in. casing. This change is consistent with the laser scan observations.

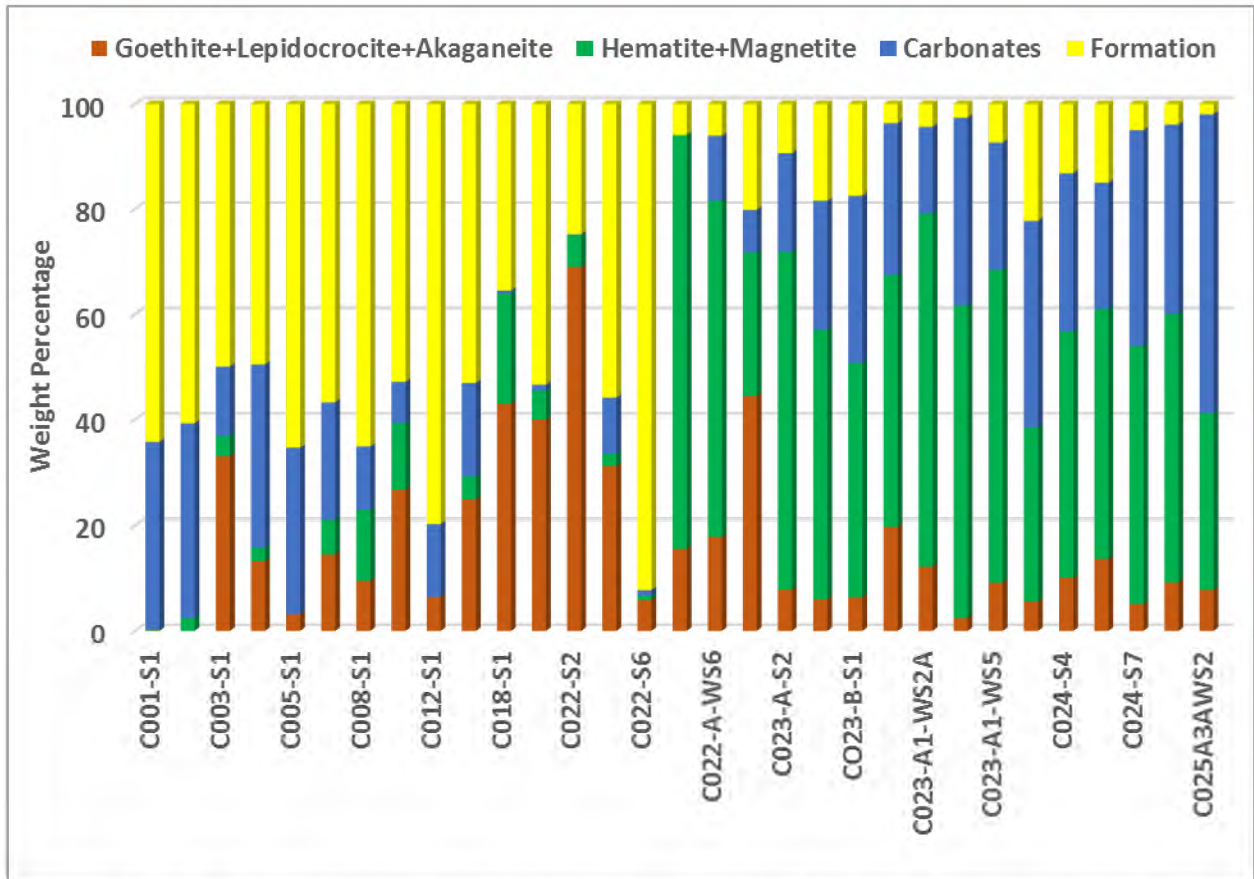
Figure 239: Recalculated Percentages of Iron Hydroxides, Iron Oxides, Carbonates, and Formation

Figure 239 shows a bar graph of the weight percentages of iron hydroxides (goethite, lepidocrocite, and akaganeite [red]), iron oxides (magnetite and hematite [green]), carbonates (siderite, barite, aragonite, and witherite [blue]), and formation (quartz, plagioclase, mica [illite], and cristobalite [yellow]). The samples were sorted by depth and examined for trends in the dominate phases as a function of well depth. Iron hydroxides were present in larger amounts at the upper portion of the well, while iron oxides were dominant at the lower portion of the well. High weight percentages of formation were present in scale samples collected from C022 and above. Samples below C022 showed significantly lower weight percentages of formation. This observation reflects the blowout event. Formation was carried by the escaping gas during the blowout and contaminated the OD surface of the joints above the failure (joints 22 and above).

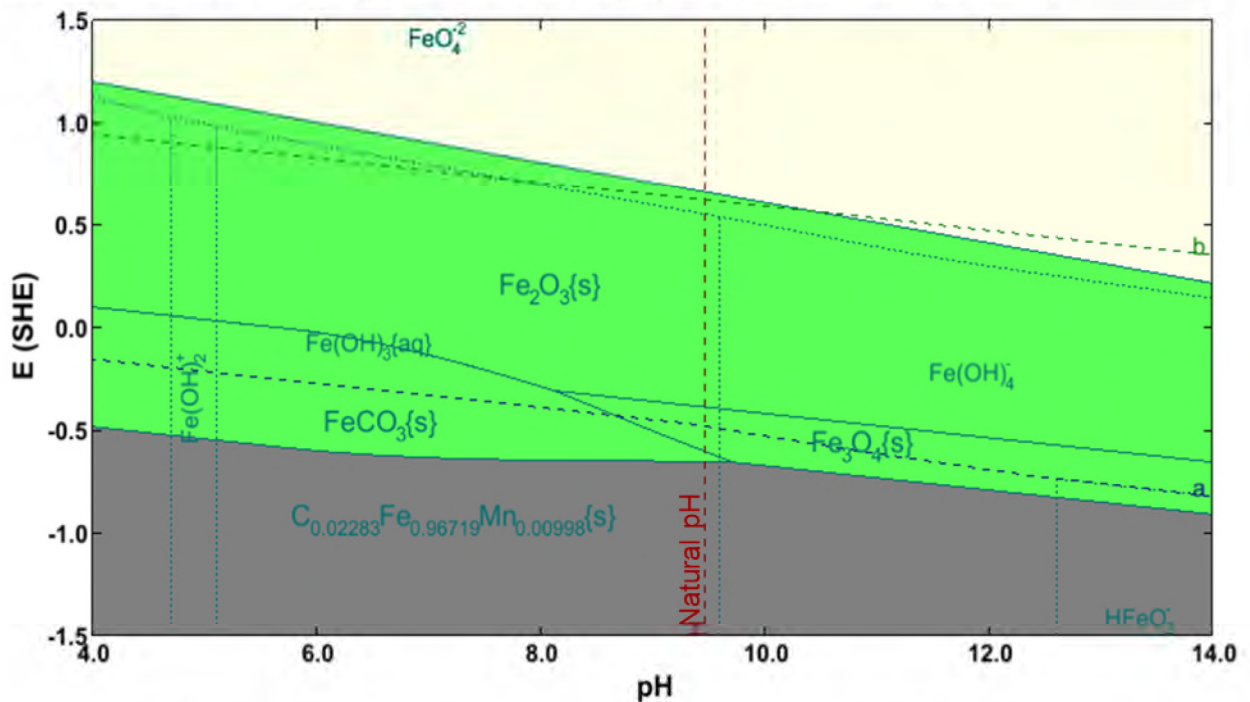
Figure 240: Ferrous/Ferric Hydroxide Stability Domains in the Presence of Carbonate (Condition 1)

From the calculation of the Pourbaix diagram using condition 1 with high amounts of CO<sub>2</sub> in the system, the ferrous ion in solution is not present in Figure 240. The natural pH is too high (approximately 9.4). The stability domain for siderite (FeCO<sub>3</sub>) extends beyond the natural pH, which means that siderite (FeCO<sub>3</sub>) can coexist with magnetite (Fe<sub>3</sub>O<sub>4</sub>).

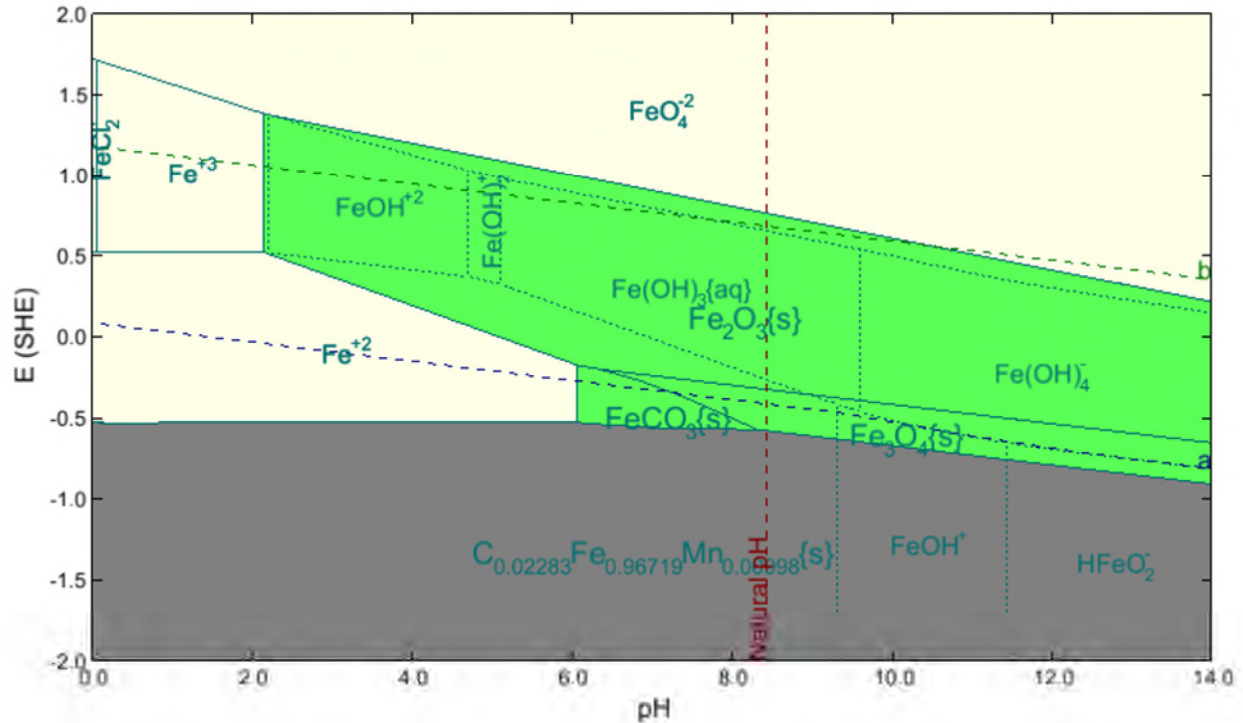
Figure 241: Ferrous/Ferric Hydroxide Stability Domains in the Presence of Carbonate (Condition 2)

The amount of CO<sub>2</sub> concentration was reduced to a more realistic level, and bicarbonate was eliminated in condition 2. The resulting Pourbaix diagram (Figure 241) shows that the natural pH becomes 8.4, and the natural pH is in the magnetite (Fe<sub>3</sub>O<sub>4</sub>) domain. This also means that siderite (FeCO<sub>3</sub>) would not naturally form in the field. The stability diagram confirms that at the location of maximum corrosion there was no siderite (FeCO<sub>3</sub>), or only traces of siderite (FeCO<sub>3</sub>) were observed—it did not naturally occur in this environment. Magnetite (Fe<sub>3</sub>O<sub>4</sub>) formation is qualitatively and quantitatively favored over siderite (FeCO<sub>3</sub>), even if excess CO<sub>2</sub> was present. This also supports that CO<sub>2</sub> corrosion was unlikely.

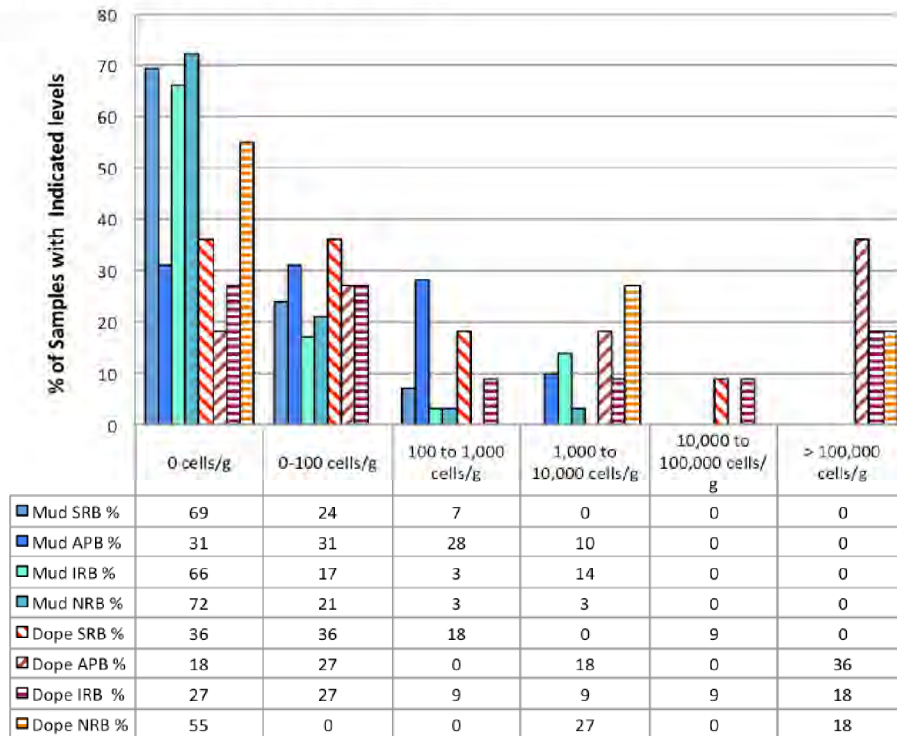
**Figure 242: Culturable Bacteria per Gram of Sample**

The samples collected from SS-25 in Aliso Canyon (August 8, 2018) did not show great abundance of sulfate-reducing bacteria. Although sulfate-reducing bacteria was present in the scales collected from the 7 in. casing (specifically from C025 and C026), the amount detected was low (less than 1,000 cells/g). GHB and APB were identified in samples taken from areas within Type I corrosion features (C025S06, C025S13,

C025S14, C025S16, C025S17, and C025S19). Cell counts from these samples ranged from 10–2,100 cells/g. APB and GHB were present in 82% of the crude oil samples and 69% of the scale samples. MPN analysis in Figure 242 showed that the bacteria population profile of the scales (mud) collected from the OD of the 7 in. casing and the oily material (dope) were different.

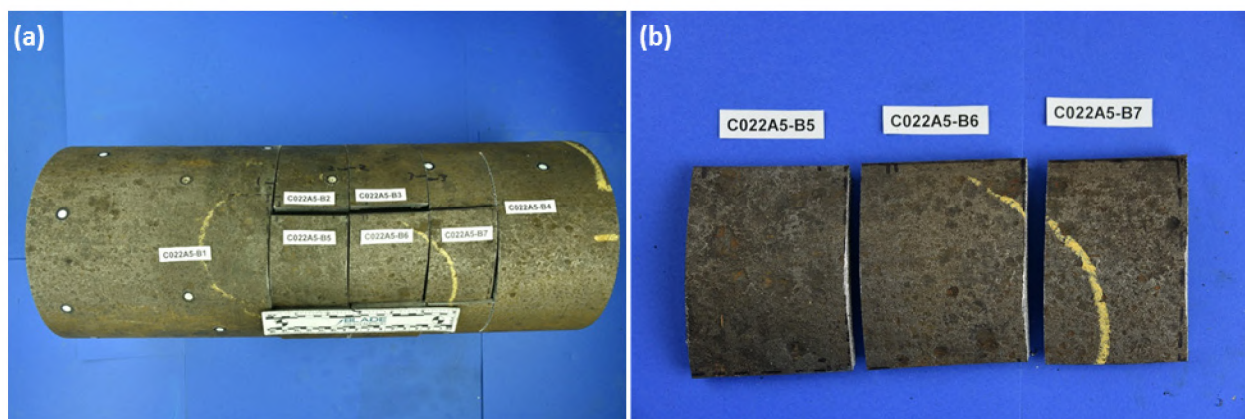
**Figure 243: Specimens with Type II Feature Extracted from Joint 22**

Type II features were characterized as pit-shaped corrosion without striated grooves. These features were small in diameter (0.05–0.5 in.) and shallow. The depth of the metal loss was less than 20% of the wall thickness, based on the laser scan data. These localized features were distributed along the length of the extracted 7 in. casing, with the highest density occurring between joints 15 and 25.

Three Type II specimens were extracted from joint 22 for a detailed investigation. Figure 243 shows the pipe segment where specimens C022A5B5, C022A5B6, and C022A5B7 were extracted. C022A5B5 contained a combination of large (0.25–0.5 in. diameter) and medium (0.1–0.25 in. diameter) size pits. C022A5B6 mostly contained medium size pits, while C022A5B7 contained both medium and small size pits (<0.1 in. diameter).

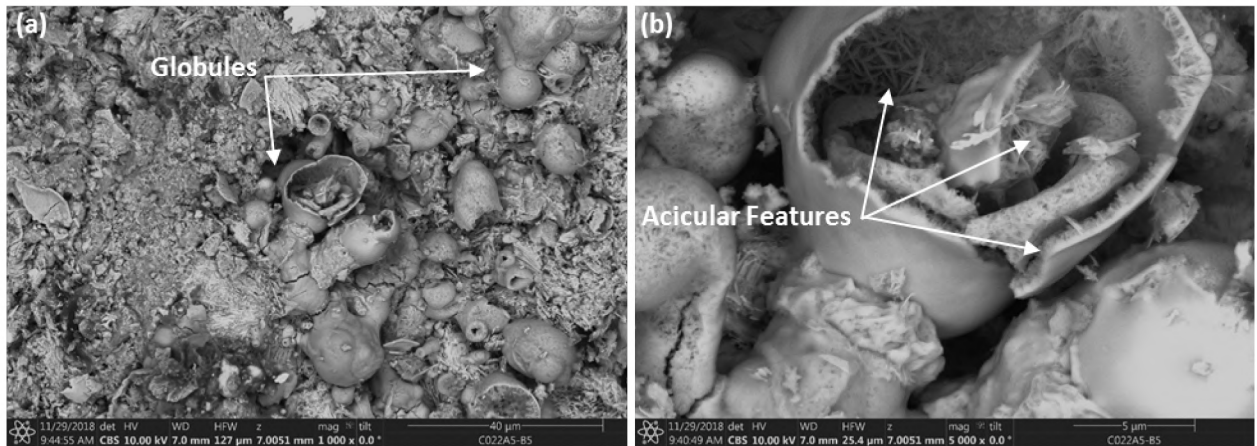
Figure 245: Backscatter Image of (a) Globules and (b) Acicular Features

EDS analyses of corrosion deposits on the OD surface showed approximately 35–40 at% O, 35–40 at% C, 20–25 at% Fe, 1–2 at% Cl, 0.2–0.5 at% S, and small amounts (<1 at%) of K, Mn, Al, Si, and Ca. The results show high concentrations of carbon and oxygen. EDS of the small acicular features showed approximately 50 at% O, 26 at% C, 21 at% Fe, and 3 at% Cl (Figure 246). The acicular features were rich in O. Raman spectroscopy identified modified hematite ( $Fe_2O_3$ ), iron oxide combination, and organic matter within the

Type II features on the OD surface of specimen C022A5B5 [38]. Modified hematite ( $\text{Fe}_2\text{O}_3$ ) was identified on the area where most of the globules were found.

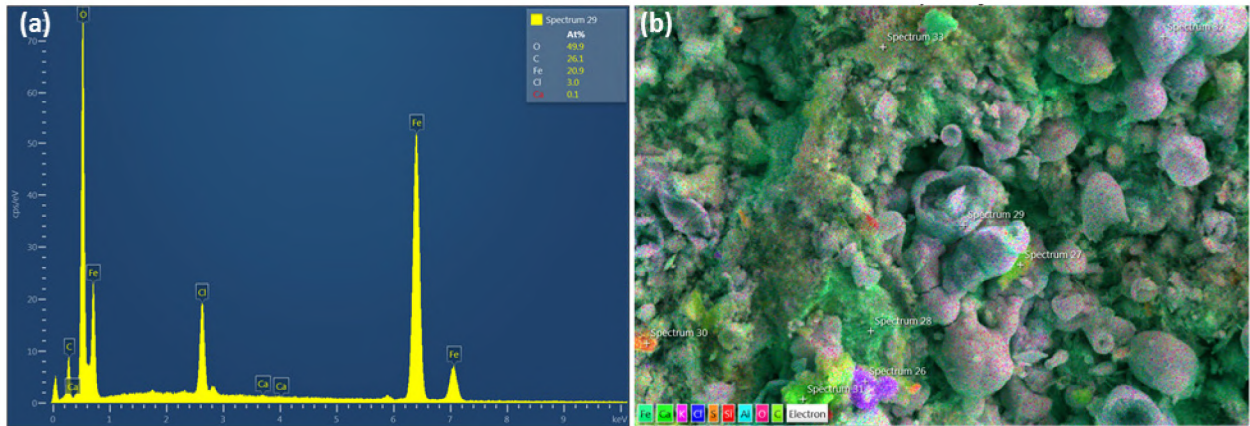
**Figure 246: (a) EDS Spectrum and (b) Dot Map Overlay for Corrosion Deposit on Specimen C022A5B5**

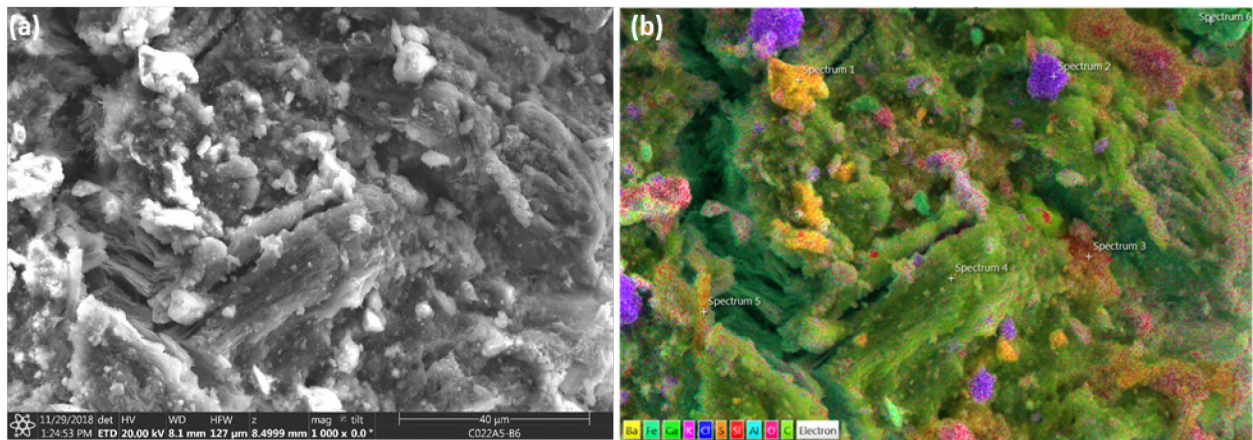
Globules were observed in the corrosion feature on specimen C022A5B6. Extra-cellular material was not observed on the OD surface of the specimen. Particles with Ba (3 at%) and S (3 at%) were identified on the surface, based on the EDS analysis (Figure 247). Raman results confirmed that the particles rich in Ba and S were barite ( $\text{BaSO}_4$ ). Barite was most likely associated with the kill fluids used during the kill attempts (Section 2.1.3). The elevated sulfur in this area was due to the presence of these particles. Aside from barite ( $\text{BaSO}_4$ ), modified hematite ( $\text{Fe}_2\text{O}_3$ ) and some organic matter were identified on the surface of this specimen.

**Figure 247: (a) SEM Image and (b) EDS Dot Map Overlay for the Deposit on Specimen C022A5B6**

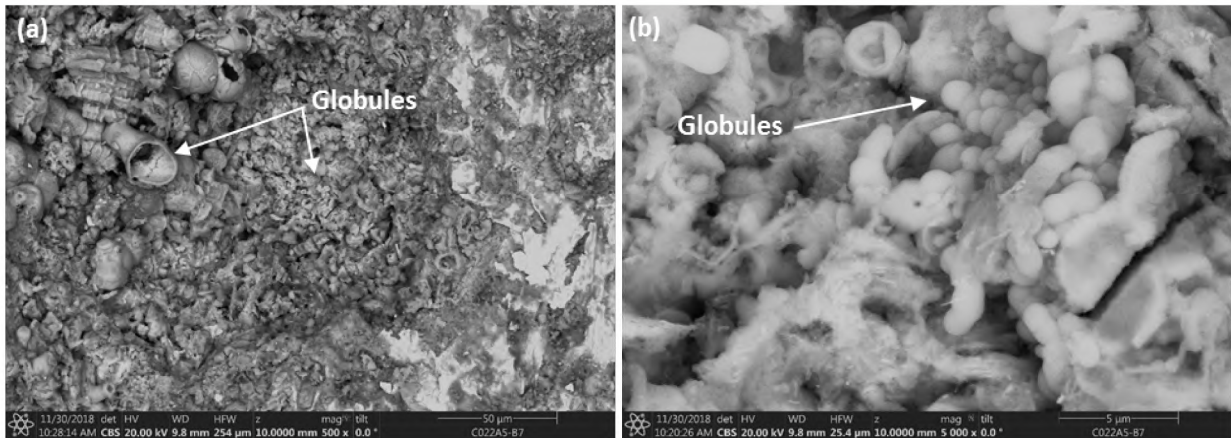
Globules were observed on the OD surface of specimen C022A5B7 (Figure 248 [a]). Extra-cellular material was not observed on the OD surface of the specimen. Figure 248 (b) shows a high magnification image revealing the presence of tiny globules ( $< 5 \mu\text{m}$  size). The EDS analysis showed that the tiny globules contained approximately 38 at% Fe, 30 at% C, 29.5 at% O, 2 at% Cl, and 0.5 at% K. Raman spectroscopy confirmed the presence of modified hematite ( $\text{Fe}_2\text{O}_3$ ), iron oxide combination, and organic matter on the surface of specimen C022A5B7.

**Figure 248: Backscatter Images of C022A5B7 Taken at (a) 500× and (b) 5,000×**

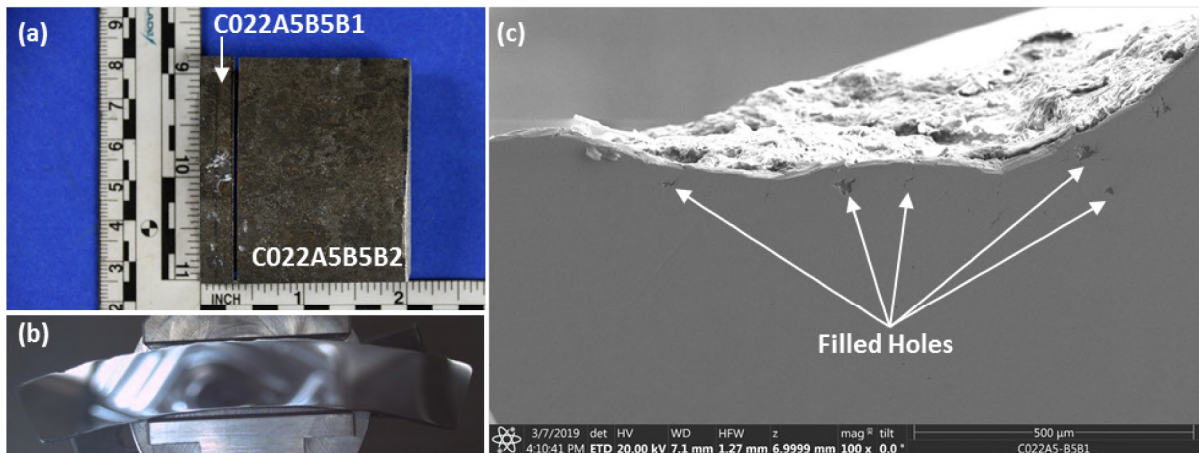
Tunnels were observed in the striated grooves associated with the Type I corrosion features. The Type II corrosion features did not contain striated grooves. A cross section was made through the local corrosion pits on specimen C022A5B5B to investigate the presence of tunnels within the Type II features. Figure 249 shows the (a) cut location of the (b) metallurgical cross section.

The cross section revealed the corrosion profile and the presence of small filled holes a few microns below the metal surface (Figure 249 [c]). These small holes were between 20 and 50 μm in diameter. Raman spectroscopy identified modified hematite and some organic matter in the deposit inside the holes [38]. The EDS analysis of the same deposits identified 44 at% C, 33 at% O, and 17 at% Fe as well as small amounts of Al, Mn, and Si. These results were consistent with the analyses of the corrosion deposit within the local pits.

**Figure 249: (a) Specimen C022A5B5B Cut Layout (b) C022A5B5B1 Polished Cross Section**

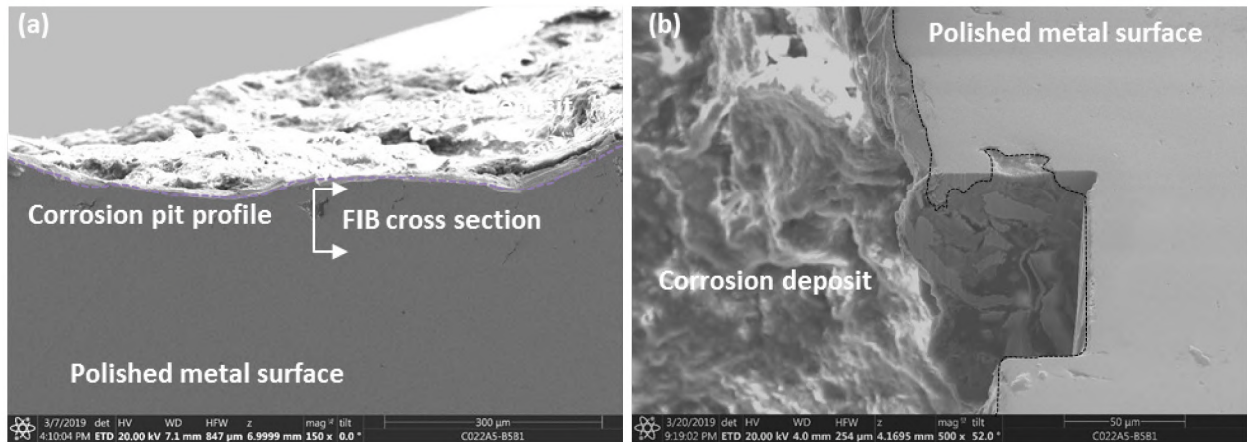
Figure 250 (a) shows an SEM image of the small hole below the Type II corrosion feature. Figure 250 (b) shows the FIB cross section of the filled hole. The dashed black lines in Figure 250 represent the metal surface. The FIB cross section shows that the filled holes were not associated with tunnels. These holes were most likely an artifact of cross sectioning an irregular corrosion pit profile. Figure 251 shows a schematic that demonstrates how an irregular corrosion profile can create filled holes on the metallographic cross section. The observations from the FIB cross section, EDS, and Raman analyses suggest that tunnels were not present in the Type II corrosion features. This was consistent with the macroscopic observation that striated grooves were not present in the Type II corrosion features.

Figure 250: (a) SEM Image of Corrosion Pit and (b) FIB Cross Section of Small Hole

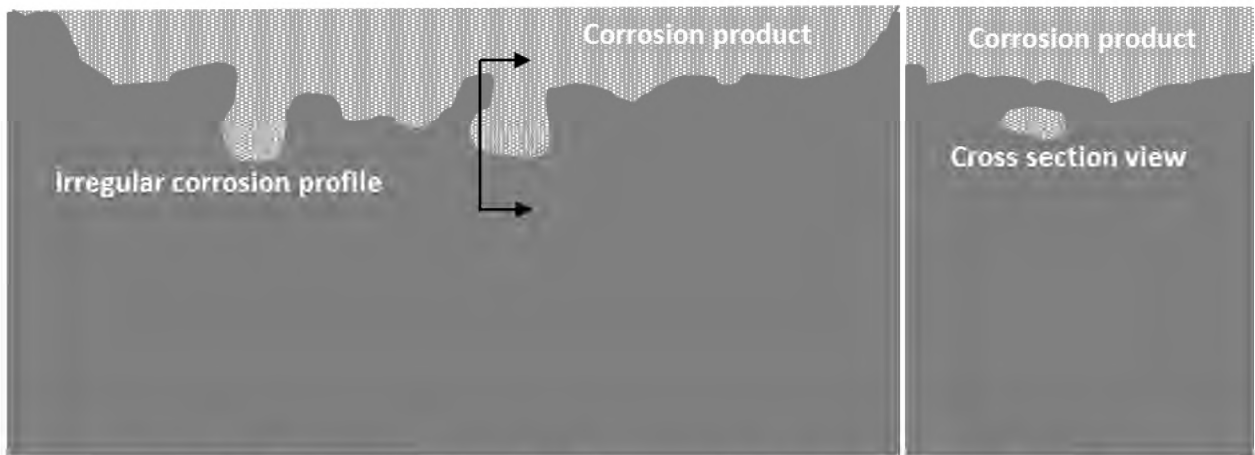
Figure 251: Schematic of Small Hole Generated by Metallographic Cross Section

The corrosion mechanisms for Types I and II appeared to be different, based on the corrosion morphology. The Type II corrosion features did not contain striated grooves, tunnels, or extra-cellular material, which suggests that microbes had a minimal contribution to the localized pitting. The Type II corrosion was a localized attack on the metal surface. The localized pitting was most likely caused by a breakdown of the passive film or by the formation of a local anodic site. However, pits within pits, which can be caused by microbial activity, were observed. Therefore, microbial activity cannot be fully ruled out. To fully understand the contribution of microbes to the formation of the Type II corrosion would require a more detailed investigation, which would be beyond the scope of this work. The detailed investigation was focused on the Type I features that caused the axial rupture.

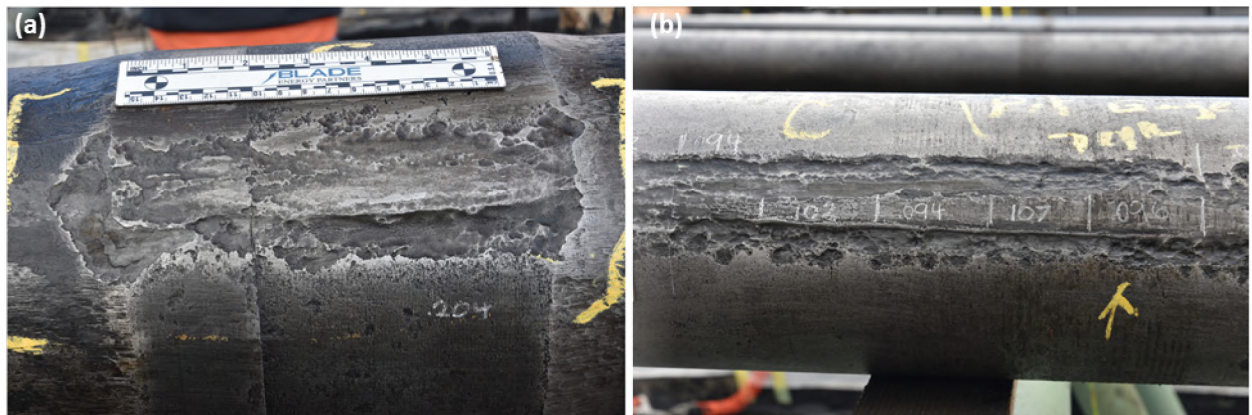
The Type III corrosion feature had a rectangular shape with little to no corrosion attack in the middle region. The rectangular shape of the Type III corrosion consisted of scoop-shaped features. This corrosion occurred mainly on the 7 in. casing connections, with one feature occurring in the pipe body of joint 20. (Figure 252).

**Figure 252: (a) Type III Corrosion Feature on 7 in. Casing Connection and (b) Pipe Body**

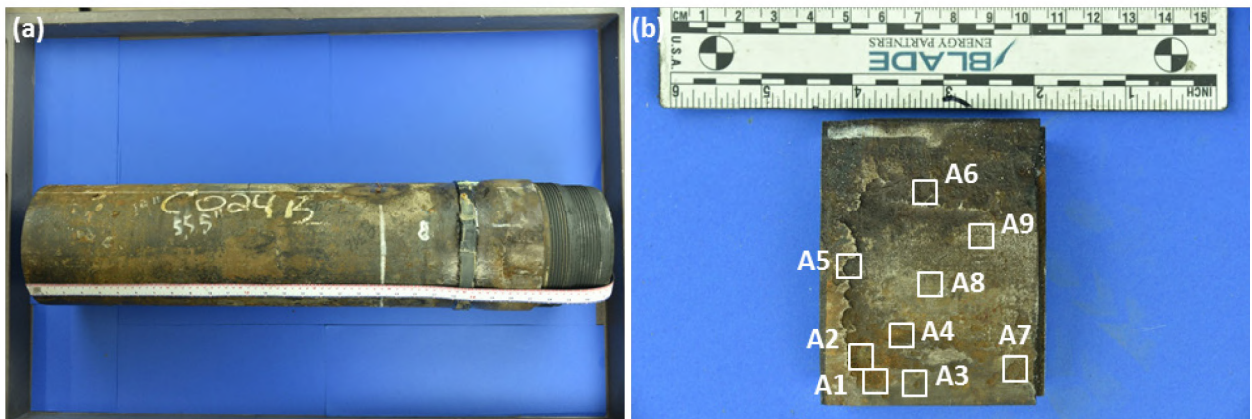
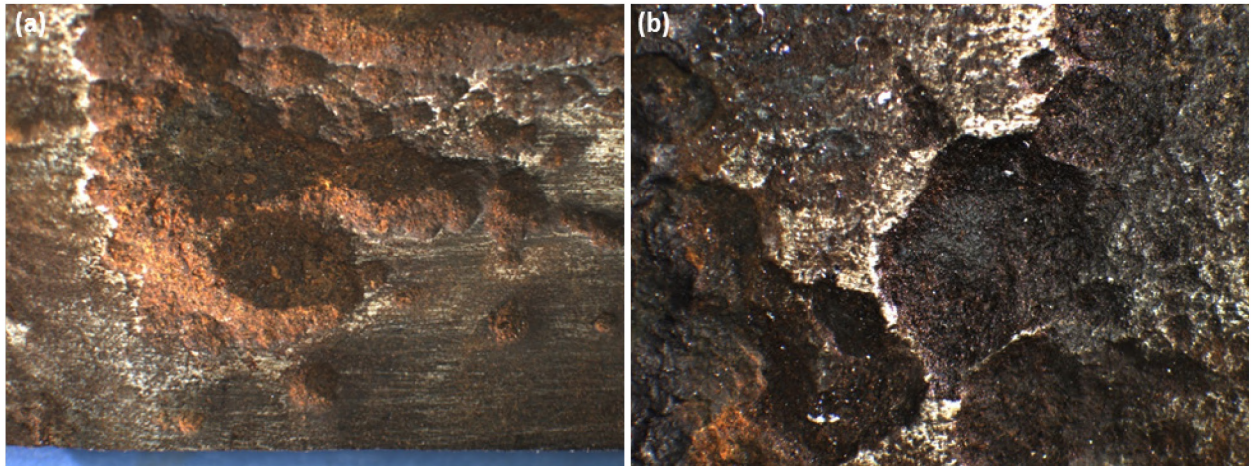
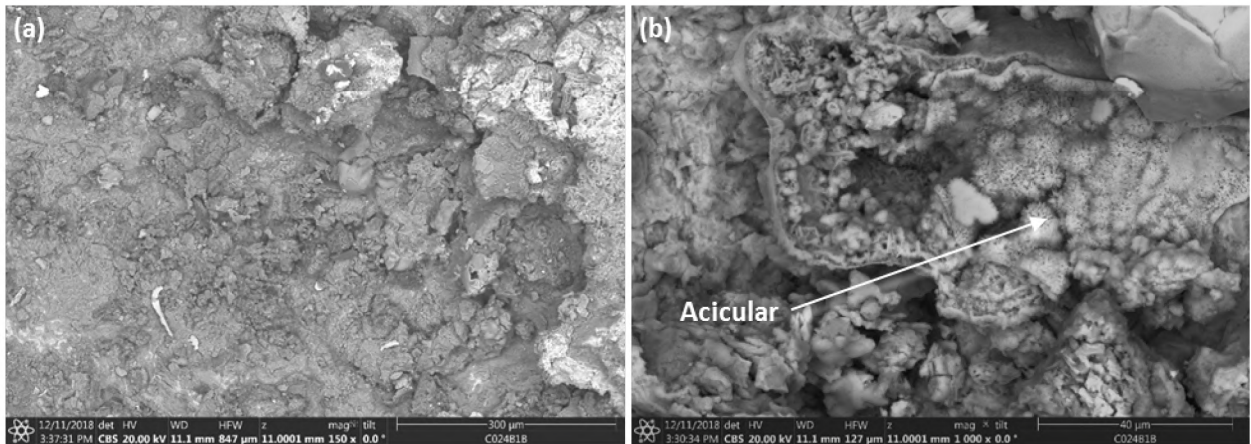
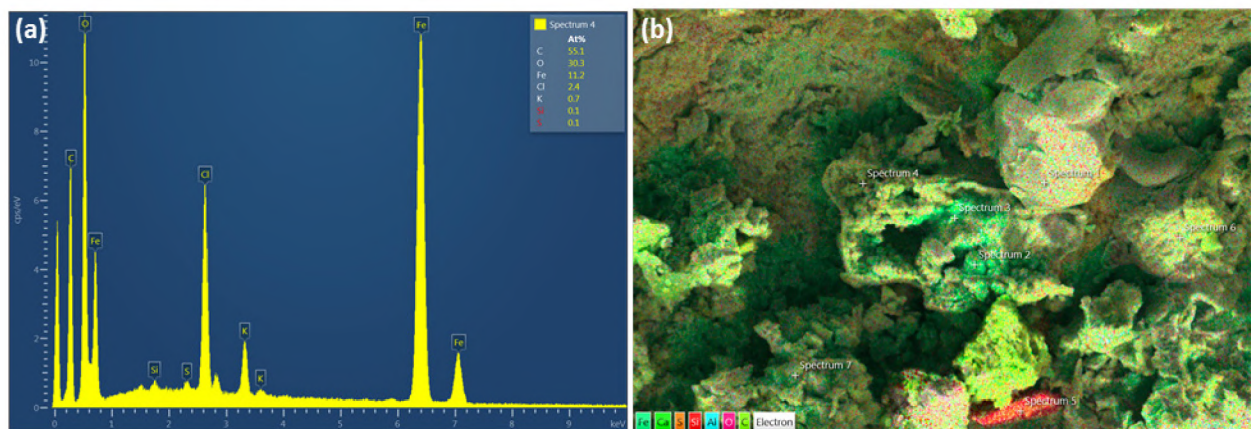
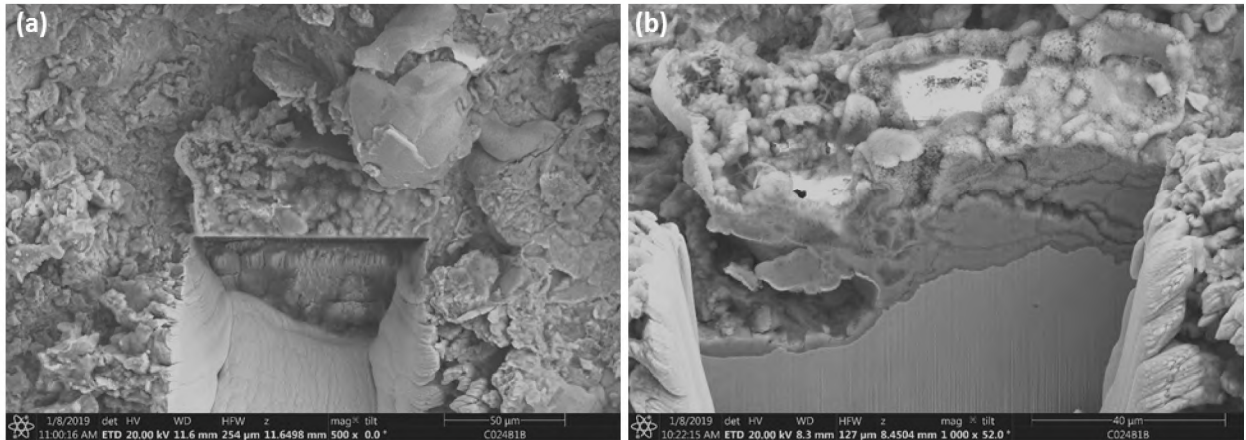
Specimen C024B1B was extracted from connection 24 (Figure 253). Stereoscopic images revealed deposits ranging in color from orange to brown (Figure 254). The morphology of the deposit on the surface of specimen C024B1B appeared to be needle-like (Figure 255) [39] [40] [41]. EDS analyses (Figure 256) showed that these small acicular (needle-like) features contained approximately 55 at% C, 30 at% O, 11 at% Fe, and 2 at% Cl, being similar to the Type II corrosion deposits. Raman spectroscopy identified modified hematite ( $Fe_2O_3$ ), barite ( $BaSO_4$ ), iron oxide (FeO) combination, and organic matter within the Type III feature. Elemental analyses of other areas within the feature also showed the presence of Ba and S. Barite was most likely associated with the kill fluids used during the kill attempts (Section 2.1.3). The FIB cross section in Figure 257 shows the details of the corrosion deposit morphology observed on top of the Type III corrosion feature.

**Figure 253: (a) Connection C024B and (b) Type III Corrosion Specimen C024B1B**

Figure 254: Stereoscopic Images of C024B1B (a) Area 1 and (b) Area 5

Figure 255: Backscatter Images of Specimen C024B1B A1 Taken at (a) 150 $\times$  and (b) 1,000 $\times$

Figure 256: (a) EDS Spectrum and (b) Dot Map Overlay for Type III Small Acicular Features

**Figure 257: (a) FIB Cut and (b) Cross Section View of Specimen C024B1B Corrosion Deposit**

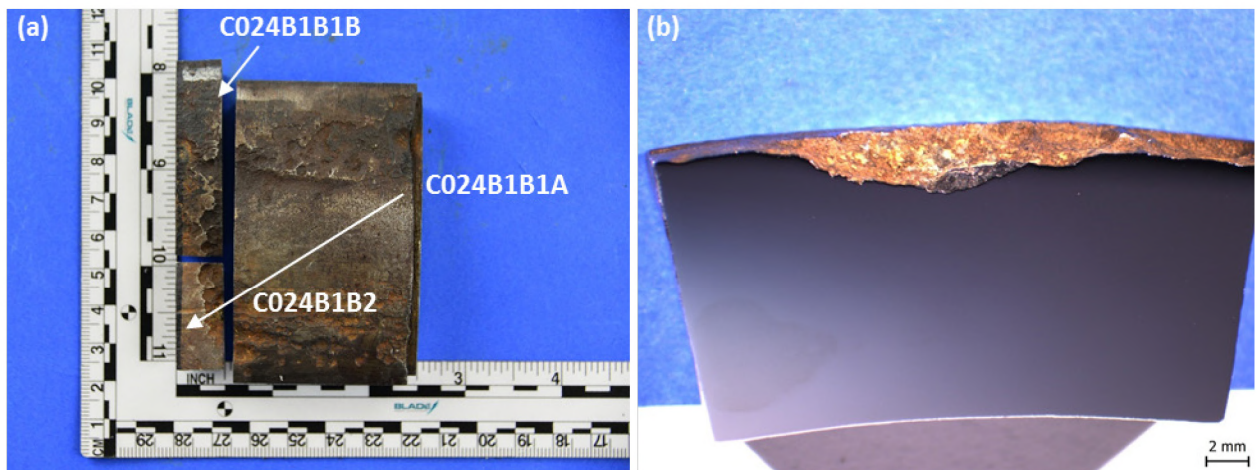
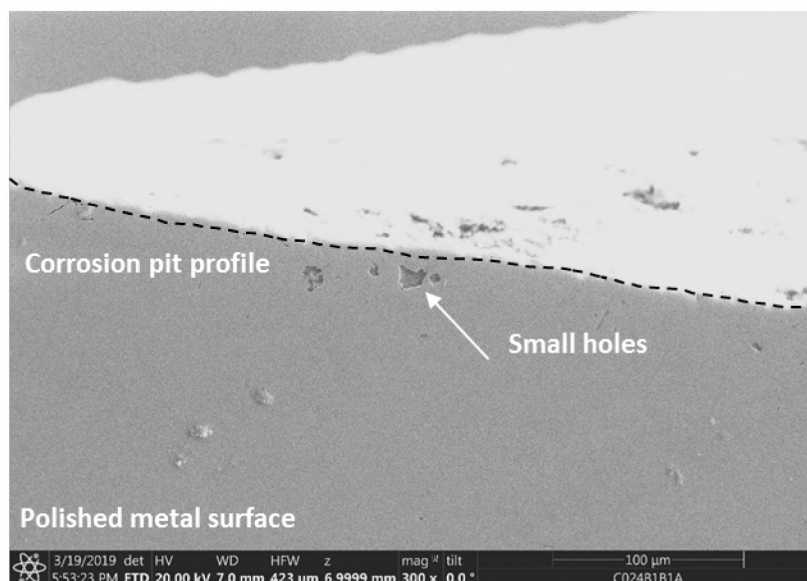
Figure 258 (a) shows the cut locations for the cross section of specimen C024B1B1A, revealing the Type III corrosion profile (Figure 258 [b]). Small filled holes were observed below the OD surface of the Type III feature (Figure 259). These small holes were similar to the holes observed in the Type II corrosion feature. They contained corrosion products with approximately 50 at% O, 27 at% Fe, and 20 at% C. Raman spectroscopy indicated that these corrosion products were composed of organic matter, modified hematite ( $\text{Fe}_2\text{O}_3$ ), magnetite ( $\text{Fe}_3\text{O}_4$ ), maghemite ( $\gamma\text{-Fe}_2\text{O}_3$ ), and some carbonates. Raman spectroscopy did not identify siderite ( $\text{FeCO}_3$ ).

**Figure 258: (a) C024B1B Cut Layout and (b) C024B1B1A Corrosion Profile**

**Figure 259: SEM Image of Small Holes Under the Metal Surface of C024B1B1A**

Galvanic corrosion may explain the occurrence of Type III corrosion features. Galvanic corrosion occurs when two different materials are connected in the presence of an electrolyte (liquid). As previously mentioned, the 7 in. casing was of grade J55 steel, while the 11 3/4 in. casing was mostly of grade H40 steel. The two metals have different compositions. When the two casings are in contact, one casing can act as an anode (prone to corrosion) and the other can act as a cathode (more noble). The anodic metal can have an increased corrosion rate.

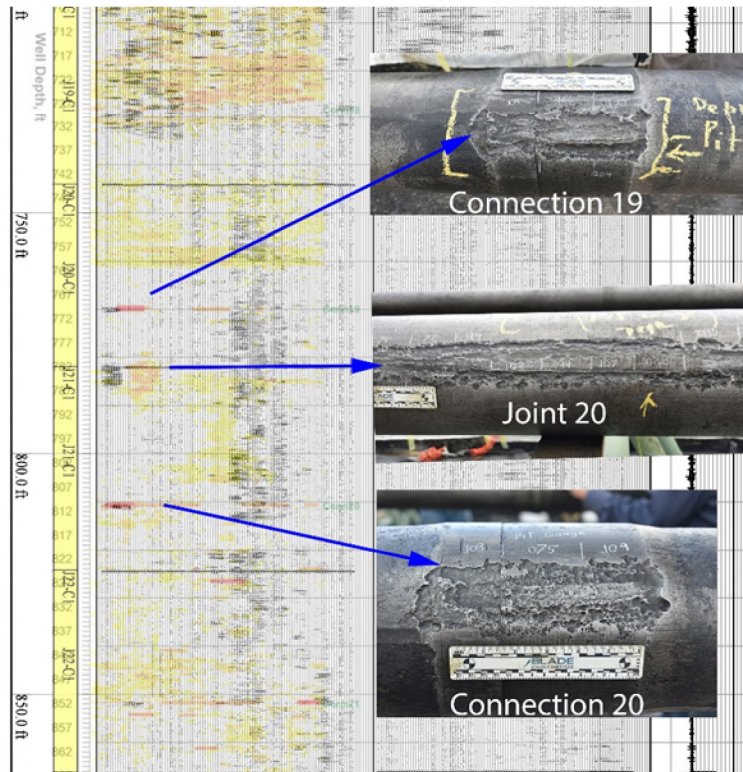
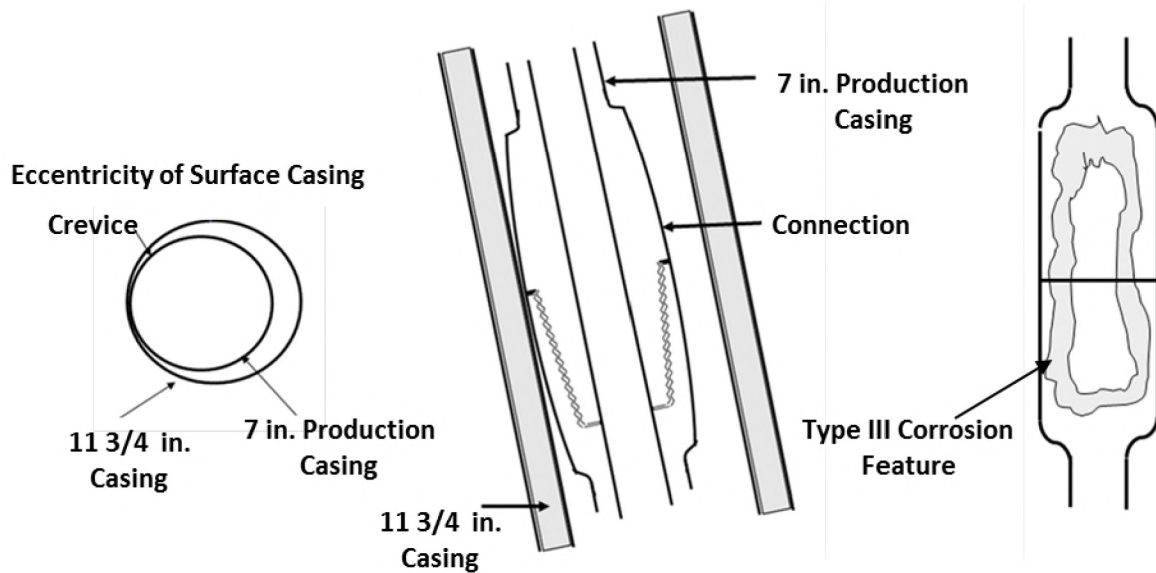
Logs from the SS-25 casings revealed that features on the outer diameter of the 7 in. casing mostly matched the locations on the inner diameter of the 11 3/4 in. casing. Figure 260 shows an overlay of the laser scan data for the 7 in. casing and the HRVRT log data for the 11 3/4 in. casing. Type III corrosion features were often observed in the 7 in. casing connection (connections C014 to C025). The figure identifies some of the Type III feature locations. This observation suggests that crevice corrosion occurred at these locations. Crevice corrosion is a form of corrosion where occluded areas become more anodic with respect to the surrounding metal. The outer diameter of the 7 in. casing, especially the connection (with larger outer diameter compared to the casing body), could have been in contact with the inner diameter of the 11 3/4 in. casing. Figure 261 shows a schematic that demonstrates how a crevice would have formed between the ID of the 11 3/4 in. casing and the OD of the 7 in. casing. The general shape of

the Type III features suggests that crevice corrosion was the most likely corrosion mechanism, with possible contributions from galvanic coupling.

Figure 260: Laser Scan Data Overlaid with HRVRT Log Data

Figure 261: Schematic of 7 in. and 11 3/4 in. Casing Contact
