**Blade Supplemental Report (Vol. 2: SS-25 Well Failure Causes)**

# Root Cause Analysis of the Uncontrolled Hydrocarbon Release from Aliso Canyon SS-25

May 31, 2019

# SS-25 Casing Failure Analysis

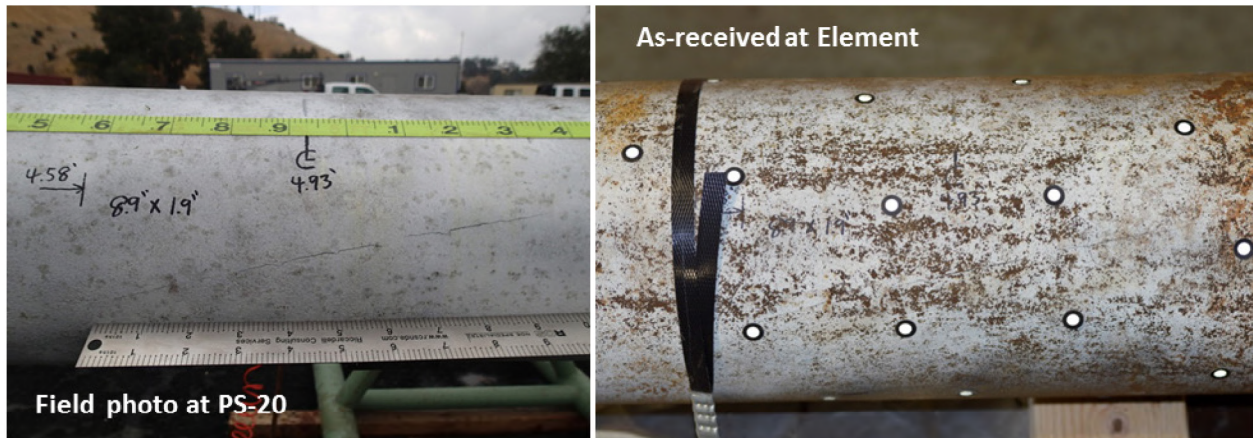
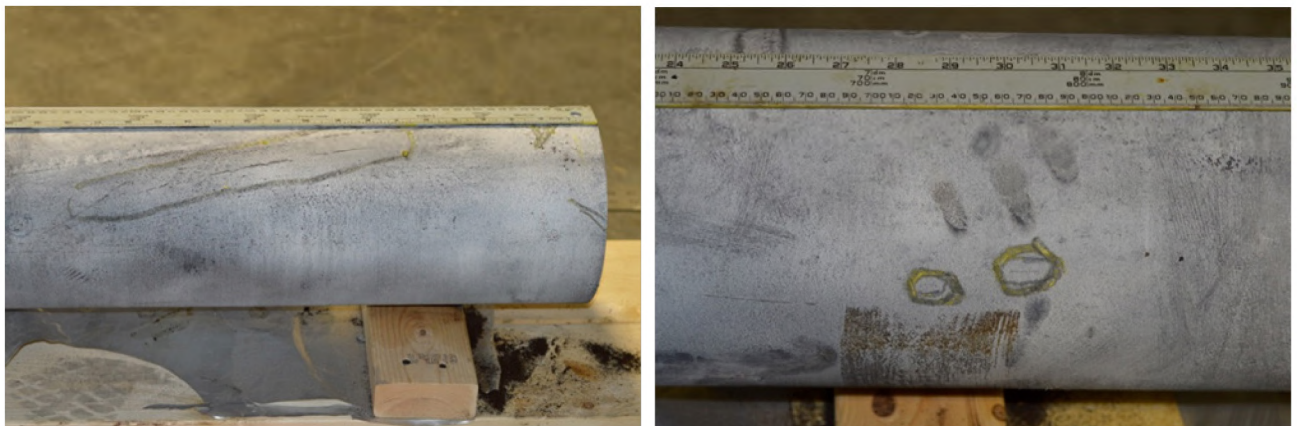
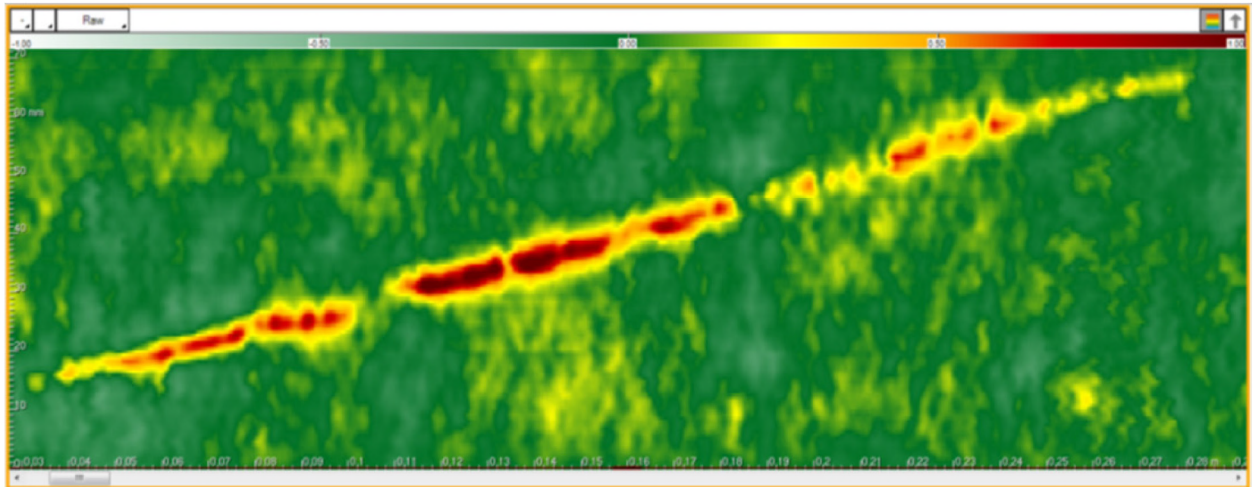
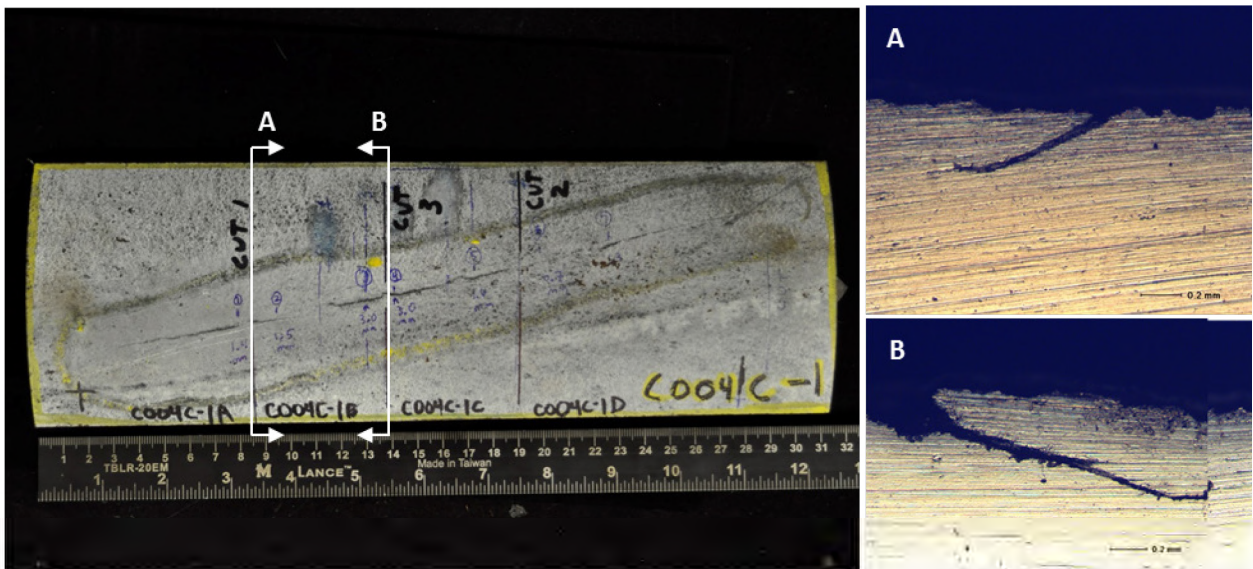
Oblique linear indications were identified during the field MPI of the 7 in. casing. Figure 262 shows images of a linear indication after field MPI and in the as-received condition at Element Materials Technology, an ISO 9000 certified lab. The objective was to determine if the linear indication occurred downhole or during the manufacturing process.

**Figure 262: Field and As-Received Images of the C004C Linear Indication**

A linear indication identified on joint 4 was selected for examination. NDE was performed at Element to re-establish the length of the oblique linear indication. Fluorescent MPI identified two additional linear indications but did not detect the original indication. Black and white MPI was repeated in an attempt to confirm the original indication. Both the original indication and two additional indications were confirmed with the black and white MPI. Figure 263 shows the Element MPI results.

**Figure 263: Black and White MPI Results for C004C**

Eddyfy's eddy current technology was used to map the indications [79]. Figure 264 shows a 2D depth color map of the oblique linear indication. The map was used to determine cut locations for sectioning. A section adjacent to the deepest location was selected for metallographic cross sectioning (Figure 265).

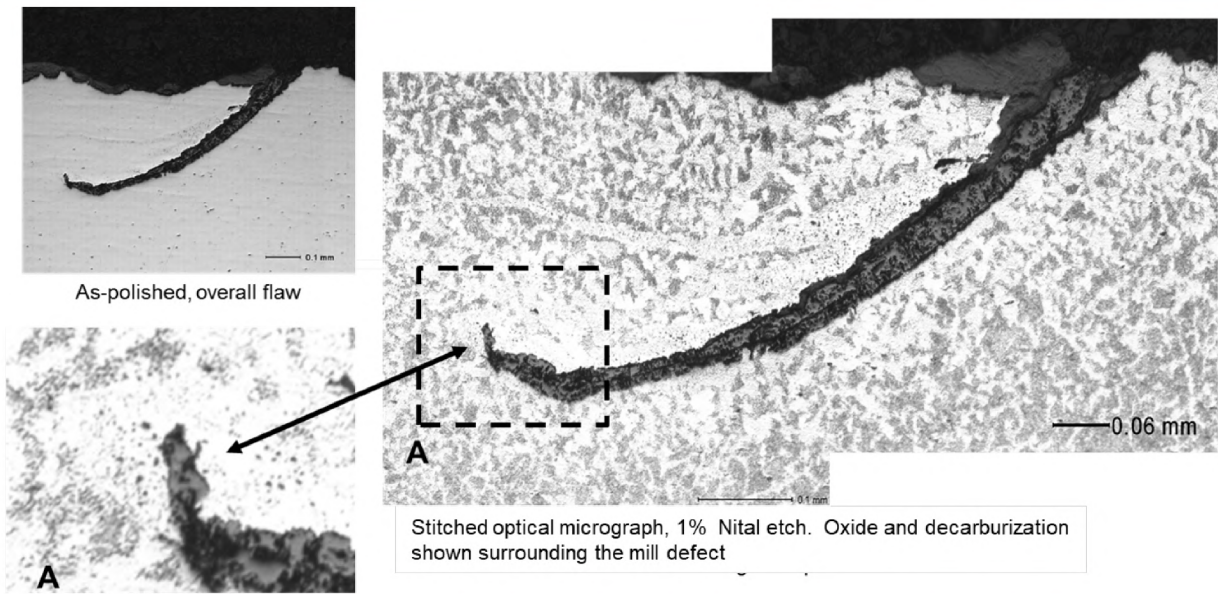
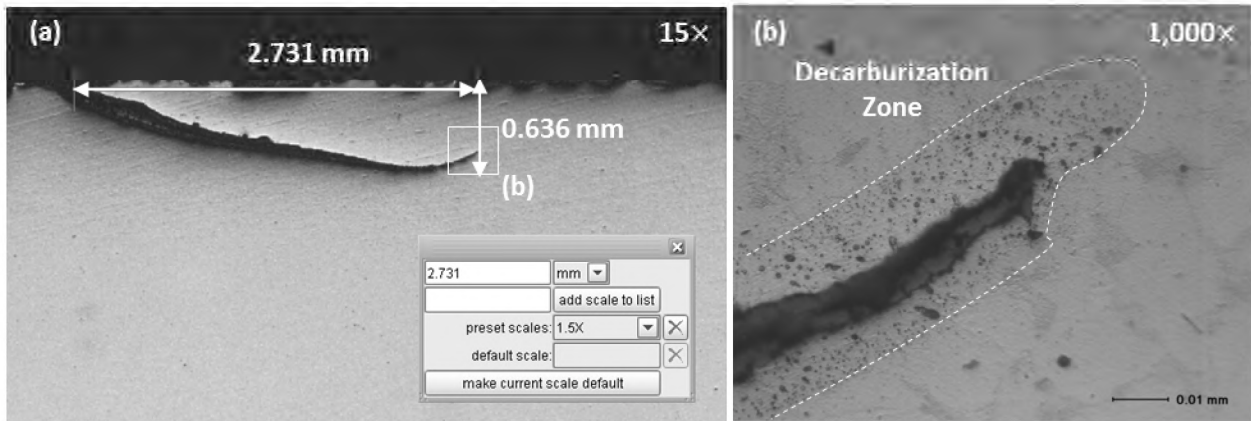
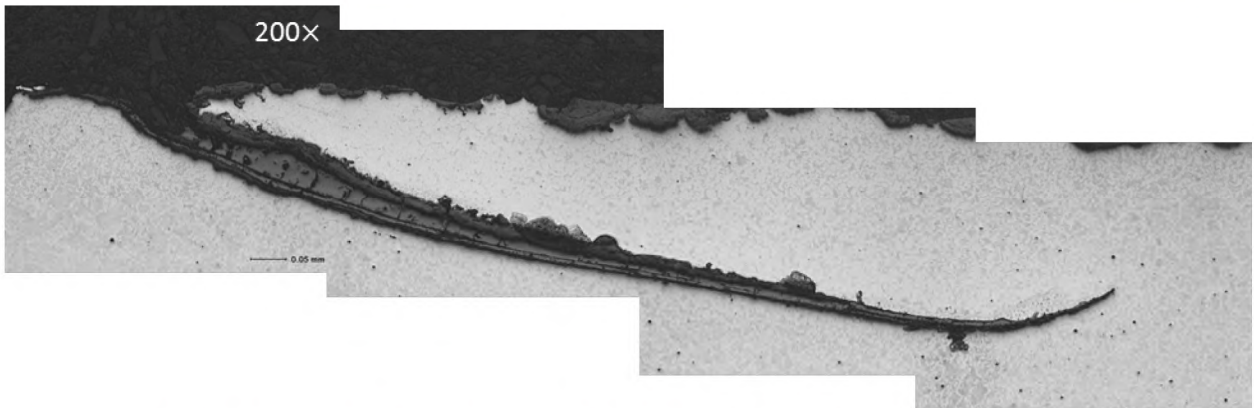
The cross sections A and B were examined in the polished and etched conditions. Figure 266 shows the micrographs for cross section B in the polished and etched conditions at low and high magnifications. The indication had a shallow depth of 0.27 mm and a width of 0.57 mm. The indication was surrounded by an oxidation layer and a decarburization layer. This observation suggests that the indication was exposed to high temperatures and is a mill defect (lap, sliver, etc.) that formed during the manufacturing process. Since the tip of the mill defect was surrounded by an oxidation layer and a decarburization layer, crack initiation and growth did not occur during the lifetime of the well.

**Figure 266: Micrographs of Cross Section B (a) Polished and (b) Etched with 1% Nital**

Figure 267 shows micrographs for cross section A in the polished and etched conditions at low and high magnifications. The linear indication has a width of 2.731 mm and a depth of 0.636 mm (7.9% NWT). The 1,000× micrograph in Figure 267 shows oxidation and decarburization around the tip of the indication. Figure 268 is a stitched micrograph of the crack taken at 200× in the etched condition. The stitched micrograph shows that the oxidation and decarburization layer surrounds the entire indication. Again, the oxidation and decarburization layer suggests that the indication was exposed to a high temperature environment and is a mill defect. The high magnification micrograph in Figure 267 shows the mill defect is surrounded by an oxidation layer and a decarburization layer. This observation further confirms that the mill defect did not grow during the lifetime of the well.

**Figure 267: Micrographs of Cross Section B (a) Polished (15×) and (b) Etched with 1% Nital (1,000×)**

Figure 268: Metallographic Cross Section A Etched with 1% Nital and Taken at 200×

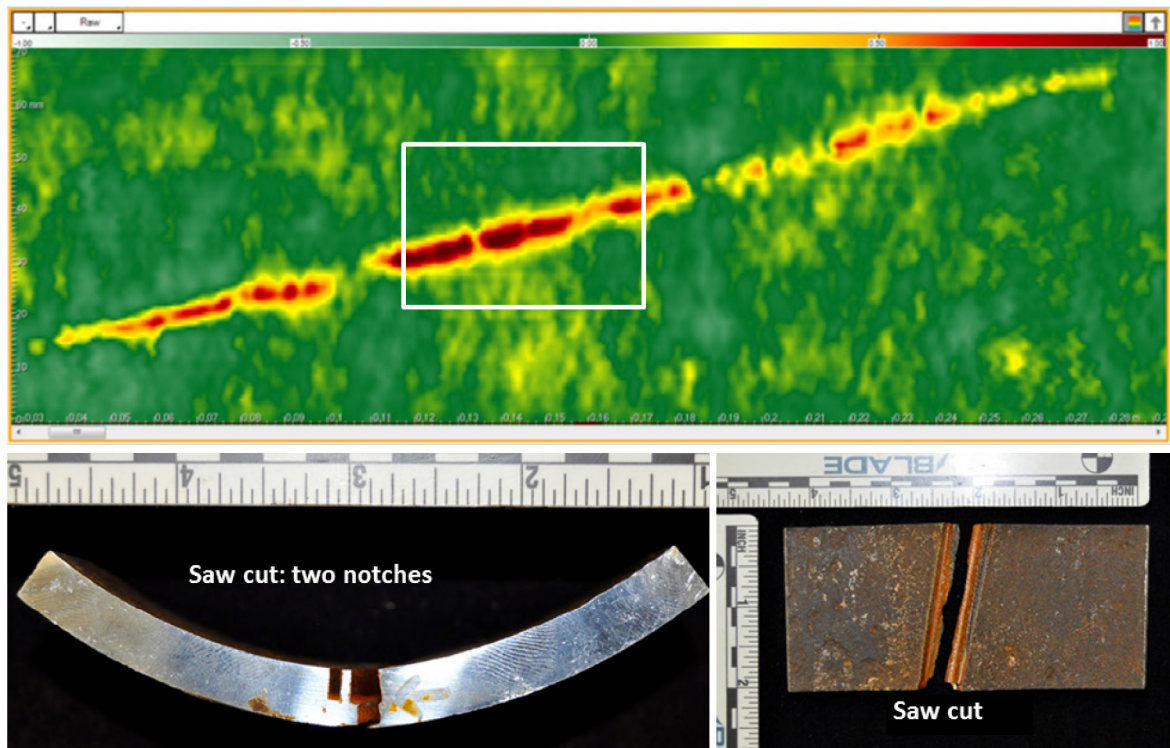
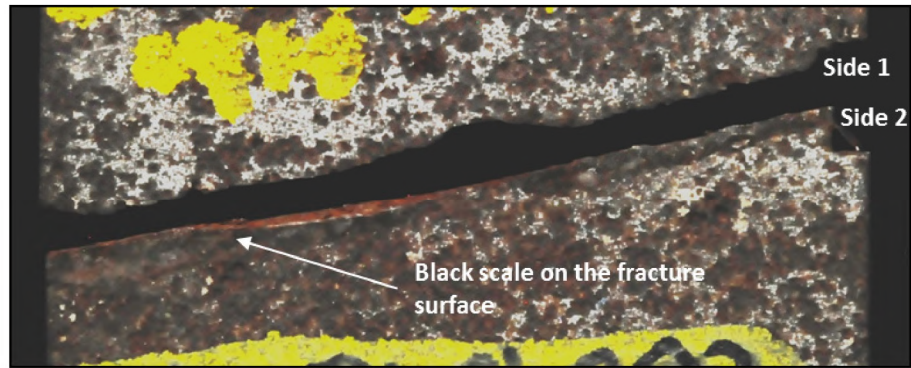
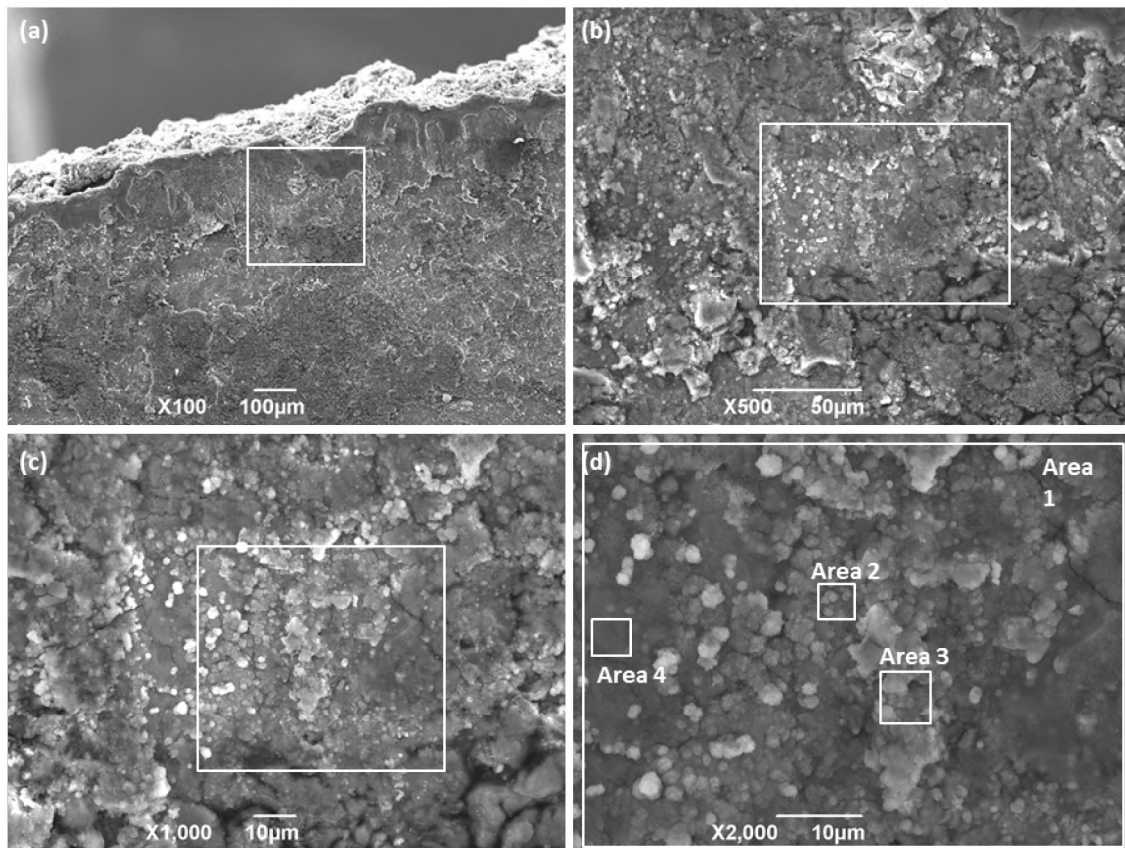
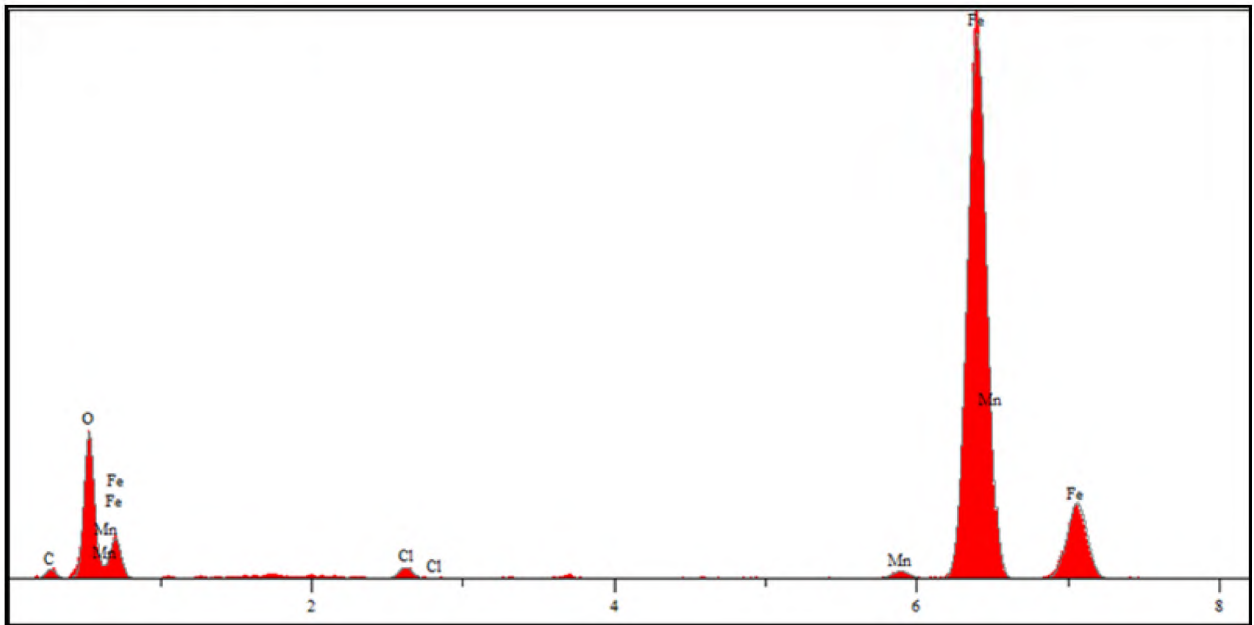
The opened linear indication (mill defect) was stored in a desiccator over the weekend. Flash rust occurred. Figure 269 shows the opened linear indication and flash rust. Most of the flash rust was removed by sonic agitation in a 3% Alconox solution for a total of six minutes. The specimen was cut into smaller pieces for SEM and EDS examination and analysis. The visual examination of the fracture surface showed a black oxide scale (Figure 270).

Figure 269: C004C1C After Opening at Liquid Nitrogen Temperature

**Figure 270: C004C1C Fracture Surface After Opening at Liquid Nitrogen Temperature**

Figure 271 shows SEM images of the fracture surface after cleaning. The images show an oxide scale with small crystalline particles that are consistent with high temperature oxidation. Figure 271 (d) shows four locations selected for EDS examination. EDS results identified high levels of O and Fe at all four locations. Figure 272 shows the EDS spectra for Area 1.

Table 17 shows the EDS results for C, O, Fe, and Mn for all four locations. The EDS results suggest a mixture of  $Fe_xO_y$  type oxide, which is consistent with high temperature oxidation.

The evidence shows that these features were manufacturing defects. The evidence also shows that these features did not grow over the lifetime of the well and did not pose a threat to the integrity of the 7 in. casing.

**Figure 271: SEM Images of C004C1C Taken at (a) 100×, (b) 500×, (c) 1,000×, and (d) 2,000×**

Figure 272: EDS Spectra for C004C1C Area 1

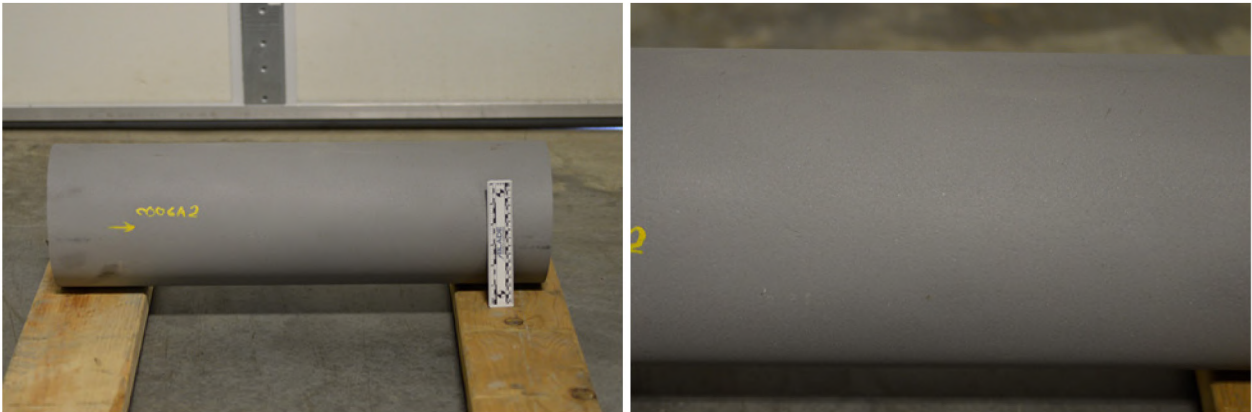
**Figure 277: Post Abrasive Blasting for Specimen C006A2**

MPI was primarily performed at Superior Shot Peening, but in some cases, MPI was completed at Element. The location for performing MPI was solely based on scheduling considerations. Linear indications were not identified in any of the 7 in. casing inspections. This suggests that the pipe specimens were free of any surface breaking cracks.

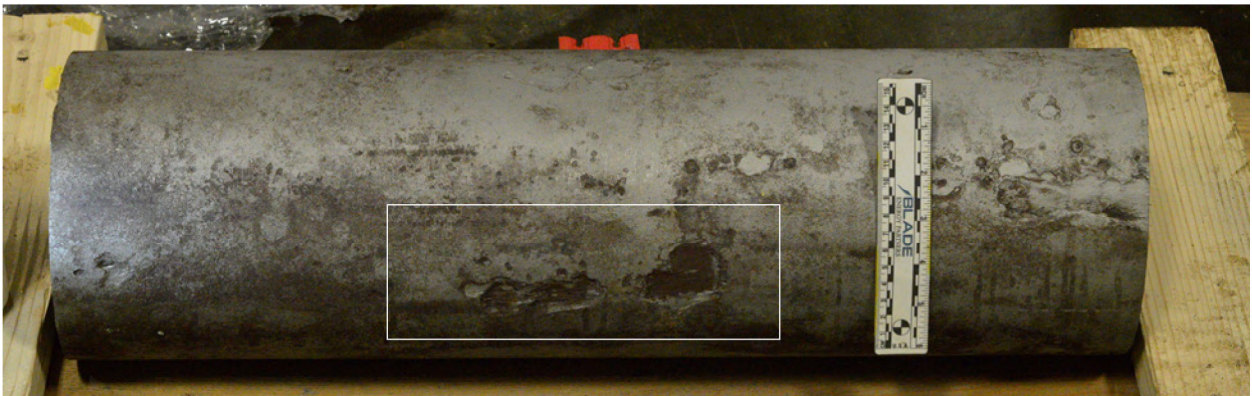
**Figure 278: Joint 24 Features Identified After Abrasive Blasting**

One corrosion feature was identified on joint 24 (Figure 278) during visual examination of the blasted specimens despite efforts to avoid extracting such features. The corrosion feature was not visible during the initial inspection due to the surface condition of the joint. The corrosion feature was extracted and preserved after it had been discovered, and the test layout was shifted to accommodate the feature extraction.

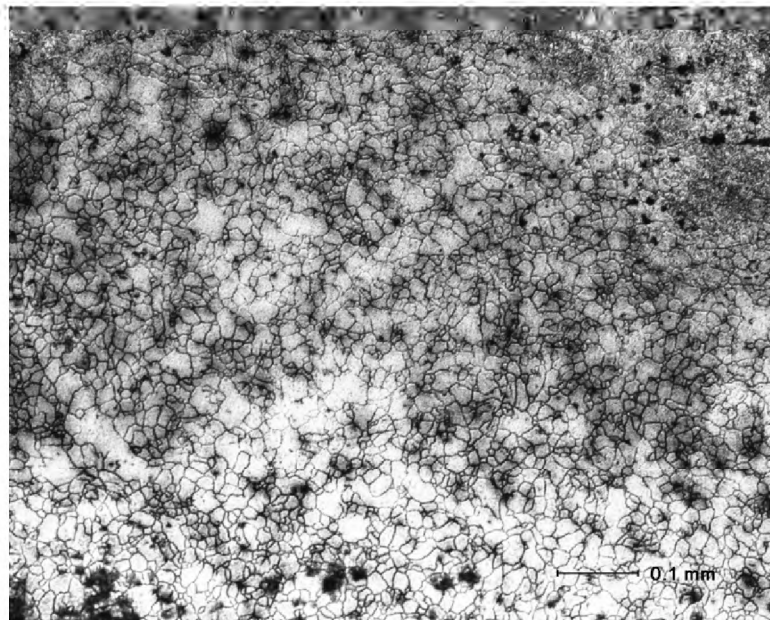
Figure 282: Joint 22 Grain Size 7.0 at 100 $\times$  4% Picral

Grain sizes were measured for each of the 7 in. casing joints and were determined based on ASTM E112 [82]. The general repeatability and reproducibility for the comparison method is approximately  $\pm 1$  grain size. Figure 282 shows a micrograph of joint 22 at 100 $\times$  after etching with 4% picral acid. The ASTM grain size measured for joint 22 using a comparison method was 7.0. Figure 283 shows a histogram for the ASTM grain sizes for all 25 joints. The statistical data for the grain sizes are shown to the right of the histogram. The average grain size for all of the joints is 7.54 with a standard deviation of 0.63. Grain size for grade J55 material is not specified by the current API 5CT. In general, a finer grain size is preferred for better mechanical properties and resistance to corrosion and cracking. The average grain size for the vintage grade J55 material is above 5.0, which is the generally accepted boundary between coarse and fine grain.

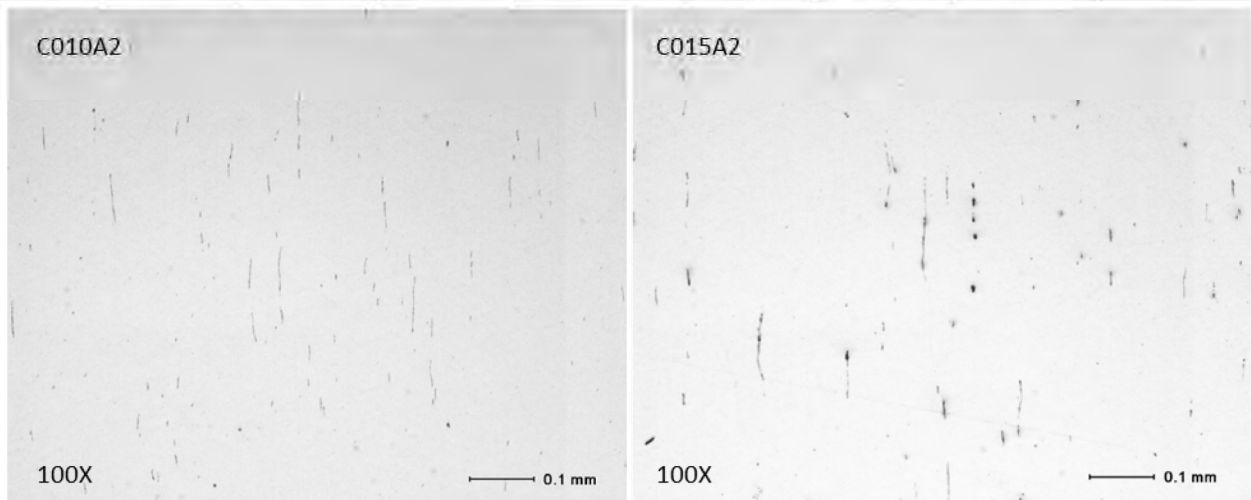
Figure 284: Polished Micrograph for Joints (a) 10 and (b) 15 Showing Inclusions at 100X

Table 24 shows the Element ASTM E45 Method A results for each joint. It shows that the highest Severity Level of 2.5 occurred in both the thin and heavy series for Type A inclusions. The results are consistent with MnS inclusions, which are typical of carbon steel. Figure 284 shows micrographs at 100 $\times$  of polished specimens taken from joint 10 and 15. The micrographs show the inclusion morphology, size, and distribution.

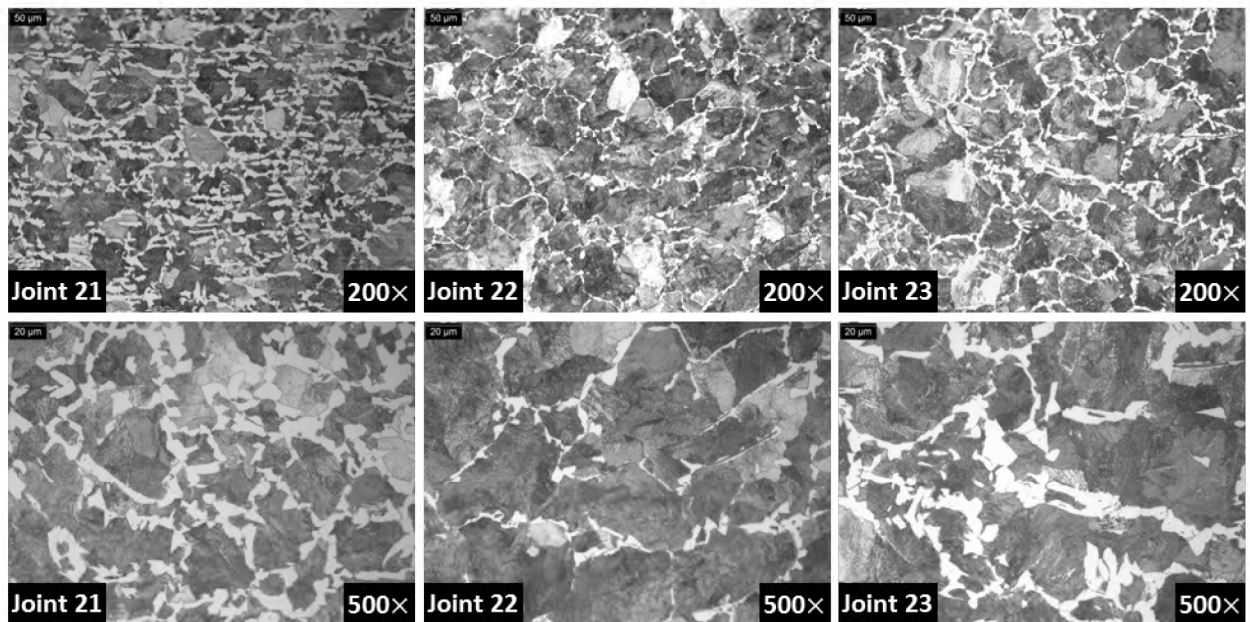
Figure 285: Micrographs of Joints 21, 22, and 23 Microstructure at 200× and 500×

microstructure. The microstructure was examined at 200× and 500× with an inverted stage metallurgical microscope using ordinary reflected light. All evaluations revealed pearlite and grain boundary ferrite. Figure 285 shows images from the metallurgical evaluation for joints 21, 22, and 23 with a similar microstructure for all three joints. This microstructure was typical for all 25 joints.

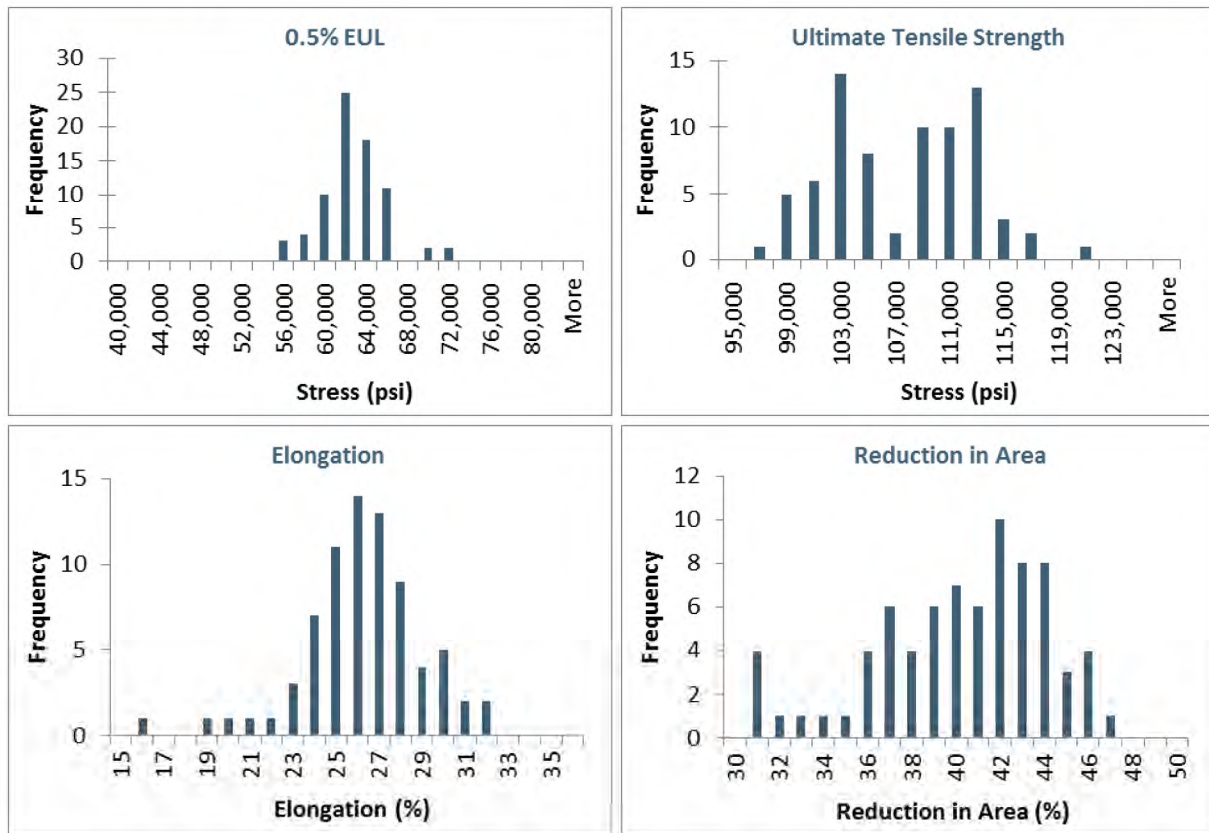
Figure 289: Tensile Property Frequency Plots

Figure 289 shows histograms for each of the properties calculated from the flat grip tensile test data. The total specimen count shown in the histograms is 75. The 0.5% EUL, elongation, and reduction in area histograms appeared to be normally distributed, while the ultimate tensile strength histogram did not.

The absolute minimum value for 0.5% EUL occurred in joint 4 and was 54,500 psi. This value was slightly below the minimum requirement of 55,000 psi, but the average 0.5% EUL value for joint 4 was 55,333 psi, which is over the minimum requirement. The failure joint (joint 22) had a minimum value of 62,500 psi, which is greater than the minimum requirement.

The sample average value was used to evaluate the 0.5% EUL of the 7 in. casing. A 95% confidence interval was constructed to estimate how close the 7 in. casing sample mean was to the population. The results show that the average value for the 0.5% EUL is greater than 59,476 psi, with a 0.95 degree of confidence. This value is greater than the required minimum of 55,000 psi. The results suggest that the yield strength of the 7 in. casing meets specifications and did not contribute to the failure.

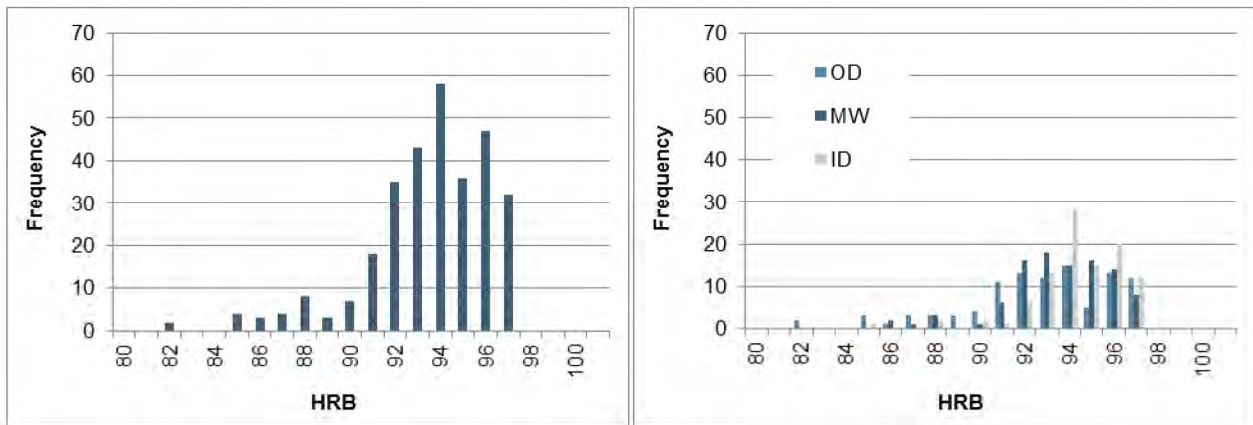
Figure 295: Hardness Rockwell B Value Distribution

Table 29 shows a summary of the results. The minimum and maximum HRB values for all indentations were 82 and 98, respectively. The average and standard deviation HRB values for all indentations were 93.5 and 2.75, respectively. Figure 295 shows the HRB value distributions. The left plot shows the distribution for all the hardness indentations. The right plot shows the same data separated by through thickness position. The results show that the hardness for the 7 in. casing is consistent.

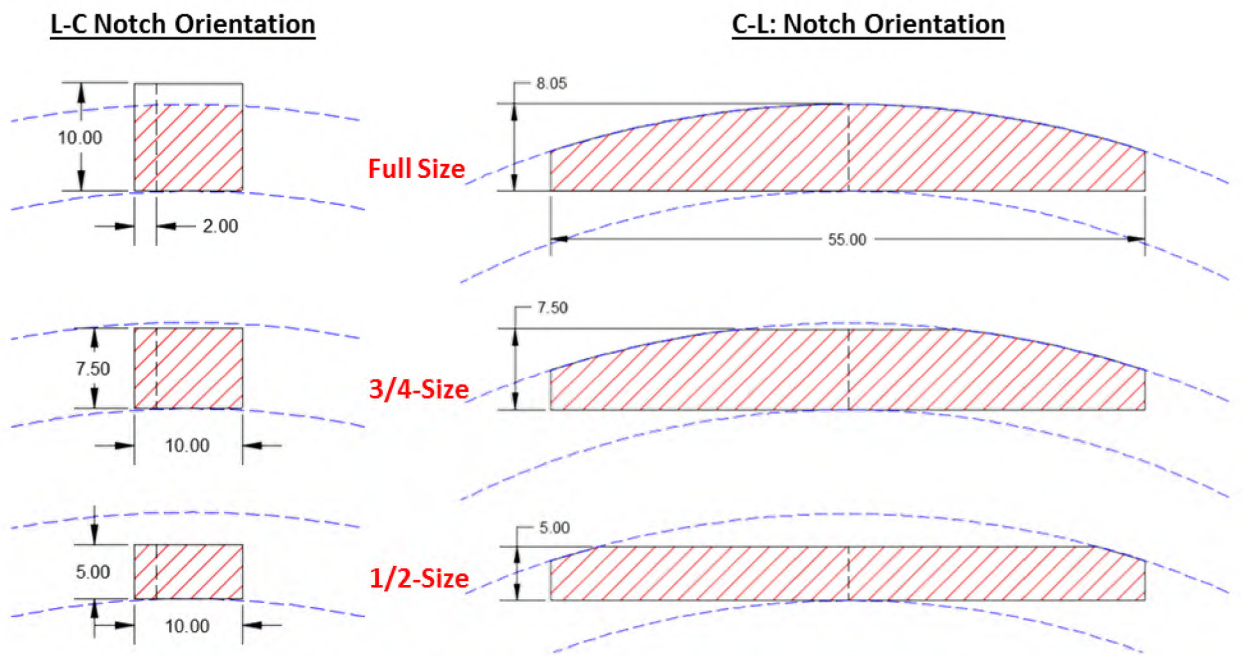
Figure 299: Full, Three-Quarter, and Half-Size CVN Specimen Layout

Figure 299 shows a cross section of the full, three-quarter, and half-size specimens in relation to the 7 in. casing wall thickness. The schematic shows that half-size specimens were required for testing. The NWT of 0.317 in. was not thick enough to accommodate larger sizes. This was the case for both the L-C and C-L orientations.

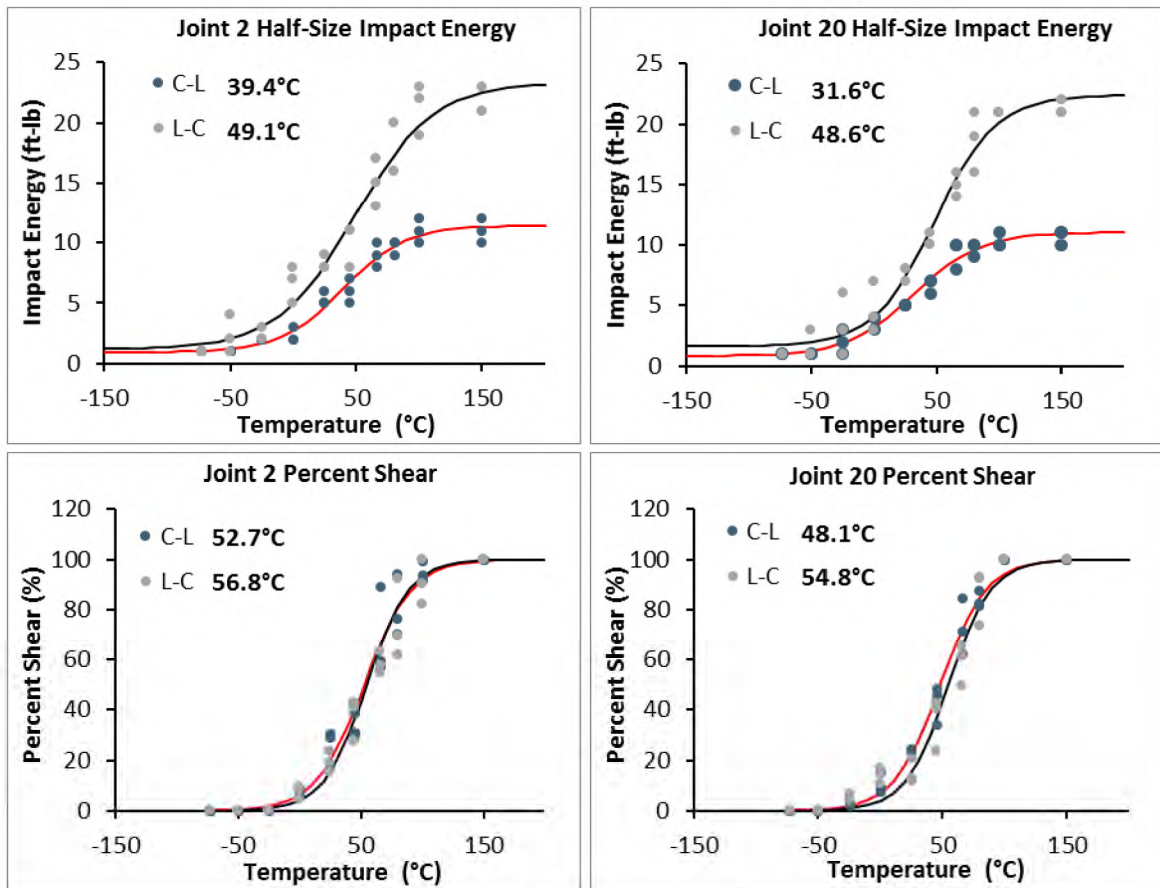
Figure 302: DBTT Curves for Joints 2 and 20

Figure 302 shows the 10-point DBTT curves for joints 2 and 20 for impact energy and percent shear. The impact energy curves show a difference between the C-L and L-C orientations. The C-L orientation has lower impact energy values as compared to the L-C orientation. The C-L and L-C impact energy DBTT for joint 2 is  $39.4^{\circ}\text{C}$  and  $49.1^{\circ}\text{C}$ , respectively. This is a difference of  $9.7^{\circ}\text{C}$ . The upper shelf impact energy for the C-L orientation is approximately 11 ft-lb, whereas the L-C orientation is approximately 23 ft-lb. The upper shelf for the L-C orientation is approximately twice as large as the C-L orientation.

The percent shear DBTT curves show comparable results for both orientations. The C-L and L-C percent shear DBTT for joint 2 is  $52.7^{\circ}\text{C}$  and  $56.8^{\circ}\text{C}$ , respectively. This is a difference of  $4.1^{\circ}\text{C}$ , which is less than the difference observed with the impact energy DBTT. The percent shear DBTT plots suggest that the fracture mode at each temperature is similar for both orientations.

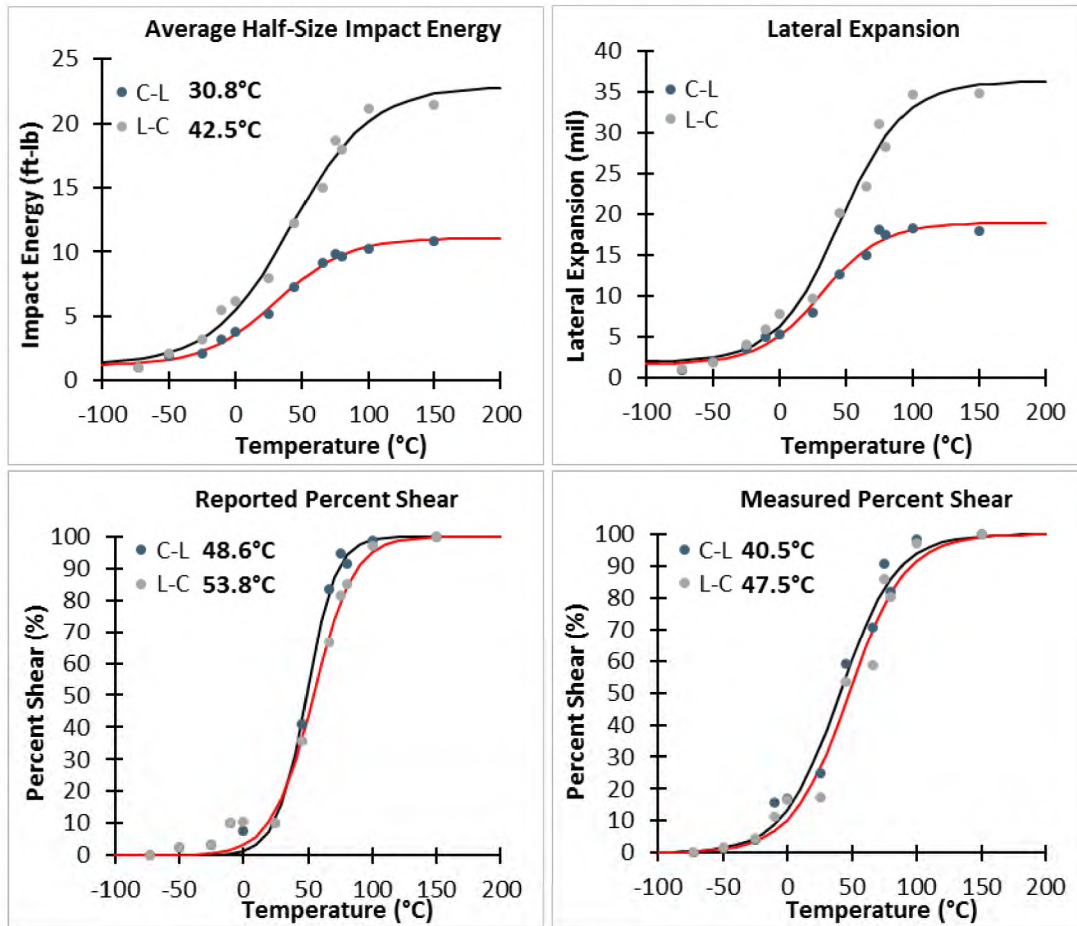
Figure 303: Average CVN Properties Plotted Against Temperature

DBTT curves for the remaining joints were constructed using five temperatures based on the results for the 10-point curves for joints 2 and 20. The chosen temperatures were -50, 0, 45, 75, and 100°C. Triplicates were tested at each temperature for all 25 joints. Figure 303 shows the average results for each property at every tested temperature. The points represent averaged values obtained from the CVN testing, and the lines represent the best fit curve for the points based on Eq. 21. Values at each temperature vary over how many specimens were used to obtain the average at that point.

Values for -50, 0, 45, and 100°C were averaged over 75 specimens (all joints), and 75°C was averaged over 69 specimens (joints 2 and 20 were not tested at this temperature). Values for -73, 25, 66, 80, and 150°C were averaged over six specimens (joints 2 and 20 only). Values for -10°C were averaged over three specimens (joint 22 only). The DBTT values for impact energy, reported percent shear, and measured percent shear are included in the plots. The results are consistent with the observations made for joints 2 and 20. The upper shelf impact energy for the L-C orientation is approximately double the C-L orientation. The upper shelf value for the L-C and C-L orientations is approximately 21 ft-lb and 10 ft-lb, respectively. The lower shelf for both orientations is approximately 1 ft-lb.

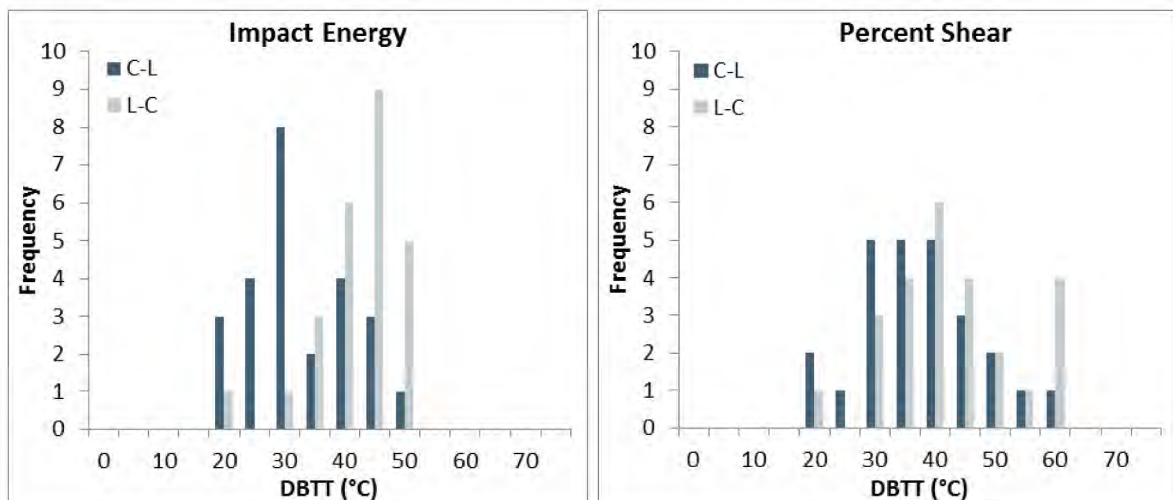
Figure 304: Impact Energy and Percent Shear DBTT Histograms

DBTT for impact energy and percent shear were calculated for all 25 joints. Figure 304 shows histograms of the results. The average impact energy DBTT in the C-L and L-C orientations is 31.2°C and 39.5°C, respectively. The average percent shear DBTT in the C-L and L-C orientations is 35.5°C and 40.3°C, respectively.

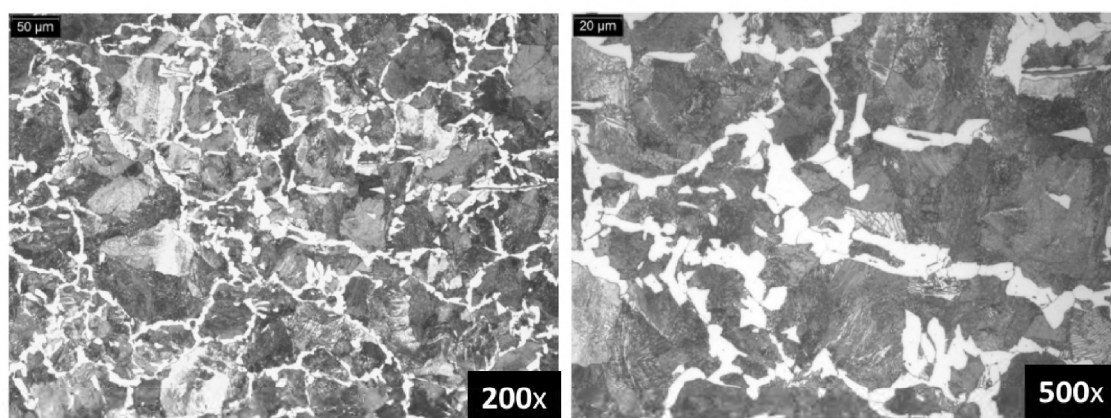
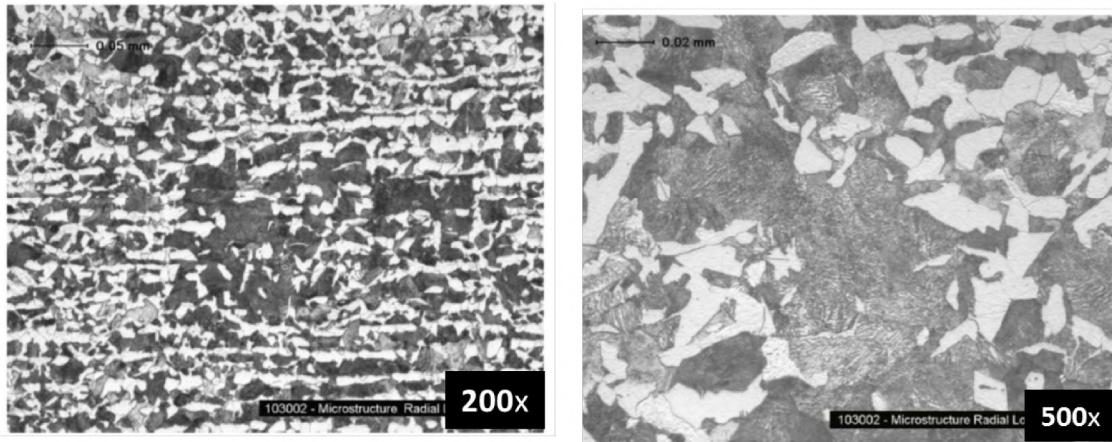
Both vintage and new grade J55 have fine grains, with an average size of ASTM 7.45 and ASTM 8.0, respectively, per ASTM E112 [82]. Despite the similarity in grain size, the difference in microstructure is significant. Figure 305 and Figure 306 are micrographs of the vintage and the new grade J55 microstructure in longitudinal direction, respectively. The major difference in microstructure can be identified as follows:

- The microstructure of the vintage grade J55 consisted of a network of pro-eutectoid grain boundary ferrite ( $\alpha$ -Fe), while the new grade J55 microstructure appeared as typical banded ferrite.
- The amount of pearlite in the vintage grade J55 is higher than in the new grade J55.

- Difference in manufacturing process—rolling temperature, reduction rate, and cooling control.
- Difference in heat treatment—as a rule, even in the 1960s or earlier, grade J55 casing and tubing products were supplied as-rolled and were not heat treated unless necessary. For example, grade J55 casing could be heat treated to combat “ring worm” corrosion [81]. It is not clear if the vintage grade J55 was post-heat treated.
- Difference in carbon contents—the carbon content in vintage grade J55 is 13% higher than the new grade J55, which resulted in a higher amount of pearlite.

As a consequence, the performance between the vintage and new grade J55 should be significantly different.

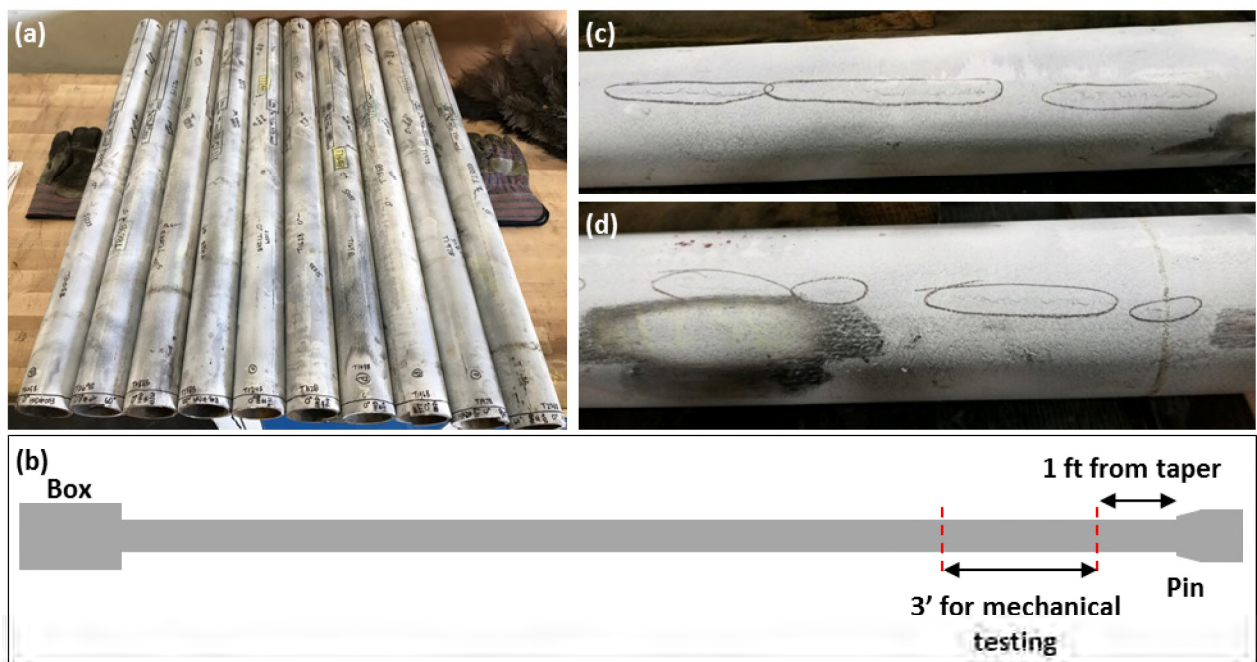
Figure 307: (a) 2 7/8 in. Layout, (b) Schematic, and (c)(d) T021B MPI Features

Linear indications were identified by MPI on the material extracted from joint 21 (T021B). Figure 307 (a) shows mechanical testing layouts for the joints. Figure 307 (c) and (d) show the T021B linear indications identified by MPI. The indications were aligned axially and spanned most of the 3 ft section. The mechanical testing layout was modified to avoid the linear indications. Figure 307 (b) shows a schematic of the extraction location for the tubing testing material.

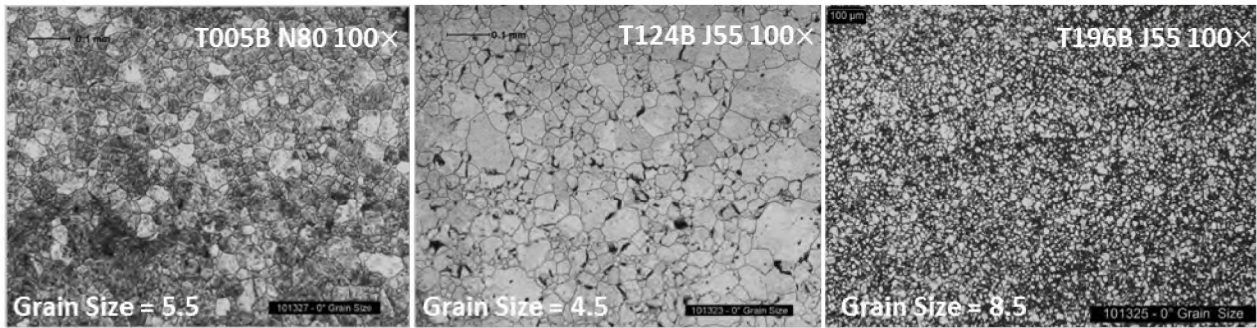
**Figure 308: Grain Size Micrographs for (a) T005B, (b) T124B, and (c) T196B Taken at 100×**

The grain size was determined based on ASTM E112 [82]. Section 7.1.3 briefly describes the ASTM method. Table 35 shows the grain size results for the 2 7/8 in. tubing. The grade N80 grain size was found to be 5.5. The grain sizes for the grade J55 joints ranged from 4.5 to 8.5 and had an average value of 6.88. The standard deviation for the grade J55 grain sizes was 1.70. Figure 308 shows grain size micrographs for the (a) 5.5 grade N80 material, (b) 4.5 grade J55 material, and (c) 8.5 grade J55 material.

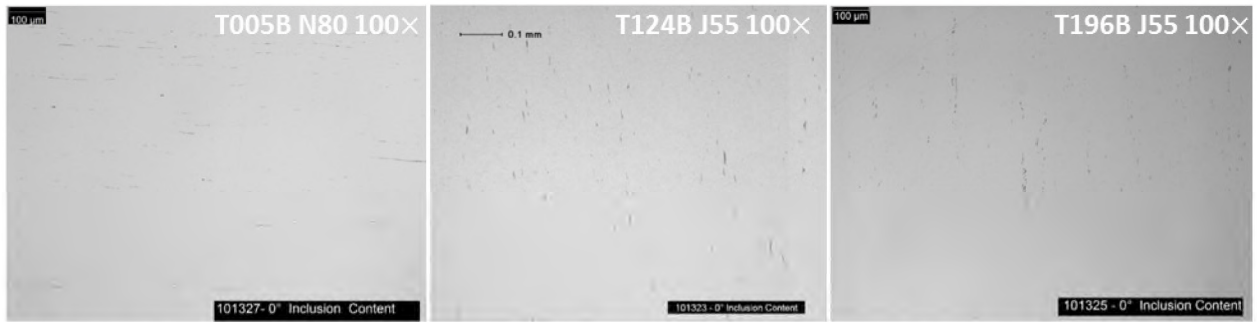
**Figure 309: Microcleanliness Micrographs for (a) T005B, (b) T124B, and (c) T196B Taken at 100×**

Microcleanliness was based on ASTM E45 A [83]. Section 7.1.4 briefly describes the method used to determine the microcleanliness for the tubing materials. Table 36 summarizes the results for each tubing joint. The maximum severity level for grade N80 was 2.5 for Heavy Type A. The maximum severity level for grade J55 was 2.0 for Heavy Type A. The results are consistent with MnS inclusions typical of carbon steel. Figure 309 shows micrographs of (a) T005B, (b) T124B, and (c) T196B in the polished condition at 100×. The micrographs show the MnS inclusions typical of carbon steel.

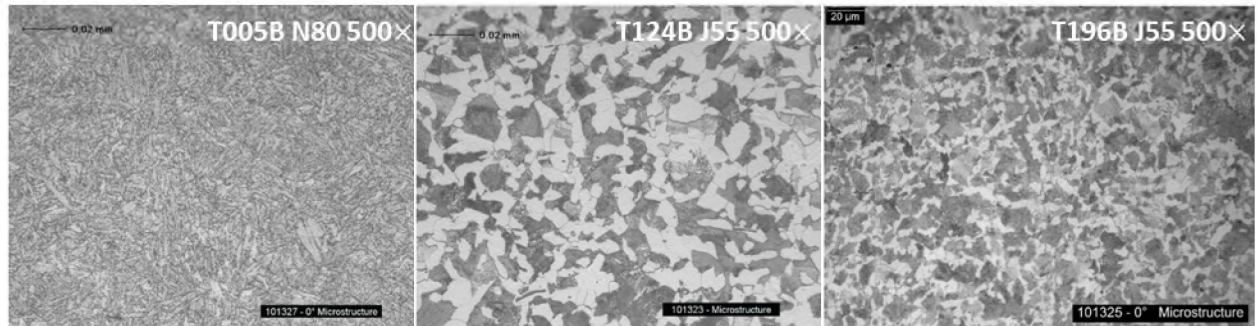
**Figure 310: Microstructural Micrographs for (a) T005B, (b) T124B, and (c) T196B Taken at 500×**

The microstructure was evaluated for the selected tubing joints. Specimens were etched with 3% Nital, and micrographs were taken at 200× and 500×. Micrographs of the grade N80 material revealed tempered martensite. Micrographs of the grade J55 material revealed ferrite and pearlite. These observations are consistent with typical grades N80 and J55 microstructures. Figure 310 shows examples of the microstructure micrographs for grades (a) N80 and (b)(c) J55 material.
