**Blade Supplemental Report (Vol. 2: SS-25 Well Failure Causes)**

# Root Cause Analysis of the Uncontrolled Hydrocarbon Release from Aliso Canyon SS-25

May 31, 2019

# SS-25 Casing Failure Analysis

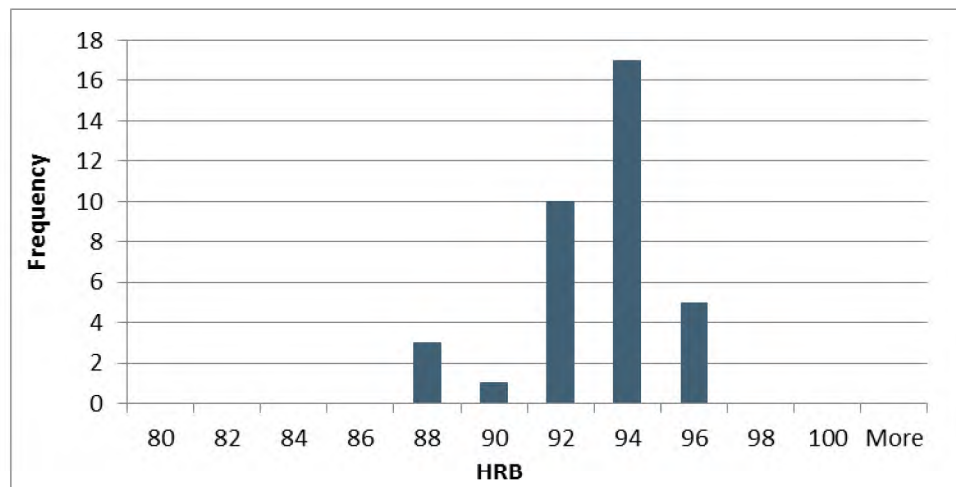
**Figure 311: Hardness Rockwell B Distribution for J55 Joints**

Table 39 shows the HRB results for the remaining grade J55 specimens—the values ranged from 88 to 96 HRB, and the average value was 93.5 HRB. Figure 311 shows a histogram of the HRB values. The distribution appears to be normal, with a standard deviation of 2.0 HRB. The results show consistent HRB values for the sampled grade J55 joints, with no hardness anomalies.

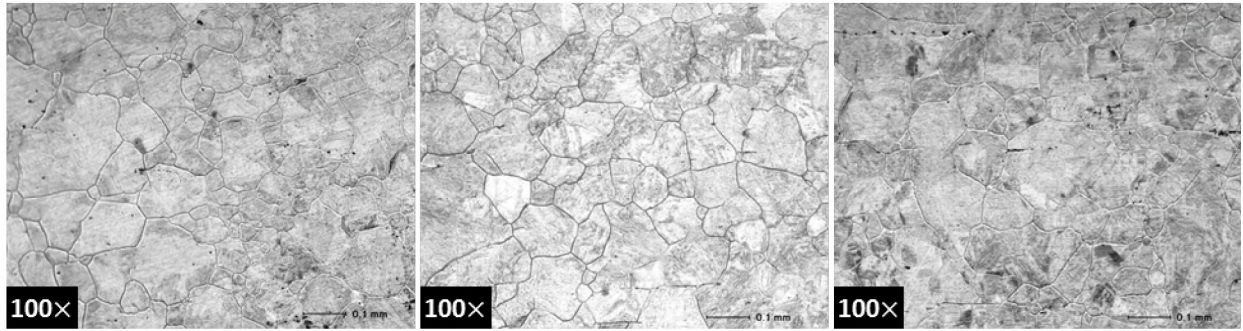
Figure 312: 11 3/4 in. Casing Grain Size Micrographs Taken at 100×

Element measured the grain size for the 11 3/4 in. casing. The results for the three locations were 2.5, 2.5, and 2.0 resulting in an average value of 2.33. Figure 312 shows micrographs from the three locations taken at 100×. The micrographs show a consistently coarse grain size.

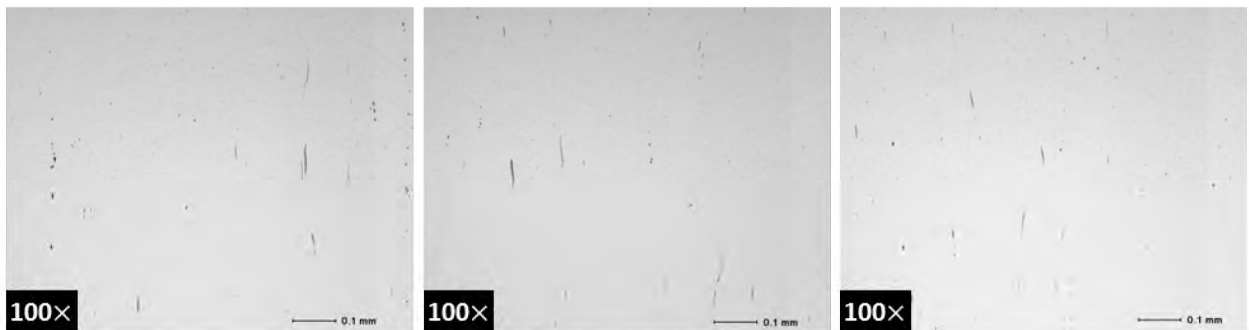
Figure 313: 11 3/4 in. Casing Micrographs from Three Locations Taken at 100×

Figure 313 shows the micrographs of the polished specimens used for the microcleanliness investigation. Table 42 summarizes the results from three locations. The severity levels were low for all four Types. The highest severity occurred in Type A, which most likely corresponded to manganese sulfides. Figure 314 shows microstructural micrographs taken from three different locations. The specimens were etched with 4% picral to reveal the microstructure. The images show a typical pearlite–ferrite microstructure.

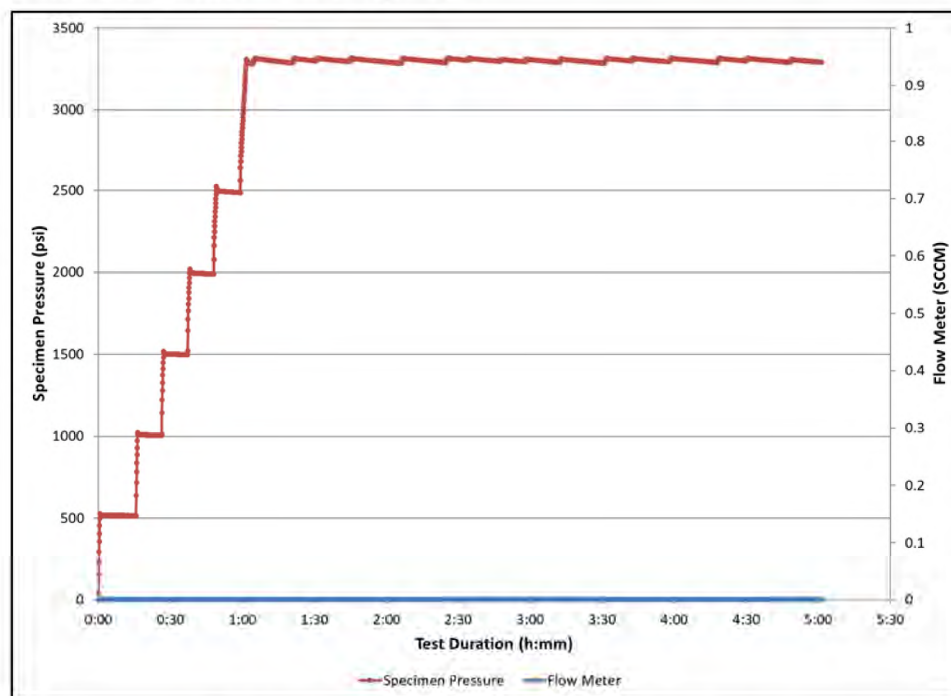
Figure 4: Ideal 'No Leak' Pressure Test Example

Figure 4 shows what an ideal pressure test would be expected to look like. The graph shows internal test pressure and gas flow rate through the boot vs. time. The load step increments and hold periods are clear.

The flow rate through the boot is zero SCCM. The minor pressure variations can be attributed to temperature effects and pressure-related expansion.

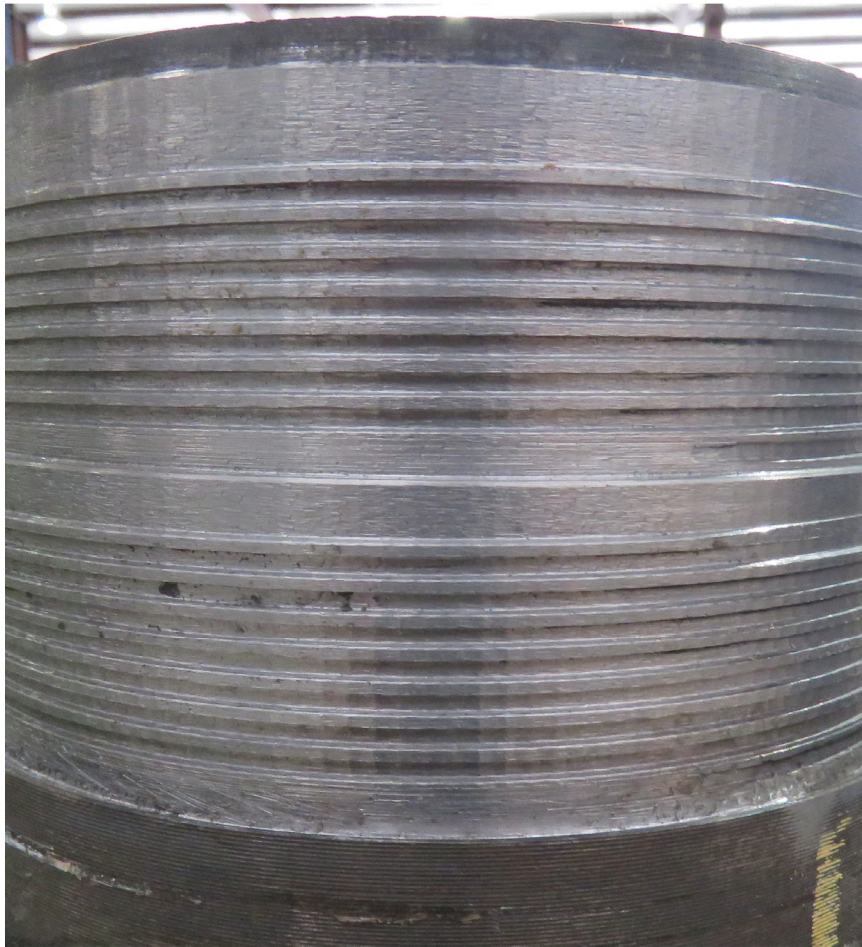
**Figure 5: C001B Pin Threads Condition after Cleaning**

After break out, the pin and box threads were cleaned and visually inspected. The threads were found to be in very good condition with no obvious galling, metal burrs, erosion paths, or damage to the threads and seal areas. There was no obvious relationship between the thread condition, the breakout torque, and whether or not a particular connection leaked. Figure 5 is a representative photo of the condition of the threads after break out and cleaning. The original machined surface condition is still visible.

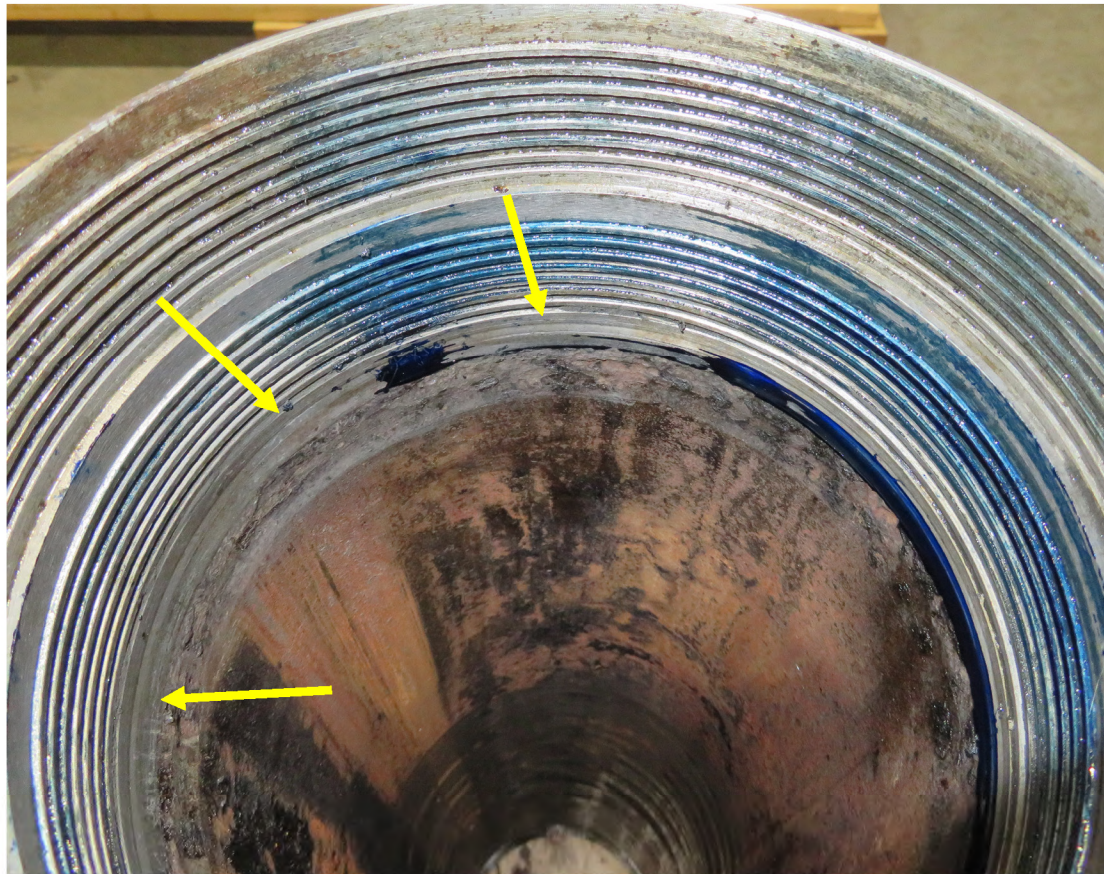
**Figure 6: C023A1C Blueing Results**

A paste-like blue dye was first applied to the pin nose seal before carefully making the connections up to hand-tight torque. This type of blueing process is commonly used as a quality check to detect high-spots or gaps during machining and assembly processes through the transfer of the dye from one surface to another when the surfaces contact. The connections were then carefully backed out by hand so that the blueing transfer from the pin nose seal to the box seal area could be observed. The transfer of the dye from the pin nose seal to the box seal was incomplete for both connections. Figure 6 shows the blueing

results for C023A1C where the arrows in the picture point to areas where the dye was not transferred to the box seal.

While results of the blueing process are qualitative in nature, they can be helpful for identifying areas where there is a gross lack of seal contact at hand-tight makeup. However, even if the dye transfers completely across the seal surfaces at hand-tight makeup, the connection may still leak. Therefore, blueing results can be used to identify connections that have a high probability of leaking, but they will not definitively identify connections that will not leak.

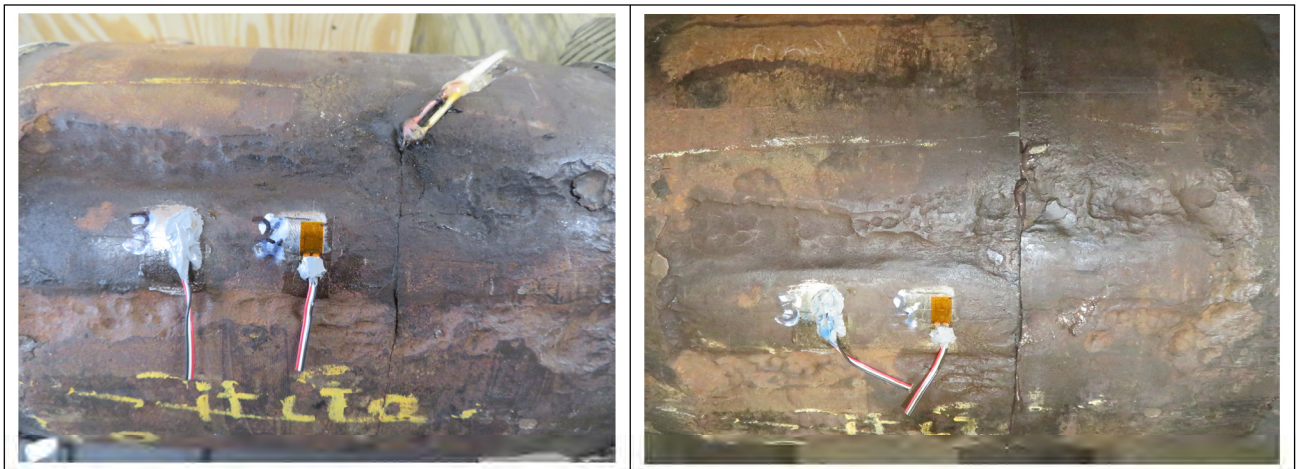
**Figure 7: C023A1C Before Breakout (left) and after Power Makeup (right)**

The fact that the connections had been made up to the estimated recommended torque and still leaked demonstrates that the leaks were not associated with the low breakout torques and that the low breakout torques were therefore not a consequence of any mechanisms associated with the parting of the 7 in. casing. The left panel in Figure 7 shows the how the corrosion on connection C023A1C was aligned in the original condition before being broken out. The right panel shows the corrosion misaligned after C023A1C was broken-out, cleaned and then made-up to 8,000 ft-lb. These results also indicate that the original makeup torque was less than 8,000 ft-lb.

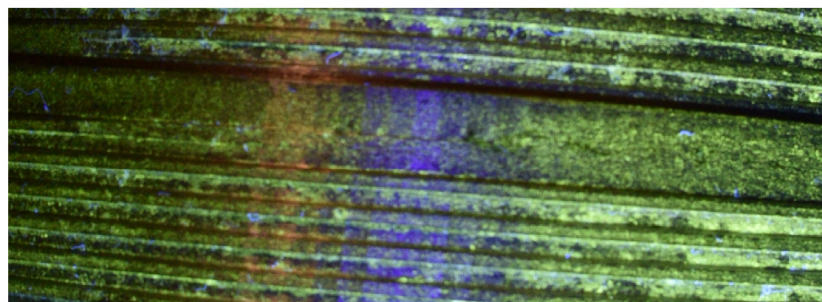
Figure 8: Ultraviolet Magnetic Particle Inspection of Threads

After the connection testing was completed, the connections identified in Table 7 were broken out and their threads were cleaned. The pins of four chosen connections underwent ultraviolet (UV) magnetic particle inspection (MPI) for detection of fatigue cracks within the threads. Figure 8 shows a picture of the UV MPI inspection.

The four connections chosen were C001B, C011B, C019B, and C025B. None of the pins had any surface-breaking defects (cracks).

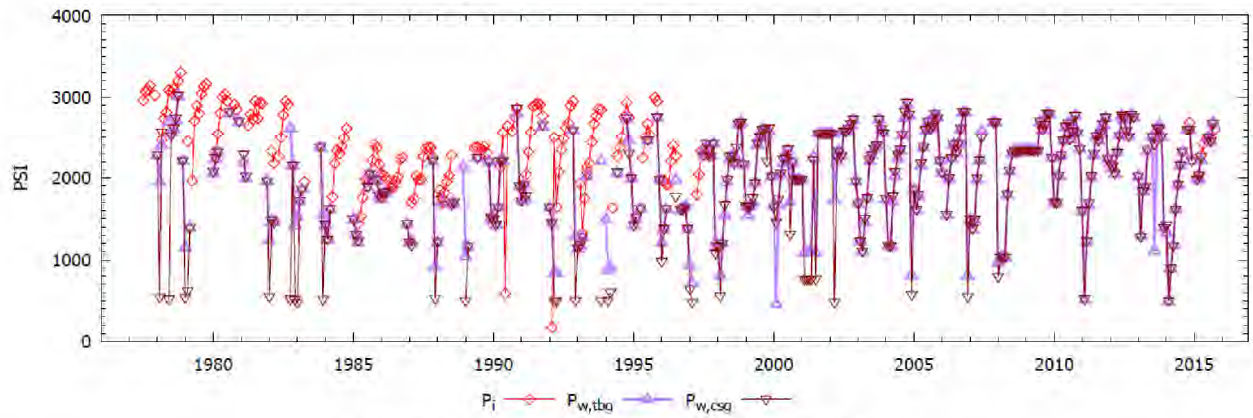
Figure 9: SS-25 Casing Pressure History ( $P_{w,csq}$ )

The testing results suggest that some of the Speedtite connections leaked very small amounts of gas into the 7 in. × 11 3/4 in. annulus over time. It can be concluded that the volume of gas would also have varied over time, depending on the internal pressure that the casing was exposed to, which was a function of the ongoing storage operation (injection or withdrawal). Figure 9 shows the SS-25 casing pressure history from 1977 to 2016.

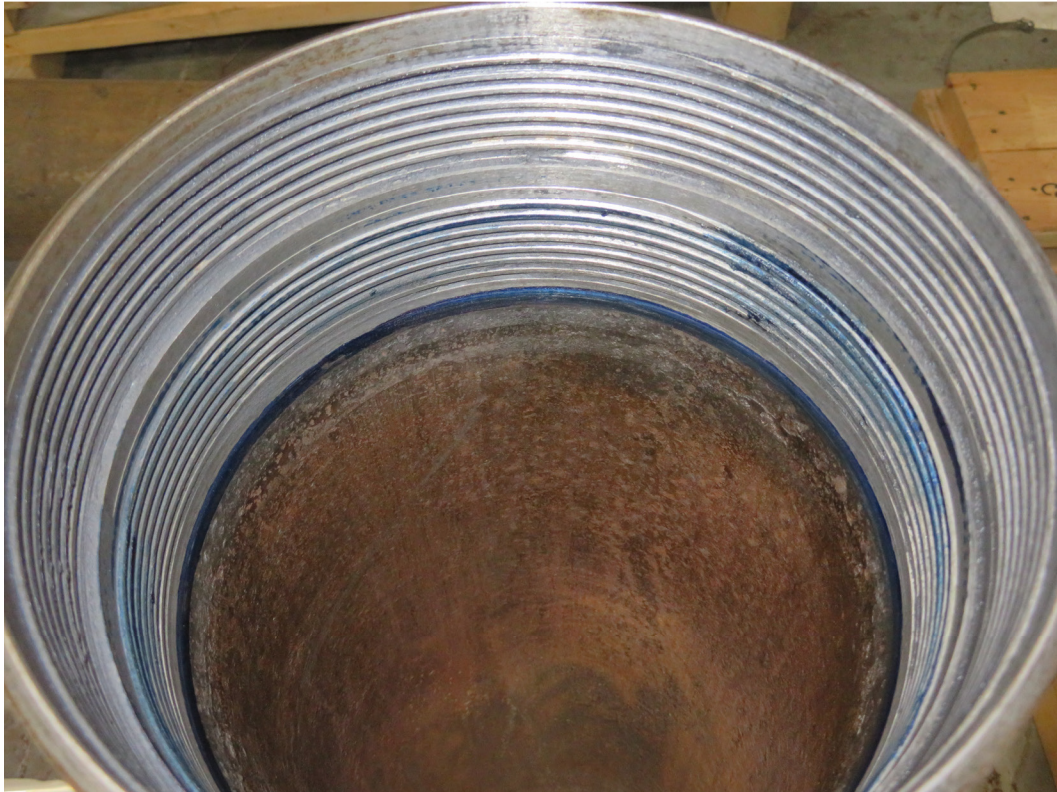
Figure 20: Representative Full Blueing Transfer on C002B

The blue dye was also applied to the remaining seven connections that leaked and to three of the connections that did not leak during the original testing. Some of the connections that leaked had small areas of no blue transfer while others had full blue transfer across the ID seal area. The results from the connections that did not leak had full blueing transfer across the ID seal area. Table 10 shows a final summary of the connection test results.

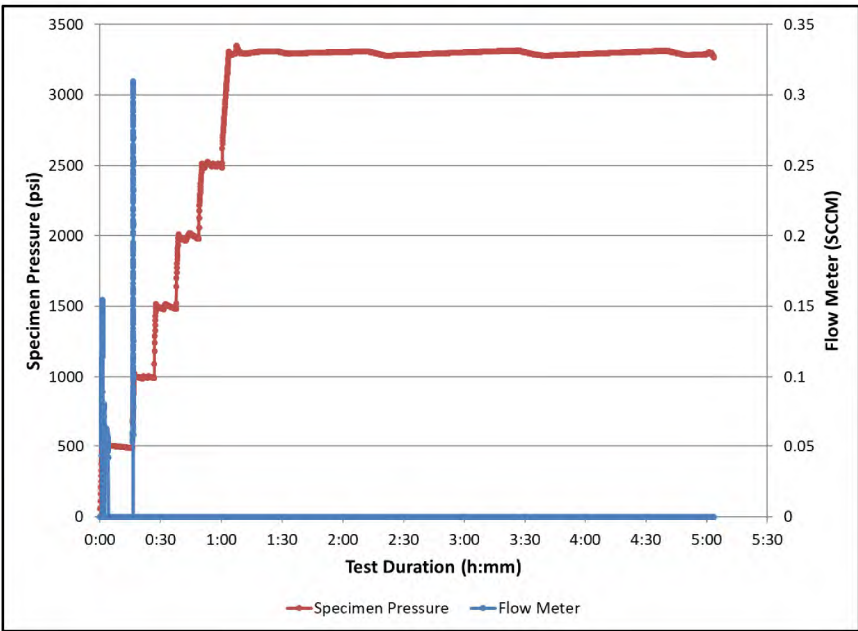
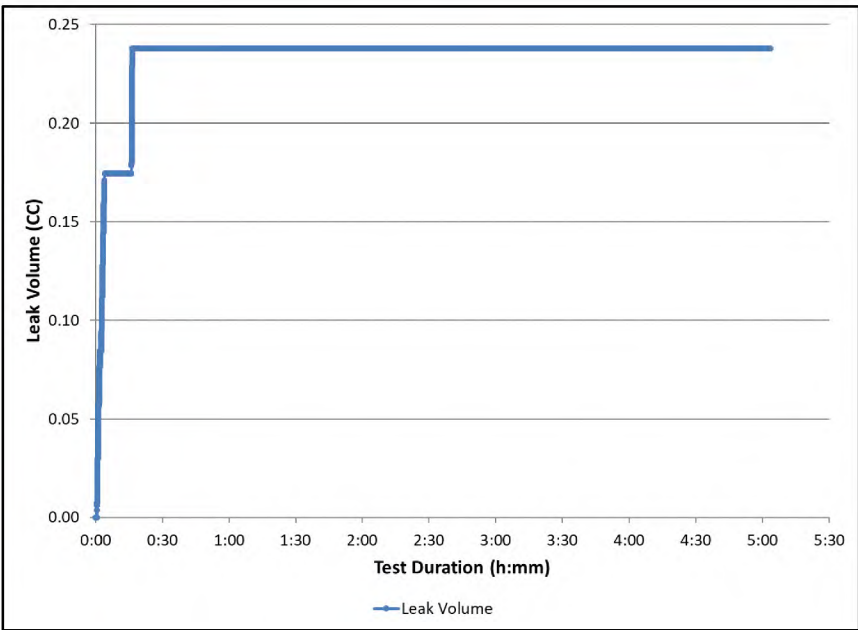
<b>Connection Test Data Sheet</b> SS-25 7" 23.0 ppf J55 Casing, Speedtite Connection Connection: <u>C001B</u>		No Leak

<b>Test Date:</b>	<b>Comments:</b>	
1. 12, Sept. 2018	1.) Test conducted with 4 SCCM flow meter; No Leak.

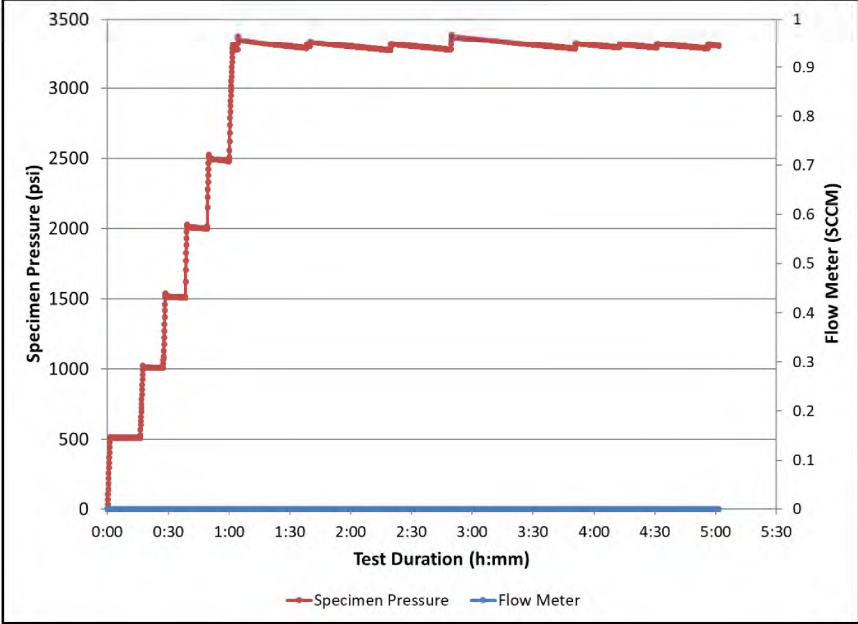
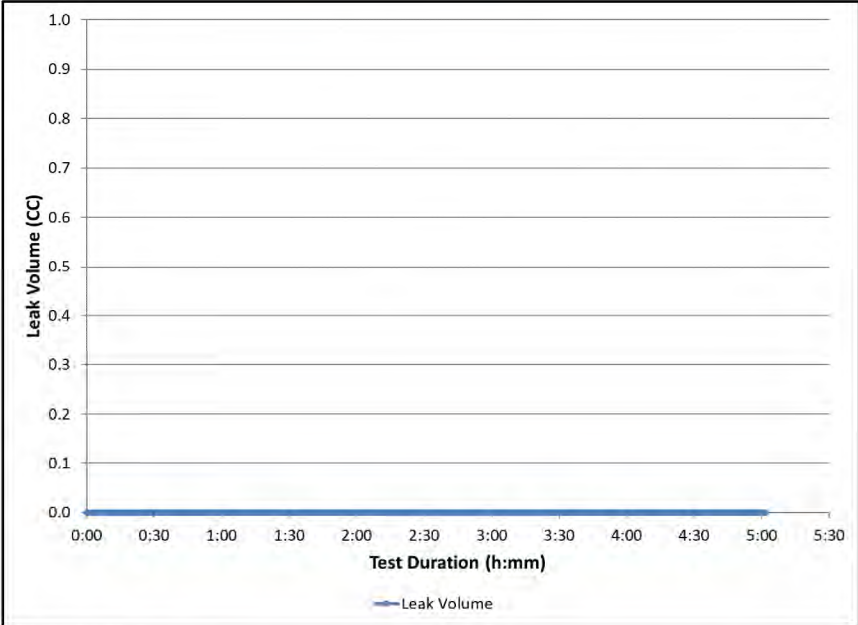
<b>Connection Test Data Sheet</b> SS-25 7" 23.0 ppf J55 Casing, Speedtite Connection Connection: <u>C005B</u>		No Leak

<p><b>Test Date:</b>                  1. 16, Aug 2018                  2. 24, Aug 2018</p>	<p><b>Comments:</b>                  1.) Tested with 4 SCCM flow meter. Flow through the meter peaked at 3.4 SCCM and was determined to be from differential expansion of the connection and external sealing boot. 2.) Retested with 50 SCCM flow meter; No Leak.</p>

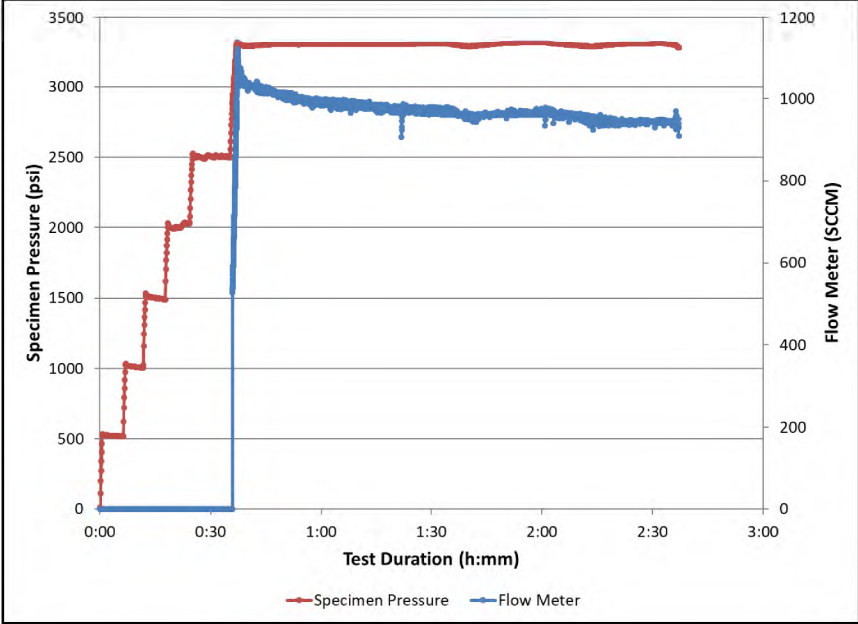
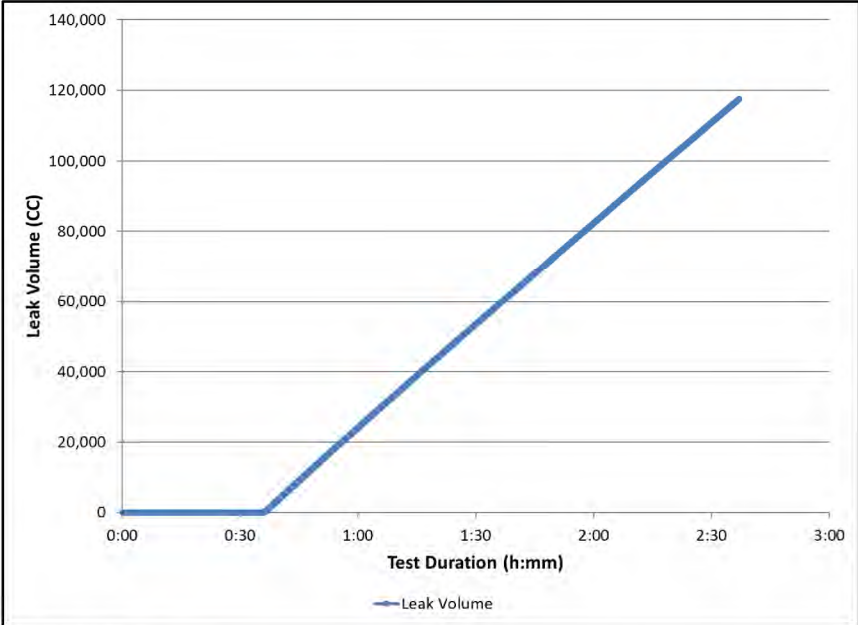
<b>Connection Test Data Sheet</b> SS-25 7" 23.0 ppf J55 Casing, Speedtite Connection Connection: <u>C016B</u>		Leak

<b>Test Date:</b> 1. 10, Sept 2018 2. 10, Sept 2018 3. 10, Sept 2018	<b>Comments:</b> 1.) Tested with 4 SCCM flow meter. Leaked beyond flow meter range. 2.) Tested with 500 SCCM flow meter. Leaked beyond flow meter range. 3.) Tested with 50,000 SCCM flow meter. Flow rate peaked at 1,120 SCCM.

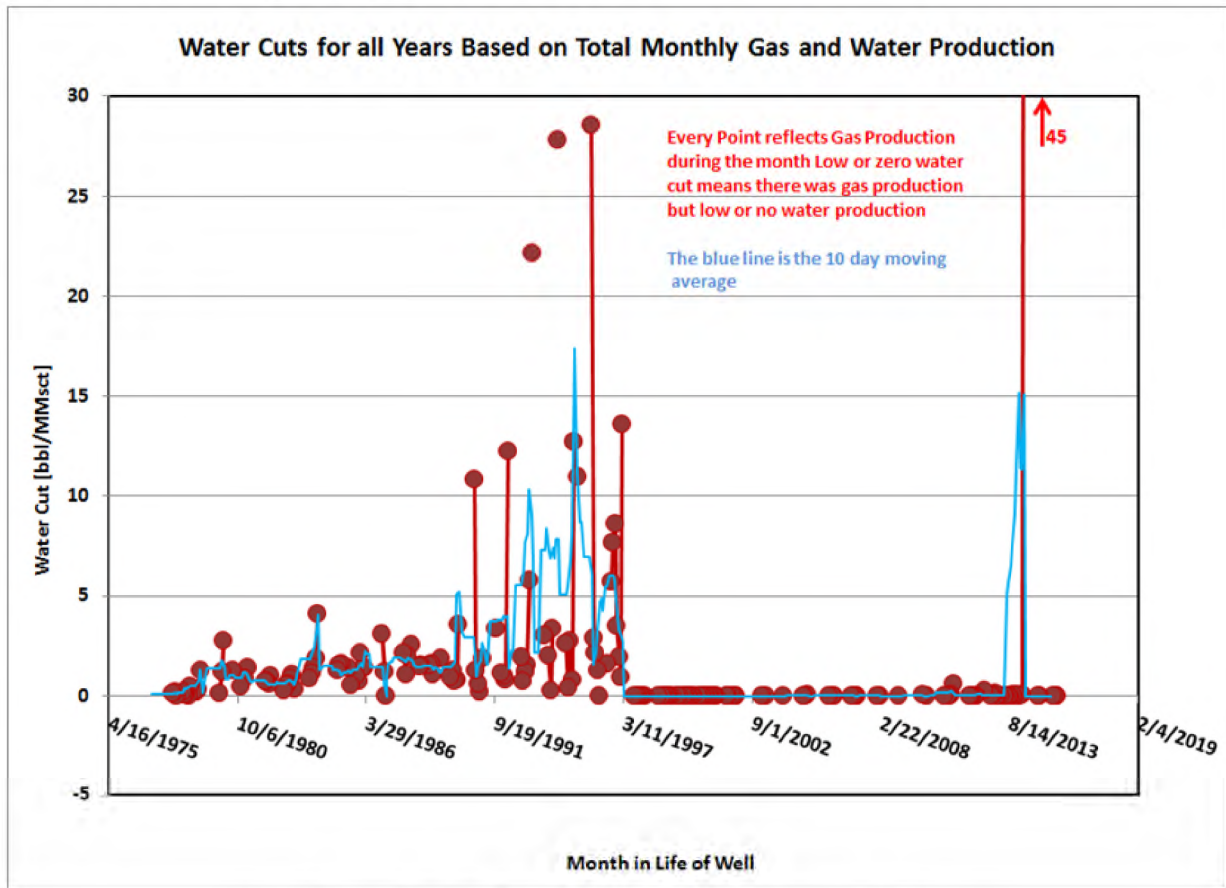
Figure 1 shows all recorded data concerning water production in terms of water cut (bbl water/MMscf gas). The data were based on cumulative monthly production volumes. This, however, does not mean that the well was producing gas back for the entire month. Rather, production times varied randomly during each month from a few days to as much as 25 days.

There are two distinct periods of withdrawal operations recognizable. From 1977 to 1997 the water cut was almost consistently above saturation of 0.57 bbl/MMscf, and the ten-day moving average seems to indicate gradually increasing water production. Then in early 1997, the water cut fell below 1 bbl/MMscf. The reason for this abrupt change is unclear.

Figure 1: SS-25 Production—Historical Water Cut

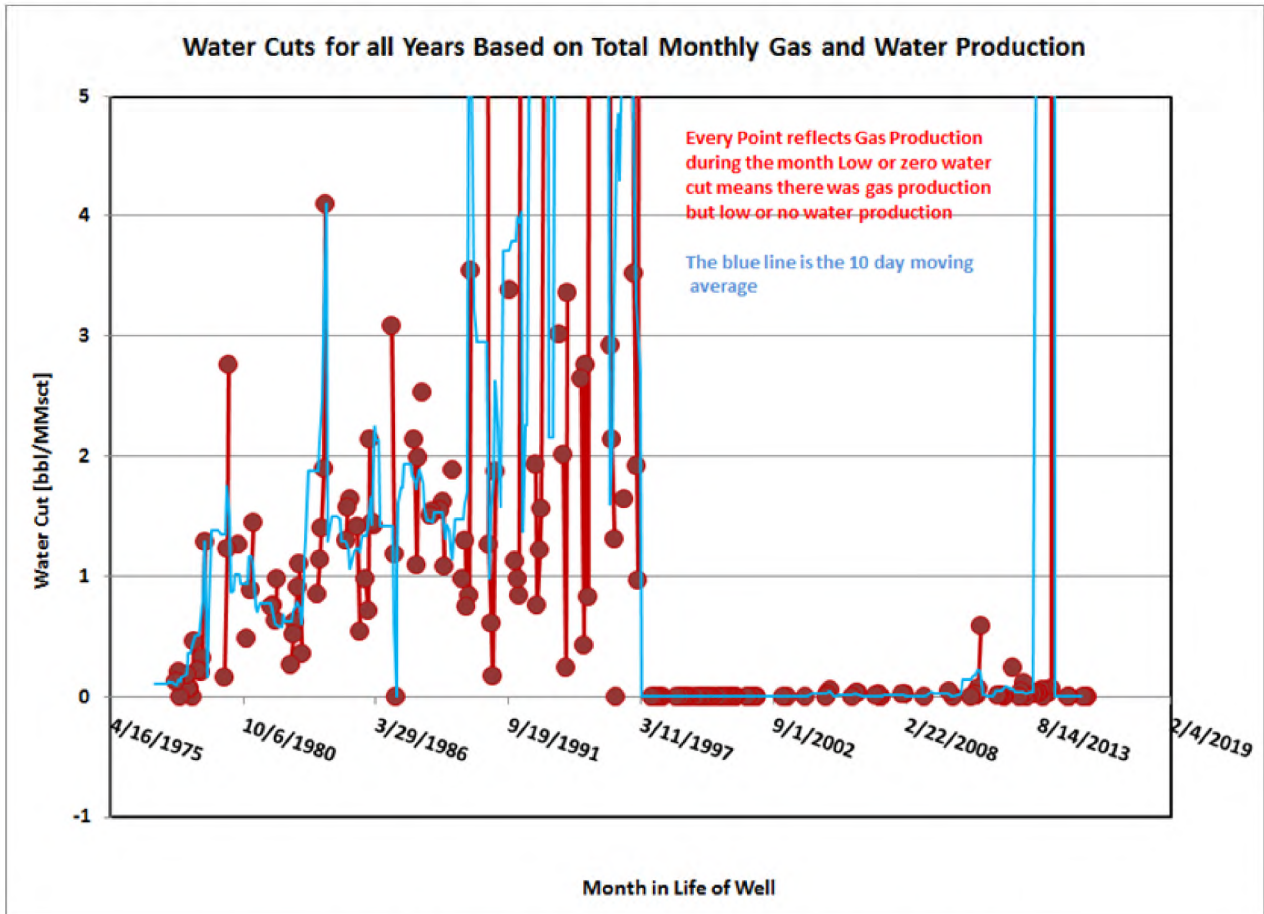
Figure 2 shows the same data on an expanded vertical scale in order to highlight the water cut differences before and after 1997.

Figure 2: SS-25 Production—Historical Water Cut (Expanded Scale)

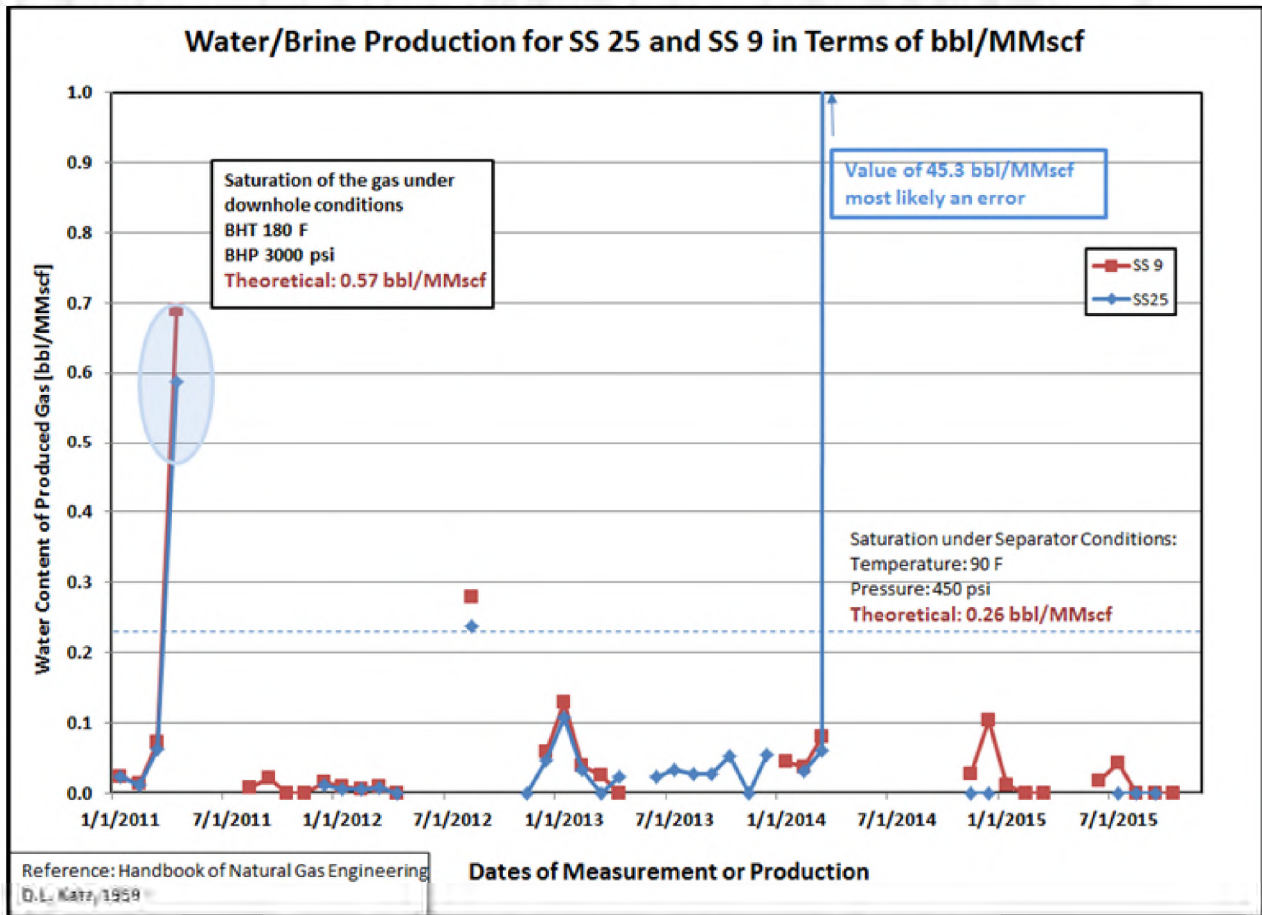
Figure 3 shows details of the water cut data for the most recent withdrawal from 2011 to mid-2015 for SS-25 and SS-9. With two exceptions, the water cut for both wells is below 0.1 bbl/MMscf, as measured in the separator. Even accounting for the water content carried out with the gas, the saturation level of 0.57 bbl/MMscf is not reached. Therefore, it can be concluded that, except for occasional well intervention procedures, the produced gas is totally under-saturated under downhole conditions.

Figure 3: SS-25 and SS-9 Water Cut Comparison, 2011–2015

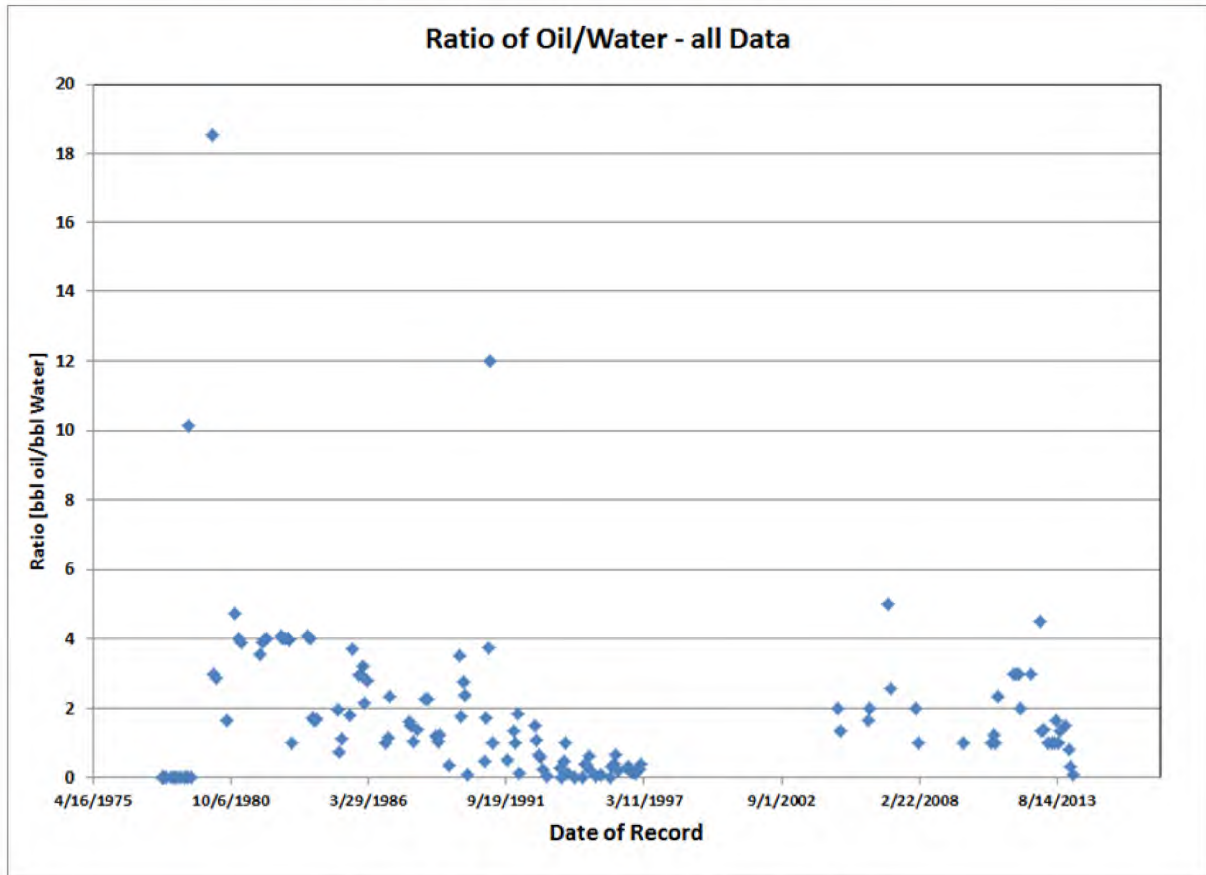
Even though the field is now used for gas storage, a small amount of oil is still produced during withdrawal. Figure 4 shows the SS-25 oil production data in terms of oil/water ratios for the entire 38-year period. On average, the oil production is twice the water production with some large variations. As a consequence, given the nature of this residual oil, corrosion in the production casing and tubing was very likely retarded through corrosion inhibition provided by the oil.

Figure 4: SS-25 Production—Oil/Water Ratio

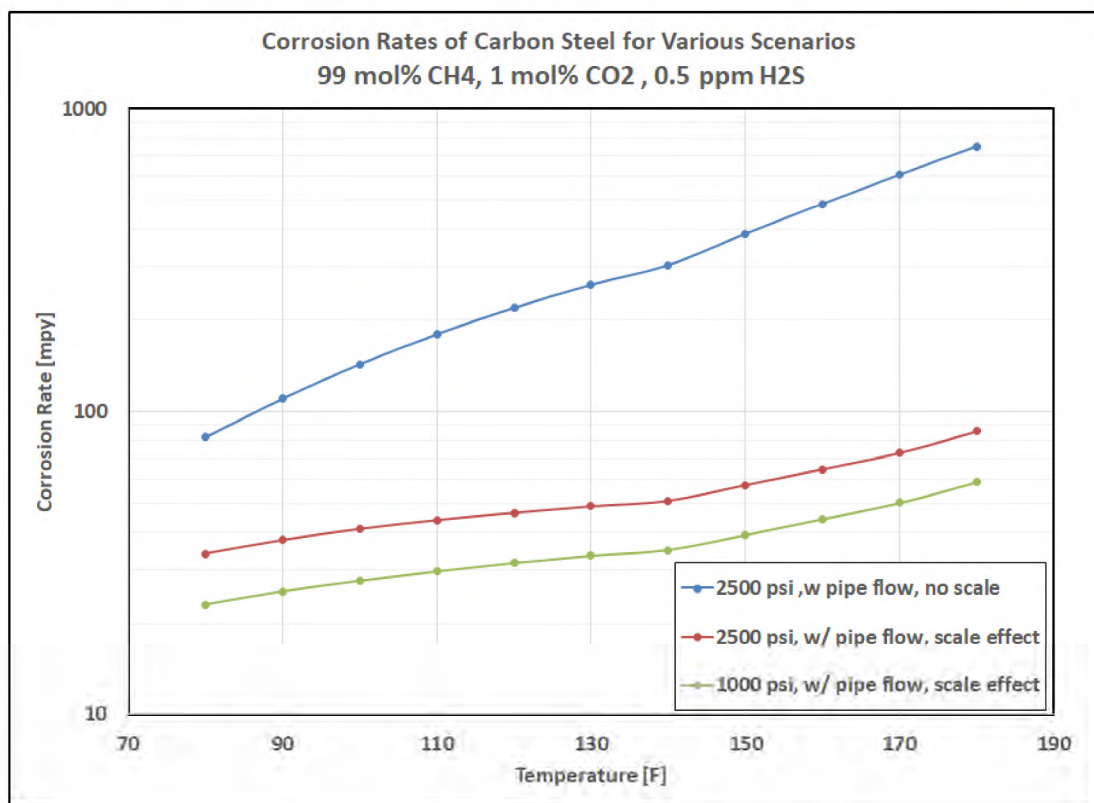
If scale is allowed to form, the corrosion rate decreases by a factor of ten, and can be supported by experimental data where the effect depends on the liquid volume to surface area ratio.

**Figure 5: Traditional Corrosion Rate Model Results**

Furthermore, if the pressure were reduced to cut the CO<sub>2</sub> partial pressure in half, the corrosion rate responds by being reduced by 30 to 40%. The corrosion rates modeled by the OLI software may have occurred in SS-25 even when accounting for scale formation. This would result in a maximum cumulative corrosion loss downhole of over 200 mils, which would have destroyed the tubing and a significant portion of the casing.

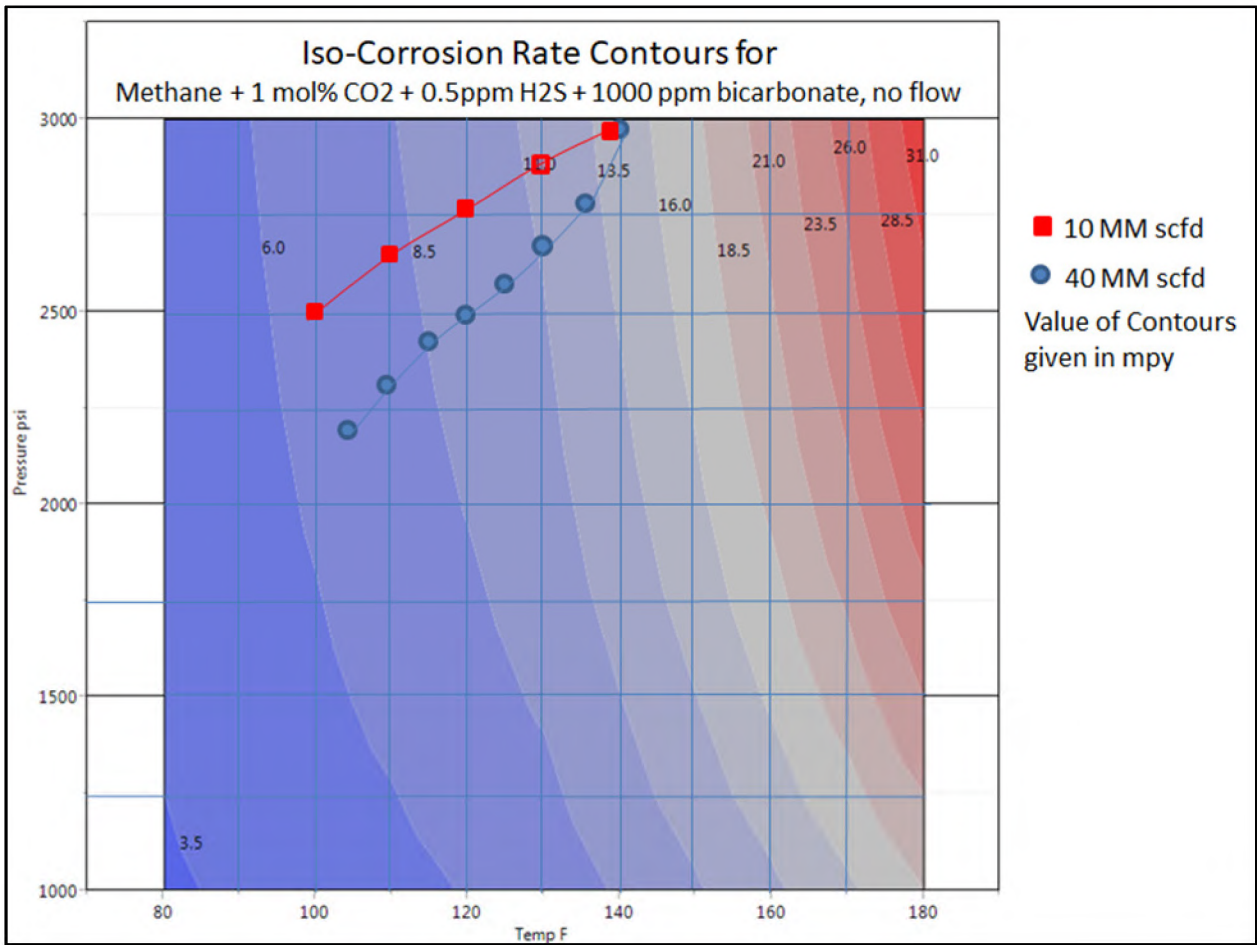
**Figure 8: Iso-Corrosion-Rates Contour Model**

This figure illustrates Iso-Corrosion Rate domains in the temperature-pressure grid applicable to SS-25 downhole conditions. The numbers in the graph are the corrosion rates within the specific contour areas. Superimposed are the temperature–pressure characteristics for two extreme production rates: 20 and 40 MMscf/D (Figure 7).

The results show that the gas flow rate has little effect on the corrosion rate. This may be because the higher flow rate is compensated for by the lower pressure which results in a higher water content in the flowing gas. What is important is the fact that these rates had been calculated with bicarbonate present in the condensed water. These data are justified because, as soon as CO<sub>2</sub> saturated condensed water touches the steel surface, the corrosion process generates the bicarbonate. At the point of condensation, only a very thin film of condensate exists. It becomes saturated in CO<sub>2</sub> immediately, and an iron carbonate film quickly forms at this location, thereby retarding the corrosion process. The observed corrosion rates are comparable to those observed in the laboratory [5].

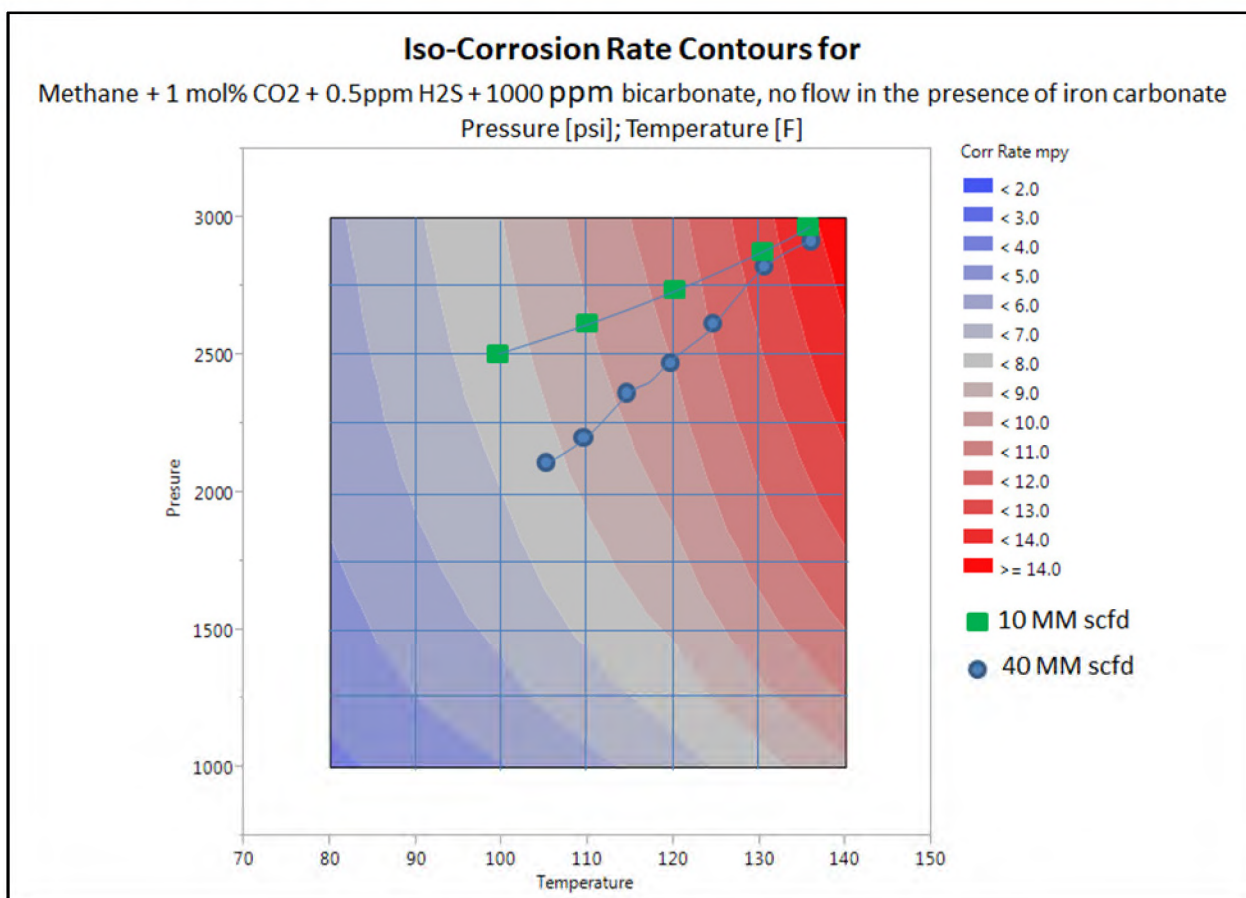
Because of the importance attributed to the iron carbonate (the presence of iron ions in solution), the same calculations were repeated with some iron carbonate in the solution at the start. This modification had little effect on the overall results (Figure 9).

**Figure 9: Iso-Corrosion-Rate Contour Model with Iron Carbonate**

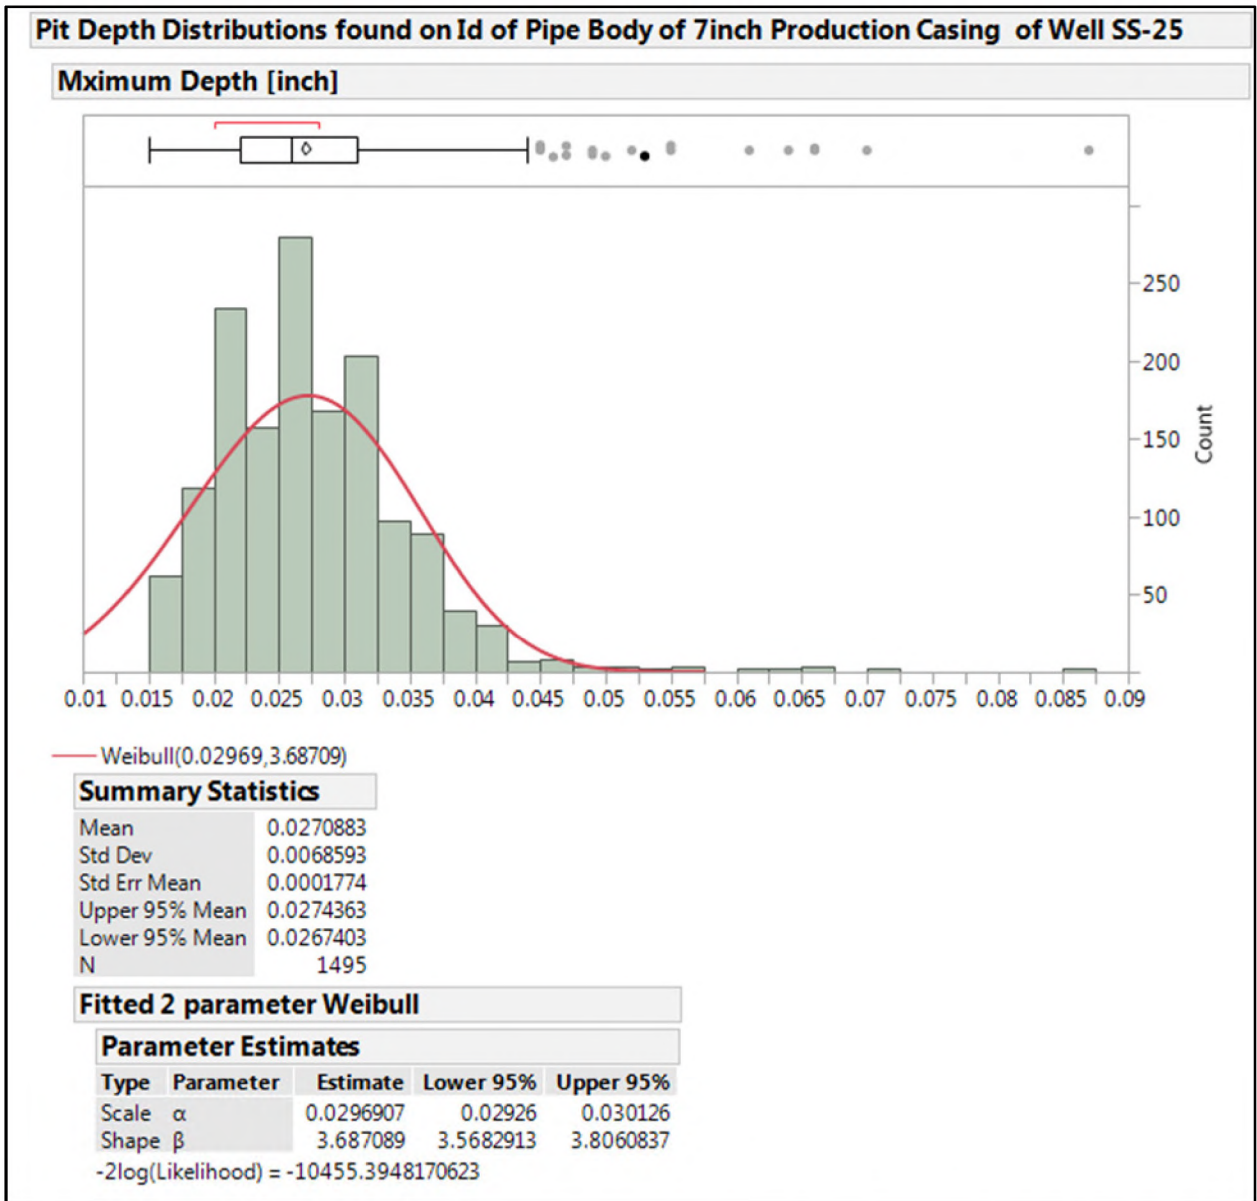
The analysis and summary (Table 3) of the overall frequency distribution provided a limited picture of the corrosion phenomena. Figure 10 and Figure 12 show the extreme value (Weibull) plots for the two sets of maximum penetration data from the pipe and connection segments.

Figure 10: Frequency Distribution of Maximum Corrosion Feature Penetration on Pipe Body
