**Blade Supplemental Report (Vol. 2: SS-25 Well Failure Causes)**

# Root Cause Analysis of the Uncontrolled Hydrocarbon Release from Aliso Canyon SS-25

May 31, 2019

# SS-25 Casing Failure Analysis

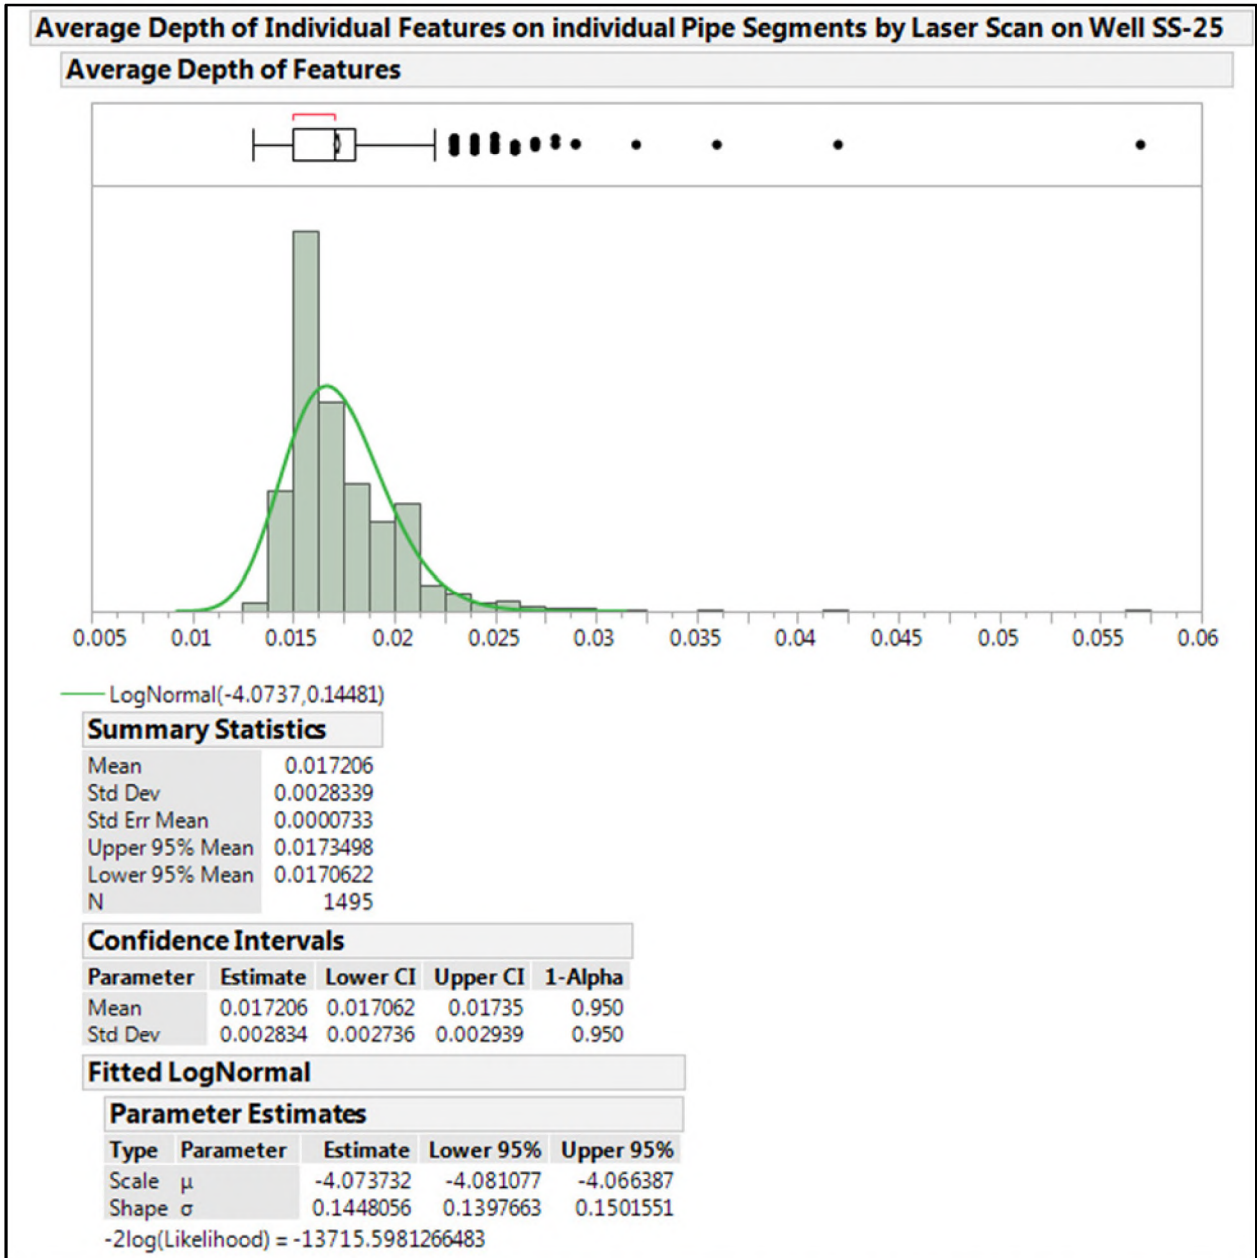
By comparison, the mean maximum pit penetration on the connections (Figure 11) is 0.0378 in. (39 mils) with a larger standard deviation of 0.0008 in. (0.8 mils). The comparison between the two means is significant, which at this time only means that pitting on the connections are higher by an average of 44% over the pipe body penetration.

Figure 11: Frequency Distribution of Average Corrosion Feature Penetration on Pipe Body

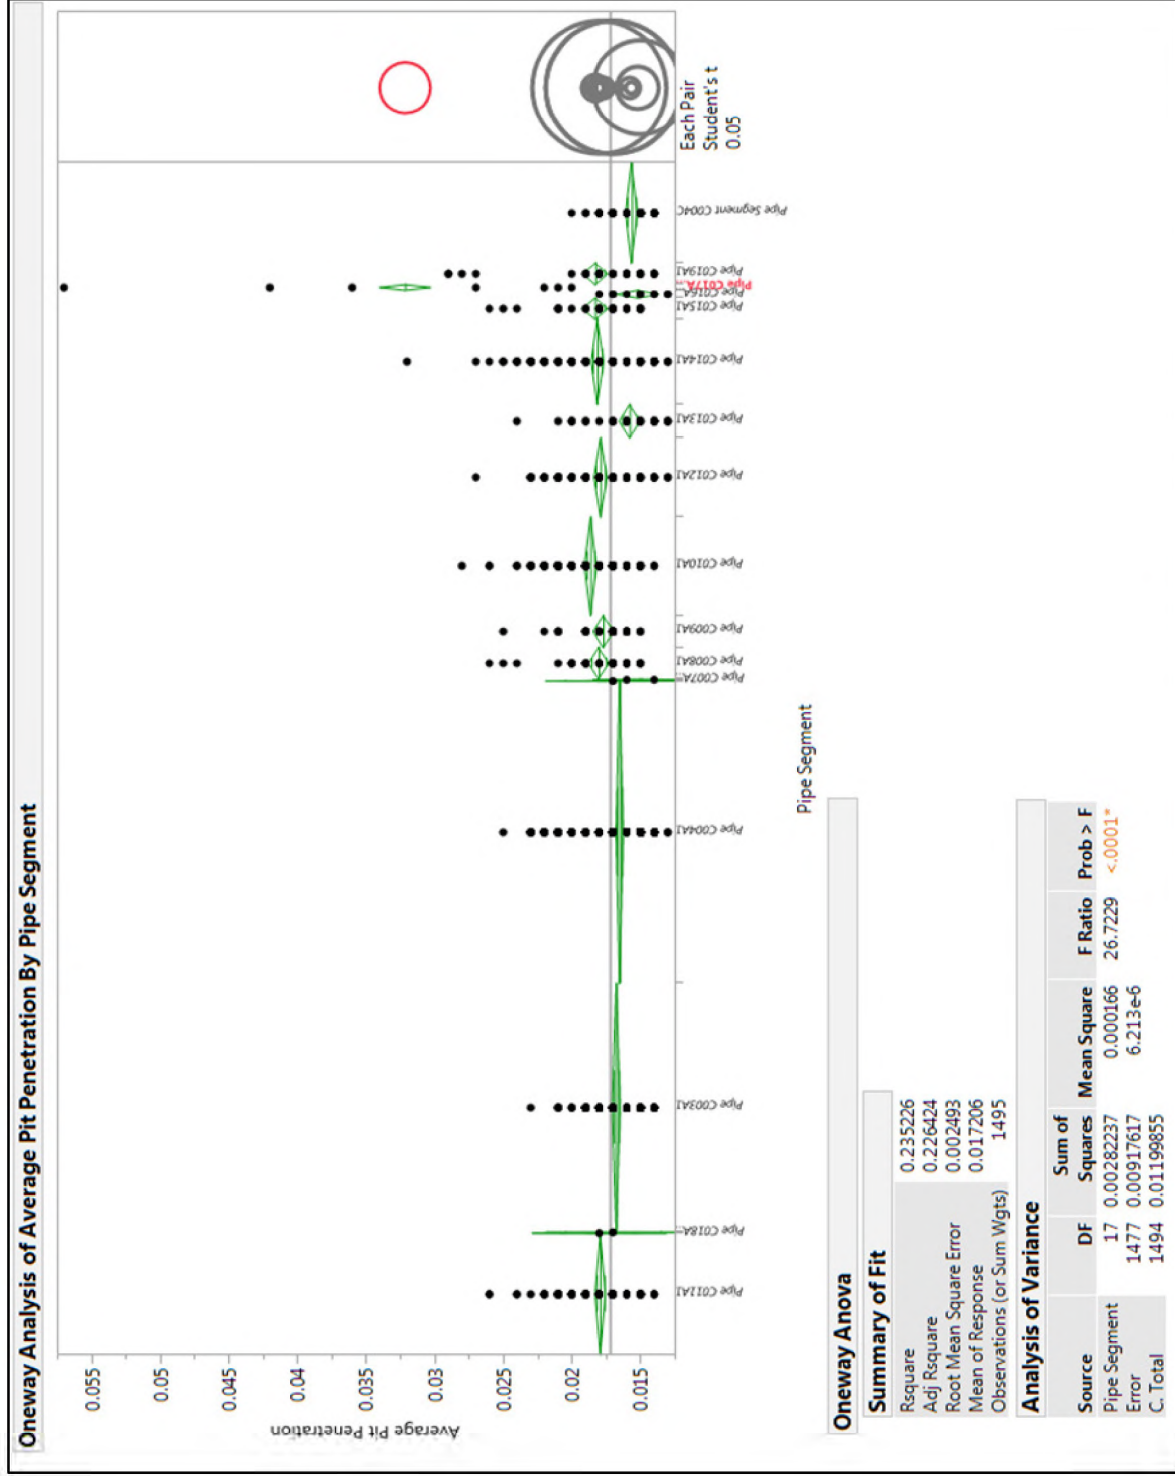
Figure 17 and Figure 19 lead to the same conclusions by means of the average penetration rather than the maximum ones. In Figure 17, one finds that the mean for the average depth of the corrosion features on pipe segment C017A1 is significantly above the global average of all pipe segments. The reason is not clear since no significant differences between the pipe segments have been reliably established.

Figure 17: Comparison of Average Feature Penetration on Pipe Body for Each Pipe Segment

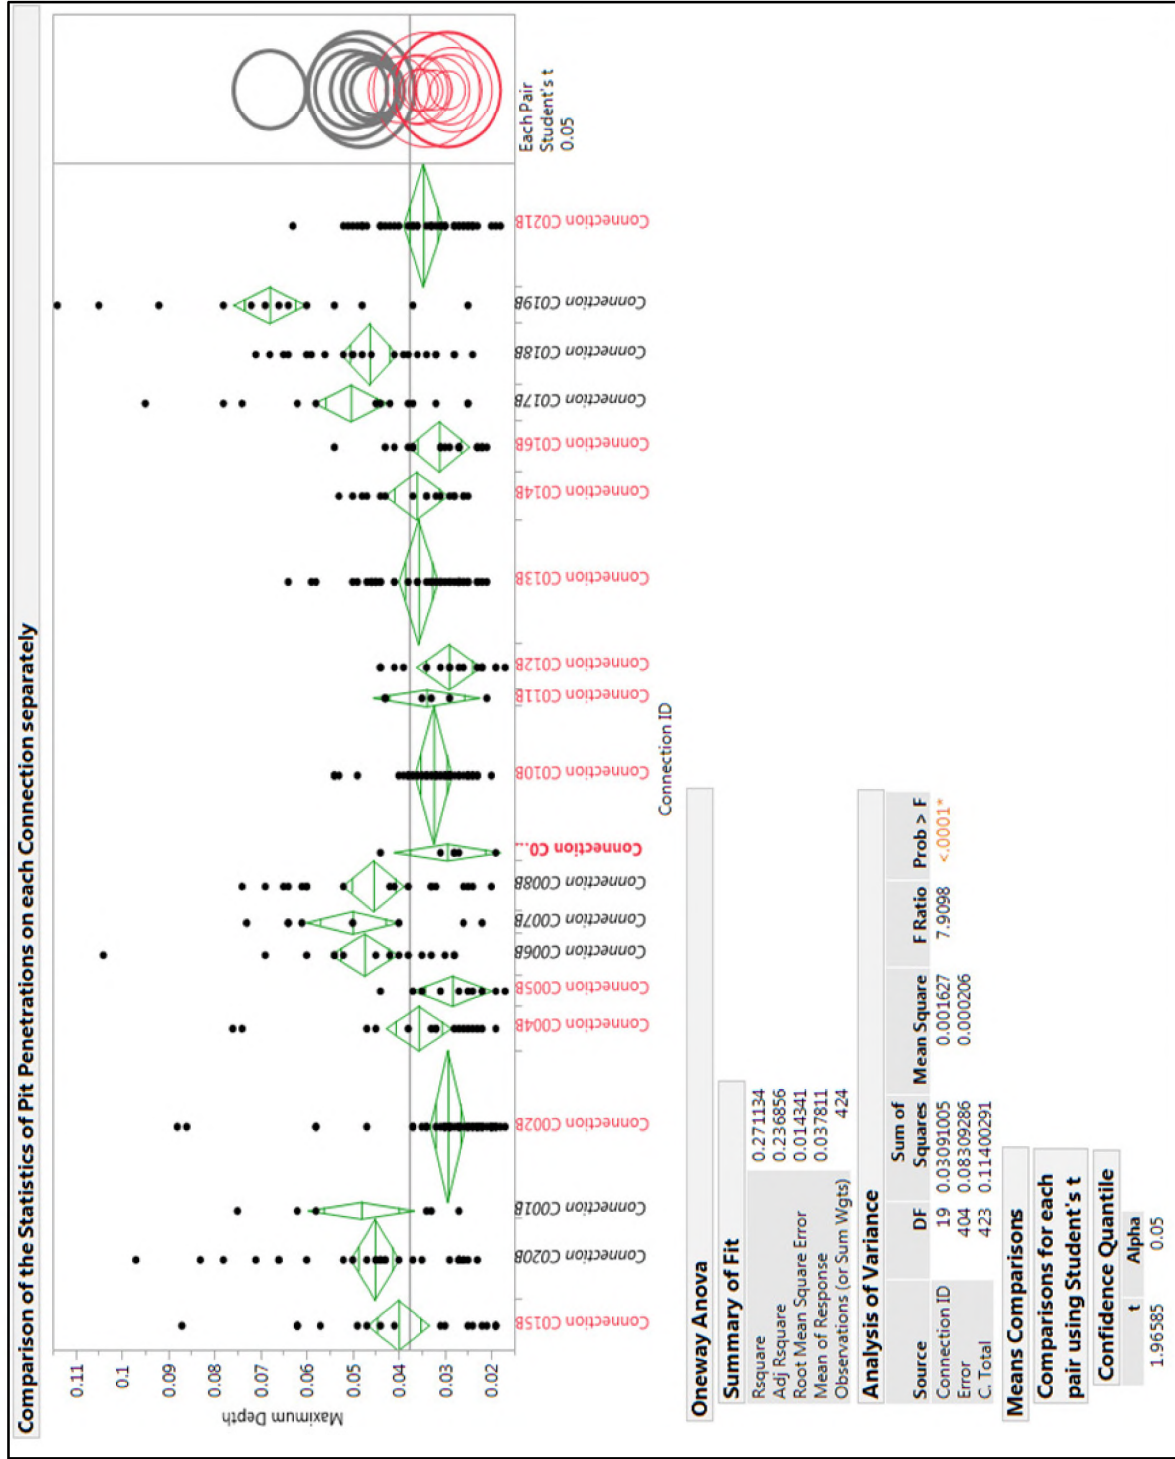
Figure 18, the individual frequency distribution correlation with each connection, mirrors the conclusion that had been reached earlier by comparing the Weibull correlation in Figure 12, which is that there is a certain overlap in the frequency distribution before the divergence occurs. We now find that this overlap was essentially confined to joint C003A1 and connection C004A1.

Figure 18: Comparison of Maximum Feature Penetration on Connection Body for Each Pipe Segment

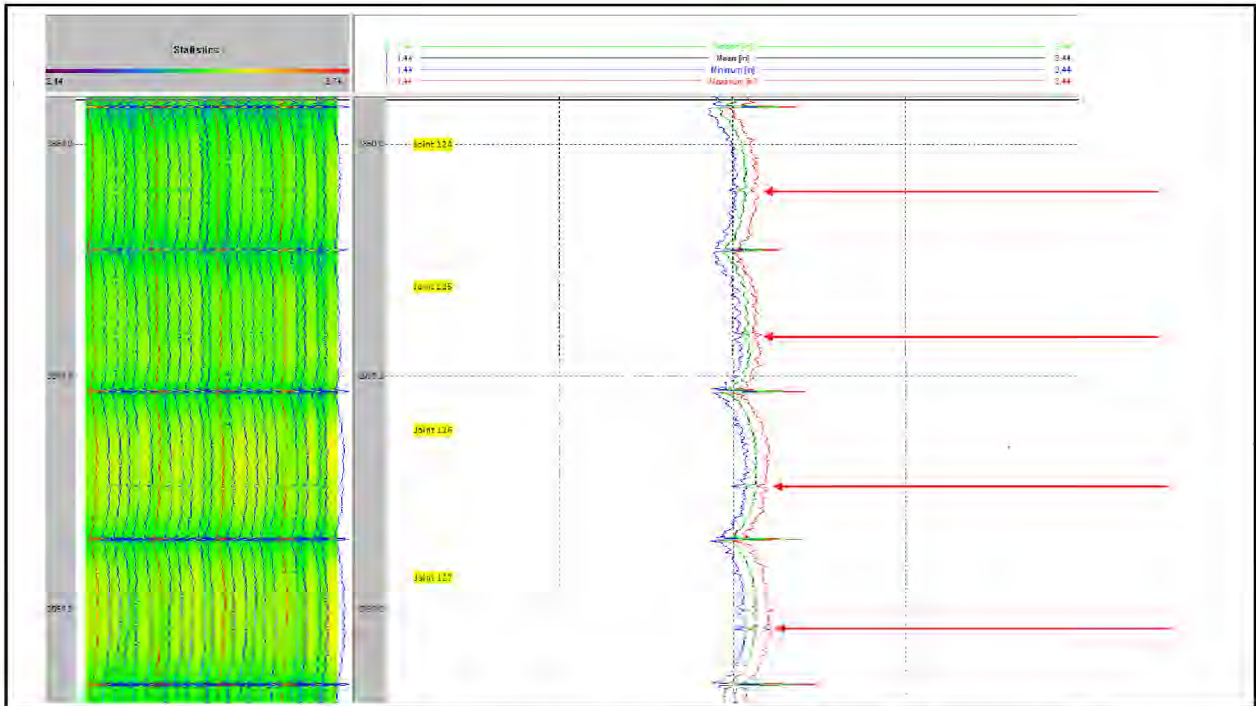
Figure 1 shows an example of the bulging phenomenon and circumferential features. The individual traces of each caliper finger are shown on the left, and the calculated minimum, average, and maximum diameters are shown in blue, green, and red respectively. Smaller diameters are to the left, and larger diameters are to the right. The tubing pipe body seems to be radially flared out or bulged, i.e., the ID in the middle is larger than at the ends of each joint. This was evident in joints 83–234 (2,564–7,250 ft). Circumferential features were also observed. They are denoted by red arrows pointing to short lengths with a small reduction in diameter.

Figure 1: Example of Bulging and Circumferential Features (Red Arrows) Observed on Numerous 2 7/8 in. Tubing Joints [6]

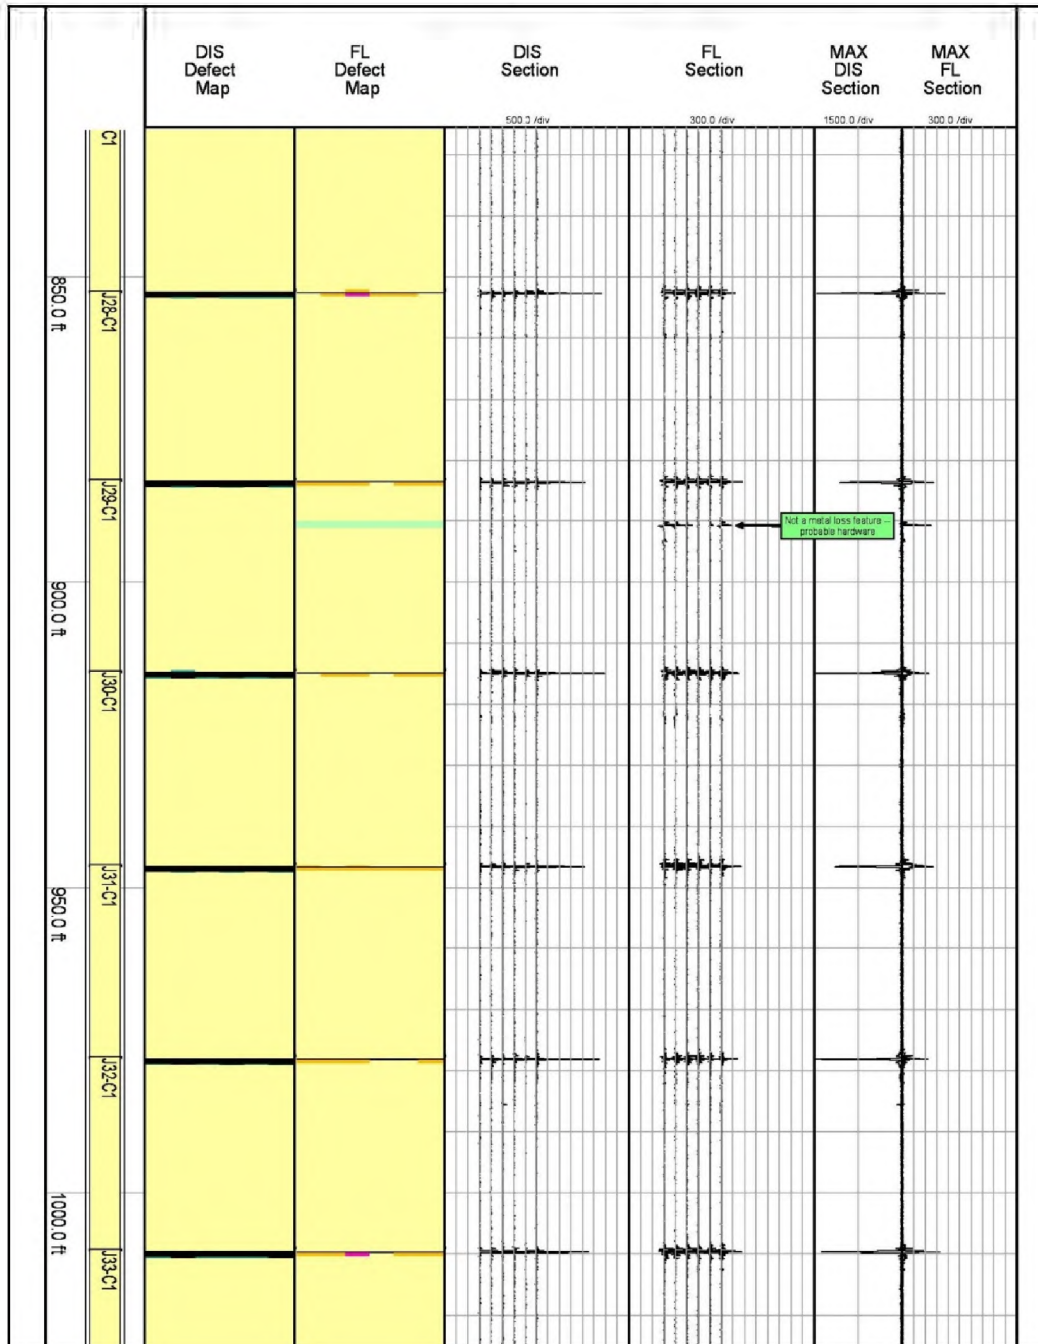
Figure 3 shows the portion of the MicroVertilog log for the depths 830–1,020 ft. Metal loss features are not present. At ~891 ft, denoted by a green box, we see the call-out by Baker Hughes “Not a metal loss feature – probable hardware.” The way we interpret this is that the parted 7 in. casing was in contact with the tubing at this location, and the MicroVertilog registered this as an external hardware.

Figure 3: MicroVertilog Log of 2 7/8 in. Tubing, 830–1,020 ft [6]

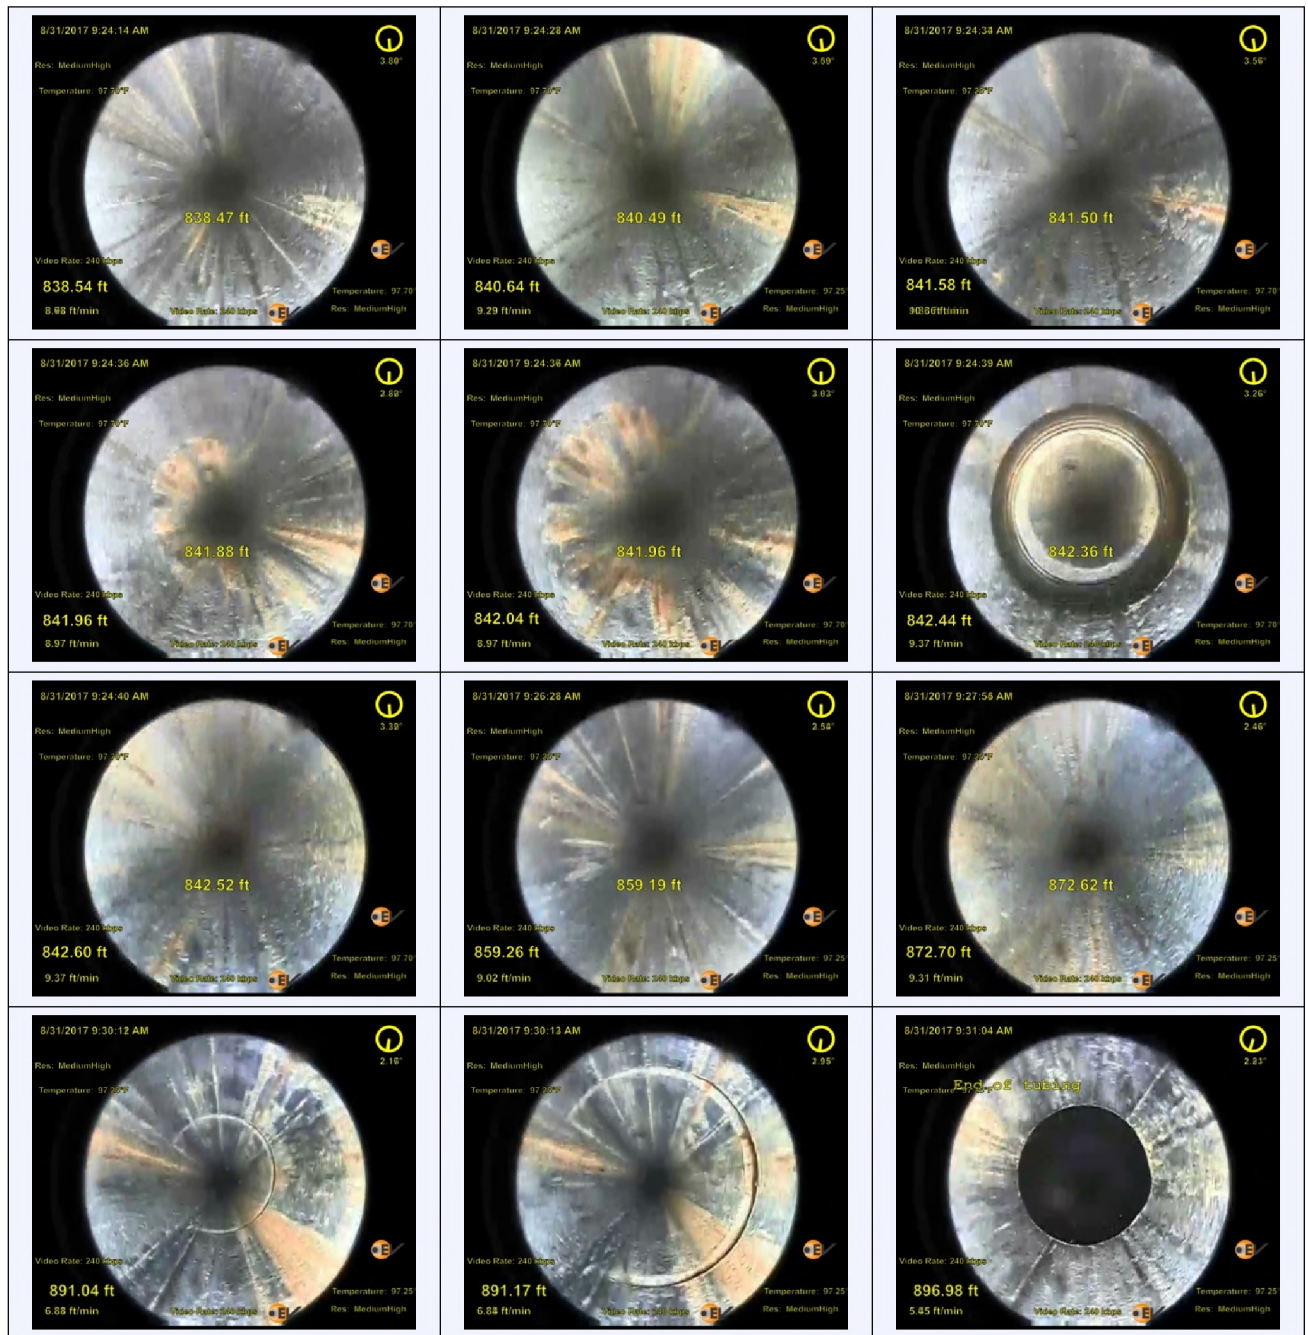
The cameras were run twice to look at the 7 in. casing failure concurrent with the extraction of the 2 7/8 in. tubing. Figure 7 shows some images of the tubing. The images agree with the observations of the previously discussed tubing inspection logs—no abnormalities were observed in the tubing. Note that the two images on the left hand side of the bottom row show the internal circumferential feature. The 7 in. casing failure is shown in Section 2.2.5.

Figure 7: Camera Screenshots of Tubing ID

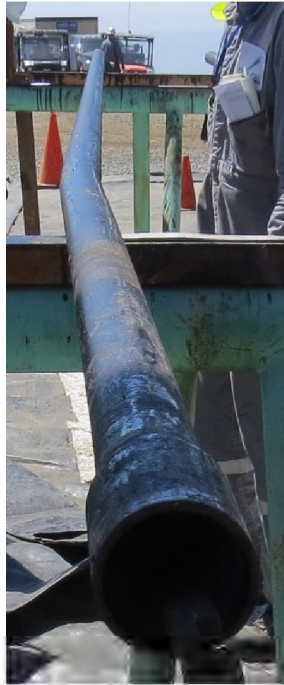
Baker Hughes was not able to run the MicroVertilog inspection logging tool through the tubing below 3,608 ft. A successful pass-through was achieved by using additional weight bars. We realized after the extraction of the tubing that this issue was related to deformation in the pipe body. Figure 8 shows the most severely bent tubing joint—joint 116 located at ~3,608 ft. There was a noticeable bend located in the upper third of this tubing joint (the uphole end is closest to the viewer, and the downhole end is into the page). Further evaluation of the extracted tubing is found in separate reports [1] [2].

Figure 8: 2 7/8 in. Tubing Joint 116 After Extraction

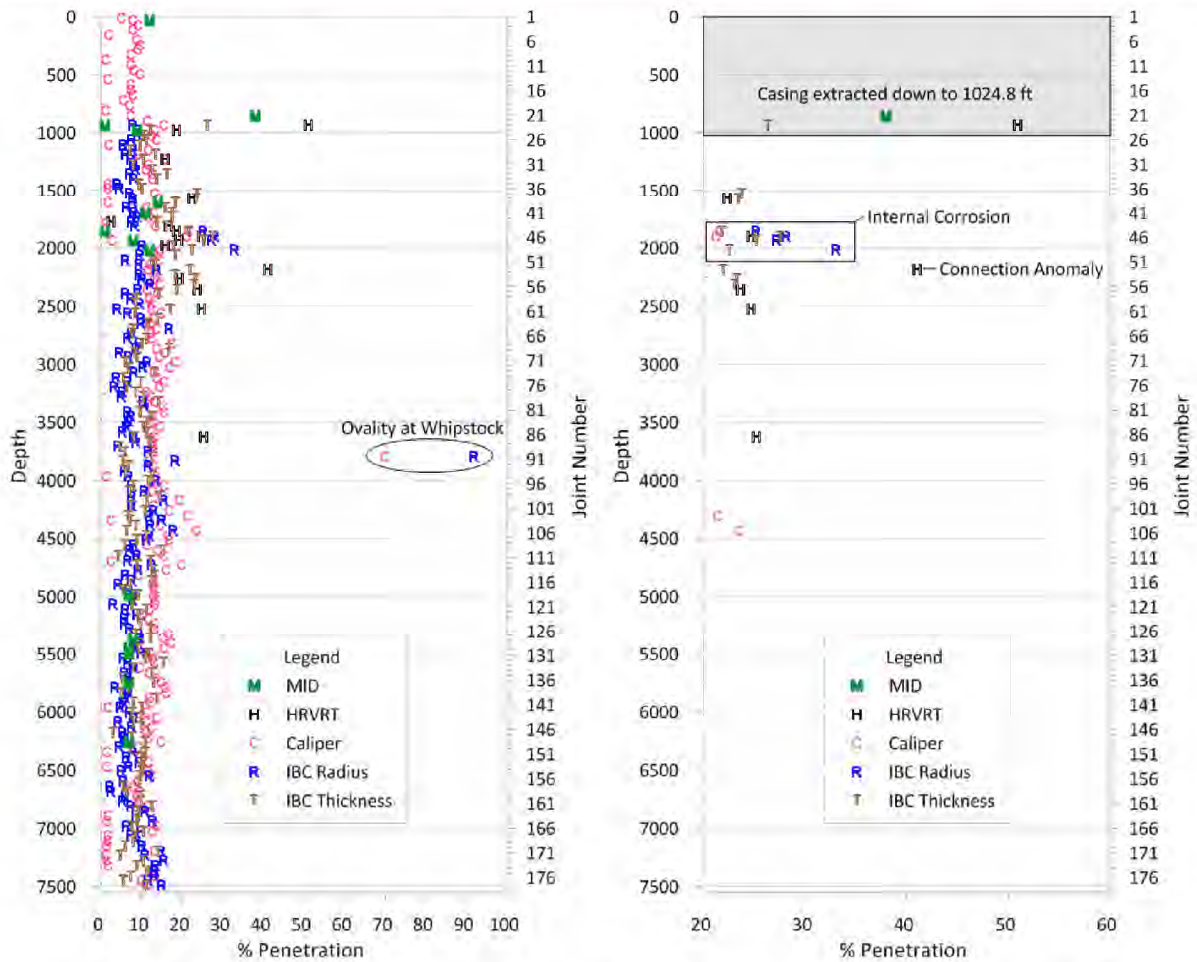
Figure 9 shows the metal loss features observed for the 7 in. casing for surface to 7,500 ft. The logs used were HRVRT, caliper, MID-2, MID-3, and the Isolation Scanner. The x axis is the percentage of penetration into the nominal casing wall thickness. For example, the nominal casing wall thickness for 7 in. 23 lb/ft is 0.317 in., and a 10% penetration would be a defect that extended into the wall thickness by 0.0317 in. The figure also shows the deepest defect for each joint. Most of the defects observed were less than 20%. The left graph shows 0–100% while the right graph shows 20-60%. The features annotated on the figure are discussed in detail in this section.

Figure 9: 7 in. Casing Defects by Depth, Joint Number, and Percent Penetration

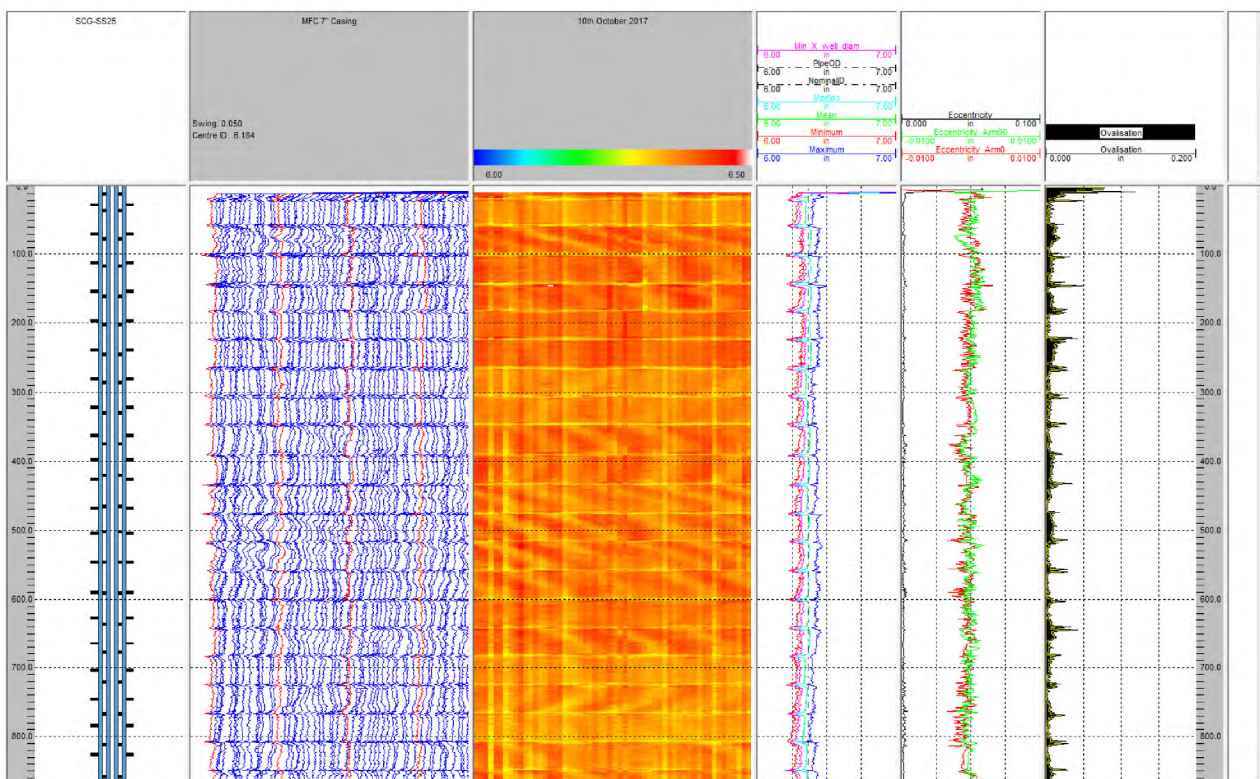
Figure 10 shows the caliper data for the 7 in. casing from surface to 866 ft. The right track is ovalization (in black) displayed in inches and is the half of the maximum ID minus the minimum ID. The EV-Epidote software calculated ovalization using the caliper data for the 7 in. casing and, aside from the whipstock location at ~3,830 ft (Figure 11, Figure 12), found a range of ovality of 1–2%<sup>ii</sup>. The ovality in the area around the whipstock was 6%, which in our interpretation was expected.

Figure 10: 7 in. Caliper Summary [7] to 866 ft

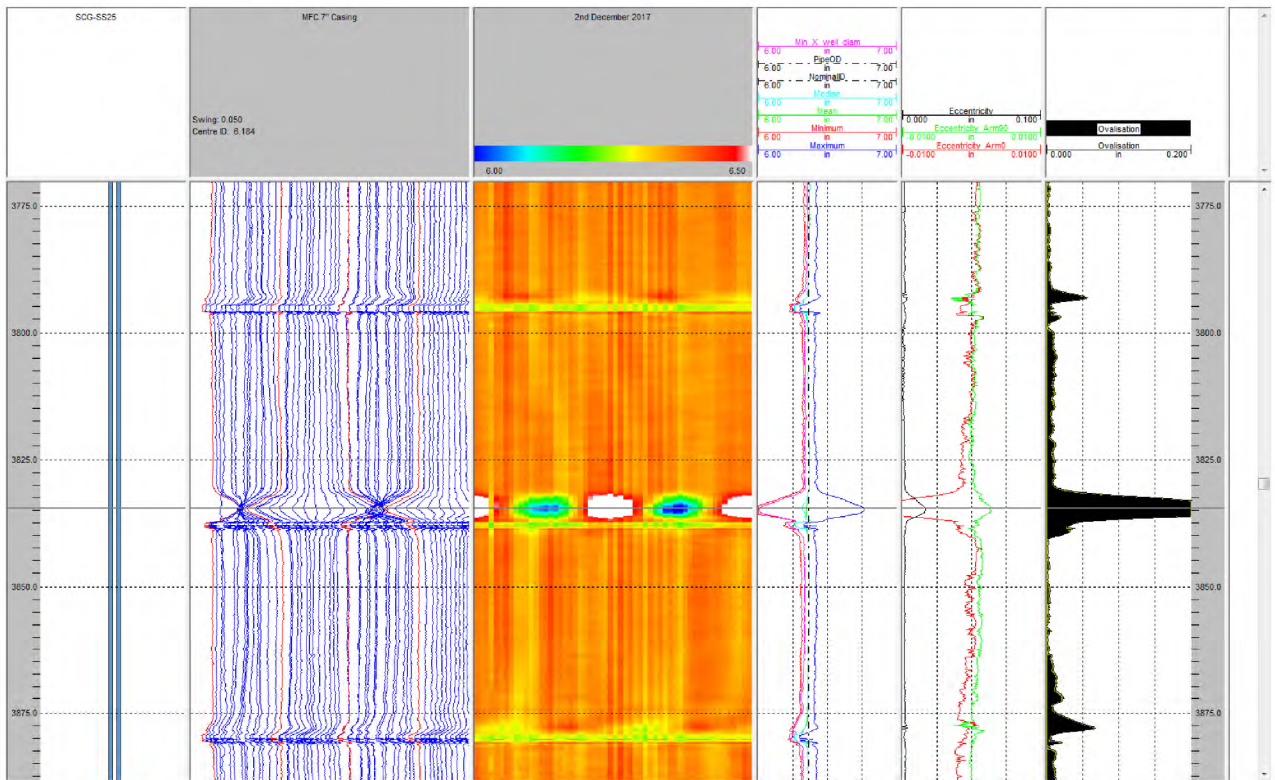
Figure 12: 7 in. Caliper Data [7] Showing Ovalization at 3,834 ft

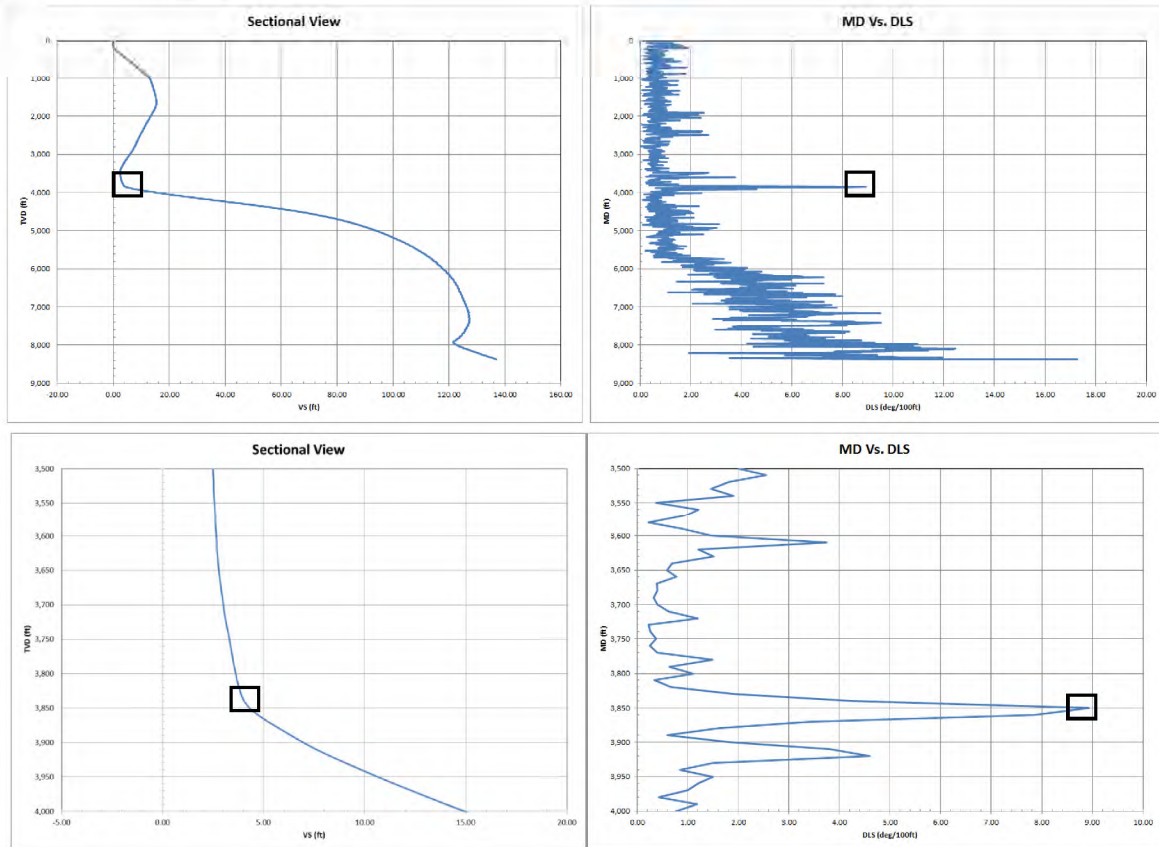
Figure 14 shows the well trajectory of SS-25. A large dogleg is located in the region of the whipstock and denoted with black boxes. We interpret the ovality observed in the 7 in. casing as being the result of the whipstock induced dogleg.

Figure 14: SS-25 Trajectory [8] (Whipstock Area in Black Box)

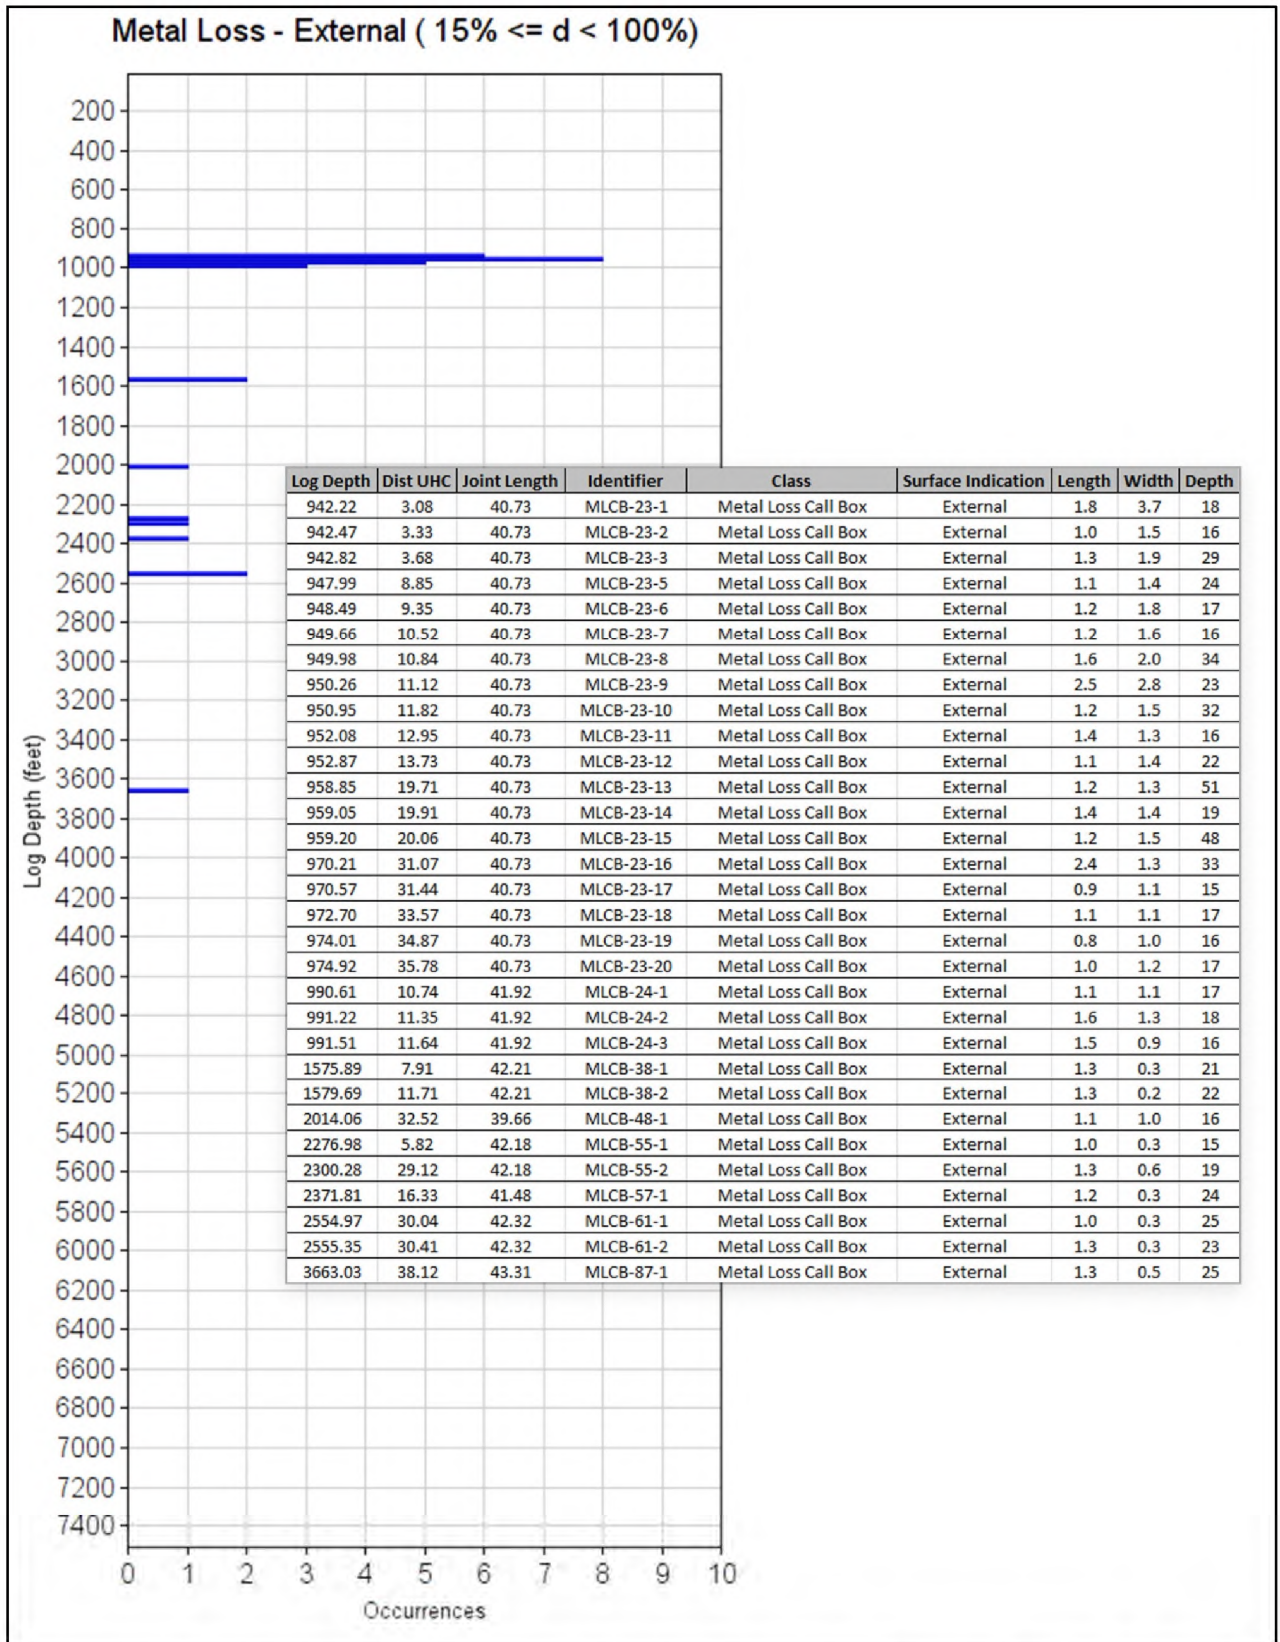
External corrosion in the 7 in. casing was also present in other locations. Figure 16 shows the location and dimensions of all the HRVRT external metal loss features that exceeded 15% penetration for the 7 in. casing between 939 and 7,500 ft. The depth vs. occurrence graphic and the inset table show an extensive external corrosion clustered above 1,000 ft.

Figure 16: 7 in. Summary of External Metal Loss by HRVRT [9]; Extracted Top 1,024 ft

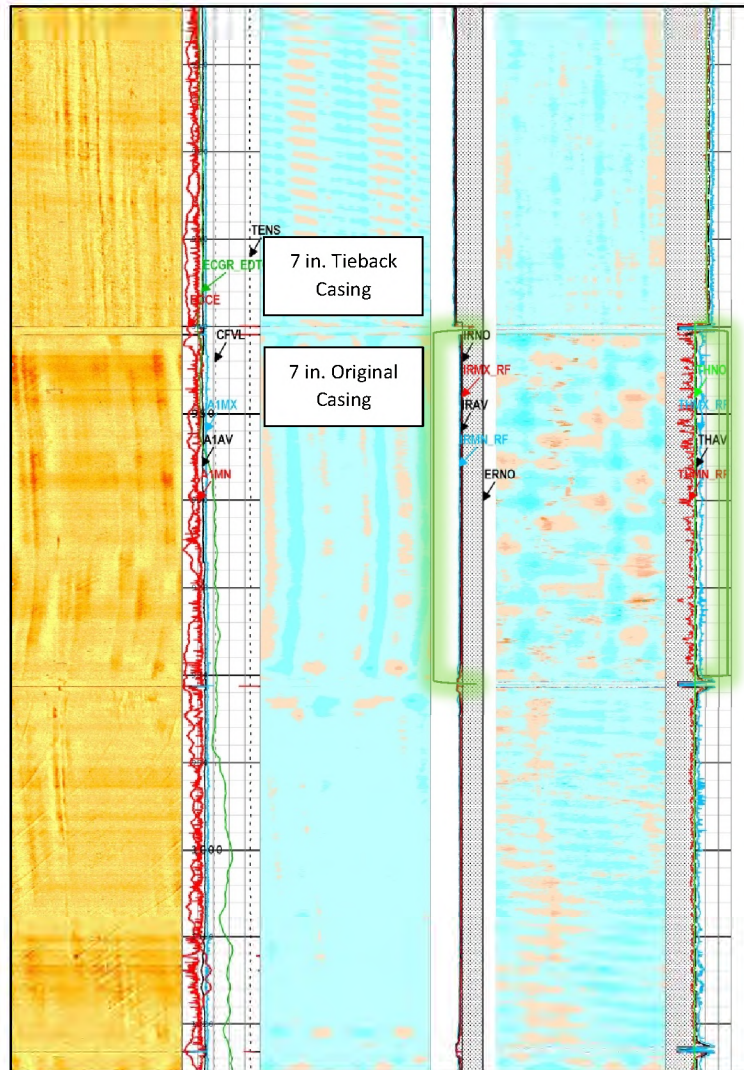
Figure 17 shows the UCI log at a depth range similar to Figure 15’s HRVRT log. The UCI log shows the same pattern of external corrosion on the joint beginning at 939 ft, like the HRVRT, but does not show the external corrosion on the joint beginning at 982 ft. In general, the ultrasonic logs (namely, UCI and IBC) agree very well with the HRVRT log in terms of position and severity of metal loss features.

**Figure 17: 7 in. UCI Log [10], December 2, 2017, External Corrosion at 939–980 ft - Green Bracket**

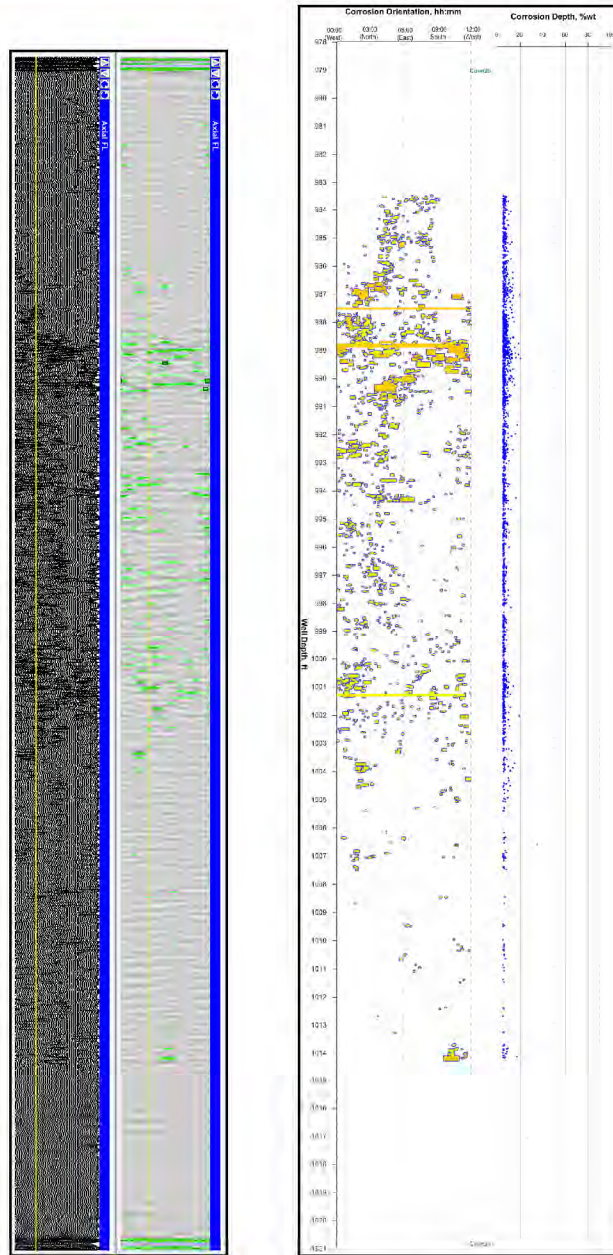
Two reports [1] [2] detail the severity, location, and type of corrosion observed in the extracted joints. Figure 18 shows just the 7 in. casing joint C026 observed by the HRVRT log (on the left) and Laser Scan (on the right). The HRVRT log was in situ; the Laser Scan data was acquired post-extraction. We observed a positive correlation in location and severity of features. One of the Laser Scan features at a depth of 1,006.5 ft approaches 40% penetration; this is a Cased Hole Dynamics Tester (CHDT) plug and was not present during the HRVRT logging.

Figure 18: 7 in. Casing Joint 26, HRVRT [9] Flux Leakage Tracks (left), Laser Scan (right)

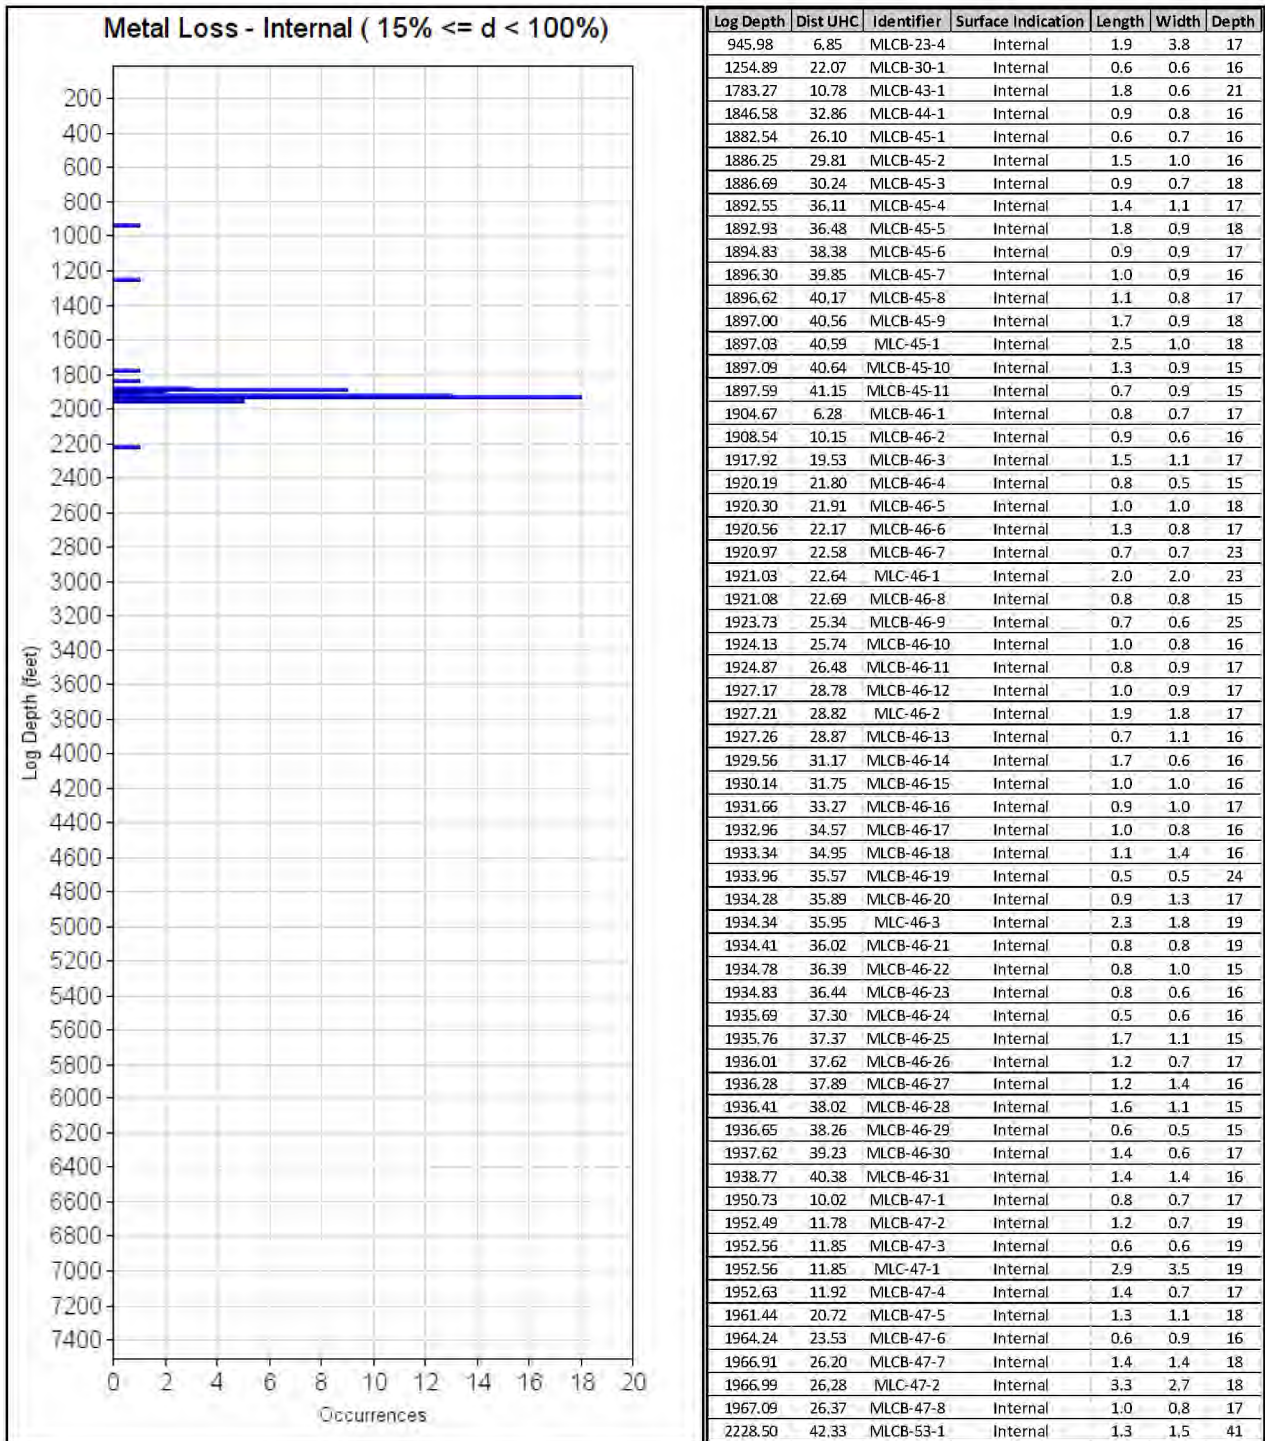
Figure 19 shows the location and listing of the 61 internal metal loss features observed in the HRVRT log. The range of penetration was 15–41%. Most of the defects (56 out of 61) were concentrated in a 200 ft zone centered at ~1,900 ft. For this zone, there is good agreement between the HRVRT, caliper, and Ultrasonic logs in regards to penetration; the range was 16–28%. Other areas of internal corrosion were present but isolated (not clustered), infrequent, and of low penetration. One notable exception was the internal defect at 2,228.5 ft—the HRVRT log found that it had a penetration of 41%. This defect was observed neither in the caliper, UCI, and IBC logs nor in the video imaging.

Figure 19: 7 in. HRVRT [9] Summary of Internal Corrosion

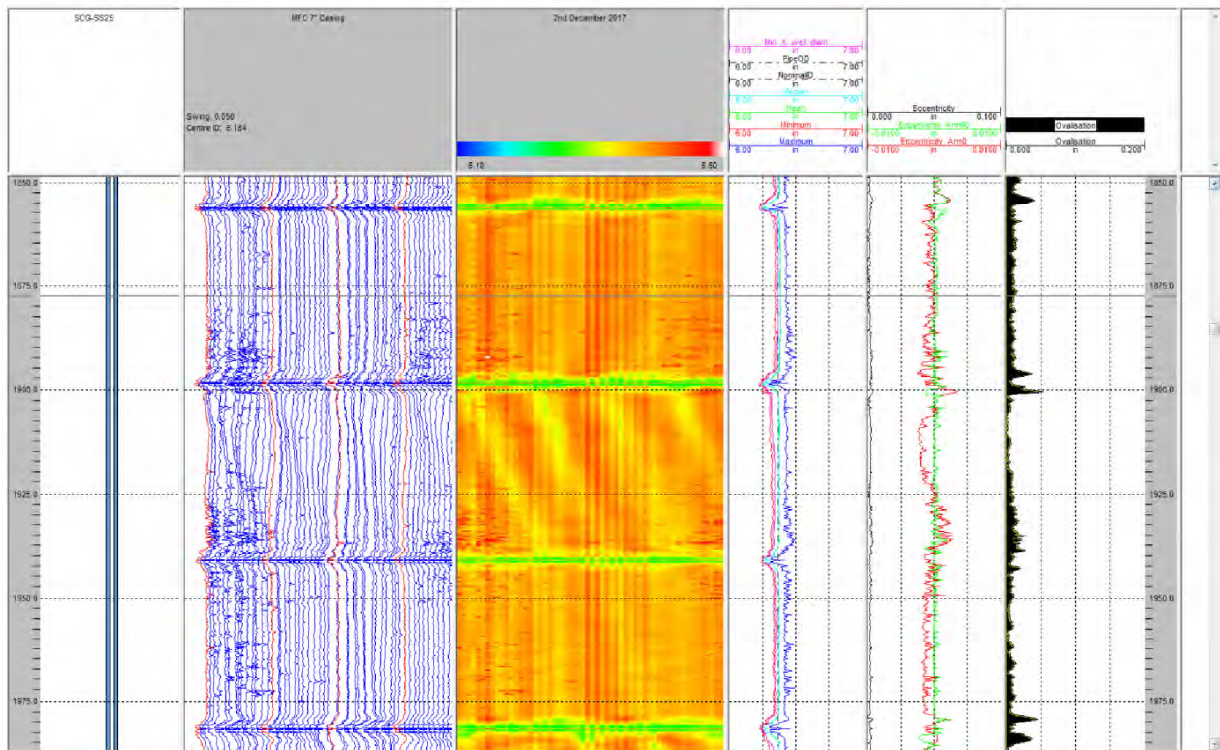
Figure 20 shows the 7 in. casing joints—the worst three joints with internal metal loss found by the caliper log at the depths of 1,840–2,010 ft. The graphic shows that the defects were clustered and vertically oriented on or about the same clock position. Figure 21 shows HRVRT log with the same depth range of Figure 20. The ultrasonic logs are not shown here, but the caliper, HRVRT, and ultrasonic logs all show the same pattern of internal metal loss.

Figure 20: 7 in. Caliper Log [7] Showing Internal Corrosion at 1,850–1,985 ft
