**Blade Supplemental Report (Vol. 2: SS-25 Well Failure Causes)**

# Root Cause Analysis of the Uncontrolled Hydrocarbon Release from Aliso Canyon SS-25

May 31, 2019

# SS-25 Casing Failure Analysis

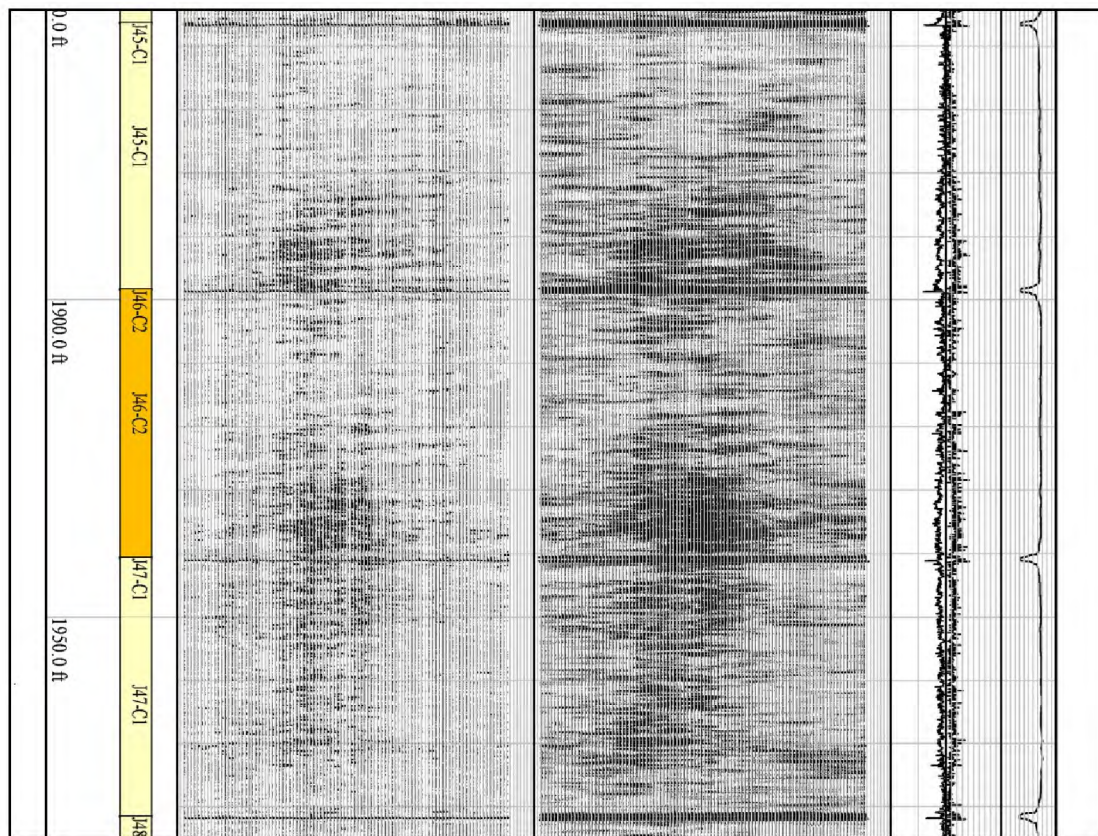
Figure 20 shows the 7 in. casing joints—the worst three joints with internal metal loss found by the caliper log at the depths of 1,840–2,010 ft. The graphic shows that the defects were clustered and vertically oriented on or about the same clock position. Figure 21 shows HRVRT log with the same depth range of Figure 20. The ultrasonic logs are not shown here, but the caliper, HRVRT, and ultrasonic logs all show the same pattern of internal metal loss.

Figure 21: 7 in. HRVRT [9] Log Showing Internal Corrosion at 1,850–1,985 ft

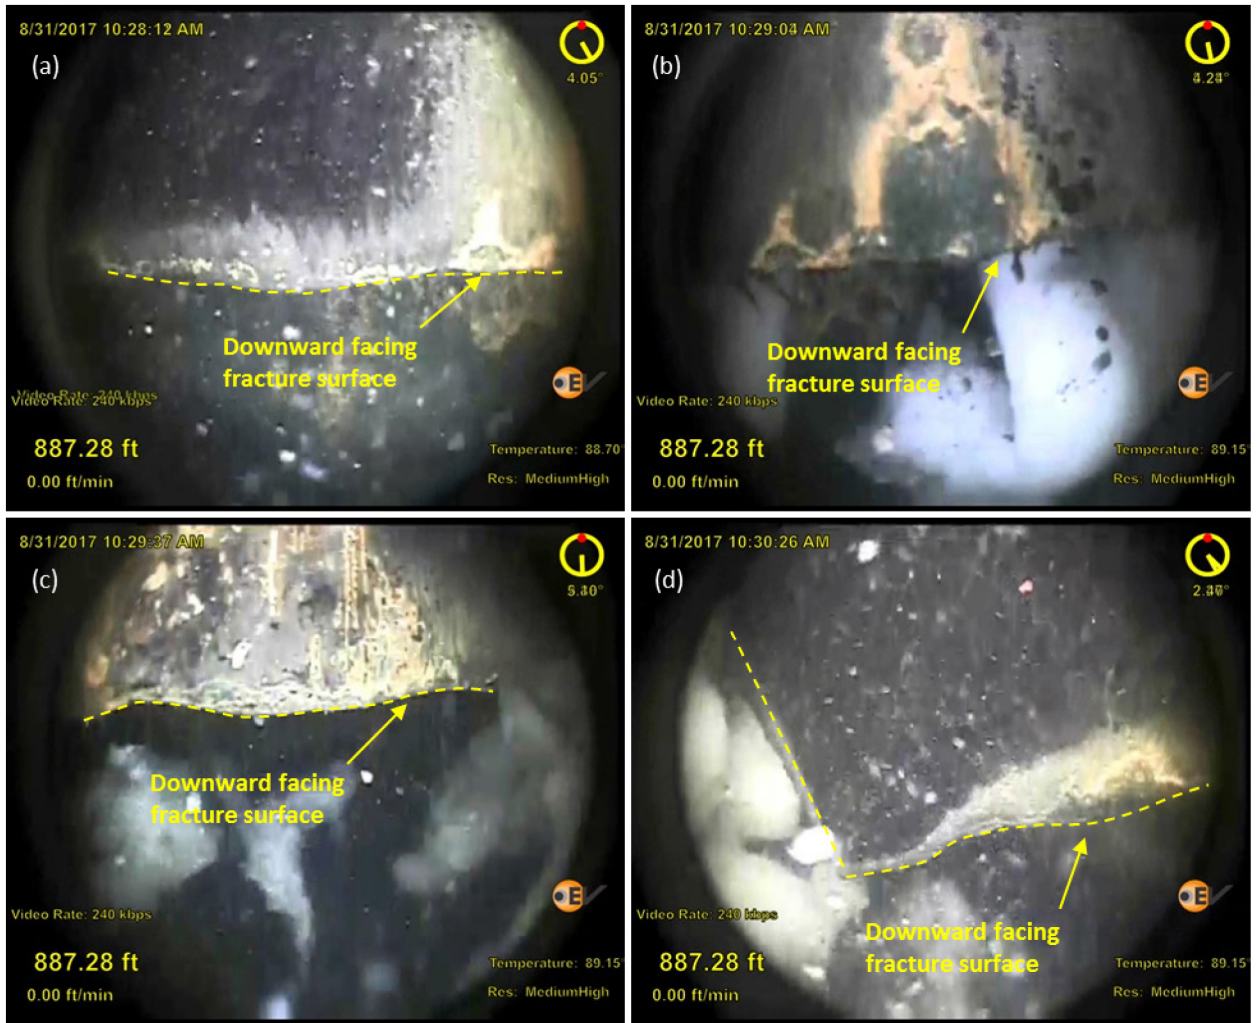
Figure 24, Figure 25, and Figure 26 show the 7 in. casing failure as seen by the video imaging of August 31, 2017. The 7 in. casing was found to have completely parted at 892 ft near the base of joint number 22. The distance between the upper and lower parted sections was approximately 5 in. Additional images of the 7 in. casing failure can be found in Appendix B.

Figure 25: Video Imaging from August 31, 2017, Parted 7 in. Casing (Upper Portion)

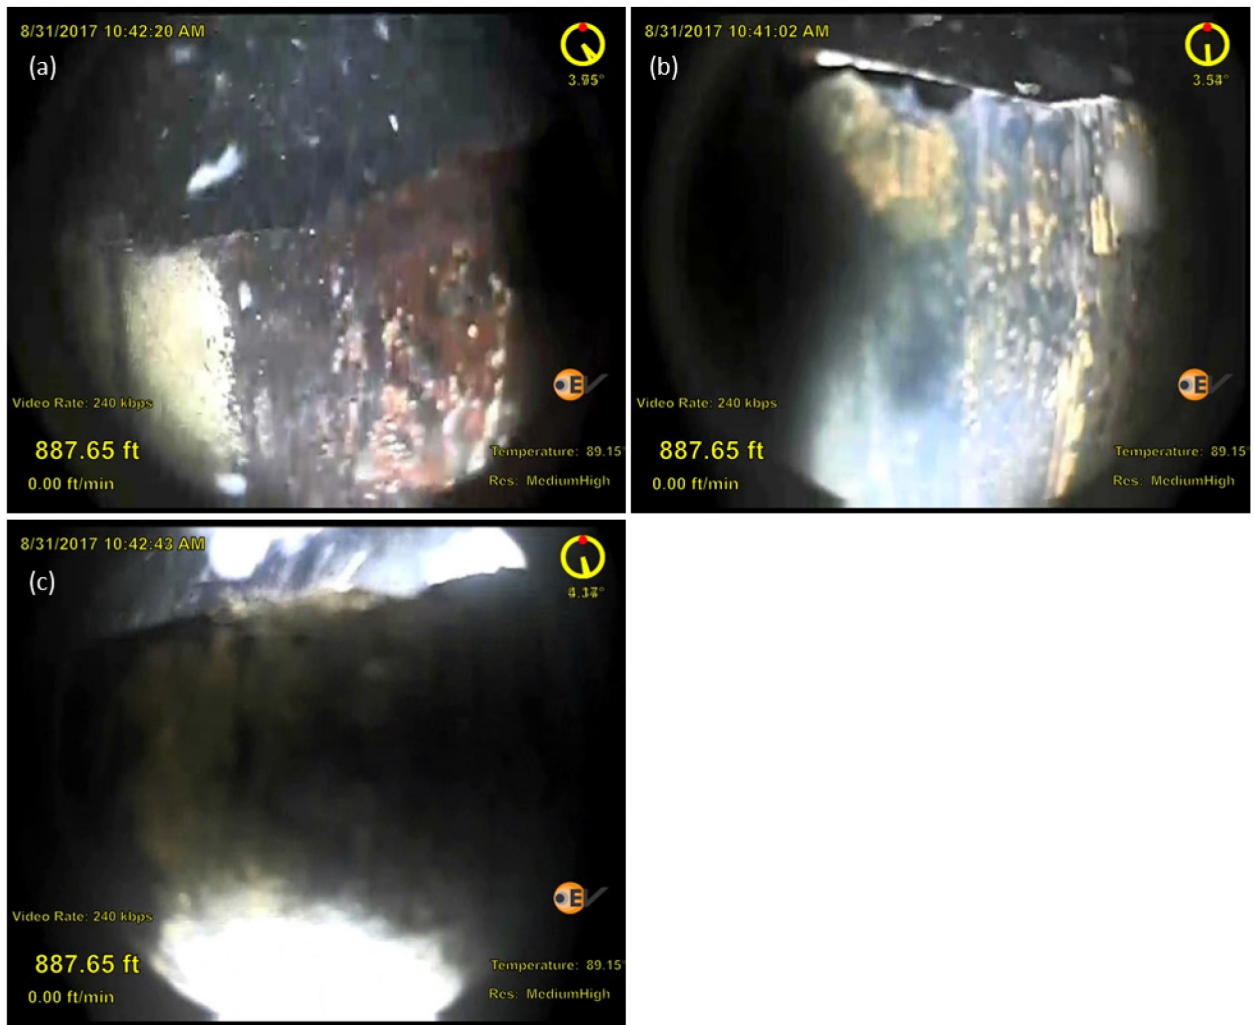
Figure 26: Video Imaging from August 31, 2017, Parted 7 in. Casing (Lower Portion)

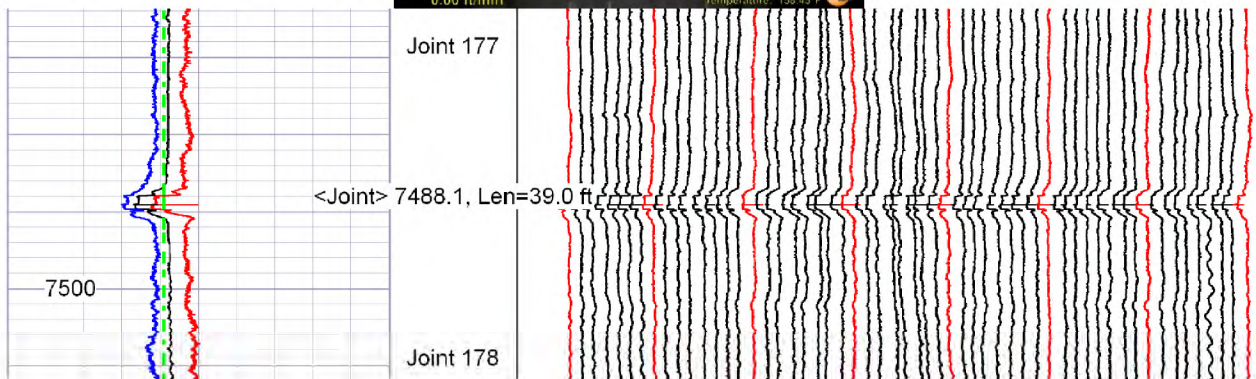
The fluid clarity was mostly good but at times poor, which may have obscured some features; even with poor clarity, we were able to observe over 60 connections. There were minor defects that appeared to be small pits or gouges near some connections; the most common location of the defects was where the pin nose met the box. No visible threads were observed. There were no indications of a connection leak (e.g., washout or erosion). The surface condition was generally good and agreed well with the logging data. Figure 27 shows an example of a 7 in. connection as captured by video imaging—connection 177 at 7,488.1 ft. This connection is a representative example because it shows small gouges, no visible threads, and no indication of a leak. The lower portion of the figure shows a portion the caliper log for the same connection. The connections were slightly smaller in diameter than the pipe body. The mean pipe ID for joint 177 was 6.282 in. while the mean ID at the connection was 6.208 in.—a difference of 0.074 in. We interpreted that the connections defects were, in most cases, gouges at the connections related to the passage of bits, mills, scrapers, packers, and other tools.

Figure 27: December 11, 2017 EV Camera (Images Above) and December 2 Caliper Log (Bottom), 7 in. Casing Connection 177 at 7,488.1 ft, Minor Gouges

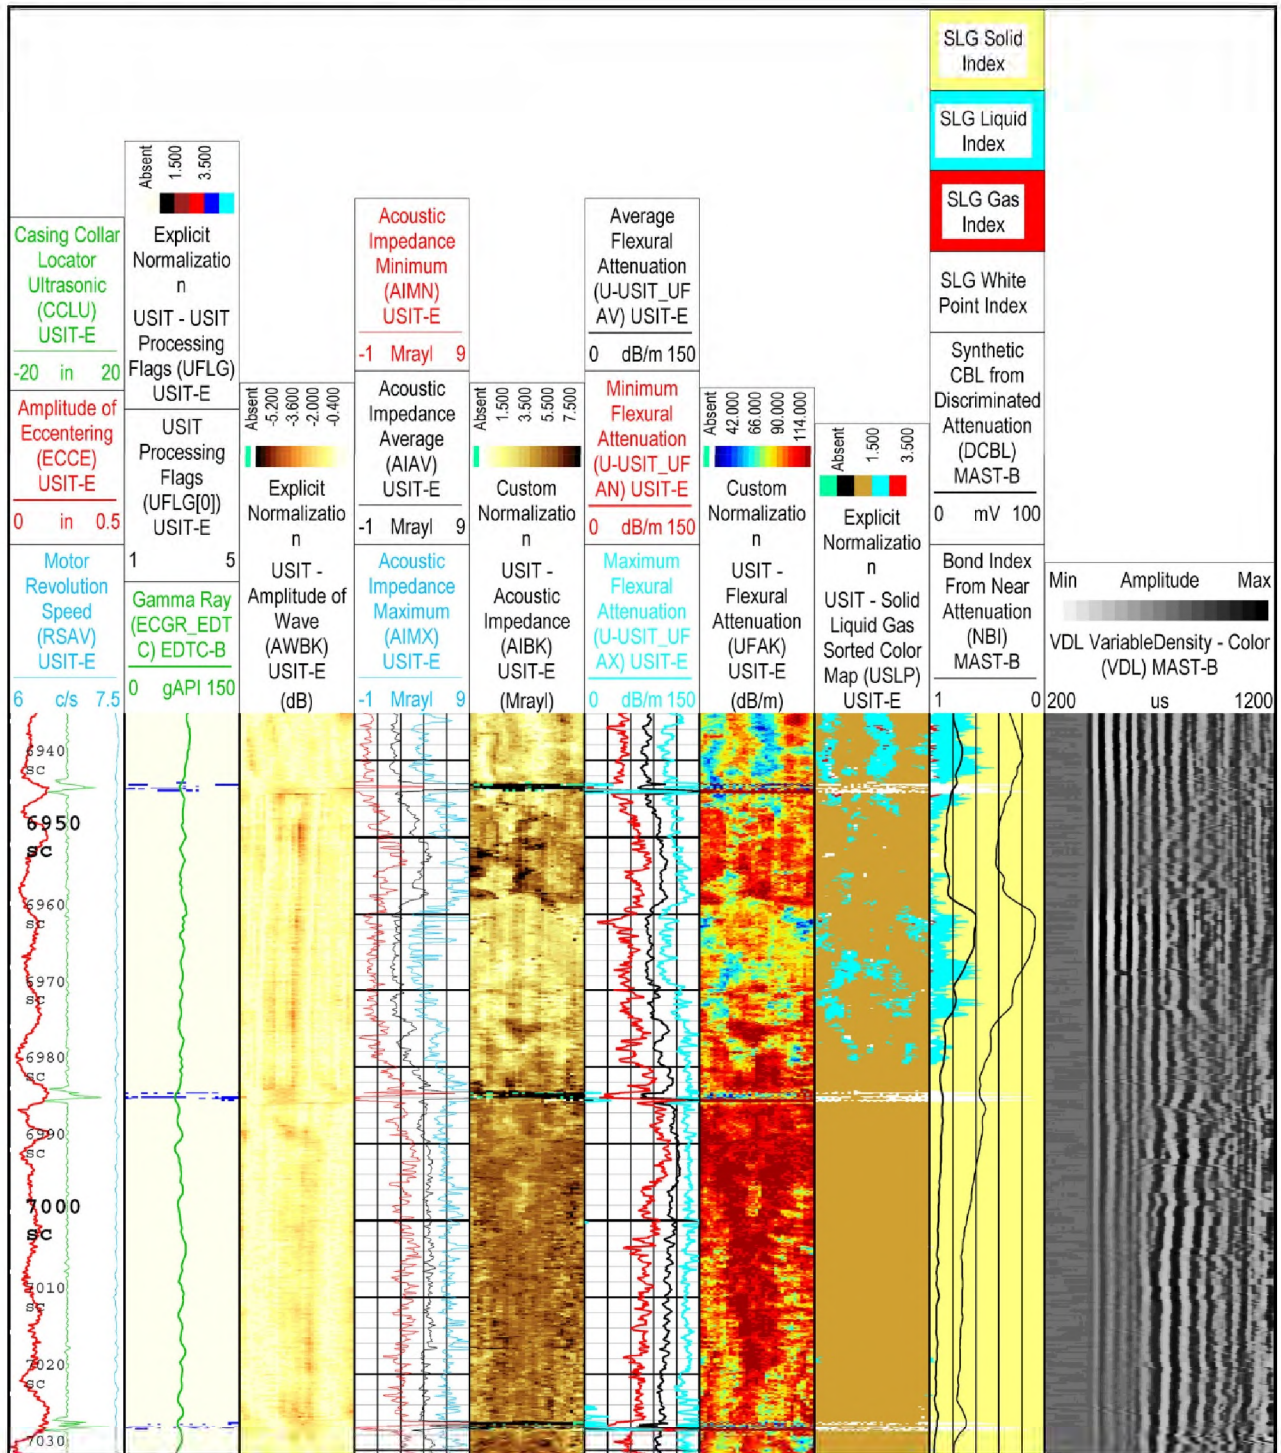
Figure 30 shows the Isolation Scanner log for 6,940–7,030 ft. Schlumberger interpreted that the cement top in the 7 in. annulus was at 6,980 ft, and we concurred. After the initial cementing of the 7 in. casing in

Figure 30: 7 in. IBC and CBL [10] Log Showing Top of Cement at 6,980 ft

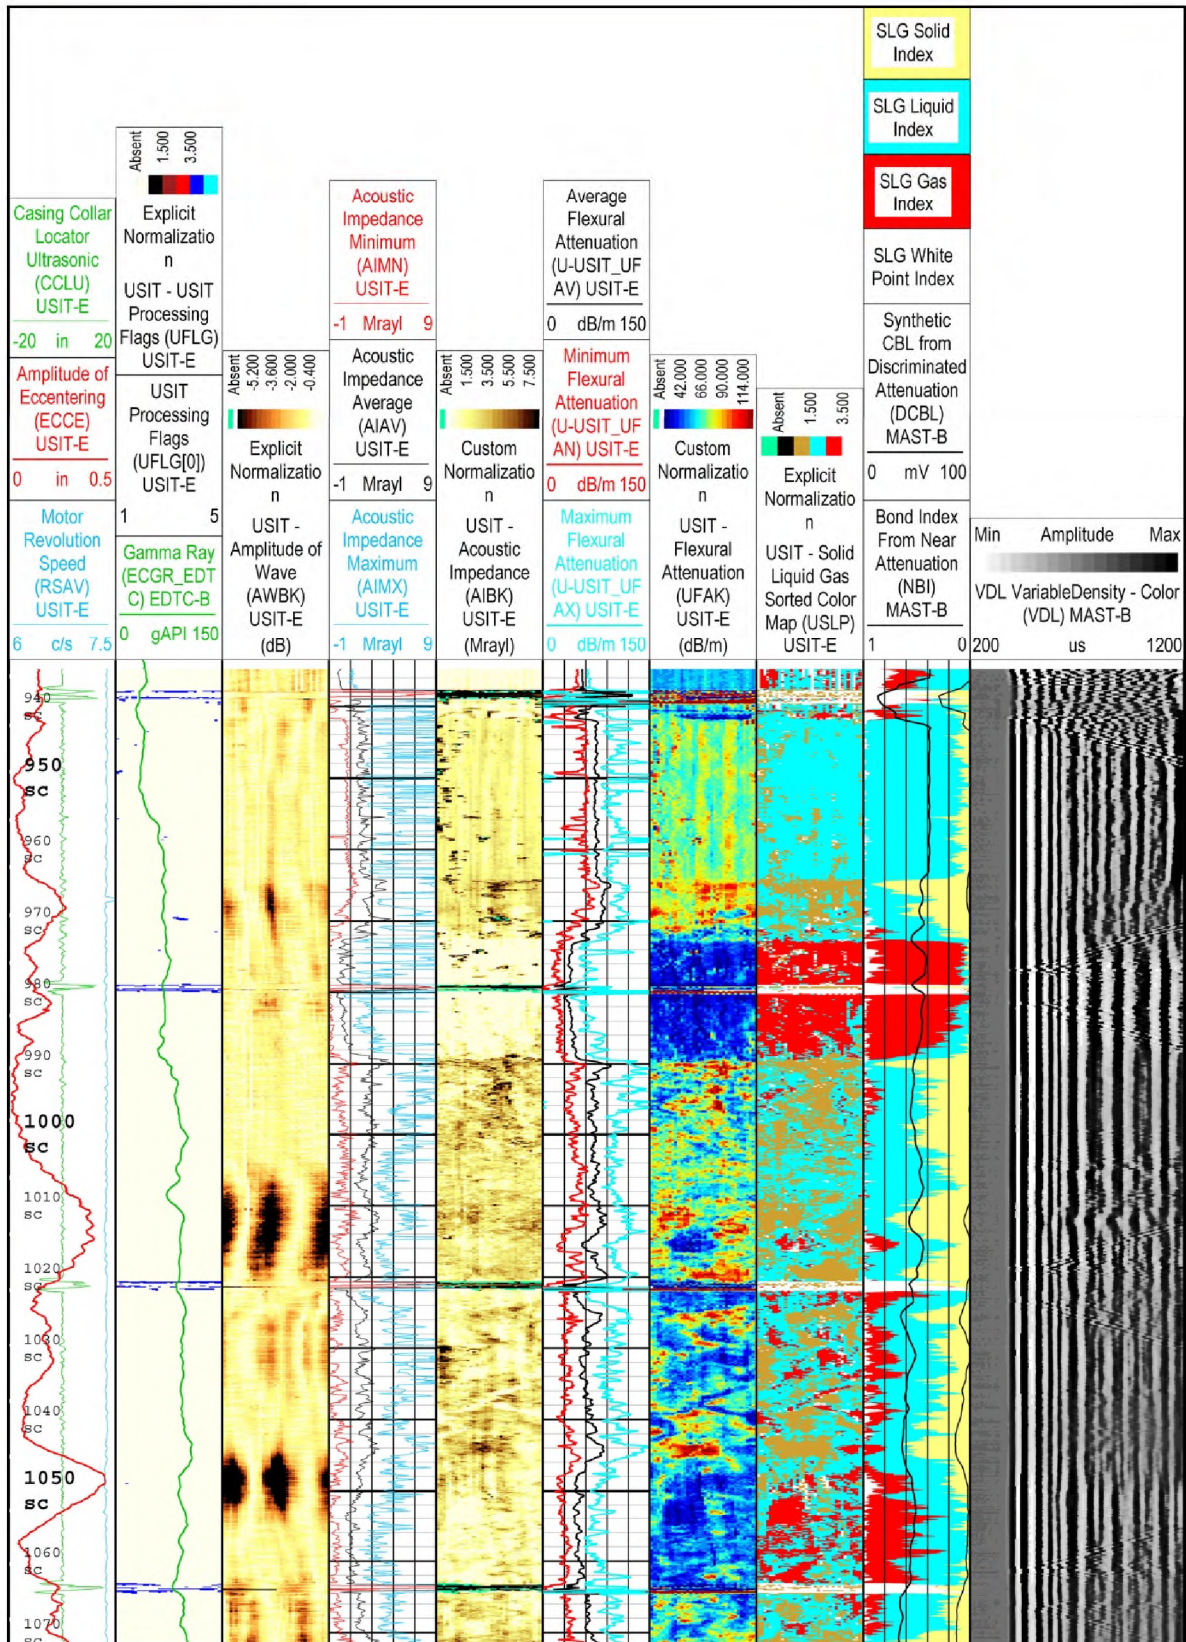
Figure 31 shows that this annulus was logged as a combination of solids, liquids, and gases (second track from right to left: light blue, red, and yellow).

Figure 31: 7 in. IBC and CBL [10] Log Showing Annulus Condition 940–1,070 ft

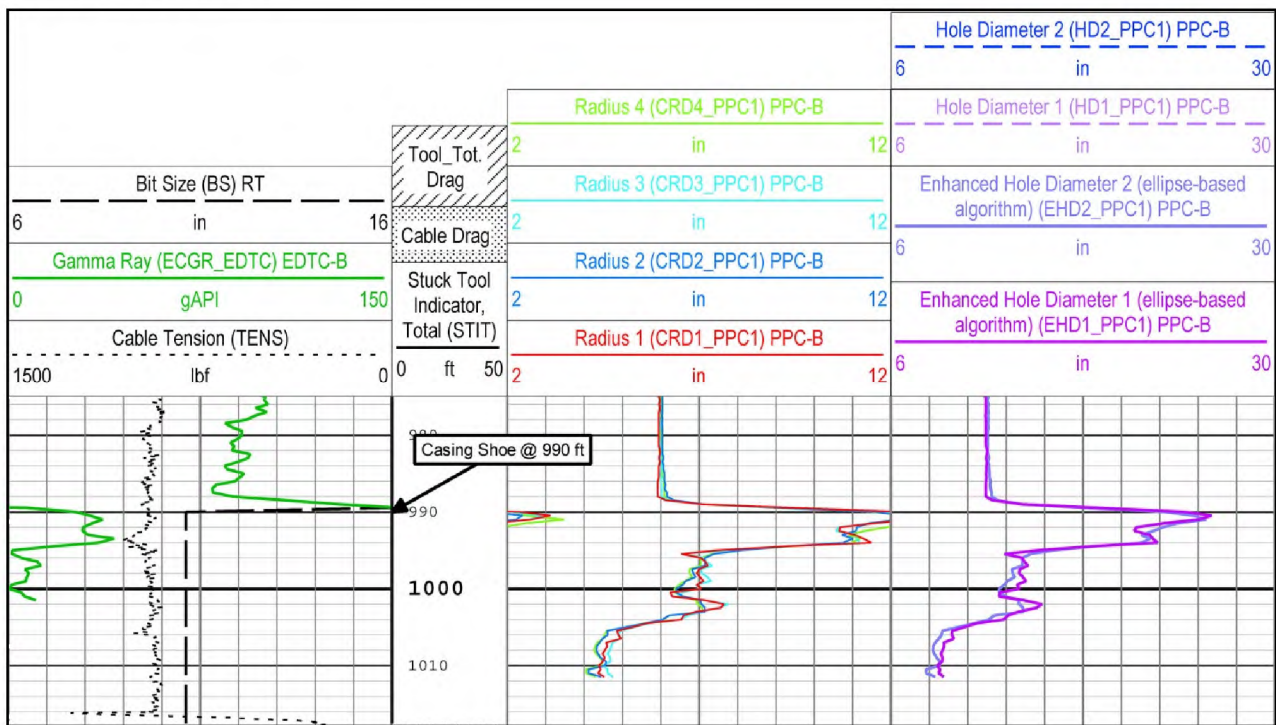
Figure 32 shows the caliper log, which identified a 24–26 in. diameter area at 990–994 ft directly below the 11 3/4 in. surface casing shoe, which is denoted by the black arrow and annotation. The Formation Microresistivity Imager (FMI) also confirmed the diameter. In 1953, when the original openhole was drilled, the hole diameter was reported as 16 in. down to 990 ft and 10 5/8 in [12]. thereafter. The 24–26 in. observed was much greater than both the original openhole diameters; we could not ascertain if this hole enlargement was related to drilling and cementing operations from 1953, or related to the October 23, 2015 blowout. Additional observations on the FMI log regarding conductive fractures are found in the Hydrology report [14].

**Figure 32: 4-Arm Caliper [15] Log, 940–1,070 ft**

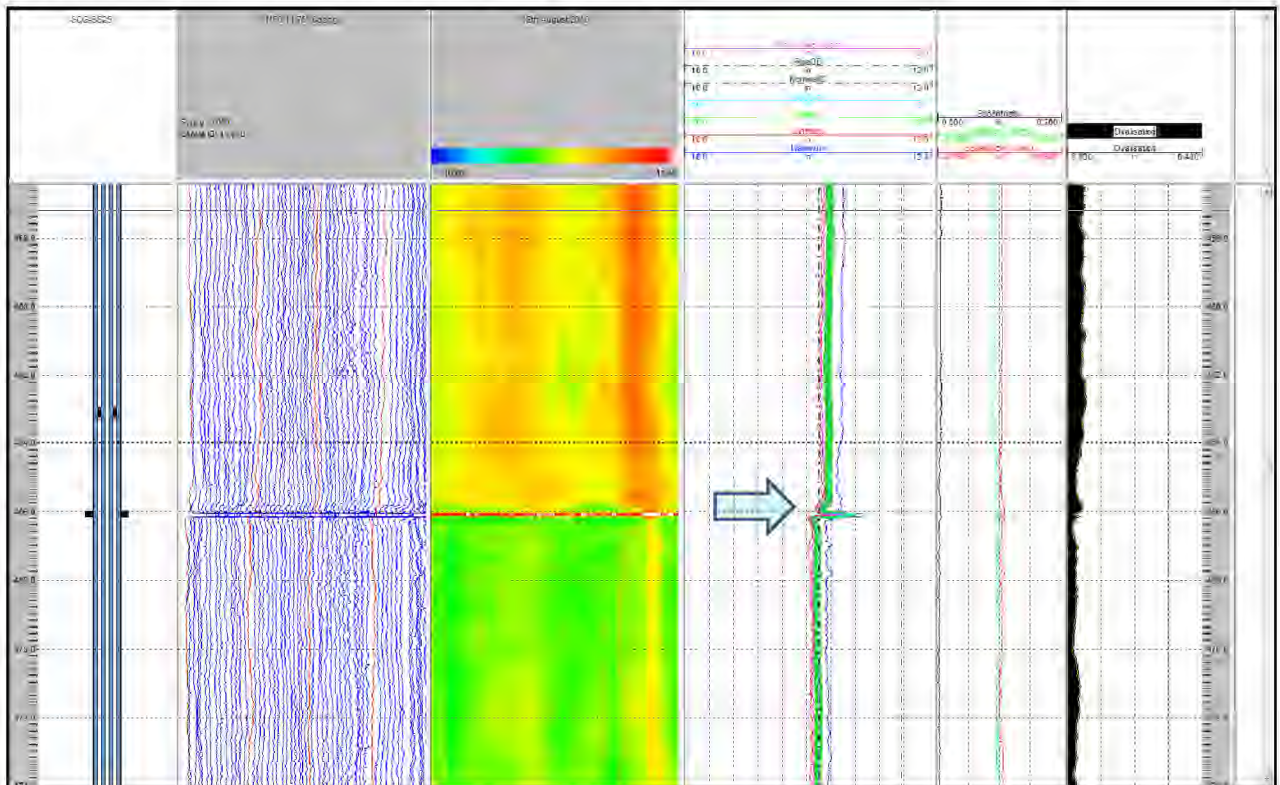
The 11 3/4 in. caliper log shows three joints (namely 1, 13, 25) that may have been a heavier weight casing than the 42 lb/ft reported during the original drilling and completion records. Figure 33 shows what the heavier weight casing looked like on the 11 3/4 in. caliper log. At a depth of ~466 ft, the mean ID (green highlighted line) reduced from joint 12 (above) to joint 13 (below). Our interpretation was that this reduction in ID was indicative of a casing weight change.

**Figure 33: 11 3/4 in. Caliper Log, Mean Average ID Changes (Green Line) Joints 12–13 (Arrow)**

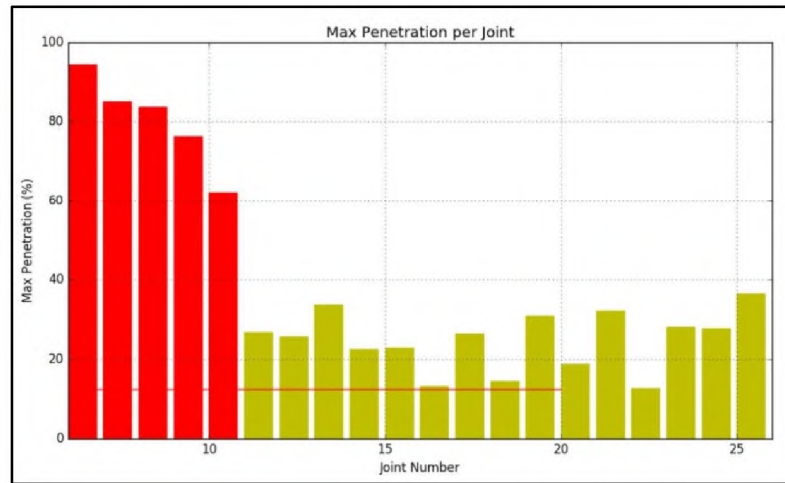
Figure 35 shows the maximum penetration by wall thickness for the 11 3/4 in. joints 6–25. The deepest wall thickness penetration occurred in joints 6–10; the deeper joints did not show the same level of penetration. Figure 36 shows an example of a location of isolated external corrosion on joint 17. Schlumberger reported that the deepest penetration was approximately 26%; the magnitude was much lower than the one shown in joints 6–10 (Figure 34).

Figure 35: 11 3/4 in. IBC [17] Summary of Maximum Penetration by Wall Thickness for Joints 6–25

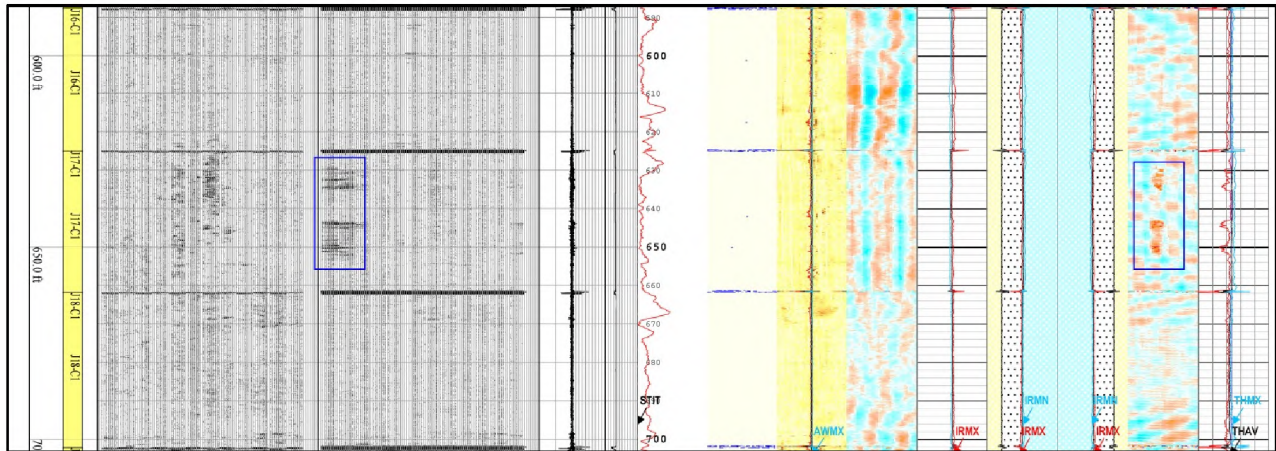
Figure 36: 11 3/4 in. HRVRT [16] and IBC [17] Log, Joints 16–18, Isolated External Corrosion at Joint 17 (Blue Box)

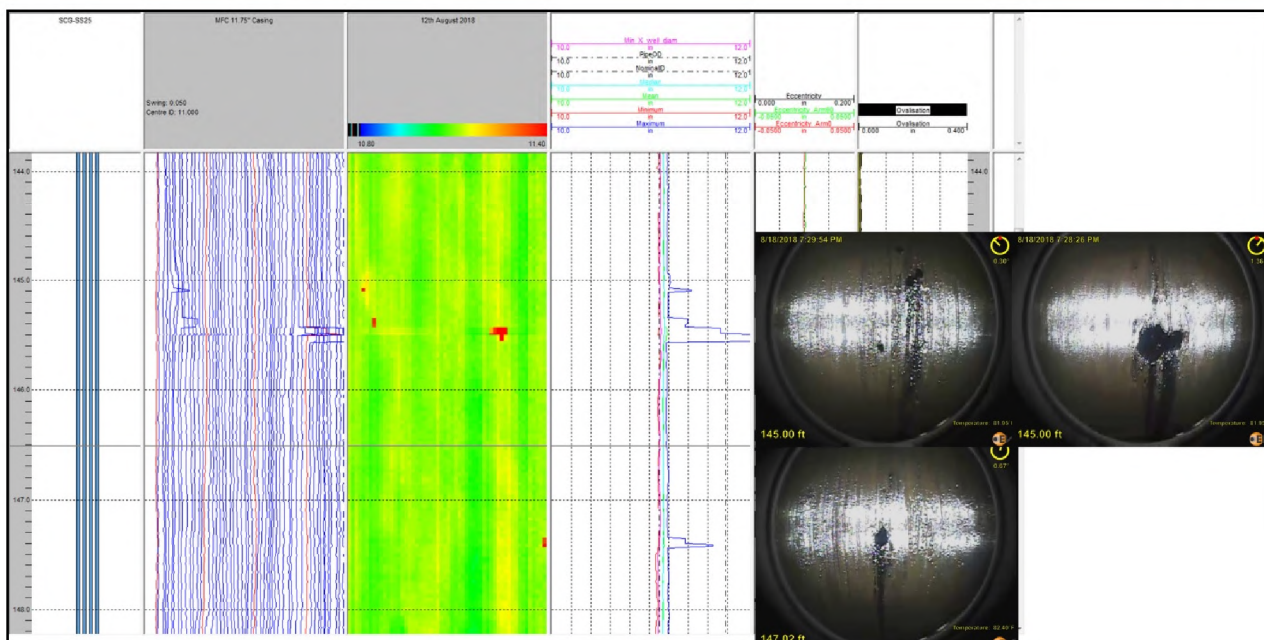
We observed the presence of holes in the 11 3/4 in. casing via the ultrasonic, MFL, caliper, and video imaging logs. The holes were observed from 134–300 ft in joints 4–8. Figure 37 shows the caliper log from 144–148 ft and video imaging at approximately 145 ft and 147 ft. The caliper log clearly shows the presence of holes in the second, third, and fourth tracks, further corroborated by the photographs from video imaging. We did not observe casing wear or pitting adjacent to the holes visually and using the caliper data. We used the caliper log to identify 58 holes; 50 holes were detected on joint 5 alone.

Figure 37: 11 3/4 in. Caliper Log [7] and Pictures from Video Imaging at 145 ft and 147 ft

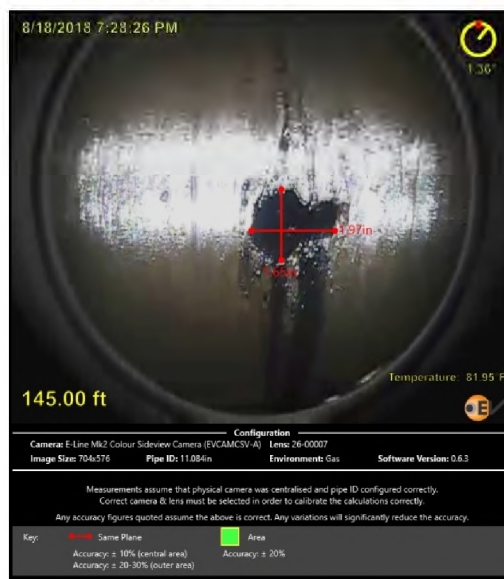
Figure 38 shows an example of a hole at 145 ft dimensioned for length and width. EV Camera provided dimensions for 24 holes. Appendices C.1 and C.3 contain additional images. There were holes through the wall thickness of the casing and what appeared to be a void or cavity extending behind the hole. For many of the holes, this visual observation was confirmed by the caliper fingers reading diameters of 14 in., which was the maximum diameter capability of the tool.

Figure 38: Picture of Hole in 11 3/4 in Casing with Dimensions from Video Imaging at 145 ft

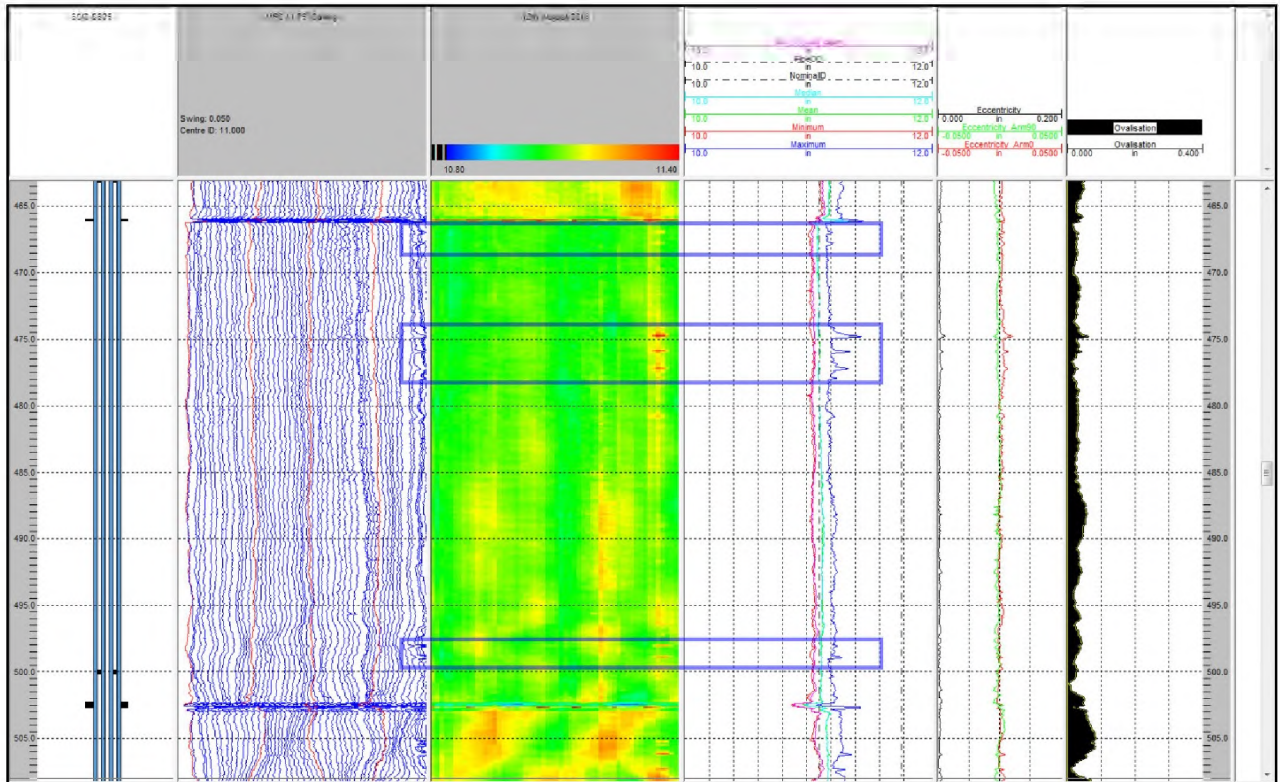
We concur with Schlumberger and Baker’s interpretation that internal metal loss was observed in many joints. But not all of the internal metal loss observed should be interpreted as internal pitting. Figure 39

and Figure 40 shows joint 13 with the internal metal loss feature highlighted in blue rectangles. Each rectangle is comprised of two, three, or four metal loss features that have uniform dimensions, regular spacing and are stacked vertically.

Figure 39: Caliper Log [7] Example of Internal Metal Features (Blue Rectangles) at 11 3/4 in. Joint 13

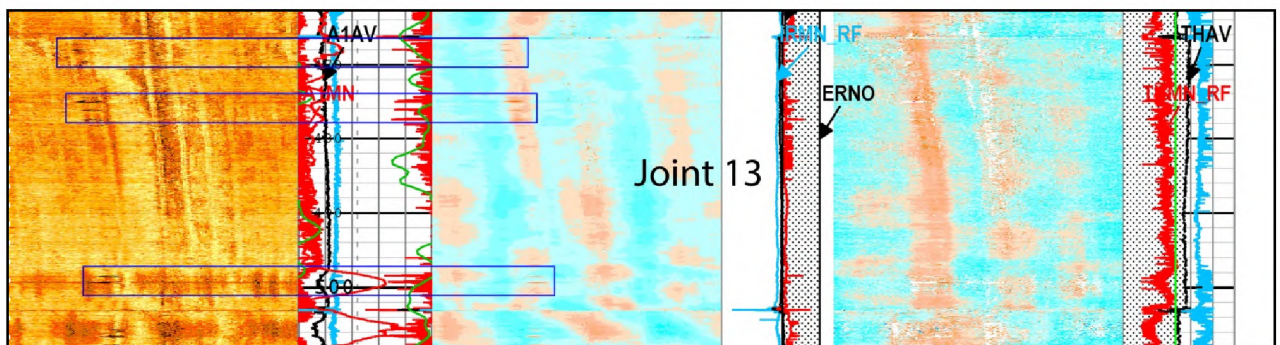
Figure 40: UCI Log [17] Example of Internal Metal Features (Blue Rectangles) at 11 3/4 in. Joint 13

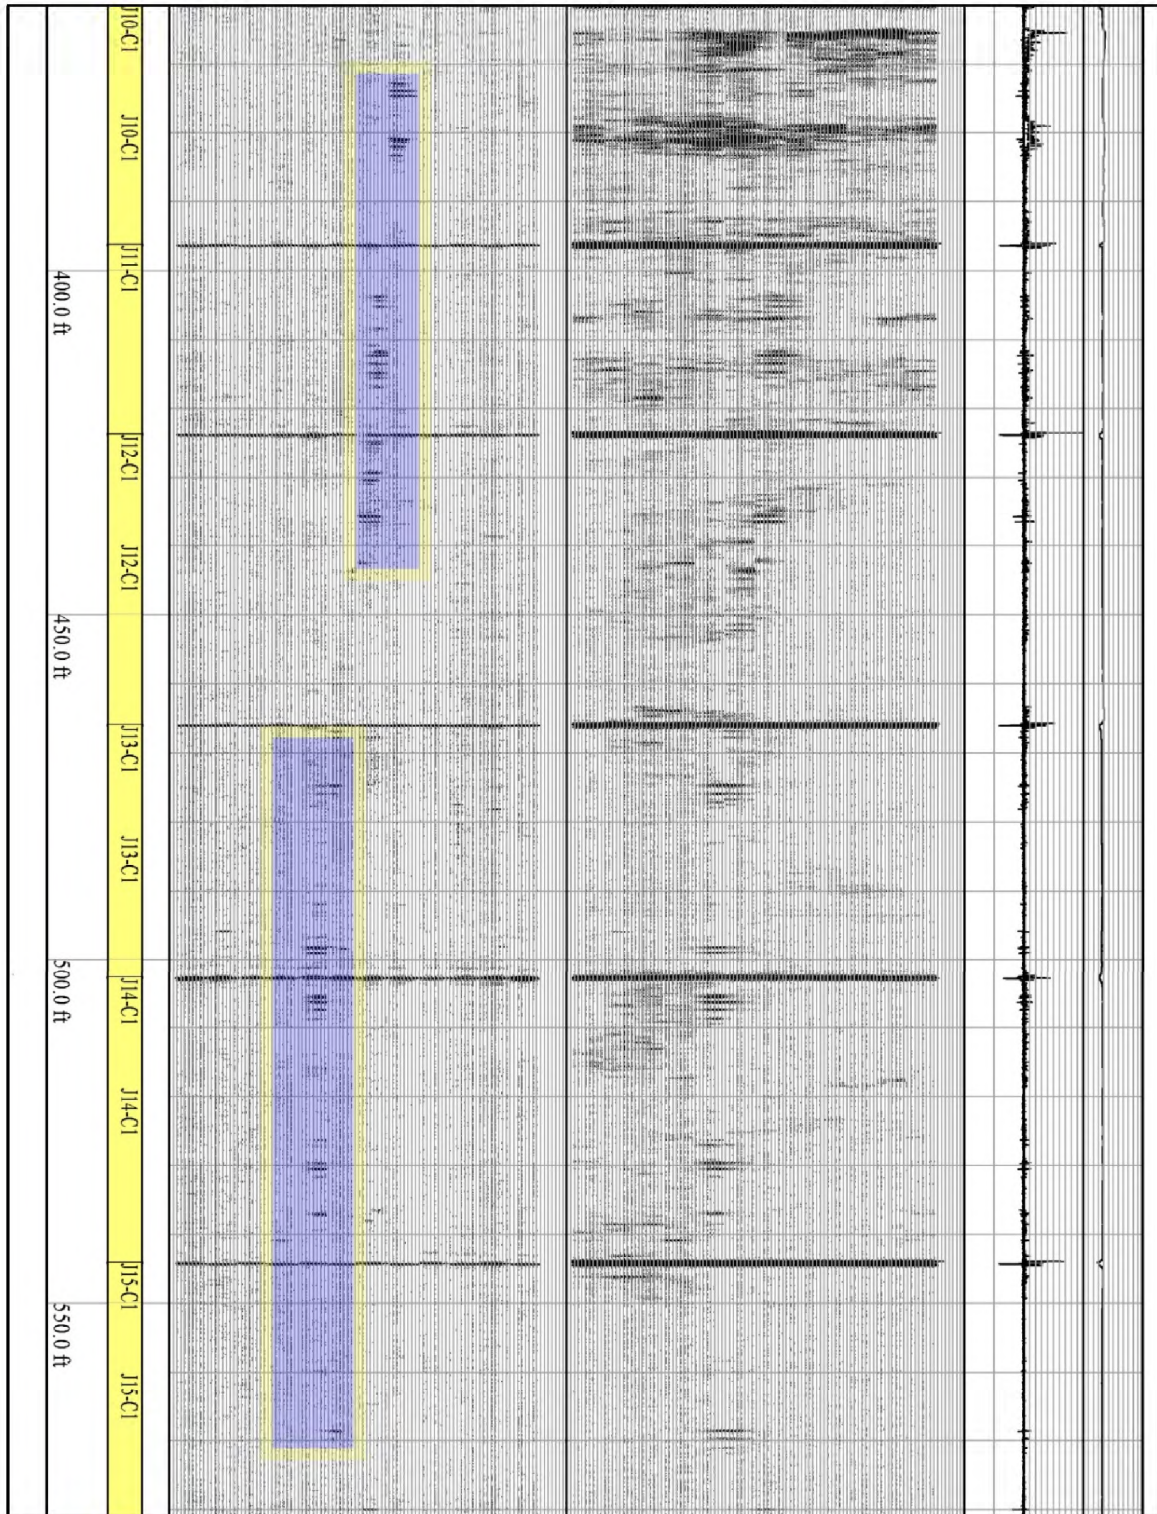
Figure 41 shows the HRVRT log for joints 10–15. Within the blue shaded rectangles are the uniform internal metal loss features. They are present on multiple joints at the same orientation, i.e., at the same clock position. Our interpretation is that if they were manufacturing related, it would be unlikely to see these features line up in the well so consistently. The uniform internal metal loss features are found almost exclusively in joints that have casing wear. Casing wear was expected to some degree considering that fishing operations, an openhole sidetrack, and approximately 6,000 ft of drilling operations were performed through the 11 3/4 in. casing. The drillpipe tool joints may have been hardbanded and caused these uniform metal loss features. Another possible explanation is the use of hardened slips (in packers,

bridge plugs, or similar service tools) imprinting their shape on the ID as the tools were set. This was discounted because no operations records of running these tools were found; if they had been run, the imprints would have likely had more circumferential characteristics than those observed.

Figure 41: HRVRT Log [16], Examples of Internal Metal Loss Features (Highlighted Blue), Joints 10–15

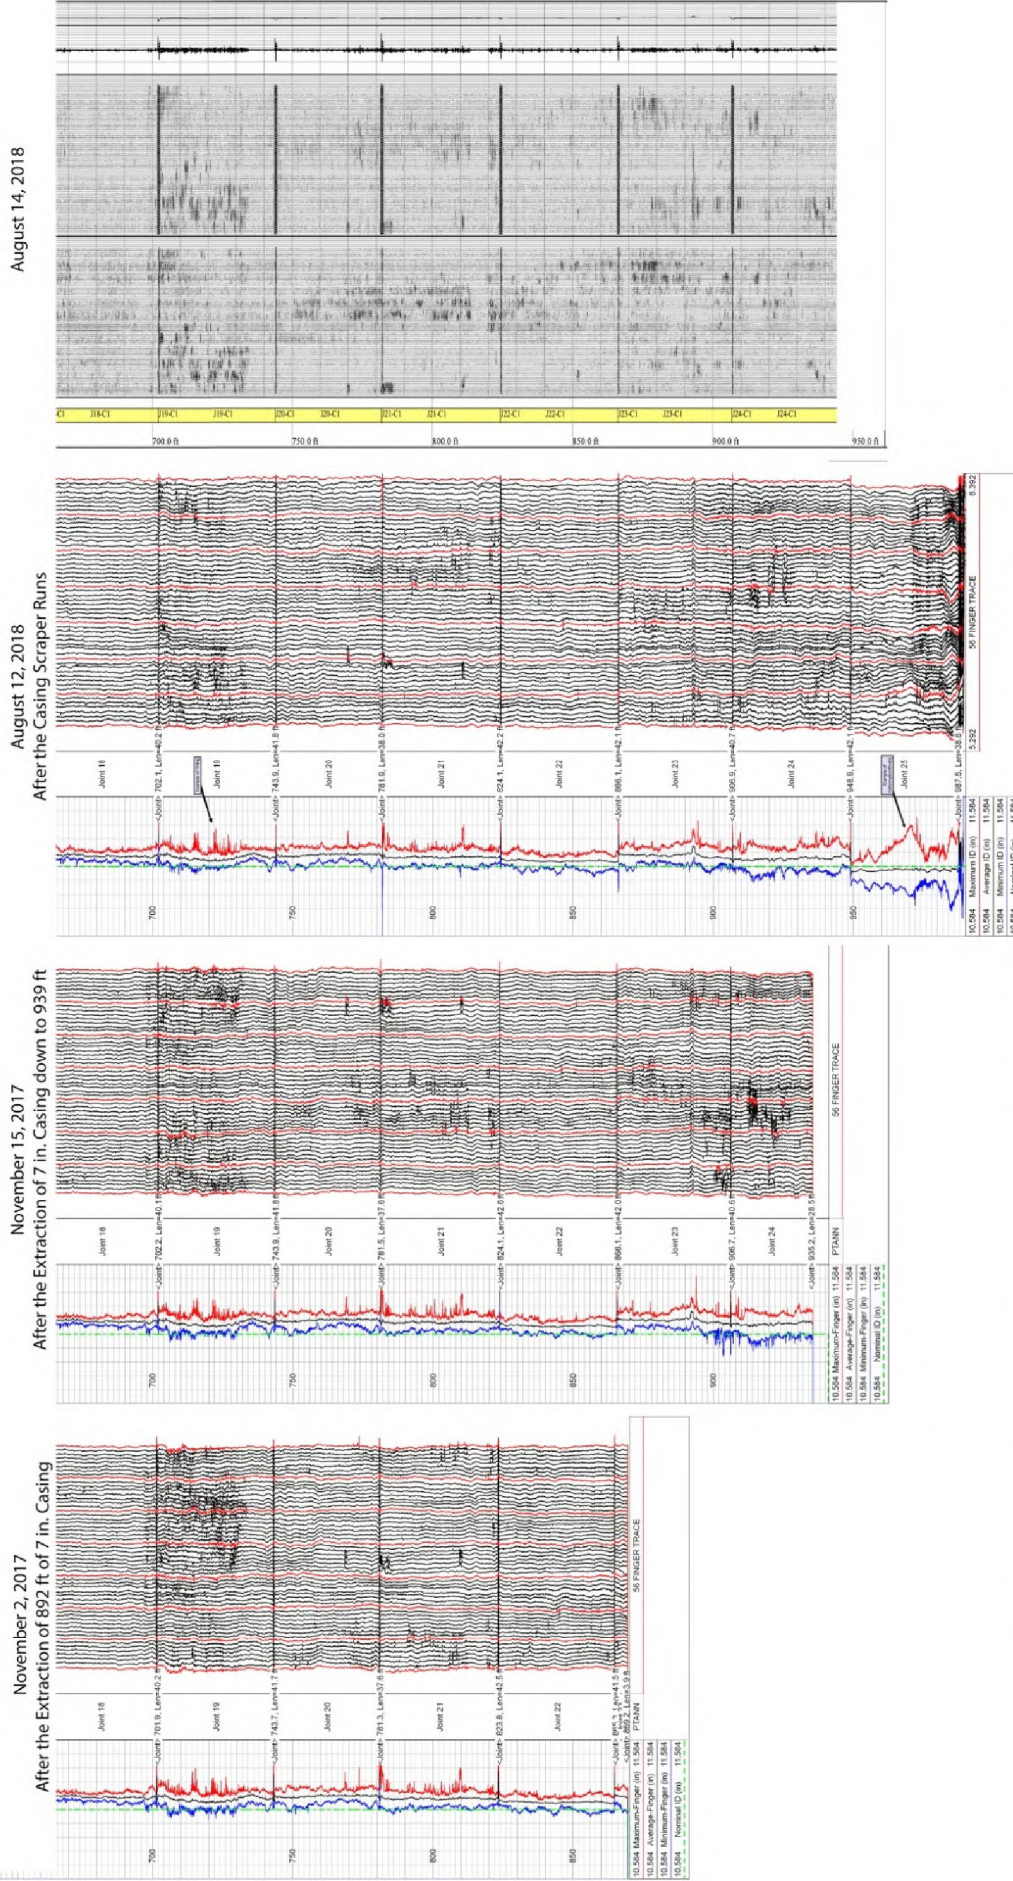
Figure 42 shows the three caliper logs and one HRVRT log run in the 11 3/4 in. casing. The caliper logs were run first, after extraction of the 892 ft of 7 in. casing (down to the upper fish), second, after the fishing and extraction of 892–939 ft of 7 in. casing (the lower fish), and third, after three 11 3/4 in. casing scraper runs. Discussion of why redundant logging was performed and what its relationship to the protection of evidence was can be found in a separate report [4].

Our interpretation is that the caliper logs repeatedly found instances of metal loss beginning at approximately 700 ft and extending to the shoe. These metal loss features were in the same location, at the same or similar penetration, and further corroborated by the HRVRT and the ultrasonic logs. Based on the scattered distribution and non-uniform penetration, our interpretation is that this internal metal loss was pitting, which was observed between 700 and 990 ft in joints 18–25. Figure 43 shows video imaging from August 19, 2018, of an oval shaped feature at ~731 ft substantiating this interpretation. Appendix C contains additional video images.

Figure 42: 11 3/4 in. Caliper Logs and HRVRT Log [16] (Right), Internal Metal Loss as Pitting from 700–990 ft

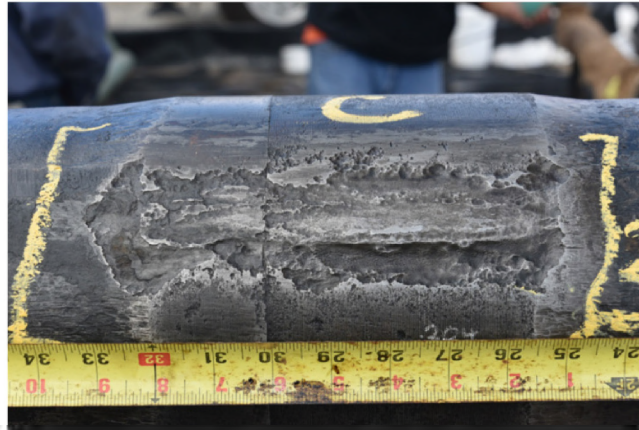
Besides connection 19, joint 20, and connection 20, additional locations for type III corrosion feature are identified in the report *SS-25 Casing Failure Analyses* [2] ; these locations coincide with the metal loss features in the 11 3/4 in. logs. Figure 45 shows the description of the type III corrosion feature.

- Metal loss along the perimeter of the rectangular shape, but middle portion is usually not affected.
- Usually seen in the connection

**Figure 45: Type III Corrosion Feature, Photograph of 7 in. Casing Connection No. 19 [2]**

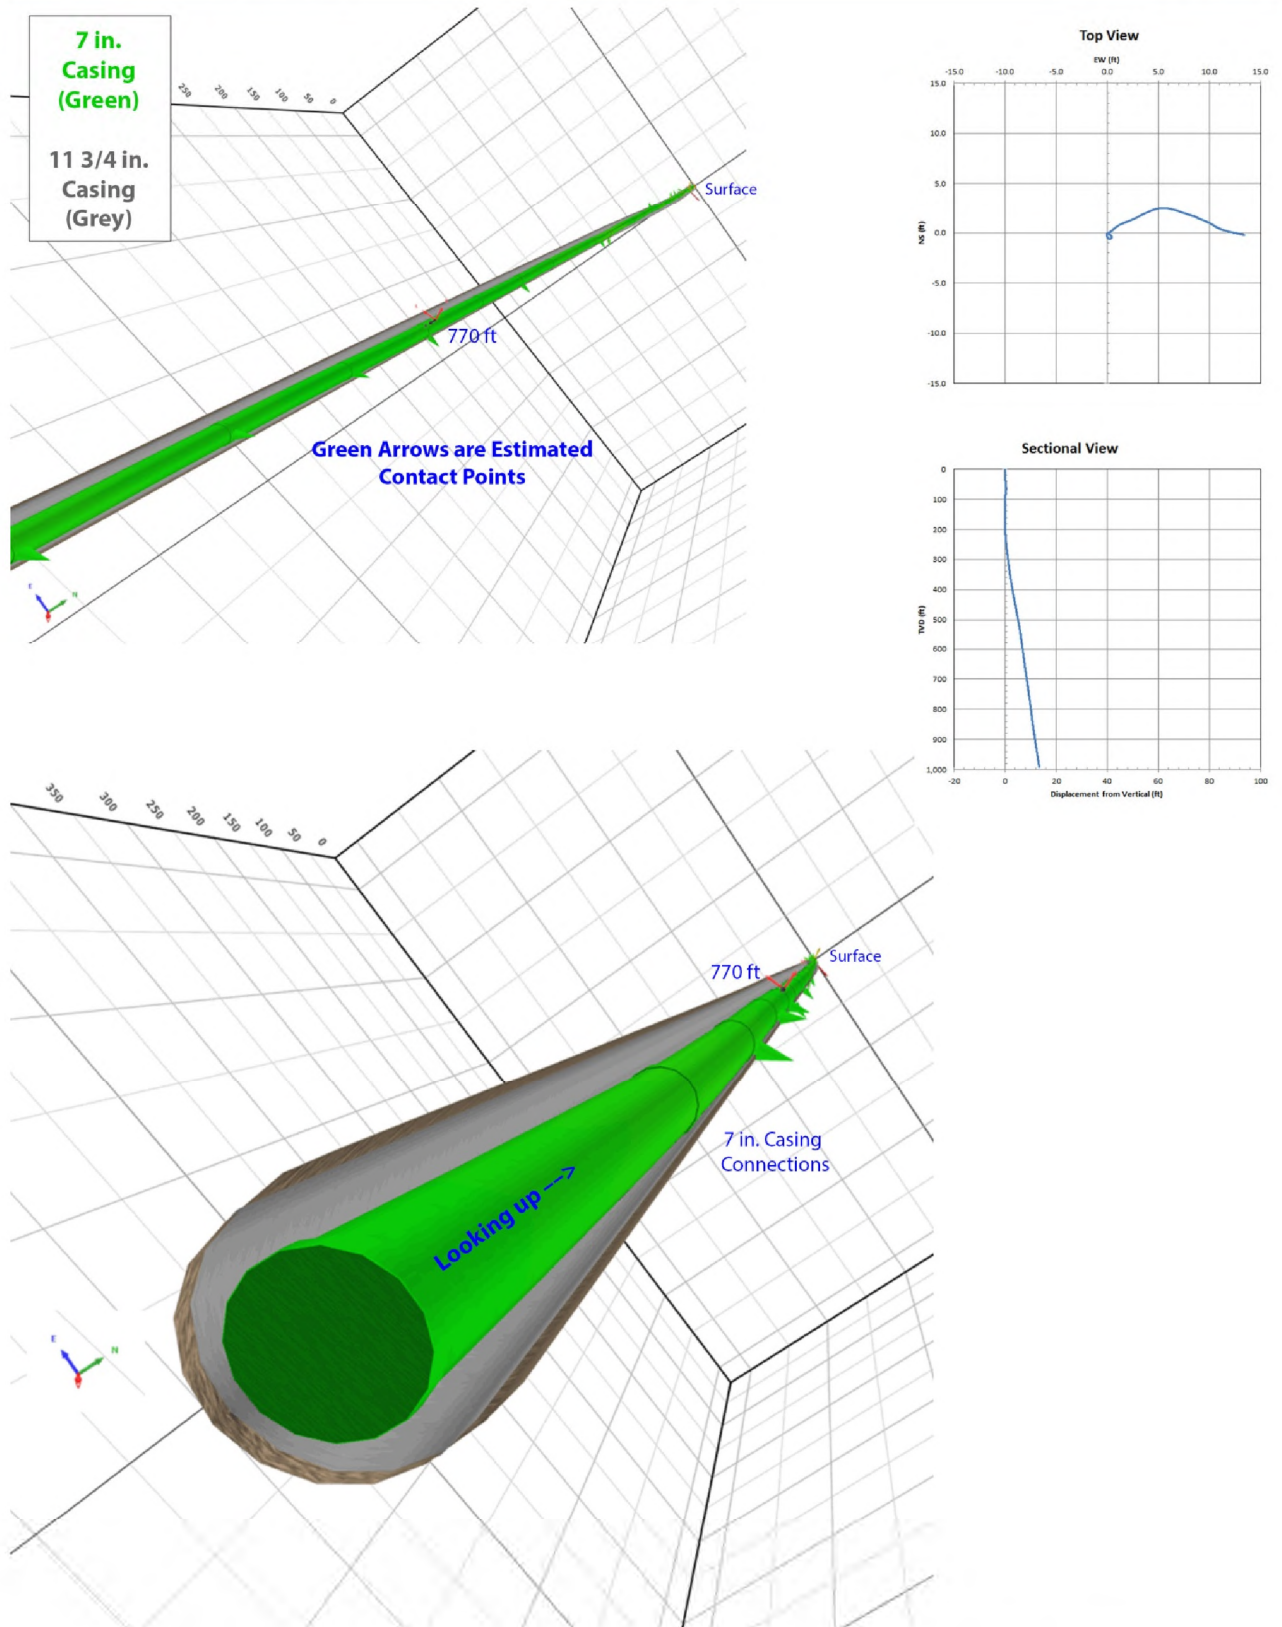
Figure 46 shows the trajectory of the well for the extents of the 11 3/4 in. casing, which is from surface to 990 ft. The average inclination is 0.94°, which may seem vertical. However, the well at 990 ft is ~13 ft to the east of the surface location; this is seen in the inset graphs entitled Vertical Section and Top View. The way we interpret the 13 ft is that contact between the 7 in. casing and the 11 3/4 in. casing was unavoidable. Denoted by green arrows are the estimated contact locations; they match the casing connections.

Figure 46: Trajectory [18] and Estimated 7 in. and 11 3/4 in. Casings Contact Locations
