Order Instituting Investigation on the Commission's Own Motion into the Operations and Practices of Southern California Gas Company with Respect to the Aliso Canyon storage facility and the release of natural gas, and Order to Show Cause Why Southern California Gas Company Should Not Be Sanctioned for Allowing the Uncontrolled Release of Natural Gas from Its Aliso Canyon Storage Facility. (U904G).

I.19-06-016 (Filed June 27, 2019)

PREPARED REPLY TESTIMONY OF ROBERT A. CARNAHAN, P.E. ON BEHALF OF SOUTHERN CALIFORNIA GAS COMPANY (U 904 G)

March 20, 2020

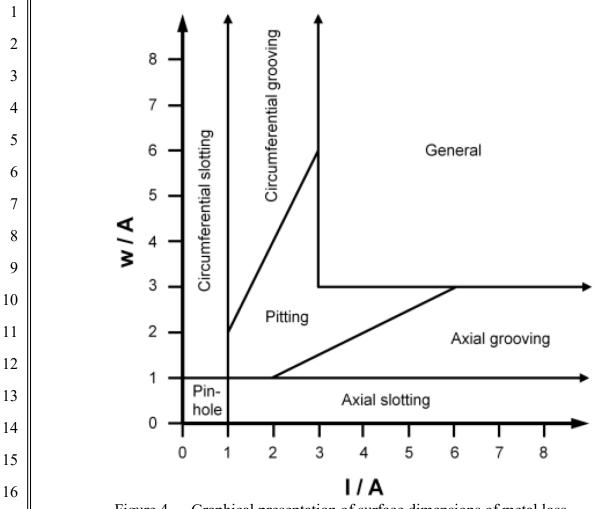
HRVRT reports provide the benefit of indicating metal loss feature dimensions (length, width, and depth), identifying metal loss as internal or external, classifying features (pinholes, pits, general, axial grooving, axial slotting, circumferential grooving, and circumferential slotting), and calculating safe operating pressure. Classification of metal loss features is based on width and length as shown in Figure 4.

Figure 4. Graphical presentation of surface dimensions of metal loss anomalies (w is width, l is length, and t is wall thickness). ²² If t<10 mm then A=10 mm. If t>10 mm then A=t.

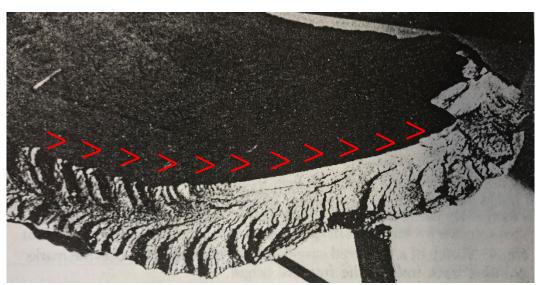
- The SS-25 fracture surface exhibits clear chevron marks at a number of locations. Chevron marks denote the direction of propagation of cracks in steels – the apex of the chevron points toward the fracture origin (Figure 14). Chevron marks on the SS-25 fracture surface show clearly that the circumferential fracture is an extension of the axial fracture (Figure 15). This interpretation is consistent with remarkably similar chevron marks shown in a textbook on failure analysis (Figure $16).^{71}$

Figure 16. Fragment of a thick-walled fractured drum. The fracture, which started at the right, ran rapidly to the left, resulting in a well-defined chevron pattern. ⁷⁶

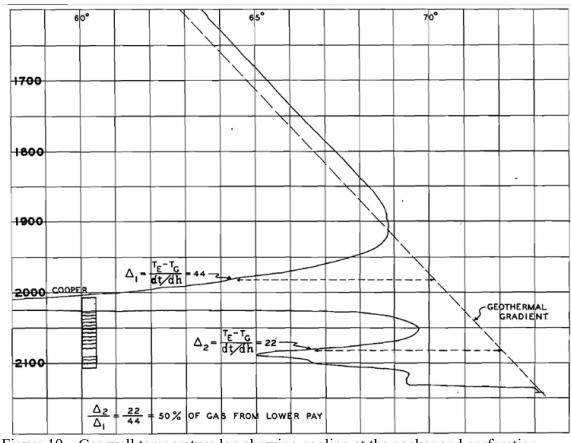
Figure 19. Gas well temperature log showing cooling at the packer and perforation (Bird, 1954).
