Blade Energy Partners' Response to SED Data Request-58

Response to SED Data Request-58

Blade response to the CPUC Data Request SED 58 related to Vertilog technology and the casing failure in SS-25 from Reply Testimony of Mr. Robert Carnahan on behalf of SoCalGas.

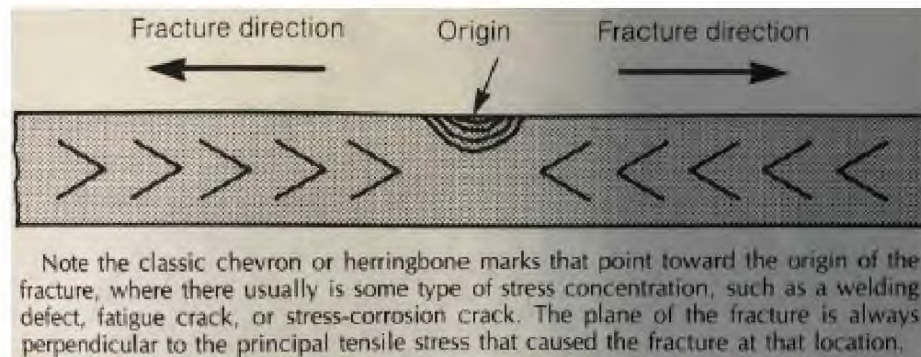
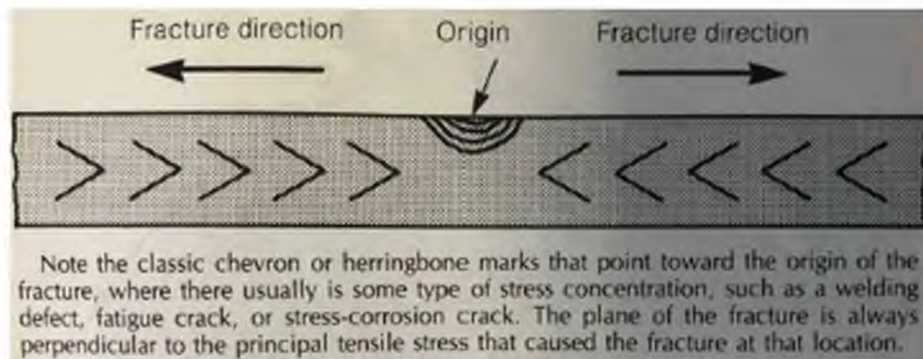
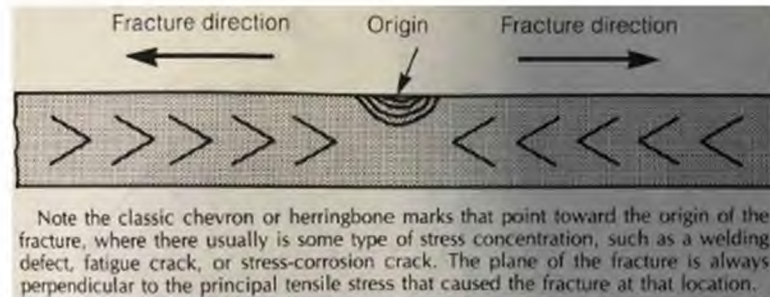
The SS-25 fracture surface exhibits clear chevron marks at a number of locations. Chevron marks denote the direction of propagation of cracks in steels – the apex of the chevron points toward the fracture origin (Figure 14). Chevron marks on the SS-25 fracture surface show clearly that the circumferential fracture is an extension of the axial fracture (Figure 15). This interpretation is consistent with remarkably similar chevron marks shown in a textbook on failure analysis (Figure 16).

Figure 14. Illustration of chevron marks on a steel fracture surface.⁷⁵

Mr. Carnahan's testimony correctly states that "the SS-25 fracture surface exhibits clear chevron marks at a number of locations. Chevron marks denote the direction of propagation of cracks in steels—the apex of the chevron points toward the fracture origin (Figure 14 provided by Mr. Carnahan in his testimony)", however, he incorrectly states that, "chevron marks on the SS-25

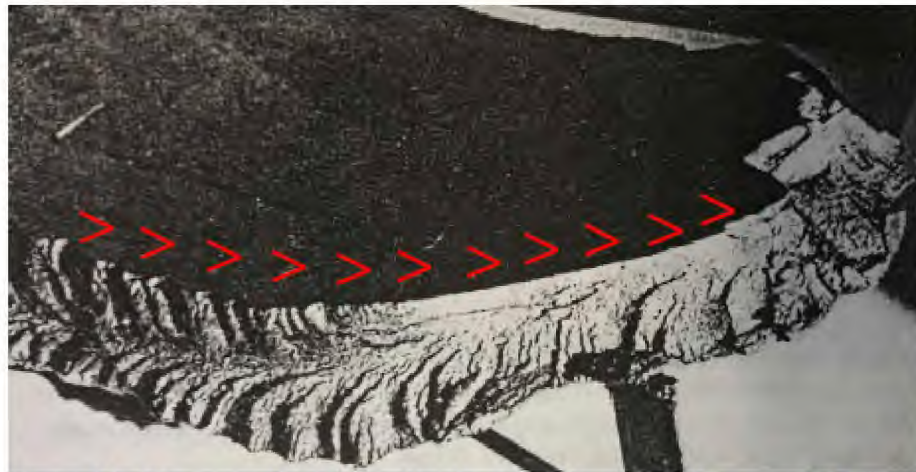
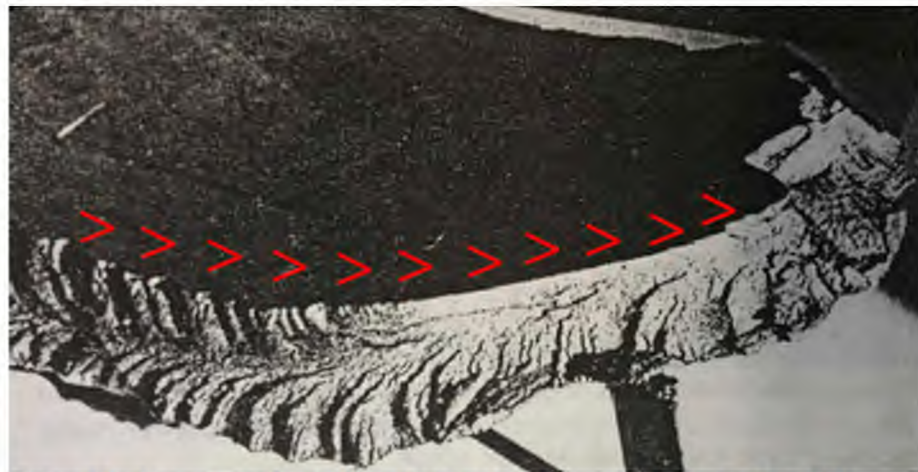
Figure 16. Fragment of a thick-walled fractured drum. The fracture, which started at the right, ran rapidly to the left, resulting in a well-defined chevron pattern.⁷⁶

Blade disagrees with the statement because the visual and stereomicroscopic examinations performed by Blade showed that the apexes of the chevron marks are in the opposite directions around the origin. This is further clarified in Figure 68(a), page 72 of the Blade Main Report below that shows the chevron marks point back towards the origin from either side of the origin. For

clarity, white dashed lines have been added to the figure to outline the chevron marks that point back towards the origin from either side of the origin. This is inconsistent with Figure 16 of Mr. Carnahan's testimony.

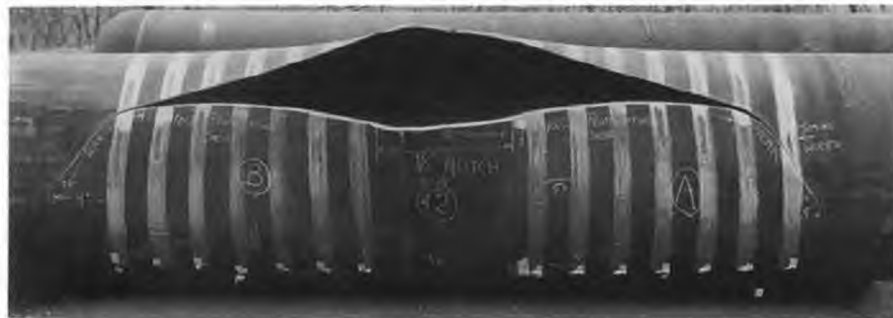
The crack arrest phenomenon as observed in the SS-25 7 in. casing has been discussed in literature, for example ASM Handbook Volume 12 *Fractography Visual Examination and Light Microscopy* and Vol. 20 *Material Selection and Design Chapter Using Failure Analysis in Material Selection*. The figure below is reproduced from ASM Vol 20 showing the arrested axial crack in a full section of X60 grade line pipe by ductile fracture at 13°C (56°F) which is 8°F above its 50% shear-area. The crack, moving at 278 ft/s (85 m/s), stopped after a short distance. The fracture was ductile and the line pipe was tough enough at this temperature to arrest the crack.

Fig. 1 Ductile fracture of a full section X60 grade line pipe tested at 56 °F (13 °C), which is 8 °F above its 50% shear-area DWT

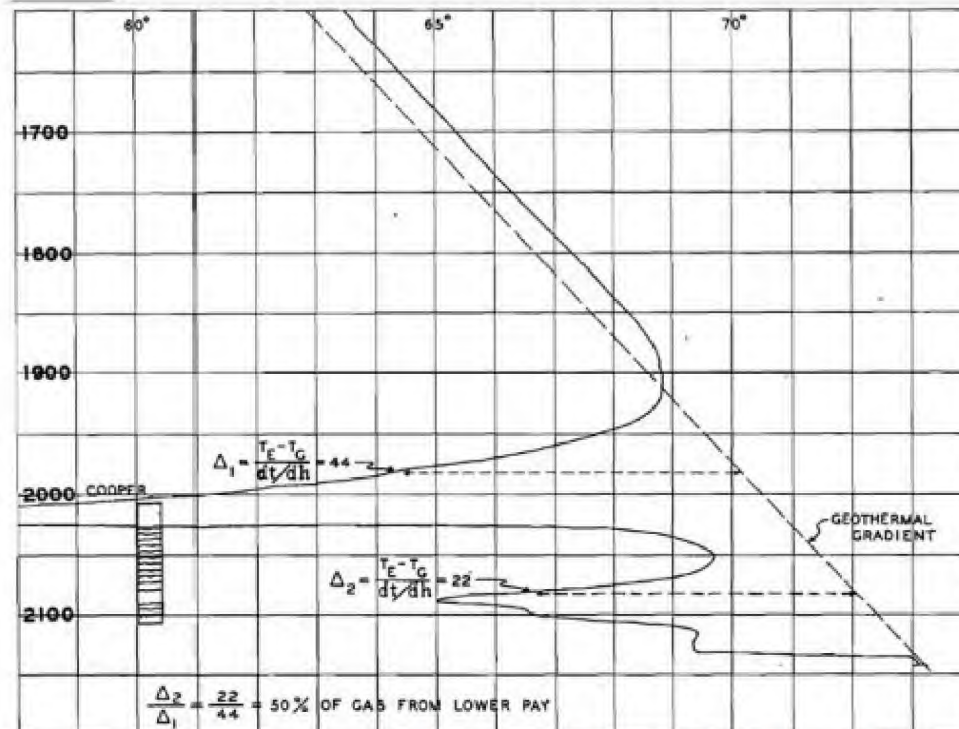
The cooling shown on the SS-25 temperature logs at this depth was not indicative of a leak. The movement of gas into or out of the storage zone always causes localized cooling; indeed, cooling behavior where a storage well meets the reservoir has been well known for many years, as can be seen in Figure 19.

Figure 19. Gas well temperature log showing cooling at the packer and perforation (Bird, 1954).
