# **CPUC Self-Generation Incentive Program**

## **In-Depth Analysis of Useful Waste Heat Recovery and Performance of Level 3/3N Systems**

**Final Report**

Itron, Inc.  
601 Officers Row  
Vancouver, WA 98661

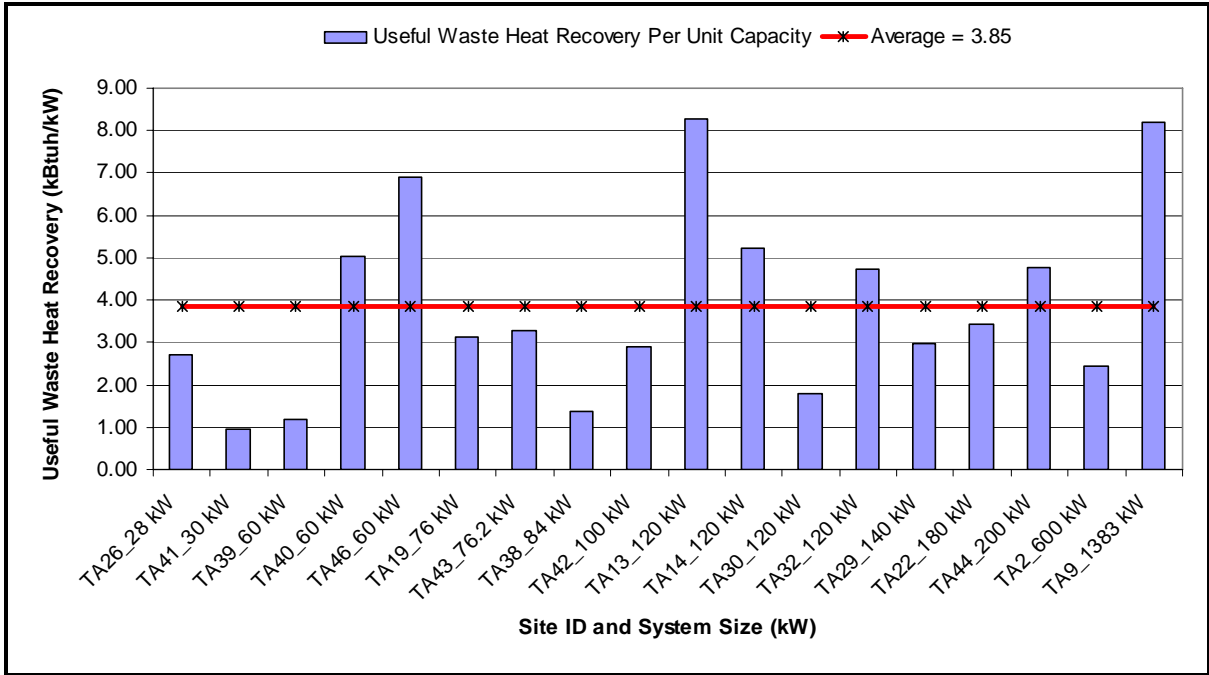
**Figure 3-1: Useful Waste Heat Recovery Per Unit Capacity by Site for Microturbines**

In general, microturbines installed under the SGIP and examined during the 2003-2005 operating period show an average of 3,850 Btu/hr of recovered useful heat per kilowatt of installed capacity, and a capacity weighted average of 5,340 Btu/hr of recovered useful heat per kilowatt of installed capacity. In addition, these same facilities show an average recovered waste heat efficiency of approximately 25%. Although there is only a weak correlation between size and useful heat recovery, it is notable that the lowest three useful heat recovery metrics occur in the smaller half of systems. This may be attributable to the relatively greater amount of front-end feasibility analysis present in larger systems.

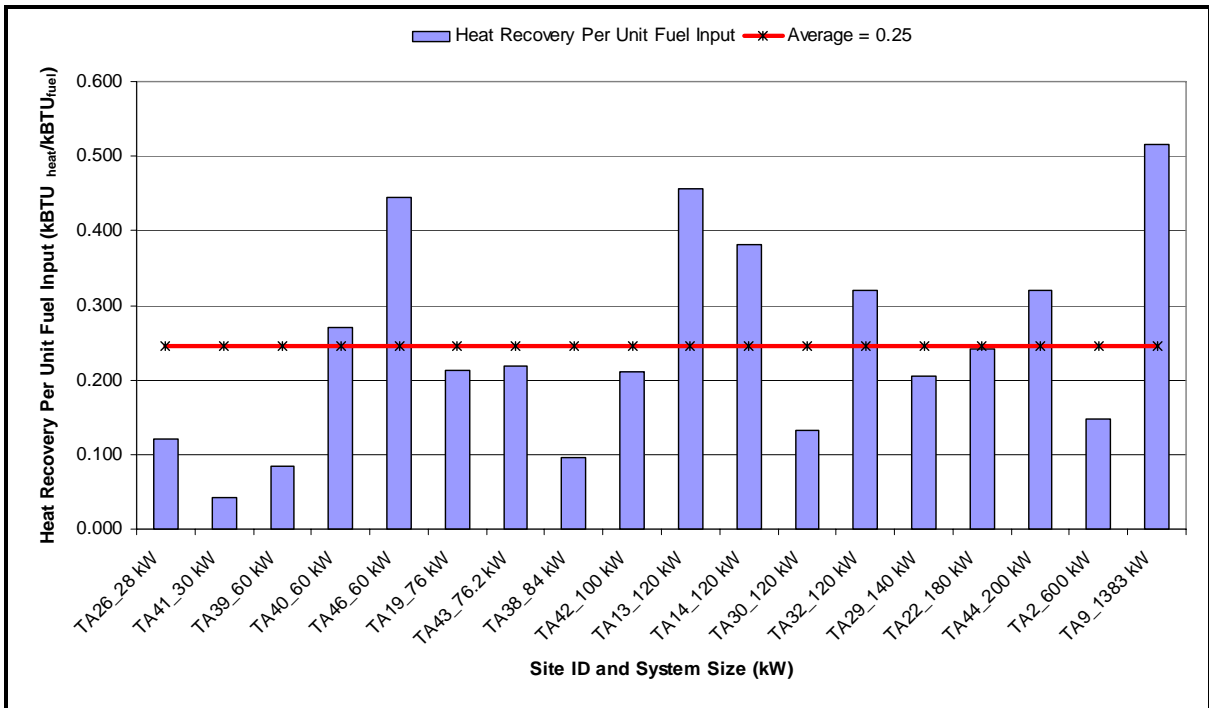
**Figure 3-2: Microturbine Useful Heat Recovery Per Unit Fuel Input Versus System Size**

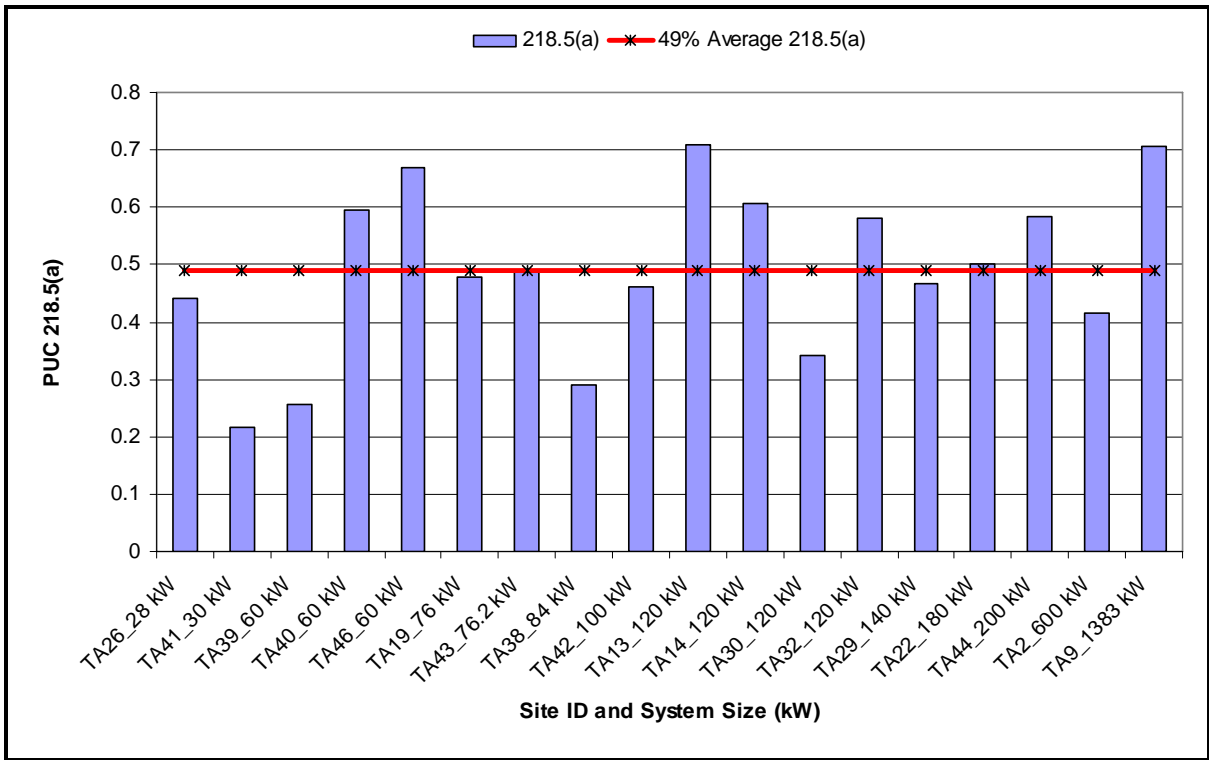
**Figure 3-3: Microturbine PUC 218.5(a) Efficiencies Versus System Size**

As the difference between the arithmetic and weighted averages in the above table suggests, there is a slight improvement in efficiency with system size. This is caused by the largest project having the highest PUC 218.5(a) result and may be explained by the additional design-stage engineering involved in larger (both in capacity and financially) projects. Figure 3-3 illustrates the variation of 218.5(a) efficiencies by system size.

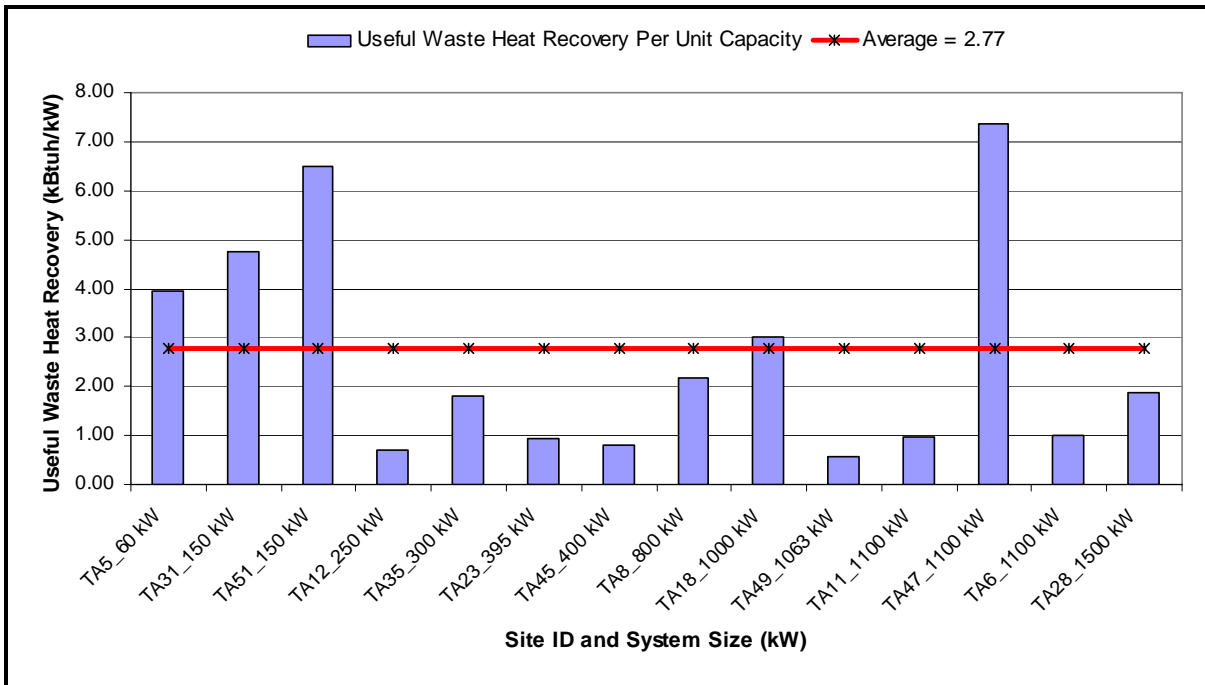
**Figure 3-4: Thermal Efficiency by Site for ICEs (n=14)**

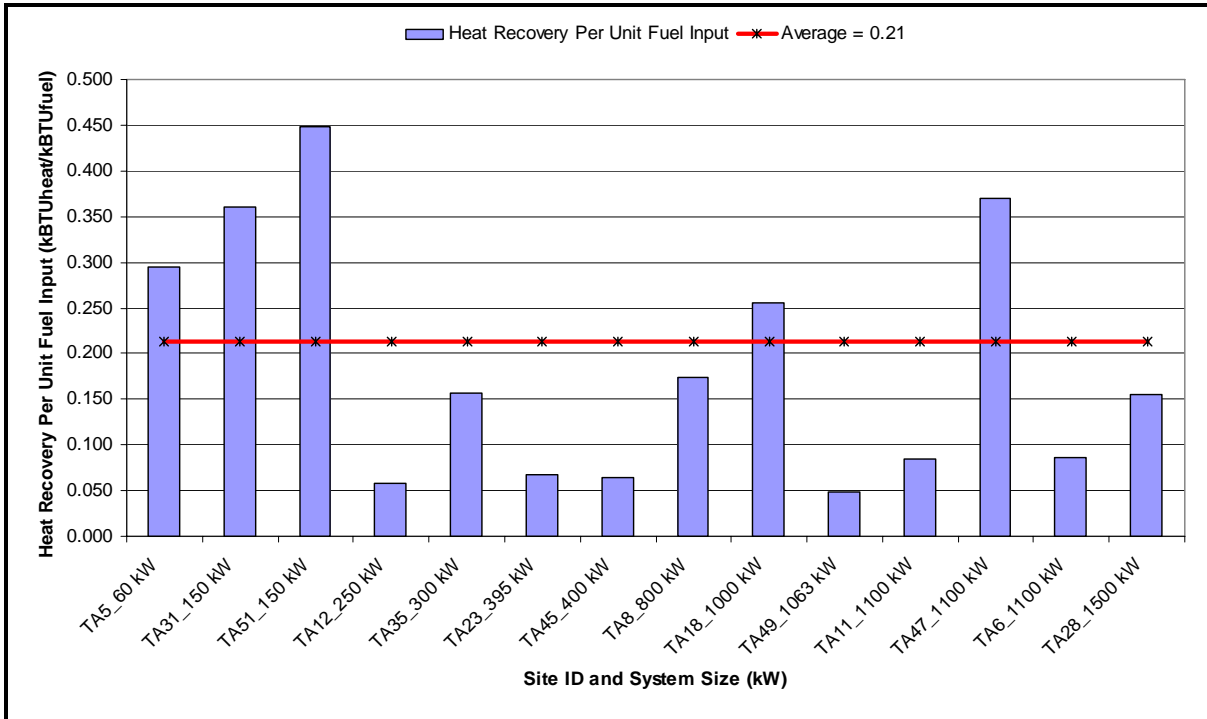
**Figure 3-5: ICE Useful Heat Recovery Per Unit Fuel Input Versus System Size**

An interesting observation for ICEs is that for both the useful waste heat recovery and the heat recovery rate, the weighted averages are lower than the averages. This suggests that larger systems do not perform as well as smaller systems. Figure 3-5 illustrates the variation of useful heat recovery rate by system size.

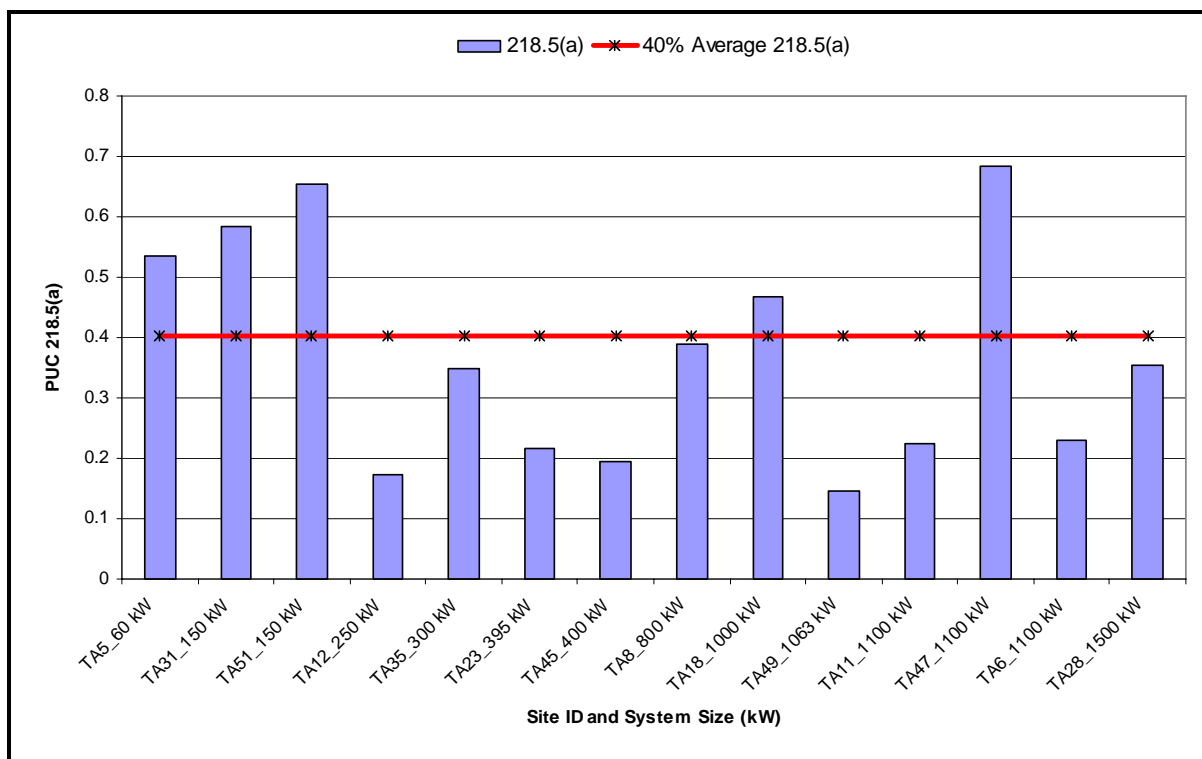
**Figure 3-6: ICE PUC 218.5(a) Efficiencies Versus System Size**

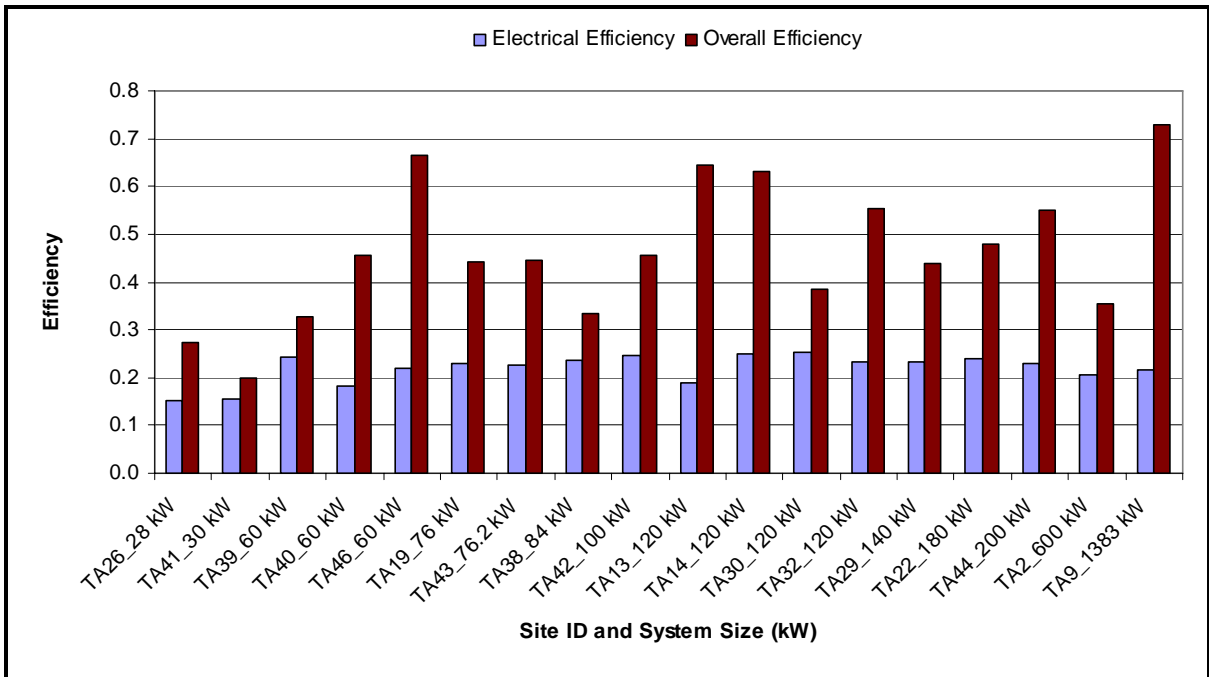
**Figure 3-7: Microturbine Electrical and Overall System Efficiencies by System Size**

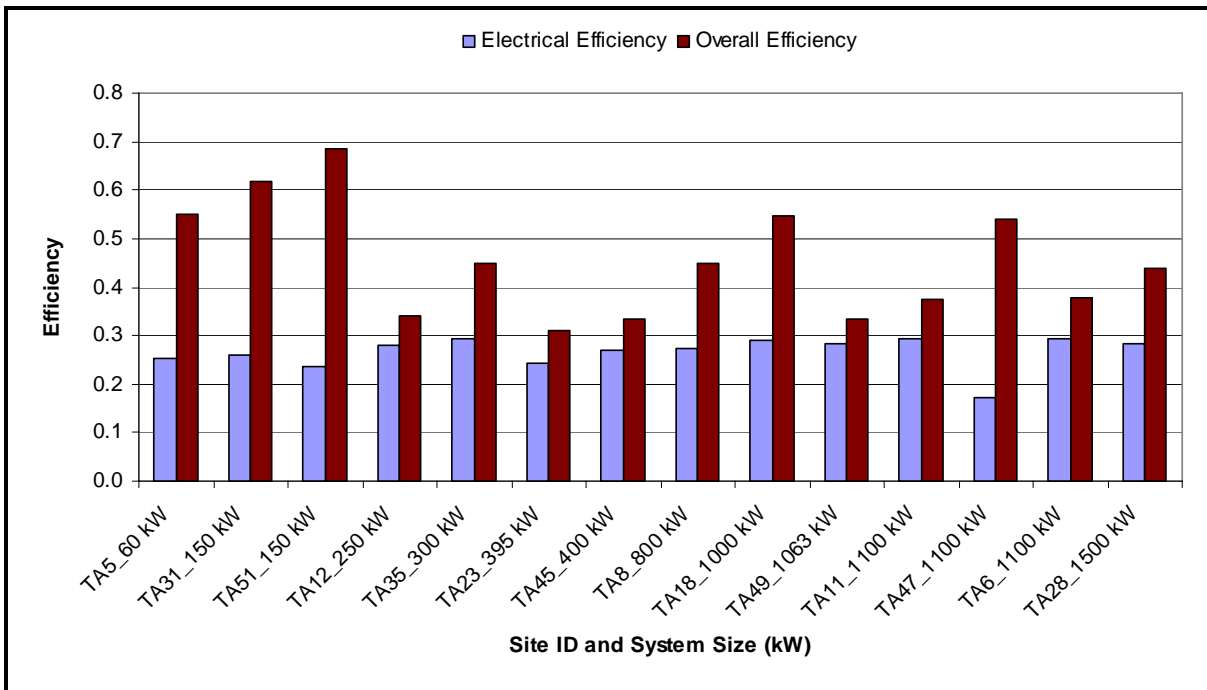
**Figure 3-8: ICE Electrical and Overall System Efficiencies by System Size**

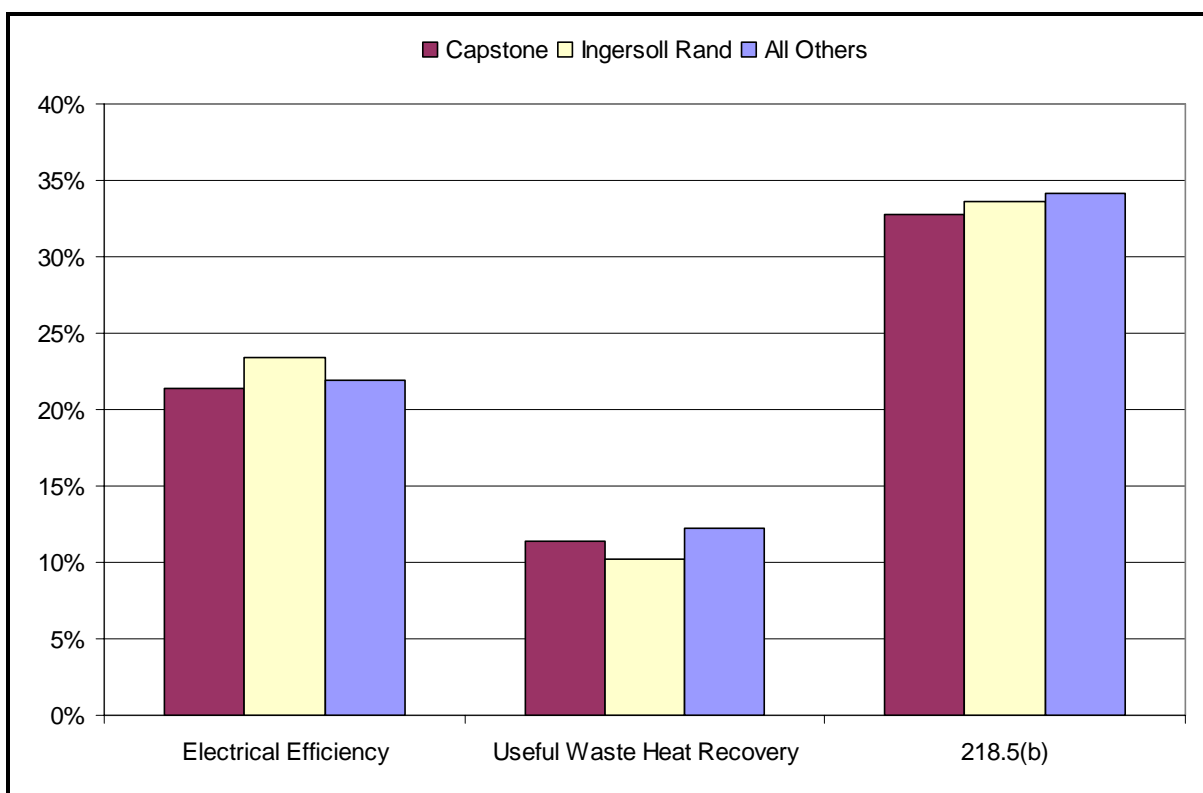
**Figure 3-9: Comparative Statistics for Microturbines**

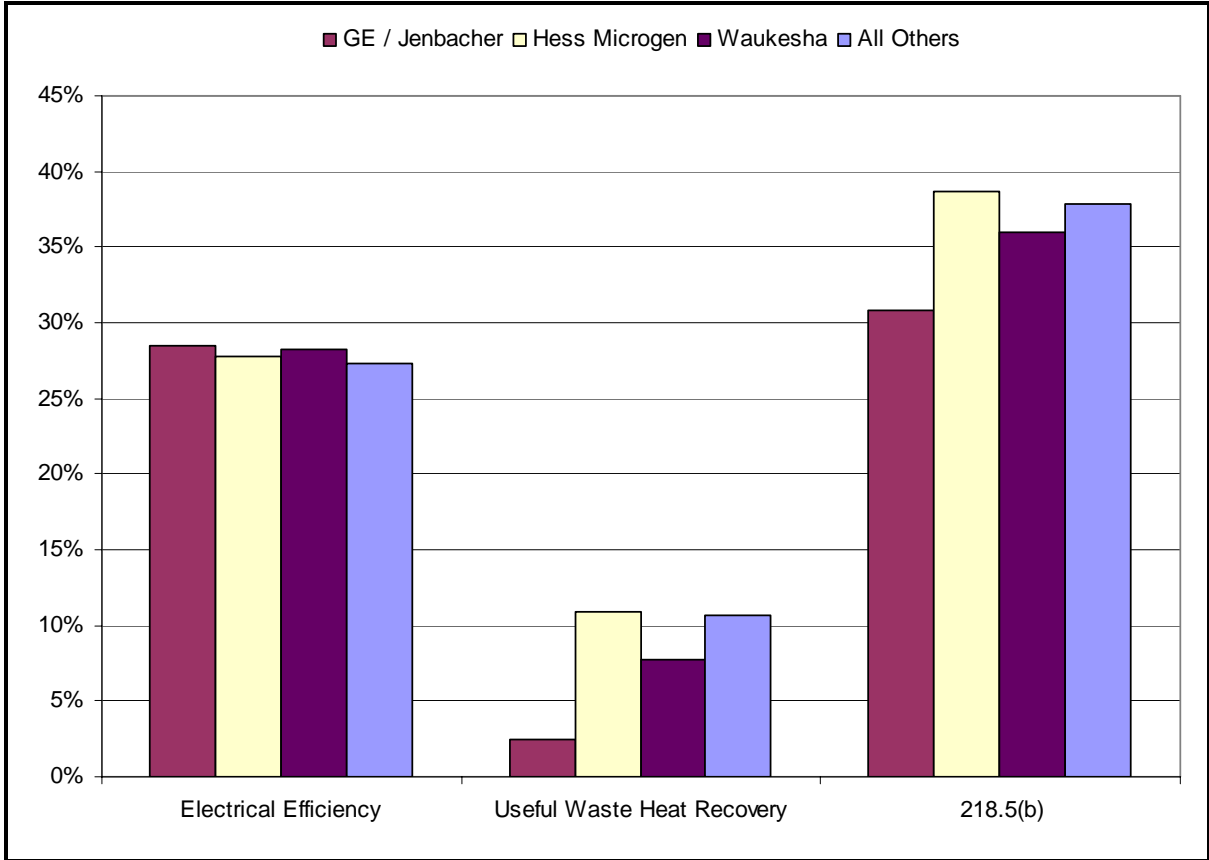
**Figure 3-10: Comparative Statistics for ICEs**

Figure 3-10 compares the key efficiency metrics for Waukesha, Hess Microgen, and GE Jenbacher against all other ICE manufacturers. In general, the Hess units are performing better than their competitors are. One possible explanation for this performance is that a relatively large equipment installer/operator routinely provides service along with operation. As a result, the Hess equipment not only operates more efficiently, it also operates at a higher

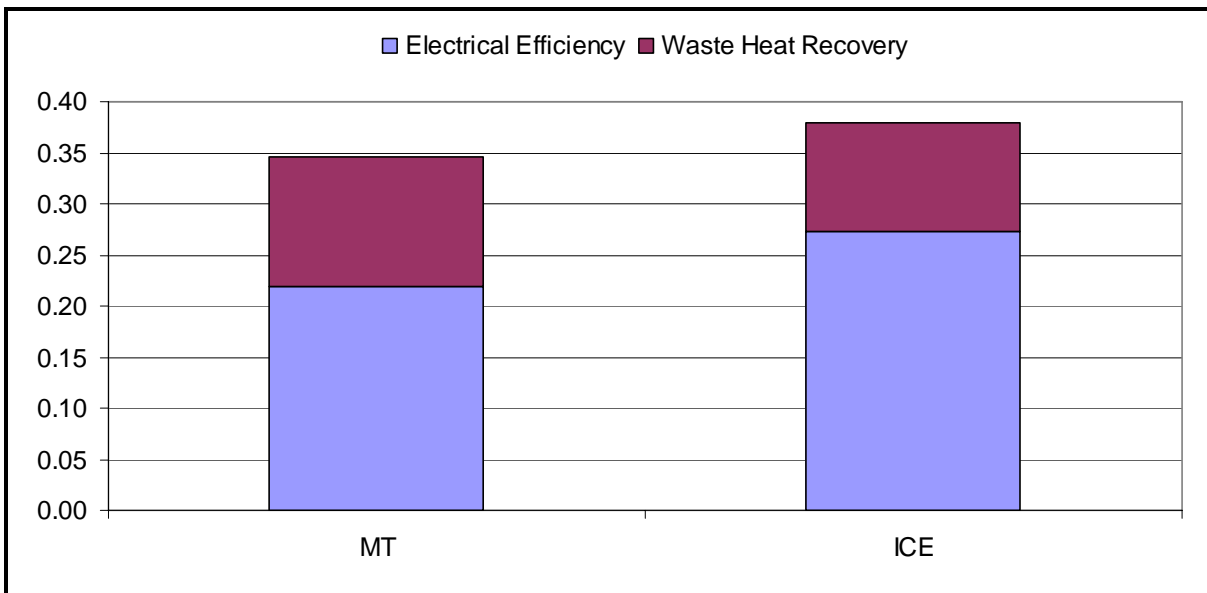
**Figure 3-11: Comparison of 218.5(b) Efficiency by Technology**

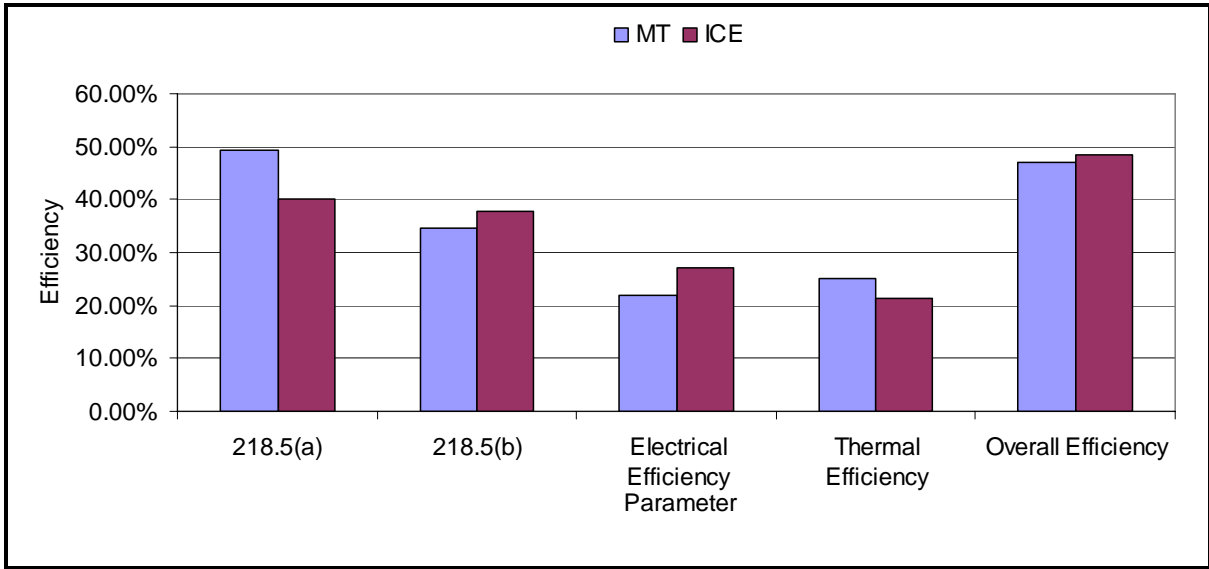
**Figure 3-12: Comparative Parameters for Microturbines and ICEs**

Figure 3-12 shows several important parameters that are used to assess cogeneration system performance.

As shown in the first two comparisons in Figure 3-12, microturbines generally have a higher PUC 218.5(a) value and a lower PUC 218.5(b) value. This is explained by the remaining three comparisons: electrical, thermal, and overall efficiency. Two general statements may be made regarding SGIP sites. First, ICEs typically have higher electrical efficiencies than microturbines (parameter 3 in Figure 3-12). Second, microturbines typically have higher thermal efficiencies than ICEs (parameter 4 in Figure 3-12). When taken together, these two statements help to explain the remaining parameters in Figure 3-12.

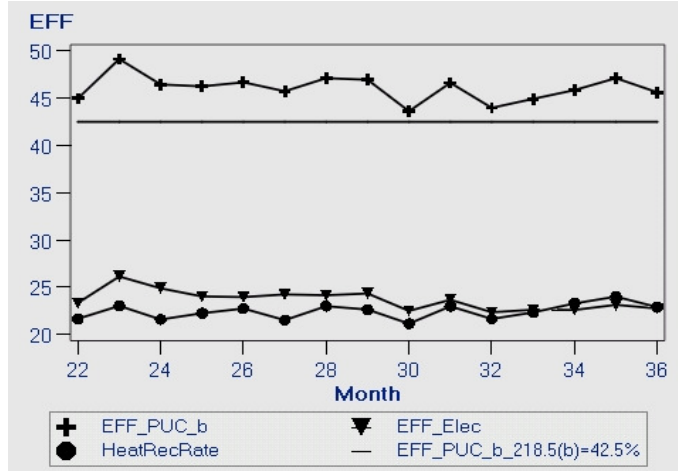
Graphical Representation of Efficiencies

Month 1 --- Jan 2003  
Month 6 --- Jun 2003  
Month 12 --- Dec 2003  
Month 18 --- Jun 2004  
Month 24 --- Dec 2004  
Month 30 --- Jun 2005  
Month 36 --- Dec 2005

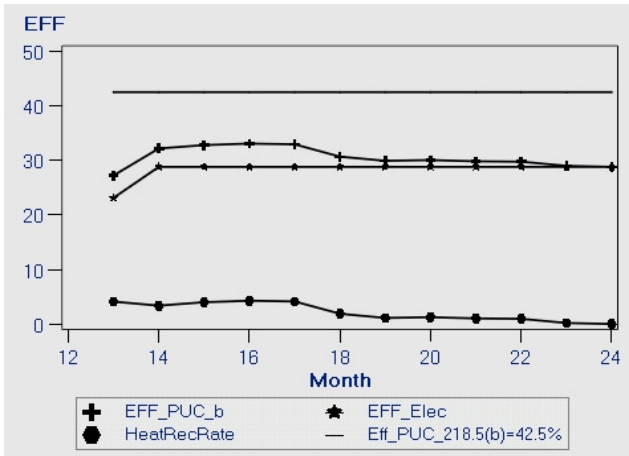
**Graphical Representation of Efficiencies**

Month 1 --- Jan 2003  
Month 6 --- Jun 2003  
Month 12 --- Dec 2003  
Month 18 --- Jun 2004  
Month 24 --- Dec 2004  
Month 30 --- Jun 2005  
Month 36 --- Dec 2005

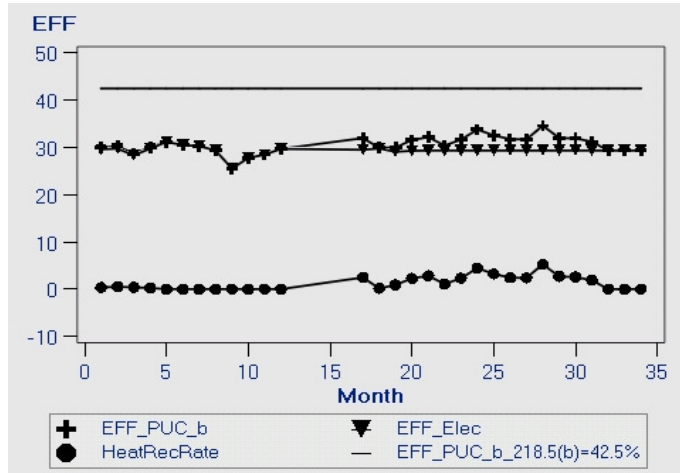
Graphical Representation of Efficiencies

- Month 1 --- Jan 2003
- Month 6 --- Jun 2003
- Month 12 --- Dec 2003
- Month 18 --- Jun 2004
- Month 24 --- Dec 2004
- Month 30 --- Jun 2005
- Month 36 --- Dec 2005

1. Is electrical efficiency correct based on technology? Yes  
 Electrical Conversion Efficiency= 29.35%  
 PU 218.5 (a) Efficiency = 3.54%  
 PU 218.5 (b) Efficiency = 30.66%

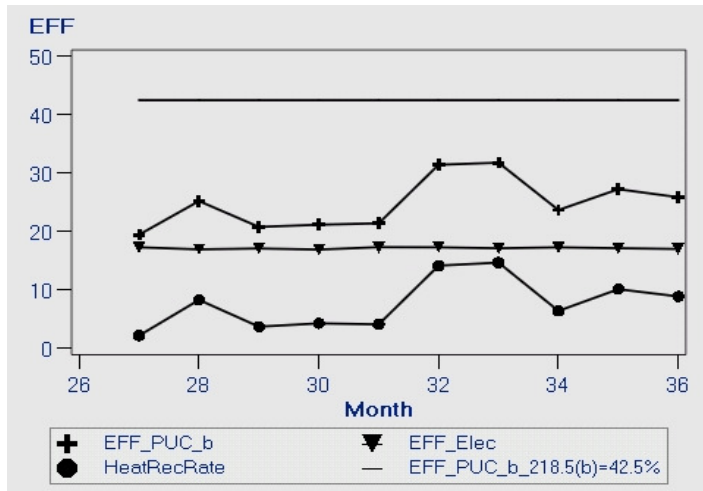
**Graphical Representation of Efficiencies**

Month 1 --- Jan 2003  
Month 6 --- Jun 2003  
Month 12 --- Dec 2003  
Month 18 --- Jun 2004  
Month 24 --- Dec 2004  
Month 30 --- Jun 2005  
Month 36 --- Dec 2005

1. Is electrical efficiency correct based on technology? Low  
 Electrical Conversion Efficiency= 17.14%  
 PU 218.5 (a) Efficiency = N/A  
 PU 218.5 (b) Efficiency = 22.50%

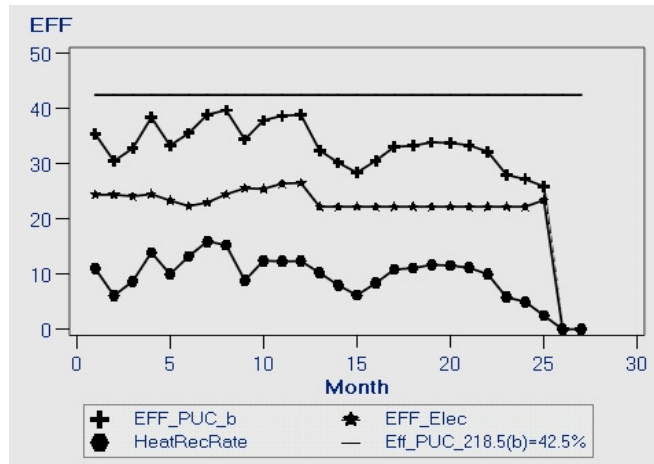
**Graphical Representation of Efficiencies**

Month 1 --- Jan 2003  
 Month 6 --- Jun 2003  
 Month 12 --- Dec 2003  
 Month 18 --- Jun 2004  
 Month 24 --- Dec 2004  
 Month 30 --- Jun 2005  
 Month 36 --- Dec 2005

1. Is electrical efficiency correct based on technology? low  
 Electrical Conversion Efficiency= 23.43%  
 PU 218.5 (a) Efficiency = 53.33%  
 PU 218.5 (b) Efficiency = 36.82%

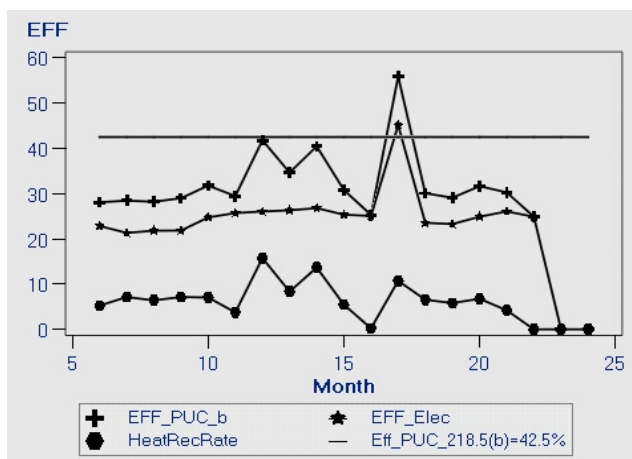
**Graphical Representation of Efficiencies**

Month 1 --- Jan 2003  
Month 6 --- Jun 2003  
Month 12 --- Dec 2003  
Month 18 --- Jun 2004  
Month 24 --- Dec 2004  
Month 30 --- Jun 2005  
Month 36 --- Dec 2005

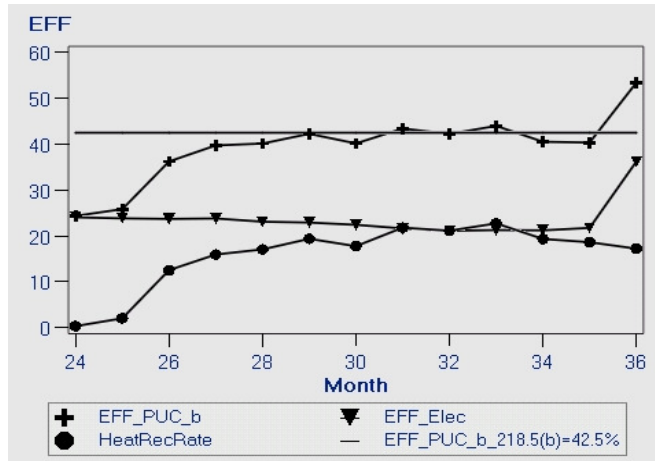
Why was the heat recovery low in Jan and Feb 2005?  
Was the system broken?

System meets 218.5(b) efficiency only if they completely recover waste heat. Heat recovery was low in Jan and Feb 2005 because of failed refrigerator pump in absorption chiller.

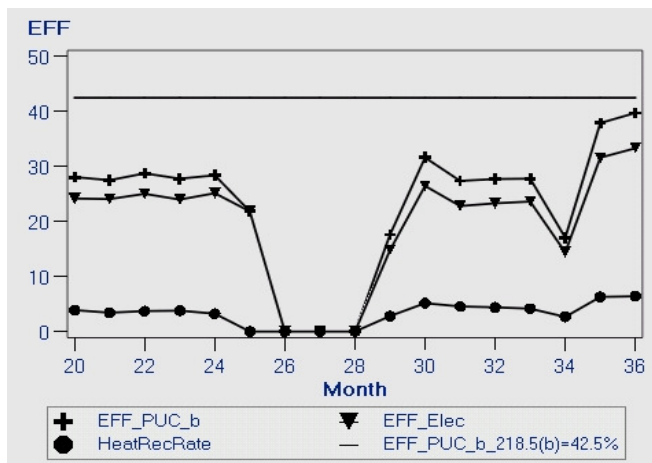
1. Is electrical efficiency correct based on technology? Yes; 23-25% is in line with manufacturer claims  
 Electrical Conversion Efficiency= 23.41%  
 PU 218.5 (a) Efficiency = 11.13%  
 PU 218.5 (b) Efficiency = 27.26%

4. Conclusion System could not meet 218.5(b) efficiency because of low heat recovery rate. Failure of heat exchanger exacerbated the issue.

**Notes:** From 12/29/04 - 05/25/05 there was no heat recovery. Heat exchanger was broken so datalogger is recording zeros. From May 2005, datalogger has been recording very low heat recovery, consistent with data prior to heat exchanger failure.

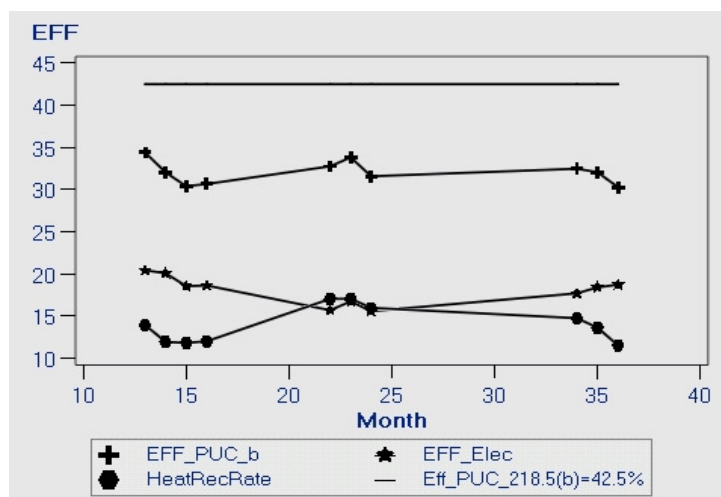
**Graphical Representation of Efficiencies**

Month 1 --- Jan 2003  
 Month 6 --- Jun 2003  
 Month 12 --- Dec 2003  
 Month 18 --- Jun 2004  
 Month 24 --- Dec 2004  
 Month 30 --- Jun 2005  
 Month 36 --- Dec 2005

1. Is electrical efficiency correct based on technology? Low  
 Electrical Conversion Efficiency= 18.37%  
 PU 218.5 (a) Efficiency = 47.44%  
 PU 218.5 (b) Efficiency = 31.91%

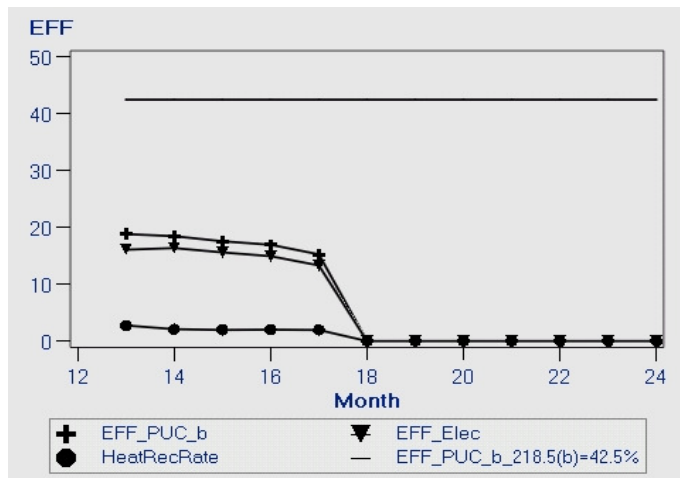
**Graphical Representation of Efficiencies**

Month 1 --- Jan 2003  
 Month 6 --- Jun 2003  
 Month 12 --- Dec 2003  
 Month 18 --- Jun 2004  
 Month 24 --- Dec 2004  
 Month 30 --- Jun 2005  
 Month 36 --- Dec 2005

1. Is electrical efficiency correct based on technology? Low  
 Electrical Conversion Efficiency= 15.62%  
 PU 218.5 (a) Efficiency = 2.27%  
 PU 218.5 (b) Efficiency = 17.76%

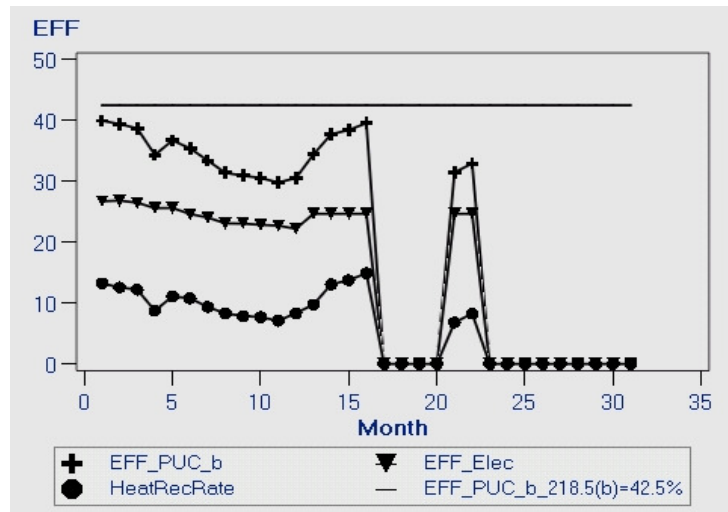
**Graphical Representation of Efficiencies**

Month 1 --- Jan 2003  
 Month 6 --- Jun 2003  
 Month 12 --- Dec 2003  
 Month 18 --- Jun 2004  
 Month 24 --- Dec 2004  
 Month 30 --- Jun 2005  
 Month 36 --- Dec 2005

1. Is electrical efficiency correct based on technology? Low  
 Electrical Conversion Efficiency= 24.68%  
 PU 218.5 (a) Efficiency = 19.68%  
 PU 218.5 (b) Efficiency = 35.20%

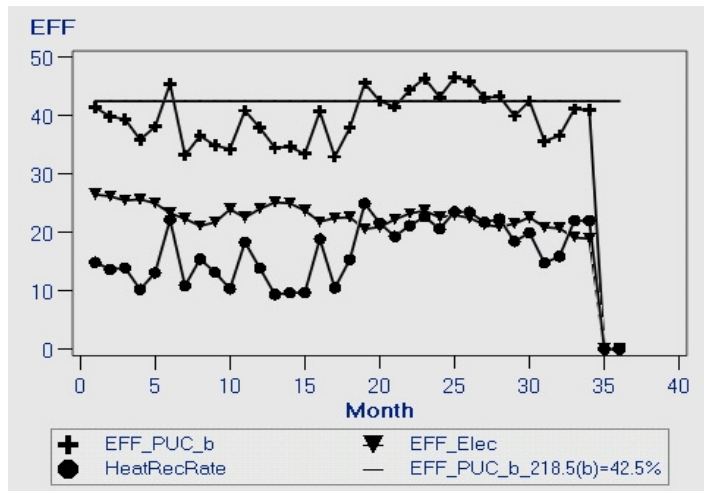
**Graphical Representation of Efficiencies**

Month 1 --- Jan 2003  
 Month 6 --- Jun 2003  
 Month 12 --- Dec 2003  
 Month 18 --- Jun 2004  
 Month 24 --- Dec 2004  
 Month 30 --- Jun 2005  
 Month 36 --- Dec 2005

1. Is electrical efficiency correct based on technology? Yes  
 Electrical Conversion Efficiency= 23.04%  
 PU 218.5 (a) Efficiency = 25.69%  
 PU 218.5 (b) Efficiency = 39.15%
