# **Blade Supplemental Report (Vol. 1: Approach)**

Root Cause Analysis of the Uncontrolled Hydrocarbon Release from Aliso Canyon SS-25

Volume 1: Approach

# **Phase 0 Summary**

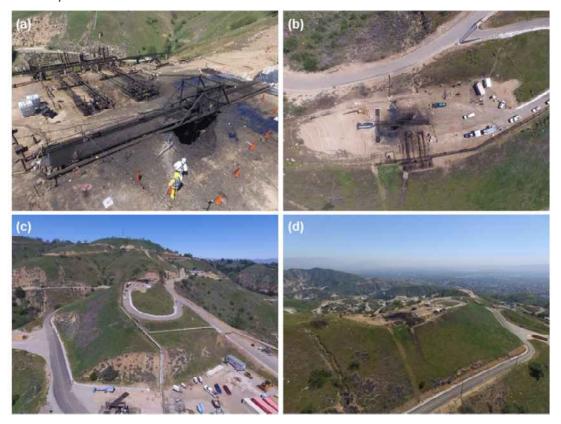
Figure 14: Example Photos of SS-25 Well Site from Drone

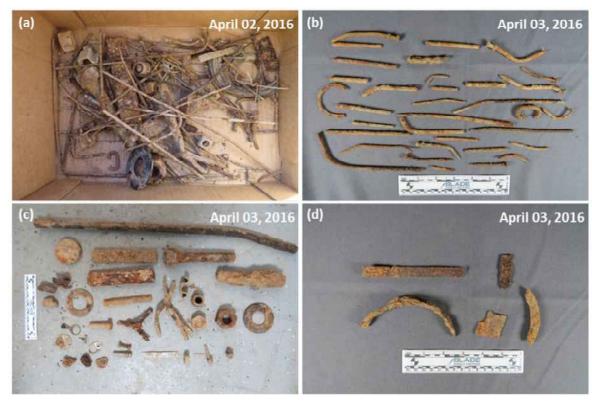
The geophysical search began on April 02, 2016 in the afternoon. The EM61-MK2 was taken to the north side of Zone 2 (north hill). AECOM personnel used the EM61-MK2 for a few hours before the brackets securing the handlebars began to break. New brackets had to be ordered before the equipment could be fixed. This caused a four-day delay with the geophysical search. From April 02 to April 05, 2016, Blade provided support as AECOM searched Zone 1 and part of Zone 2 using only the handheld metal detectors. Blade assisted by digging up located items and determining their significance. Figure 27 shows the collection of items dug up and collected on April 02 and April 03, 2016. Some of the typical items found were discarded welding rods, nails, bolts, washers, and other such irrelevant items. Figure 28 indicates the signals returned from the detector. The scale on the left is in millivolts with pink indicating a strong metal signal. The majority of the items appeared old and coated with a heavy rust layer indicating they were legacy items and unrelated to the incident.

Figure 27: Objects Found during the Geophysical Search on (a) April 02, 2016 and (b)-(d) April 03, 2016

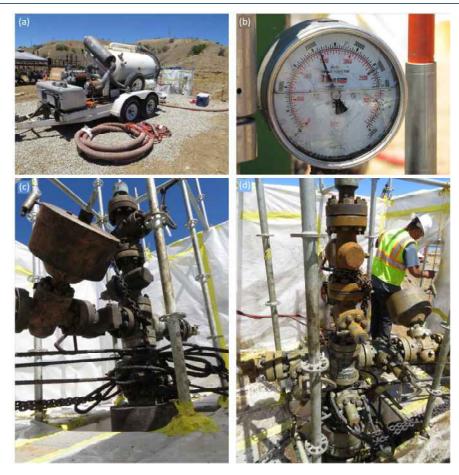
Figure 51: Hydroblasting of SS-25

In Figure 51 (a), the same truck that performed the pressure washing on Frew 8 was requested. The water pressure came in at just over 21 ksi, as recorded by (Figure 51 [b]). This was considered high enough without any risk of damage. Final results are shown in Figure 51 (c) and (d). Photos were sent to RCS Inc. for evaluation. Light sandblasting was recommended to remove the flash rust that occurred immediately. Argus accommodated this request and the wellhead surfaces were considered clean enough for MPI.

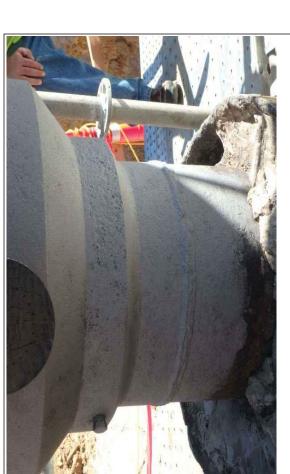
Description: GW located at lower end of wellhead surface casing

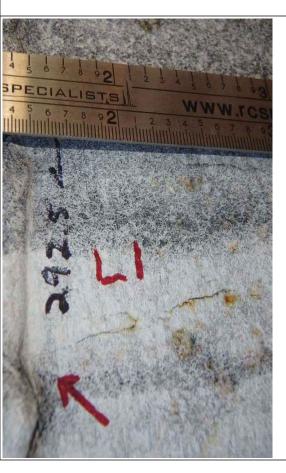
Description: Surface lamination detected at 292.5 degrees below girth weld

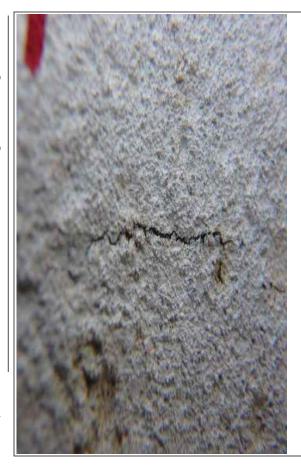
Description: macro of surface lamination

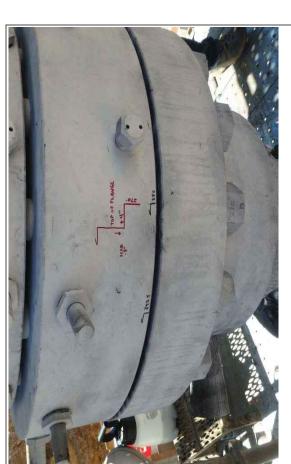
Description: General location of surface scab on upper flange

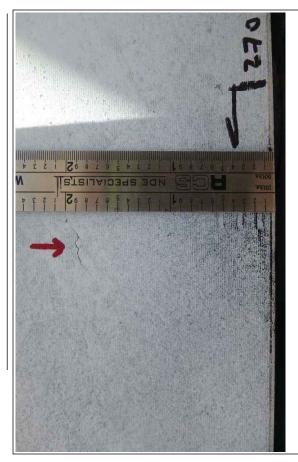
Description: Surface scab: Vertical measurement

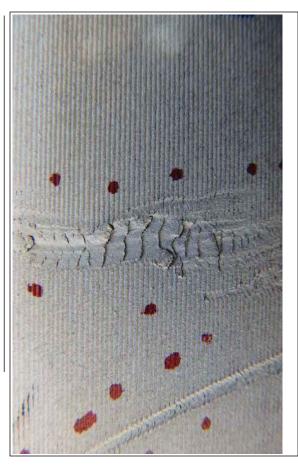
Description: Macro of surface gouge; material displacement

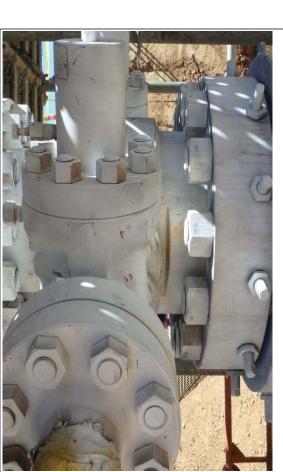
Description: General location of surface anomalies

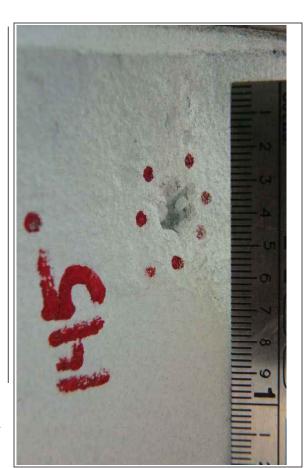
Description: Macro of surface anomaly at 145 degrees: pit

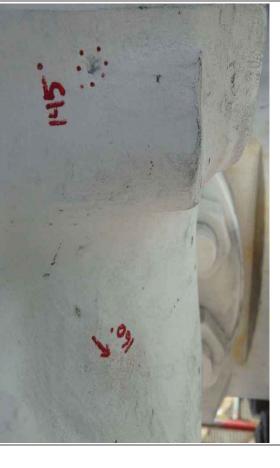
Description: General location of surface anomalies

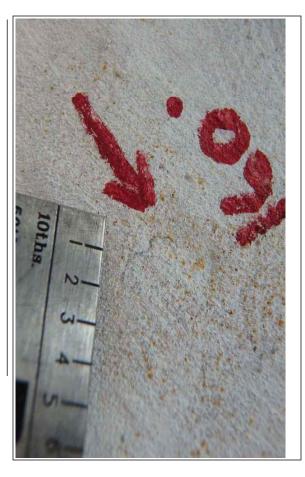
Description: Macro of surface anomaly at 160 degrees: scab

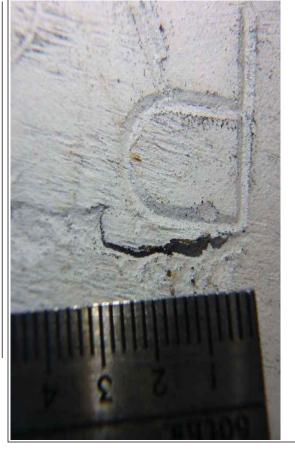
Description: Macro of lower surface anomaly

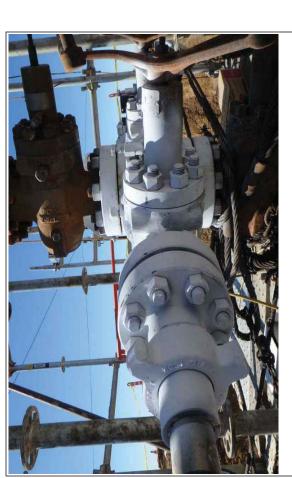
Description: General location of surface anomalies

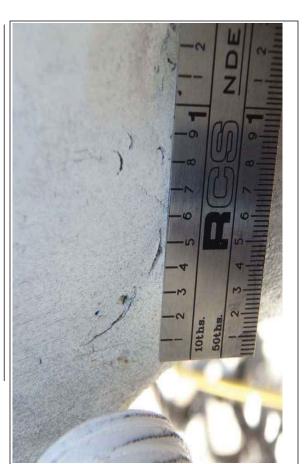
Description: Close-up of surface anomalies: horizontal measurement

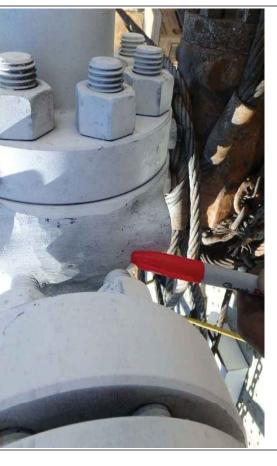
Description: General location of surface anomalies

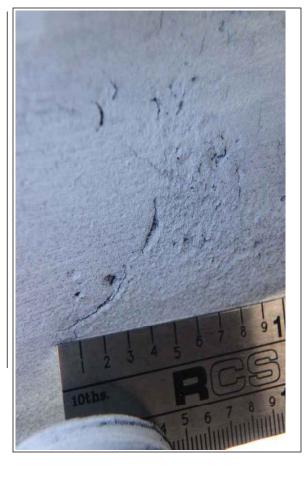
Description: Close-up of surface anomalies: vertcal measurement

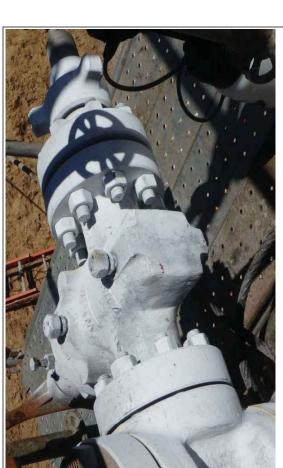
Description: General location of surface anomaly

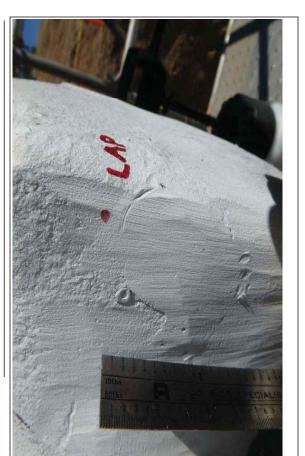
Description: General location of surface anomaly: vertical measurement

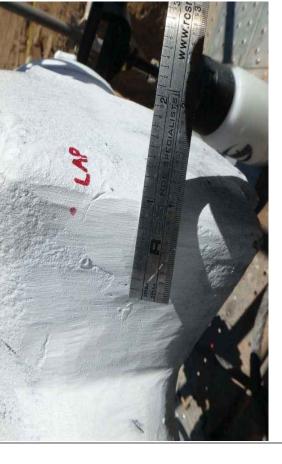
Description: General location of surface anomaly: horizontal measurement

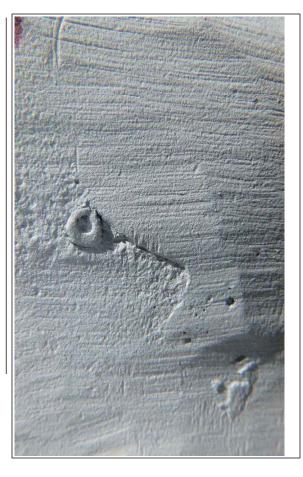
Description: Close-up of surface anomaly

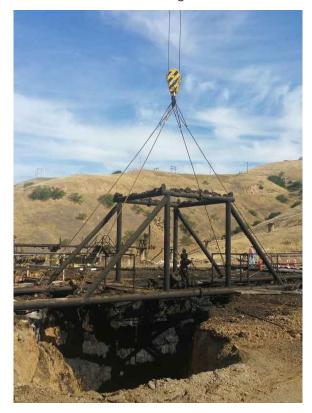
Figure 18: Wellhead Access Bridge On-Site – Obstructing Crater Remediation Access

Further clean-up of the SS-25's site and remediation of the crater required access, which was being obstructed by the wellhead access bridge placed over the crater (Figure 18). R&D Technical Services developed a plan [5] to remove the wellhead access bridge.

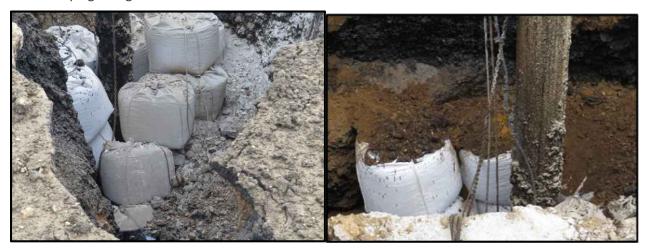
Figure 33: Conductor Appearance Before (Left) and After (Right) Excavation

Figure 33 demonstrates that Super Sack containers successfully protected the Conductor from large falling debris and cuttings from the excavation activity. Super Sack containers were removed after completing the 1:3 slope grading of the crater walls.

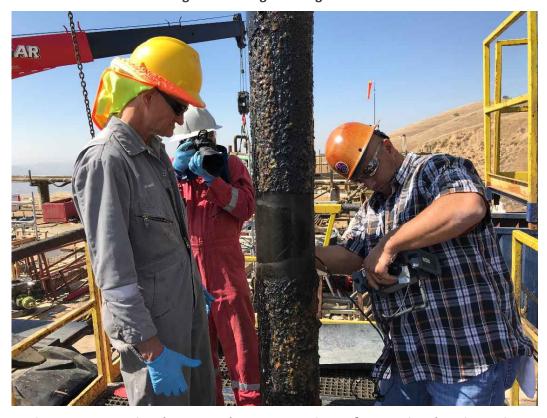
Figure 22: Inspecting the Area Below a Connection Before Cutting the 7 in. Casing

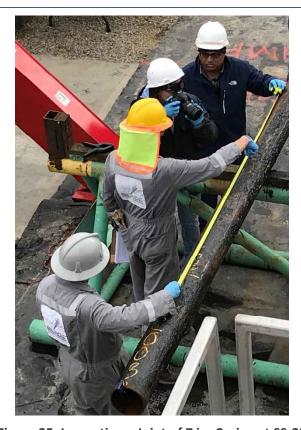
Figure 25: Inspecting a Joint of 7 in. Casing at SS-25

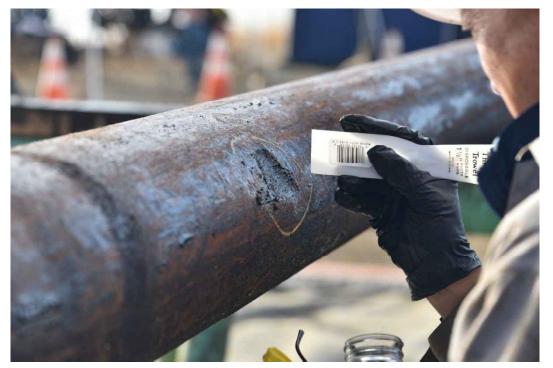
Figure 26: Inspecting and Collecting Scale Sample from a Joint of 7 in. Casing at SS-25

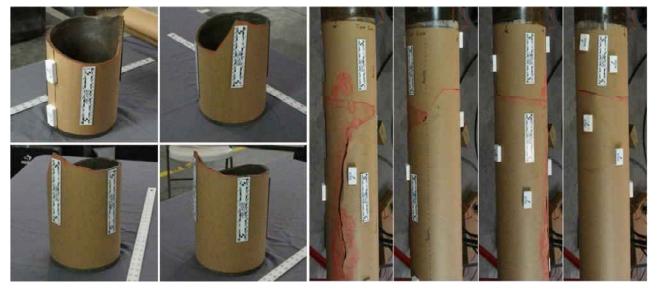
The failure was reconstructed using both segments. The fracture surfaces were traced onto paper and plastic, cut, and positioned back to their original state. The reconstructed failure was then examined for missing pieces. Figure 11 shows the reconstruction of C023A1. The paper outlines the fracture surfaces and captures the bulging associated with the axial rupture. Figure 12 shows the completed paper reconstruction of the upper circumferential parting (C022B) and the lower circumferential parting and axial rupture (C023A1). Corrosion adjacent to the failure was also transferred to the paper for reference. The paper was removed from both casing segments and fitted together to show the original state of the 7 in. casing before the failure. The reconstruction found that all failure pieces were recovered from the well.

Figure 12: Completed Paper Reconstruction of C022B and C023A1

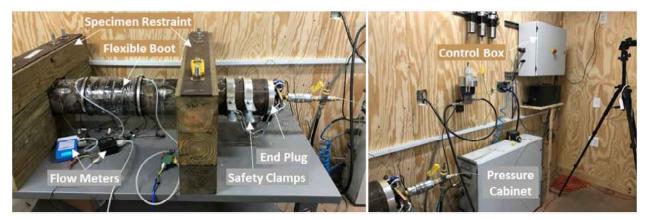
Connection testing showed that nine of the 25 tested connections leaked. Leaking connections included C002B, C004B, C011B, C012B, C016B, C019B, C021B, C023A1C, and C025B. The highest leak rates came from C016B and C023A1C, which leaked at 1,120 SCCM (57 SCFD) and 196 SLM (9,967 SCFD), respectively. The results show that the connections did leak and contributed to the  $11\,3/4\,$  in.  $\times$  7 in. annulus environment. The connection testing report [6] discusses additional tests administered to the connections, including break out and bluing. The results from the supplementary testing are not discussed in this report.

**Figure 22: Connecting Test Setup**
